### Remedial Action Work Plan - East Middle School

# Remedial Action Work Plan

East Middle School

1 October 2023

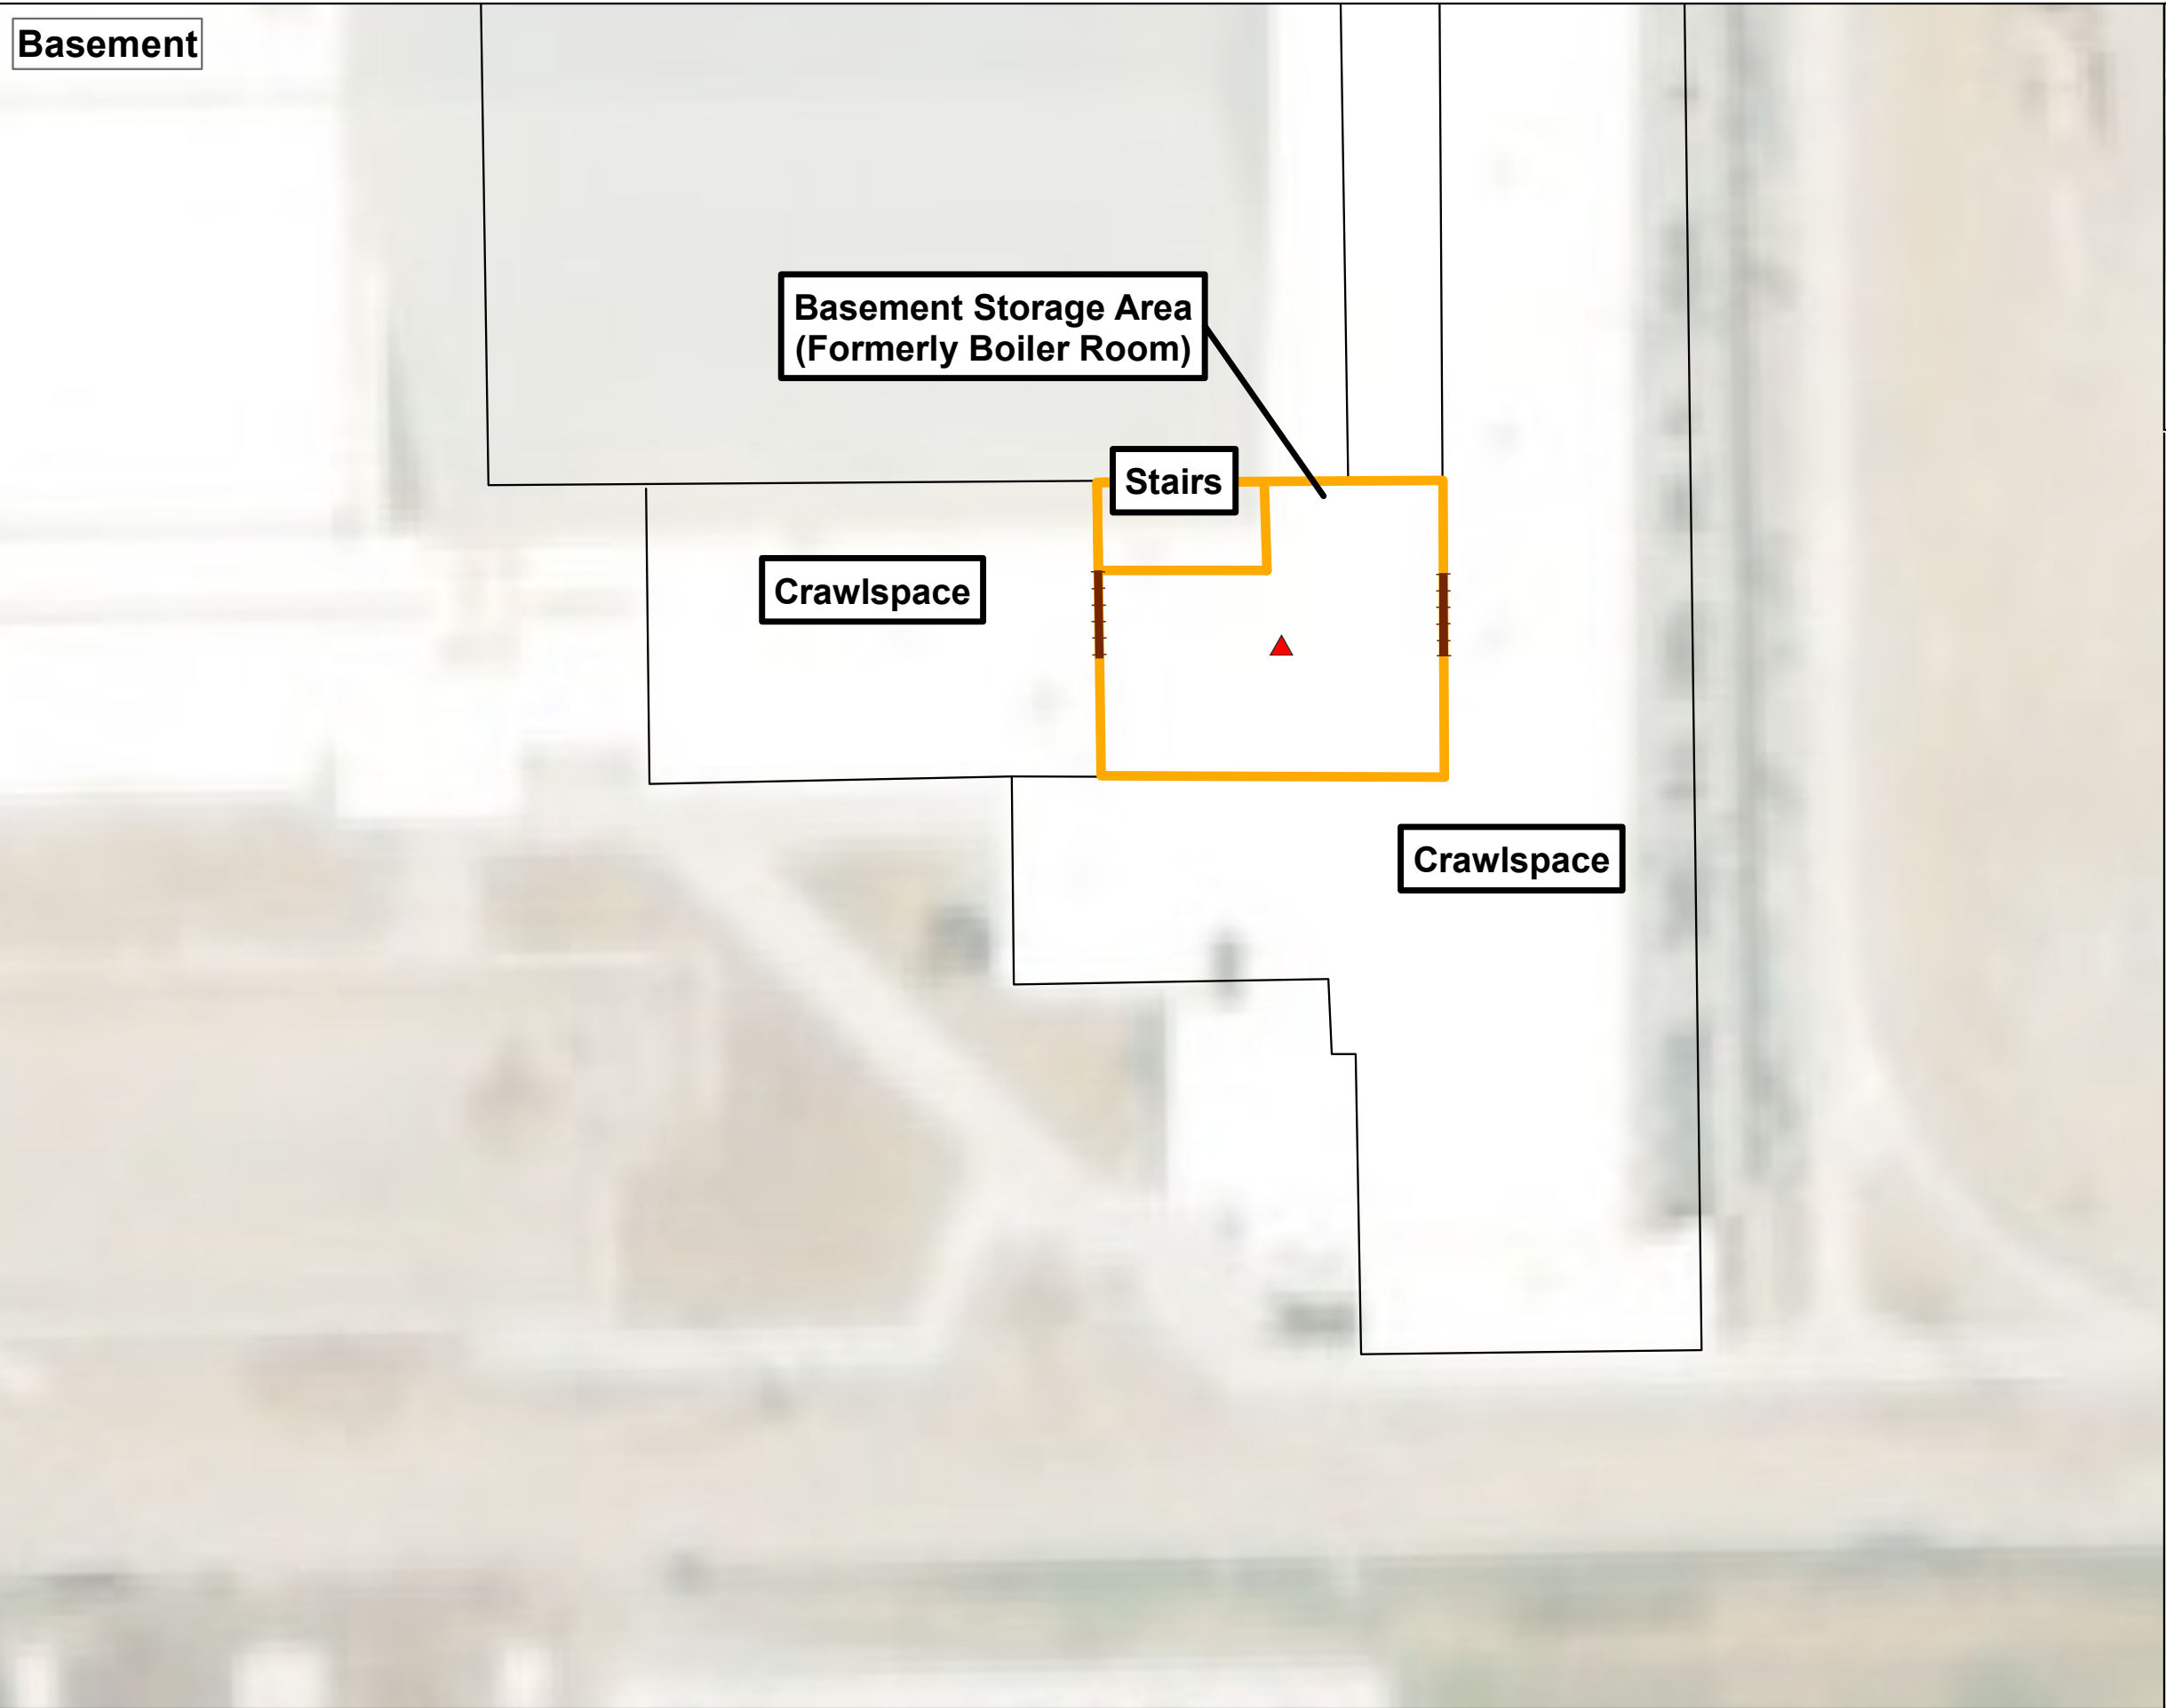
**Figure 2**  
**East Middle School Basement**  
**RA Work Area**  
 2600 Grand Ave  
 Butte, MT 59701

The basement storage area has been previously referred to as the “basement boiler room”, however field sampling efforts have confirmed that it is not a boiler room, but rather serves as a basement storage area. As shown on Table 2, lead was detected in exceedance of the Butte Priority Soils Site-Specific Residential Action Level for surface dust in the floor surface dust sample and associated duplicate sample collected from the basement storage area, prompting the need for remedial action.

Access to the basement storage area is adjacent to the south gym on the first floor. Access is currently restricted to engineering and janitorial staff. The basement storage room consists of an approximately 1,400 square foot rectangular area. The room contains equipment for the upstairs gym, including nets, balls, cones, and other recreational equipment. Steel utility conduits run throughout the basement storage area. There is a crawl space area with exposed soil to the west (no door), and a hallway crawl space with exposed soil through a doorway on the east side. In November 2022, soil from both crawl spaces were sampled, and no constituents were detected above the Butte Priority Soils Site-Specific Residential Action Levels. See Appendix A for photographs of the basement storage area.

School materials (i.e., sporting equipment) stored in the basement storage area will be collected and disposed of accordingly. Large materials will be wrapped in heavy-duty plastic (6-milimeter plastic or similar sheeting that will resist puncture) and placed in a designated waste container. Smaller debris and materials will be placed directly into the designated waste container. After all materials are removed, accumulated dust will be wiped from horizontal surfaces and pipe chases, working from higher to lower surfaces. Following the initial wipe down, a high-efficiency particulate vacuum (HEPA) will be used to clean all surfaces including ceilings, shelves, doors, and floors, again working from higher to lower

Access to the basement storage area and west kitchen storage room will be controlled by securing the entrances. The access door will be securely shut and locked, with access restricted to authorized personnel.

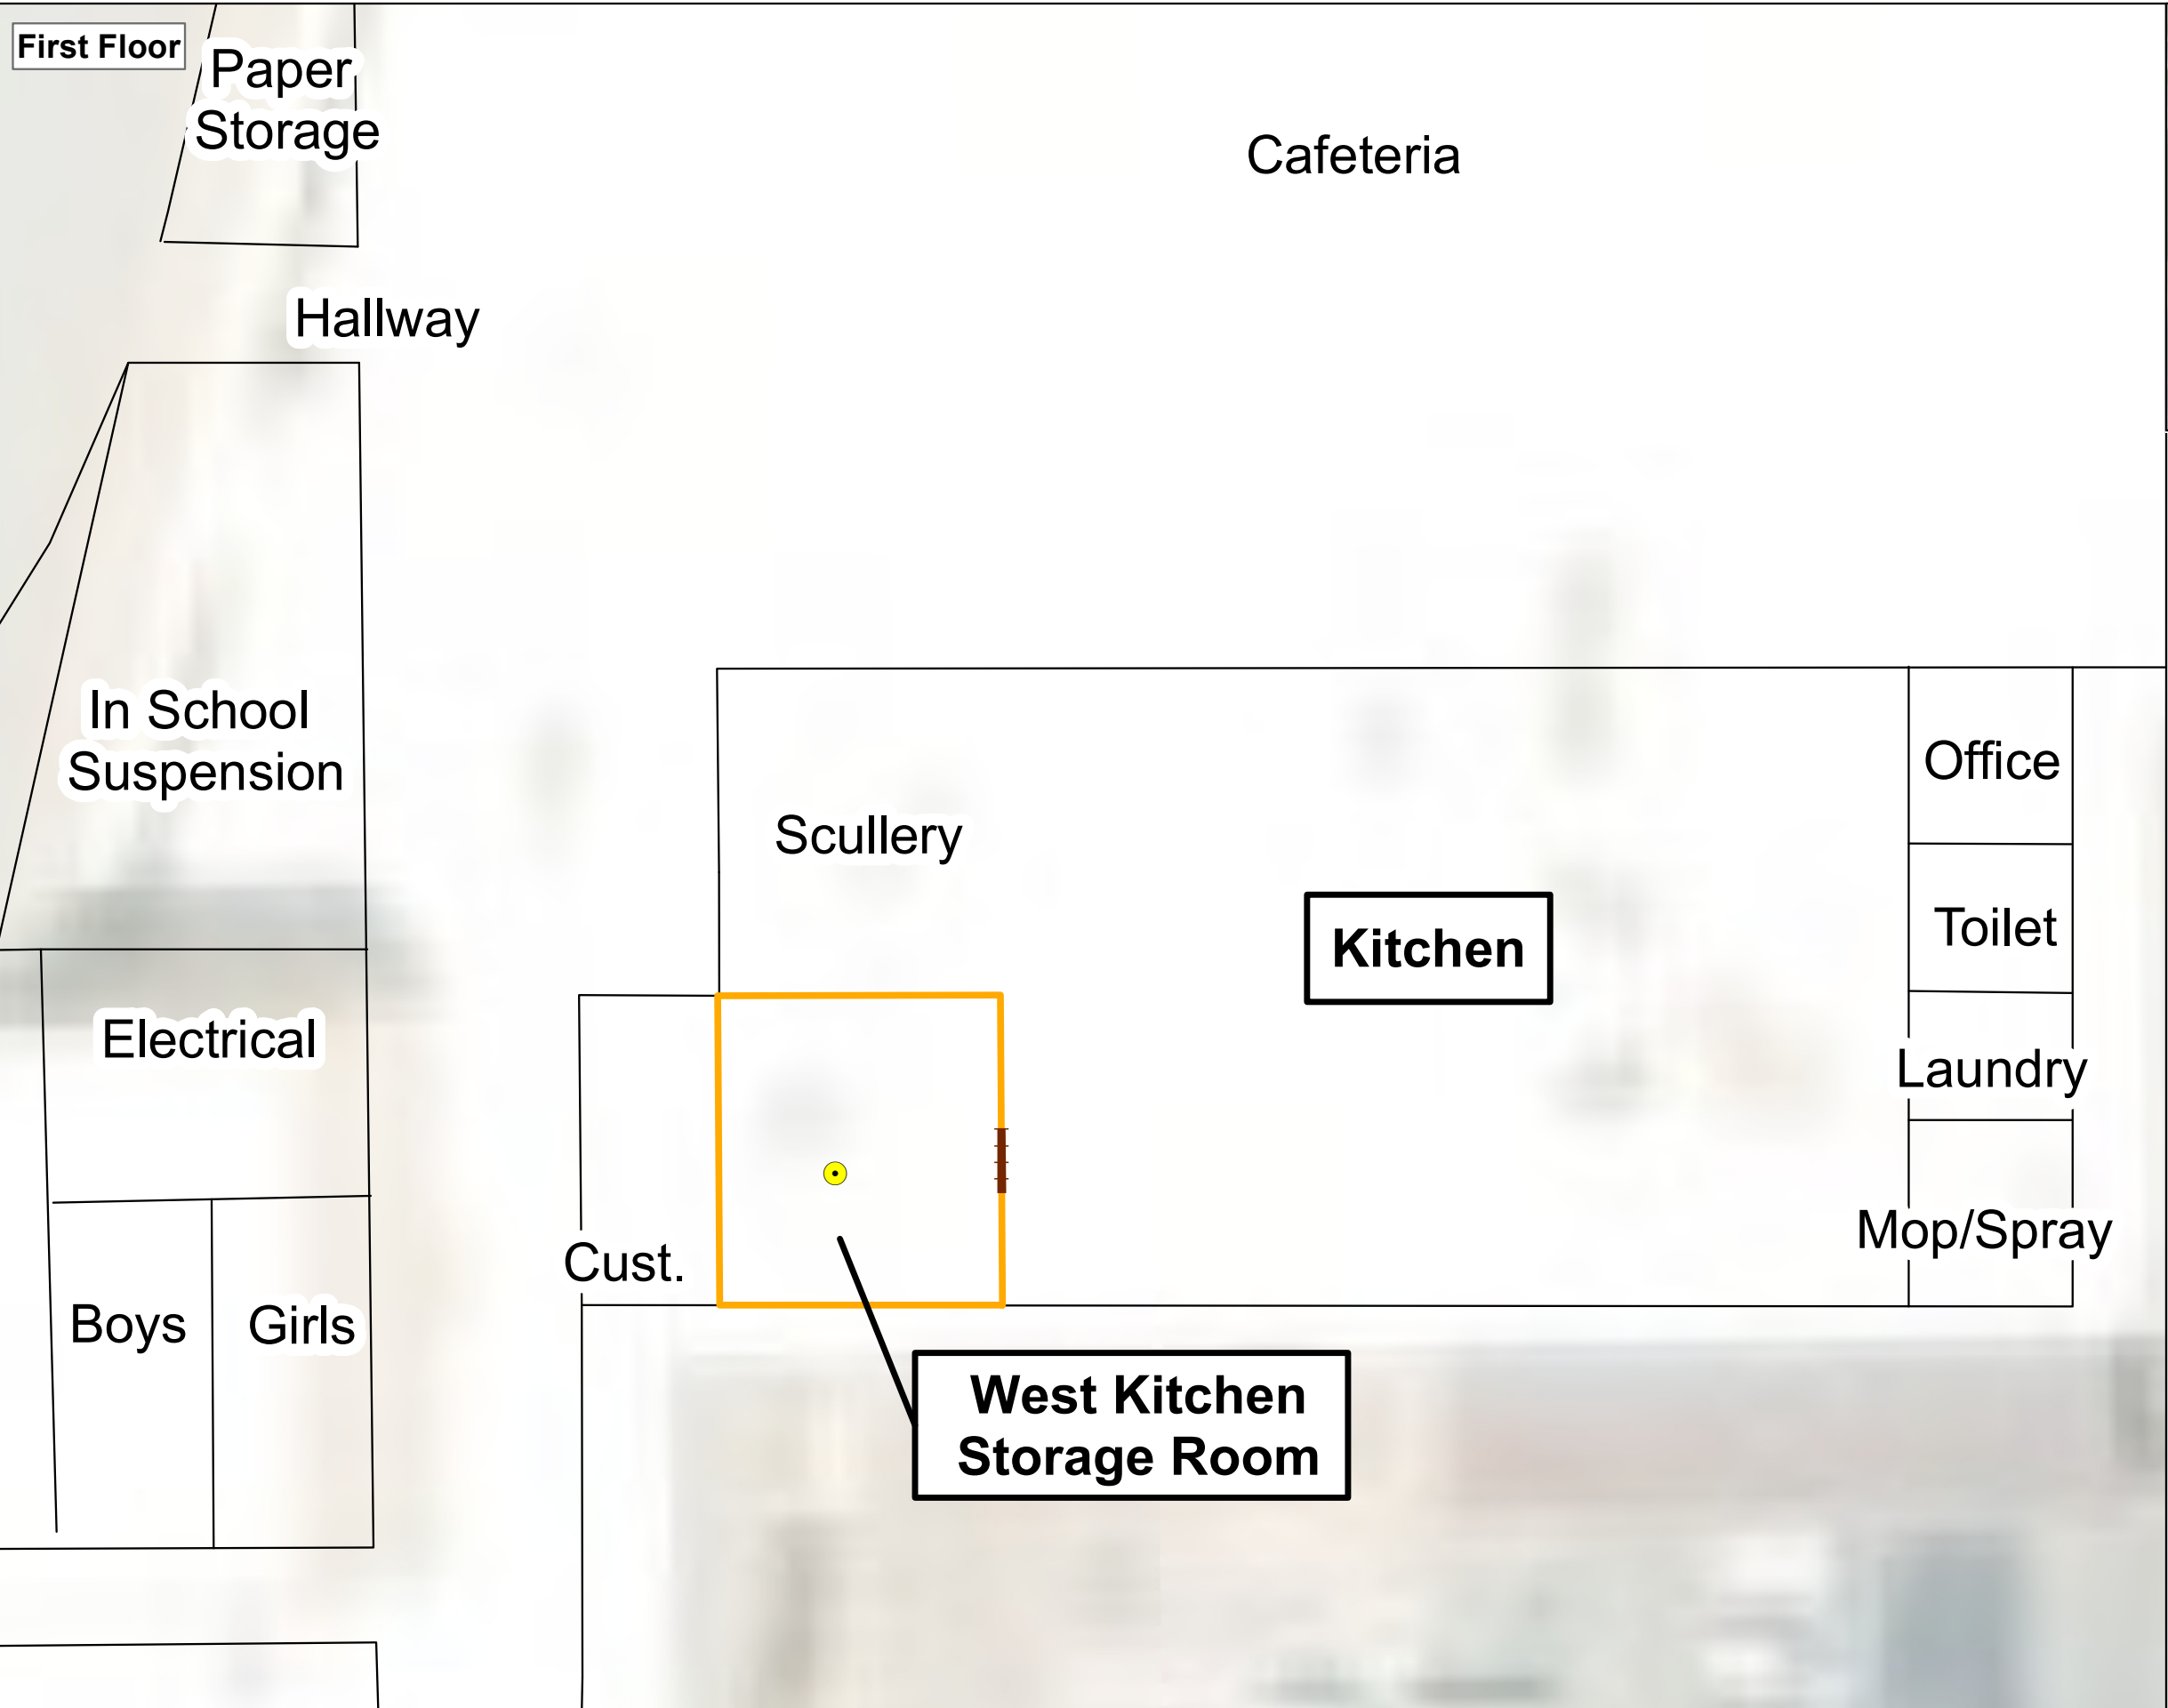
**Figure 3**  
**East Middle School Kitchen**  
**Storage Room RA Work Area**  
2600 Grand Ave  
Butte, MT 59701

The west kitchen storage room is in the west corner of the kitchen, south of the cafeteria. As shown on Table 2, lead was detected in exceedance of the Butte Priority Soils Site-Specific Residential Action Level for surface dust in the micro-vacuum surface dust sample taken from the top of shelves from the kitchen storage room, prompting the need for remedial action.

Access to the kitchen storage room is through the cafeteria on the first floor. The room itself is locked and currently restricted to cafeteria staff. The storage room is an approximately 225 square foot rectangular area. The room contains stainless steel metal cabinets for food storage, food carts, and cash registers. There is a crawl space in the northwest corner, however the pathway is incomplete due to a secured crawlspace access door.

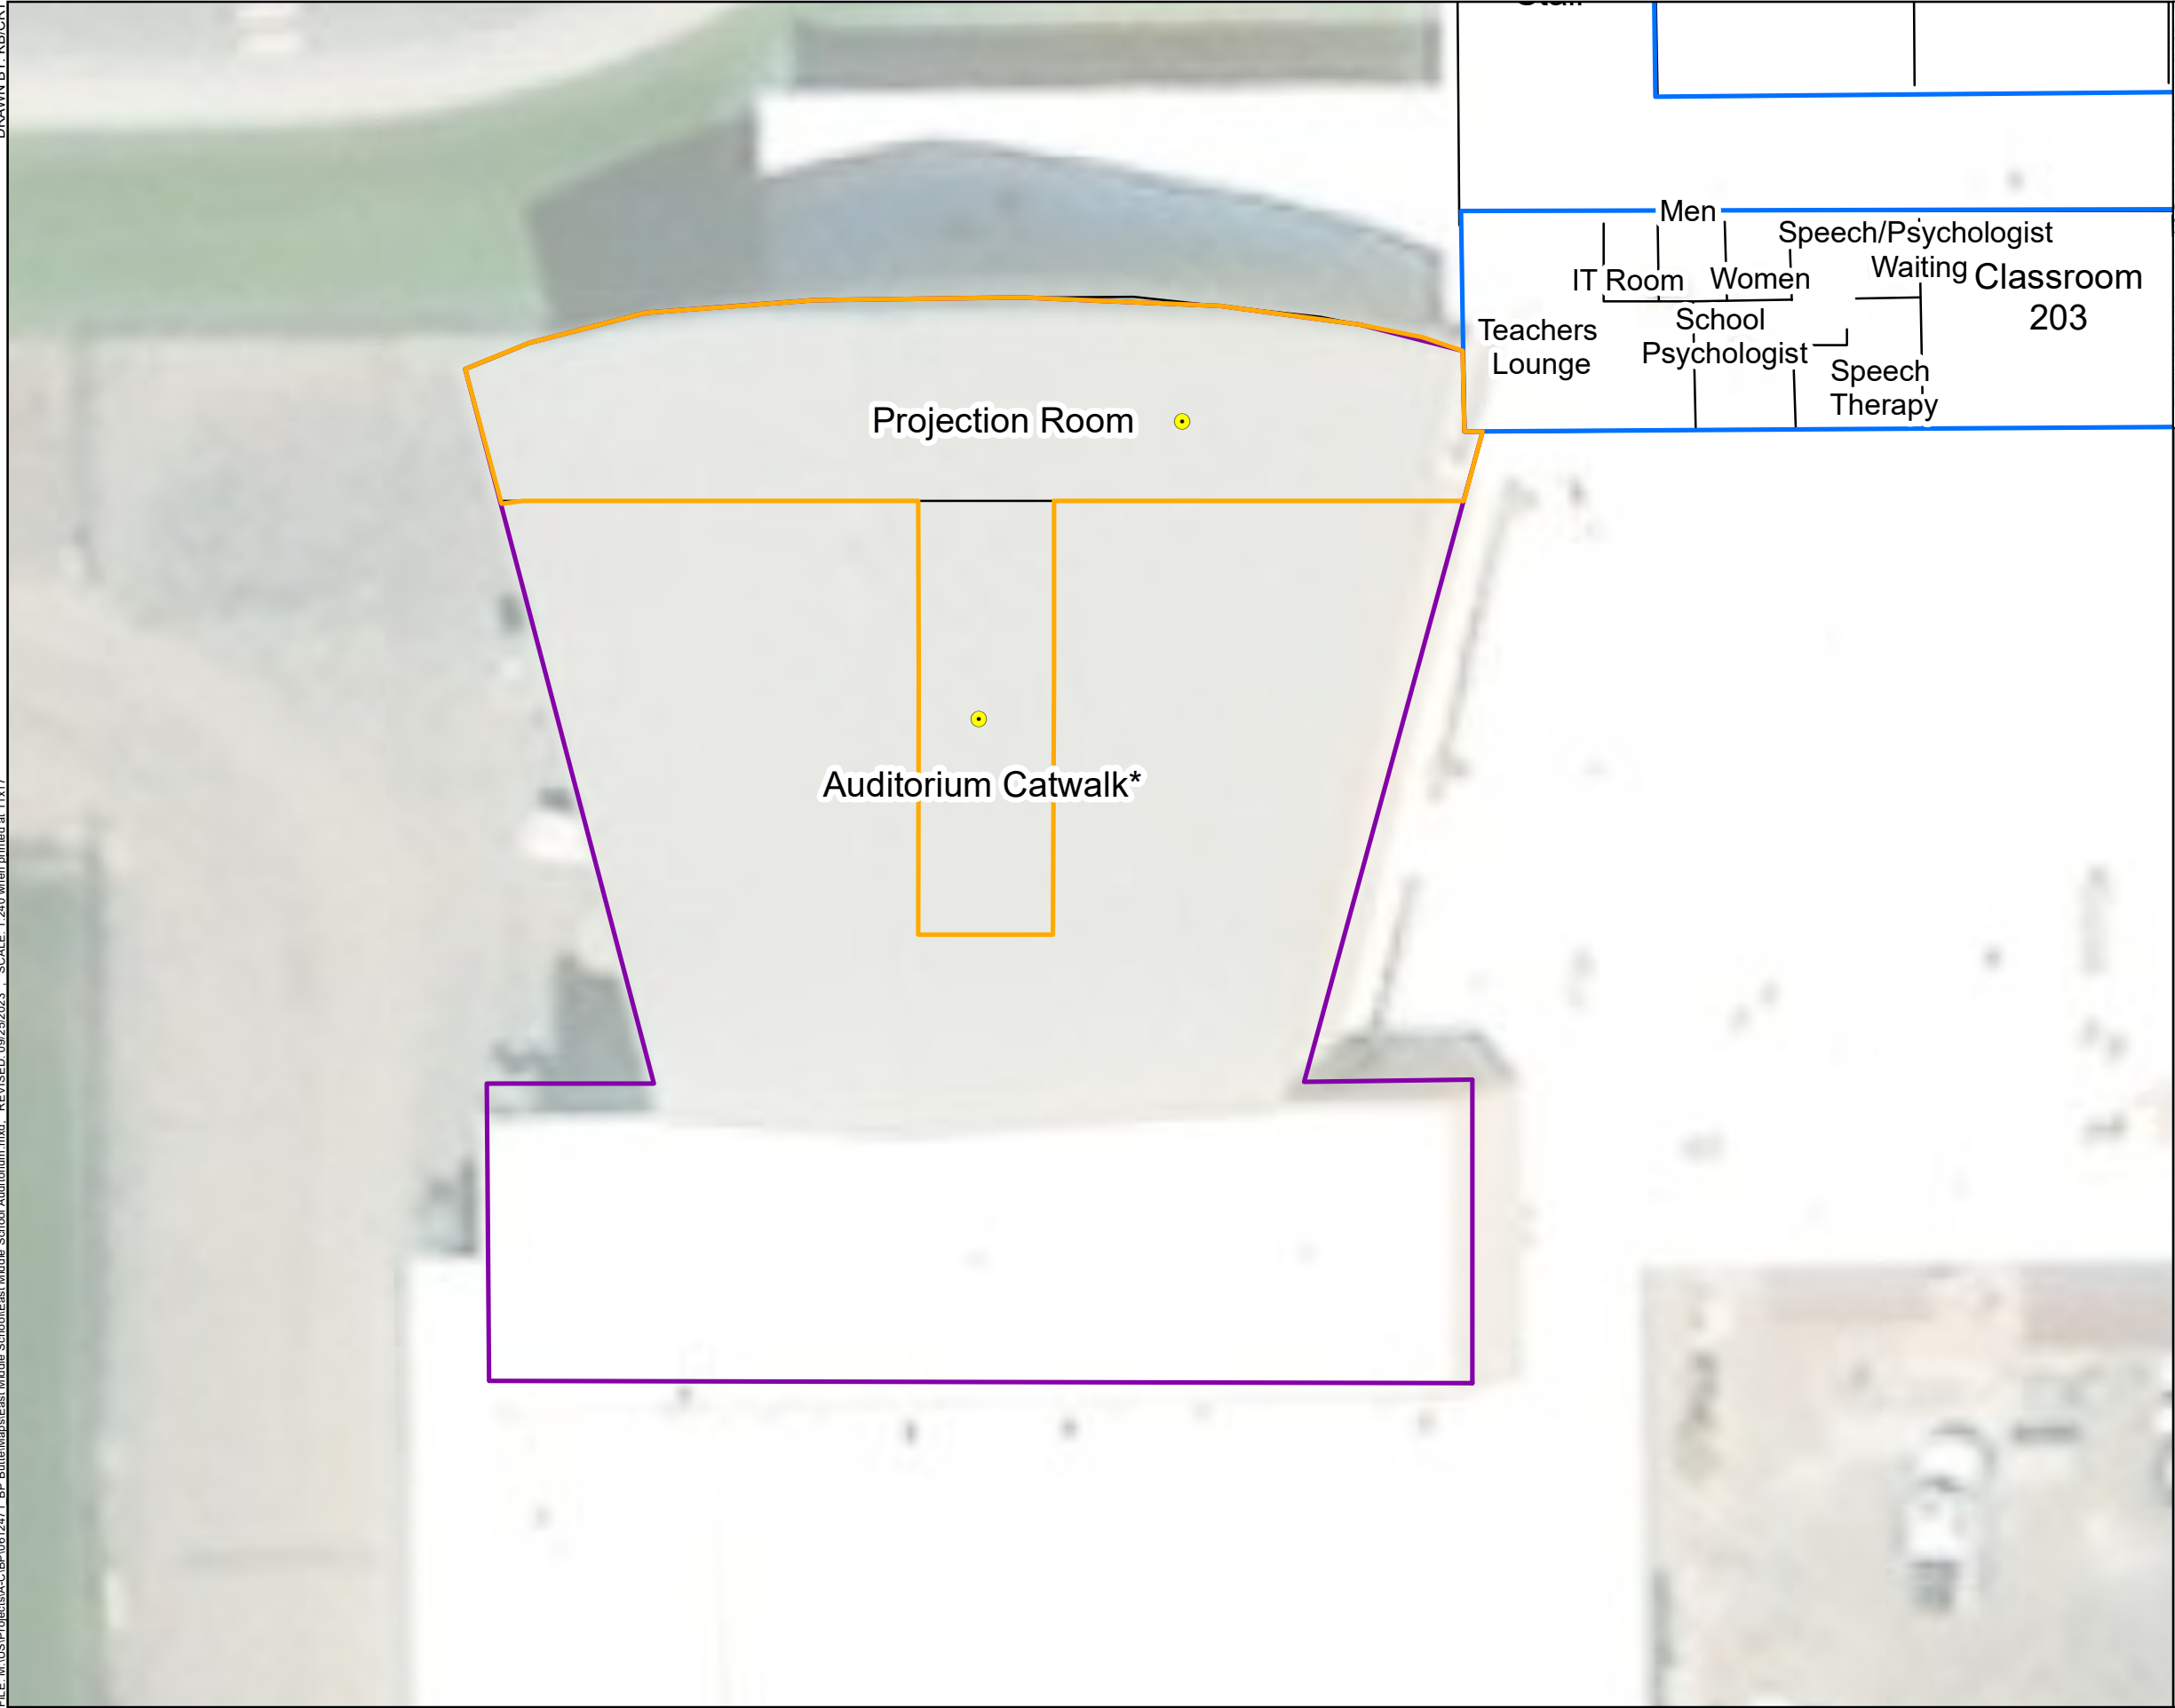
**Figure 4**  
**East Middle School Auditorium**  
**Catwalk RA Work Area**  
 2600 Grand Ave Butte, MT 59701

The auditorium catwalk is located above the auditorium and is accessed through the stage controls/lighting room located at the north end of the auditorium. As shown on Table 2, lead was detected in exceedance of the Butte Priority Soils Site-Specific Residential Action Level for surface dust in the micro-vacuum surface dust sample taken from the catwalk structure (i.e., handrails and baseboards). The entrance to the auditorium catwalk was temporarily sealed and access was restricted in 2022.

Access to the auditorium catwalk will be controlled by securing entrances and applying appropriate signage. A permanent access door will be constructed and installed at the catwalk access point and will be securely shut and locked. Additionally, appropriate signage will be applied to the catwalk access door. Signage will be white, black, and red, with a warning label, "DANGER: DO NOT ENTER HAZARDOUS AREA. AUTHORIZED PERSONS ONLY."

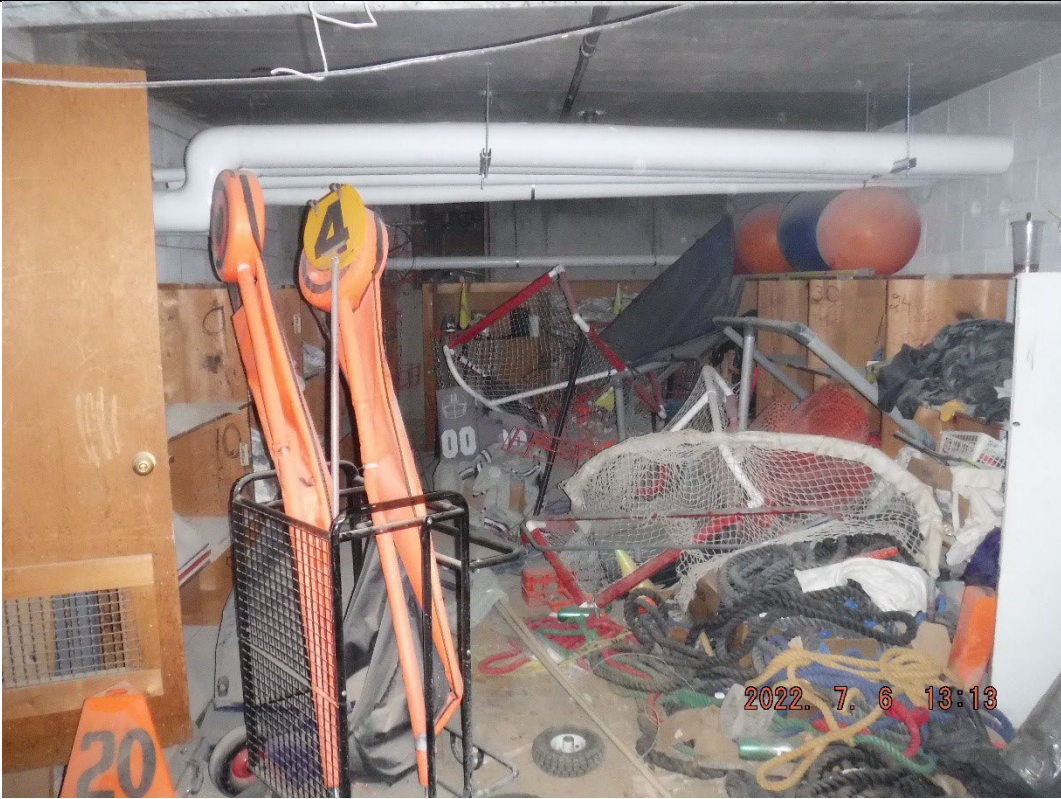
**Photograph: 1** | View of basement storage area, from bottom of stairwell, facing south.

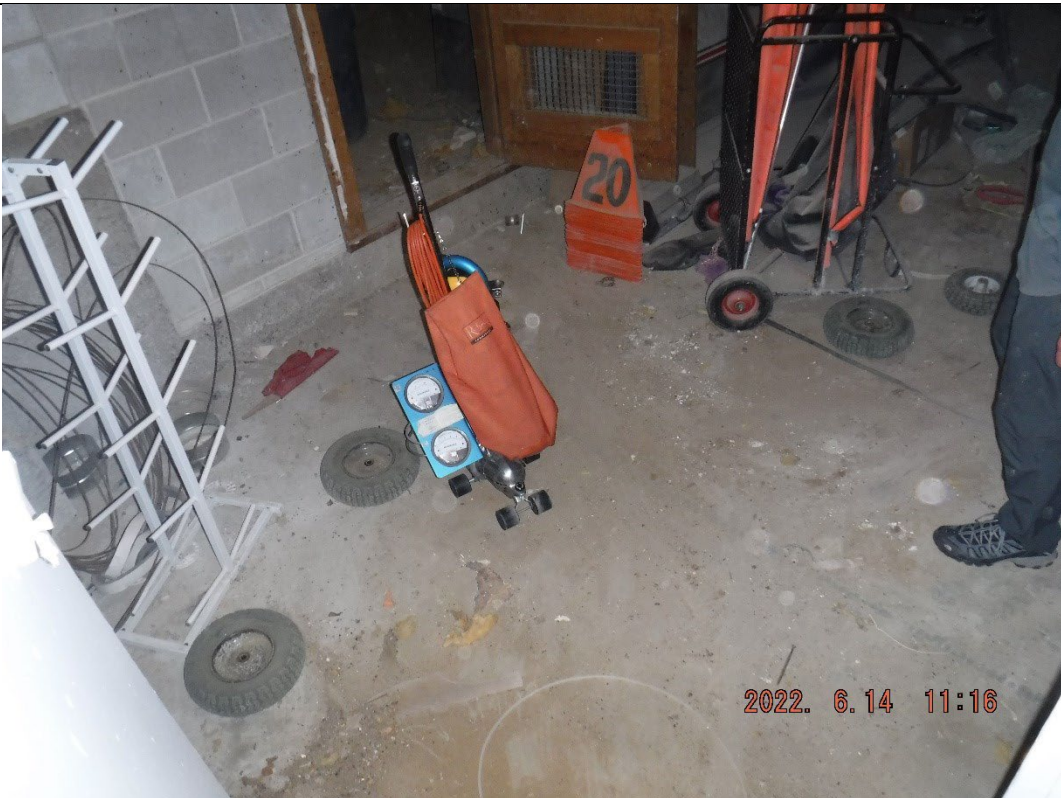
**Photograph: 2** | View of basement storage area floor, facing towards doorway that leads to eastern crawl space, facing southeast.

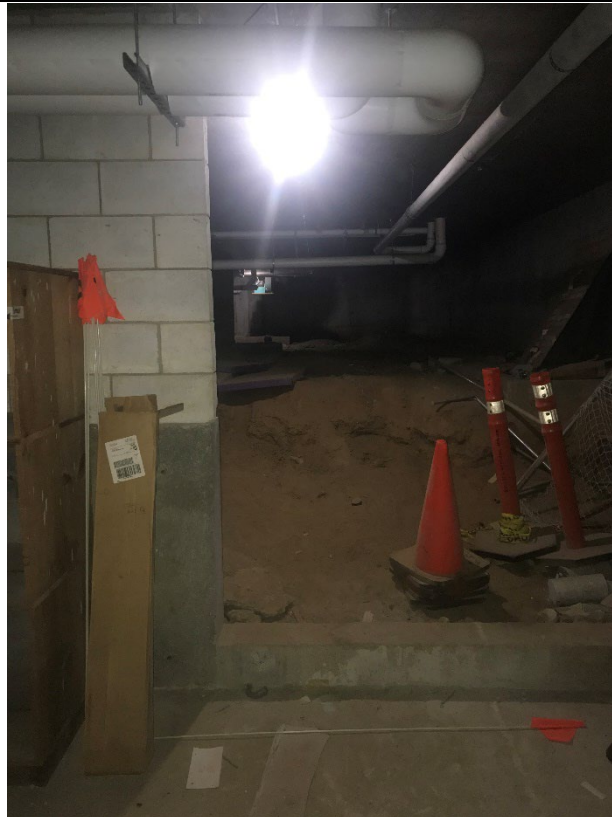
**Photograph: 3** View of entrance to western crawl space, taken from center of basement storage area, facing west.

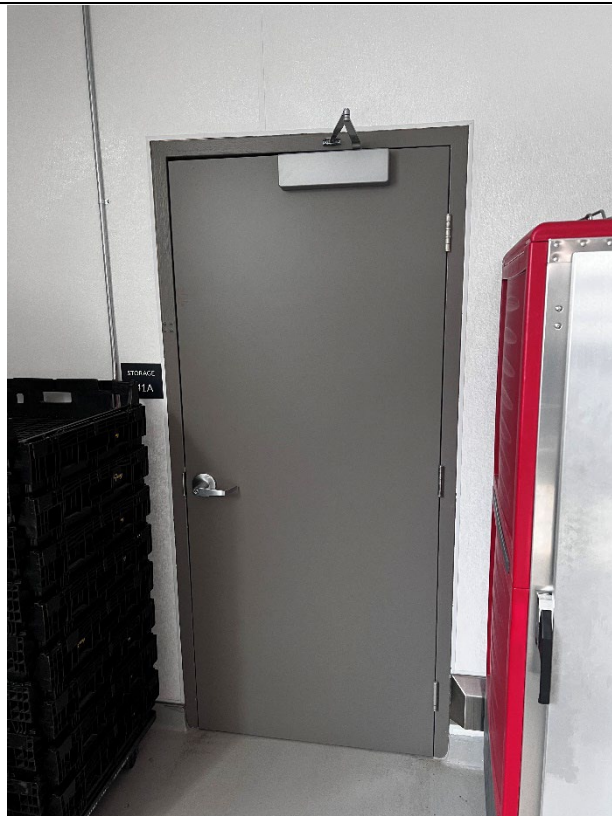
**Photograph: 4** Door in kitchen leading to kitchen storage room. Access to the kitchen storage room is restricted to kitchen staff.

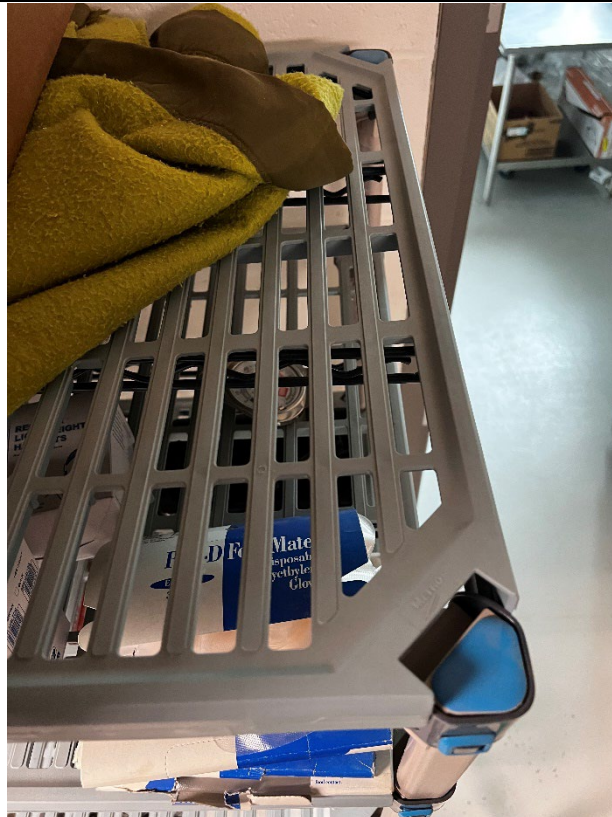
**Photograph: 13** Top of cart near door to the room.

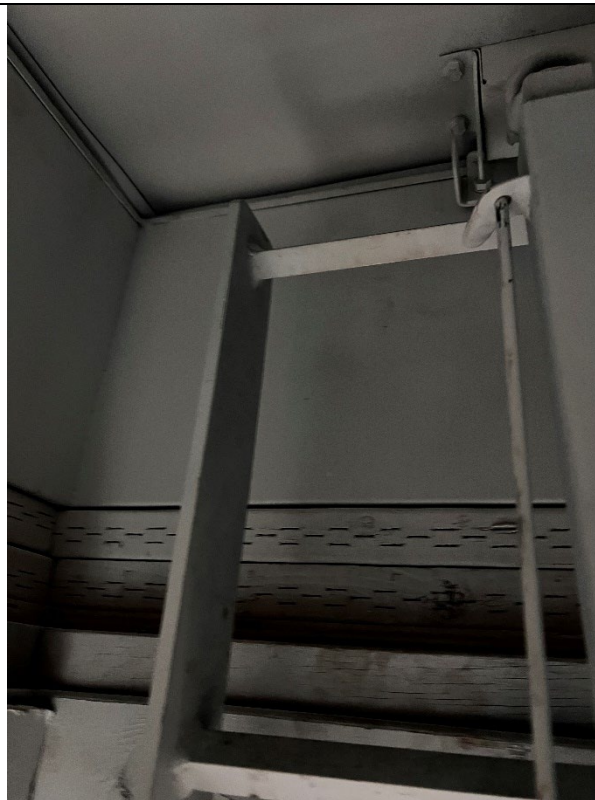
**Photograph: 14** Upper area of roof access point. Note: Little to no traces of dust that was found on top of the sampled cart was found at this location.

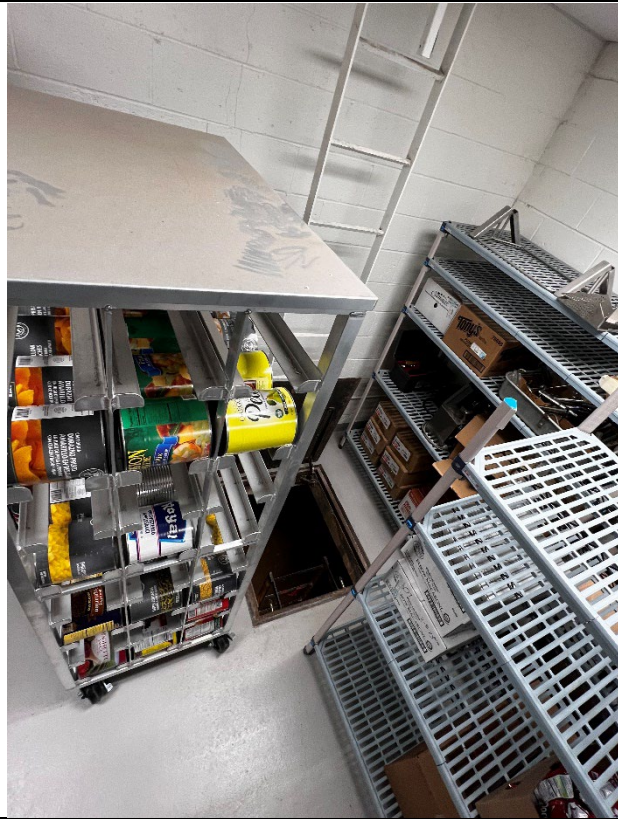
**Photograph: 15** View of crawl space access opened, taken from middle of storage room.

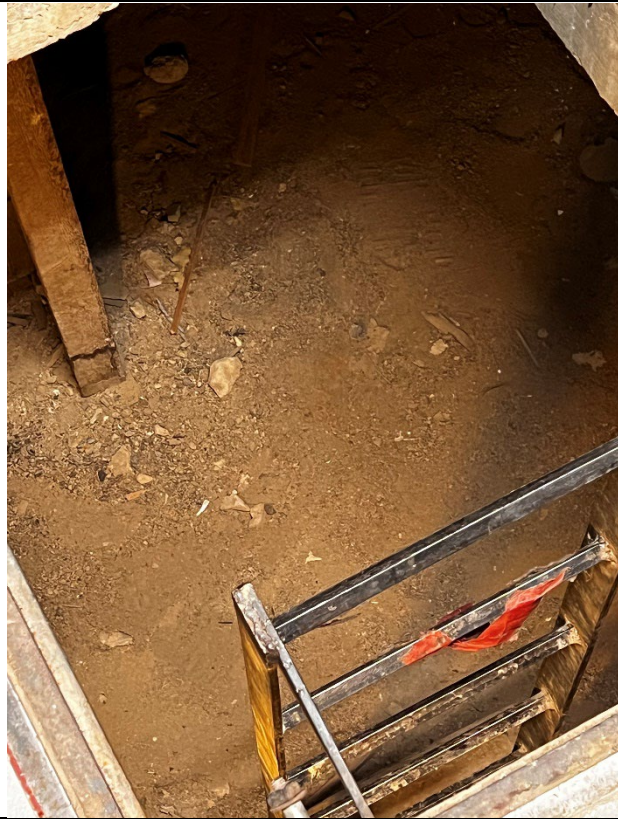
**Photograph: 17** Earthen floor of crawl space.
