# Integrated assessment of the buried wreck site of the Dutch East Indiaman 't Vliegende Hart

Tine Missiaen<sup>1</sup>, Ine Demerre<sup>2</sup> & Valentine Verrijken<sup>3</sup>

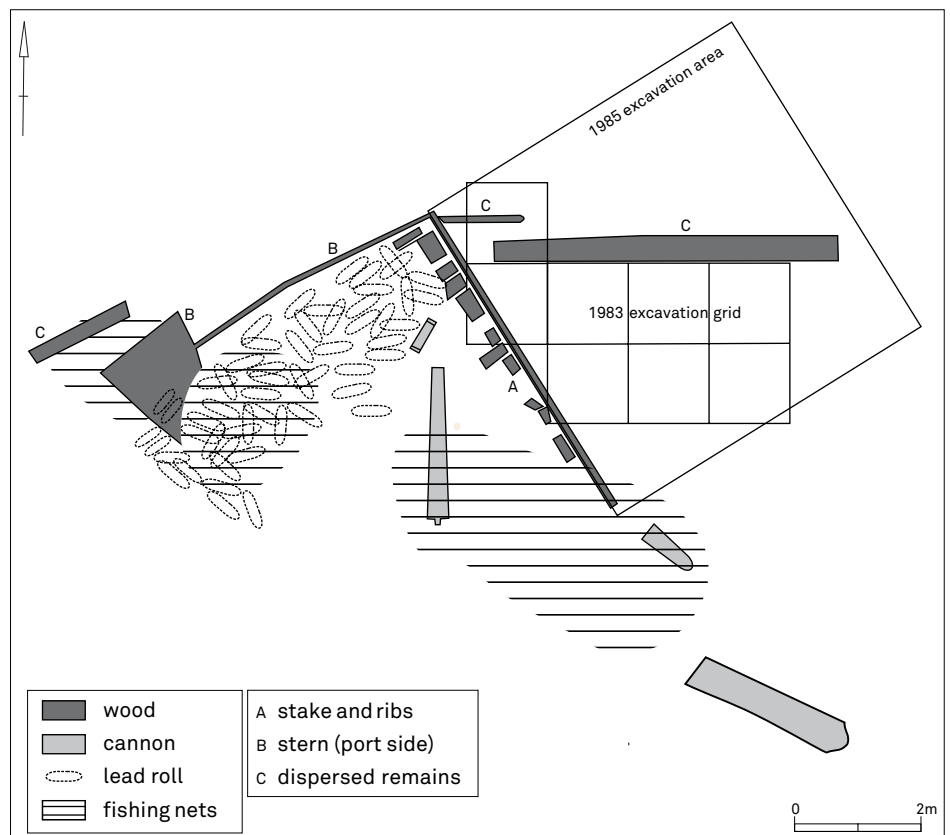
Structural fragments found in 1983 included remains of the stern and hull on the port side (fig. 5). They can most likely be linked to the lower hold of the ship. The fragments indicate that the stern lays inclined to the port side at an angle of 55 degrees<sup>40</sup>. Further to the southeast three cannons, various lead rolls and fishing nets were found (fig. 5). The western side of the wreck site showed an abrupt slope, while towards the east the slope was more gentle<sup>41</sup>.

An area of roughly 3x6 m was excavated down to 1 m depth (fig. 5); no dispersed material was observed north of this area. Similar to 1981 the shallow sediments consisted of a thin surface layer of sandy silt overlaying sandy-clayey deposits marked by a hard shell layer at the bottom. Most likely this layer can be linked to the upper Holocene unit described by Mathys<sup>42</sup>. Most of the artefacts were found in the underlying clay layer (<0.5 m thick), which seems to suggest that the ship sunk to this layer at the time of the wreckage<sup>43</sup>.

**FIG. 5** Remains of *'t Vliegende Hart* wreck site observed during diving investigations in 1983 (after Gawronski & Kist 1984). Structural fragments include a.o. wooden fragments of the stern (B) and hull (A). Nearby also several cannons and a large number of lead rolls were found, partly covered by fishing nets. The 1985 excavation area is also shown on the right (after Sills Consortium Recoveries Ltd 1985). *Overblijfselen van het wrak van 't Vliegende Hart zoals blootgelegd tijdens het duikonderzoek in 1983 (naar Gawronski & Kist 1984). Houten fragmenten van de opbouw zijn o.a. afkomstig van de achtersteven (B) en de scheepsromp (A). Vlakbij werden ook een paar kanonnen en een groot aantal loden ballastrollen gevonden, gedeeltelijk bedekt door vissersnetten. Het opgravingsgebied uit 1985 is ook aangeduid rechts (naar Sills Consortium Recoveries Ltd 1985).*

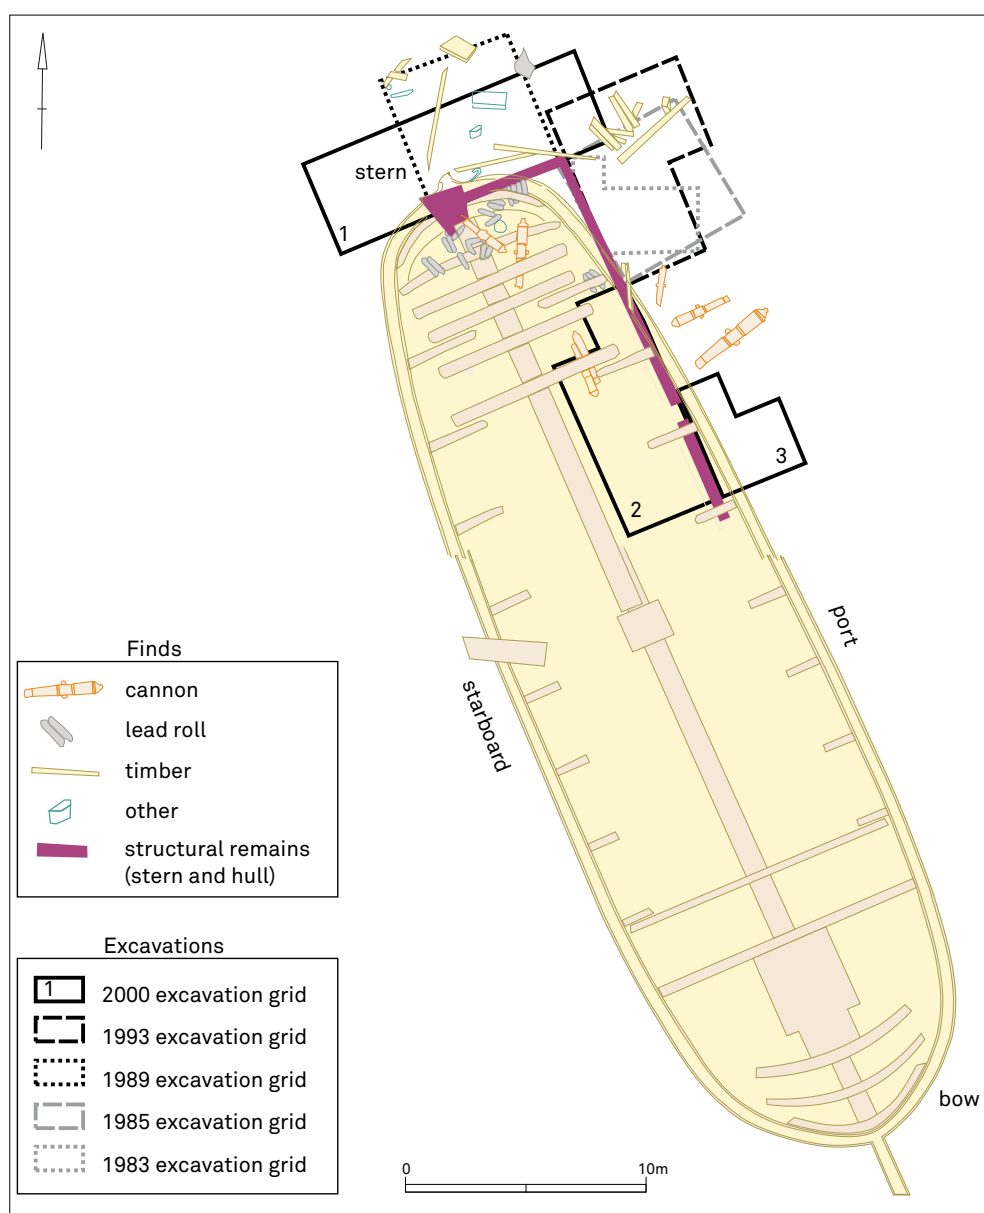
In 2000 three extra trenches were excavated near the sternpost and on the port side of the wreck (see fig. 6)<sup>51</sup>. The excavated areas were located both inside and outside of the wreck structure. The results confirm that the main stern remains are located between the sternpost and the port side. There seems to be no indication of a collapse of the port side to the east. The inclined sternpost protruded roughly 0.5 m above the surrounding seabed. Fishing nets, chains and ropes were found tangled around the sternpost. The structural remains of the hull confirmed the large gap roughly 12 m south of the stern<sup>52</sup>.

**FIG. 6** Schematic drawing of the wreck based on historical drawings and excavation works in 1988-1993 (after 3H Consulting Ltd 2005). Different finds are indicated. Black and grey rectangles mark the trenches excavated in 1983, 1985, 1989, 1993 and 2000 (trench 1, 2 and 3). The structural remains of the stern and hull are marked in purple.

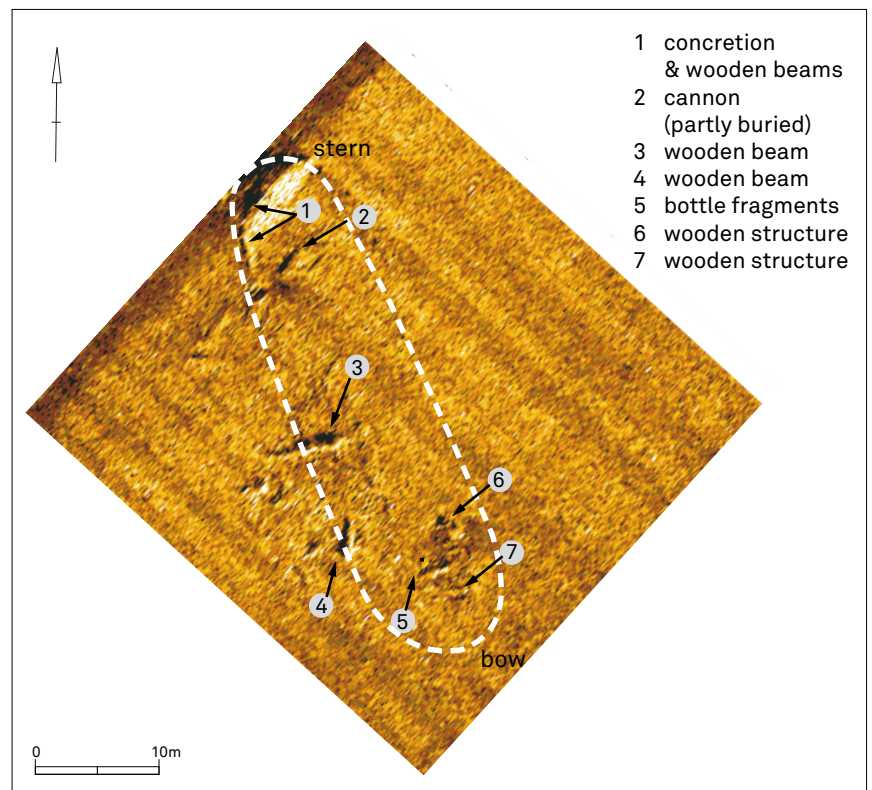
**FIG. 7** Side-scan sonar image obtained in 2009 from the 't Vliegent Hart wreck site (courtesy by RCMG). The dotted line marks the (supposed) outline of the ship based on 1993 data (see fig. 6). The stern remains stand out clearly at the top. Different smaller fragments protruding from the seabed are observed near the bow. Elongated features are most likely due to wooden beams or cannons. Numbered arrows refer to some of the wreck remnants observed in 2010 (see fig. 9).

Many of the wreck remains observed on the seabed in 2010 correspond well with prominent features on the side-scan and multibeam data from 2009 (see numbered arrows in figs. 7 and 8), but in some cases no match was found. The diving surveys in August and September 2010 also revealed larger parts of timber than in June. This further confirms the fact that the site is sub-

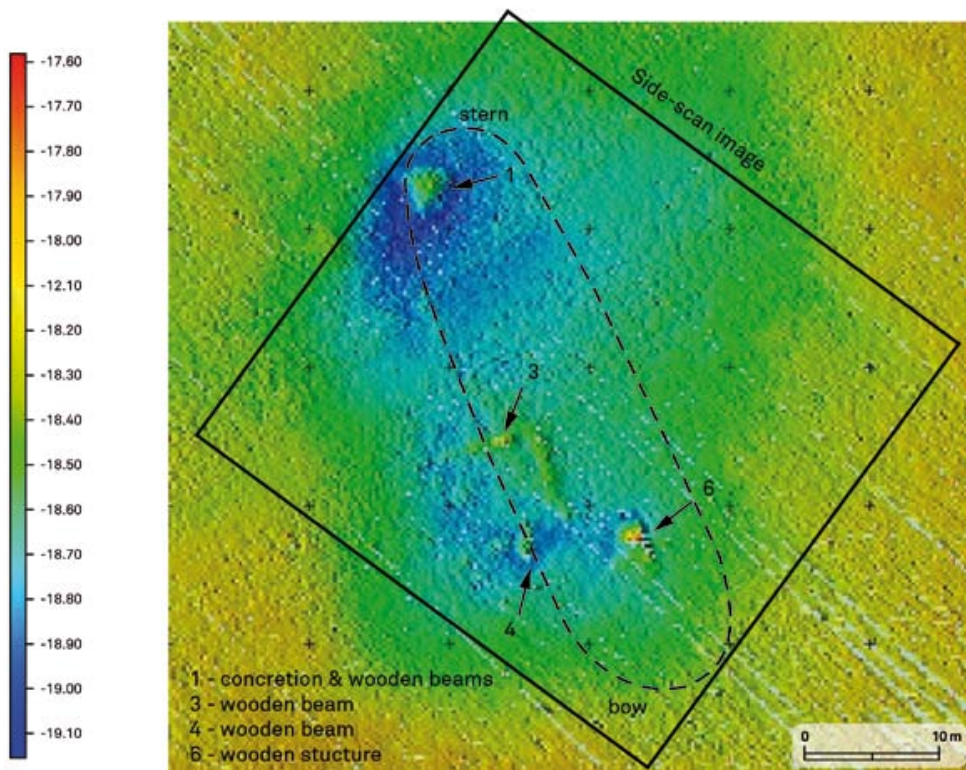
**FIG. 8** Multibeam image obtained in 2009 from the 't Vliegende Hart wreck site (courtesy by MDK - Afdeling Kust - Vlaamse Hydrografie). Depth in m MLLWS (Mean Lowest Low Water level at Spring tide). The dotted line marks the (supposed) outline of the ship based on 1993 data (see fig. 6). Only few protruding wreck fragments are observed. Elongated features are most likely due to wooden beams or cannons. The stern remains stand out clearly. Numbered arrows refer to some of the wreck remnants observed in 2010 (see also fig. 9).

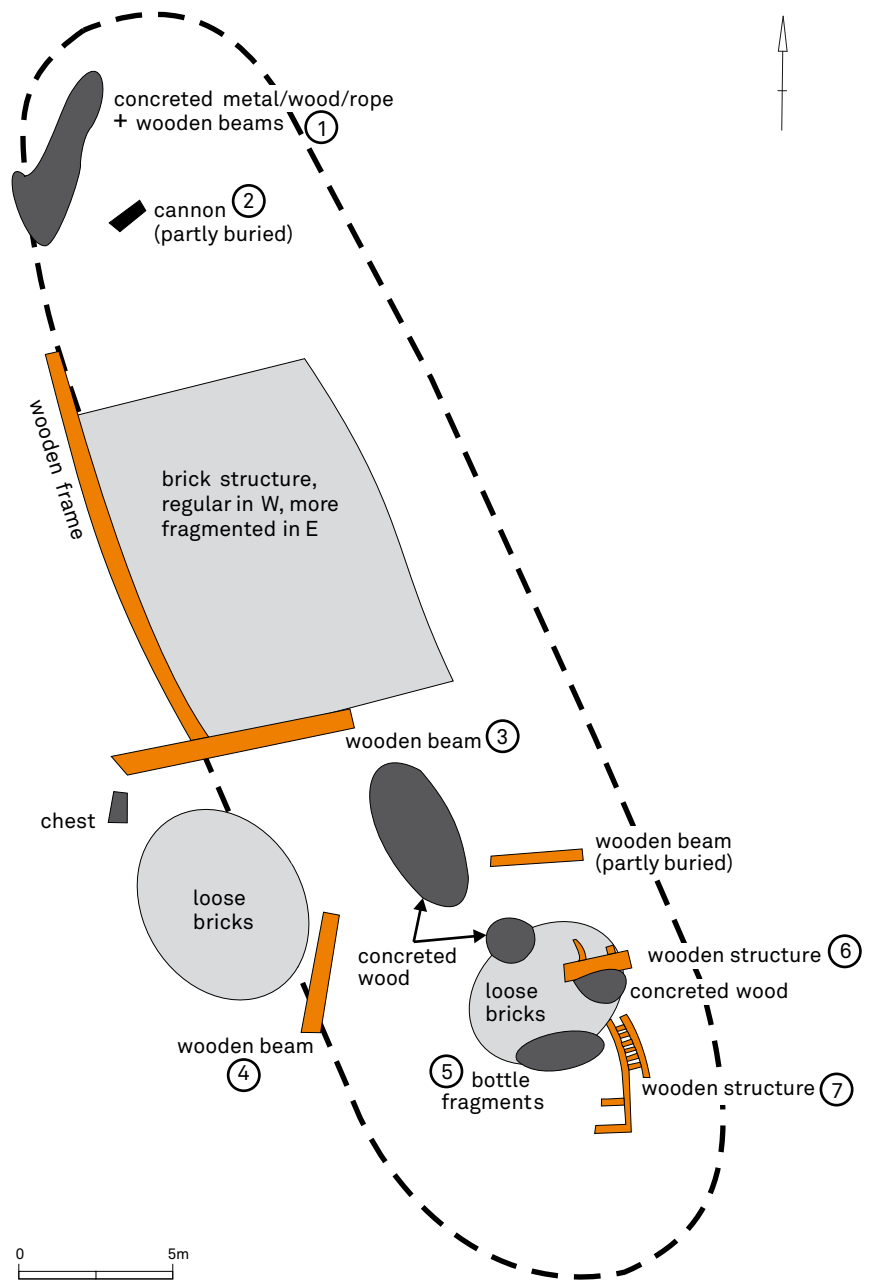
The results indicate the presence of a number of scattered wreck remains on the seabed over a length of 37 m. A schematic overview of the exposed wreck remains observed in 2010 is presented in figure 9. In the northwest a partly buried cannon was observed adjacent to a large elevation (also clearly visible on side-scan and multibeam data) with metal concretions but also wood, rope (presumably remains of old fishing nets) and sediment. This concretion is bound on the northwest side by two sloping wooden timbers. Most likely the timber could be related to part of the stern. These results are consistent with previous diving observations (1983, 2000) revealing wood constructions, fishing nets, ropes and concretions in this area as well as several cannons<sup>56</sup>. However this time no structural remains of the sternpost and adjoining hull were observed on the port side. This is not so surprising since these remains were chiefly found below the seabed after careful excavation.

More importantly, the 2010 diving investigations also revealed structural remains of timber and large beams in the southeast, towards the bow. The most northern feature in that area is part of a large wooden beam, concreted together with smaller wooden fragments and with an elevation of up to 0.5 m above the sea floor. It matches well with the sharp protruding feature (nr. 6) observed on the multibeam images (fig. 8) and the side-scan data (fig. 7). This feature could not yet be identified. Its size might however suggest it is part of a crossbeam of the ship. The most southern wooden structure consists of two long wooden beams following the length of the interpreted wreck orientation. In between is a series of wooden planking, superimposing the western beam and underlying the eastern beam and lined up very close to one another. The latter seems to suggest that we are dealing with hull or ceiling planking, nearing the end of the hull structure, either near the keel or the bow of the ship. The other two beams might be part of floor timbers.

**FIG. 9** Schematic drawing of the wreck and structural remains exposed during diving investigations in 2010. The dotted line marks the (supposed) outline of the ship based on 1993 data (see fig. 6). Numbers refer to marked features observed on the 2009 side-scan and multibeam data (see figs. 7-8).

Further to the north, an elongated structure of over 10 m long with regularly aligned bricks was observed. Although the exact position of this structure is still liable to some uncertainty (due to the limited survey and insufficient georeference), it can most likely be linked to the brick layers observed in 2000 (see section 3.3). The assembly of loose bricks is regularly aligned in the length of the wreck (resembling a turned over wall) and is likely the ship's ballast, probably combined with a function as cargo of building material. The western edge of the brick area is bounded

by wooden timbers sticking out of the sediment which seem to indicate remaining parts of the hull structure (hull planking - floor timbers or futtock and ceiling planking) on starboard side where the bricks were stacked. Towards the east the brick structure becomes increasingly irregular. South of the main brick area, on the starboard side, a concreted regular (tool?) box and a long and broad wood concreted beam (possibly one of the riders of the ship) were observed. The latter corresponds well with the elongated feature clearly visible on the multibeam and side-scan data (figs. 7 and 8, feature nr. 3).

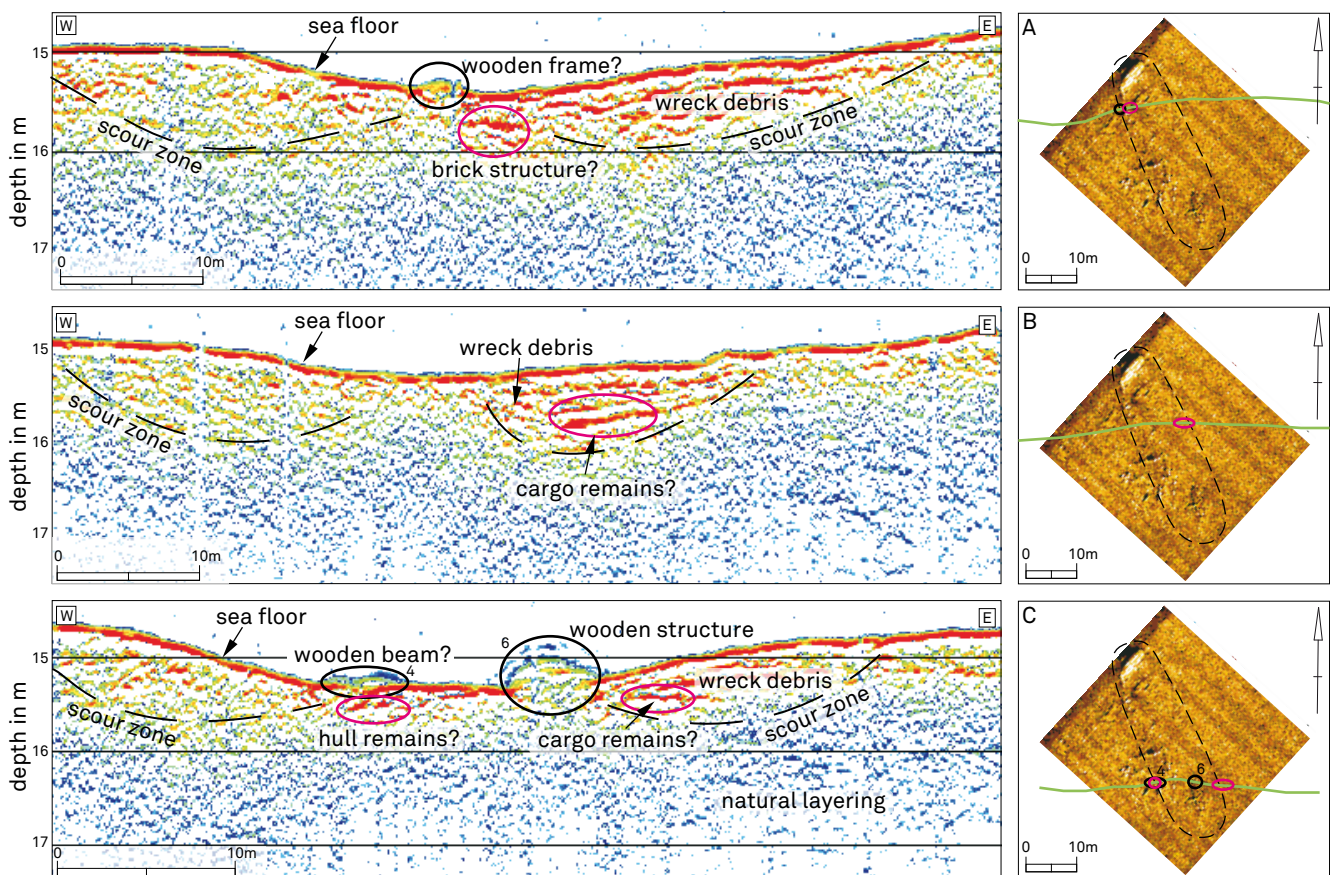
**FIG. 11** Seismic profiles crossing the wreck site roughly W-E. Black circles = exposed objects; red circles = buried wreck remains (numbers refer to fig. 9). Two scour fill zones, west (starboard) and east (port) of the wreck, can be observed. Discontinuous shallow reflectors on the east are most likely related to scattered wreck debris. The high-amplitude reflectors on the port side are probably related to the brick cargo (profiles B & C). Possible small hull remnants are observed on the starboard side (profiles A & C). Exposed objects are seen either as large diffractions (profile C) or as small side-reflections (profiles A & C).

East of the port side the shallow geology is marked by an infilling stratigraphy with discontinuous reflectors (fig. 11). Most likely these reflectors can be linked to sediment layers containing various wreck debris. The infill sequence has a maximum depth of 1.2 m and extends up to 15–20 m from the port side (fig. 13). The latter is probably a direct result of the inclination of the wreck, which caused the wreck debris to be spilled over a large distance on the port side. The eastern boundary coincides roughly with the limit of the shallow depression in the seabed that surrounds the wreck (fig. 13). Similar to the western starboard side, most likely also this eastern infilling zone can be linked to scouring processes when the wreck was still (partly) exposed.

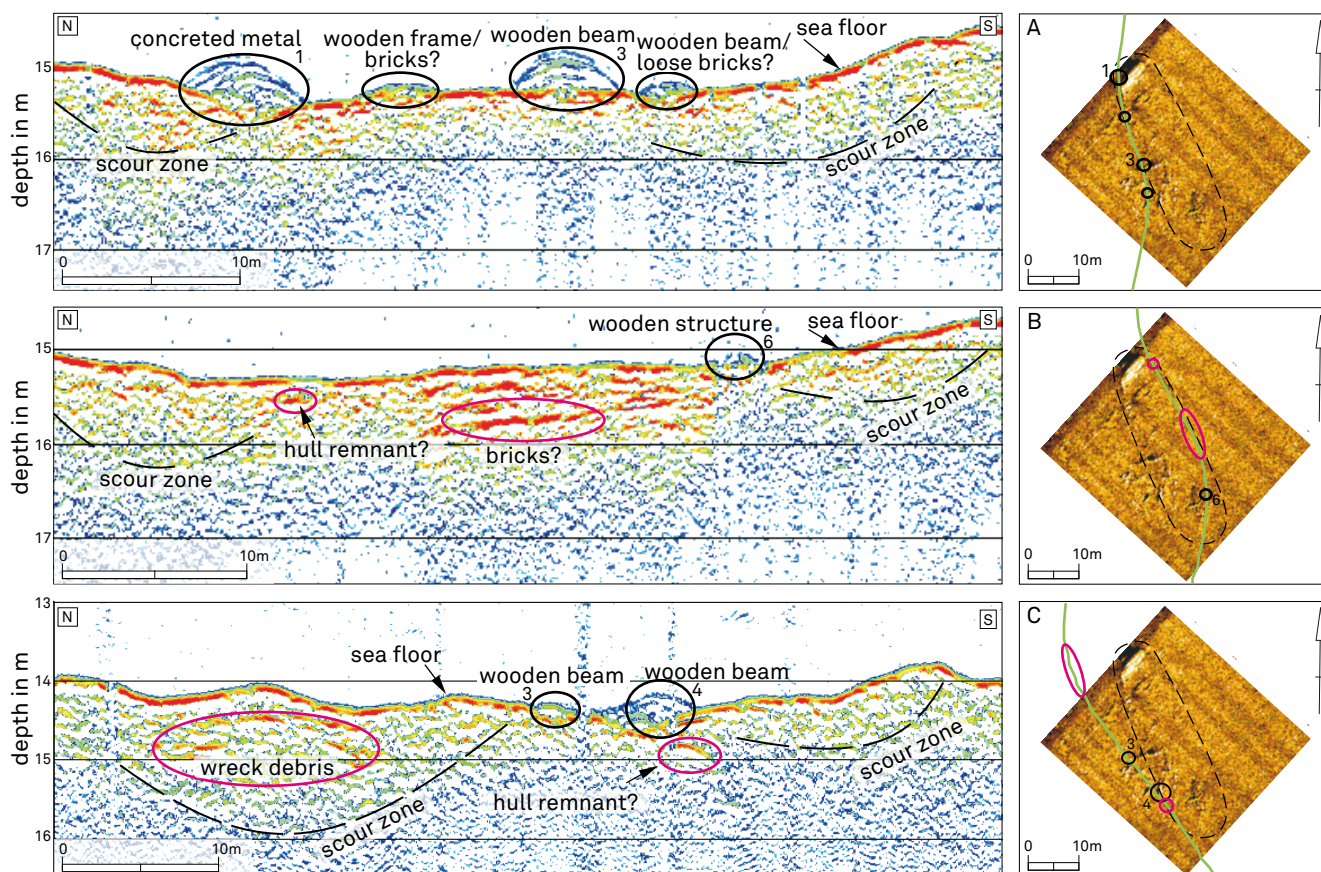
**FIG. 12** Seismic profiles crossing the wreck site roughly N-S. Black circles = exposed objects; red circles = buried wreck remains (numbers refer to fig. 9). The high-amplitude reflectors on the port side are probably related to the brick cargo (profile B). Zones with discontinuous, shallow reflectors are most likely related to scattered wreck debris (profile C). Possible small hull remnants are observed near the stern and bow (profiles B & C). Exposed objects are seen either as large diffractions (profile A) or as small side-reflections (profiles B & C). *Seismische profielen doorheen het wrakgebied (N-Z oriëntatie). Zwarte cirkels = uitstekende objecten; rode cirkels = begraven wrakfragmenten (cijfers verwijzen naar fig. 9). De opvallend sterke reflectoren aan bakboordzijde zijn waarschijnlijk in verband te brengen met restanten van de bakstenen lading (profiel B). Zones met zwakke, ondiepe reflectoren zijn waarschijnlijk afkomstig van verspreide wrakresten (profiel C). Mogelijke kleine resten van de scheepshul zijn te zien nabij de achtersteven en boeg (profielen B & C). De aanwezigheid van verscheidene objecten op de zeebodem is duidelijk, ofwel als grote diffracties (profiel A) ofwel als kleine (soms nauwelijks waarneembare) zijreflecties (profielen B & C).*

The port side of the wreck is often marked by a number of short, strong and shallow reflectors (figs. 11B-C & 12B). It is likely that this marked stratification can be linked to the cargo remains (bricks). It also confirms the excavation results from 2000 where locally buried layers of bricks were encountered (trench 2)<sup>61</sup>. The continuation of some reflectors east of the wreck could be due to the inclination which caused the cargo to be spilled outside the wreck on the port side. Towards the east the reflectors become weaker and discontinuous which seems to point towards more scattered wreck debris. The stratification often becomes more chaotic in the previously excavated areas which could be due to the disturbance in these trenches.

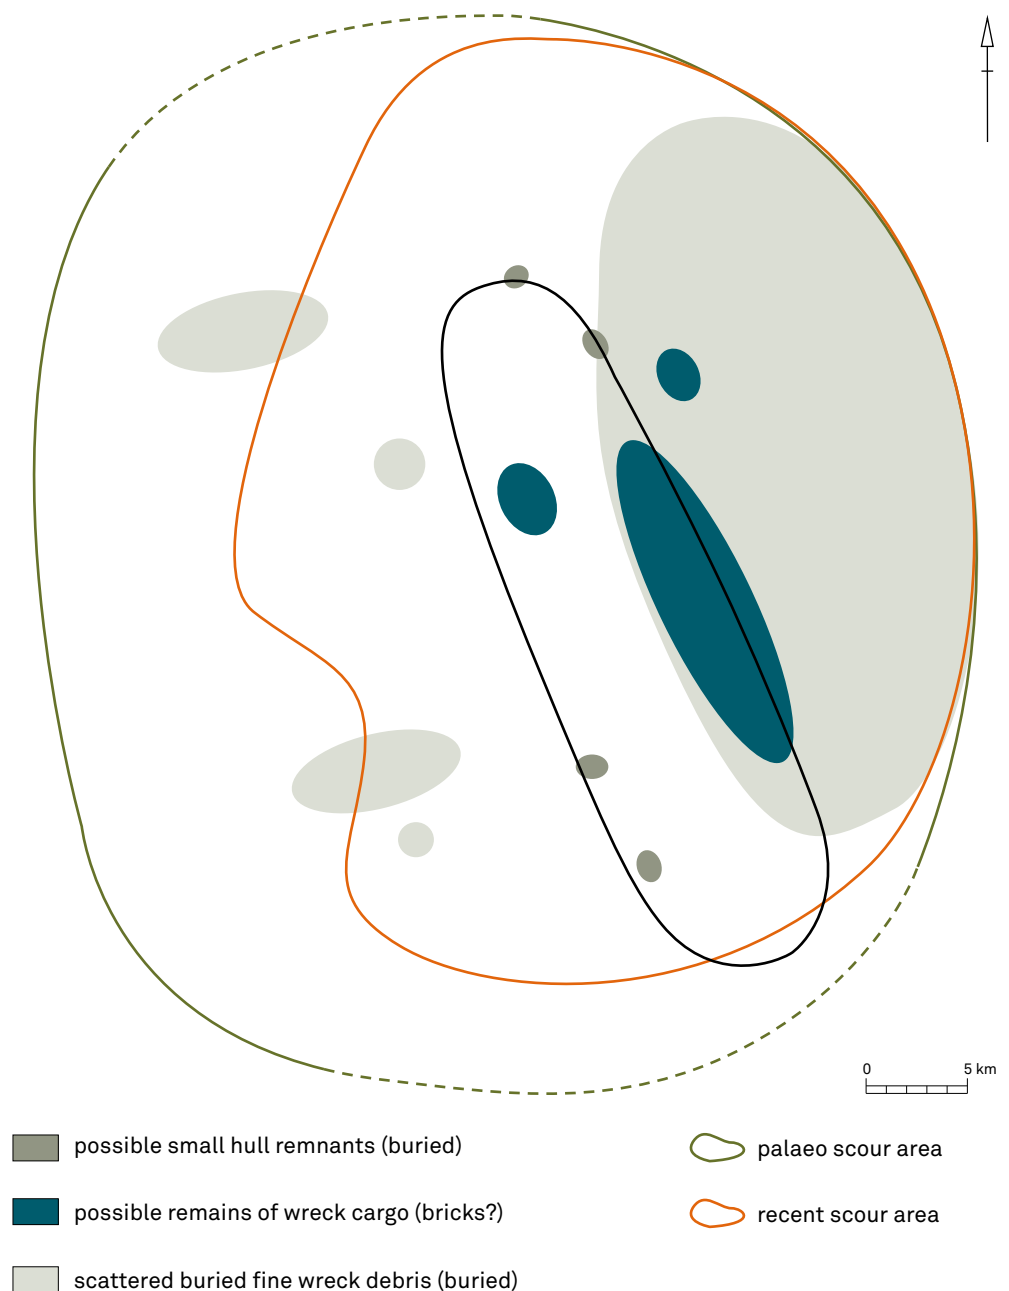
**FIG. 13** Tentative interpretation map of the wreck site area, showing the distribution of buried cargo remnants, wreck debris and scour fill zones based on the seismic data. The (supposed) wreck location is marked by the black line.
