## Relationships between Outside and Interior Appearance Inspection and Actual Bio-Deterioration of Structural Members in Existing Wood Houses

**Abstract.** *The inspection of the used house which is necessary to be evaluated is carried out without removal of the interior or exterior finishing materials. However, where the interior or exterior appearance was degraded, there was not always a bio-deterioration of the wooden structural member in the existing wood houses. Therefore, the interior or exterior appearance of the 103 used wood houses were inspected and the bio-deterioration of all wooden structural members were investigated after removal of the finishing materials. Then, the relationships between the appearance degradation and the actual bio-deterioration of the wooden structural members in the used wood houses were studied. The results were summarized as follows:*

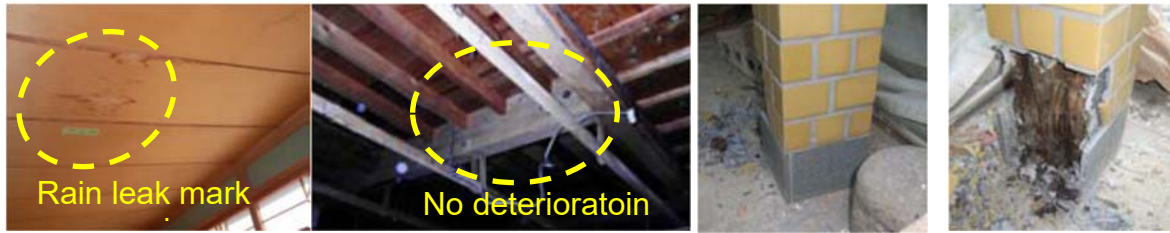
On the most of the dealing with the used houses, only the appearance inspection is conducted. So, the result of the appearance inspection needs to match the position of the bio-deterioration. However, the occurrence of the appearance degradation and the bio-deterioration of structural members were not the same, as mentioned above. For example, there was no decayed member in the 2<sup>nd</sup> floor system near the position of the rain leak mark on the ceiling of the 1<sup>st</sup> story found by the appearance inspection, as shown in Figure 8. And, the bottom of the column decayed even though no degradation were found by the appearance inspection, as shown in Figure 9.

**Figure 8.** Not decayed structural member of floor system in 2F (right) in spite of the rain leak mark on the ceiling (left).

**Figure 9.** Decayed bottom of column (right) in spite of no degradation found by the appearance inspection.
