EARLY CONCRETE STRUCTURES AND POST-PATENTED SYSTEMS: LESSONS TO PRESERVE EARLY 20th HISTORICAL HERITAGE

Keywords: Historical Structure, Reinforced Concrete, Pathology, Condition.

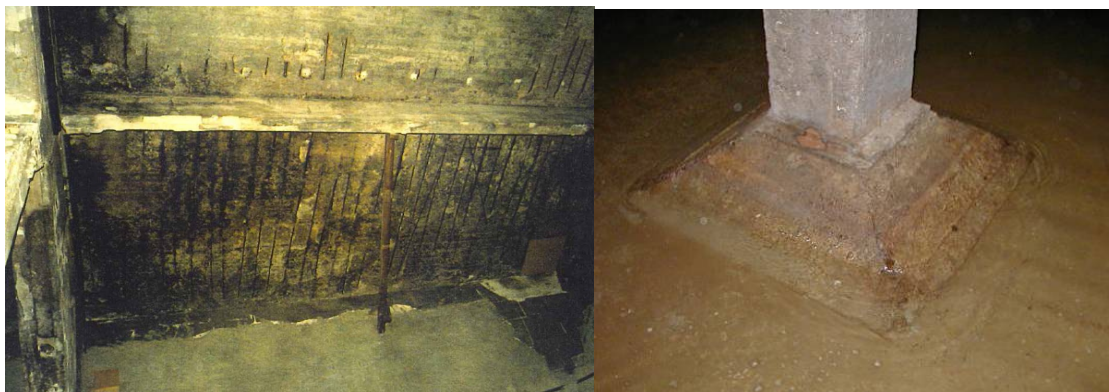
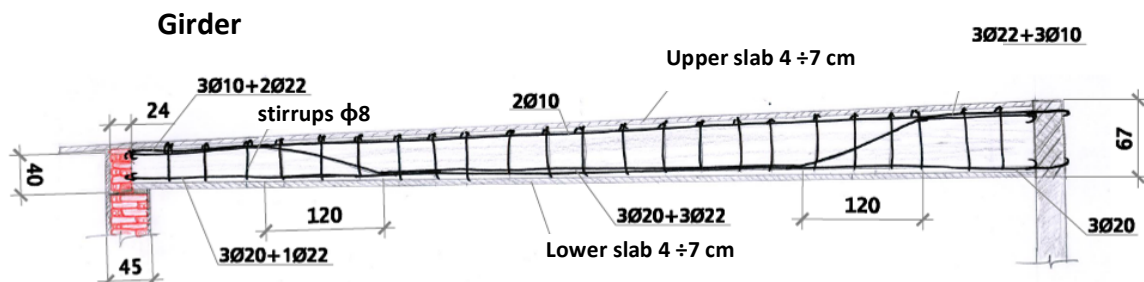
Figure 2: Usual structural layout: a) slab and narrow beams in structure Nr 3, b) trapezoidal foundation (structure Nr 2), c) beam reinforced scheme (structure Nr 6)

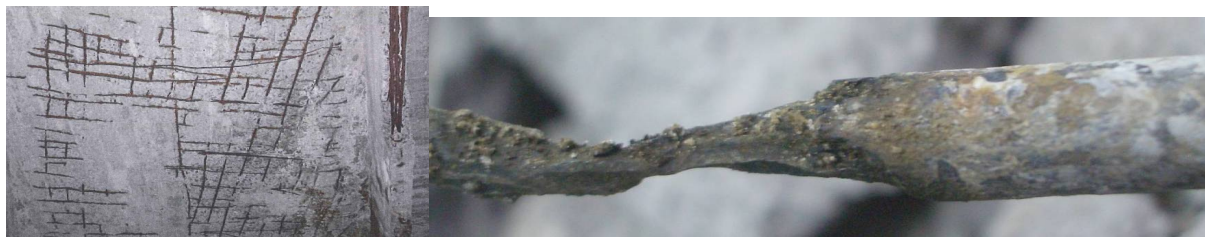
Nearly all the studies included visual inspections for signs of pathologies. Issues related to durability were mainly observed: parallel concrete cracking in longitudinal reinforcements and the appearance of corroded reinforcements, even with cross-sectional reductions, all caused by the corrosion of steel bars. The results are summarised in Table 1; Figures 3 and 4 shows typical structural damage. This pathology was found to affect more than 80% of the structures and can be considered a widespread problem. The remaining 20% included one partial study of a building focused on well-maintained interior parts of the buildings where no corrosion would be expected due to exposure to the interior environment.

Figure 3: Typical rebar corrosion: a) lower side of a slab (structure Nr 5) b) detail of pitting (structure Nr 4)

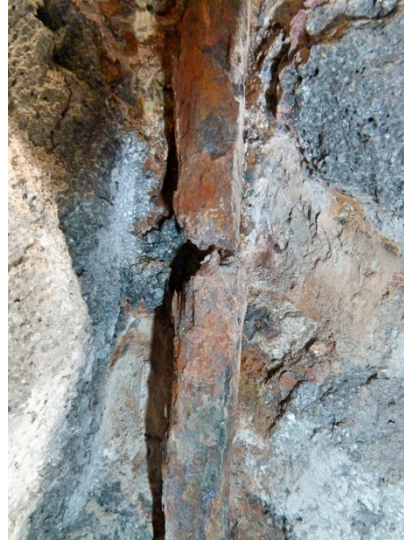
Whenever both measures, concrete cover and carbonation depth, were taken, it could be checked that the carbonation depth always exceeded the reinforcement bar depth. An exception was noted in two tests from a column in one the structures, where the depth was close to zero. The zone was in the tidal range, and the water saturating the pores prevented the penetration of air inside. Nevertheless, the columns were highly affected by pitting corrosion.

Figure 4: Cross section reduction in column (structure Nr 15)
