NON-DESTRUCTIVE TECHNIQUES IN THE CONSOLIDATION WORKS OF THE CHURCH OF S.M. OF ITRIA IN PIAZZA ARMERINA (ITALY)

Keywords: Historical structure, masonry, foundation, non-destructive inspection

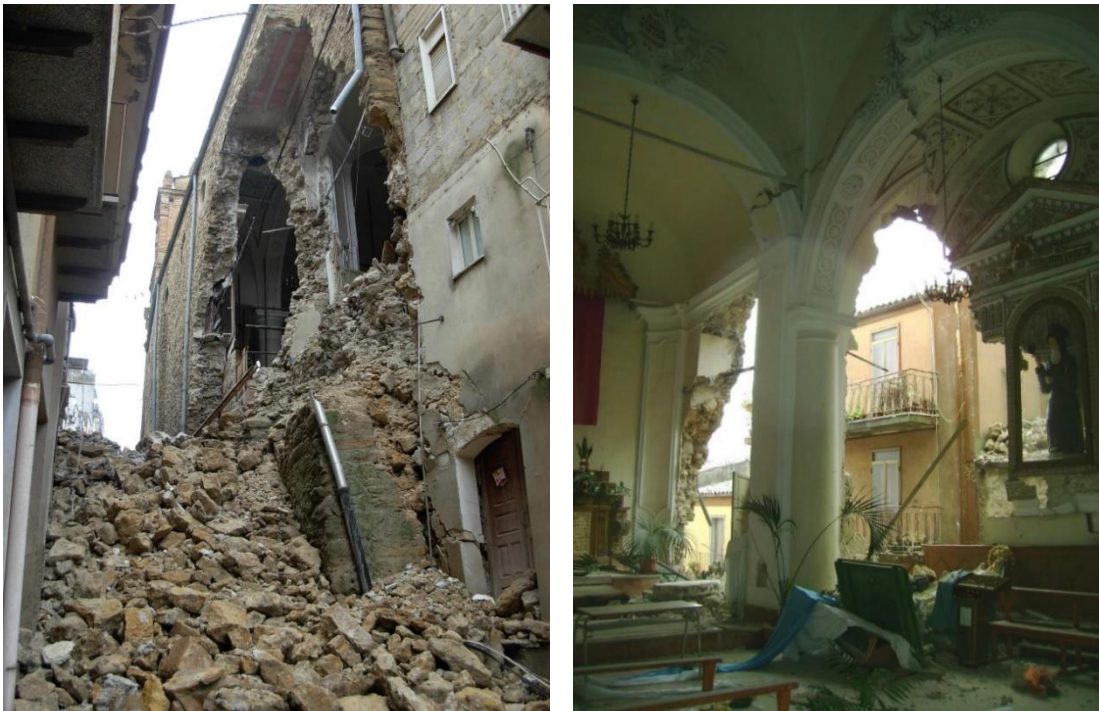
The causes of the collapse (fig. 1) were initially attributed to foundations' failure, but geological and geotechnical tests, carried out by the municipality and the Curia of Piazza Armerina, stated the substantial geological stability of the site and the absence of slipping surfaces along which a landslide could occur. It was, therefore, excluded that it was foundations' failure of the wall which did not show, in the visible part, lowering.

Analysing the drawings of the previous projects, it was evident the collapse occurred in correspondence to a discontinuity of the wall, due to the construction of a niche; the photographs highlighted the masonry, consisting of irregular stone, had a reduced interlocking between the orthogonal walls. Furthermore two vertical cracks were detected. This led to the hypothesis that the most probable cause of the collapse could be attributed to the higher load on the wall, due to the replacement, occurred in the 1980s, of the existing wooden roof with an iron and brick floor. The new roof was connected to reinforced concrete curbs, placed over the longitudinal load-bearing walls and on the walls above the transverse arches.

Figure 1: Pictures of the collapse from the outside and inside the church

With the knowledge hitherto acquired, a kinematic mechanism was, therefore, hypothesized that had produced a deformation of the wall, with a consequent partialisation of the resistant section and breaking due to peak load. By comparing historical and tests' data, the result was the intervention carried out in the 1980s had accelerated the degradation process and had been a contributing cause of the collapse.

Aware that the removal of the current roof structures would have caused incalculable damages to the monument, it was decided not to intervene on them and rebuild the wall by eliminating the previous discontinuities and consolidating the existing walls.

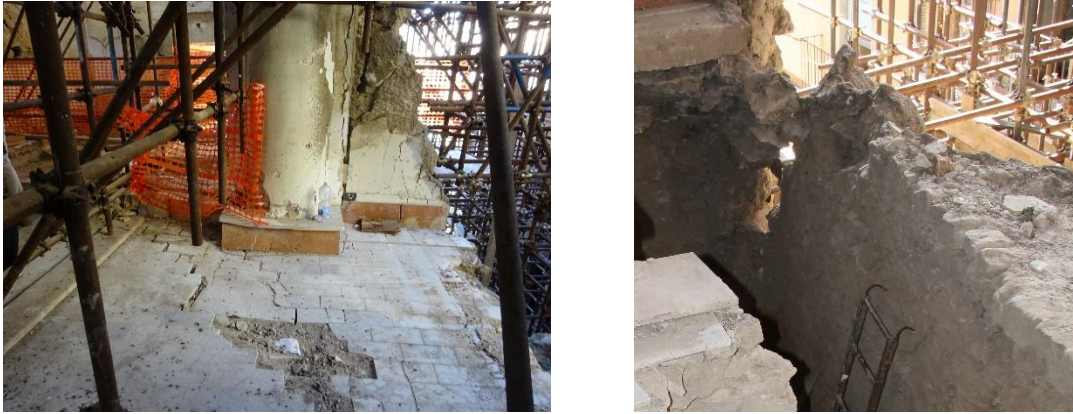
Once the construction site was set up, on 8 November 2018, the cracking situation was significantly worsened compared to the survey carried out in the design phase, mainly concerning cracks on the floor with relative failure of the pillar, near the apse, due to heavy rains that occurred at the end of October.

The excavation work, begun under the collapsed wall at the apse, showed an evident rotation of the lower part of the wall collapsed (fig. 2) and traces of an underground compartment, which led to the need to integrate previous punctual investigations with tests on the entire subsoil of the church. This was necessary in order to have an updated situation after 12 years from the collapse and check the presence of potential underground masonry structures and cavities.

Figure 2: Crack on the floor in proximity of the pillar and the rotation of the wall under the collapsed one

To avoid immediate risks, it was however necessary to take urgent ground consolidation measures below the pillar adjacent to the apse.

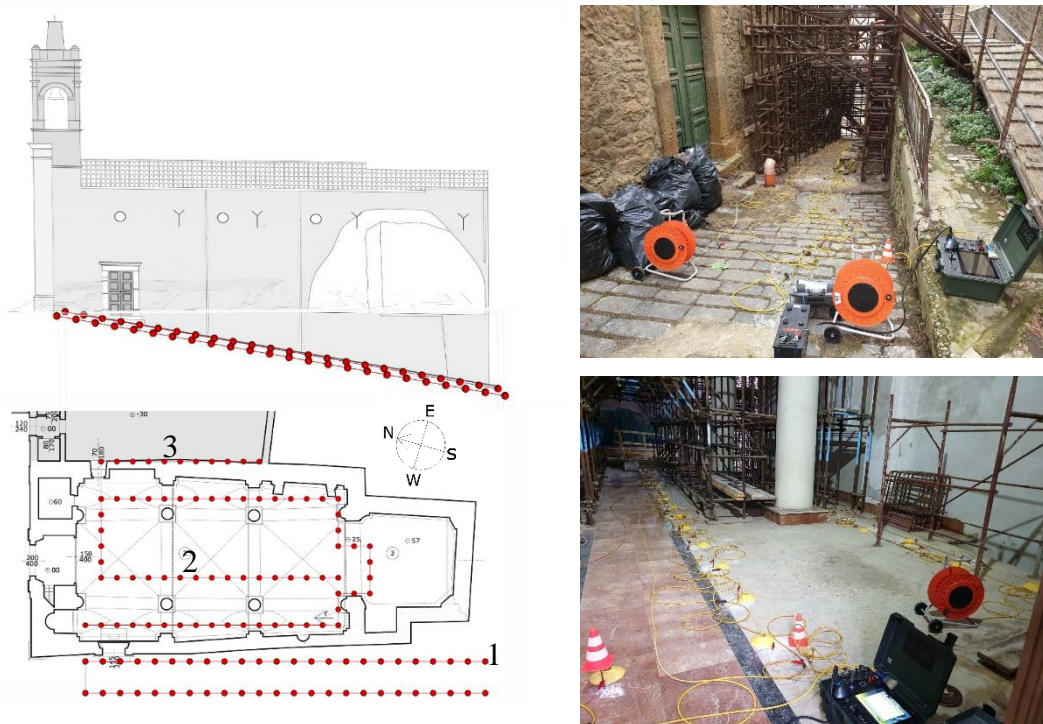
In particular, the electrodes were positioned externally, along via Itria, the area affected by the collapse of the wall, in adherence to the Church, setting the electrodes at 1.30 m (tomography No. 1); along the internal perimeter of the church, also paying attention to the colonnade foundations of the right nave of the church, due to the lowering of the column near the apse, setting the electrodes at 1 m (tomography No. 2); inside and outside the wall of the church adjacent to the sacristy, setting the electrodes at 1.30 m (tomography No. 3) (fig. 3).

Figure 3: Setting of the pegs regularly spaced along the three determined alignments

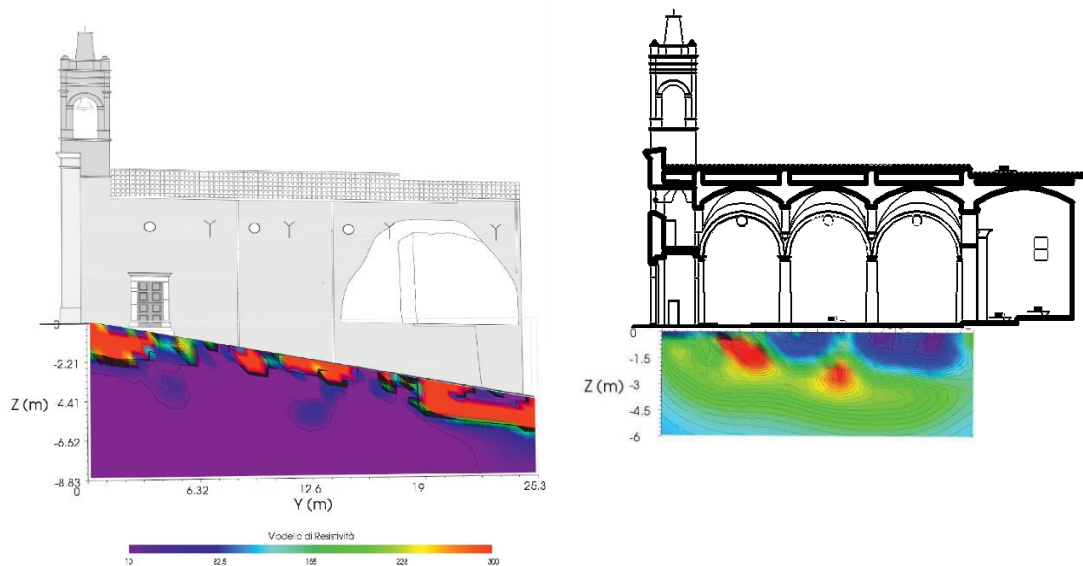
Tomography No. 1: the portion of ground investigated consists almost entirely of medium saturated sands, with resistivity values between $10 \Omega \cdot m$ and $100 \Omega \cdot m$. Some areas have been identified along the electrical spreading line with significant deformations of the induced electric field, such as to define areas corresponding to decompressed material and/or the

presence of potential voids, with resistivity between $160 \Omega\cdot\text{m}$ and $300 \Omega\cdot\text{m}$, affecting thicknesses up to 2 m deep from the road surface. The volume of these degraded thicknesses was defined by the evaluation of the ZY cross-section. In particular, from the documents referring to tomographic cross-section 1, we highlighted the critical points of the areas presenting significant deformation of the electric field and having probably triggered the failure at the base of the building, due to potential reflux phenomena at the base, with the consequent collapse of the wall along Itria Street

Tomography No. 2: the ground inside the church consists almost entirely of dry filling material, with resistivity between 10 and $100 \Omega\cdot\text{m}$. In particular, it is clear that this filling material is located in the central nave of the church up to 3 m deep (fig. 4). This result led to the hypothesis of the presence of a pre-existing structure subsequently filled, a crypt or a passage, part of the XIVth century church, some news had been found by means of preliminary historical research. This hypothesis was subsequently confirmed by the discovery, following the excavations, of an underground room below the apse (an area not affected by the tomographic survey) connected through a door to the part below the central nave.

Figure 4: Results of tomography No. 1 and No. 2

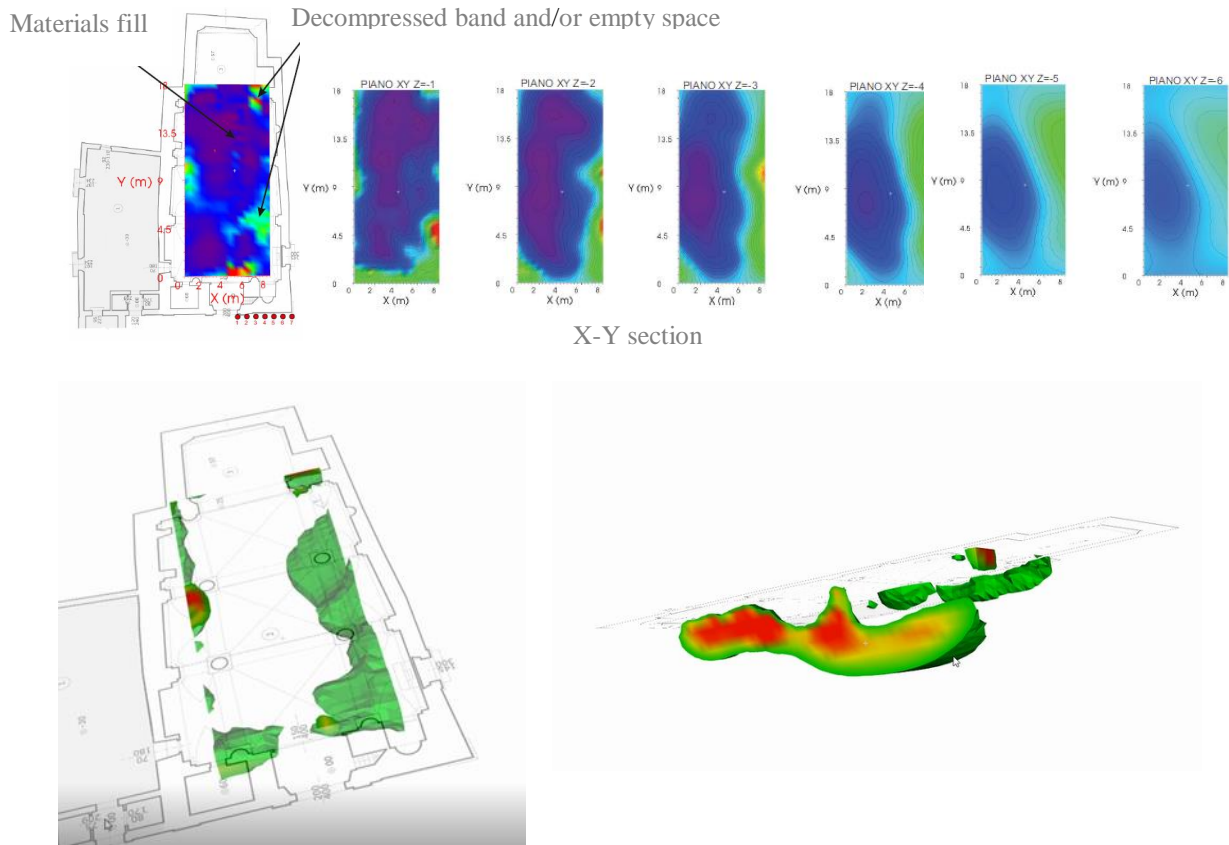
The analysis of the XY sections (fig. 5), at depths varying from 2 m to 6 m, shows areas of the ground with significant deformations of the induced electric field. Such areas correspond to decompressed material and/or partial presence of voids, already starting from the depth of about 1 m of the portion of the southeast corner building. These areas are increasing in depth and breadth at the collapsed wall between $150 \Omega\cdot\text{m}$ and $200 \Omega\cdot\text{m}$, with deformations superimposable with those already detected in tomography No. 1. With the investigation carried out, it was also possible to identify areas with even higher resistivity, between $250 \Omega\cdot\text{m}$ and $300 \Omega\cdot\text{m}$, at the pillar near the apse affected by the collapse.

Figure 5: Results of tomography No. 2 (XY sections and 3D model)

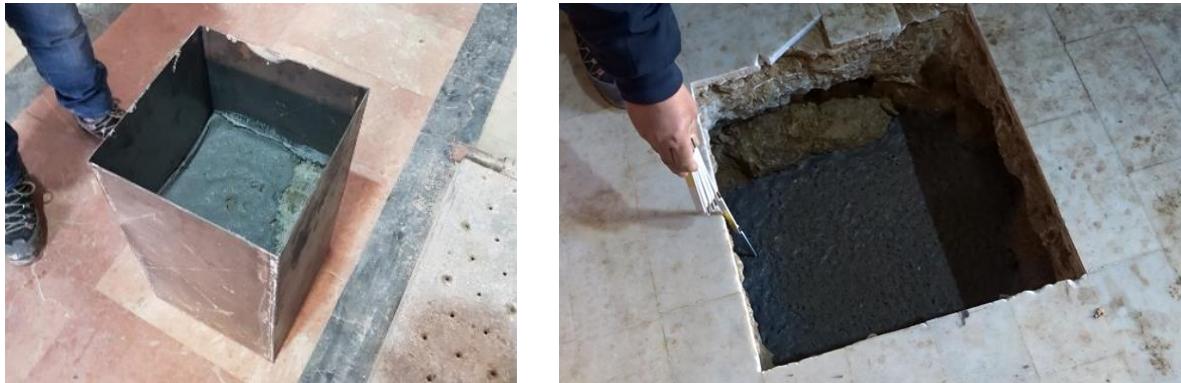
Figure 6: Confined and free expansion test of the expansion mortar

After a careful market investigation, a premixed expansive mortar composed of cement and particular additives and expansive agents was chosen, having the main characteristic of combining 100% average expansive capacities and mechanical capacities suitable for holding loads in foundations between 7.3 MPa and 11 MPa (Betonfix Espando type by Kimia). It is a material normally used for ground consolidation, filling voids and cavities and tunnel applications for anchoring nails. To ensure its reliability, two tests were carried out on site, one in a 0.30x0.30x0.60 m metal specimen, with confined expansion, and the other in a 0.50x0.50x0.40 m excavation inside the Church flooring, with free expansion. Both tests have shown within half an hour an increase in the volume of the mortar cast in situ in the confined case by 100% and 70% in the free one (fig. 6).

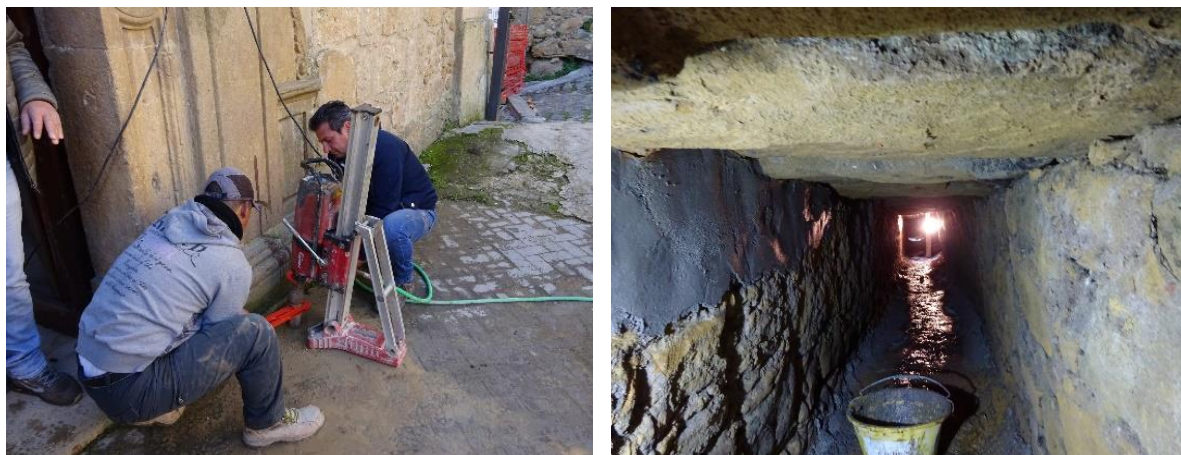
From the visual inspection inside the conduct, several water infiltrations were noticed, coming from the side of the church, with low, but still continuous influxes at the base of the conduct. The water that flows into the conduct from the mountain side disappears, significantly, to infiltrate below the concrete base without knowing the path that follows in depth, being the concrete slab damaged in several points, with some portions removed by runoff water within the same conduct.

Figure 7: Perforation in the ground and interior view of the conduct

The intervention on the conduct was preparatory to the ground consolidation interventions. In particular, a compensation chamber has been created, upstream of the conduct, to avoid excessive flow in the conduct itself. The concrete at the base of the conduct was restored and the walls and the base were covered with three layers with different performances: polyolefins (TPO), non-woven fabric (TNT) and draining sheet (Enkadrain type) to allow the drainage of dispersed water and prevent the flow of water from the conduct towards the church.

The injections were carried out with staggered perforations and by injecting the material under pressure regulated by a pressure gauge, from the deeper valve, and advancing along the path. Once this stage was completed, the operation was repeated to make the material exit the upper valve, until it was rejected. Once the external injections were completed, the internal injections were placed at higher distance and consuming less mortar, as the ground was already partially consolidated by the material injected through the external perforations (fig. 7).

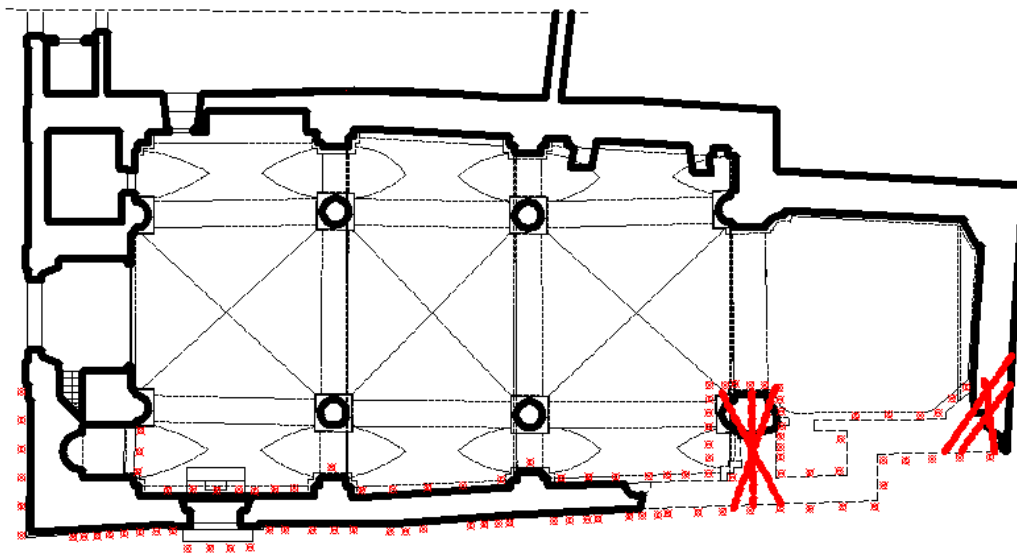
Figure 8: Plan of the church with points of perforation in the ground and with the perforations reinforced with carbon rods placed to create interlocking at the corner of the new wall with the existing one

Once the material was identified, a set of mortar injections was realized through perforations to the external and internal side of the wall on Itria Street and Itria Square, between 0.50 m and 1 m distant and between 2 m and 6 m depth. The rotation perforations, performed vertically or slightly inclined towards the wall, allowed the insertion of drilled rigid PVC canes with an external diameter of 34 mm and an internal diameter of 27 mm; the canes equipped with tip caps were equipped with valves not more than 1 m distant each other.

The rebuilt wall was also connected with the opposite wall through new chains in order to improve the box-like behaviour of the entire load-bearing wall structure. In particular, a series of perforations reinforced with carbon rods were made and 3 chains at 3 heights were placed to create the interlocking at the corner of the new wall with the existing orthogonal one: at the foot level of the church, at the roof level and at the intermediate level (fig. 8, 9). Two other chains were built on the sides of the closing arch of the apse.

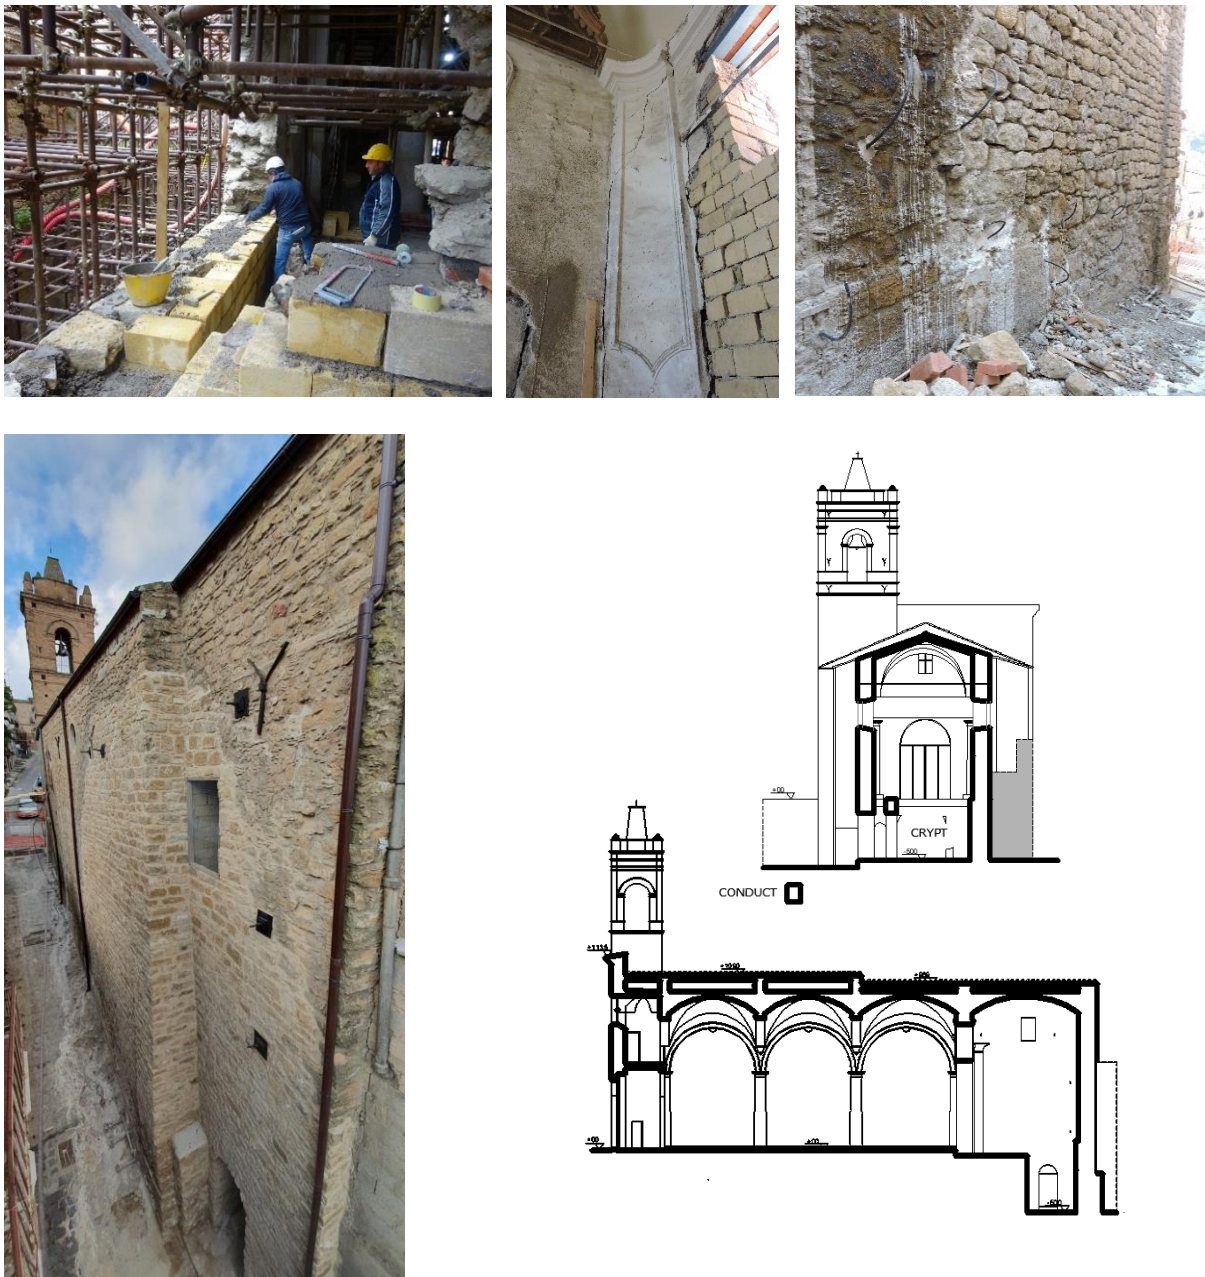
Figure 9: Photographs of the reconstructed wall and drawings of the church with the found underground room

Once the rotation of the remaining wall below the collapsed one was verified and the relative deformation, the demolition and the reconstruction of this wall was carried out, by means of stone ashlar of the quarries of Aidone, for almost the entire thickness, and with fair-faced external layer, using the ashlar recovered after the collapse and kept in the Curia spaces. The new wall has a variable thickness, in correspondence with the existing niche, which was no longer built, reaches 2 m.
