## **PATHOLOGICAL AND STRUCTURAL ASSESSMENT OF A RESIDENTIAL BUILDING IN LOTA, CHILE**

*The "Anibal Pinto Building" is a 5 stories reinforced concrete and masonry structure, built in 1966. Besides of an aggressive coastal environment and poor maintenance, this building has experienced one major earthquake (Mw 8.8 in 2010). As a consequence, cracks, concrete spalling and reinforcement corrosion is observed in several structural elements.*

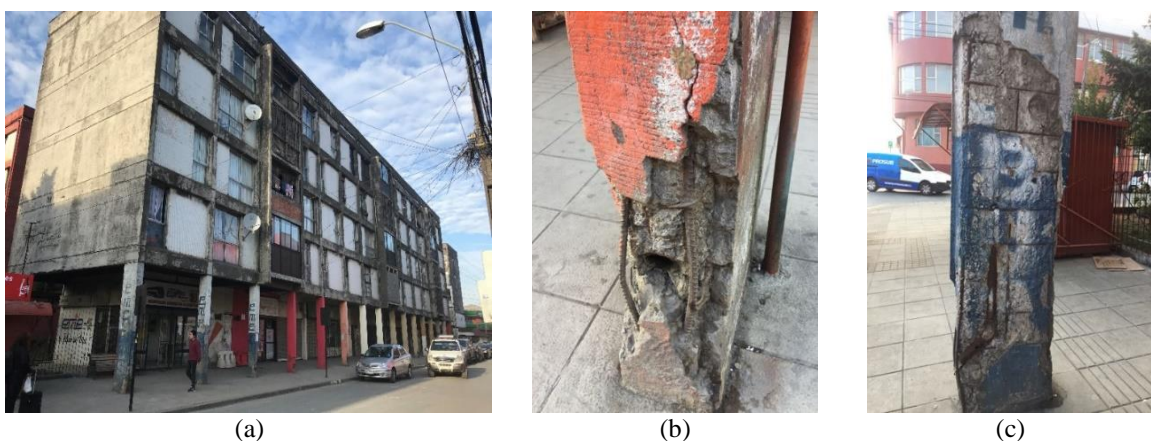
The “Anibal Pinto Block” is a five stories residential building structured on reinforced concrete frames and shear walls, with masonry partition walls. All connected by a reinforced concrete slab that provides rigid diaphragm conditions. The building has 47.5 m x 8.8 m in plan and a total height of 13,5 m. The ground level has a commercial use, while the upper levels have 8 apartments per floor. This building was constructed in 1966 and at that moment no seismic regulation was mandatory in Chile, but engineering designs were already strongly influenced by the traumatic experience of the Mw 9.5 Valdivia earthquake (1960). Considering its age, the Anibal Pinto Block has been exposed for more than 50 years to an aggressive costal environment and has experienced the Mw 8.8 Maule earthquake in 2010 [11]. Currently, this structure presents extensive damage that may imply a potential risk to community (Figure 1). Hence, a structural assessment was required to decide what action needs to be taken.

**Figure 1:** Anibal Pinto Block.  
(a) General view, (b) damage on internal columns, and (c) damage on lateral column

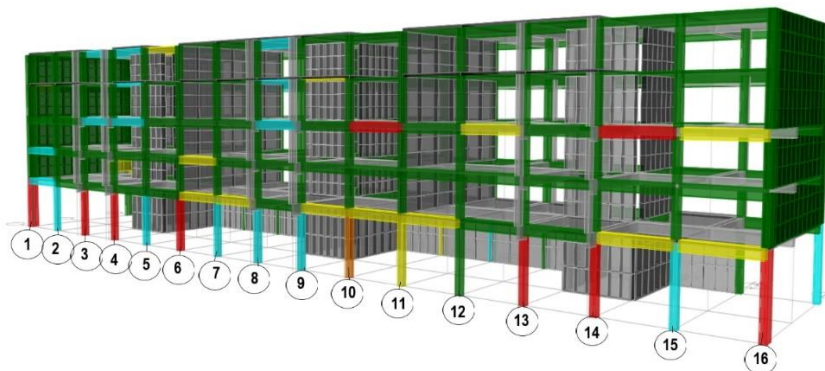
A survey was conducted to identify damage on reinforced concrete elements, such as, cracks, spalling, carbonation, corrosion and rebars buckling or failure [12]. This information was presented as a color diagram (Figure 2) representing damage severity according to Table 1. It can be observed in Figure 1 that the base columns suffered moderate to severe damage, being at least seven columns on a condition near to collapse. Hence, this level was considered as the critical zone.

**Figure 2:** Damage diagram of the building

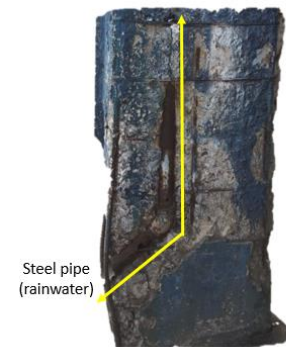
One particular condition observed in some columns (1-3-4-6-8-9-11-13-14-16) was the inclusion of a steel pipe inside of the column core to be used a rainwater drainage (Figure 3). In most cases, these pipes have suffered severe corrosion affecting the surrounding concrete and rebars.

**Figure 3:** Steel pipe

- The drain pipe longitudinally embedded in the column considerably reduced its structural capacity in compression, flexocompression and shear, but more critically it promotes internal process of carbonation and corrosion.

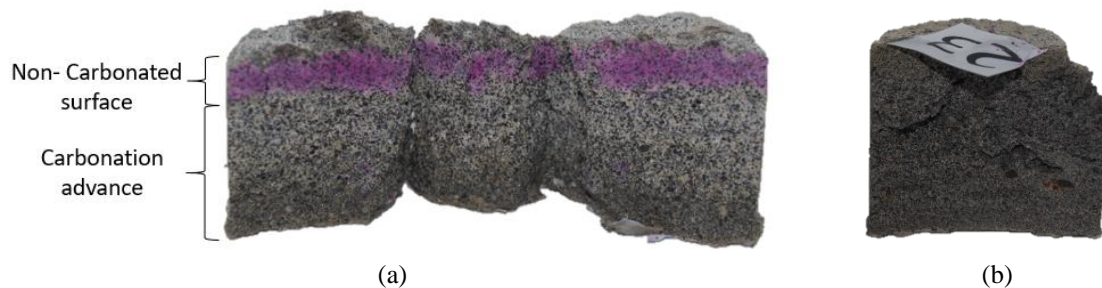
Together with the above, 27 concrete core samples were extracted and tested to determine the depth of the carbonation. Figure 4 shows the results of a carbonation test performed on columns in the front of the building. All the coating mortar samples extracted from the columns have carbonation, and penetration into concrete was also observed.

**Figure 4:** Test results of carbonation with phenolphthalein solution.  
(a) Partially carbonated sample, and (b) Fully carbonated sample

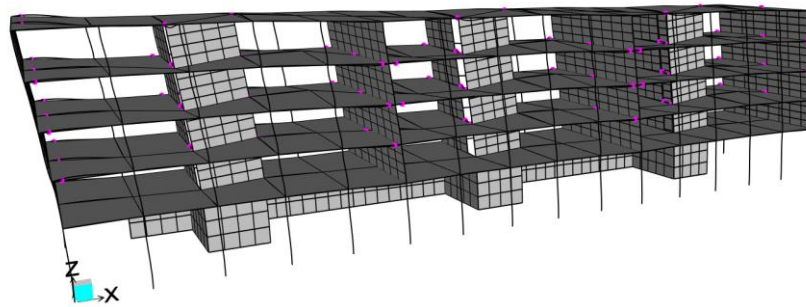
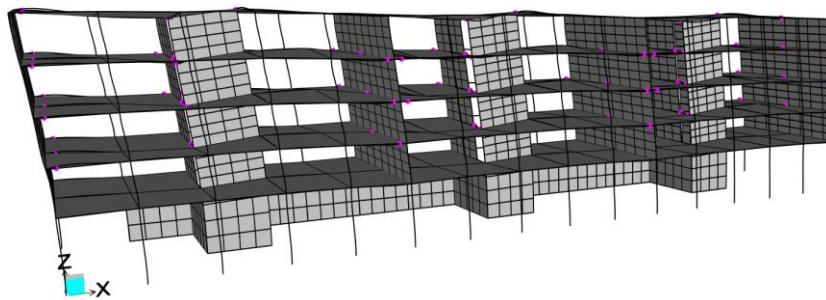
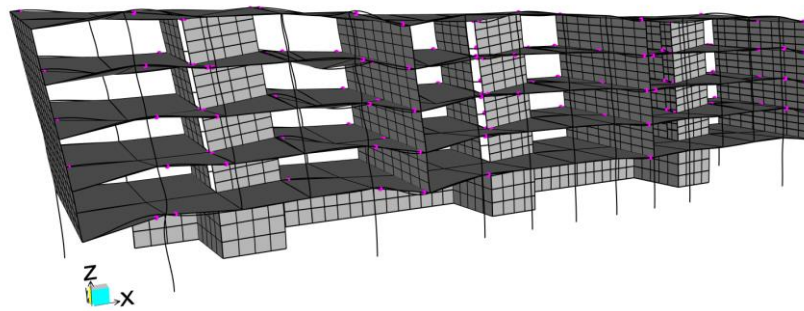
The results of the Time-History analysis are presented in Table 7 and Figure 10, where the magenta dots represent plastic hinges. It is observed that the seismic event of 2010 do not affect significantly the vertical elements (columns and walls) and most of the damage was

concentrated in the beams. Roof displacements and interstory drift are small and within the range accepted by current Standards [27, 28], even in the case of the severely damage building (Model 3). This is explained by the secondary importance of columns to control lateral displacements, which is mostly resisted by shear walls. These stiff elements (shear walls) not only imposed strong restrictions to lateral displacements, but also produce low natural periods. These periods are below the range where most of the earthquake's energy is concentrated (only 5% of the energy affects structures with periods below 0.15s), which explains why this kind of structures were able to withstand the 2010 Maule earthquake. However, the elimination of columns in Model 3 produced an increment in the number of plastic joints in beams, because of the building rotation generated by the early activation of rotational modes. This condition sets an alert and reveals the need of retrofitting columns to prevent further damage in the structure, not only in vertical elements, but mainly in beams and slabs.

**Figure 10:** Plastic hinges generated on the structure.  
(a) Model 1, (b) Model 2, and (c) Model 3

- The structure under study presented local failures that did not compromise global stability, especially due to the amount of shear walls of the building, which have not presented significant damage. Even tough, repairing is needed to comply serviceability requirements and control further structural deterioration due to rotational effects.
