POINT-LOAD TEST ASSESSMENT AS STUDY OF ADOBE BUILDINGS DAMAGED AFTER THE 2017 PUEBLA EARTHQUAKE

Keywords: Adobe Masonry, Point-load test, Vernacular architecture, Seismic affectation

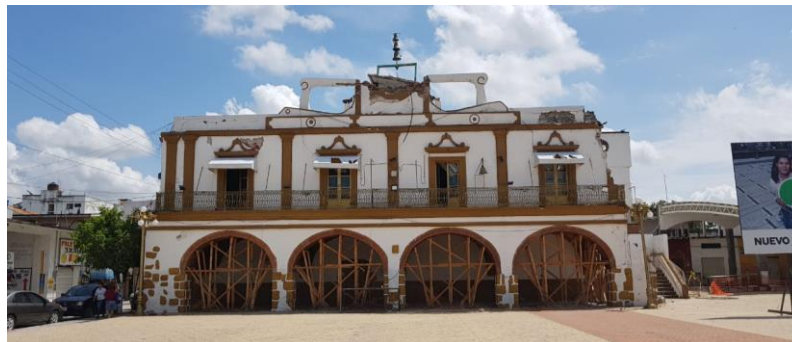
and History (INAH)¹ reported a total number of 259 buildings affected, suffering damages classified as severe in the 47% of the whole ensemble [3]. The study case of Jojutla de Juárez, was the most affected locality of Morelos presenting important structural damages or total collapse in the built heritage, being the traditional earthen buildings, made of adobe bricks, the most vulnerable buildings to seismic efforts (See Fig. 2).

Figure 2: Municipality of Jojutla de Juárez after the 2017 Puebla Earthquake

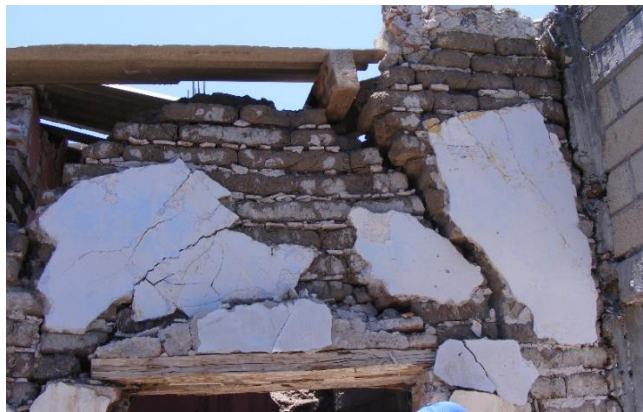
In the study case of Jojutla de Juárez, the traditional adobe houses of the locality were fairly modified over the years, changing the ancient materials and construction systems for modern ones; the vast majority of the buildings had important alterations to its morphology too. Besides, the conservation and maintenance of the constructions were precarious, as a result of the lack of knowledge and interest of the vernacular technologies, which always responded to the natural environment [9]. On the other hand, the traditional houses which conserved their morphology, dimensions, materials and techniques; had a better performance against the 2017 Puebla earthquake, suffering non significant damages, as it has been demonstrated in posterior research works [7] [10].

Figure 3: Damaged adobe building with mixed construction techniques

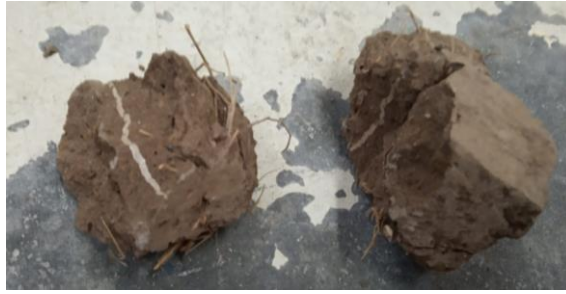
The value σ is the main purpose which the point-load test follows and it is going to be compared with other values of mechanical resistance obtained by other tests. Other interesting aspect of the test is to observe the rupture mode of the fragments, finding relations between the composition of adobes, their morphology, size, fibres distribution or aggregates (See Figure 6).

Figure 6. Fracture in adobe fragments with point-load equipment
