## SEISMIC BEHAVIOUR OF LA MERCED TEMPLE IN MORELIA, MEXICO

LIDIA MEJIA<sup>1</sup>, GUILLERMO MARTINEZ<sup>1\*</sup>, BERTHA OLMOS<sup>1</sup> AND JOSE  
MANUEL JARA<sup>1</sup>

<sup>1</sup>Civil Engineering Department  
Universidad Michoacana de San Nicolás de Hidalgo (UMSNH)  
Av. Gral. Francisco J. Mújica S/N, Felcitas del Río, 58004 Morelia, Mich., Mexico  
e-mail: guillermo.martinez@umich.mx (\*corresponding author)

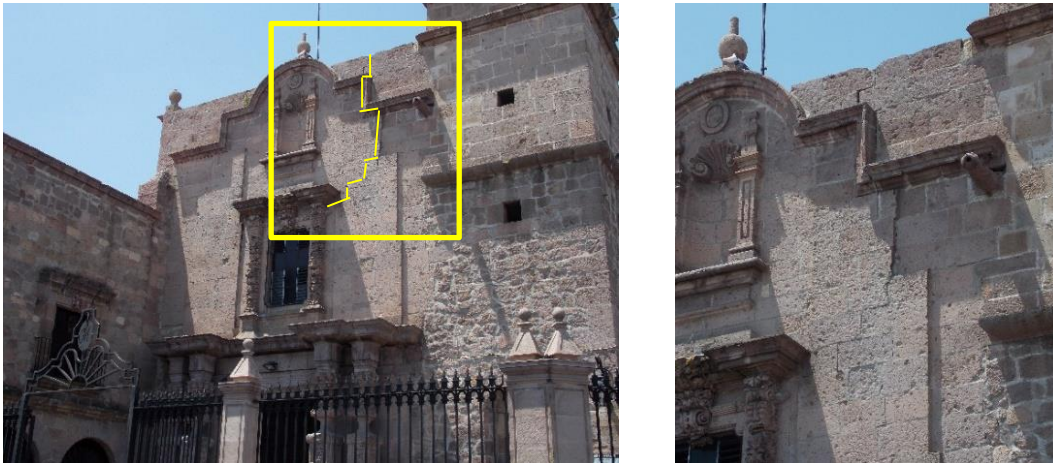
It presents slight damage composed by a shear crack caused by the interaction of the facade with the bell tower, which starts from the upper corner of the coral window and extends vertically as shown in Figure 6.

**Figure 6:** Main façade damage

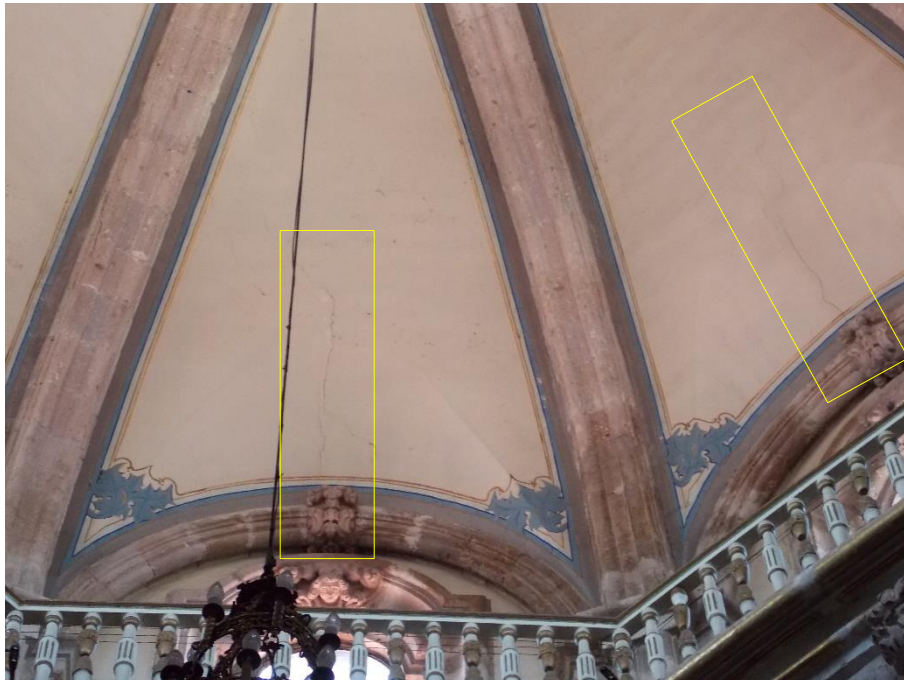
The dome has cracks in each of its eight shells between ribs as shown in Figure 7. The cracks reach the lantern ring, damage that can also be attributed to past seismic actions. On the outside, the rocking effect of the pinnacles that are located on the drum ornamentation is evident, some of which have failed due to shear as indicated in Figure 8. Without any doubt, the pinnacles damages has been caused by historical earthquakes.

**Figure 7:** Cracks on the masonry dome

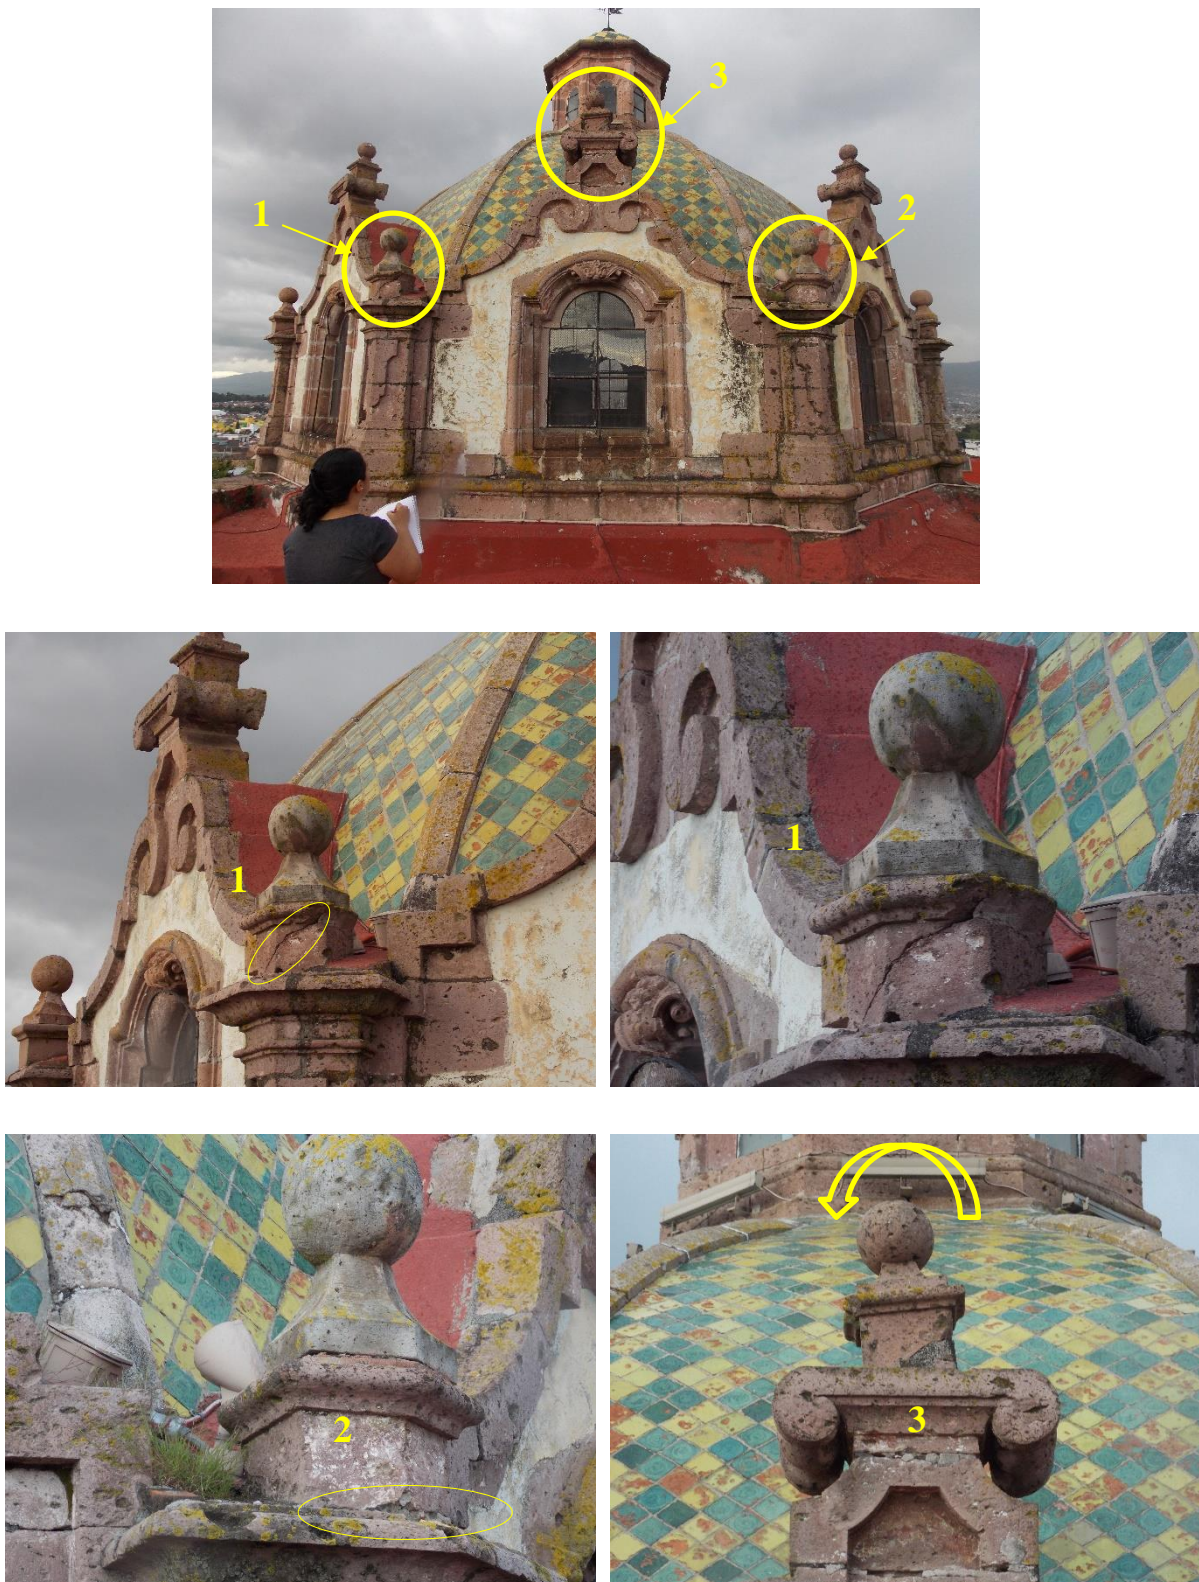
**Figure 8:** Pinacles rocking and shear base damages

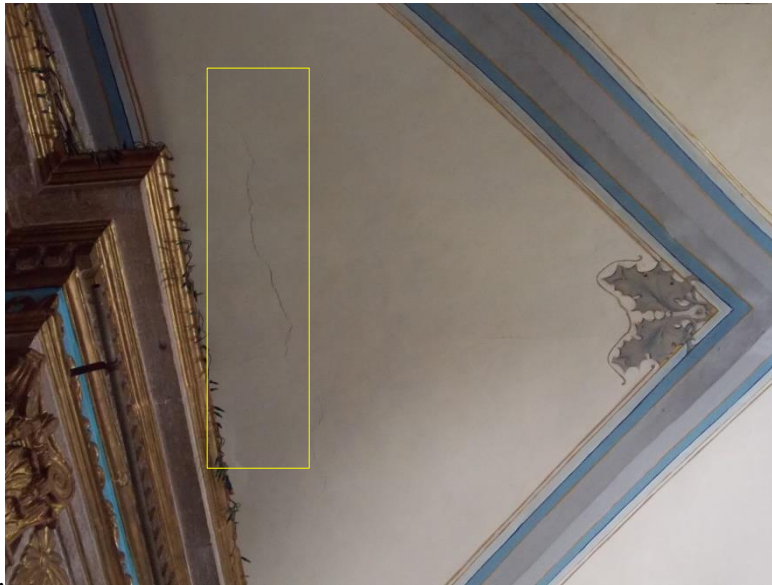
The lunette nave vaults have Sabouret cracks, Figure 9, as well as shear cracks that have practically been connected to each other in such a way that they can form rigid blocks that could become unstable in future seismic events of importance as seen in the Figure 10. It is also clear that such damage patterns can be associated without major error to the seismic action of the past.

**Figure 9:** Vault Sabouret crack

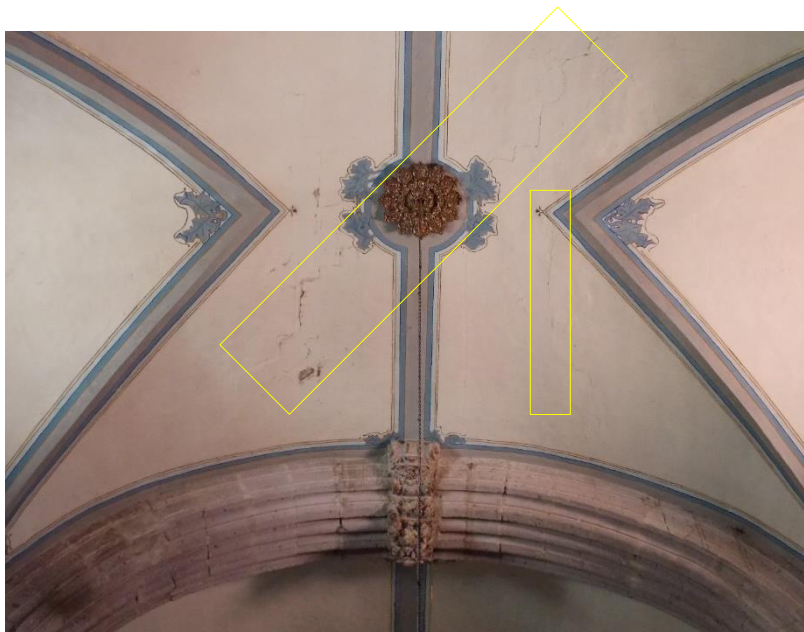
**Figure 10:** Main nave vault cracks

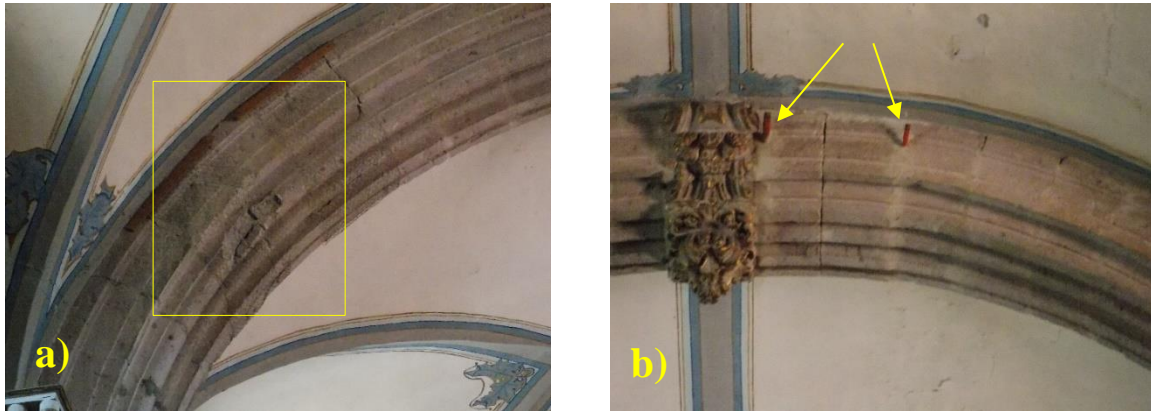
These arches are 0.96m wide and 0.40m height. One of these arches shows damage to the intrados of one of its kidneys as shown in Figure 11a, so a safety mesh has been placed to prevent damage to people who come to church every day. These arches have also lost their mortar joints between dowels and in recent years mortar injections have been made to consolidate them as shown in Figure 11b. Subjectively, it is not clear whether the damages observed could have been caused by seismic action.

Figure 11: a) Daños en arco fajón and b) mortar injection nozzles

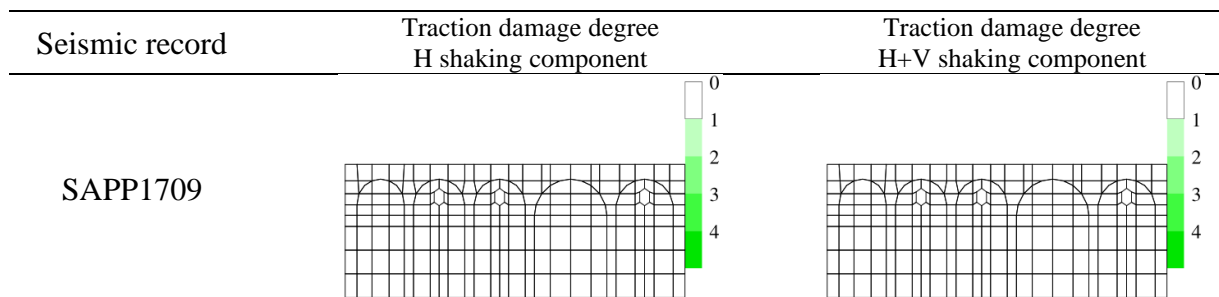
The longitudinal macroelement has a high resistance and a high lateral stiffness as shown in Figure 15, and for the whole seismic demand no damages were obtained, so that the considered seismic demand does not cause any traction, compression or shear damages.

Figure 15: Longitudinal macroelement traction damage for one of the seismic records

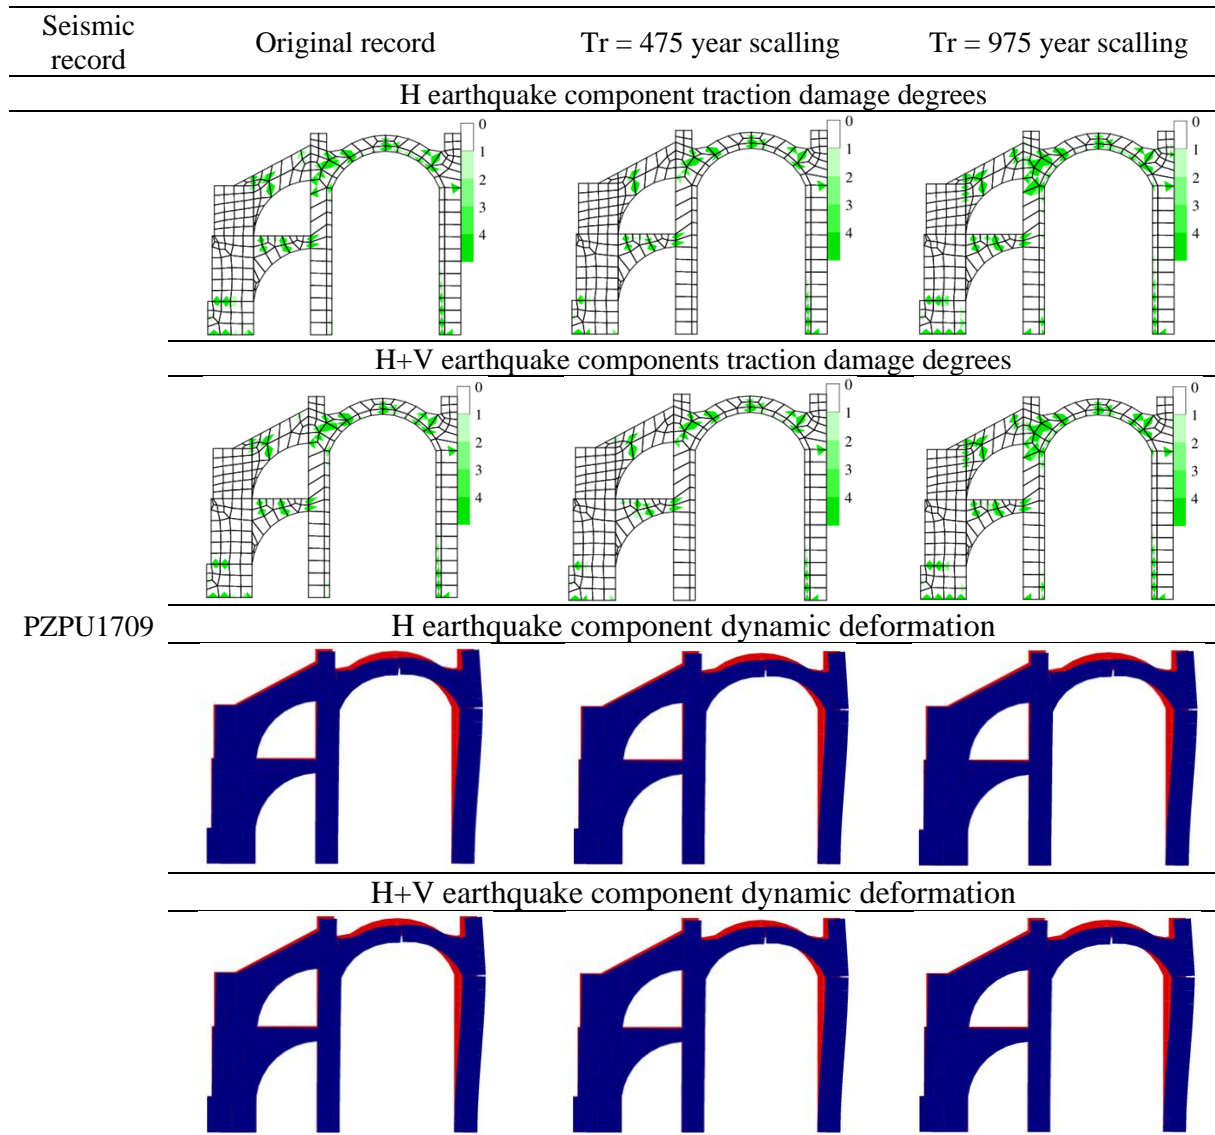
In the nave transverse direction, the structural behavior was similar for all the considered seismic demand in terms of damage distribution, with moderate to extensive damage degrees at the key and springers of the vaults and arches. Such damages can be associated to the crack pattern observed in the vaults, and it is appreciated that the damage pattern does not change significantly when the earthquake vertical component is involved in the analyses, attributing such a situation to the reduced span of the nave of only 6.69m.

**Figure 16:** Transversal macroelement traction damages and dynamic deformations
