## SEISMIC VULNERABILITY ASSESSMENT OF A 17<sup>TH</sup> CENTURY COLONIAL ADOBE CHURCH IN THE CENTRAL VALLEY OF CHILE

**Abstract.** *This paper focuses on the seismic vulnerability assessment of the San Judas Tadeo's church in Malloa (Chile), an iconic example of Colonial Chilean architecture. This small adobe structure is a single-nave building consisting of the main nave, a bell-tower located in the façade, two external wooden galleries and additional units such as the sacristy, chapel, and two services areas.*

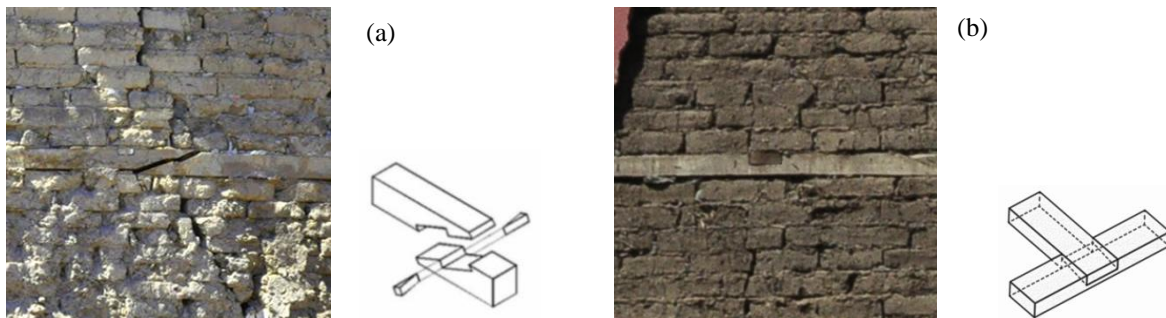
The *hooked scarf joint*, which is employed to connect the wooden horizontal elements, is a traditional method of joining two members end-to-end. This technique offers remarkable capacity in the longitudinal direction because it extends resistive area of the joint, thus maximum allowed force heightens, but the link mostly depends on the mechanical fastener employed to keep the joint closed, Fig. 2a.

The *halved joint*, another traditional link, is used to join two orthogonal members by removing material from each at the point of insertion so that they overlap, Fig. 2b. The amount of material removed is equal to half of the width, so the connections are weak and prone to split.

Following the 2010 Maule earthquake, the failure of the joint interlocking between wooden elements is observed in particular for the hooked scarf joint. The link failures are shown by the slippage between the wooden elements in the horizontal direction, determining the propagation of vertical and diagonal cracks along the entire height of the wall, see Fig.2a.

**Figure 2:** Traditional timber joints in Malloa parish: (a) hooked scarf joint, and (b) halved joint

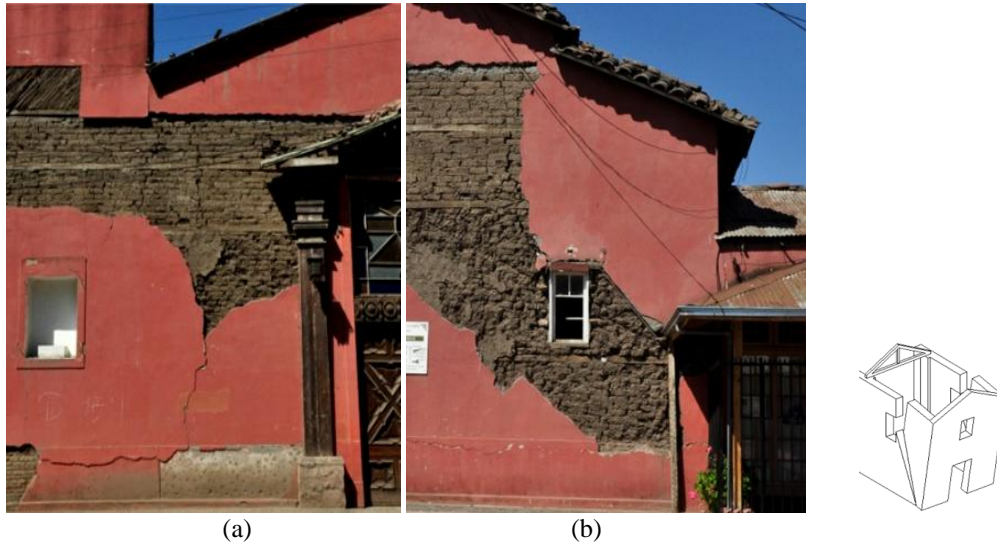
and doors. This crack pattern, observable in the internal (Fig. 4a) and external (Fig. 4b) elevations of side walls, suggests the activation of out-of-plane failure mechanisms, triggered by horizontal flexure of the wall, and involving the upper part of the discretized longitudinal walls between the openings (Fig. 4). The rotation towards the outside occurs around a horizontal hinge defined by the crack in correspondence of the wooden horizontal reinforcements of the W01, located at 4.6m above ground level.

**Figure 3:** Deep vertical cracks in the main façade[5]

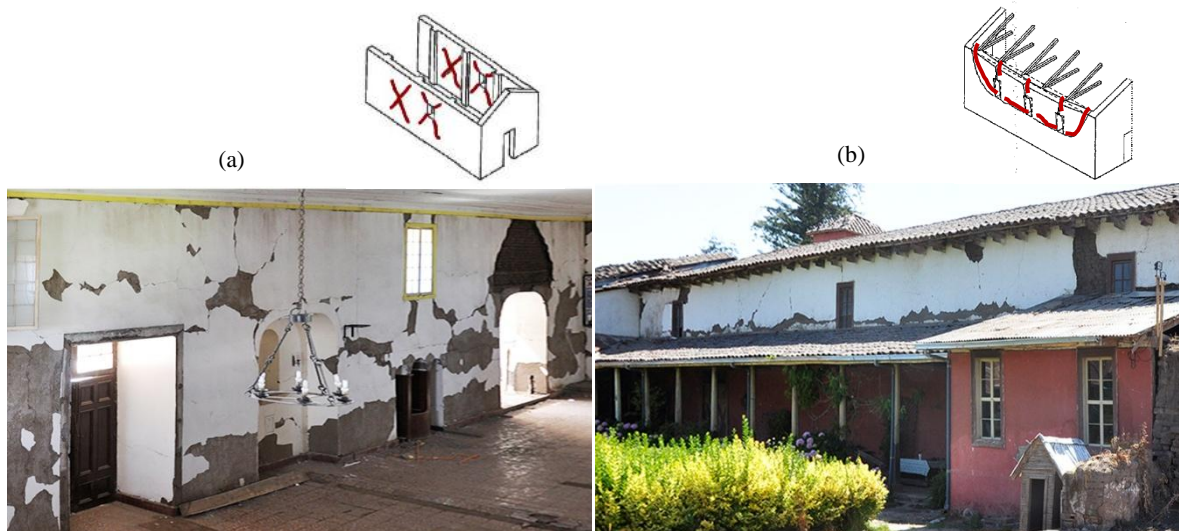
The San Juan Tadeo parish has suffered severe damage after the 2010 Maule earthquake. In particular, different seismic behaviors depending on the construction techniques were observed in the main block (W01), the service areas (W02), and the sacristy and rear chapel (W03). The main block of Malloa parish consists of heavy and thick walls (slenderness  $H/t=6.8$ , where  $H$  and  $t$  are the height and thickness of wall respectively), wooden beam bonds within the thickness and corner keys. Despite this, the traditional anti-seismic system, based on the use of timber, keeps the walls working together (*box-behavior*). In the main façade, the failure of joints, which used to attach (kink) end-to-end two horizontal members, aided the propagation of deep vertical cracks. The compound overturning of the thick façade ( $H/t=5.2$ ) is highlighted by vertical cracks passing through the wall thickness (Fig.3a-b) and the disconnections between the façade and the longitudinal side walls, internally observable. Furthermore, the presence of timber corner keys provides reinforcement improving the post-elastic behavior of the walls. Thus, a part of the longitudinal side walls and the façade continue to work together. The diagonal cracks observed in the longitudinal walls highlight the activation of an overturning mechanism that involved the façade and triangular portions (two side wings) of the longitudinal walls around a horizontal hinge, located at 72cm above the ground level. The shape of façade macro-element depends on several factors, mainly: the length and number of corner keys, the masonry-wood friction, and the distance between openings and wall-corner. Significant vertical cracks are also visible in the upper part of longitudinal side walls of the nave, mainly near the openings of windows

Diagonal shear cracks caused by the seismic action along the in-plane direction of the wall nave were observed near the openings, in correspondence with the spandrels.

**Figure 4:** Deep cracks observable in the (a) internal and (b) external elevations of side walls [5]
