STRUCTURAL EVALUATION AND MAINTENANCE OF BROOKS AQUEDUCT HISTORIC SITE

ALIREZA ROUHI¹, NIGEL G. SHRIVE^{2*}

Keywords: Reinforced Concrete, Aqueduct, Structural Evaluation, Durability, Numerical Modeling, Damage

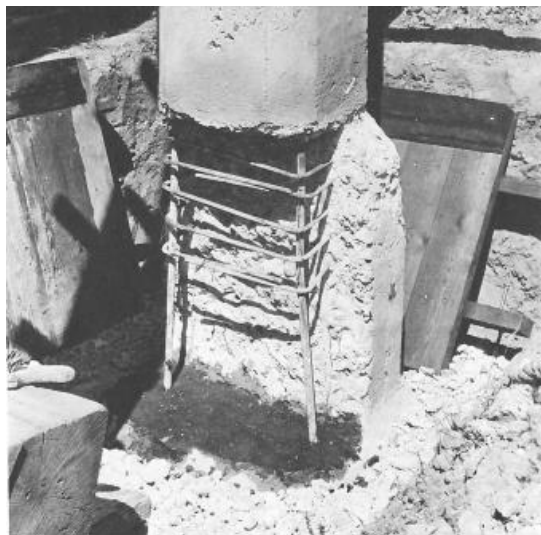
The concrete in the aqueduct has been subject to significant damage and deterioration since the early stages of operation (e.g.: Figure 3). The damage is mainly due to a lack of durability from issues unknown at the time of construction. Some of the most critical issues are a high water-cement ratio, lack of freeze-thaw resistance (air-entrainment), lack of proper cover over the steel, lack of pre-stressing of the concrete in tension areas such as the flume, inconsistency in the placement of rebars, alkali-silica reaction of the concrete in contact with the soil, lack of rebars in the footings, and poor grading of the aggregates (by today's standards) [3].

Figure 3 : Repair of footing – 1927 [3]

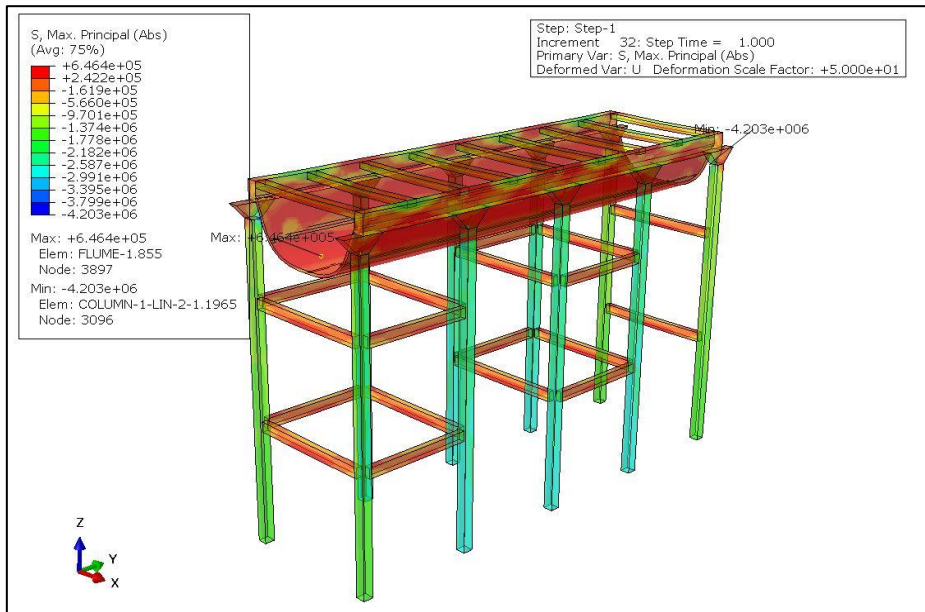
maximum principal stresses in the concrete are shown in Figure 4. The maximum compressive stress is 4.02 MPa, while the maximum tensile stress was found to be 0.58 MPa: both of these stresses are well below the strength of the concrete. Principal stresses in the flume and column caps are shown in Figure 4.

Figure 4 : Maximum principal stresses in concrete under normal loading conditions

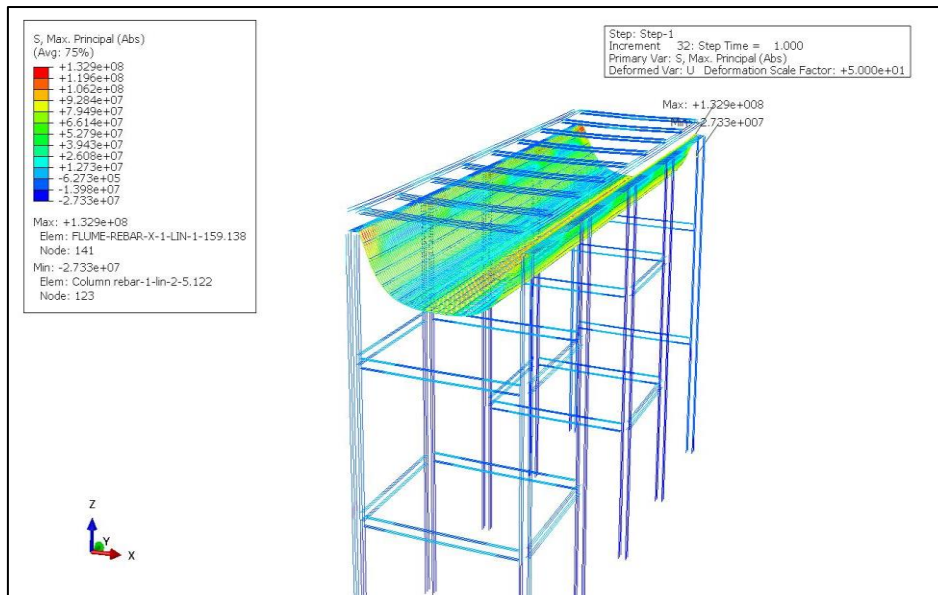
Axial stresses in the rebars are presented in Figure 5. The maximum rebar tensile stress is 140 MPa, and the maximum compressive rebar stress is 28 MPa which are also well below the yield strength of the reinforcement.

Figure 5 : Maximum principal stresses in rebars under normal loading conditions

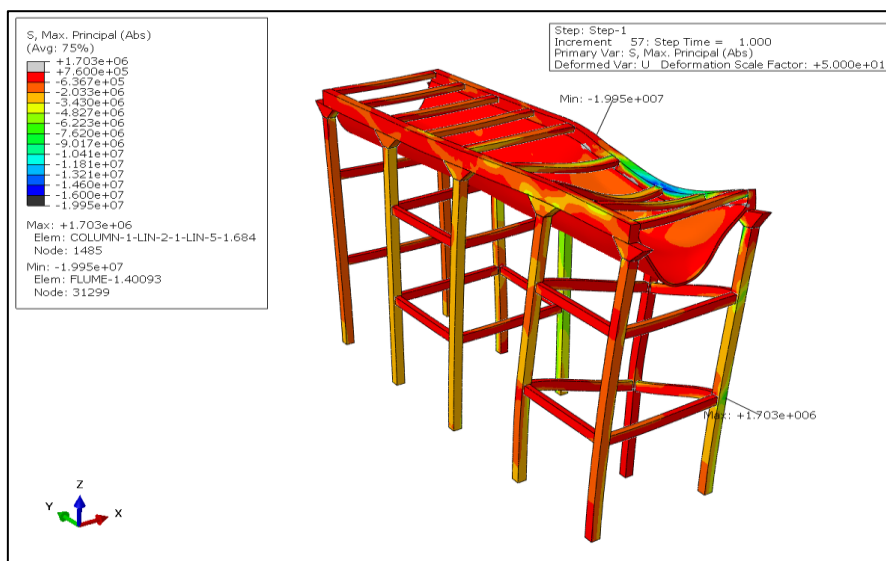
Differential settlement under one column can happen due to local poor soil conditions. This kind of settlement would induce displacements and stresses, and possibly cause damage to the structure. To evaluate the effect of such possible settlement on the structure, a 50 mm downward displacement was applied to each of the five columns on one side of the flume in turn. Because of the symmetry of the structure along the longitudinal centerline of the flume, the effect of the settlement of the columns on the other side of the flume will be the same. Results of the analysis due to the settlement at one column are shown in Figure 6 and Figure 7. The results show that except for very local areas due to the concentration of stresses in very small elements, the compressive and tensile stresses in the structure are well below levels that would cause damage despite imposing such a big and unusual settlement.

Figure 6 : Maximum principal stresses in concrete due to the 50 mm settlement at one column

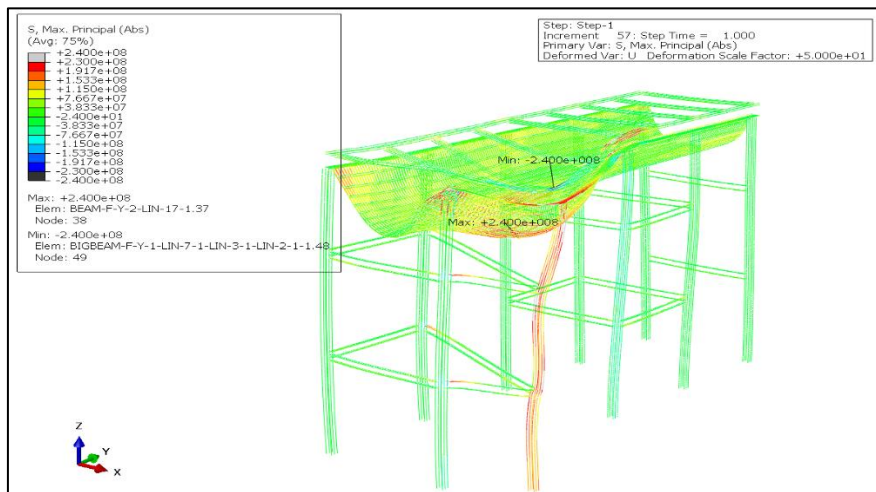
Figure 7 : Maximum principal stresses in rebars due to the 50 mm settlement at one column

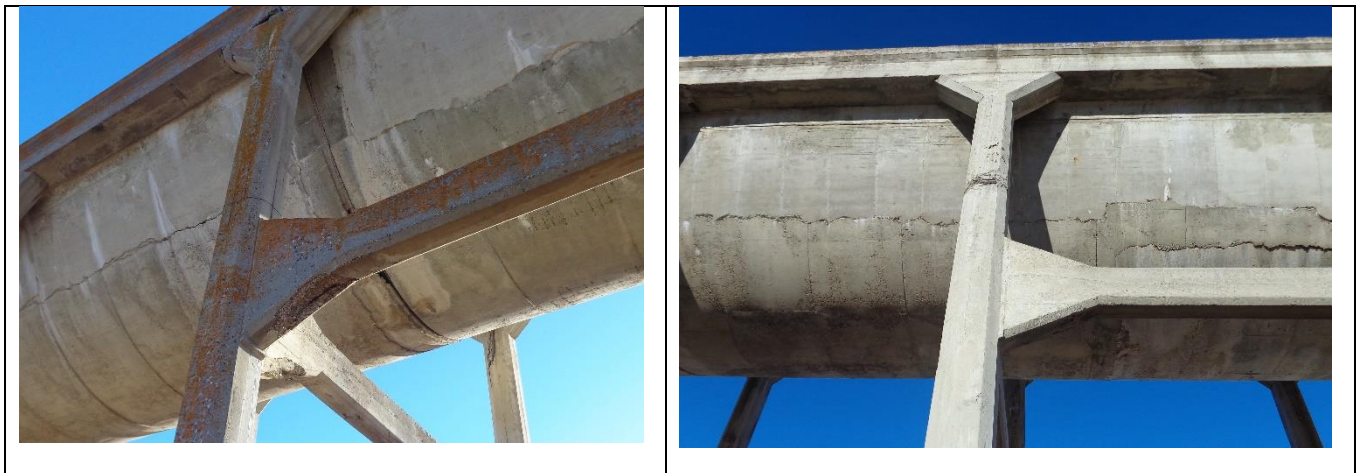
Creep in concrete is defined as an increase in strain in the concrete under sustained load. The creep rate is higher at higher temperatures and is accelerated with rapid heating as well as fast cooling. In the case of Brooks Aqueduct, the aqueduct has an east-west alignment, so the south side is exposed to more sun than the north side and is therefore subject to higher temperatures and less humidity than the north side. This is obvious from the extensive amount of lichen on the north side where more moist conditions exist, and the lack of lichen on the south side of the aqueduct (Figure 8). A possible effect of this situation is differential creep between the north and south columns of the aqueduct. This case was studied by imposing a 25 mm relative movement on the south side of the structure to represent the shortening of columns due to differential creep. The results of this analysis are shown in Figure 9 and Figure 10.

Figure 8 : Lichen on a column and beams on the north side of the aqueduct (left) due to the existence of more humidity and cooler temperatures compared the south side (right)

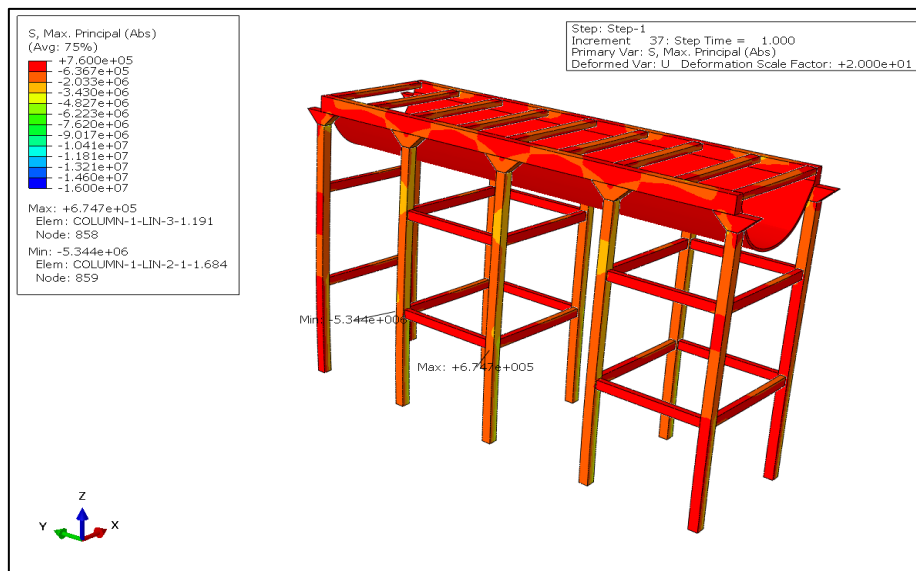
Figure 9 : Max. principal stresses in concrete due to settlement in all south columns

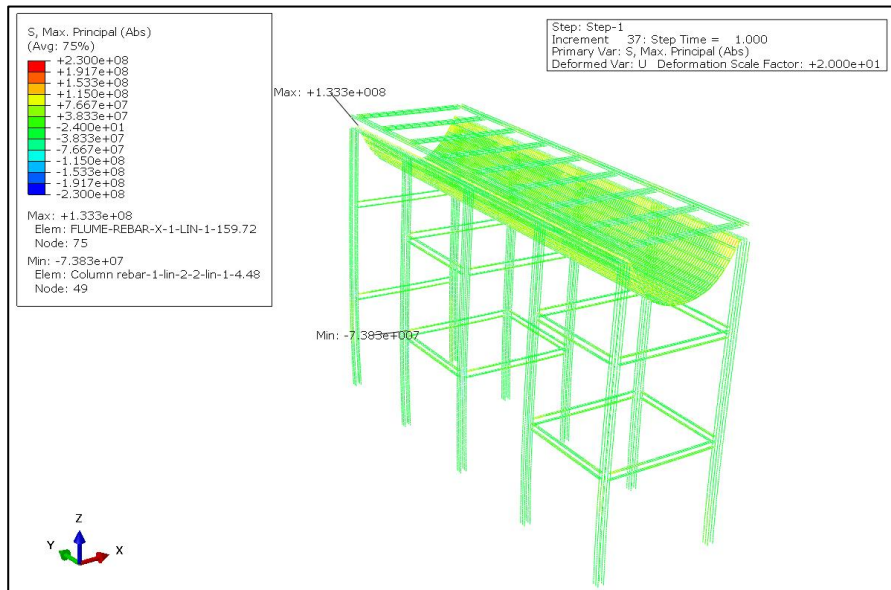
Figure 10 : Max. principal stresses in rebar due to settlement in all south columns

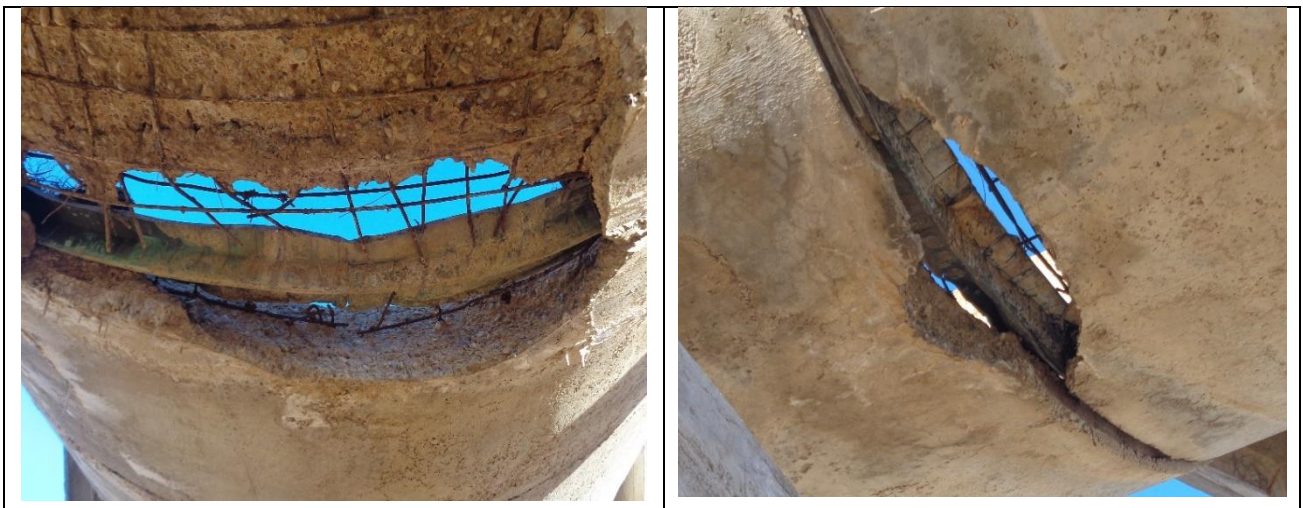
Based on the results of the analyses and comparing the results with the site inspections, it can be concluded that the most probable cause of deterioration of the concrete near the expansion joints is the infiltration of water through damaged joints and the consequence of the accumulated water in these areas freezing/thawing or corrosion of steel (Figure 11).

Figure 11 : Deterioration of flume at expansion joints

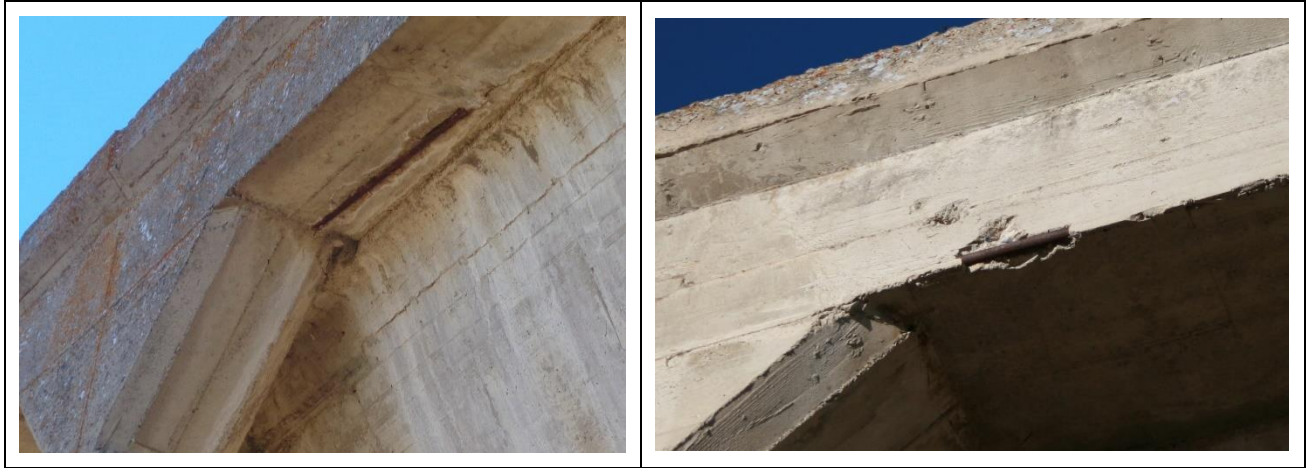
Corrosion of steel could have happened due to lack of adequate concrete cover, poor quality of concrete and poor workmanship in proper placement of the rebars in the concrete according to drawings and specifications. As shown in Figure 12, in some places, the reinforcing bars were placed at the edge of the concrete formwork and thus had little or no cover which makes them very vulnerable to corrosion and deterioration. Damage and deterioration of longitudinal beams at expansion joints are also shown in Figure 13.

Figure 12 : Lack of proper cover for concrete

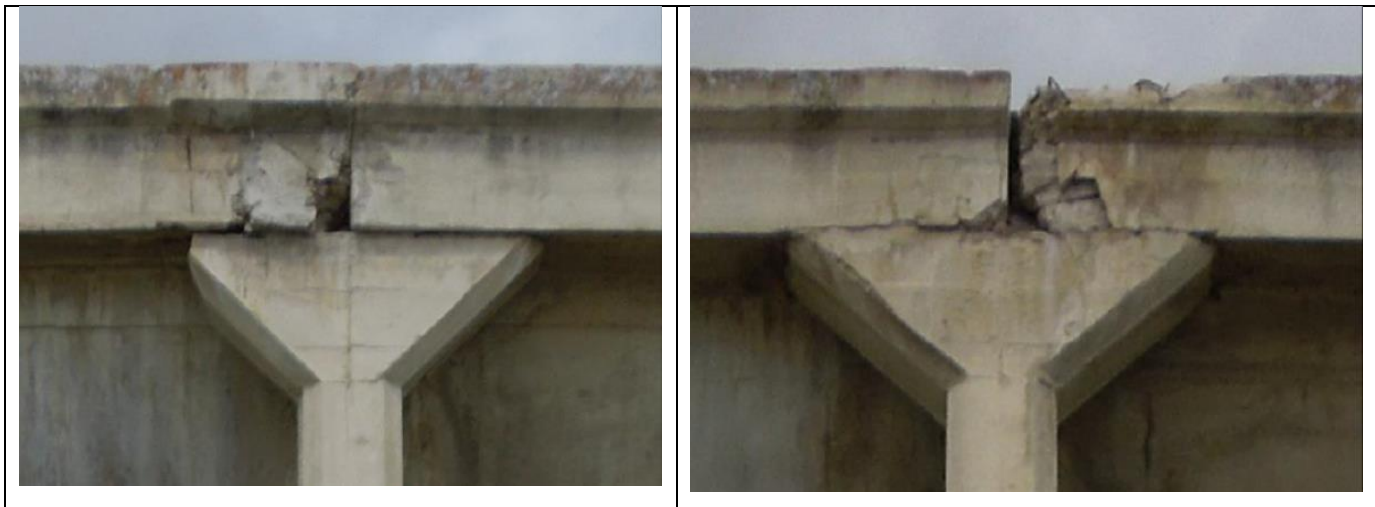
Figure 13 : Deterioration of longitudinal beams near expansion joints
