THE RESTORATION INTERVENTIONS OF “FORTE MARGHERA” IN VENICE

FILIPPO CASARIN¹, RICCARDO CIANCHETTI^{2*}, TOMMASO DALLA VIA²,
MARTINA MEGGIATO² AND MARCO MOCELLINI¹

Keywords: Venice Lagoon, military architecture, fort, Marghera

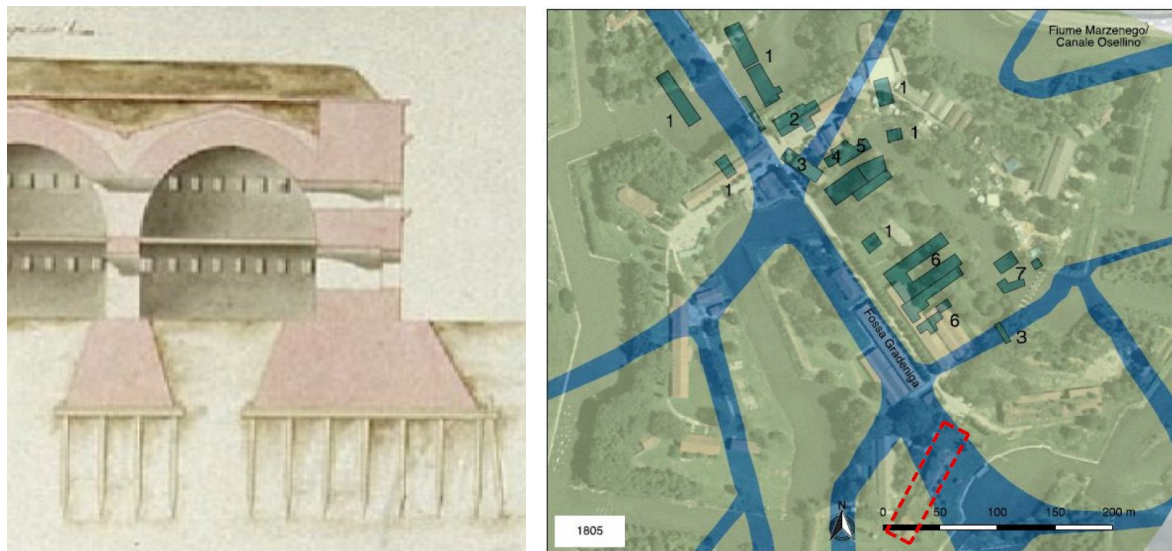
Figure 4: layout of the original French blueprint of the foundation of the head and inner transverse walls (left); map with indication of the palaeochannels in the area of Forte Marghera (right): highlighted in red building nr. 8

The investigations on the foundations and on the soil allowed to confirm the layout as represented in the historical blueprints, with some minor differences (e.g. the foundation width for the massive perimeter walls).

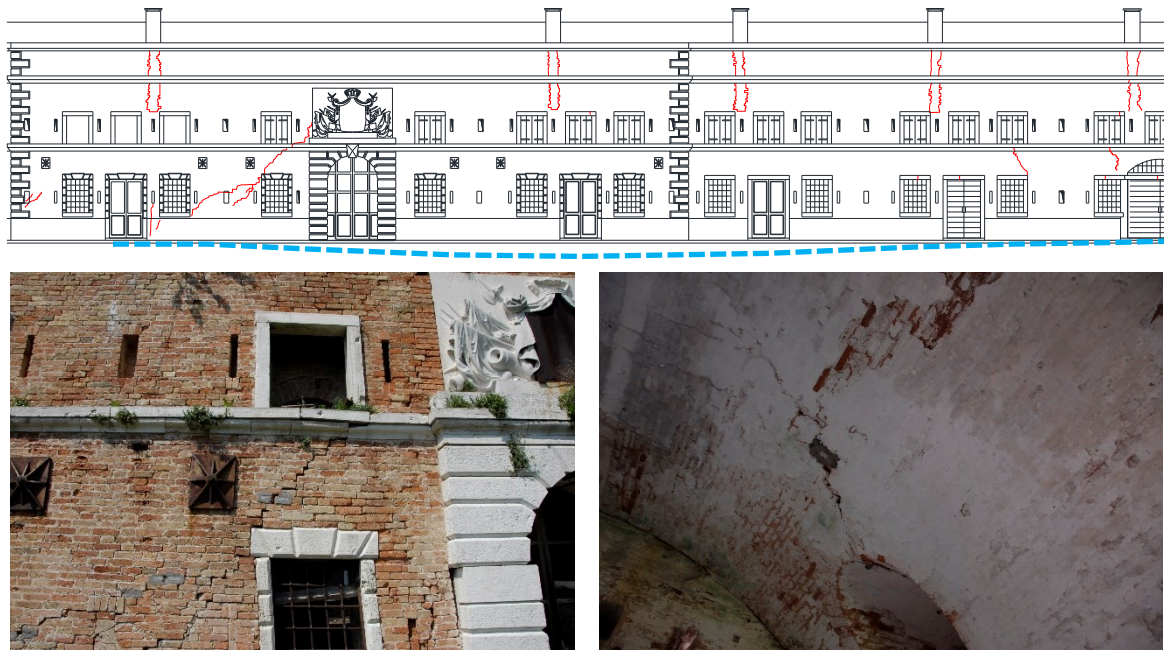
Building nr. 8 has an extensive cracking and deformation pattern, attributable to foundations' differential settlements. From the available documentation, it is noted that buildings 8 and 9 have very large masonry foundations, with the presence of wooden poles to intercept the deeper load-bearing layers (Figure 4, left). The study of historical hydrography has however shown that part of building 8 appears to have been partially built over a palaeochannel, subsequently filled with soil for the construction of the fort (Figure 4, left). A series of investigations were therefore executed to investigate the nature of the foundation soil in a widespread manner, in order to highlight any difference in the soil capacity or critical issues. A series of electrical piezocone penetration tests CPTu (n. 4 on the North side and n. 4 on the South side of bldg. nr. 8, plus nr. 4 tests along building nr. 9) were performed with depth variable between 15 and 30 meters, together with nr. 5 soil boring at a depth of 20 meters with undisturbed sampling for laboratory tests. Several excavations aimed at highlighting the foundations were also carried out, with execution of sub-vertical surveys aimed at the interception of wooden poles to a depth of 5 meters.

Figure 5: crack pattern in building nr. 8: it is highly visible a well-defined differential settlements trend

The penetrometric tests explained the differential settlements trend encountered in building nr. 9, given the visible change in the soil resistance between -2,0 ÷ -4,0 m, where the foundations / poles find support, between tests nr. 1, 2, 8 (denoting a certain capacity) and 3 to 7, remarkably weaker, approximately located in correspondence of the filled channel.

- Geotechnical tests were able to characterize the soil main parameters, stratigraphy and mechanical capacity, also explaining the visible differential settlements of the west barrack, most likely due to unsatisfactory soil compaction in the works of channel filling;

For the west barrack (nr. 8), considered the wide crack pattern and the marked trend of differential settlements, it is planned a strengthening intervention at the foundations level, in order to restore the safety conditions without considering the successive architectural restoration as for building nr. 9. Intervention will consist either on the improvement of the soil mechanic characteristics (e.g. jet grouting) or the insertion of a series of micropiles through the existing masonry foundations in order to connect them to the deeper and stiffer soil layer (over consolidated silty clay) named “caranto”. At the present time, the design outcome is still open: structural and geotechnical modeling will drive the intervention type.

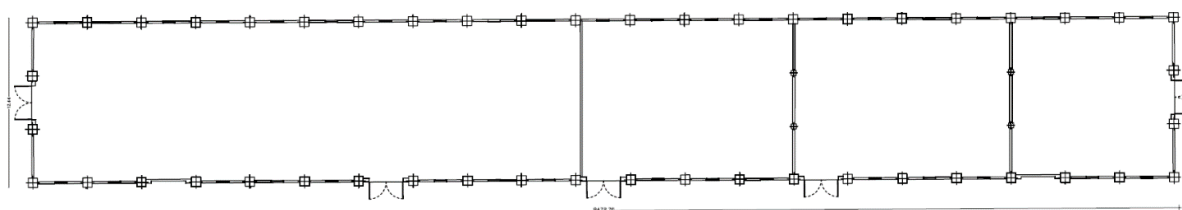
Figure 7: building nr. 29, plan view

The depot building nr. 29, built in the early twentieth century, has completely different structural characteristics (Figure 7). This building is made by squared masonry pillars (0.65x0.65m) spaced 4 meters, with bricks masonry single-leaf spandrel walls. It has an elongated rectangular shape, 12.5x85 m, one storey, with pillars high 3,30 m; the roof, currently collapsed, was a wooden pitched roof, with wooden trusses supported by masonry pillars.

The depot building (nr. 29) has very different structural characteristics: low thickness walls, one principal resistance direction, collapsed roof. The seismic analysis highlighted a good longitudinal behavior, thanks to very long and regular walls, but a high vulnerability in transversal direction. The limit analysis approach, implemented to define the stability of the masonry panels under the seismic actions, indicated a general unsafe situation, mainly for the very low thickness of the walls that are not retained by the roof structures.

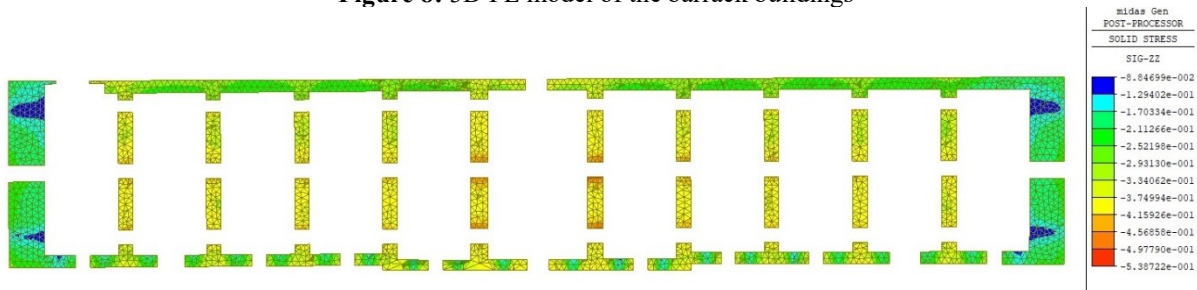
Results obtained in terms of σ_{ZZ} stress (compression) indicate that the average value of compressive stress at the ground level corresponds to approximately 0,4-0,5 N/mm² (**Figure 9**). Average compression stress on vaults is lower than 0,2-0,45 N/mm². The seismic behaviour of the building is characterized by the large thickness of masonry walls, which can easily absorb the seismic actions. The main vulnerability is due to the construction method of the facades, which are juxtaposed to the transversal walls and to the barrel vaults and may be subject to hammering effects. Out-of-plane vulnerability is connected only to non-structural elements, such as chimneys or stone cornices. Regarding the interaction between soil and foundation, considering only gravity loads, the inner walls, which are loaded by the vaults, present an average stress about 0,25 N/mm², instead in the longitudinal facades, which are loaded only by their self-weight, the calculated stress at the ground level is about 0,18 N/mm². This difference in soil stresses, due to the constructive discontinuity between facades and inner walls that do not allow any stress distribution, may have caused differential settlements, which may partially explain the actual crack pattern.

Figure 9: compression stress on masonry walls at the ground level

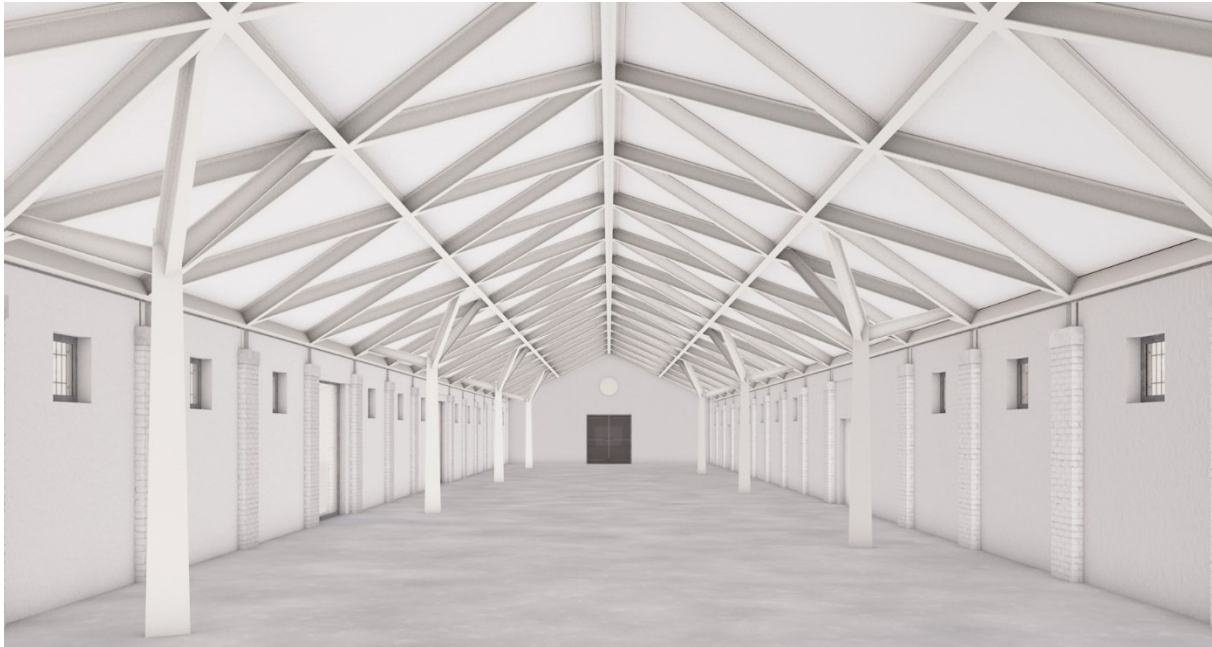
Figure 10: rendered view of the new steel roof structure

For the depot building (nr. 29), the complete collapse of the roof allowed to propose a new steel roof structure which contribute to the seismic retrofitting of the building at the same time leaving the internal space completely free and unitary so as to promote flexibility of use for temporary exhibitions. The steel structure is made by welded IPE profiles creating a global

reticular beam, acting in its plane as bracing system for the roof and for the masonry walls. Ten new steel columns act as static support for the roof structures and as seismic-resistant elements: the triangular shape columns are connected to the roof profiles by inclined branches, forming seismic portals, fixed at their basis, which can absorb both horizontal and seismic actions.

As for the original wooden roof, the structural function of the existing masonry pillars is maintained, using them as vertical support for the steel roof; the connection system is studied in order to transfer only vertical actions, avoiding horizontal thrust on masonry, using the original holes of the wooden trusses to center the roof load.

Roof steel elements collaborate with existing masonry walls for the seismic resistance, both in the transverse direction, through the façade walls which are enlarged and connected to the roofing structures, and in the longitudinal direction where the panels between pillars will be reinforced and will become bracing elements. These panels are therefore reinforced by:

- Connections to masonry pillars by the insertion of stainless steel rebars, completely hidden inside the mortar joints;
- Reconstruction of the upper part of the walls, currently collapsed, with reinforced masonry (steel rebars inserted inside the mortar joints);
- Application of steel reinforced strips (FRCM) on the internal side of the panels, using lime mortar, in order to confer tensile resistance to the masonry.
