VULNERABILITY ASSESSMENT OF ITALIAN RATIONALIST ARCHITECTURE: TWO CASE STUDIES

Abstract. *The work is focused on the structural vulnerability assessment of two historical constructions, chosen as case-studies representative of a recurrent typology of Italian rationalist architecture, dating back to the Fascist period, often hosting public offices. Both examined buildings have similar dimensions and geometry, being characterised by five/six storeys and by an almost square plan with an inner courtyard, and are located in Emilia-Romagna, in zones of medium seismic hazard. The older building, dating back to the Thirties and located in Ravenna, has a mixed masonry-reinforced concrete structure, while the other one, built in the late forties and located in Parma, is characterised by an unreinforced masonry structure with some limited reinforced concrete elements. For the vulnerability assessment of the two buildings, a multi-disciplinary approach was followed, including the historical documents search concerning both the investigated buildings and the surrounding areas, the detailed geometrical and structural survey, the identification of materials, and in situ and laboratory tests to e

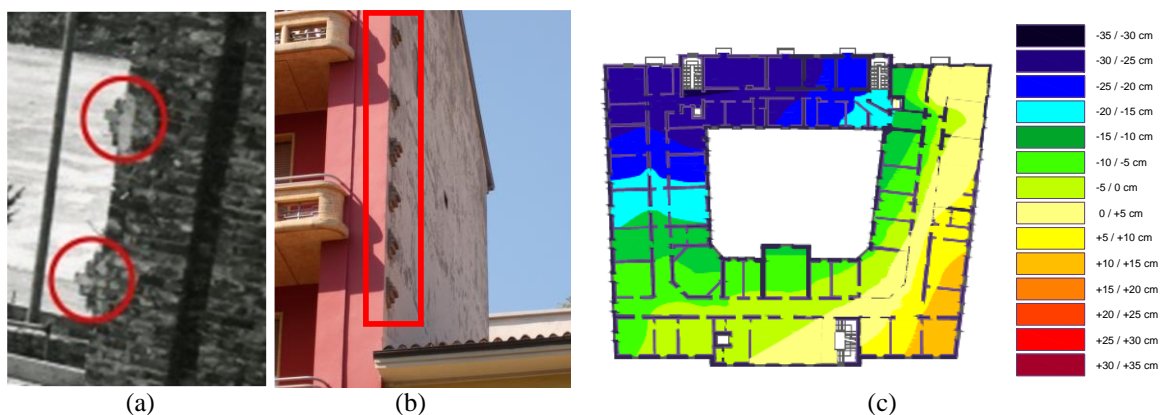
Figure 4: (a) Detail of the connection technique adopted in MagisPo building, with overhanging masonry teeth; (b) application of a similar technique in another coeval building nearby; (c) differential settlements at the third level of the building, as resulting from in-situ surveys

This Section provides a general overview of performed activities, common to both the investigated structures, while the following subsections deepen the specific choices related to each single case study. For the two considered buildings, a complete geometric and architectural survey was first performed. Despite the availability of the historical drawings, several discrepancies were found indeed between the original drafts and the present appearance of both palaces. For the MagisPo building, a detailed topographic survey of the differential settlements at different floors was also carried out (Fig. 4c), in order to compare it with the one carried out before the retrofit intervention.

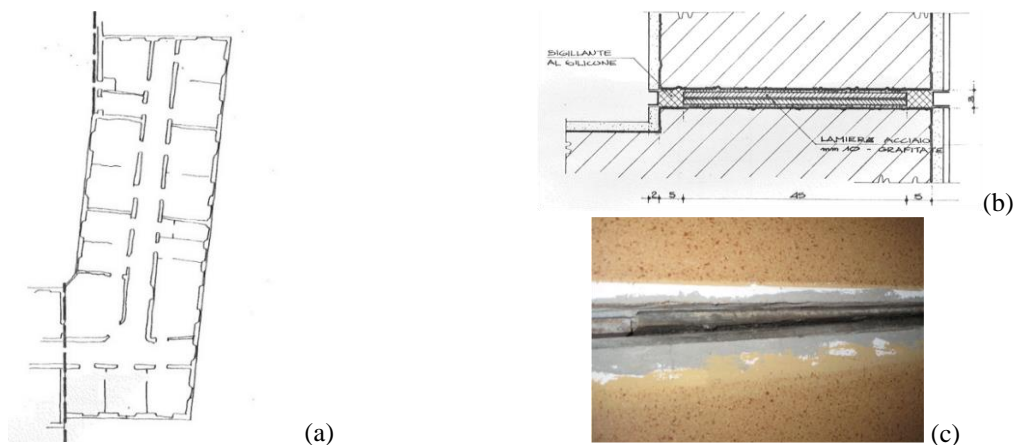
Figure 5: (a) Static joint separating the East wing from the rest of the building; (b) sketch and (c) realization of the joint

Different models were considered for both the structures examined. Besides a general model of the whole building (Fig. 14), other possible scenarios were investigated, based on the relevant information collected for each case study. For the MagisPo, the behavior of the two portions separated by the joint (realized during the retrofitting intervention dating back to the '80s) was also investigated. It was generally found that the weaker direction for the building under seismic action was that parallel to the main façades, for the presence of two RC frames at the ground floor, interrupting the continuity of shearwalls. Another problem highlighted in the analyses was represented by masonry spandrels, which were weakened by the presence of niches hosting the shutters and the heaters. The return period of the maximum seismic action sustainable by the whole building was found to be slightly lower than 350 years, while it was almost halved when considering the building split into two independent portions. However, this latter scenario seems to be less realistic, since documental findings and in situ survey have proved that the joint between the two parts is more effective with regards to vertical loads than horizontal ones.

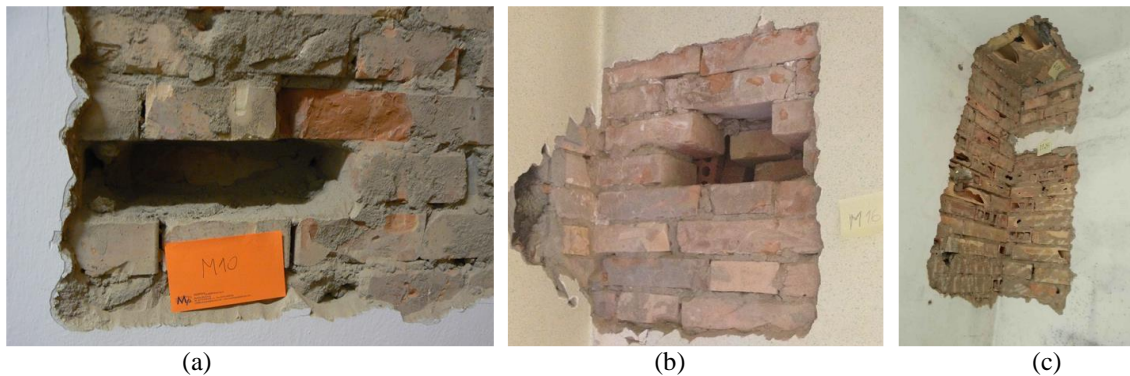
Masonry walls are generally constituted by solid bricks and lime mortar, but hollow bricks were also found at the upper levels of the building (see Fig. 10c). Most of the floors are realized with RC joists and interposed hollow clay blocks, with a 50 mm unreinforced concrete deck. The floor right above the main entrance is instead characterized by a bidirectional grid of RC joists with two layers of interposed hollow clay blocks (Fig. 9b), while the two rooms near the corners of the building, between the ground and the 1st floor, are covered by a lightened slab with radial reinforcement.

Figure 10: Removal of plaster portions at different locations of the Guilds' Palace: (a) internal masonry wall at the 1st floor; (b) connection between two perpendicular external walls at the 2nd floor; (c) connection between perpendicular walls and the ceiling at the 5th floor

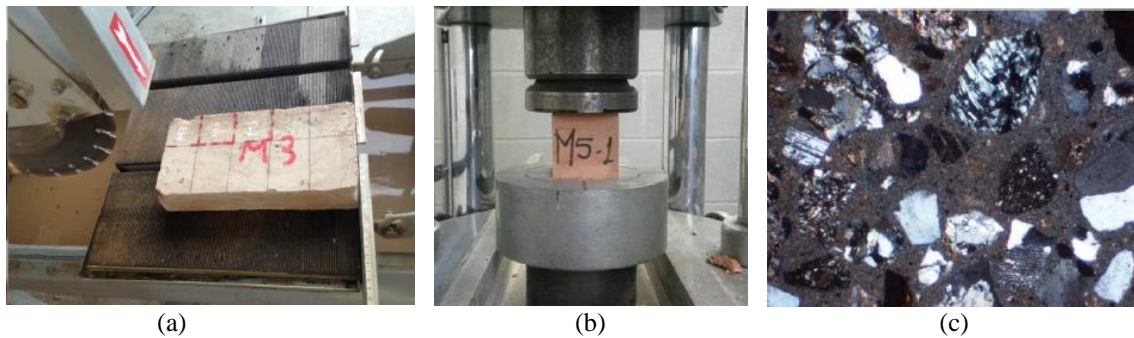
Figure 11: (a) Cutting operations to obtain cubic samples from the removed solid brick; (b) execution of compression test on cubic sample; (c) image of a mortar sample at the optical microscope

Compressive tests were carried out on cubes with 50 mm side obtained from bricks extracted from the building walls (approximately 4 or 5 cubes for each brick, Figs. 11a,b). These tests provided an average strength value of 23 MPa. Lower compressive strengths were found for those samples taken from the underground level, where different, lower quality bricks, characterized by a paler color, were used. From laboratory tests, mortar was classified as poor. A masonry pier located at the underground floor was chosen to perform a double flat jack test (Fig. 13d), which provided a masonry compressive strength value of about 2.4 MPa. This value corresponds to the minimum value suggested in the commentary document [8] joined to the current Italian Code [9] for the category “solid brick masonry with lime mortar”. Considering an intermediate level of knowledge [9, 10] achieved through the in situ survey, and taking into account that the results of the double flat jack test were referred to the masonry with the poorer

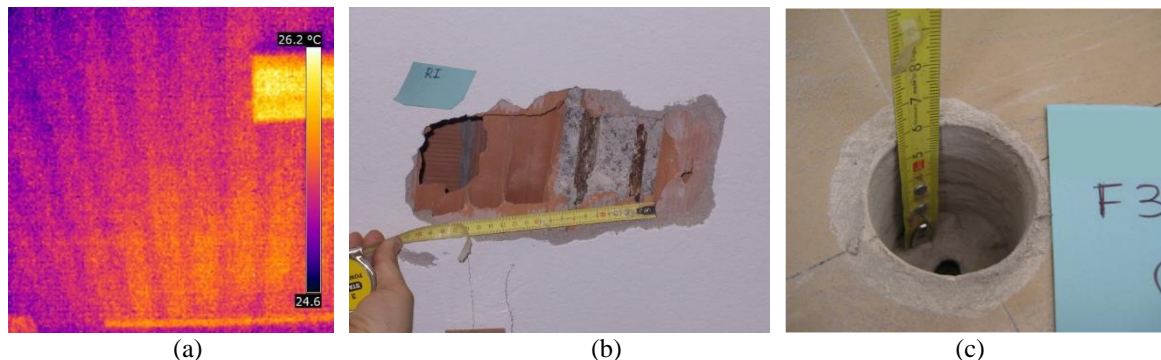
Figure 12: In situ survey on floors: (a) thermographic analysis; (b) removal of plaster layer and concrete cover; (c) core drilling at floor extrados

The direction and typology of floors were checked by means of visual inspections and non-destructive techniques, like thermographic (Fig. 12a) and pacometric analyses, supported by semi-destructive local essays (Fig. 12b), consisting in the removal of plaster layer and concrete cover, and in the measurement of rebar diameters and spacing. Floor stratigraphy was deduced by means of coring at floor extrados (Fig. 12c), while its thickness was measured by performing small drill cores. Similar techniques were also adopted for RC elements (beams, concrete ring

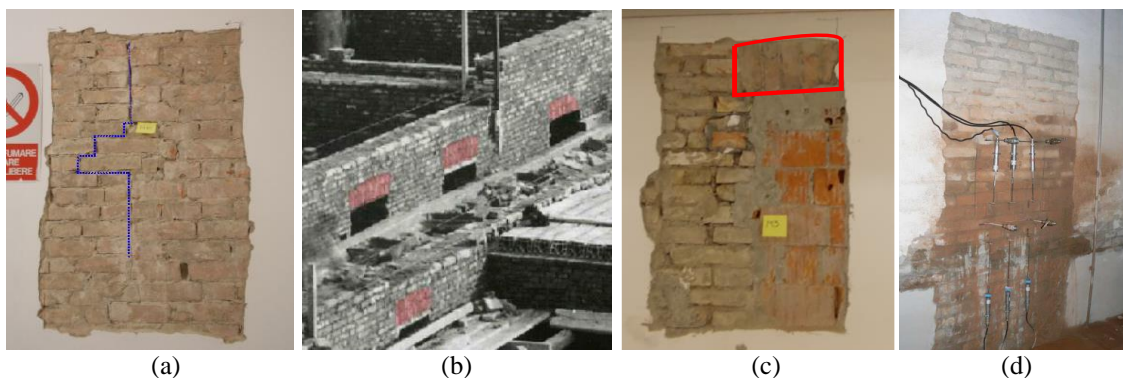
Figure 13: In situ survey: (a) connection between two wall portions realized at different times; presence of flat arches above the openings at the underground floor from (b) historical photos and (c) direct essays; (d) double flat jack test on a masonry pier of the underground floor
