How to reduce craters in the painting process of a PIM company?

Gustavo Rodrigues Guimarães;Dr. Jonas Gomes da Silva;Dr. Mariana Sarmanho de Oliveira Lima

Dept. of Industrial Engineering, Federal University of Amazon (UFAM)

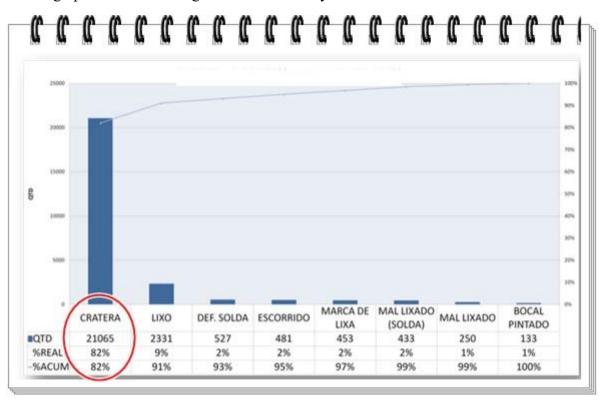
Figure 4: Q Number of Tank Painting defects in February 2012.

The choice of the crater defect as the main defect to be studied was made from the analyzes in the sector that showed that this defect corresponded to the highest index among all problems, as shown in Figure 4, with the Pareto graph of Tank Painting defects of February 2012.

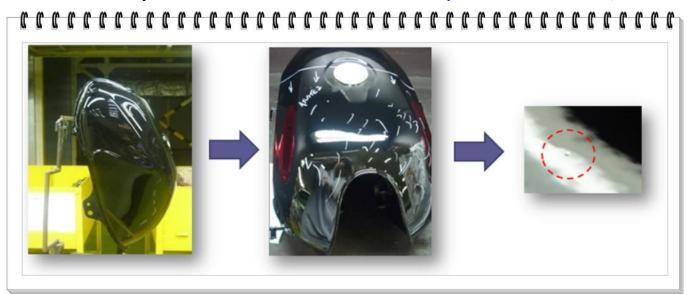
Figure 5: Crater defect feature Source: Author

The defect occurred in all fuel tank models and all colorings, and in black coloration models, the defect was clearer. One of the characteristics observed was that the crater always occurred at the top of the tank, as can be seen in Figure 5.

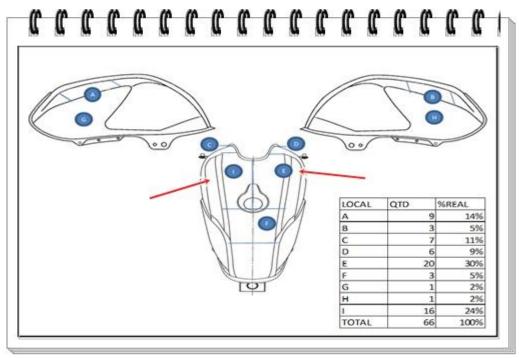
Figure 6: Fuel Tank Pictographic Analysis Source: Author

A pictographic analysis of the fuel tank was made, where 10 varnished pieces of random models and colorings were analyzed. The amount of defect per piece was found to be an average of 66 craters, concentrated in regions I and E, as shown in Figure 6.

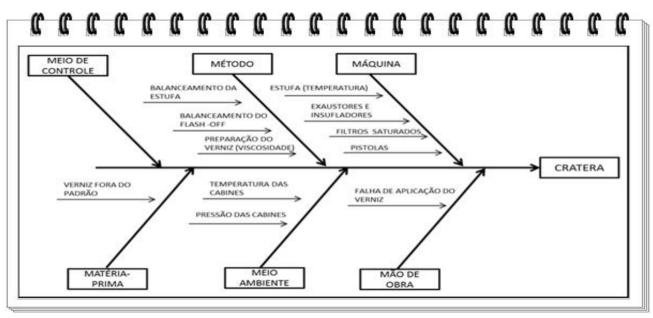
Figure 7: Potential Causes of Crater Defect

According to observations made and the staff's experience of the painting process, eleven possible causes

were raised for the problem as illustrated in Figure 7.

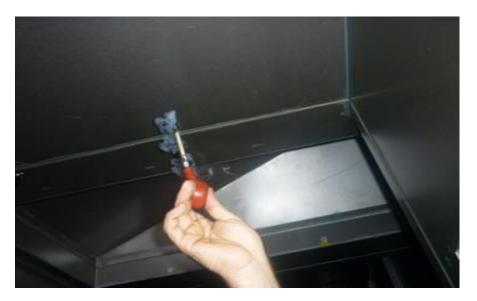
Figure 8: Air Balancing Analysis Source: Author

The second step was to analyze the air balance within the flash-off generated by the Insufflator and Exhaust. For this, a tool was used that generates smoke less dense than air, allowing to verify its direction (Figure

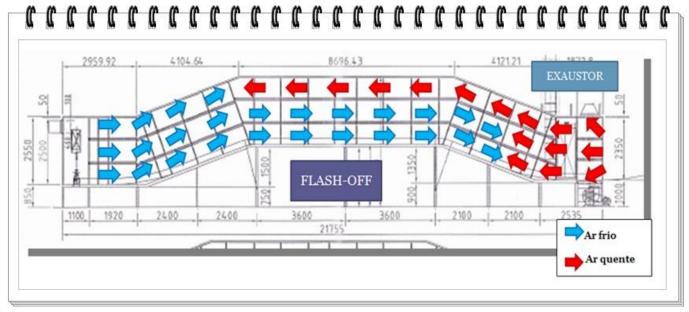
Figure 9: Air balance inside Flash-off analyses.

Regarding the balance within the flash-off, it was verified that the hot air generated by the greenhouse was entering the flash-off, as shown in Figure 9.

From this analysis, a hypothesis was raised for the appearance of the crater defect. The warm air from the greenhouse being less dense than the cold air would flash in from the top and this would cause the tank varnish to heal faster in the upper region.

Thus, when passing through the greenhouse, the upper region of the tank would have greater difficulty in releasing the solvents contained in the varnish, thus generating the craters.

Upon the hypothesis raised, actions were defined to contain the crater defect. The first action was to regulate the inflator shut-off valve so that more cold air was thrown into the flash-off. The second action was to regulate the exhaust shut-off valve so that hot greenhouse air would no longer enter the flash-off and no cold flash-off air would enter the greenhouse, which would decrease efficiency equipment and may cause other problems in painting. The plan has two actions and is described in Chart 3.

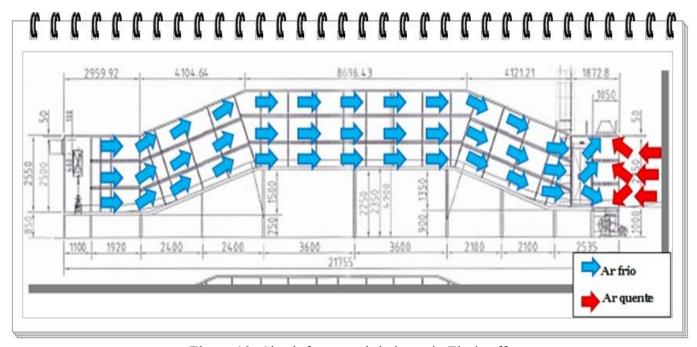
Figure 10: Check for new air balance in Flash-off.

With the planned actions, the flash-off and greenhouse air balancing were as described in Figure 10.

With the new balancing, it was found that warm greenhouse air no longer entered the flash-off and neither cold flash-off air entered the greenhouse, as shown in Figure 11.

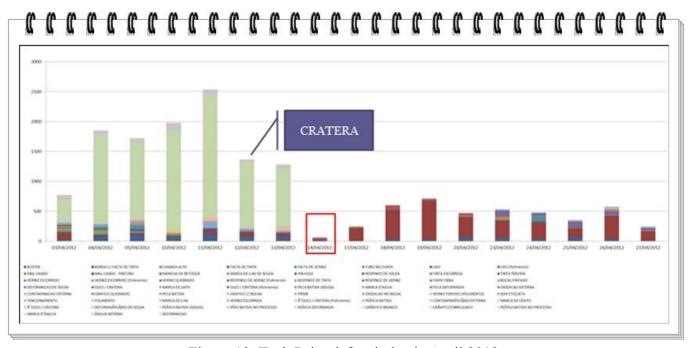
Figure 12: Tank Paint defect index in April 2012.

Analyzing the production data of the Varnish Line on the days following the actions performed, it was observed that the crater defect no longer appeared among the largest defects of the Line (Figure 12).
