# Thermal failure in a clamping bolt of a shunt reactor

This article presents the detection and analysis of a thermal failure produced in a core clamping bolt of a 5 MVAR gapped three-phase shunt reactor. Gases were detected in this shunt reactor during its operation at a substation in Mexico. Using dissolved gas analysis (DGA) and Duval's triangle method, temperatures up to 700°C were estimated in the shunt reactor. Overheating evidence was detected in one of the core clamping bolts during an internal inspection of the shunt reactor. The author and the reactor manufacturer believe that

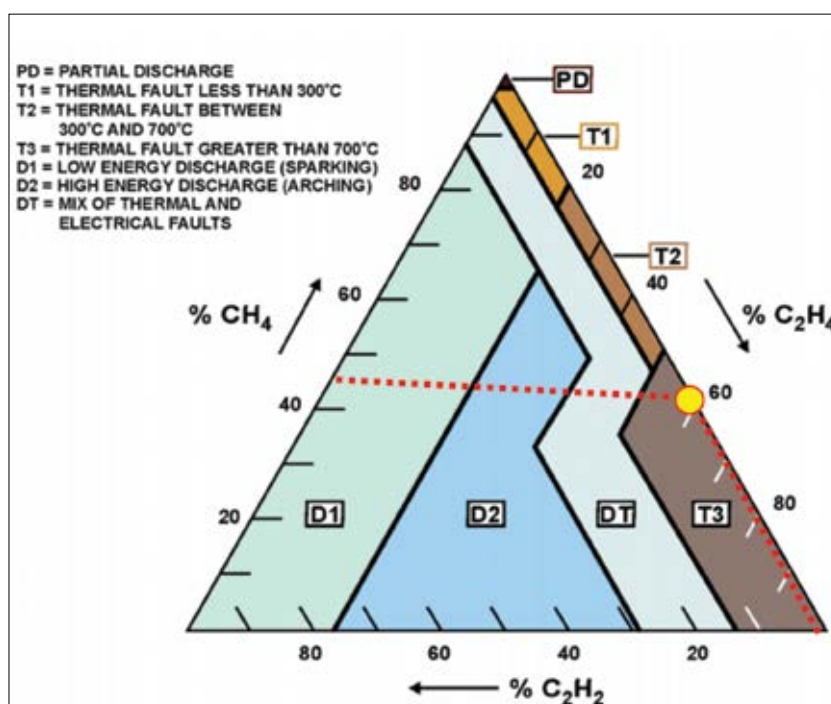
Figure 1. Identification of the thermal fault in the shunt reactor using Duval's triangle method

hydrogen (H<sub>2</sub>), ethylene (C<sub>2</sub>H<sub>4</sub>), acetylene (C<sub>2</sub>H<sub>2</sub>), and methane (CH<sub>4</sub>) were detected in the shunt reactor, indicating the presence of a possible high-temperature fault. Table 2 shows the dissolved gas analysis (DGA) results obtained in the shunt reactor [9]. A thermal fault was confirmed using Duval's triangle method and the DGA results of Table 2. From Duval's triangle, a thermal fault type T3 was diagnosed in this shunt reactor, see Figure 1. A thermal fault type T3 indicates a failure in insulating oil and/or paper above 700 °C with evidence of carbonized oil, with metal coloration or melting. The possible causes for these thermal faults could generate overheating regions, partial discharges, and sustained electric arcs [11]-[13]. Despite the detection of gases in the shunt reactor, the Mexican electric utility company and substation operators decided to run the failure of the shunt reactor, which never fully occurred.

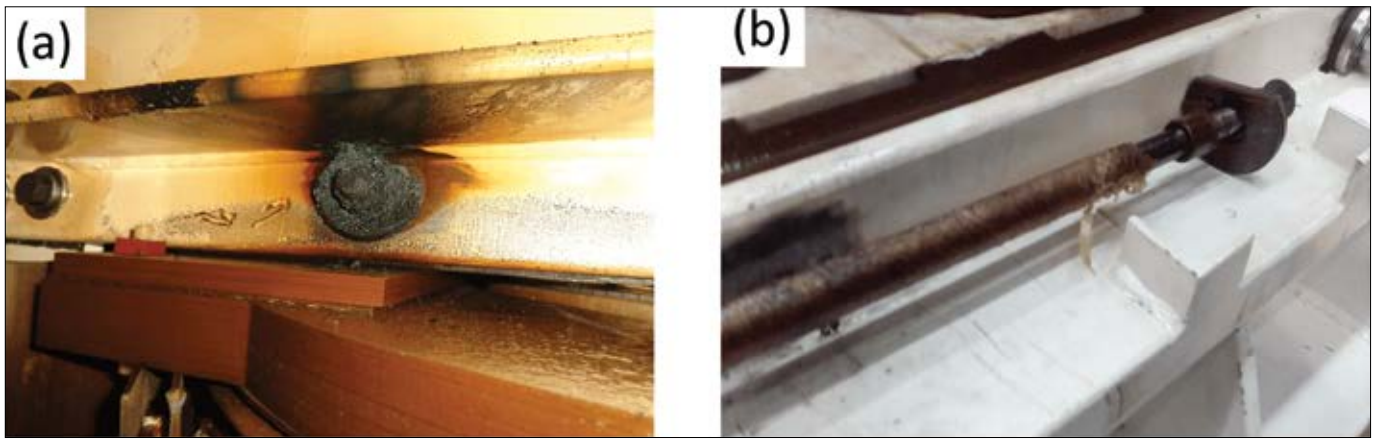
## Visible signs of overheating were found in the region of one of the non-magnetic stainless steel clamping bolts in one of the top low-carbon steel clamping frames of the shunt reactor

The carbonized residue of insulation was found around the bolt region, with more found on the top coil region. The clamping bolt was removed from the top frame, and the manufacturer discovered that an important part of the insulation along the bolt had been damaged and destroyed, leaving the bolt bare, see Figure 2 (b). Generally, several layers of insulating paper are employed to insulate the clamping bolts from the core yokes and frames. The insulation along the bolt prevents possible contact between the bolt and the core frames and contact between the bolt and the magnetic core laminations. The author and manufacturer believe that the main cause of the damaged bolt insulation was produced by the loosening of the bolts produced by the vibration of the shunt reactor in conjunction with a low torque applied to the bolts during the tightening process [14]. The reactor vibration loosened the clamping bolt, damaging and destroying its insulation and producing a short circuit between the core frame and the bolt, generating the circulation of a high current in the bolt and generating high temperatures in the bolt-frame region. Thermal faults have been detected in high-voltage shunt reactors due to vibrations [15], [16].

Figure 2. a) Bolt and frame with signs of overheating, b) insulation of the bolt destroyed [9]

Based on the simulation results, the manufacturer decided to repair the shunt reactor, reinforcing the insulation of all the stainless-steel clamping bolts with several layers of fiberglass to prevent future short-circuit failures. In addition, the manufacturer replaced all the pressboard spacers with thick fiberglass spacers, and a bolt torque of 57 Nm was verified for all the bolts during the tightening process. Finally, the temperature of the repaired shunt reactor was monitored and tested in the high-voltage laboratory before shipping the shunt reactor to the customer.

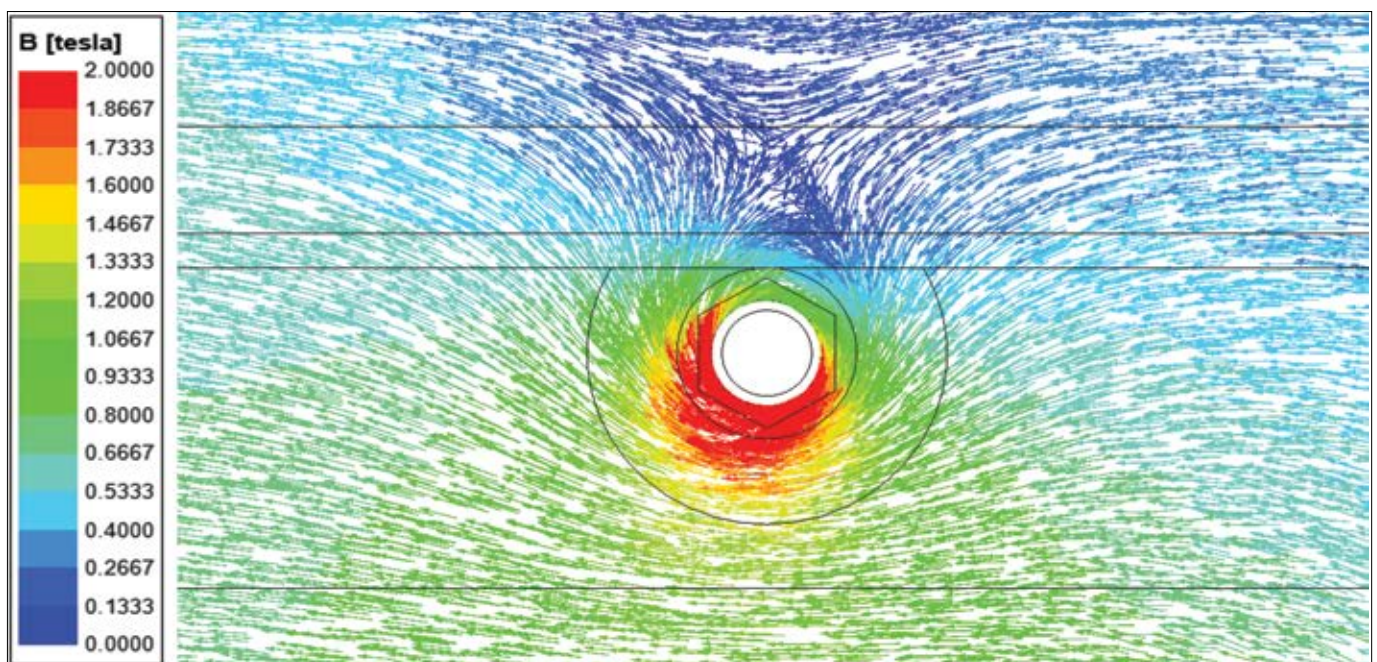
them. For this reason, these bolts are omitted in the model of Figure 3. A current density of 130 A/cm<sup>2</sup> and a short circuit current of 160 A were computed in the clamping bolt under short circuit conditions. This current circulates in the bolt, passing through the magnetic core holes. This current produces a small and saturated region with a magnetic flux density of 2 T around the magnetic core holes, see Figure 4.

Figure 4. Magnetic field distribution in the magnetic core region around the magnetic core hole

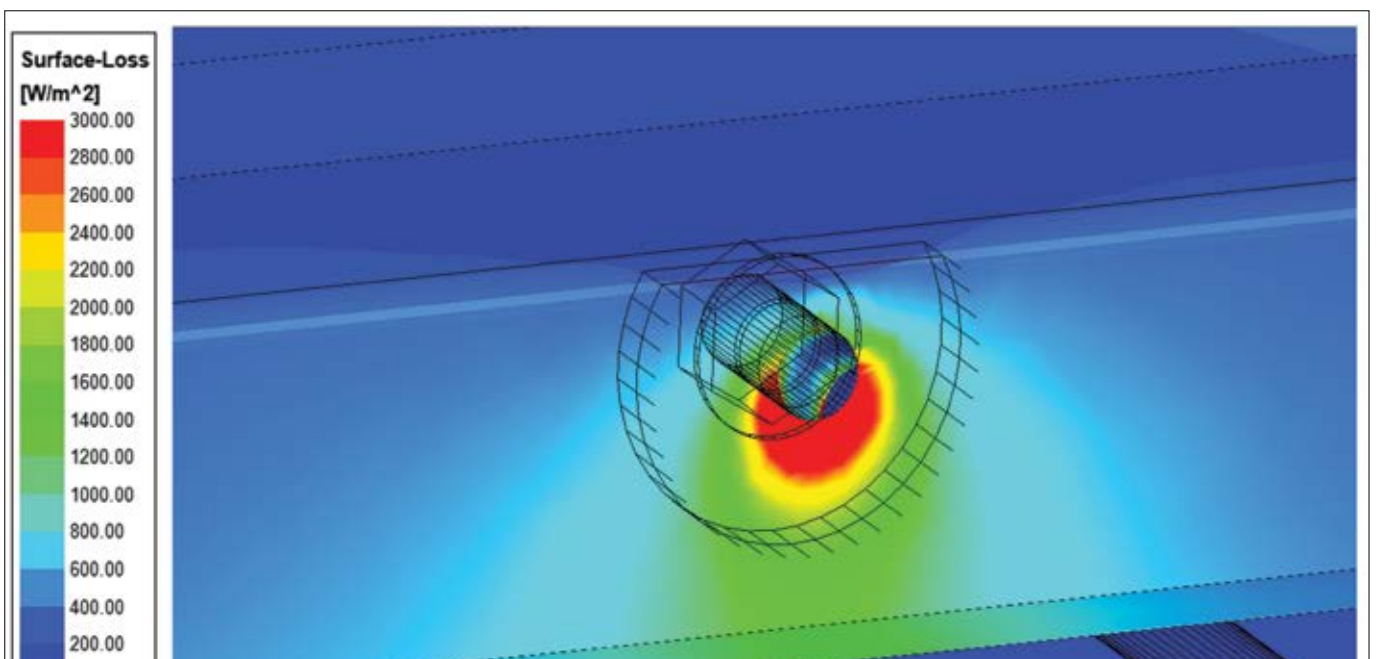
Figure 5 shows the loss density distribution in the clamping frame region. A maximum loss density of 3000 W/m<sup>2</sup> was computed in the frame region in the bolt-hole region. Figure 6 shows the current

Figure 5. Loss density distribution in the bolt-frame region

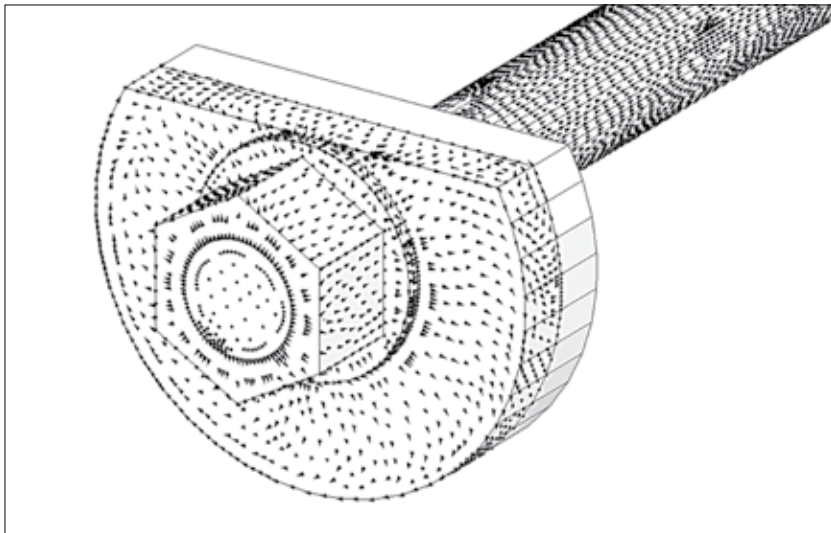
**A current density of 130 A/cm<sup>2</sup> and a short circuit current of 160 A were computed in the clamping bolt under short circuit conditions**

Figure 6. Short circuit currents circulating in the clamping bolt

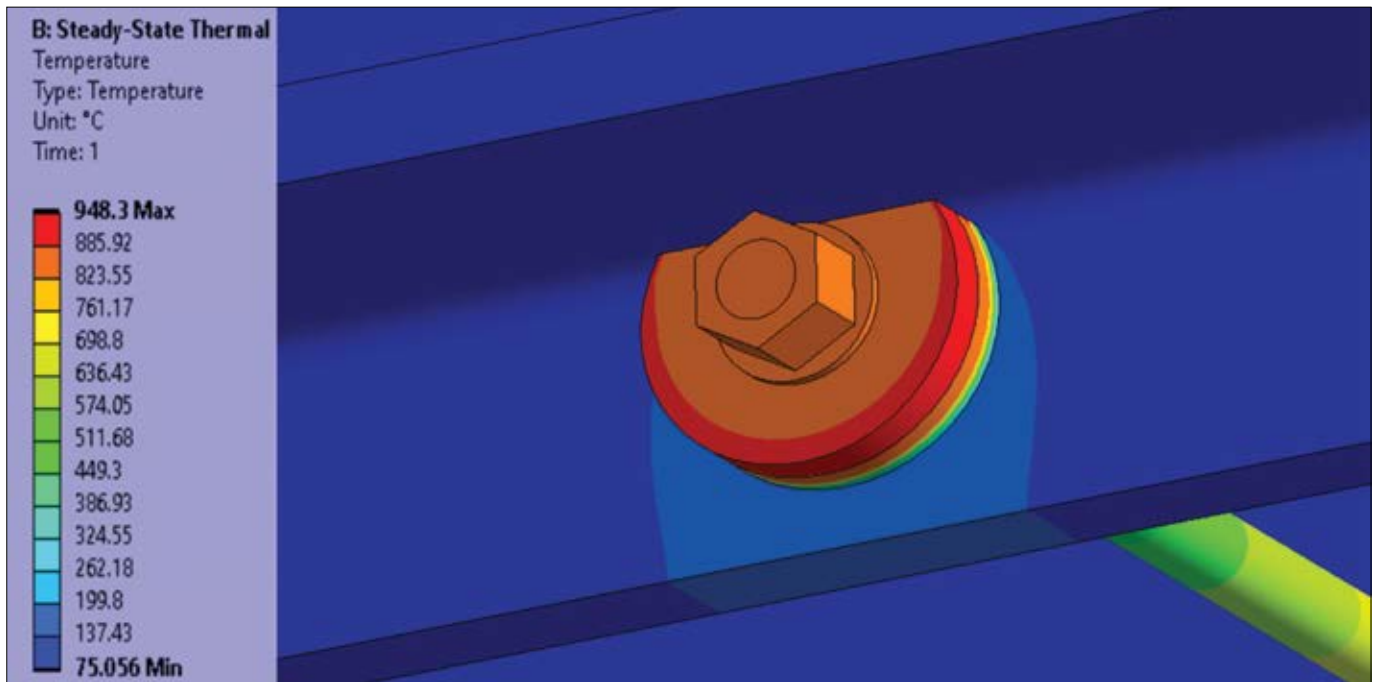
Figure 7 shows the temperature distribution during the presence of the short circuit current in the clamping bolt. The bolt reached an average temperature of 850 °C and a maximum temperature of almost 950 °C. The poor circulation of the oil in the bolt-magnetic core region helped to increase the temperature of the bolt.

Figure 7. Temperature distribution in the clamping bolt and frame region
