## RESEARCH BY DIRECT METHODS OF THE BASE METAL OF MAIN CIRCULATION PIPELINE OF THE POWER UNIT 3 OF THE SOUTH UKRAINE NPP AFTER 200 THOUSAND HOURS OF OPERATION

*R.L. Vasilenko, S.V. Gozhenko, Y.A. Krainyuk, O.G. Rudenko*

*National Science Center “Kharkov Institute of Physics and Technology”, Kharkiv, Ukraine*

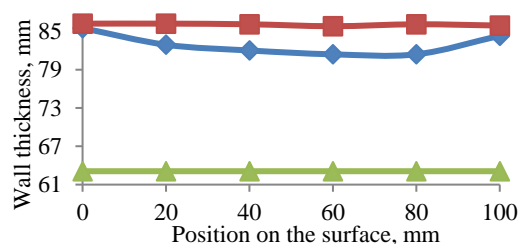
*Fig. 2. Thickness of the wall of the bend in the area of cutting out the BM sample from the MCP of unit 3 of the South Ukraine NPP: —▲— normative; —■— initial; —◆— after sampling*

It can be seen from the figure that the residual thickness of the pipe wall is greater than the normative one. The cutting of the BM sample did not affect the operational characteristics of the MCP.

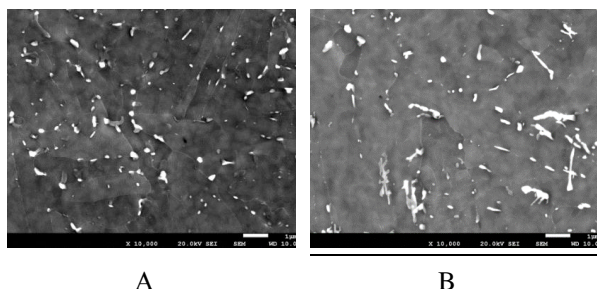
**A** **B**  
 Fig. 3. The surface of the BM of:  
 A – after 100 thousand hours of operation;  
 B – after 200 thousand hours of operation

The examination at higher magnification showed that the secretions are located both on the borders of the grains and in their bodies. Moreover, the size of allocations along the grain boundaries increases during the operation of the MCP. Based on the research conducted during the last 100 thousand hours of operation in the BM, the number of discharges (larger than 80 nm) decreased by  $\approx 33\%$  while simultaneously

increasing their average size by  $\approx 39\%$  (increasing the cross-sectional area of discharges).

It is natural to assume that there is a merger of already existing allocations and an increase in their size due to the migration of individual elements from the body of BM grains (in particular, carbon).

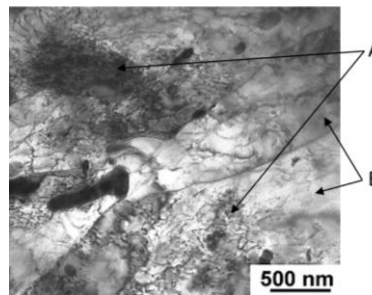
Studies of the structure of BM in a transmission electron microscope showed that in individual grains after 200 thousand hours of MCP operation, there is a significant increase in the density of dislocations relative to the average level (Fig. 4).

Fig. 4. The structure of the BM of the MCP after 200 thousand hours of operation:

A – a cluster of dislocations; B – BM grains

On the background of light grains, the allocation in the form of globular dark particles is clearly visible. The ratio of components in the composition of particles can change, but at the same time they can be characterized as complex carbides.

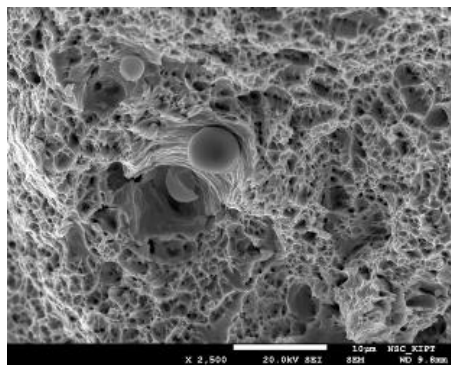
Fig. 5. Relief of the central fracture zone of the sample of BM of the MCP after tensile tests at 20 °C

The fracture surfaces after all mechanical tests of samples of BM of the MCP are characterized by a pitted relief, areas with faceted relief were not detected. The destruction has a viscous intragranular character.
