Effects of Ground Failure on Bridges, Roads, and Railroads

The long duration and strong velocity content of the motions produced by the 27 February 2010 Maule earthquake resulted in widespread liquefaction and lateral spreading in several urban and other regions of Chile. In particular, critical lifeline structures such as bridges, roadway embankments, and railroads were damaged by ground shaking and ground failure. This paper describes the effects that ground failure had on a number of bridges, roadway embankments, and railroads during this major earthquake. [DOI: 10.1193/1.4000024]

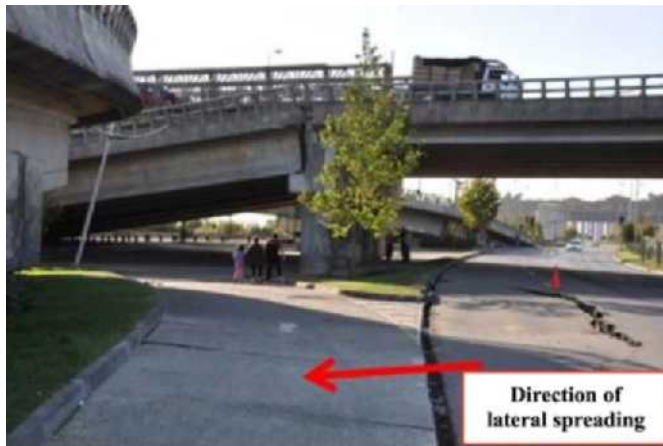
lane of Calle Nueva road and continuing hundreds of meters northward and southward along a pedestrian walkway (Figure 5). Calle Nueva parallels the riverbank and runs under the bridge approach. Lateral spreading toward the river caused sufficient displacement to unseat the west and eastbound bridge deck (Figure 4). Closely spaced (0.1 m

Figure 4. Deck unseating at Llacolén Bridge in Concepción. Cracking resulting from lateral spreading is visible on right side of photo. View north ($S36.830380^{\circ}$ $W73.067541^{\circ}$).

to 0.2 m on center) flexural cracks on the riverside face of the 1.5 m diameter support columns were observed near the ground surface. The distribution of flexural cracking was more severe for those columns supporting the unseated deck; however, all columns at the north riverbank support experienced flexural cracking at their construction joint

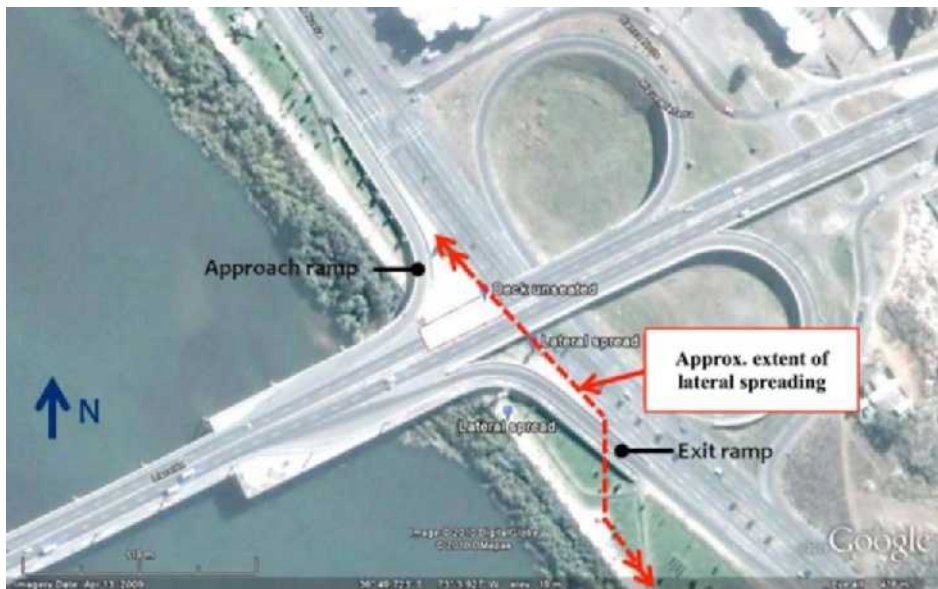
Figure 5. Plan view of the north approach to the damaged Llacolén Bridge in Concepción ($S36.830108^{\circ}$ $W73.067991^{\circ}$).

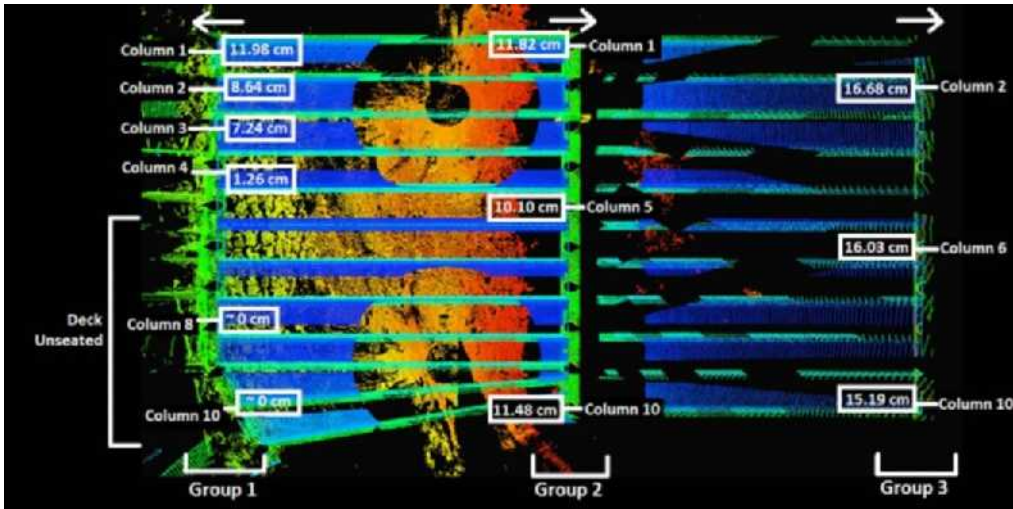
Figure 6. LIDAR measurements at the north end of Llacolén Bridge: Relative horizontal displacement of the columns with respect to their bases.

(between 2 m and 2.5 m above ground surface). Ground settlement of 0.25 m to 0.30 m also occurred at each of the exit ramp bents. According to FHWA (2011), the nearby ground settled up to 0.4 m and experienced significant shaking, resulting in a 0.25 m separation between the columns and the surrounding ground. Terrestrial LIDAR measurements, performed after the earthquake (Kayen 2012), show that the relative horizontal displacement of the columns with respect to their bases varied from 0 cm and 12 cm away from the river at the columns in the shoreline support, while the second and third rows of columns experienced a rather uniform displacement of their upper ends of 11 cm and 16 cm, respectively, toward the river (Figure 6).

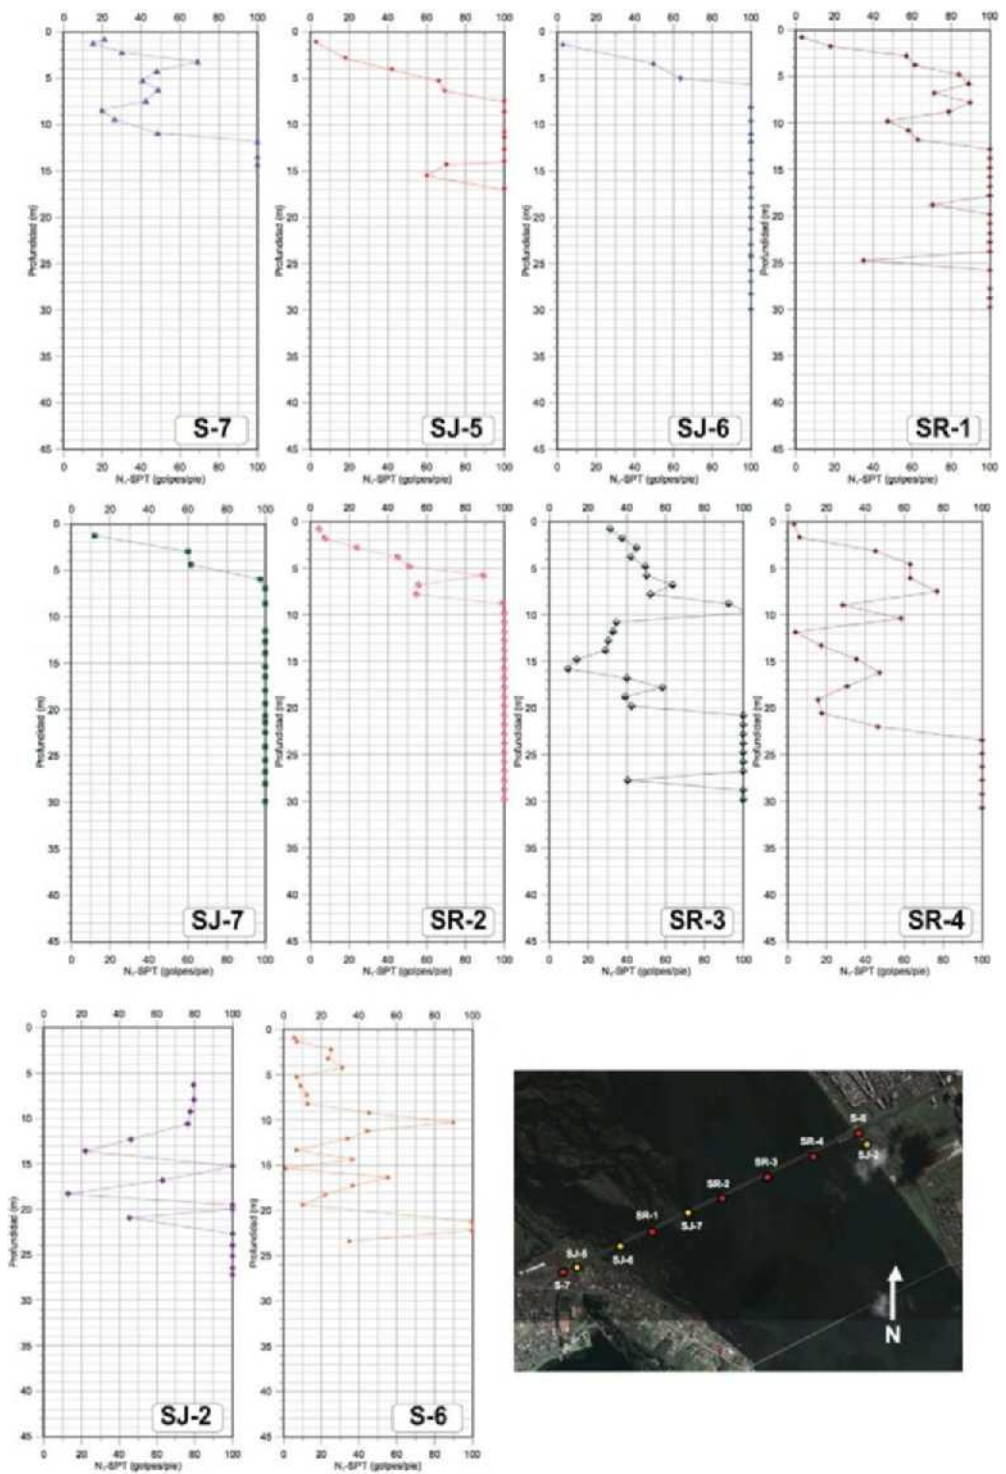
As a measure of liquefaction susceptibility, the sand liquefaction triggering relationship of Youd et al. (2001) can be used to define a normalized SPT threshold value for the occurrence of liquefaction. The recorded peak ground accelerations in downtown Concepción were about 0.4g (Boroschek et al. 2010), and assuming that these soils may have a fines content on the order of 5% to 15%, an average stress reduction coefficient of about 0.9, a magnitude scaling factor of 0.75, and a σ_v/σ'_v ratio of about 2, the Youd et al. (2001) procedure estimates that sands with normalized SPT values below approximately 30 blows/foot were likely to liquefy during this event. Figure 7 shows that liquefiable soils were present along the Llacolén Bridge at many depths especially within the upper 3 m to 5 m. At the north approach, where earthquake-induced damage was concentrated, Boring S-6 indicates that liquefiable soils were present in the upper 8 m to 9 m of the soil deposit.

Figure 7. Normalized SPT values and boring locations at Llacolén Bridge. Pre-earthquake data (Verdugo and Peters 2010). “Profundidad (m) = Depth (m),” “(golpes/pie) = (blows/foot).”

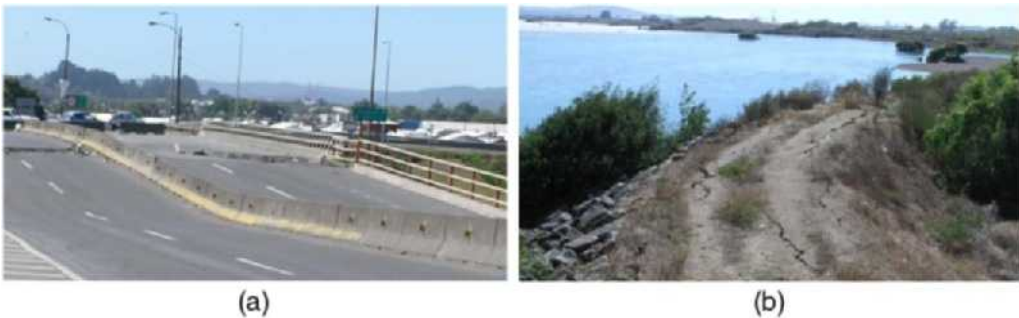
During the earthquake, the bridge suffered severe damage and was closed to the public. Liquefaction and lateral spreading at the northeast approach resulted in significant damage to the bridge superstructure (Figure 9). Most notably, liquefaction caused large settlements at several support piers and lateral displacement of the bridge deck. Visual inspection of the surrounding soils indicated the presence of fine loose sands. Several sand boil deposits with

Figure 9. Juan Pablo II northeast approach: (a) Settlement of bridge deck near bridge approach (view East, S36.815900° W73.084064°); (b) lateral spreading of northeast approach embankment.

diameters in the order of 1 to 10 meters were observed near the structure on both sides of the approach embankment.

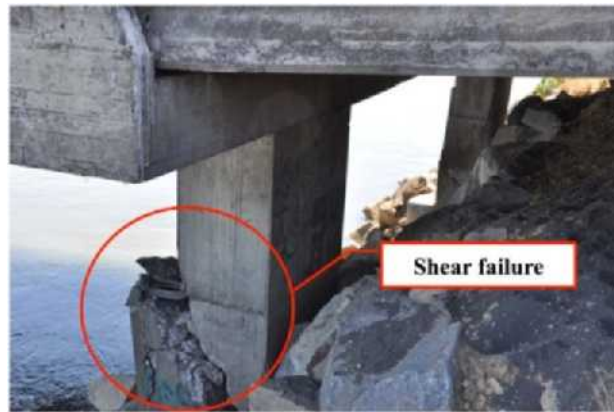
Column shear failure, vertical displacements of the bridge deck of up to 1 m, and rotation of the bridge bent of 1° to 3° occurred at the northeast approach. Figure 10 shows the shear failure of the column facing the bent's south side. The north column, also shown in Figure 10,

Figure 10. Juan Pablo II Bridge northeast approach: (a) Column shear failure, looking west, $S36.816233^\circ$ $W73.084144^\circ$; and (b) rotation and lateral displacement of bridge bent, looking east, $S36.816233^\circ$ $W73.084144^\circ$.

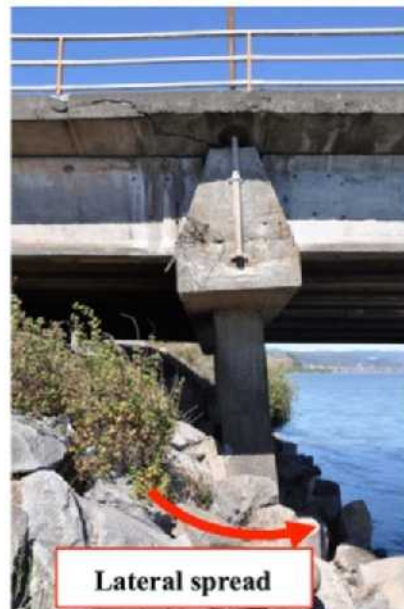
(b)

exhibited tension cracks and rotation as well as shear failure. In contrast with the damage observed at the northeast approach, the southwest approach suffered minor damage. This may be due to a combination of different soils conditions and more gentle slopes observed at the southwest approach.

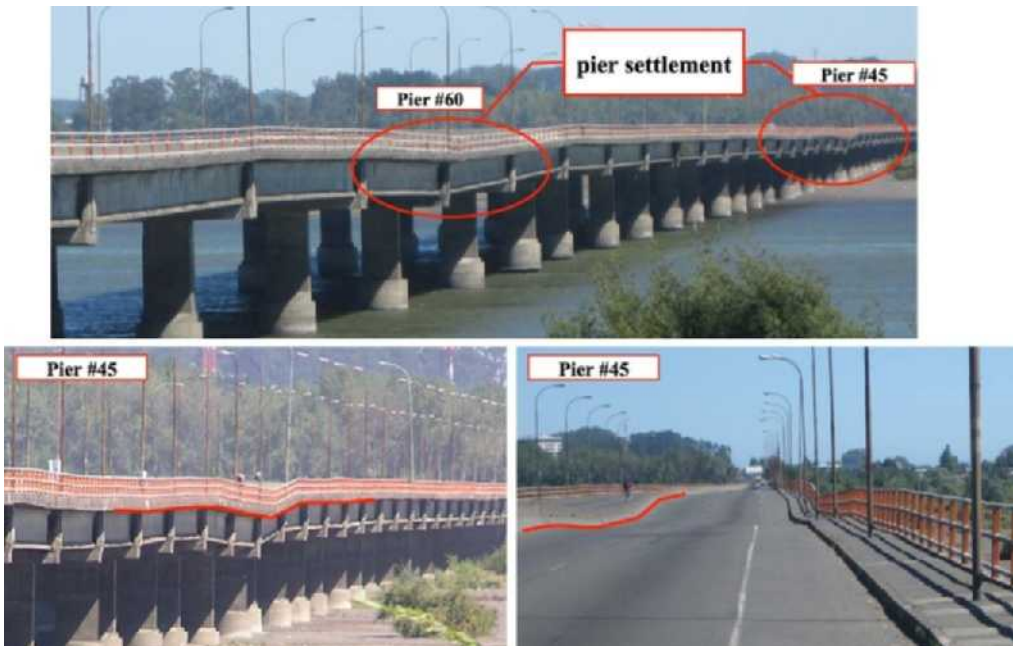
Pier settlements of 0.4 m to 1.5 m were observed at several locations along the length of the bridge (Figure 11). Vertical settlements appeared to be due to liquefaction of the soil near the pier foundations. Short pier foundation depths on the order of 16 m (in contrast to 22 m for the Llacolén Bridge) may also have contributed to these settlements. Visual inspection of the surrounding soils indicated the presence of loose sands near the surface. Although the Bío-Bío River was once navigable by ship up to the City of Nacimiento, over-logging during the twentieth century led to heavy erosion, choking the river with silt, and rendering it impassable to ship traffic. Near Concepción, the river behaves as a meandering river with fine-grained material deposited on the floodplains.

Settlements on the order of 0.6 m to 0.8 m were observed in piers #45 and #60, as indicated in Figures 11 and 12. The bridge deck accommodated these settlements with large vertical deformations, however relatively minor damage of the asphaltic layer was observed. As Figure 12 shows, settlements of piers #45 and #65 were larger on the upstream side, indicating rotation of these bents about the longitudinal axis of the bridge. This is consistent with the observations made by FHWA (2011): "... the spans of the main bridge also appeared to have experienced uneven support settlement, which tilted the columns and rotated the bridge deck about the centerline of the bridge." Soil in the vicinity of the

Figure 11. Juan Pablo II Bridge. Pier settlements (Pier #0 corresponds to San Pedro end).

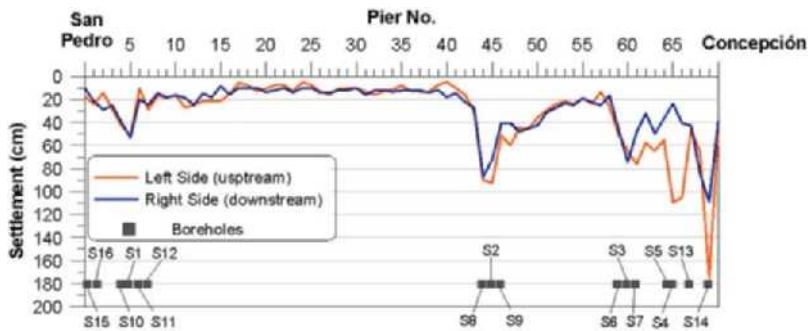
Figure 12. Juan Pablo II Bridge. Pier settlements and boring locations (Verdugo and Peters 2010).

piers showed evidence of ejected water and sand, while soil immediately surrounding the pier was depressed with standing water covering an annular zone around the pier. These observations are supported by the SPT profiles obtained after the earthquake along the bridge, shown in Figure 13, where the white color corresponds to non-liquefiable sands, green is for soils with a high content of non-plastic silts (termed as “non-liquefiable” in the report), and red is for liquefiable sands, according to the criteria used by Verdugo and Peters (2010) in their geotechnical report. Using the 30 blows/foot criterion discussed in the previous section, distinct layers of liquefiable material can be observed on the geotechnical cross-section along the Juan Pablo II Bridge.

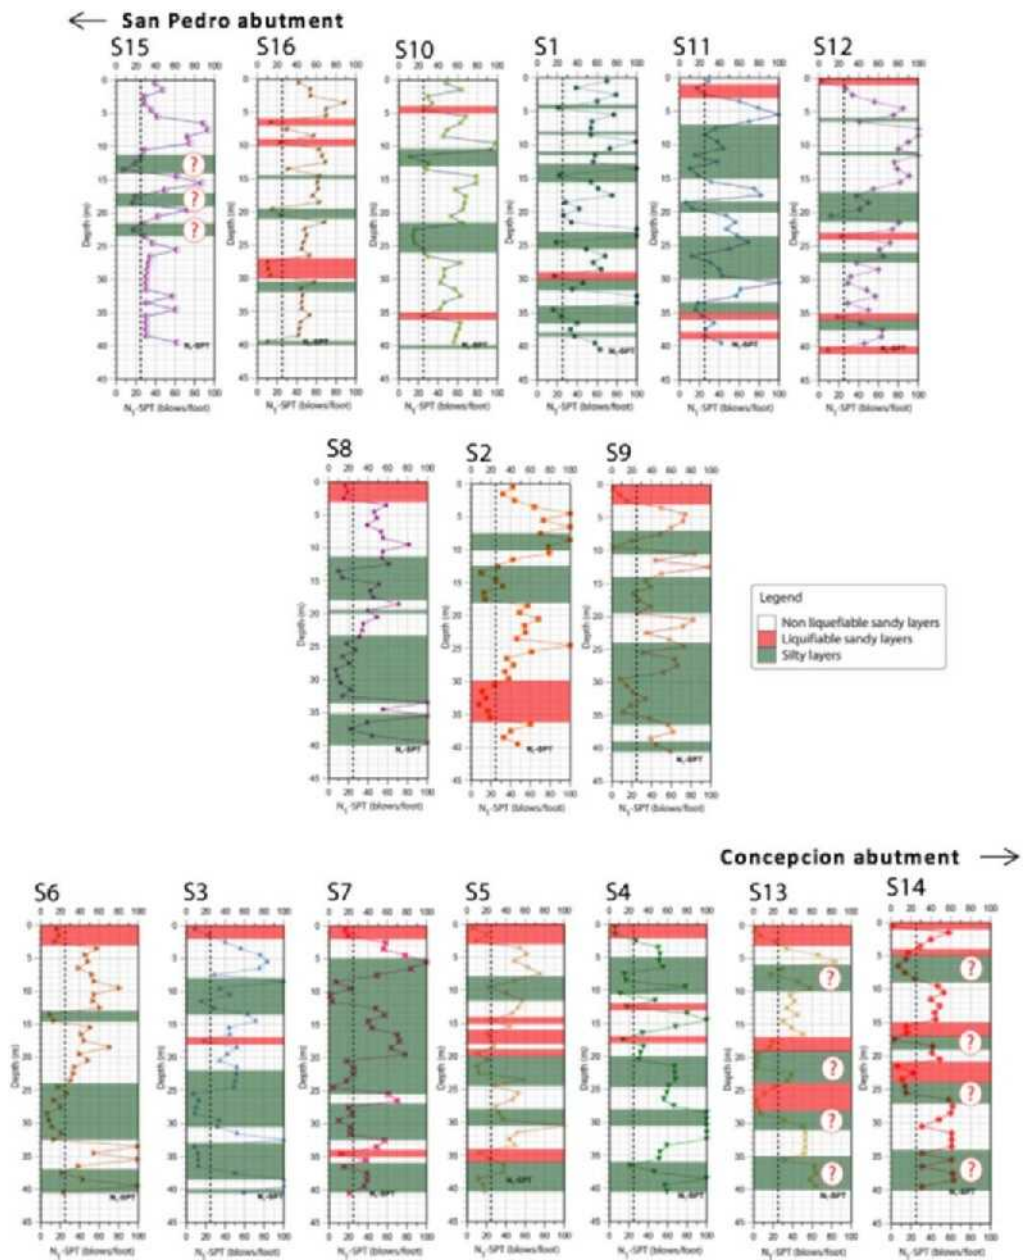
Figure 13. Normalized SPT values at Juan Pablo II Bridge (post-earthquake data). White is for non-liquefiable sands, green is for silty soils (mainly non-plastic silts), and red is for liquefiable sands (Verdugo and Peters 2010).

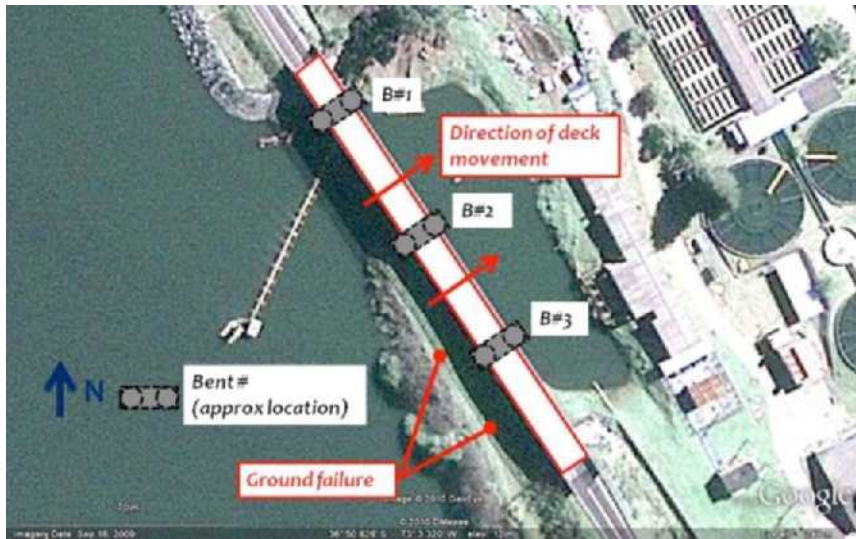
The La Mochita Bridge, shown in Figure 14, is a four-span (15, 50, 50, and 35 m spans) concrete bridge supported by seat-type abutments at each end and two-column bents at the interior locations. At this site, ground failure occurred along the NW–SE trending spit inducing transverse movement of the bridge superstructure. The transverse nature of ground failure observed at this bridge is unique compared to other failures observed elsewhere in Concepción and during past earthquakes, where lateral spreading or other ground failure typically causes bridge movement in the direction of the longitudinal axis of the bridge.

Figure 14. Plan view of the La Mochita Bridge in south Concepción describing observed damage ($S36.846841^{\circ}$ $W73.055496^{\circ}$).

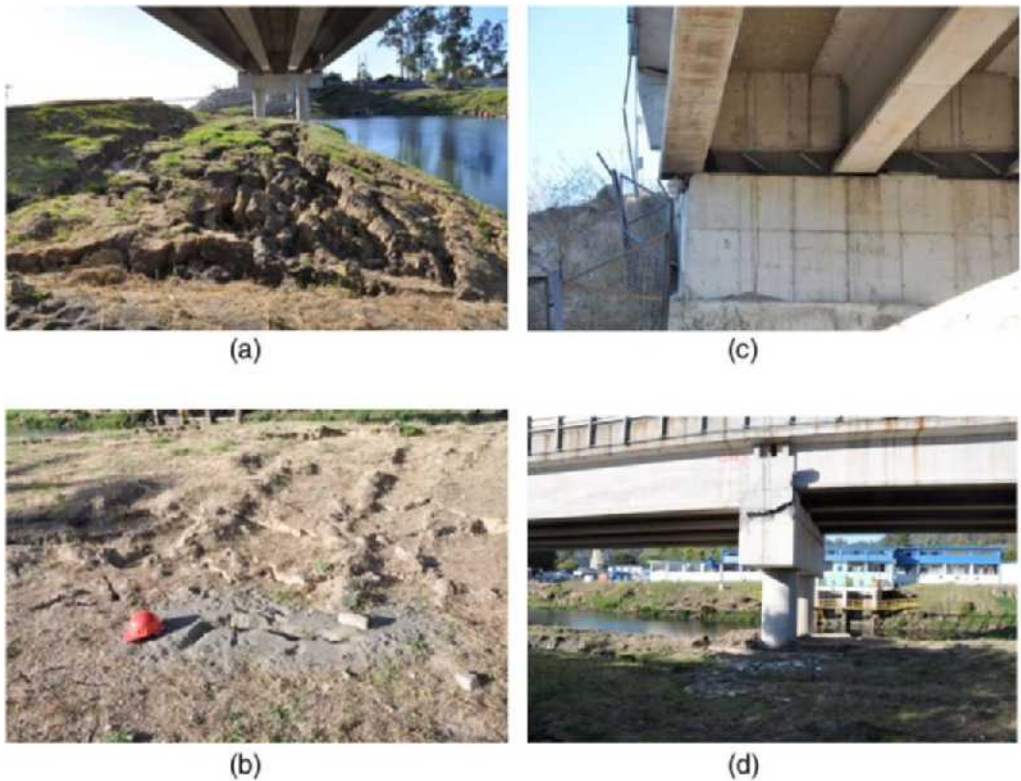
The bridge superstructure shifted transversely, largely as a unit, toward the east due to failure of the soil spit (Figure 16a). This failure may be attributable to either a deep-seated slope instability or a liquefaction-induced lateral spreading mechanism. The SPT profiles from the original project (Figure 15) show that the deep-seated slope instability is a possible mechanism of failure (note how the SPT values drop at depths of 15 m to 20 m). However, sand boils below the bridge were observed near bents #2 and #3 (Figure 16b), and the transverse rotation, or vertical movement, of the bents was limited, which suggests that liquefaction-induced lateral spreading could have also played a role in the bridge failure.

Measurements taken by the team on 15 March 2010, indicated that the north end of the bridge deck shifted 0.5 m to the east relative to the approach fill, while the south end of the bridge shifted 0.9 m toward the east relative to the approach fill on that side. LIDAR measurements show that these lateral displacements were, respectively, 0.3 m and 0.8 m (Kayen 2012). Bents #2 and #3 subassemblies (columns, bent cap, and pile cap) were observed to rotate slightly about the longitudinal axis of the bridge toward the east consistent with the deck movement. Rotations of bents #2 and #3 were measured as 2° and 4° , respectively. Bent #1 could not be accessed at the time of the teams' visit; however, views from the spit suggested that the deck moved independently of bent #1. Movement of the abutments was observed to be minimal, with the resulting damage to the superstructure largely attributed to the translation of the bents (Figure 16c). FHWA (2011) indicates that fill settlement at the abutments varied from 0.3 m to 0.8 m, and that the piers moved laterally about 0.1 m to 0.15 m, and vertically about 0.05 m to 0.1 m. It is noted that movement of the bridge, either shaking- or kinematically-induced, resulted in damage to both east and west end transverse shear keys of the interior bents (Figure 16d).

Figure 16. Liquefaction-induced damage at La Mochita bridge: (a) Looking north at bent #3, S36.847389° W73.055219°; (b) sand boils observed below the bridge, S36.847456° W73.055129°; (c) transverse shift of deck relative to south abutment, S36.847547° W73.054876°; and (d) damage to transverse shear key at bent #3, S36.847405° W73.055084°.

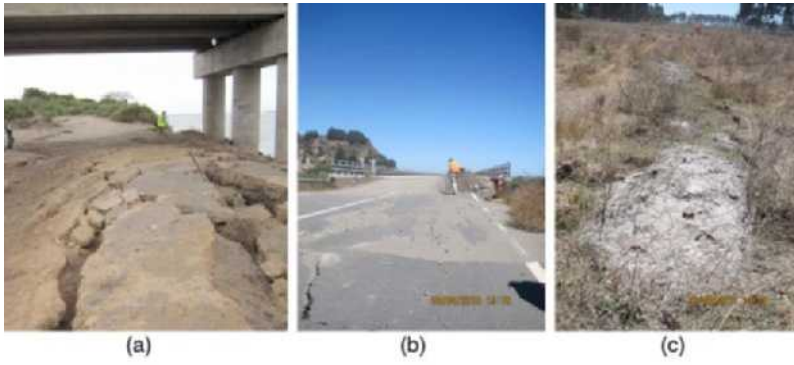
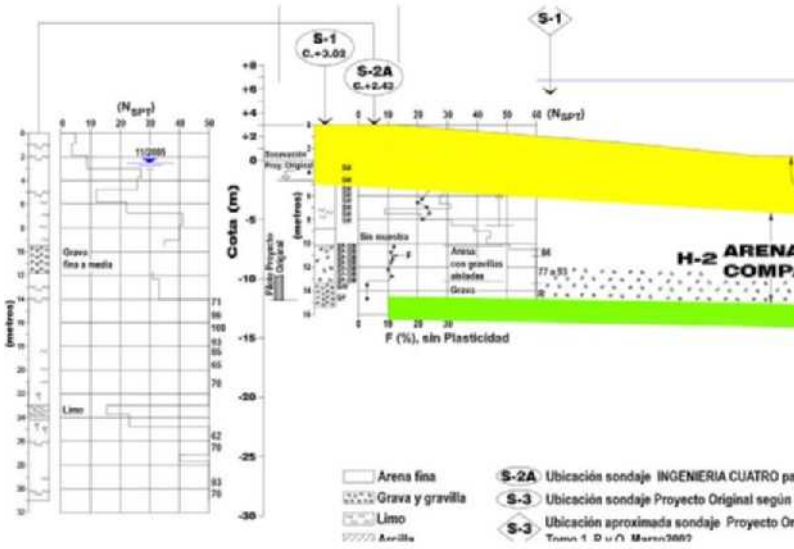
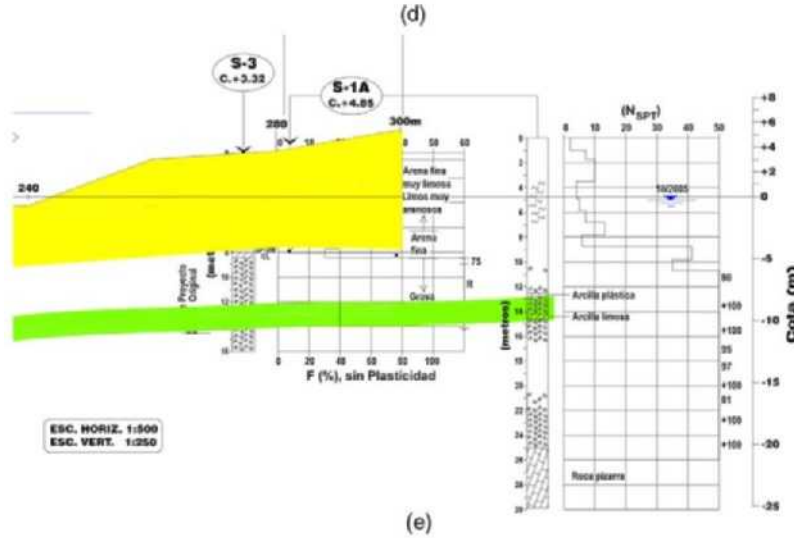
Figure 17. Mataquito bridge: (a) Lateral spreading on the south end of the bridge, S35.050712° W72.162258°; (b) approach fill settlement at the north abutment of the bridge (70 cm offset at the bridge deck), S35.050712° W72.162258°; (c) sand boils at the north end, S35.051961° W72.163217°; (d) SPT profiles at the Iloca (north) abutment; and (e) SPT profiles at the Quivolgo (south) abutment. Colors in (d) and (e) represent different soil units. SPT profiles obtained before the earthquake.

Soil conditions at the north (Iloca) abutment consist of 5 m of liquefiable fine sand with SPT values ranging from 5 to 20 blows/foot, underlain by a layer of fine compact sand 9 m thick, which in turn is underlain by sandy gravel (Figure 17d). Soil conditions at the south (Qui-volgo) abutment consist of 9 m of liquefiable fine sand with SPT values below 10 blows/foot, underlain by a layer of fine compact sand 4 m thick, which in turn is underlain by sandy gravel (Figure 17e).

Lateral spreading on the south abutment appeared to be more confined, probably due to a combination of the topography of the area and the “pile-pinning” effect. In contrast, on the north side, and due to the large extent of the fields that surround the bridge, moderate to significant lateral spreading was observed extending landward 270 m from the river edge. Lateral spreading from the edge of the abutment wall to the first row of piers was about 54 cm and the total lateral spreading from the edge of the abutment wall to the river’s edge was about 180 cm (over a distance of about 65 m). The approach embankment is about 7.6 m high, and settled about 70 cm relative to the bridge deck. The approach embankment experienced a transverse movement of about 60 cm from the centerline as manifested by cracking of the asphalt over a distance of about 200 m. The locally heaved ground, observed at the toe of the embankment, indicates soil crust compression, likely as a result of liquefaction of the underlying soil. A bridge girder was partially sheared at the first pier on the north side. The bridge remained in use after the earthquake.

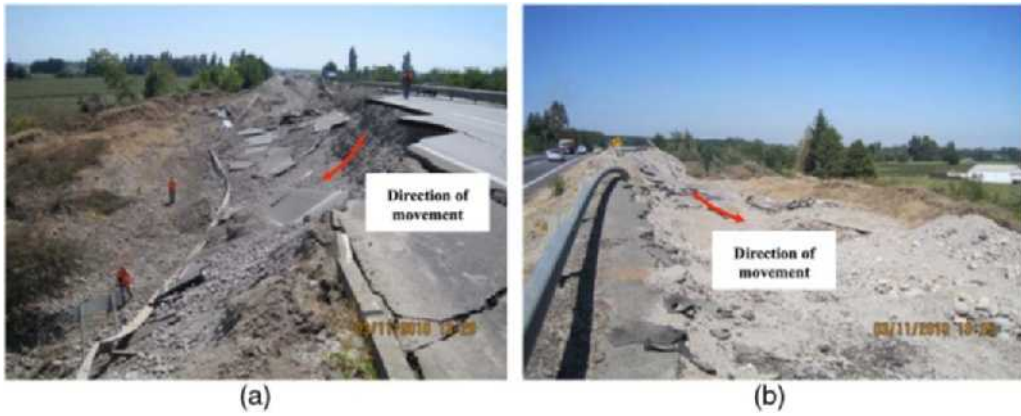
Two collapsed embankment fills were identified near Copihue and Parral. The first, shown in Figure 18, occurred along a straight section of Ruta 5 located approximately 8 km north of Parral. The southbound lanes collapsed to the west, apparently as a result of a shallow translational slide in near-surface foundation soils (~ lateral spreading), as evidenced by the failed soil mass location and a mound of soil pushed up at the west toe of the embankment (Figure 18a). The embankment failed along a length of approximately 150 m at a location where a low-lying softer soil was located at the toe. No geotechnical information could be found for this specific location. However, the soil conditions nearby consist of about 4 m of sandy silt and silty clay (SPT values below 20 blows/foot) underlain by cemented sandy silt, locally known as “tosca.” Geotechnical information found for this area shows that the location of the phreatic surface varies seasonally from 1 m to 9 m deep (Figure 19).

Figure 18. Embankment fill collapsed near Copihue, north of Parral, closing the southbound lanes of Ruta 5: (a) view from the south, (b) view from the north, S36.087891° W71.791513°.

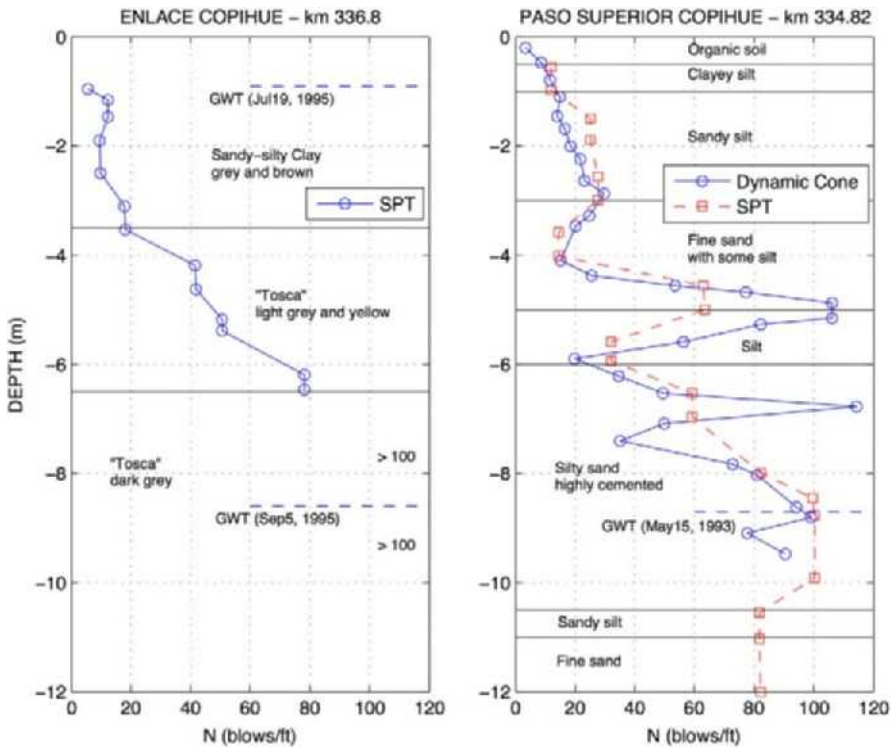
Figure 19. SPT and DCPT data in the Copihue area (adapted from MOP 2010). Pre-earthquake data.

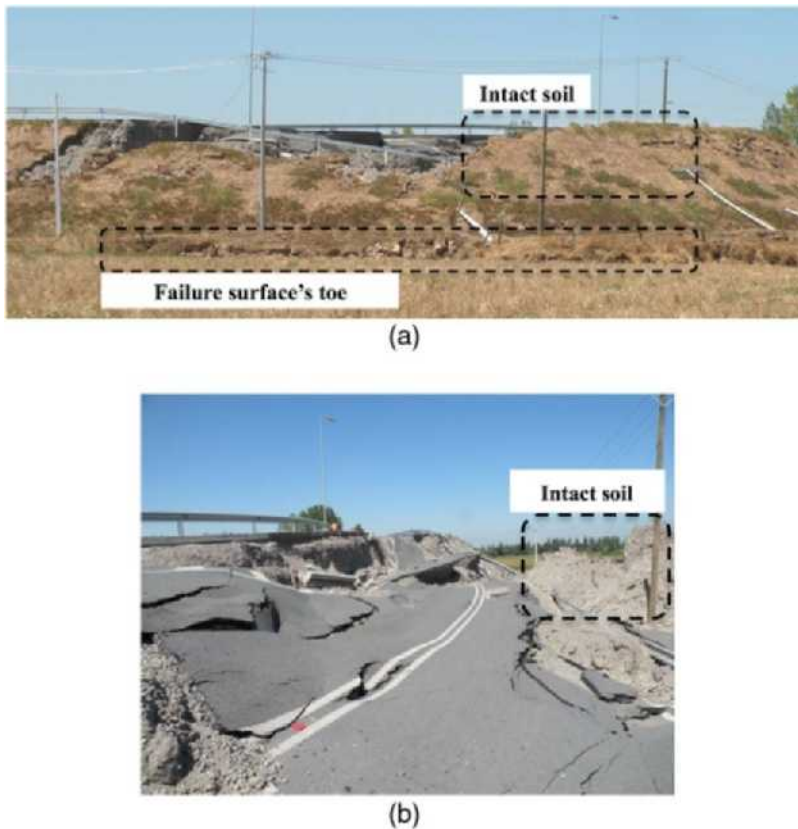
The second failure (Figure 20) occurred on an overpass of Ruta 5 located approximately 13 km north of Parral. The overpass embankment was curved and the embankment failed

Figure 20. Curved overpass embankment failure 13 km North of Parral: (a) Translational 3D slide failure, S36.0343° W71.7568°; and (b) failed outside of the curved embankment, S36.0347° W71.7558°.

over a length of about 80 m toward the outside of the curved section. Again, the failure appeared to involve a shallow translational slide in the near surface foundation soils, as evidenced by the intact failed soil mass and the mound of soil pushed up at the toe (Figure 20). Three-dimensional effects potentially contributed to failure to the outside of the curved embankment section as opposed to the inside of the embankment. As Figure 20 shows, a portion of the outside section of the slide mass displaced laterally about 6 m (Kayen 2012), and it remained completely intact.

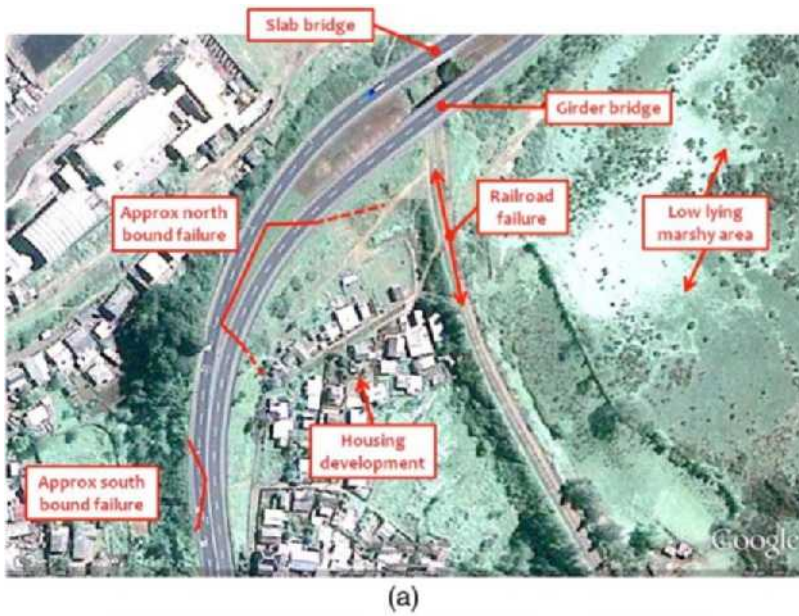
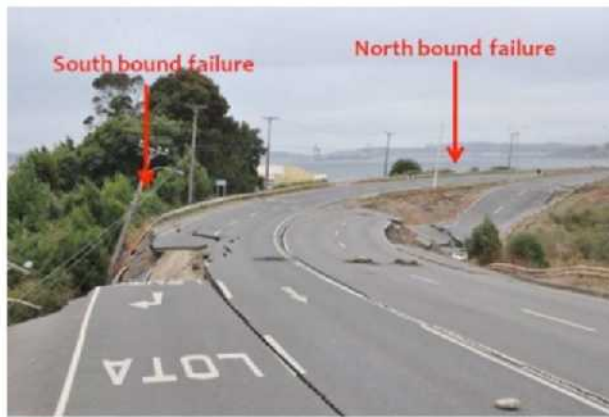
Several large ground failure areas were observed north of Lota along Route 160. Two failures resulted in damage to a roadway embankment section (denoted herein as the “southbound failure” and “northbound failure” in Figures 21 and 22, respectively), while a third failure resulted in damage to an elevated railroad section (denoted as “railroad failure” and discussed in the subsequent section). Minor side road spreading failures were also observed

Figure 21. (a) Plan view of approximate affected area, $S37.0734^{\circ}$ $W73.1469^{\circ}$; and (b) view looking north on Route 160 showing south bound and north bound failure areas, $S37.0744^{\circ}$ $W73.1480^{\circ}$.

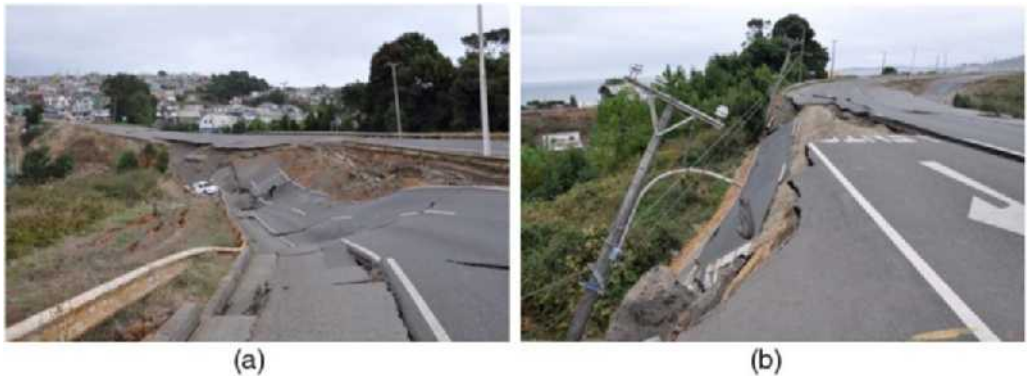
The northbound slope failure appeared to be deeply seated, perhaps due to softening of the foundation materials. It was not clear whether the southbound failure was due to a deep-seated foundation failure or due to poorly compacted earth fill in the embankment section.

Figure 22. (a) View looking south on route 160 showing north bound failure area, S37.0730° W73.1475°; and (b) view looking north showing south bound failure area, S37.0746° W73.1479°.

LIDAR measurements (Kayen 2012) indicate that the maximum lateral and vertical displacements of the failed paved road were, 6.1 m and 7.1 m respectively, for the northbound failure, and 4.9 m and 7.3 m respectively, for the southbound failure. A gray sandy fill overlaid by compacted clay fill was used in the elevated road embankment. The roadway elevation was approximately 10 m to 15 m above the valley area (10 m nearest to the overcrossing bridges, with a high point adjacent to the housing development area).

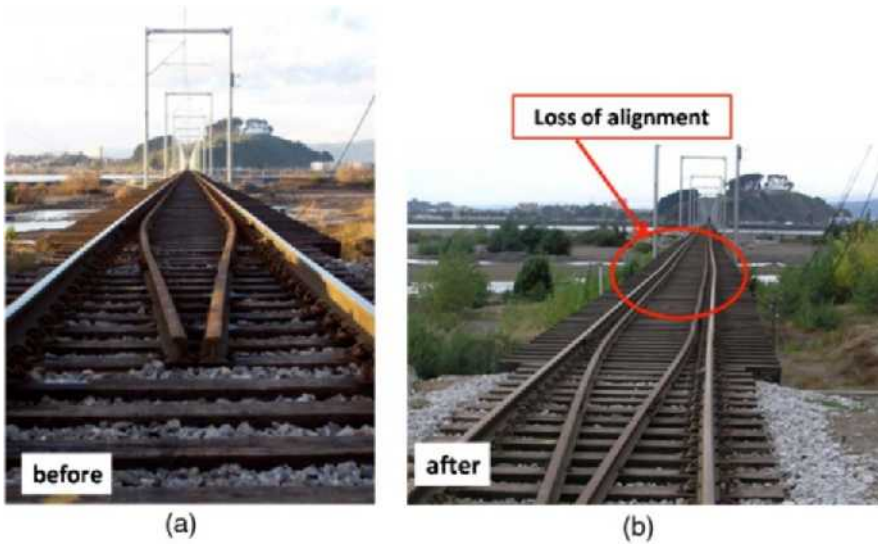
The Bío-Bío River railroad bridge is one of the oldest crossings of the Bío-Bío River. Originally built in 1889, it was retrofitted completely in 2005. This railroad structure is composed of parallel top and bottom chords separated by diagonal and vertical members in a Warren truss arrangement. Three hundred seventy pillars support the structure, covering a length of 1,889 m. The bridge was damaged during the earthquake by strong shaking and possibly lateral spreading of the riverbanks. This damage included several broken bracing rods, at least two fractured steel piles, displaced steel tubes, and a displaced retaining wall (FHWA 2011). Of the 370 pillars of the bridge, 19 were damaged during the earthquake, and several portions of the rail were bent or misaligned (Figure 23). Visual inspection of pillars near the west abutment indicates that several piles translated laterally and rotated (Figure 24). The rail lines were moved out of alignment, as shown in Figure 23b. FHWA (2011) indicates that the shoreline pier's lateral displacement toward the river was 0.7 m and that the ground around the pier settled 1.3 m.

Figure 23. (a) Rails aligned before earthquake and (b) rails bent after earthquake, S36.836097° W73.087094°.

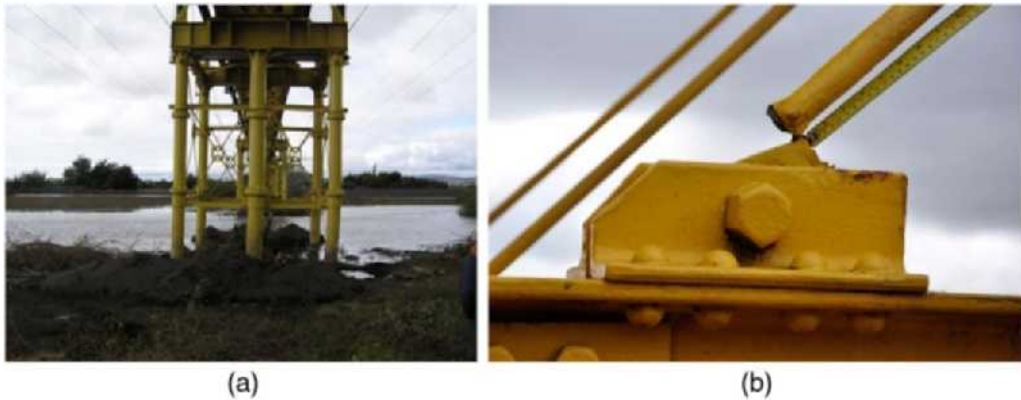
Figure 24. Bio-Bio River railroad bridge: (a) Pillars translated and rotated during earthquake; (b) detail of broken crossbar, S36.836075° W73.086969°.

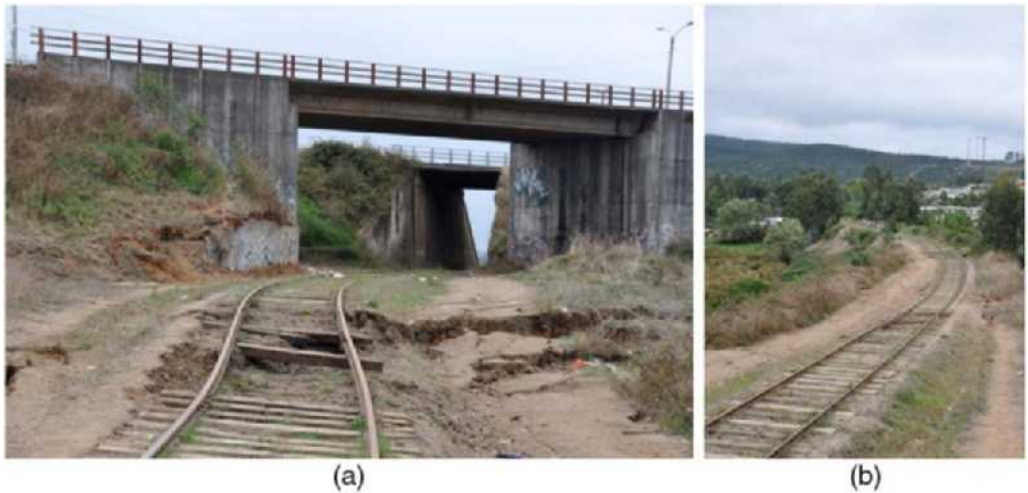
Figure 21a, denoted as slab and girder bridges). The neighboring elevated railroad failure is characterized as a slump with lateral spreading, likely due to settlement of the compacted fill (Figure 25a). The railroad was approximately 5 m to 7 m above the low-lying marshy area along the section that failed.

Figure 25. (a) Slab and girder-type overpasses at northern end of road embankment failure area, showing railroad and supporting ground settlement (view looking west), S37.0729° W73.1469°; and (b) ground failure below elevated railroad east of road embankment failure (view looking east), S37.0727° W73.1471°.
