Damage Assessment of a Full-Scale Six-Story Wood-Frame Building Following Triaxial Shake Table Tests

John W. van de Lindt, M.ASCE¹; Rakesh Gupta, M.ASCE²; Shiling Pei, M.ASCE³; Kazuki Tachibana⁴; Yasuhiro Araki⁵; Douglas Rammer, M.ASCE⁶; and Hiroshi Isoda⁷

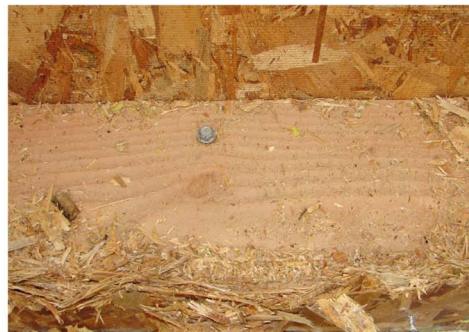
result of toe-nailing during construction and was marked as pretest damage. Fig. 7(b) shows the top of the wood screws after removing OSB on one side of the shear wall following the final seismic test. Other than the damage to GWB, no additional damage was observed, i.e., no nail withdrawal, no nail pull-through in the sheathing, and no visible stud splitting around tie-down rods. In a typical shear wall, testing without GWB failures like these are seen. But the full-scale, six-story Capstone building did not see any of these failures. This is because in shear wall testing, shear deformation is dominant, whereas in a full-scale and especially a six-story building, other deformations (such as bending and axial) are also present. Also, tie-down rods that extended the whole height of the building resisted most of the overturning forces.

Fig. 7. (a) Sill plates remaining intact (i.e., no splitting) following all five shakes; (b) close-up of sill plate after removing wall sheathing

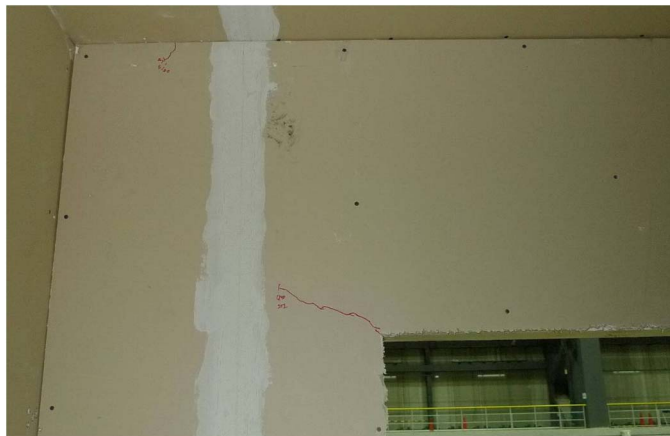
Although damage was limited to dry wall cracks only, correlation of damage to the seismic intensity test level can be identified during all five tests. In the test at Seismic Intensity Level 1, only very minor cracking was observed around the openings, as shown in Fig. 8. In many of these cases, the cracks were small enough to have been covered/filled with paint. As was anticipated, Seismic Intensity Level 2+, which slightly exceeded the design-basis earthquake (DBE), caused more damage. The cracking was definitely detectable at many locations, but was still limited to the GWB. At this

Fig. 8. Minor crack on Wall E4, Story 2 (over window opening) after Level 1 shaking

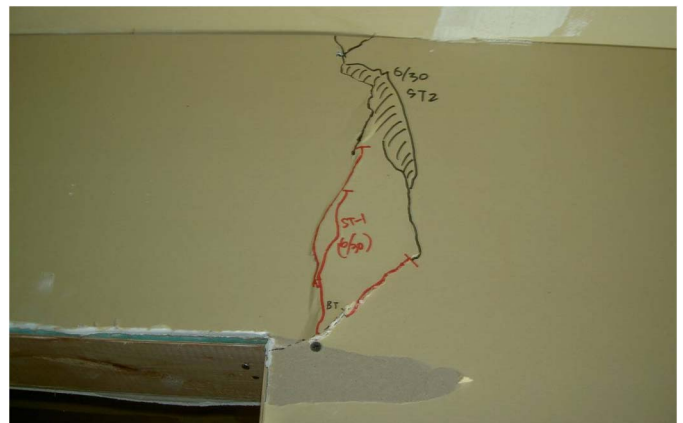
seismic intensity level, it became apparent that the stories with the larger interstory drift levels had longer, wider, and at times more numerous GWB cracks. Fig. 9 shows one of the more noticeable crack patterns that occurred above several doorways after Seismic Test 2. The diagonal pen marking indicates a section of the GWB that may have slightly pulled away, or in which the paper was loosened. Seismic Test 3 was a smaller shake, but with the steel SMF locked down, i.e., testing only the six-story wood building. During this small shake, many locations had no propagation of crack damage. For example, Fig. 10 shows a vertical crack above the doorway that occurred during Seismic Test 2 but did not widen or spall during Seismic Test 3. Because of the way the tests were performed, it is difficult to tell if the 50%/50-year earthquake used in Seismic Test 3 would have caused any appreciable damage even to the GWB. It is likely there would have been only hairline cracking such as that shown in Fig. 11.

Fig. 9. Crack on Wall D1, Story 4 (over door opening) after Seismic Test 2

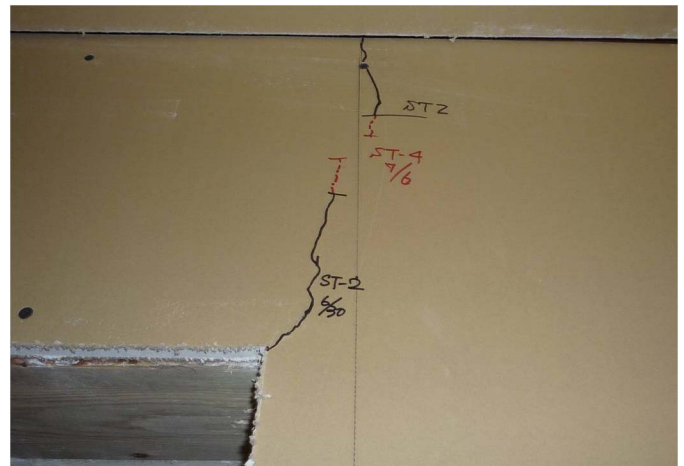
Fig. 13. Crack on Wall 2A, Story 5 (over door opening) after Seismic Test 4

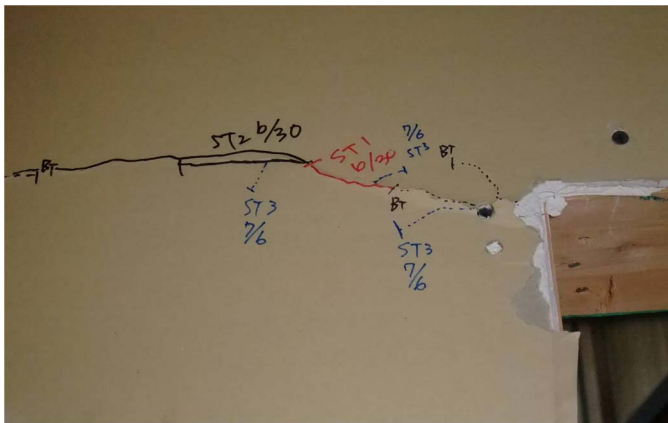
Fig. 11. Crack on Wall A3, Story 2 (over window opening)

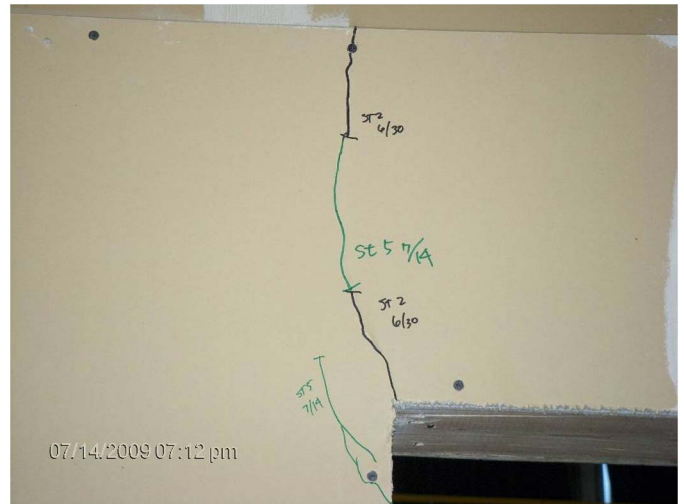
Fig. 14. Crack on Wall A3, Story 4 (over window opening) after Seismic Test 5

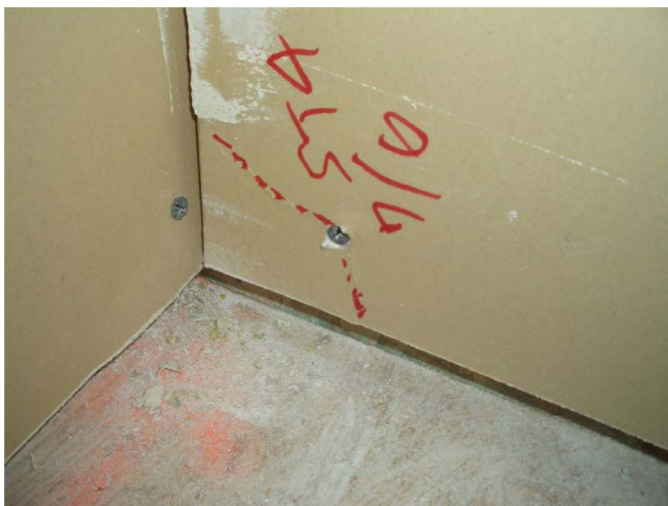
Seismic Test 4 (ST4) was a DBE level earthquake and resulted in more GWB damage. The start of some GWB spalling can be seen in the photograph. In general, Seismic Test 4 propagated existing cracks and caused some smaller cracks to branch off from the main cracks. Fig. 12 shows some new cracking near one of the corner GWB screws, indicating significant racking in the panel after ST4. The propagation discussed previously was observed routinely, as shown in Fig. 13. The “ST4” marking is for both the upward and downward propagating cracks. Repairs (structural or to the GWB) between tests were not made; thus, conclusions and correlations discussed in this paper only seek to better understand the trends.

Fig. 12. New crack on Wall D1, Story 3 (corner crushing) after Seismic Test 4

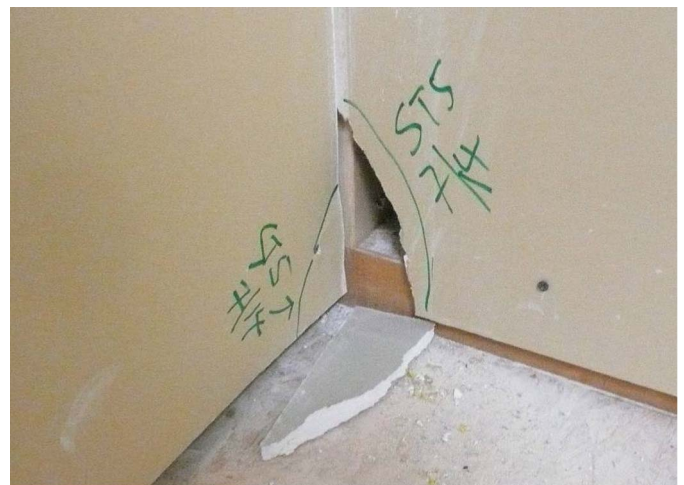
Fig. 15. Crack on Wall D2, Story 6 (corner crushing) after Seismic Test 5

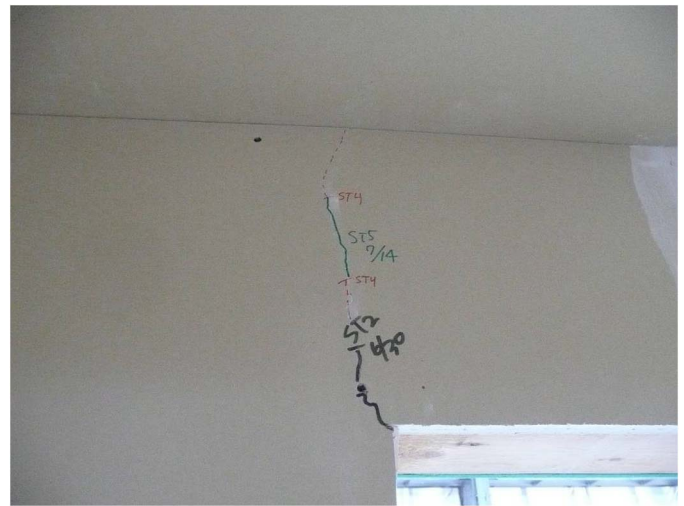
Fig. 19. Story 6, Wall E1; cracks develop all the way through panel after Seismic Test 5

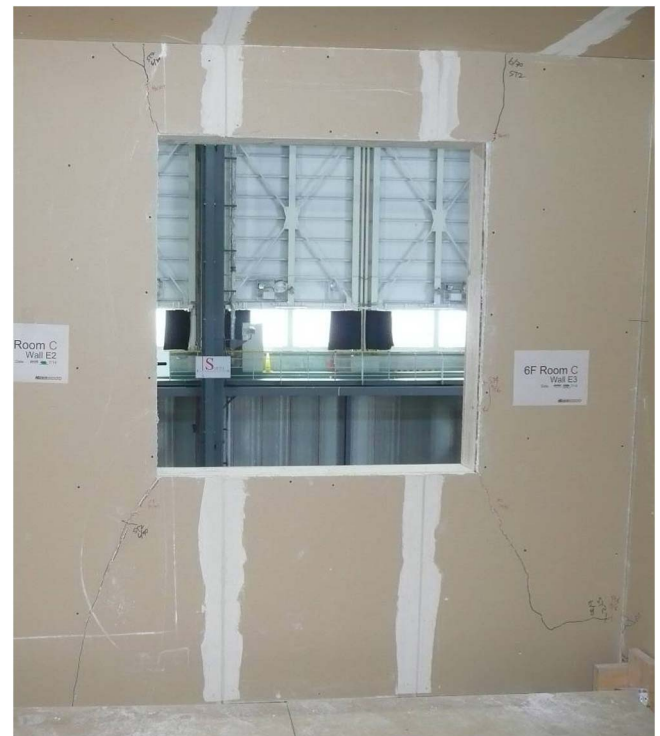
Fig. 20. Story 6, Wall E2; cracks develop all the way through panel for all corners after Seismic Test 5

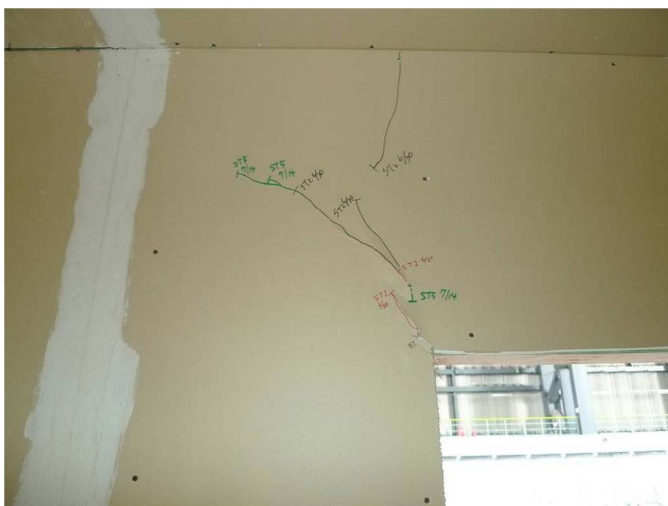
Fig. 18. Story 2, Wall E2; cracks failing to connect together after Seismic Test 5

connect following ST5 at Story 2. For some of the damaged GWB in this study, cracks tended to propagate until they connected to another crack, particularly when there was significant interstory drift caused by a combination of shear and bending. This was typical on lower stories of the building because the overall interstory drifts were lower. Comparatively, consider Story 6 following the series of five shakes. The cracks tended to propagate all the way through the panel as shown in Fig. 19. Fig. 20 shows this from a full-panel vantage point. Further, in Story 6, crushing of the panel corners was more routinely observed, as shown in Fig. 21. Most of the damage in lower stories was attributed to shear deformation,

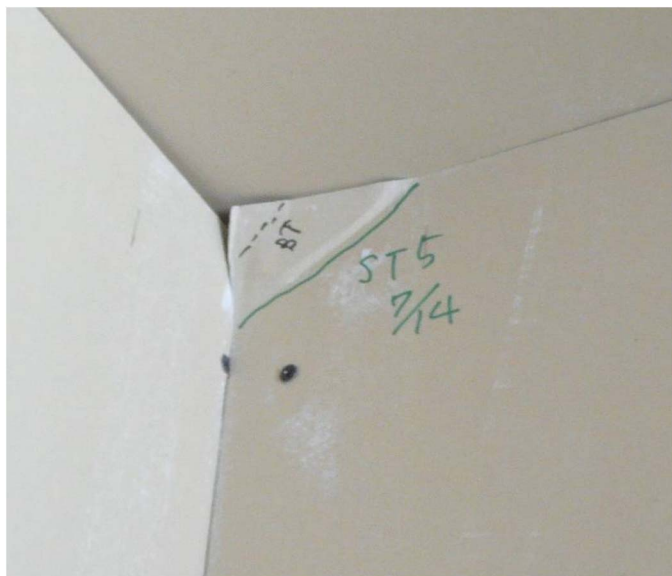
Fig. 21. Crushing of corners also seen at Story 6, Wall E5 after seismic test

whereas in upper stories the damage was attributed to a combination of shear and bending.
