DETECTION OF WATERLOGGING IN KILN COILS AND ITS EFFECT ON MOISTURE CONTENT

Steve Carroll
Watercare Industrial Services
Washougal, Washington
and
Marty Brint
Hampton Lumber Co.
Willamina, Oregon

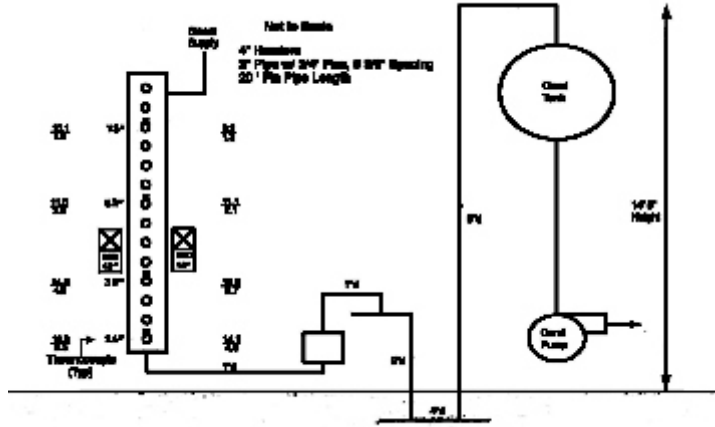
Four thermocouple probes were secured to the coil at positions shown in Figure 1. Specifically, the probes were mounted on the top of the selected fin pipes, at the inlet (steam) side of those pipes. It is felt that this positioning avoids the normal temperature

FIGURE 1. Location of probes on coils shown with black squares.

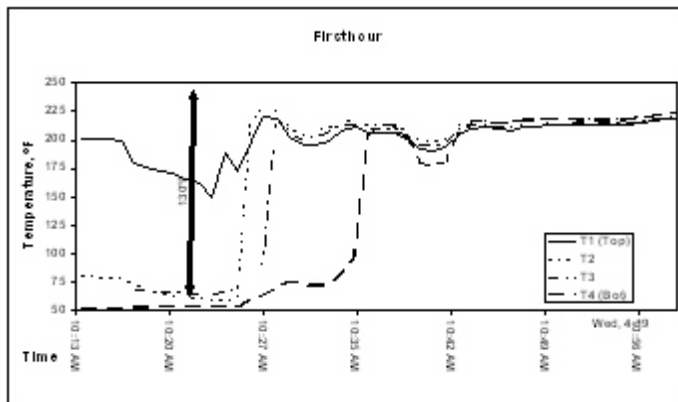
At the beginning of the schedule (Figure 2), at least 38" of coil height started out as being waterlogged (following an extended idle period). It took almost *thirty minutes* for the coil to completely purge its condensate. During that time, the bottom fin pipe was approximately *130°F cooler* than the rest of the coil.

FIGURE 2. Temperature on coil during first hour of operation. Waterlogging is evident for about 30 minutes.

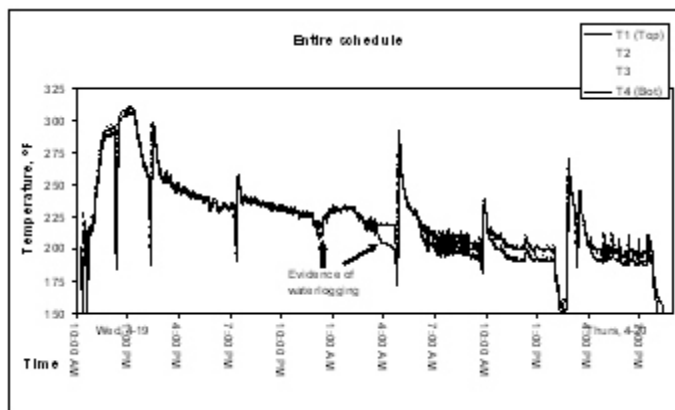
Waterlogging of the coil again became evident less than 14 hours into the schedule (Figure 3), affecting at least the bottom fin pipe. By the 17-hour mark, the bottom pipe remained waterlogged for the remainder of the schedule, with the exception of steam spikes when fans were reversed.

FIGURE 3. Temperature on coil during entire schedule. Waterlogging becomes evident after about 12 hours when the pressure in the coil decreases.

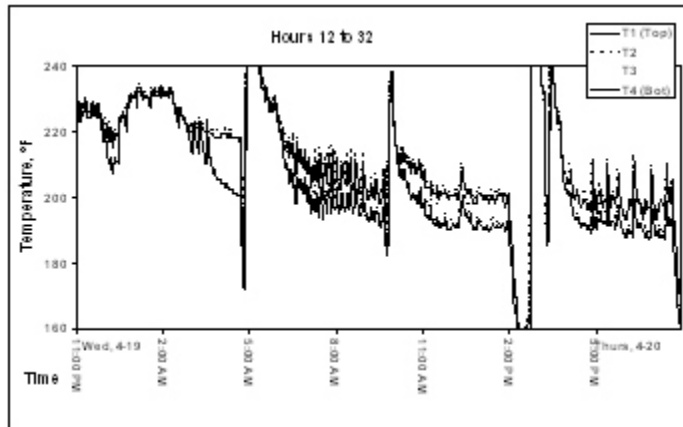
Waterlogging affected at least the bottom four fin pipes (16" of coil height) in less than 21 hours; they remained largely waterlogged for the remainder of the schedule with the exception of the brief spikes of fan reversal (Figures 4 and 5).

FIGURE 4. Temperatures on coil magnified. At each fan reversal all four temperatures become equal indicating that the coil drains when the valve opens and the pressure in the coil increases.

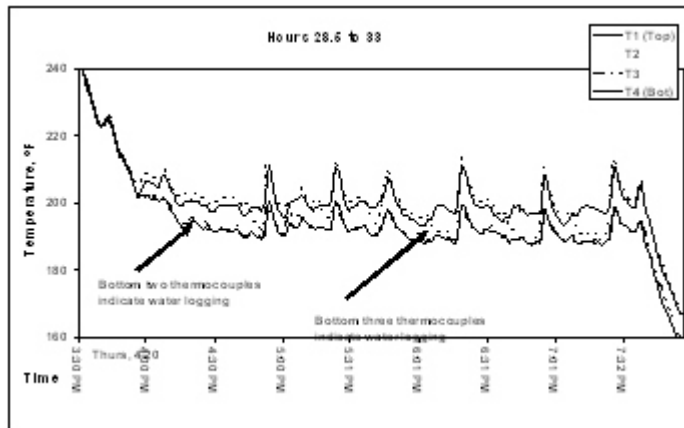
During the final three hours of the schedule, at least 38" of coil height was affected by waterlogging. Since the "T2" thermocouple was intentionally placed at the approximate height of the coil's RTD temperature sensor, the RTD's throttling of the steam valve could be readily seen in the graph.

FIGURE 5. Coil temperatures at end of schedule. The water level reaches the third thermocouple from the bottom as the coil pressure reduces.
