**The 11 March 2011 East Japan Earthquake and Tsunami:
Tsunami Effects on Coastal Infrastructure and Buildings**

Abstract: The 11 March 2011 East Japan Earthquake and Tsunami caused unprecedented damage to well-engineered buildings and coastal structures. This report presents some notable field observations of structural damage based on our surveys conducted along the Sanriku coast in April and June 2011. Engineered reinforced concrete buildings failed by rotation due to the high-velocity and deep tsunami inundation: entrapped air in the buildings and soil liquefaction by ground shaking could have contributed to the failure. The spatial distribution pattern of destroyed and survived buildings indicates that the strength of tsunami was affected significantly by the locations of well-engineered sturdy buildings: weaker buildings in the shadow zone tended to survive while jet and wake formations behind the sturdy buildings enhanced the tsunami forces. We also found that buildings with breakaway walls or breakaway windows/doors remained standing even if the surrounding buildings were washed away or destroyed. Several failure patterns of coastal structures (seawalls) were observed. Flo

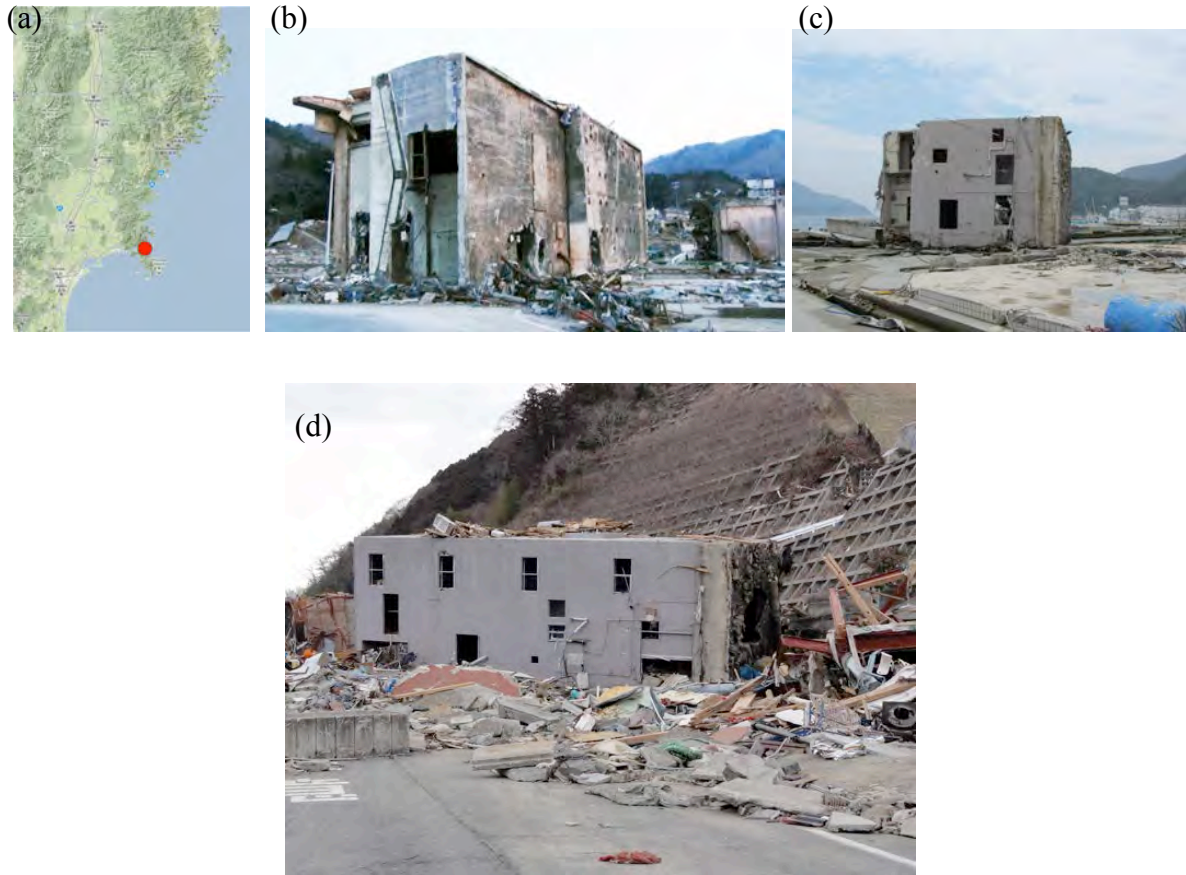
The remarkable failure of reinforced concrete (RC) buildings was observed in the town of Onagawa. The average runup height in Onagawa was 17.9 m (Max. 20.4 m and Min. 15.8 m). Several RC buildings were overturned by tsunami waves, while the structures themselves were not broken up by wave impact (see Fig. 2). This rotation failure had not been reported in the past.

Based on inundation data, the overturned buildings were fully (or at least nearly) submerged. We hypothesize that the buildings overturned by the following possible causes: a) hydrodynamic force including debris effects, b) buoyant force, and c) weakened foundation associated with soil instability. Note that hydrodynamic force is the lateral force induced by the flow and the buoyancy force is enhanced by trapped air. An additional cause could be debris-impact force on the buildings. According to video footage (Video, 2011), no large and rigid floating body (e.g. a ship) was present in the inundation flow, and a majority of debris was made of soft materials such as broken wood-frame houses and small automobiles.

Let us examine the failed four-story building shown in Fig. 2d. Considering its initial location – identified from the Google Map/Street View, the building was toppled, tumbled, and transported for more than 30 m inland; the failure must have occurred during the runup process. The steep hill embankment along the north side of the building (the left-hand side of the blue circle shown in Fig. 3b) could have acted as a flow guide causing flow contraction, and consequently enhanced the power. The building had a pile foundation but all of the piles were snapped at the building base. The building dimensions are approximately 16 m tall, 7 m wide and 7.5 m long, made with 130 m^3 of concrete (density = 2400 kg/m^3). The effective net weight of the building under total submergence is approximately 1800 kN. Without any flow, this weight would require about 180 m^3 of entrapped air to float the building, which is about a 1 m thick layer of entrapped air per story (four stories). Therefore, the failure caused solely by buoyant forces is possible even with no water flow, when the building is totally submerged and the pile foundation is ineffective.

Additionally, debris accumulation against the building effectively increases the value of A in (1). Furthermore, any debris impact could have been an additional factor for the building failure. Note that debris impact was reported as a major cause for building damage in the previous tsunami events (e.g. the 2004 Indian Ocean Tsunami by Ghobarah et al., (2006) and Yeh, (2009); the 2009 Samoa Tsunami by Reese et al., (2011)). Our analysis demonstrates that the building can overturn even without the effect of debris impact. There is an added factor to further promote the overturning failure: that is the possibility of soil liquefaction due to strong ground shaking of the earthquake that had occurred about 40 minutes prior to the tsunami arrival. With soil liquefaction, the friction between the piles and the surrounding soils would be reduced. Even though this building had a pile foundation, the fast flow speeds and the deep inundation could have snapped the piles.

Based on the foregoing analysis, the combination of hydrodynamic force, entrapped air in the building, and soil liquefaction can provide an explanation for overturning failure of the building. The deep inundation flow that caused the buildings to be fully submerged and the high velocities resulting from the fast rise and fall of the tsunami (as shown in Fig. 1b) are two factors that caused the building failure by rotation. The similar analysis can be made for the other buildings failed by rotation (e.g. those shown in Fig. 2b and c). It is readily pointed out that for a given building weight (or volume), the hydrodynamic moment (torque) is smaller for a shorter building. Building failure by rotation depends on the dimensions, orientation, foundation, and air-tightness characteristic of the building.

Figure 2. Toppled reinforced concrete buildings in Onagawa ($38^{\circ}26.5'N$, $141^{\circ}26.5'E$). The average runup height was 17.9 m. (a) The location of Onagawa. (b – d) Reinforced concrete buildings toppled by tsunami. (The photo (d) was taken by Koshimura).

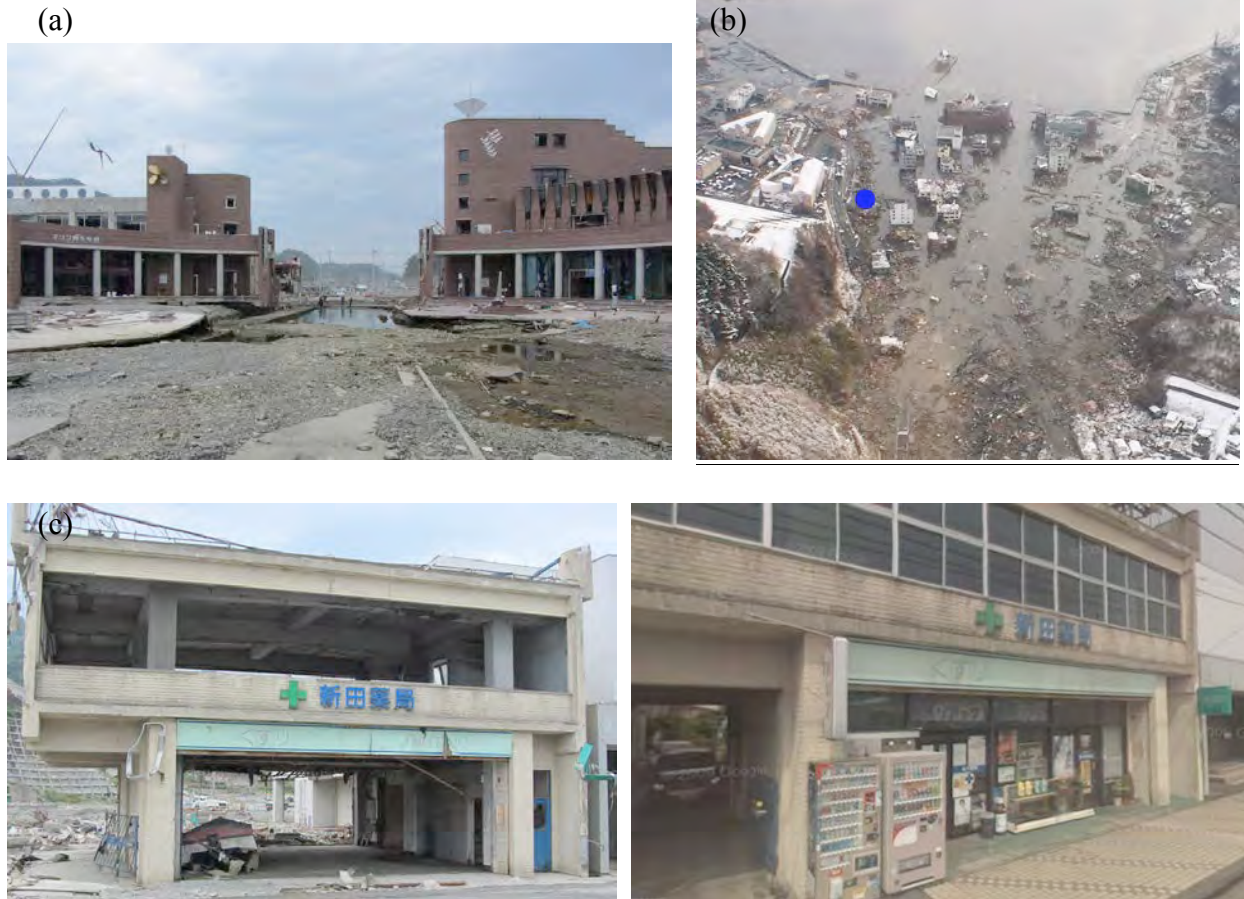
In spite of such extraordinary failure of several RC buildings in Onagawa, two large RC buildings at the waterfront and the smaller buildings directly behind them were found standing (Fig. 3a). The damage pattern shown in the figure suggests that the waterfront buildings must have acted as a barrier for the smaller buildings behind them. Video footage (Video, 2011) shows a strong jet formation in the gap between the two large forward buildings, which wiped out everything in its path. Clearly, the presence of the sturdy RC buildings altered the tsunami flows, which in turn affected the surroundings. This type of observation is not new, however. Abe et al. (1993) reported reduction and enhancement of tsunami effects on the surroundings of sturdy buildings in the town of El Transito affected by the 1992 Nicaragua Tsunami. This indicates that tsunami resilient structures should be designed with consideration of the effects from the surroundings, which resembles the design practices for high-rise buildings and long-span bridges for wind forces. Recently Reese et al. (2011) incorporated the shielding effects in their building fragility analysis for the 2009 Samoa Tsunami.

We found that some of the structurally survived buildings were those in which ground-level walls were blown off by tsunami forces; in other words, the walls acted as so-called breakaway walls. Note that the similar observations have been made from the previous tsunami events: e.g. the 1992 Nicaragua Tsunami (Yeh, 1995) and the 2004 Indian Ocean Tsunami (Dalrymple and Kriebel, 2005). Figure 3c shows a typical example in Onagawa: the right panel of the figure shows the condition prior to the tsunami attack that we obtained from Google Maps/Street View. This building formed openings piercing from the front to the back aligned with the tsunami flow direction. Those openings were not designed for tsunami protection, but the tsunami forces punched through the windows and doors.

The water pond between the two waterfront buildings shown in Fig. 3a is a very deep scoured hole (more than 3.5 m deep), where a road was located prior to tsunami inundation. Judging from the video footage (VIDEO, 2011), high-velocity and debris-laden return flow between the sturdy

RC buildings must be responsible for the formation of this deep scour hole. Figure 4c shows a scour hole observed at the side of the apartment building. Those tsunami effects on soils are typical and had been reported from previous tsunami field surveys, in particular the 2004 Indian Ocean tsunami (e.g. Dalrymple and Kriebel, 2005; Yeh et al., 2007). The following are additional observations of scour, but unlike the foregoing cases, we found deep scour in protected areas where flow velocity is low.

Figure 3. Tsunami destruction pattern in Onagawa ($38^{\circ}26.5'N$ $141^{\circ}26.5'E$). (a) A pair of sturdy large buildings at the waterfront acted like barriers for some of the weaker buildings behind. (b) An areal view (the photo was enhanced from the original taken by Satake). The waterfront buildings can be identified in the photo. The gap between the buildings created a jet flow that completely destroyed the narrow strip of the jet trajectory, and caused a deep scour hole in-between. The blue circle shows the location of the toppled building shown in Fig. 2d, approximately 200 m from the waterfront. (c) The RC building severely damaged but standing. The walls on the ground floor were punched away by tsunami. The right panel shows the conditions prior to the 2011 tsunami, taken from the GoogleMaps/StreetView.

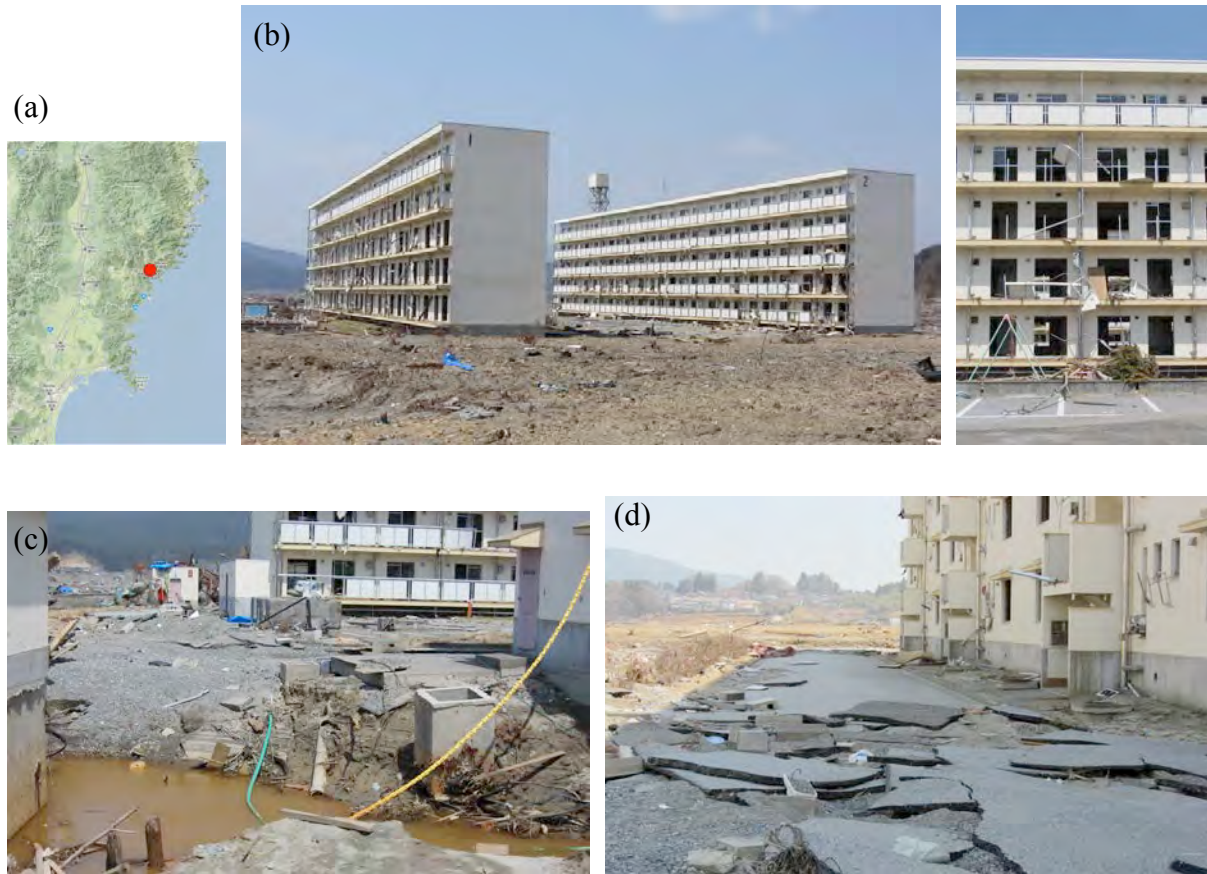
The apartment buildings in Rikuzen-Takata shown in Fig. 4 are another example. The average runup height in the vicinity of the buildings was 14.2m (Max. 15.3 m, and Min. 13.1 m). The inundation found in the apartment building was at 12.2 m reaching the top (5th) floor. The fast jet formations through the pierced windows (Fig. 4b) enhanced the net momentum flux in the flow direction in comparison with the condition of a solid object, consequently reducing the tsunami force on the building. Note the complete destruction surrounding the surviving buildings (Fig. 4). The shielding effect discussed in Fig. 3 is also evident in the second apartment building. We see clear damage contrast in the front apartment unit facing the sea and the second unit behind it.

Tsunamis can rip out pieces of asphalt pavement. This phenomenon was found in roads, harbor quay surfaces, and parking lots at many low-elevation locations near the shore. In particular, the damage shown in Fig. 4d was found in the well-sheltered area behind the front apartment unit in Rikuzen-Takata. The destroyed pavement pieces accumulated behind the first apartment unit facing the ocean, suggesting that the failure occurred during the return flow phase. It is unlikely that this damage was caused by fast flow velocities. As we discuss in the next section, the damage could result in the uplift force induced by the pore-pressure gradients that developed during the process of rapid reduction of the flow depth.

Figure 4. The RC apartment buildings survived in Rikuzen-Takata. The average runup height in the vicinity was 14.2 m. (a) The location of Rikuzen-Takata ($39^{\circ}00.5'N$ $141^{\circ}38.3'E$). (b) The tsunami punched through from the front to back doors and windows to create many piercing holes, which must have reduced tsunami forces. (c) A deep scour hole at the side of the first building facing to the sea and (d) the ripped asphalt slabs in the sheltered area behind the first building.

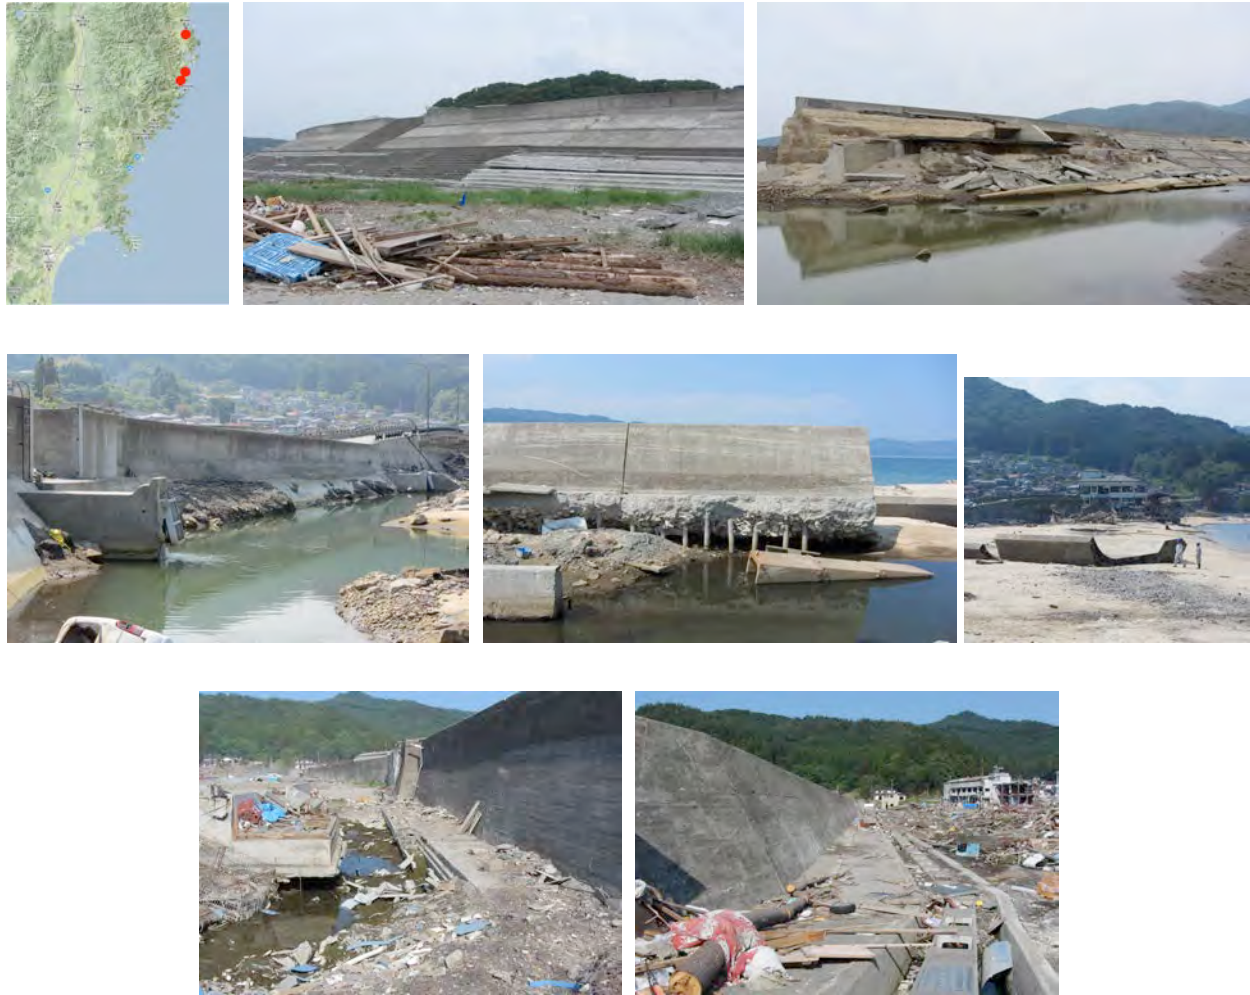
The most notable damage of coastal protection structures is attributed to scour and foundation failure. Figure 5b shows the seawall failure in Kanahama, near Miyako, where the average runup height was 11.3 m (Max. 12.6 m, Min. 10.6 m). The crown elevation of the seawall is 8.5 m TP so that the tsunami overtopped the seawall. (TP: Tokyo Pell is the Japanese sea-surface datum,

As shown in Fig. 5b, the front face of the seawall is intact with little damage. The rear face is severely undermined. Note that the sloping faces of the soil-mound infill are covered and protected by the concrete panels: note that the concrete slabs on the rear face is 25 cm thick. One section of the seawall is completely breached and a large scour-hole pond was formed behind the seawall. We found that the upper rear portion was damaged more than the lower portion as seen in Fig. 5b (in the far view). A possible explanation for this damage pattern is the suction pressure induced by the overtopping flow. Once the tsunami overtopped the seawall, the flow became quasi-steady and supercritical on the rear face. The centrifugal force associated with this downpour flow pattern induced suction-pressure force near the top portion of the rear side. Let us consider the critical flow condition at the crown with the specific energy of 3 m. Following the flow analysis of spillways by Henderson (1966), we assume the streamlines in the concentric circular formation. This circular streamline formation is closely related to the length scale of the flow-separation bubble formed on the rear 1:2 sloping surface. Assuming the radius of the inner streamline is 1.5 m, the suction pressure can be calculated to be 8.6 kPa (or 0.88 m of suction water head). This suction pressure force can lift a concrete slab of 37 cm thick even if the pressure underneath is atmospheric. Therefore, the centrifugal pressure is capable of lifting the concrete slab (25 cm thick) of the Kanahama seawall. It is anticipated that the pressure underneath the slab could be greater than the atmospheric pressure, because of the high tsunami inundation in front of the seawall and its infill that may not be completely impermeable. This could have induced positive pressure under the concrete slab creating the additional force for the panel failure. Once the protective concrete panels were removed, soil-infill was exposed to the

flow so that further scour failure in the seawall mound resulted. In addition, turbulent and high-velocity flow impingement on the rear toe of the seawall can create a large scour hole behind the seawall. We observed many seawalls that exhibit the similar failure pattern.

Figure 5c shows the failed seawall in the town of Kirikiri, where the average runup height was 17.1 m (Max. 19.0 m, Min. 13.9 m): the crown elevation of the seawall is 6.3 m TP so that the tsunami substantially overtopped the wall. This is an upright solid-concrete type seawall with a pile foundation. Deep scour was observed under both front and rear faces of the seawall. During the tsunami return flow, several seawall components were pushed out seaward and scattered on the beach. The failure mode observed suggests that the seawall was rotated counterclockwise forward (in the orientation shown in Fig. 5c) from the foot onto the adjacent beach. The seawall sections themselves were undamaged structurally; hence, this failure must be caused by soil instability in the foundation. The failure mode of the seawall segments indicates that the seaward foundation must have failed by the overtopping return flow, allowing the return-flow water to undermine the toe of seawall and push out the foot seaward.

The seawall condition in Hakozaiki is shown in Fig. 5d: the average runup height in this town was 15.4 m (Max. 17.0 m, Min. 13.4 m). The seawall is also an upright solid-concrete type. Interestingly, this seawall was not damaged although the town was completely destroyed by the overtopped tsunami (the crown elevation is 5.6 m TP). There are reinforced concrete flanges (2 m wide) protecting both the front and rear toes of the seawall. In addition the drainage gutter along the rear flange (see Fig. 5d) could have helped prevent the rear wall from excessive scour.

Figure 5. Seawall failures. (a) From north to south, locations of Kanahama ($39^{\circ}35.5'N$ $141^{\circ}56.8'E$), Kirikiri ($39^{\circ}22.3'N$ $141^{\circ}56.7'E$), and Hakozaiki ($39^{\circ}19.4'N$ $141^{\circ}54.8'E$). (b) Seawall failure in Kanahama with average runup height of 11.3 m. (c) Seawall failure in Kirikiri with average runup height of 17.1 m. (d) Seawall in Hakozaiki was intact with little damage; average runup height was 15.4 m.

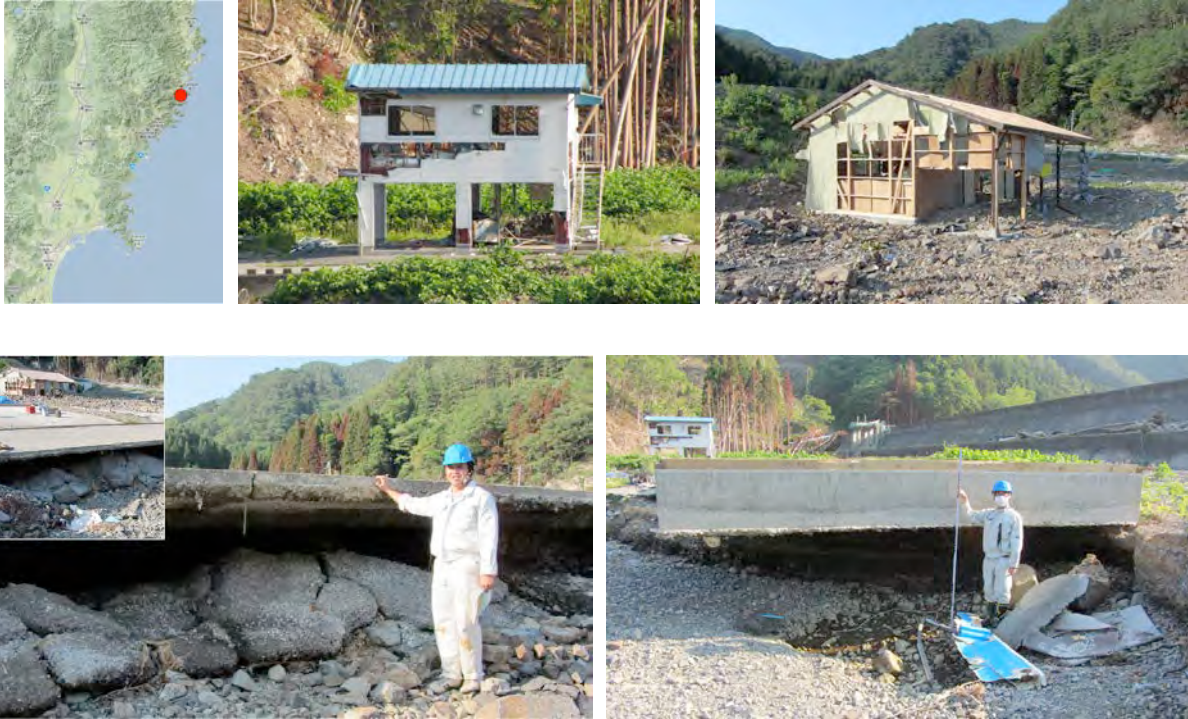
Figure 6 shows the damaged area on the seaward side of the seawall in the town of Tohni. The seawall is seen in the background of Fig. 6d, and its crown elevation is at 11.8 m TP. Tsunami overtopped the seawall: the average tsunami height was 15.5 m (Max. 17.4m; Min. 11.8 m). In spite of the significant inundation depth, we found two buildings still standing in front of the seawall. One of them is a 2-story steel-frame building, and the other is a small wood-frame shack (Fig. 6b). The tsunami flow power must have been weak enough for those buildings to survive. Nonetheless, we observed severe undermining damage in the road and scour under the building foundation (Fig. 6c and d). Considering the survived buildings, it is unlikely that shear forces or hydrodynamic lift forces that require high-velocity flows caused the substantial scour damage.

Figure 6. Undermined road and building foundations on the sea side of the seawall in Tohni. (a)

The location of Tohni: the average runup height was 15.5m ($39^{\circ}12.5'N$ $141^{\circ}53.2'E$). (b) A

couple of buildings survived from the tsunami inundation. (c) The size of the undermined

road shown is 1.5m deep and 1.5 m high. (d) The size of the undermined foundation is 1.2 m

high and 2.0 m deep.
