Bourne Leisure Ltd. Thermal Performance Measurement Report

Professor David Johnston, Centre for the Built Environment, Leeds Beckett University

May 2016

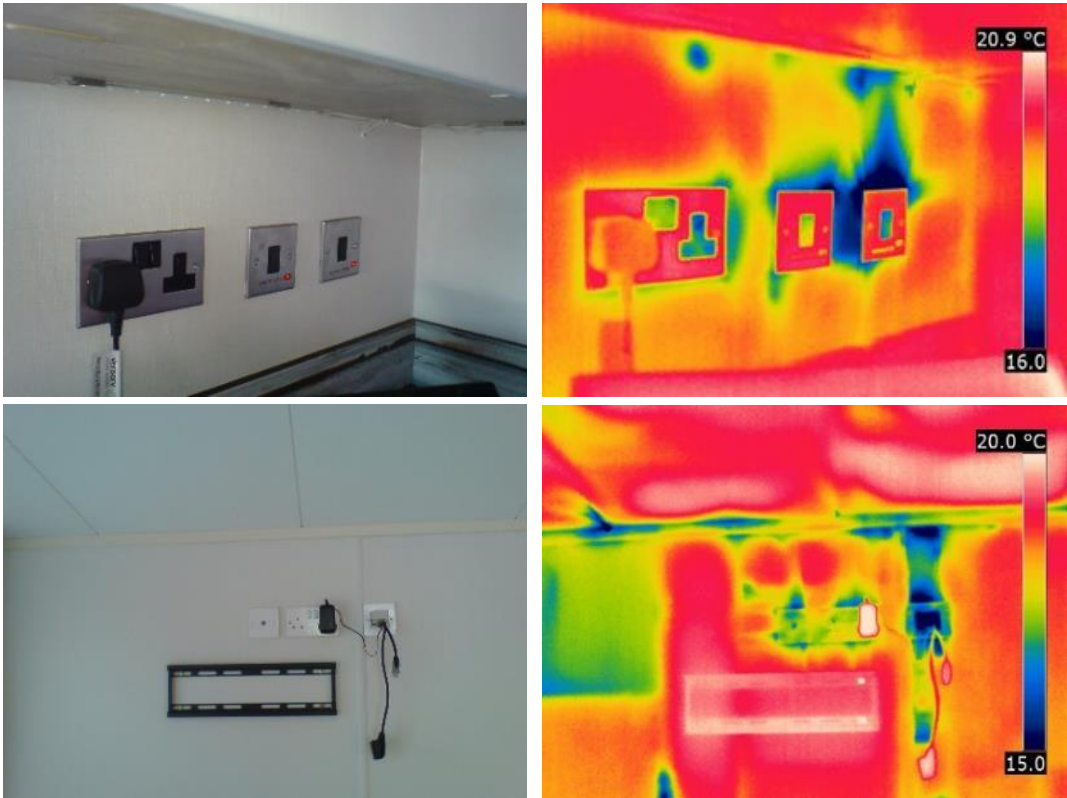
Figure 8 Air leakage around external wall sockets.

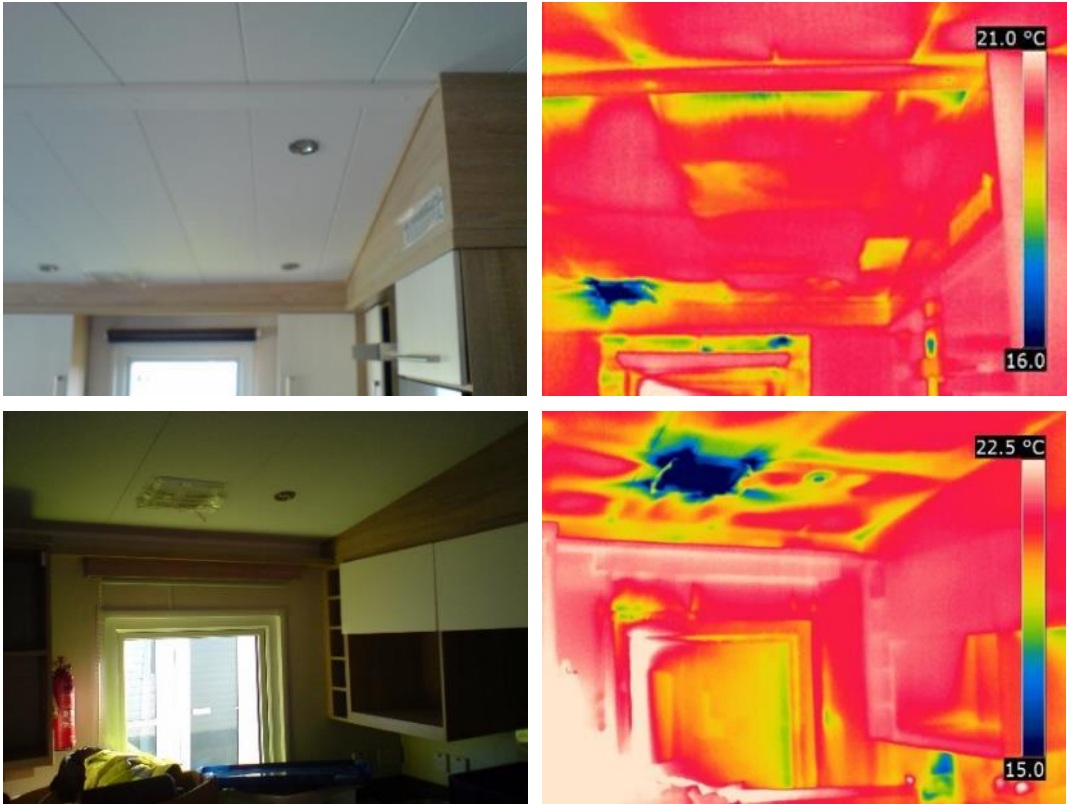
Figure 9 Air leakage around ceiling mounted extract grilles.

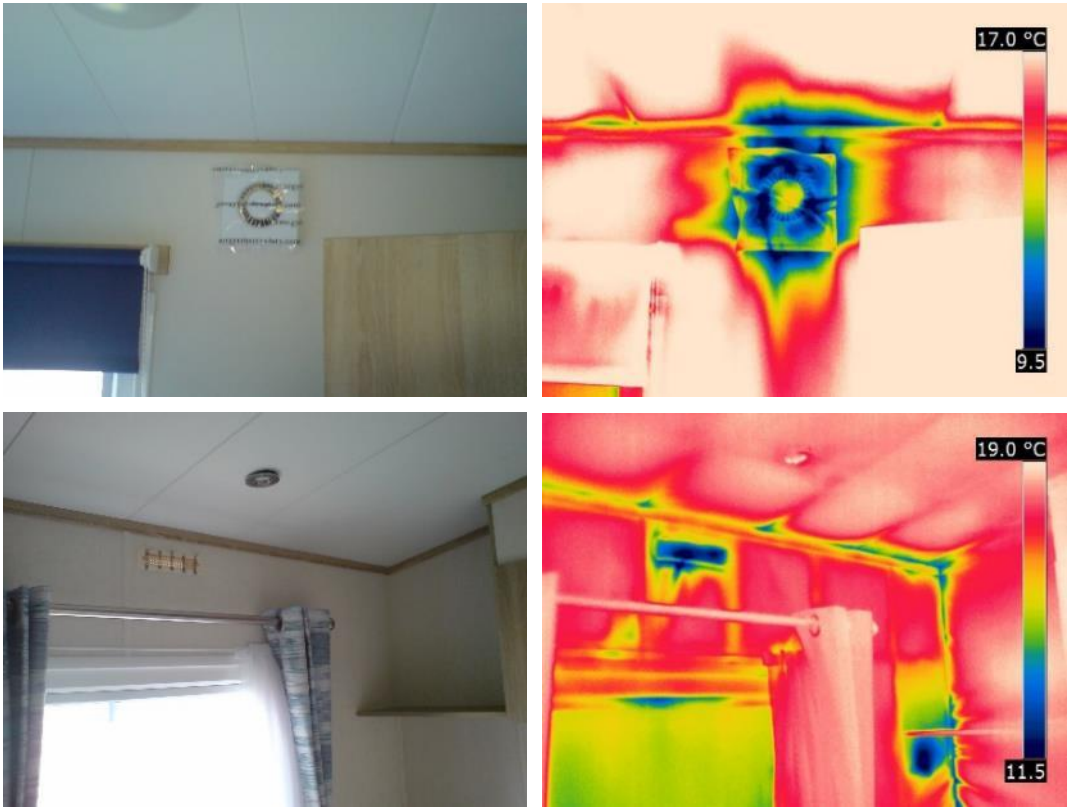
Figure 10 Air leakage around wall mounted extract fans (top) and grilles (bottom).

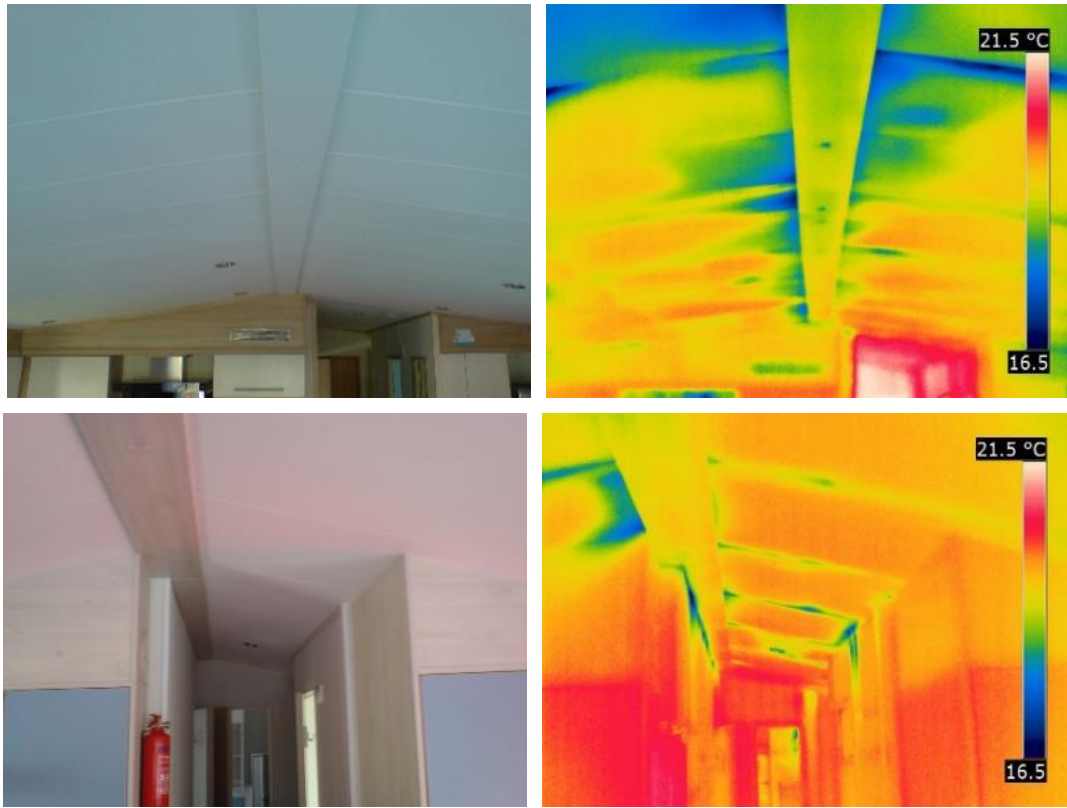
Figure 11 Air leakage at the ceiling ridge junction.

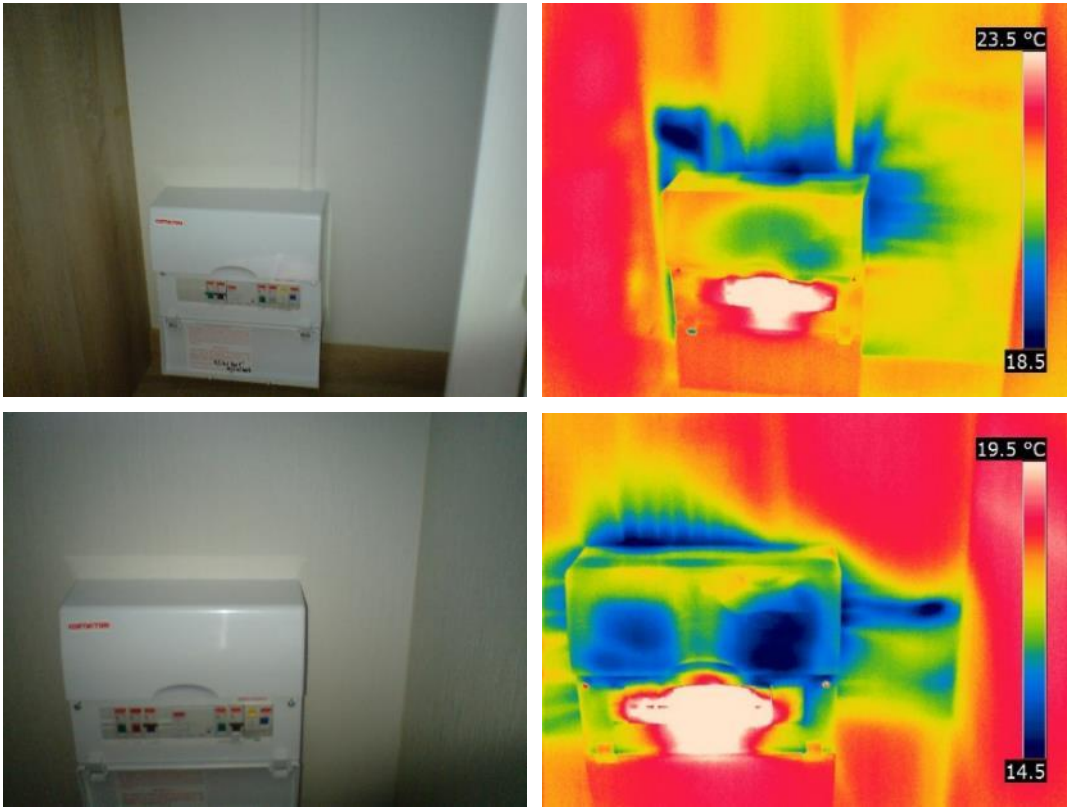
Figure 12 Air leakage around the consumer unit.

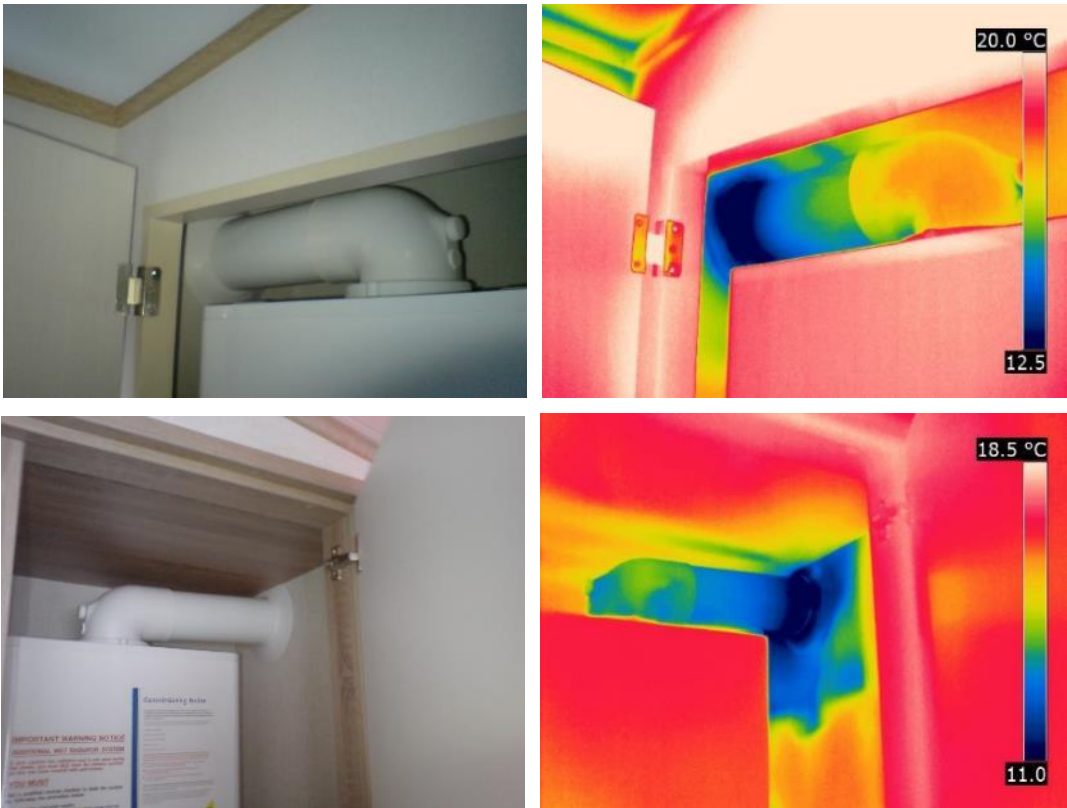
Figure 13 Air leakage around the boiler flue.

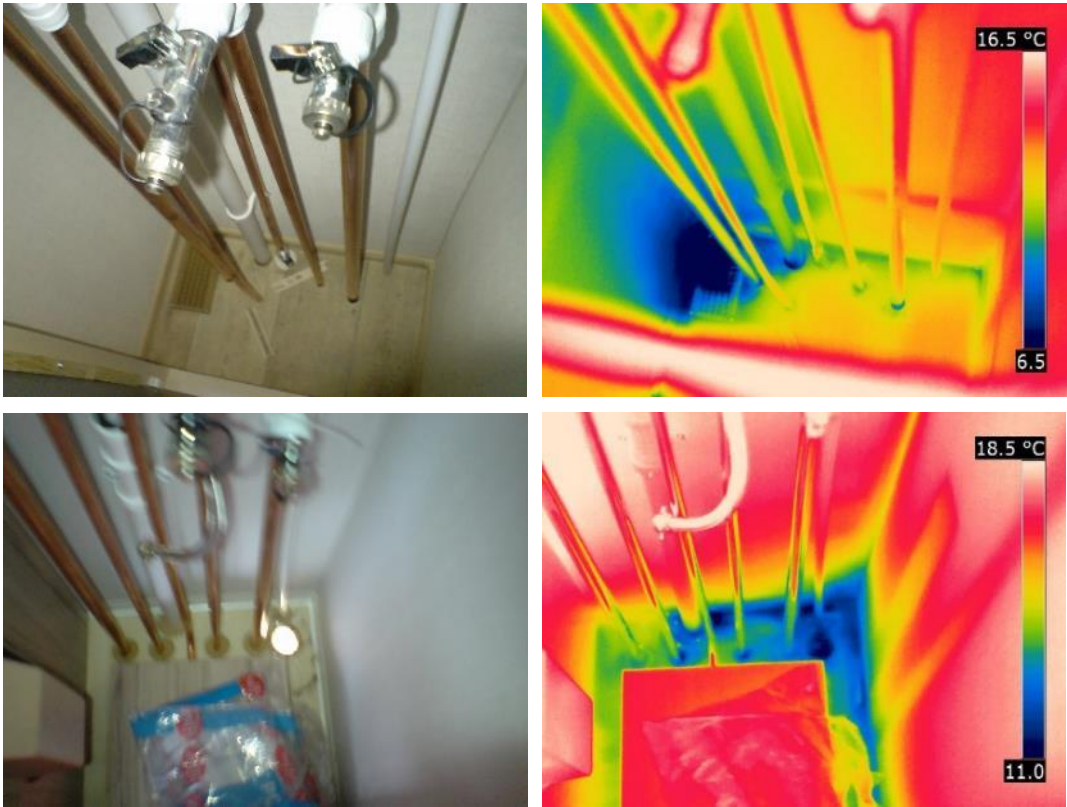
Figure 14 Air leakage around the water pipes, gas pipes and condensate drain at the boiler.

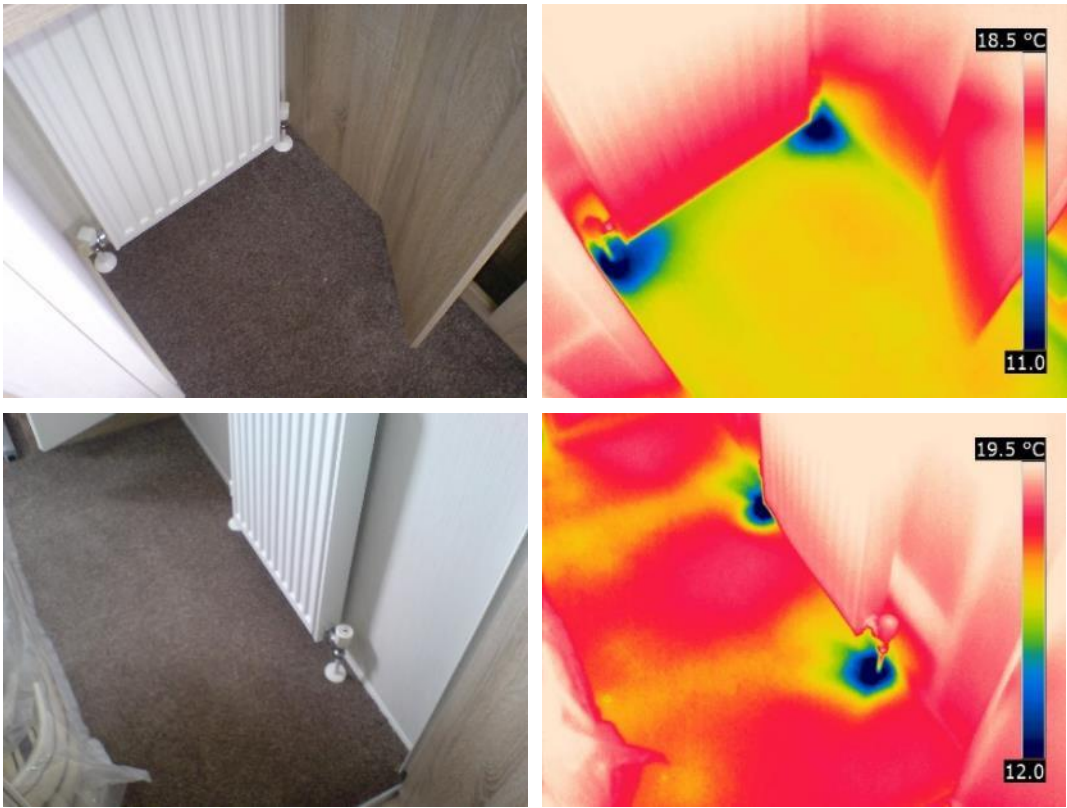
Figure 15 Air leakage around the central heating pipes where they penetrate through the ground floor.

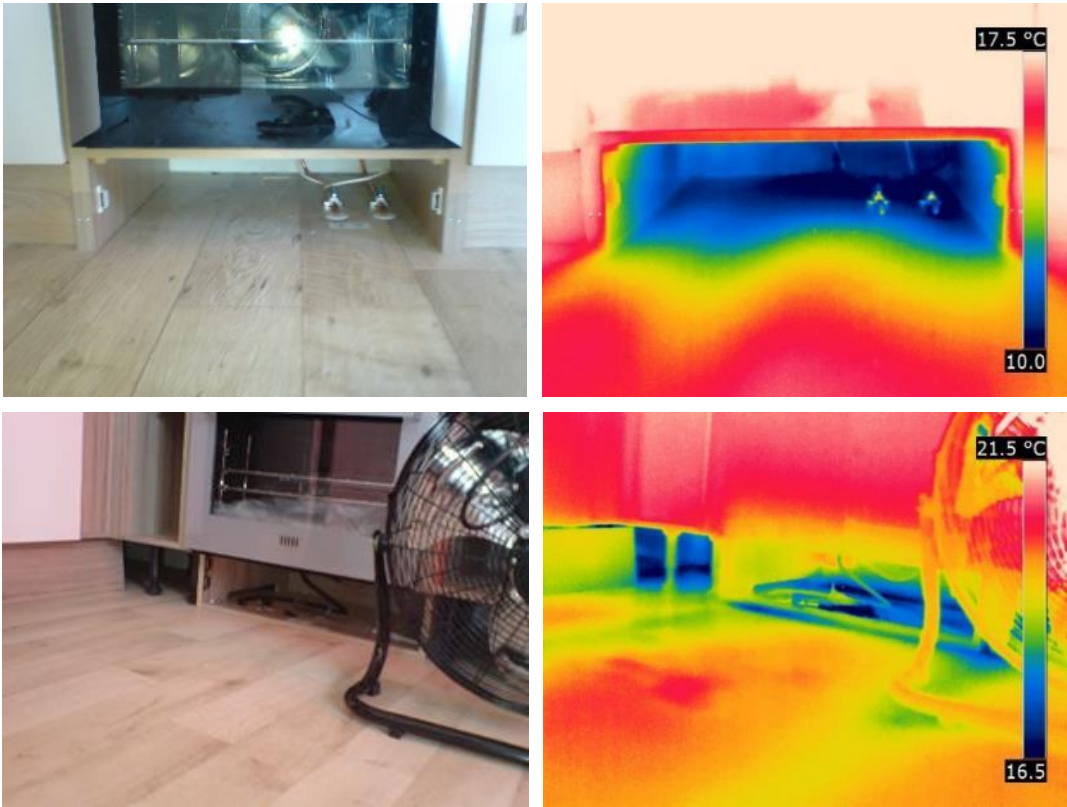
Figure 16 Air leakage around the gas pipes to the cooker.

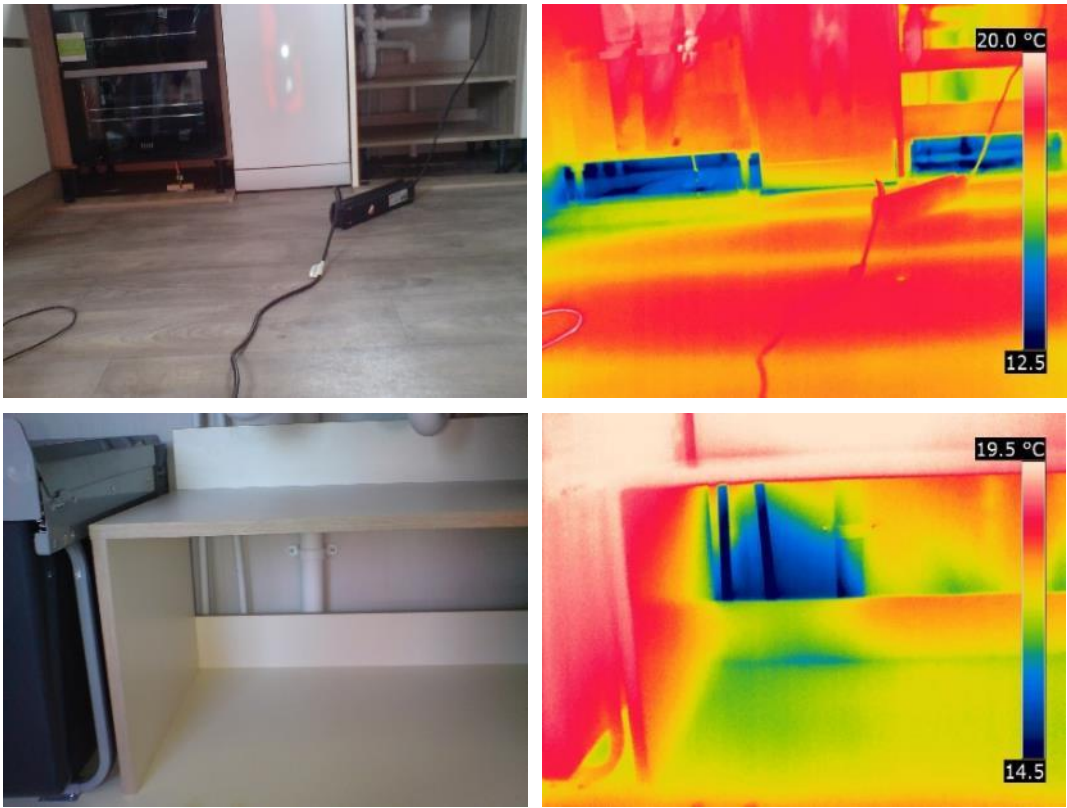
Figure 17 Air leakage around waste and water pipes under the kitchen units.

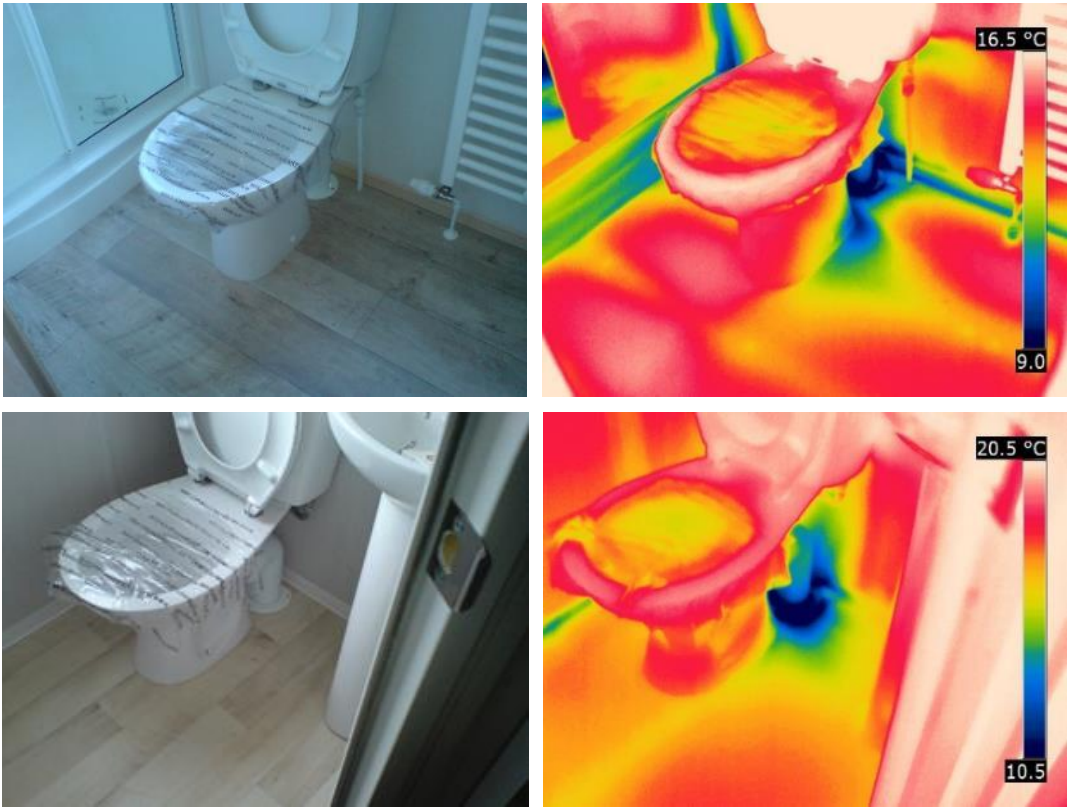
Figure 18 Around the toilet waste pipe.

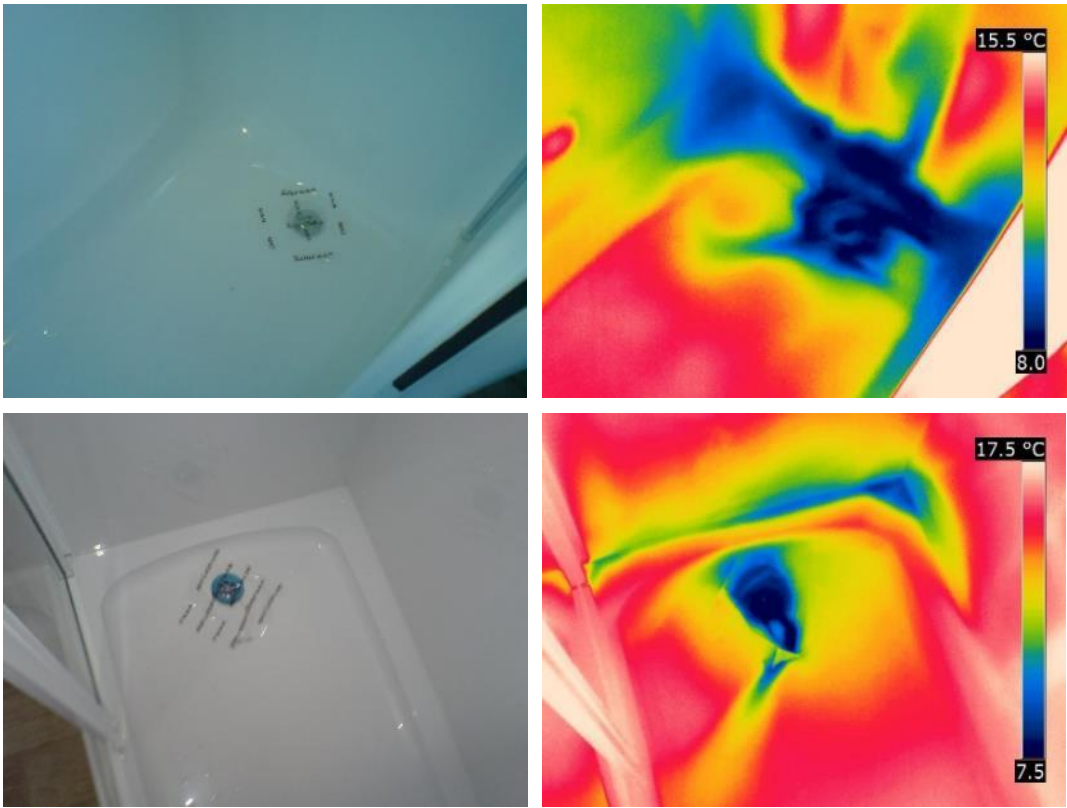
Figure 19 Air leakage from service penetrations beneath the shower tray.

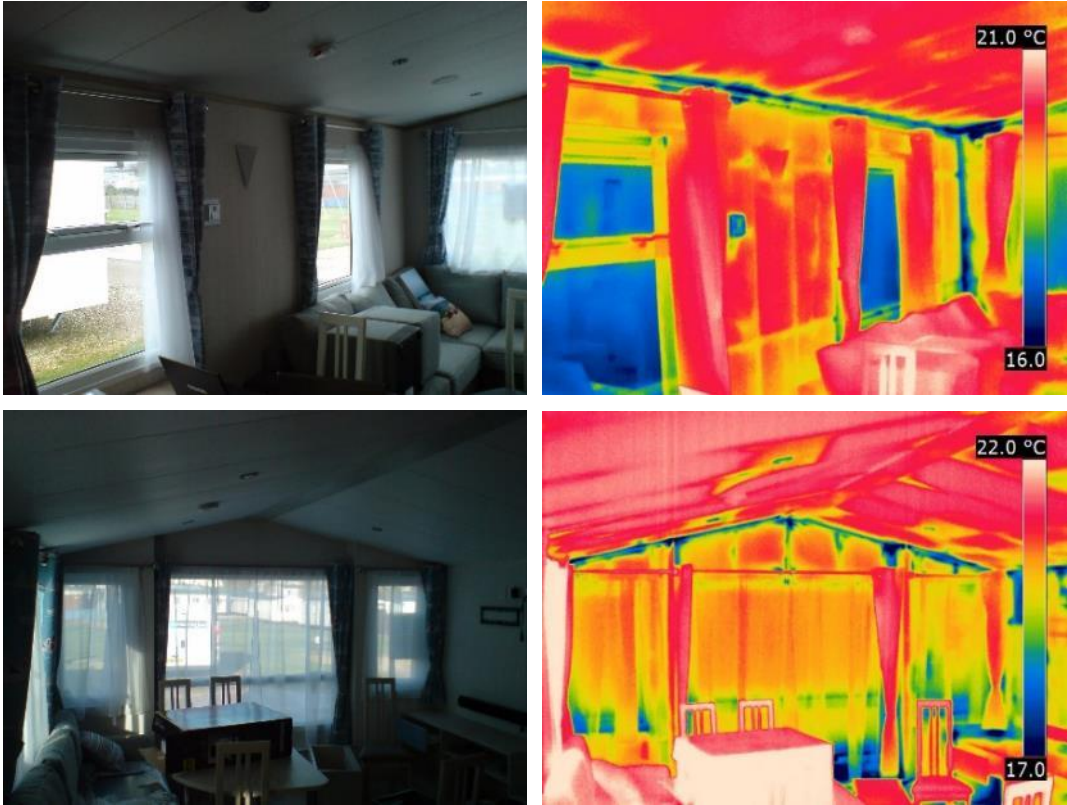
Figure 20 Air leakage at the external wall/ceiling junction (top and bottom) and at external wall corners (top).

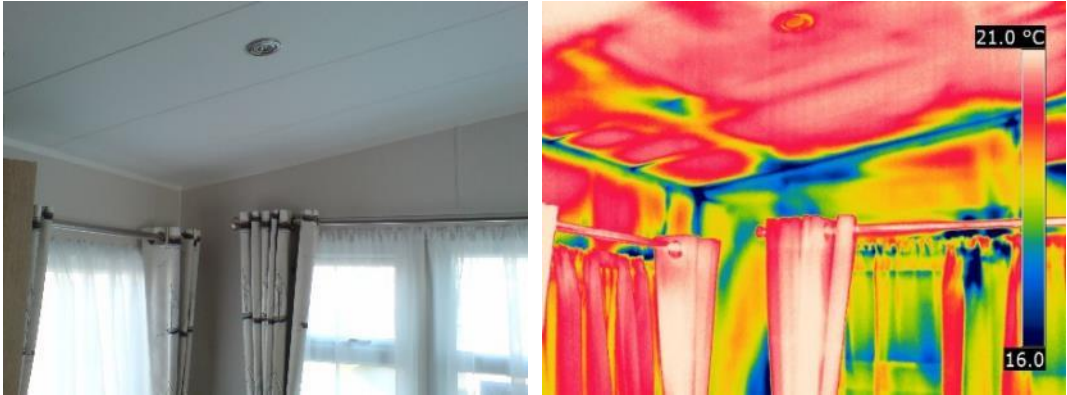
Figure 21 Air leakage at the external wall/ceiling junction in caravan D.

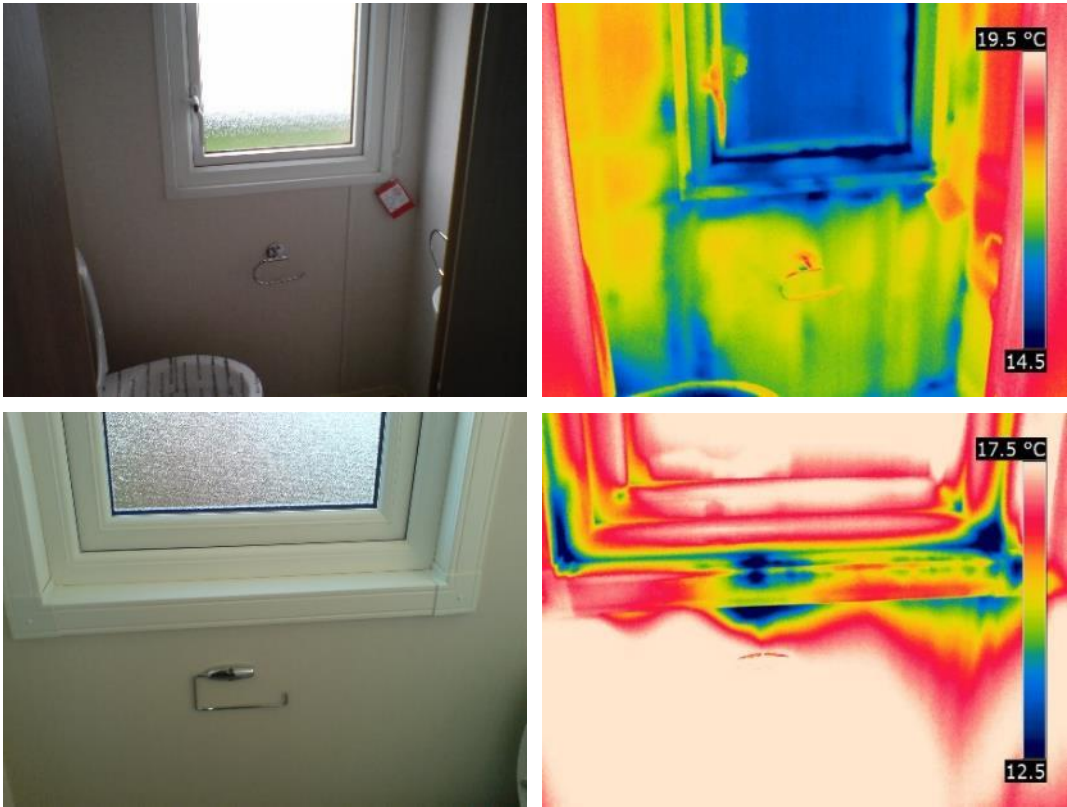
- Around the window frames (see Figure 22).
- 32 In addition, there were a much smaller number of areas of air leakage identified that were specific to particular test caravans. These were as follows:

Figure 22 Air leakage around the window frames.

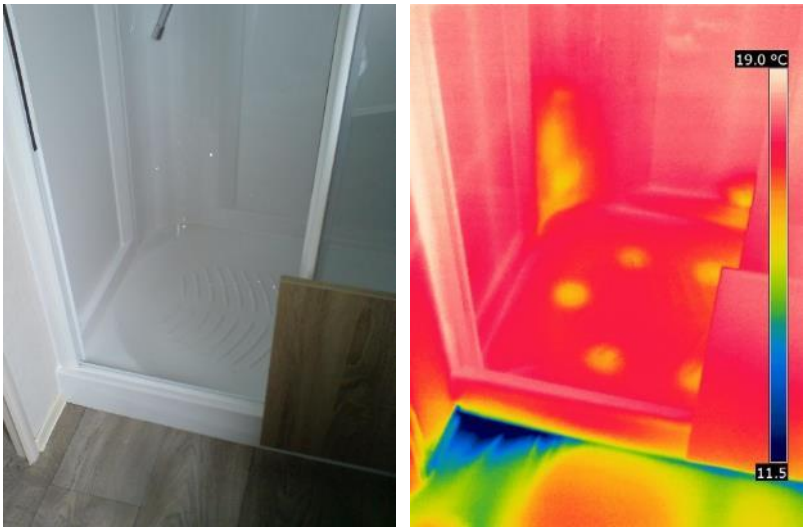
Figure 23 Air leakage at the shower tray/floor junction in caravan B.

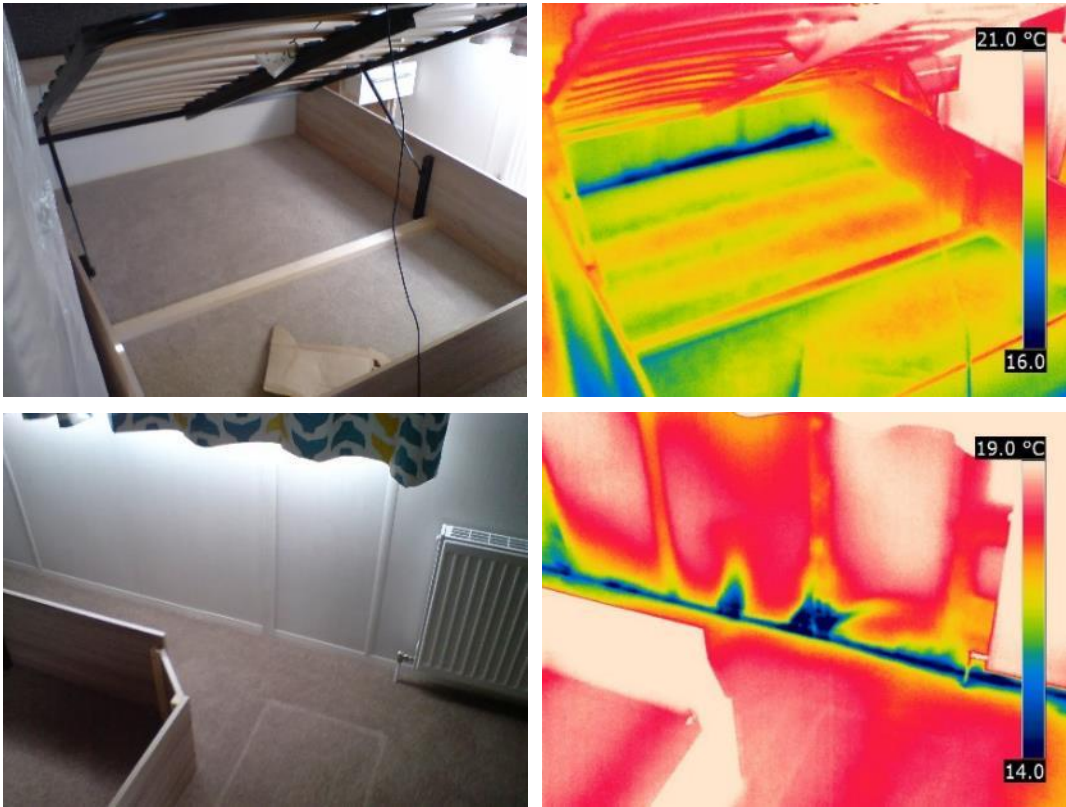
Figure 24 A leakage at the external wall/floor junction in the master bedroom of caravan A (top) and caravan E (bottom).

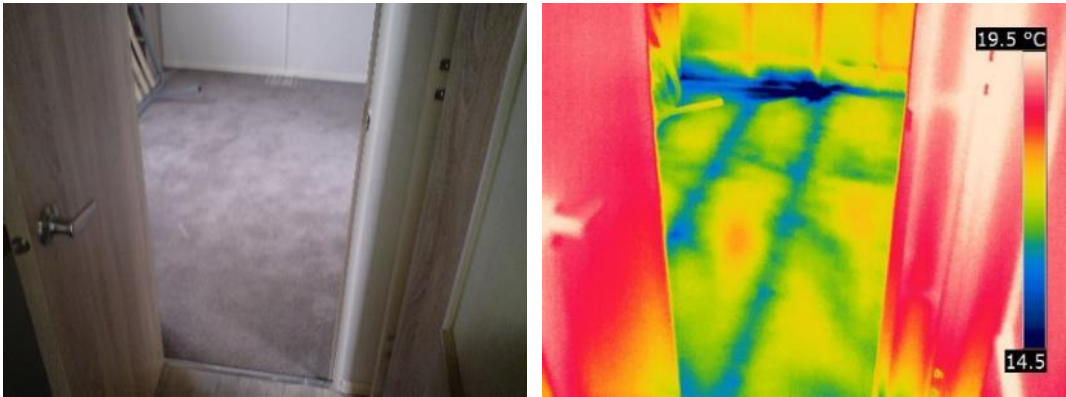
- Beneath the carpet in the master bedroom of caravan B (see Figure 25).
 - Around the front door of caravan C (see Figure 26).

Figure 25 Air leakage resulting in the carpet lifting under depressurisation in the master bedroom of caravan B.

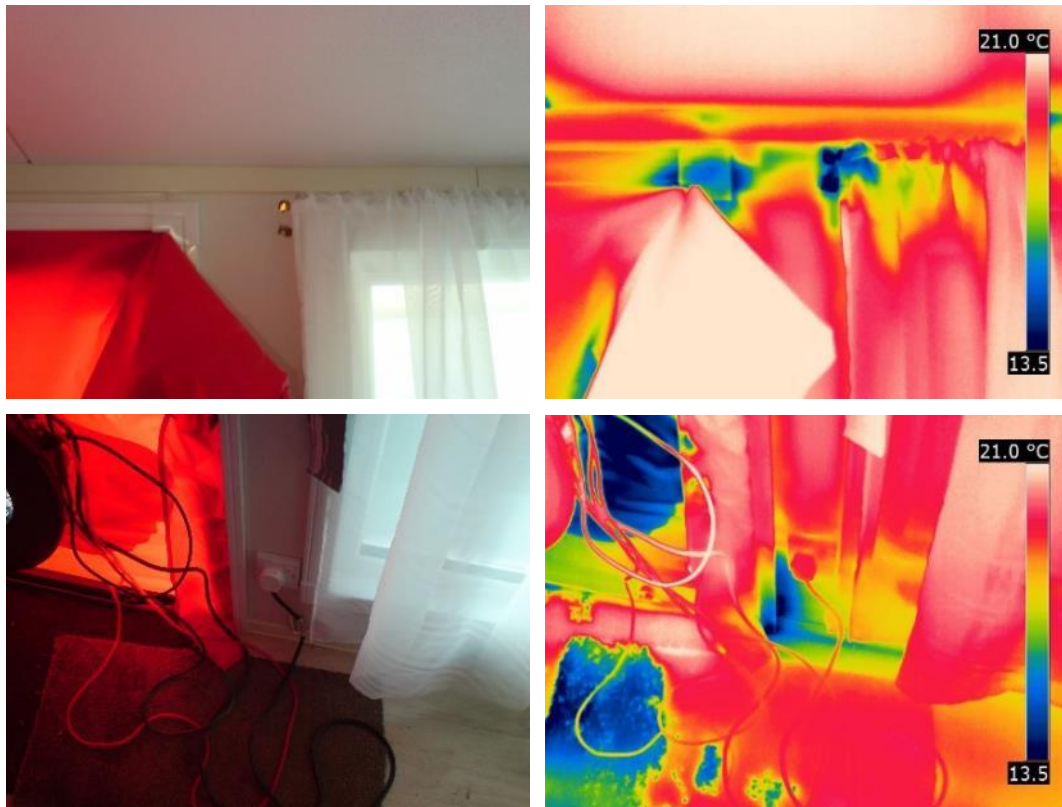
Figure 26 Air leakage around the front door of caravan C.

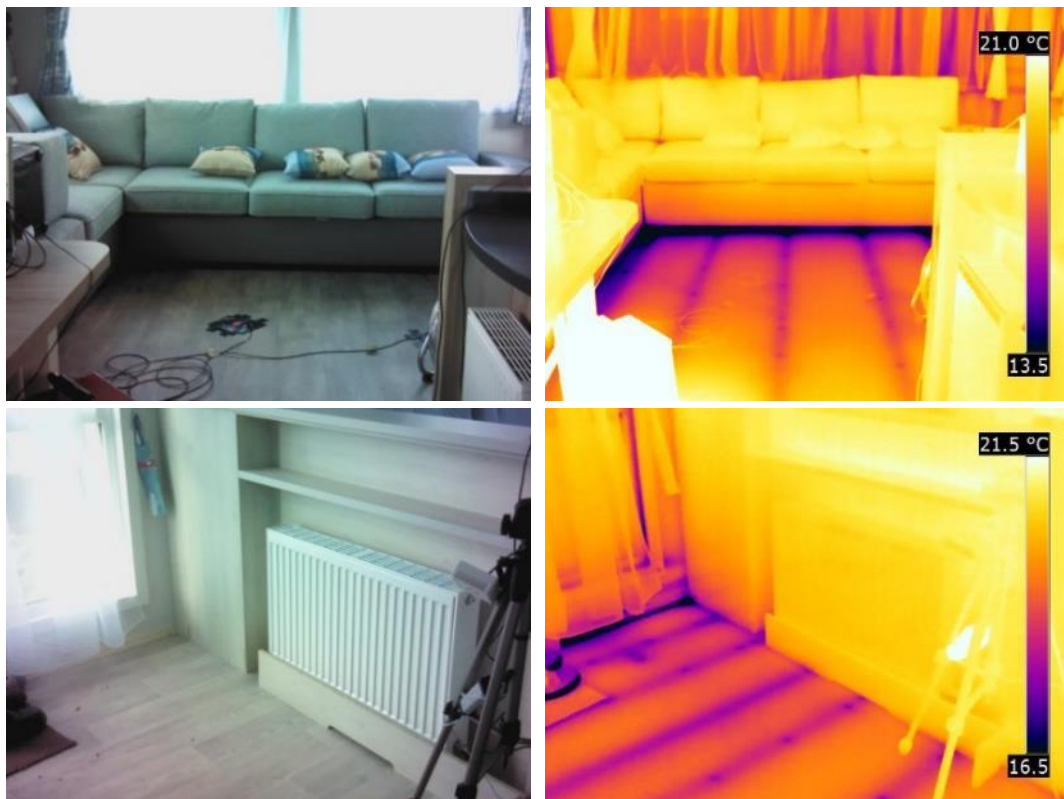
Figure 27 Thermal bridging at the ground floor joists.

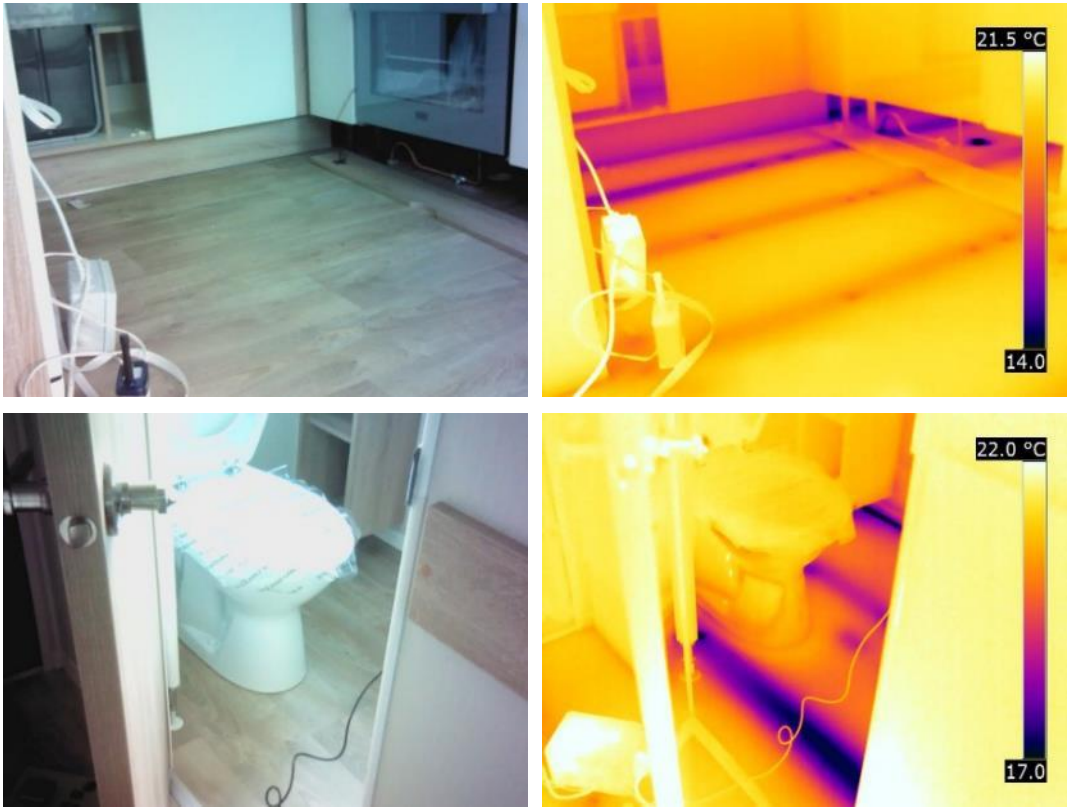
Figure 28 Steel chassis members clearly visible in the kitchen/living area (top) and bathroom (bottom) floor of caravan D.

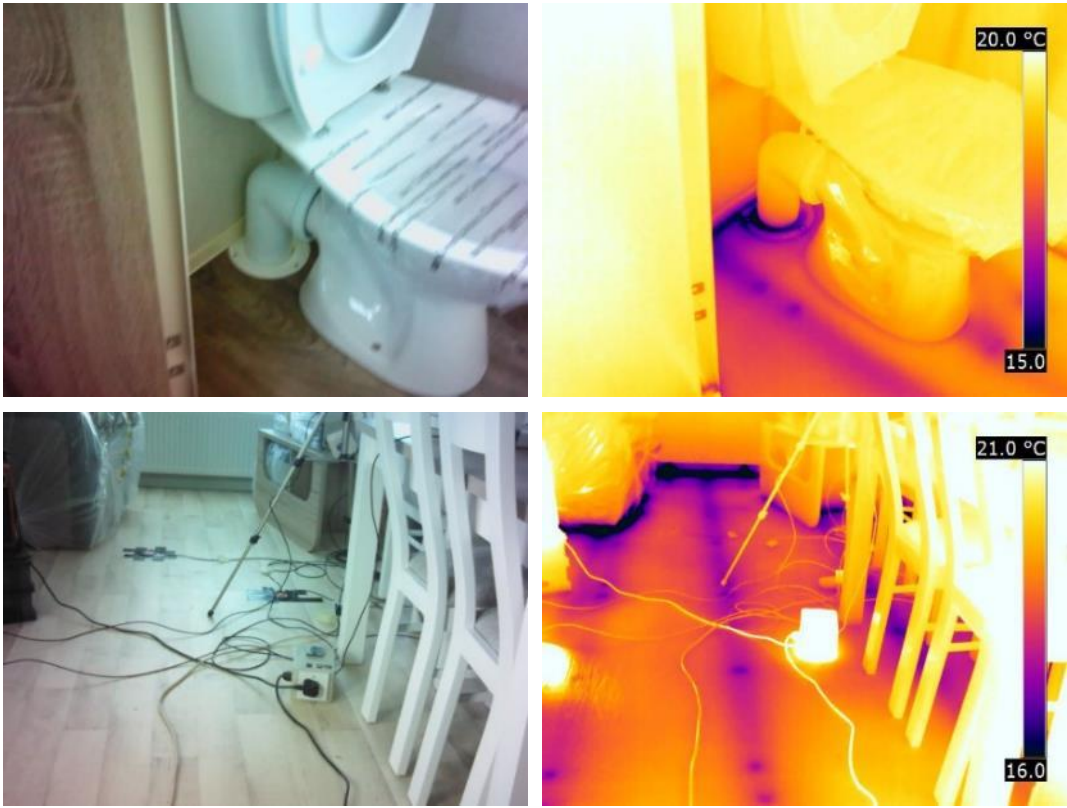
Figure 29 Joist fixings clearly visible on the floor of a number of the test caravans.

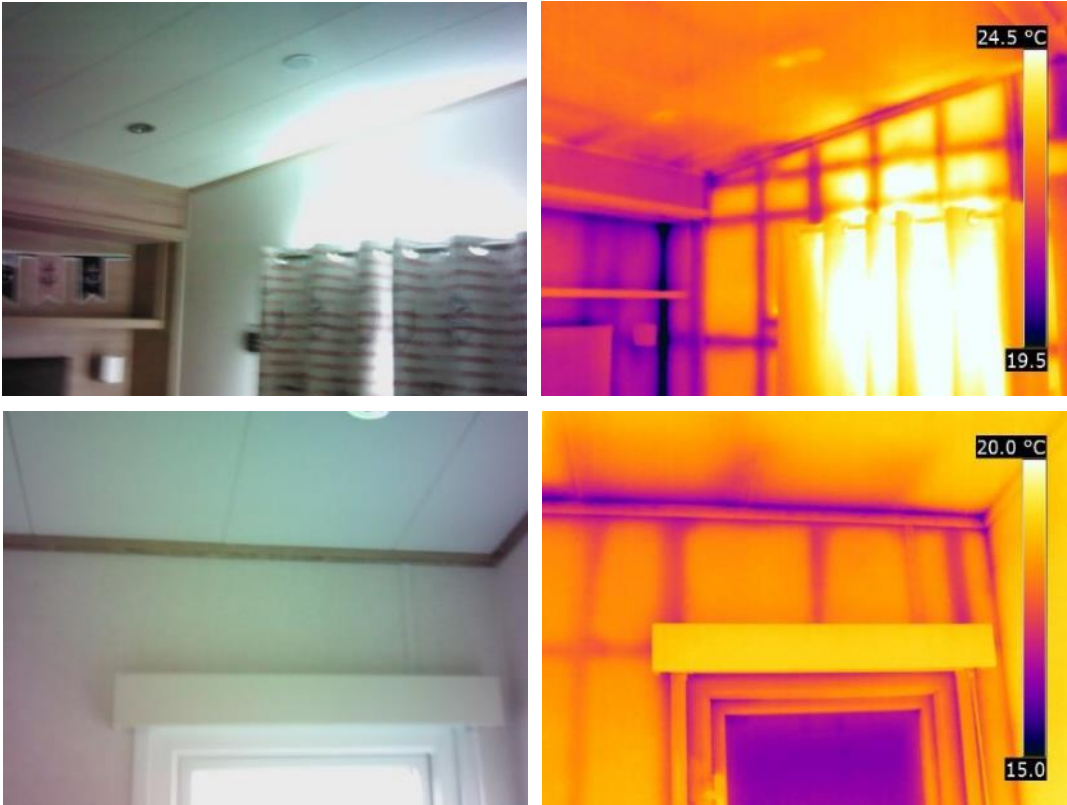
Figure 30 Thermal bridging at the vertical and horizontal studs in the external walls.

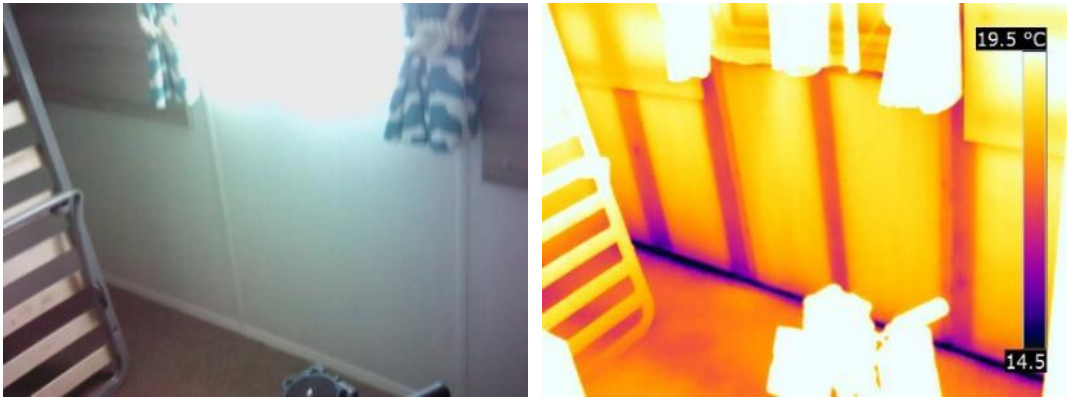
Figure 31 Lack of horizontal members in the external wall of caravan E.

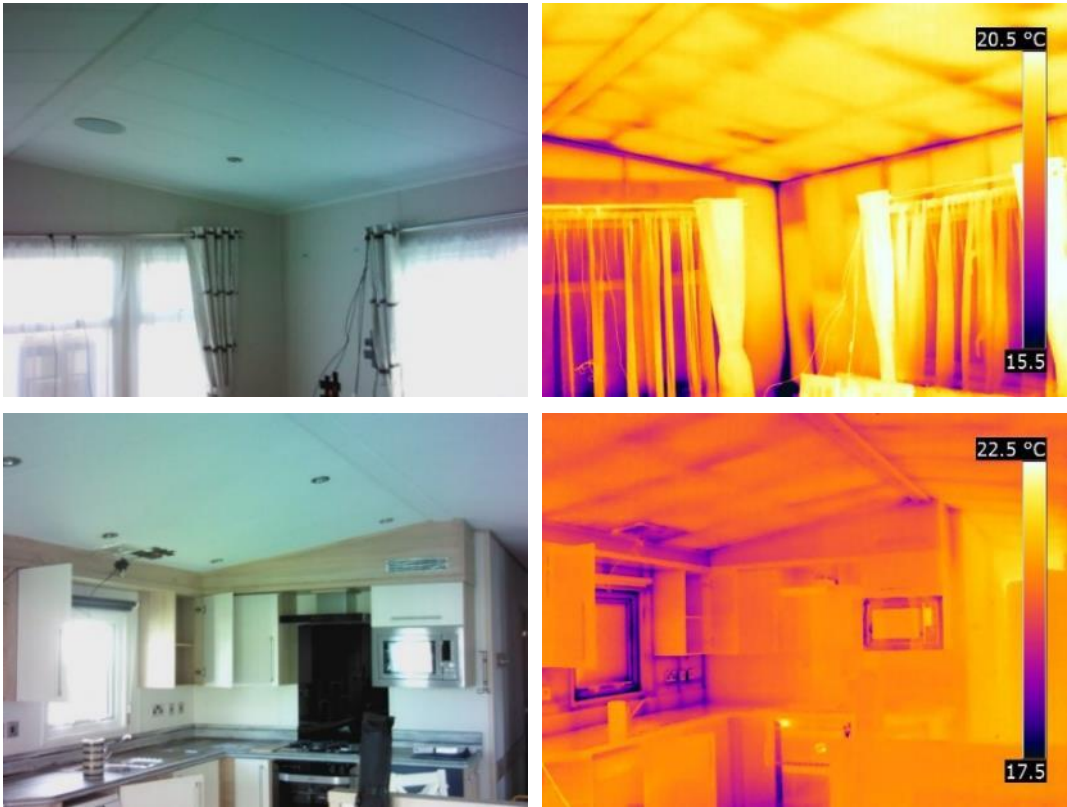
Figure 32 Thermal bridging at the roof joists and noggins.

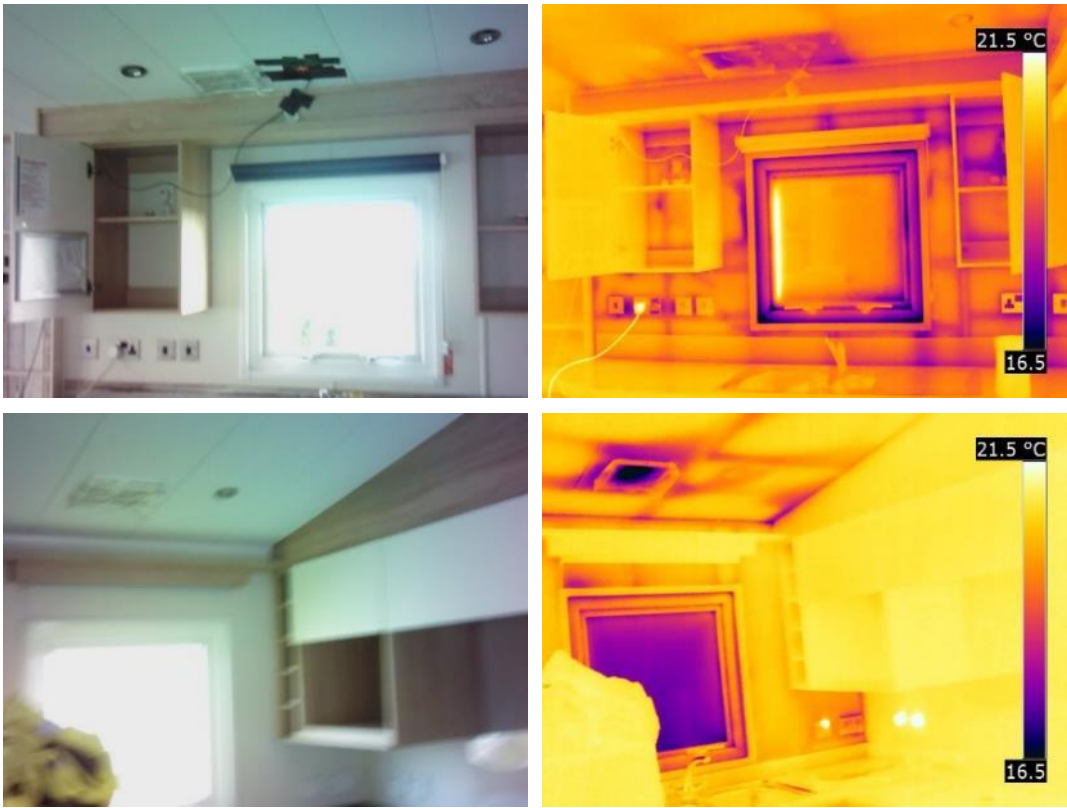
Figure 33 Thermal bridging around the ceiling mounted extract fan in the kitchen/living area.

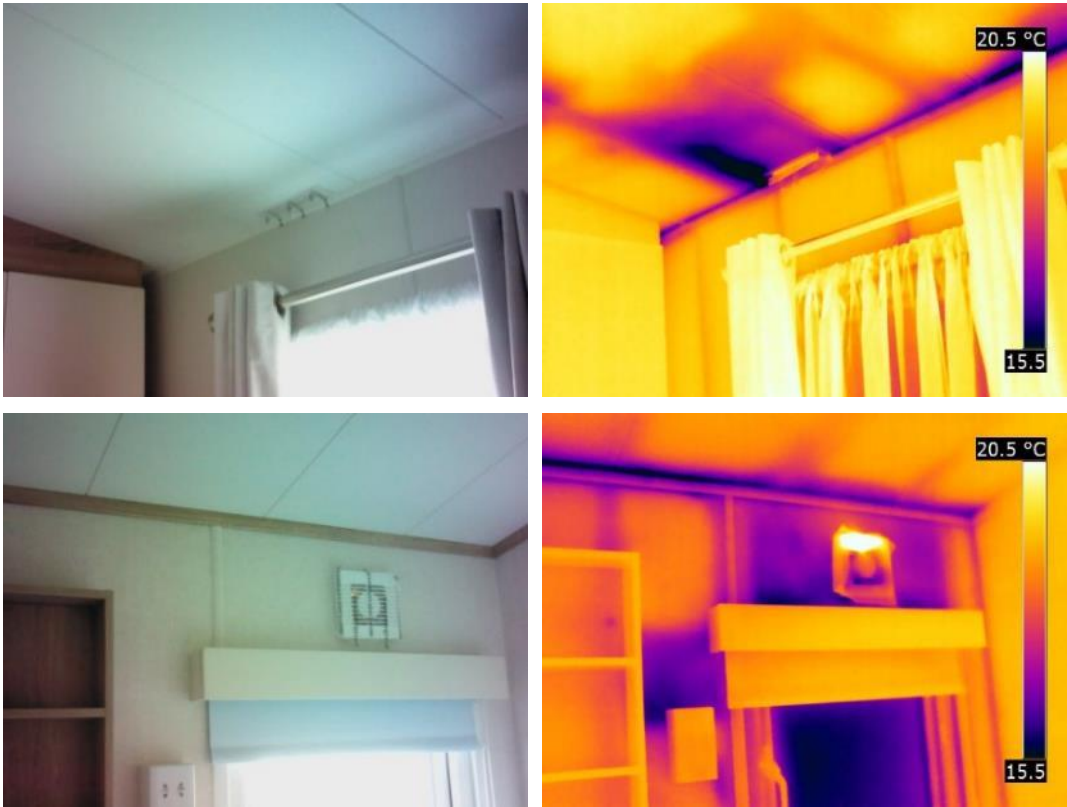
Figure 34 Thermal bridging around ceiling and external wall mounted vents.

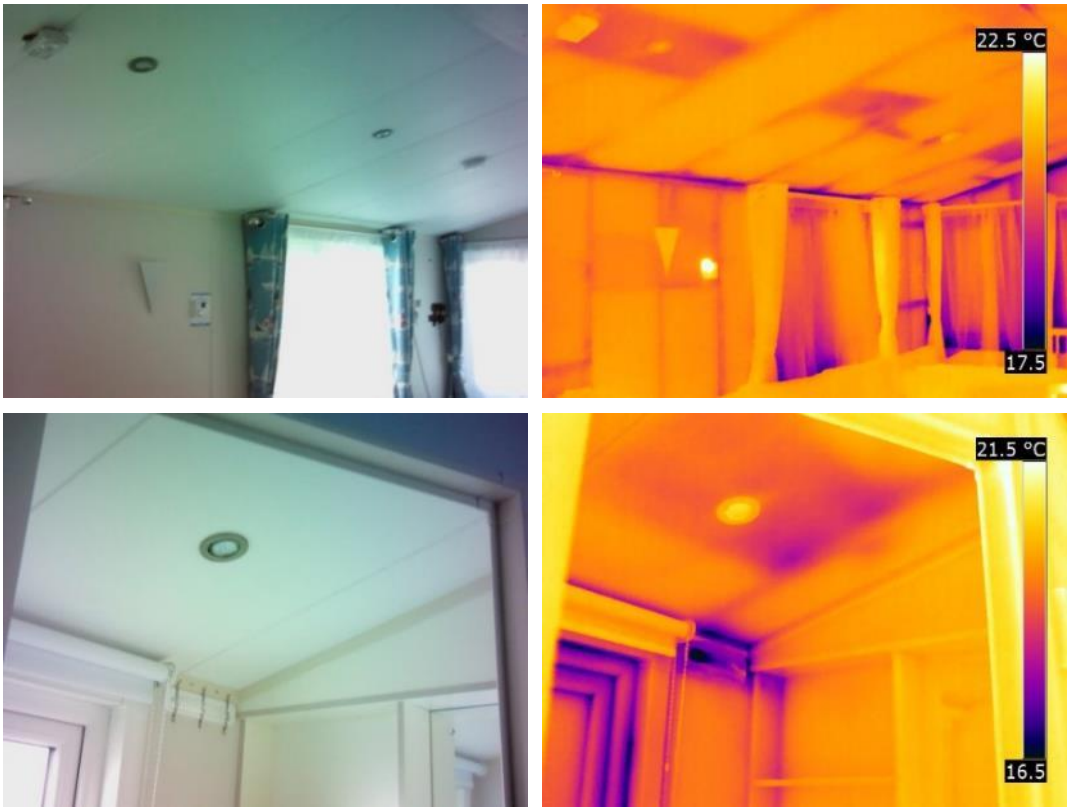
Figure 35 Thermal bridging around spotlights.
