Bourne Leisure Ltd. Thermal Performance Measurement Report

Professor David Johnston, Centre for the Built Environment, Leeds Beckett University

May 2016

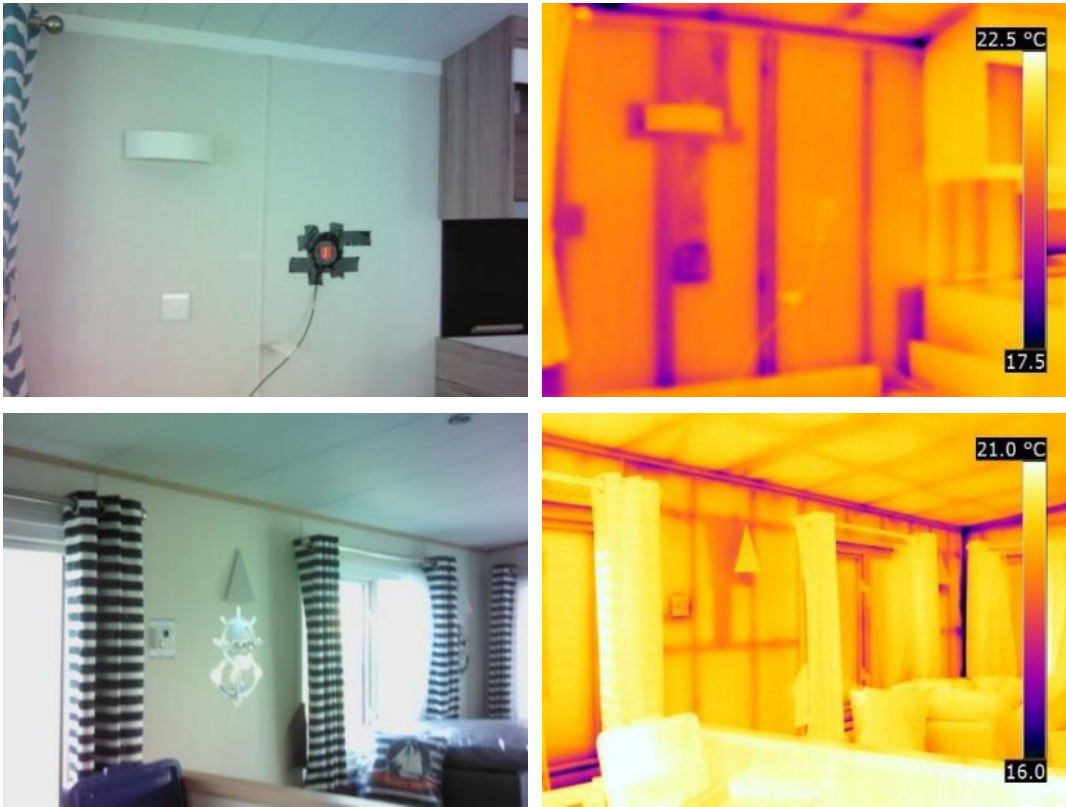
Figure 36 Thermal bridging around wall and light switches, particularly where there are cable runs.

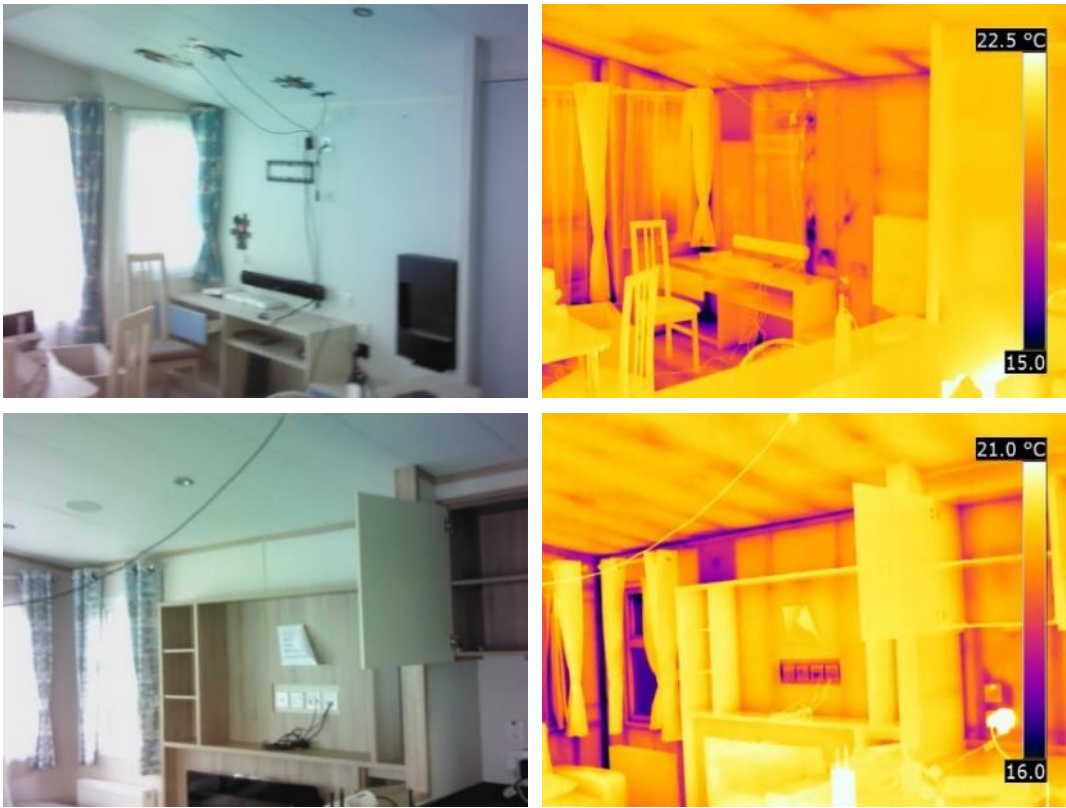
Figure 37 Thermal bridging at the external aerial fixing point.

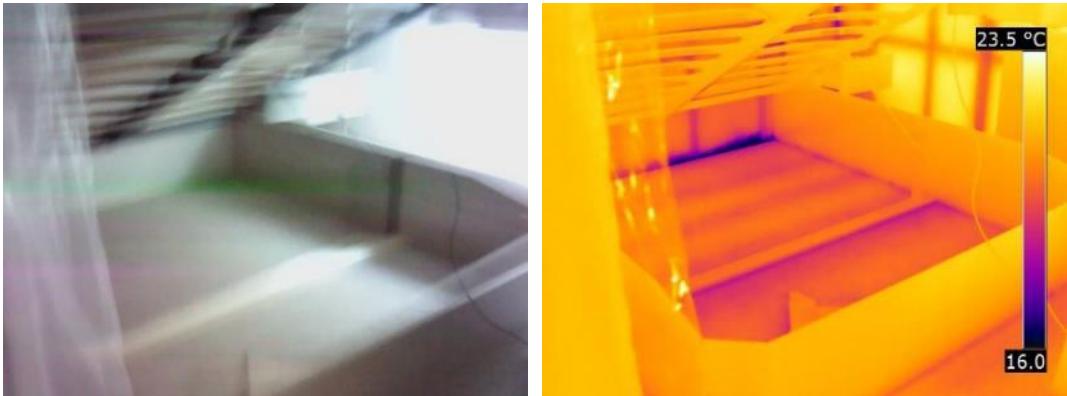
- At the external wall/floor junction in the master bedroom of caravan A (see Figure 38).
- Below the kitchen/living area window in caravan E (see Figure 39).
- Close to the ridge on the master bedroom end wall of caravan A (see Figure 40).
- At the sloping section of the kitchen/living area end wall in caravan A (see Figure 41).

Figure 38 Thermal bridge at the external wall/floor junction in the master bedroom of caravan A.

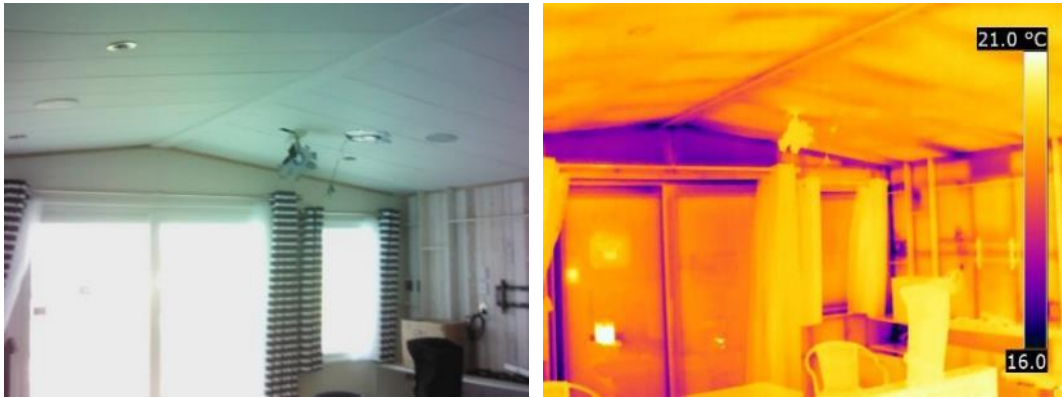
Figure 41 Thermal bridge at the sloping section of the kitchen/living area end wall in caravan A.

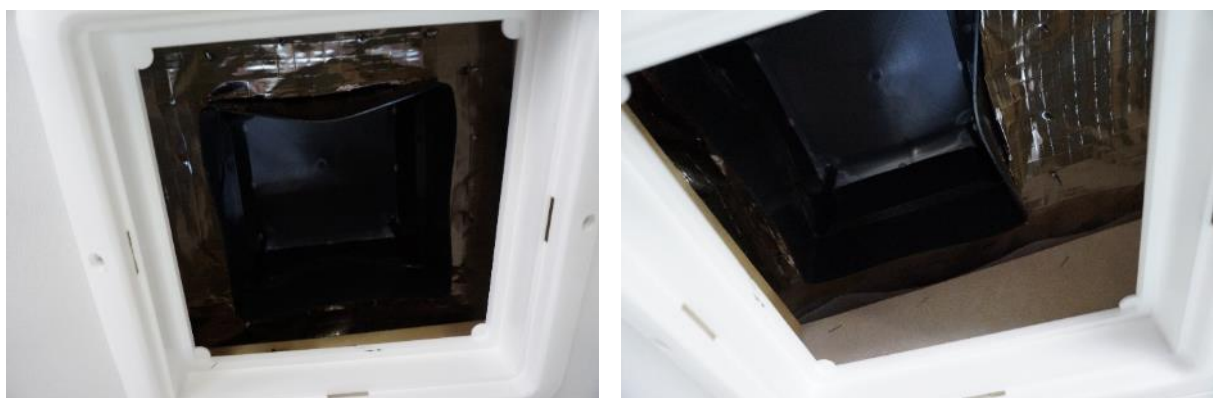
- 46 It is also clear from Figure 46 and Figure 48 that the *in situ* U-values measured at the external wall and roof anomalies are significantly higher than the design intent steady-state U-values. This can be attributed to the excessive thermal bridging that was observed at these locations. In the case of the external wall anomaly, the thermal bridging was caused by the insertion of additional timber at this location to enable the mounting of an external aerial. With respect to the ceiling anomaly, removal of the ceiling extract grille revealed either a lack of, or the omission of insulation surrounding the extract grille (see Figure 51).

Figure 51 Lack of insulation around ceiling extract vent in kitchen area of caravan B.

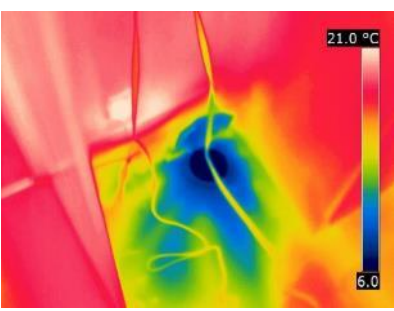
<p>Room – Lounge/Kitchen Span – 10 °C Excessive air leakage observed from under the fridge.</p>

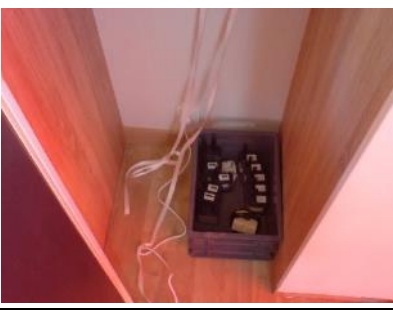
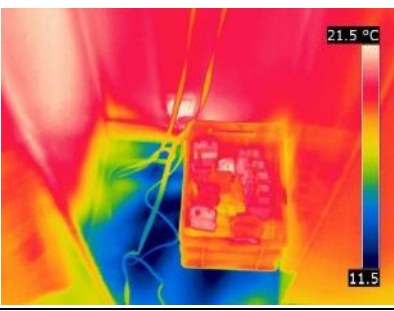
<p>Room – Lounge/Kitchen Span – 15 °C Fridge removed to reveal the temporary sealing below the fridge had become displaced.</p>
