Christ Child Bearing the Instruments of the Passion Technical Study and Treatment of a Painting on Copper from the Viceroyalty of Peru

Christ Child Bearing the Instruments of the Passion
**Technical Study and Treatment of a Painting on Copper from the
Viceroyalty of Peru**

CNS 695 Master's Project

Daniela González-Pruitt

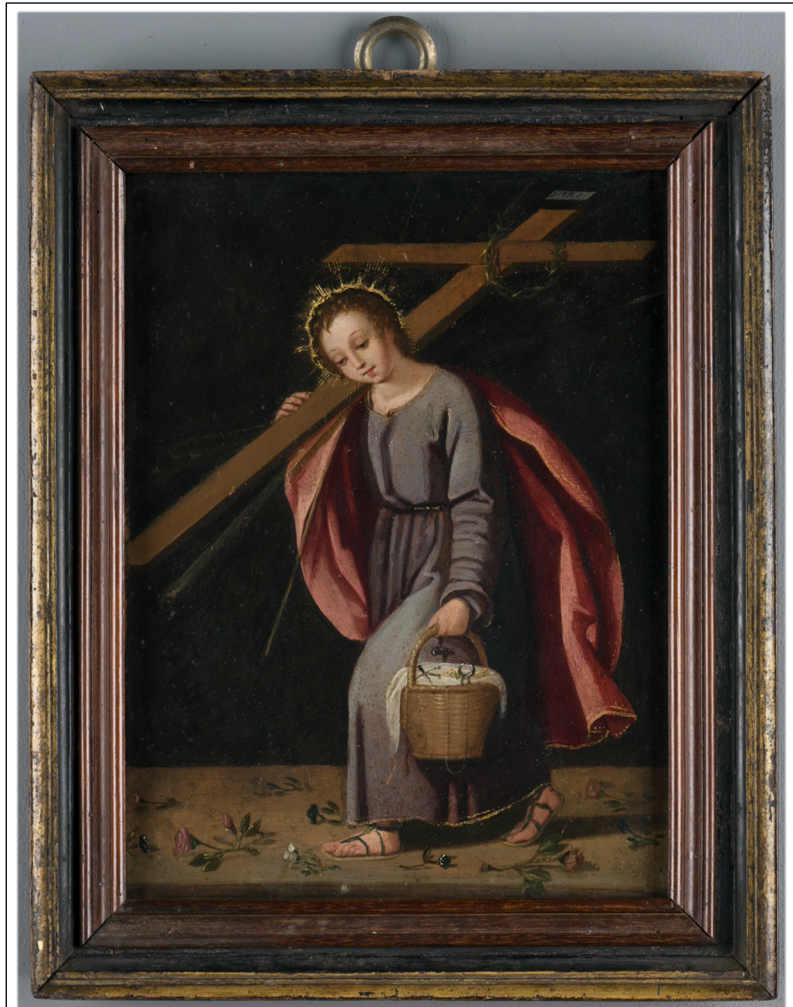
Figure 1. *Christ Child Bearing the Instruments of the Passion*, Thoma Foundation. Before treatment, in frame, normal illumination.

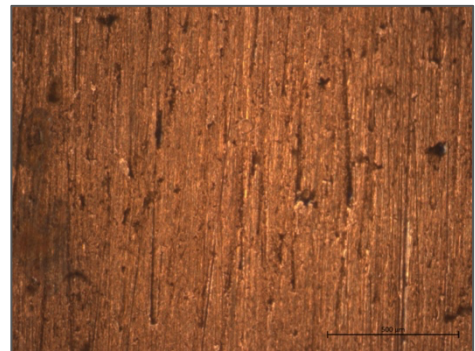
Figure 2. Recto, Normal illumination. Photomacrograph of copper roughening in an area of loss

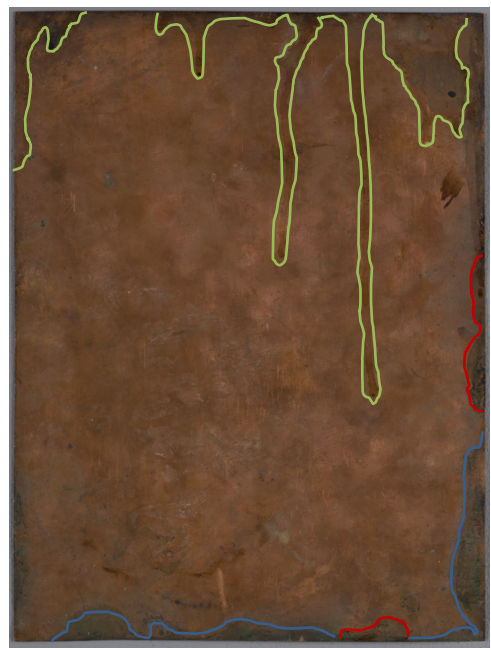
Figure 3. Verso, normal illumination. Varnish residues (green), transferred retouching media (red), and localized corrosion (blue).

borders of the verso, there are areas of green corrosion, varnish residues, and inpainting media present (fig. 3).

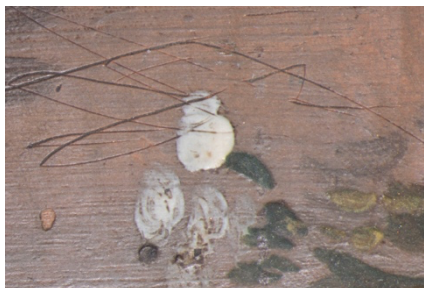
Figure 6. Recto, normal illumination. Detail of fine scratches reveal support beneath.

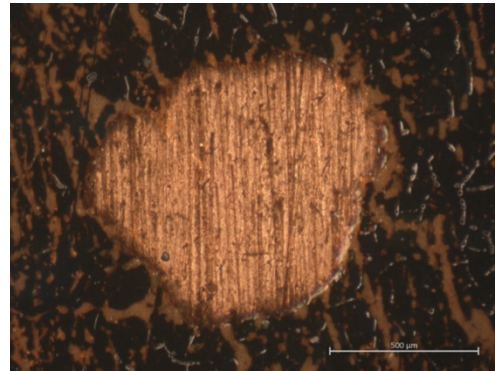
Figure 4. Recto, normal illumination. Photomicrograph of ground and paint loss.

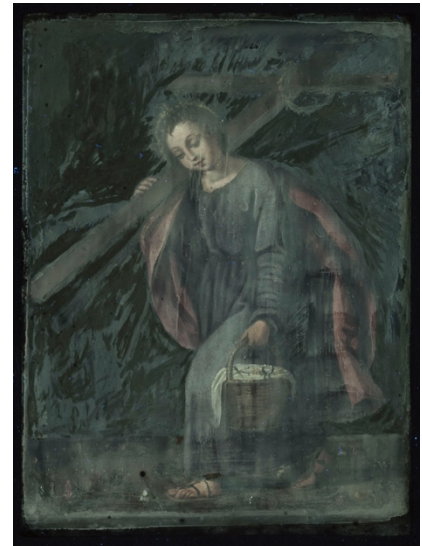
Prior to treatment, the painting had a high gloss coating that appeared varied due to the unevenly applied painted areas of retouching in the background (fig. 7). Normal viewing conditions revealed a fingerprint left in the surface coating located in Christ's mantle. When examined under UVA induced visible fluorescence, the brush-applied coating was observed to emit a greenish hue, indicatively of a natural resin. On the verso, varnish drips were observable on the top edge of the work and emitted the same color as the varnish applied to the front of the work. UVA examination revealed localized retouching in the figure of Christ and significant amount throughout the background.

Figure 7. Recto, Overall UVA induced visible fluorescence illumination. Greenish hue is the fluorescence of a varnish, while dark regions are restoration.

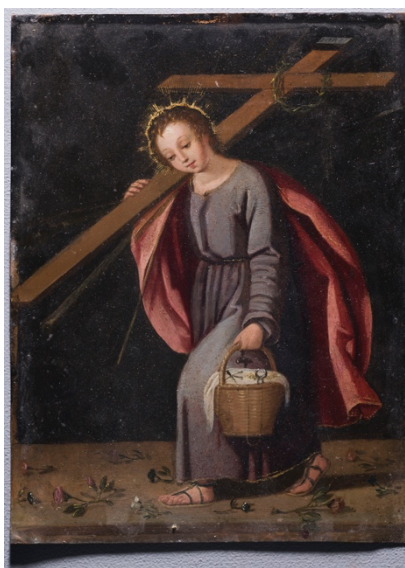
Figure 10. Recto, Overall raking illumination showing surface dust and grime.

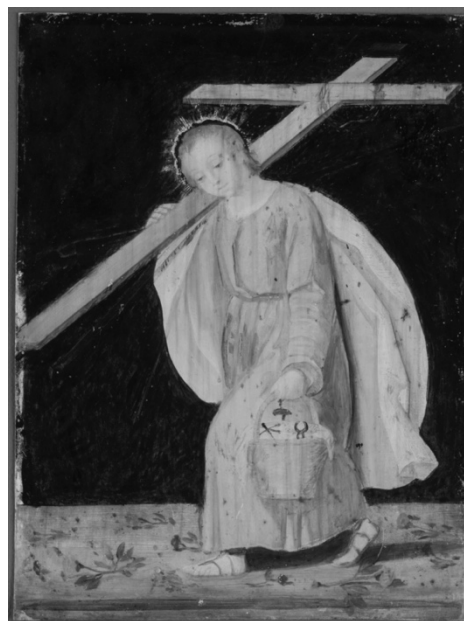
Figure 13. During Treatment, Overall reflected infrared illumination at 750nm. Areas of overpaint appear darker.

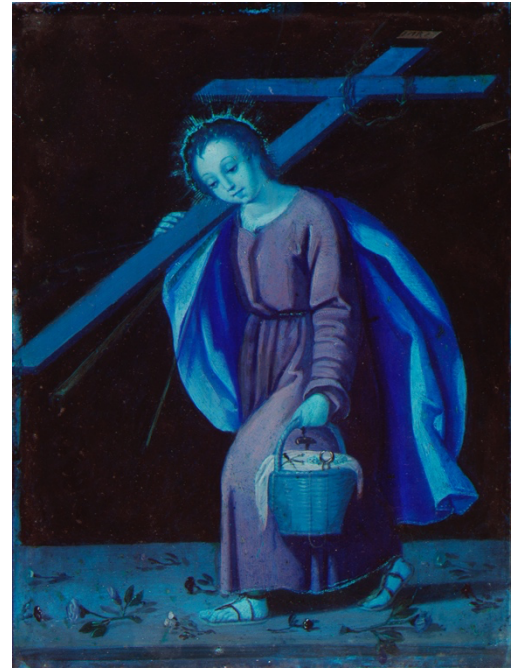
A false color image was also created (fig. 17). The 1000 nm image was used for the red channel, 800 nm for green, and 400 for blue. In this image, overpaint in the mantle appears gray and is visually distinct from original paint.

Figure 17. False color image created from images at 400, 800, and 1000 nm.

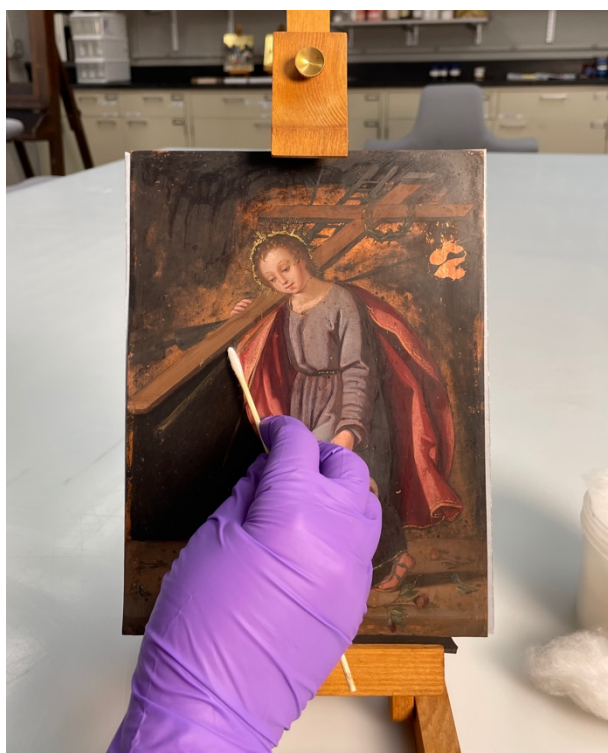
Figure 23. Removing restoration varnish and reducing liberally applied overpaint. The losses from previous damages are now visible.

Following removal from the frame, treatment of the painting began. Mention gloves here and a special support created to house the work to avoid damage while handling. Mineral spirits was used to remove dirt, grime, and corrosion from the surface of both recto and verso. Solvent testing was conducted to determine the solubility of the varnish layer, and isopropanol was found to effectively remove the varnish without affecting the original paint layers. During varnish removal, an image of the painting in ultraviolet fluorescence was regularly consulted to better distinguish overpaint. As expected, overpaint readily lifted with the varnish throughout the work (fig. 23). It was revealed during these stages that most of the black background had indeed been liberally overpainted concealing the instruments of the passion held by Christ. Removal of overpaint in the figure of Christ exposed pinpoint losses small dark spots of corrosion. FTIR analysis revealed that the restoration media is in a linseed oil medium, however it remains unclear when this paint was applied, and by whom. Areas of “green” corrosion were cleaned/degreased in order

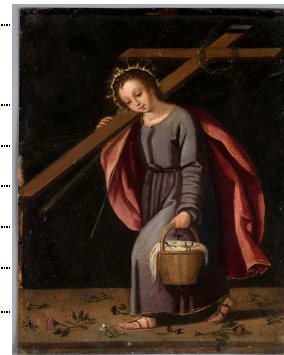
Figure 1. Christ Child Bearing The Instruments of The Passion, Front, DT

While reducing the overpaint from previous restoration campaigns, it was discovered that the painting had substantial loss in the background that had been concealed by restoration campaigns. This previous overpaint had also obscured some of the composition. As a result, for this treatment, a slightly more light-handed approach to inpainting was adopted and allowed some of the additional elements to be more discernible. Nevertheless, the inpainting is more substantial than originally anticipated due to the amount of damage.
