# Quality assessment of CIPP lining in sewers: Crucial knowledge acquired by IKT and research gaps identified in Germany

Bosseler, B, Homann, D, Brüggemann, T, Naismith, I & Rubinato, M 2024, 'Quality assessment of CIPP lining in sewers: Crucial knowledge acquired by IKT and research gaps identified in Germany', *Tunnelling and Underground Space Technology*, vol. 143, 105425.

## Quality assessment of CIPP lining in sewers: Crucial knowledge acquired by IKT and research gaps identified in Germany

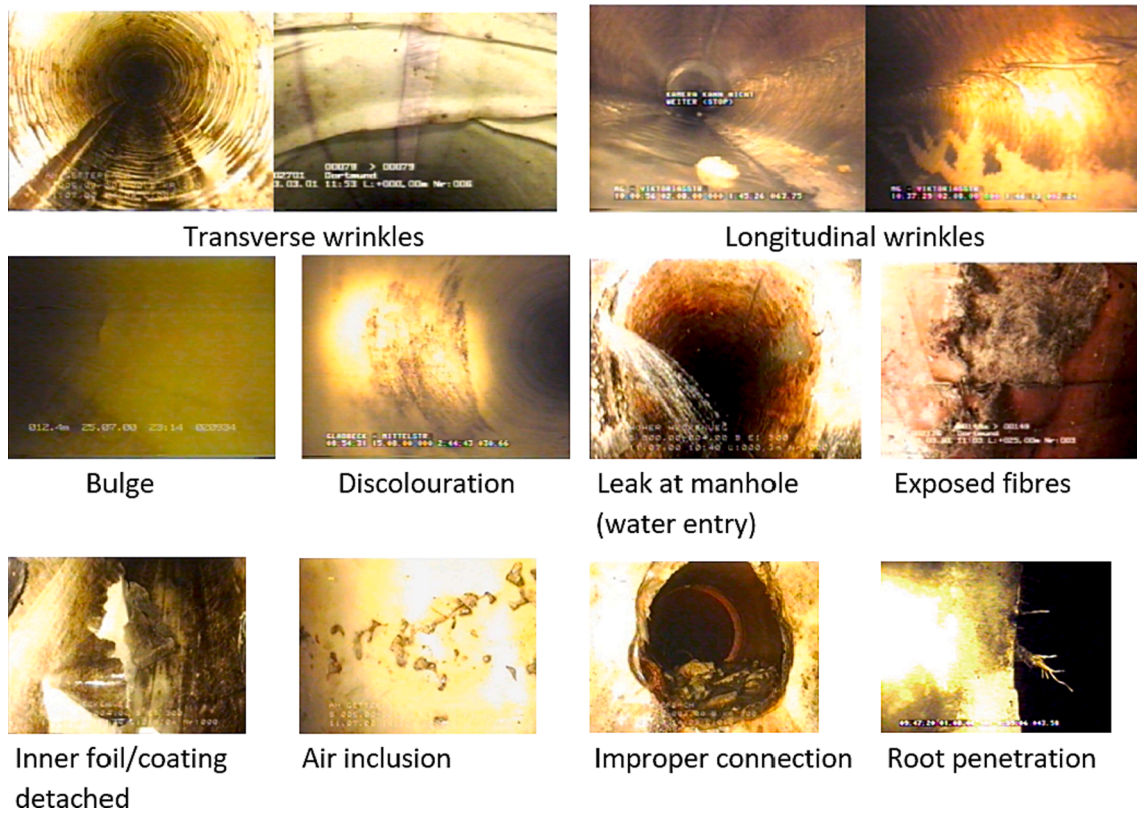
The focus of the first study (Bosseler et al., 2001) was to identify typical anomalies on 15 sections of liner (DN 250-DN 500) in six different cities in North Rhine-Westphalia, Germany. Anything that fundamentally deviated from the client's expectations of an "impeccable liner" (in accordance with the highest standards therefore faultless) was recorded as an anomaly. Based on extent of failure to the stability, water tightness or operational safety, these can also constitute a defect. So, an anomaly may or may not be a defect. This had to be evaluated separately in each individual case. Fig. 3 shows an overview of the anomalies investigated and identified.

The overall condition of the 15 lined sewer sections was assessed using CCTV inspections and leak tests, and anomalies were found in all of the inspected sewers. These were generally localized and, in most cases (e.g., wrinkling in the longitudinal and annular directions and faulty integration of laterals), could be clearly traced back to individual installation errors. For eight of the fifteen sewer pipes inspected, an acceptance video had been made at the time of rehabilitation, on which the majority of these anomalies were already recognized. In the comparison with inspection data from the project (up to 5 years later), no noteworthy changes in the liner due to operational influences (after 2 to 5 years) could be detected.

Fig. 3. Documented anomalies from examinations on 15 liner sections (Bosseler et al., 2001).

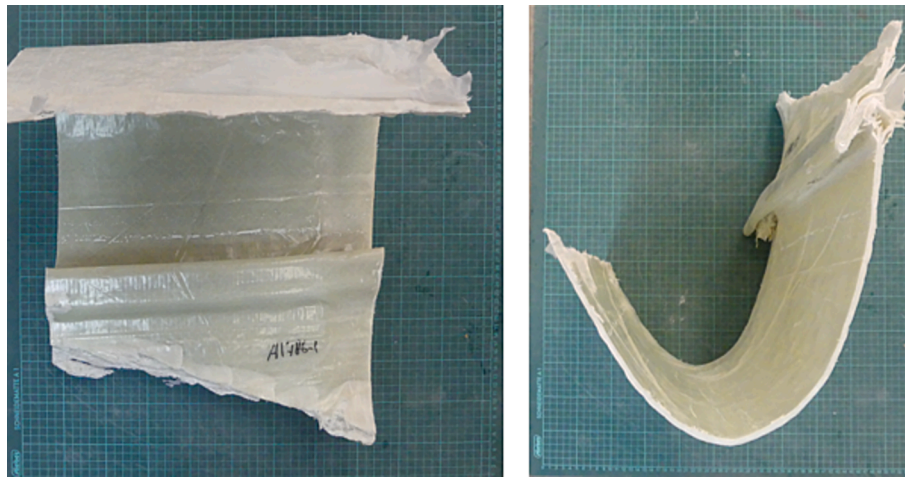
Fig. 4. CIPP liner with wrinkling that affects the entire wall thickness (Luimes/Scheperboer, 2022).

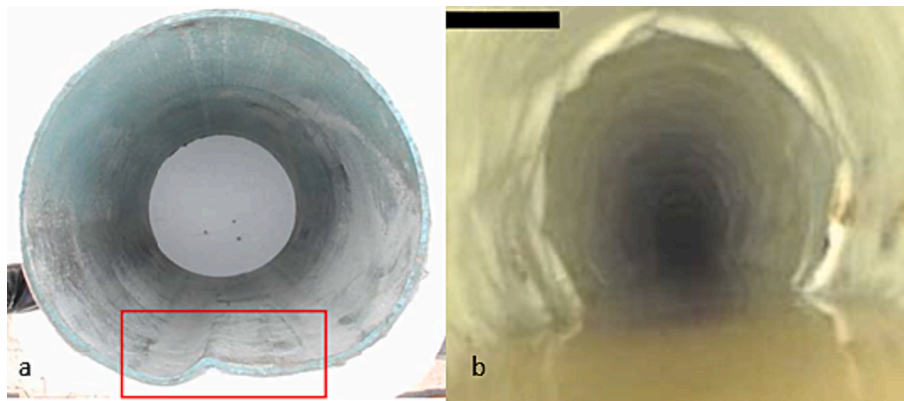
These include local imperfections (e.g., wrinkles and flattening), possibly ovalisation (due to joint deformation in cracked host pipes) and the annular gap between the CIPP liner and the host pipe. These are formally taken into account in the static calculation for the design of CIPP liners. However, the standard values for the ovalisation are usually only 3 % (host pipe condition II) or 6 % (host pipe condition III) (DWA, 2015). However, in Bosseler & Schlüter, 2003 deformations of up to 23 % of the nominal diameter were determined on removed test specimens (Fig. 5a), exceeding the standard value of 3 % used in static calculation many times over. In other cases, wrinkles appeared in the circumferential direction (Fig. 5b).

Possible causes for transverse wrinkles can be, for example, offsets or positional deviations in pipe joints, compression of the liner during installation, particularly in bends, dimensional changes in the sewer,

Fig. 5. Examples of imperfections in liners: a) Local pre-deformation at the bottom (Bosseler & Schlüter, 2003); b) wrinkles running in circumferential direction (Bosseler et al., 2009).

curves and other irregularities in the pipe, regularities in the host pipe and problems inserting the liner (Bosseler et al., 2009). As a rule, such wrinkles are statically less critical, but they can be points of attack on the liner when cleaning using high pressure jetting and a cause of sewer blockages forming.

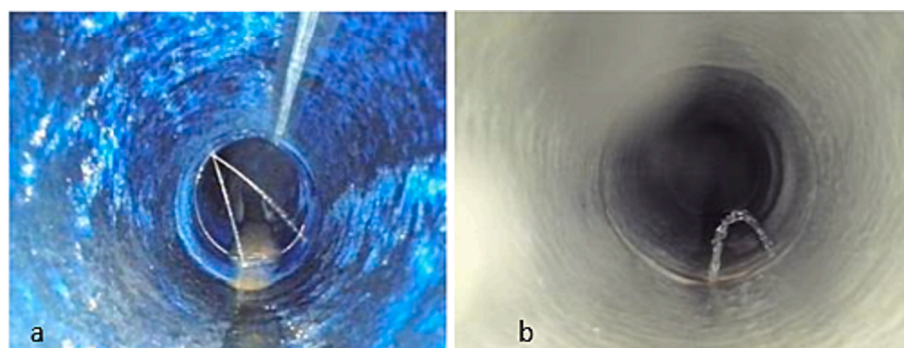
In the IKT product test “House connection liner” (Bosseler et al., 2010), water infiltration was found in nine of 30 pipes rehabilitated using the CIPP lining method in the course of an external water pressure test in the IKT large-scale test facility. The infiltration points were located in the area of pipe joints in front of bends or lateral connections and examples are shown in Fig. 6. The detailed analysis after the excavation of the rehabilitated pipes showed that buoyancy effects were mainly responsible for the damage or leaks in the liner. As the groundwater level increased, the soil pressure was relieved and lifted, which in turn led to forced deformations (angling) in some of the host pipe joints. As a result, the liners, which were bonded to the host pipe, were over-stretched at the opening pipe joints and eventually cracked.

Fig. 6. Damaged areas with infiltration after groundwater level was raised in testing (Bosseler et al., 2010) for two different products.

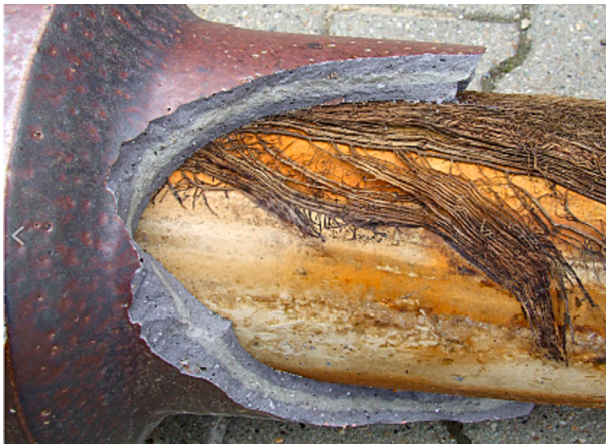
Fig. 7. Root ingrowth between liner and host pipe.
