Geotechnical observations from the 2023 Kahramanmaraş EEFIT mission

By Orestis Adamidis, University of Oxford; Teoman Efeoglu, University of Bristol; Ozcan Gozenoglu, Arup; Joshua Jones, Aecom; Gopal Santana Phani Madabhushi, University of Cambridge; Yasemin Didem Aktas, UCL; and Emily So, University of Cambridge

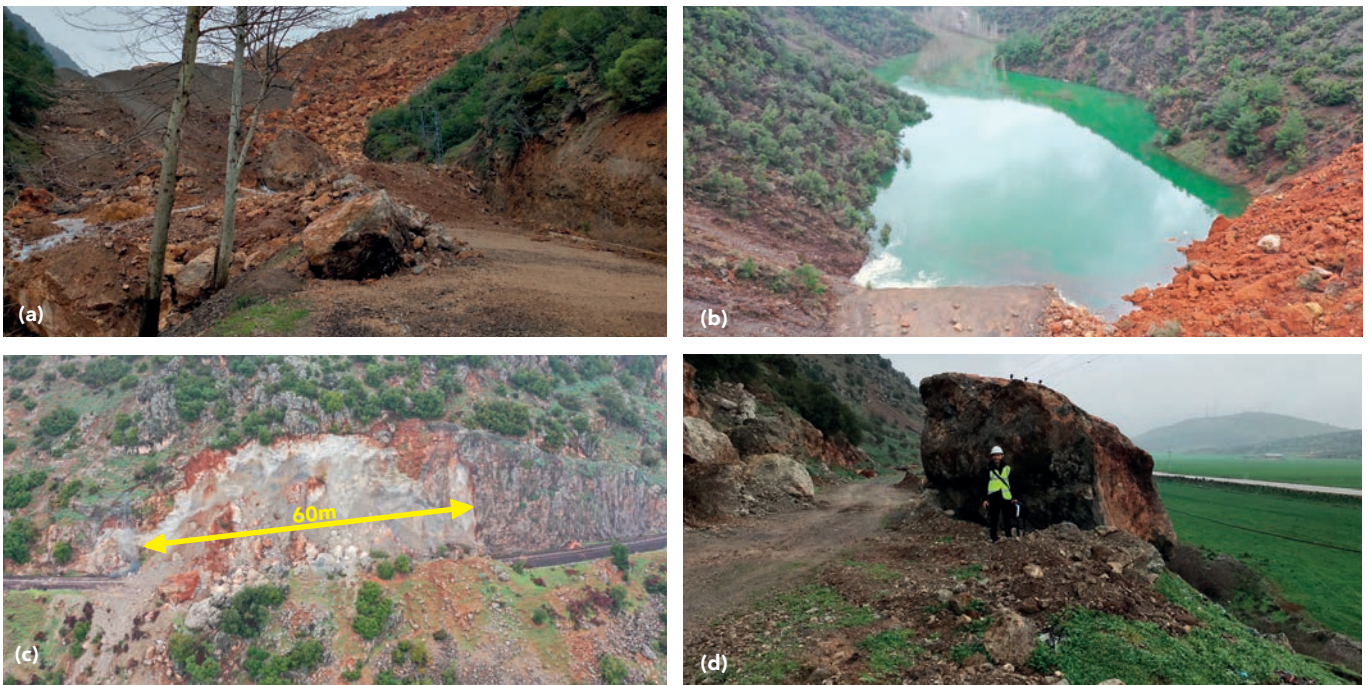
Figure 1: Landslides and rockfalls close to Islahiye

Multiple observations of landslides and rockfalls were made around İslahiye (Figure 1). A large landslide upstream of Değirmencik (Figure 1a) had blocked the local road as well as a stream that passed through the valley, creating a large reservoir (Figure 1b). Piping was visible through the natural dam (Figure 1a). The local authorities were alerted; they appeared unaware of the existence of the reservoir. Between Fevzipasa and Türkbahçe, an extensive, shallow slide failure mechanism was observed. Closer to Türkbahçe, a landslide had initiated on a rock cut made along the rail line and had blocked an approximately 60m section of the line (Figure 1c). Nearby, multiple rockfalls were observed, including a boulder of 6m by 5.5m by 4m (Figure 1d). Electricity, water and communication lines were visibly disrupted by rockfalls, with some rockfalls exhibiting runout distances in excess of 30m from the slope toe.

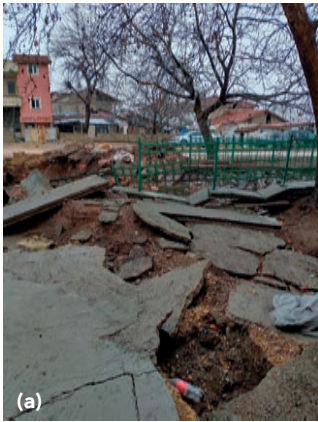
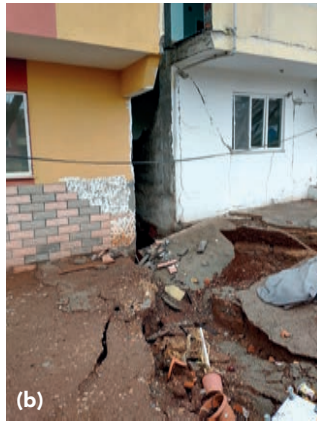
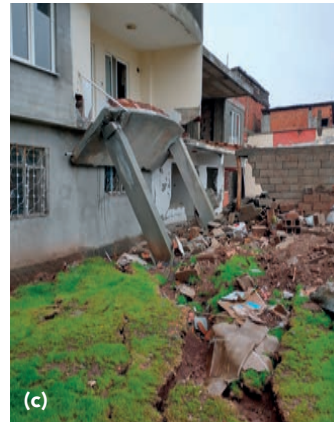
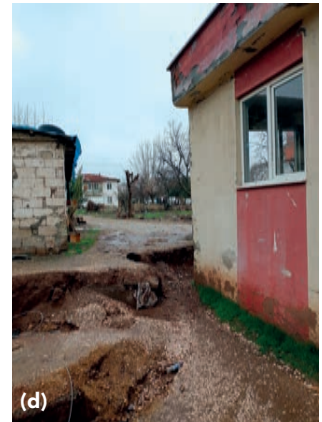
Figure 2: Surface feature interaction with buildings in Gölbaşı, Adıyaman. All photos were taken along the same rupture feature

Using the Maxar Open Data Program satellite data, the fault rupture was mapped over a length of approximately 300km. Here, surface feature interaction with buildings in the town of Gölbaşı, Adıyaman, is discussed. To the south west of Gölbaşı, the main fault segment rupture continued in an interrupted fashion towards the town. Lateral displacements consistent with a strike-slip fault rupture and with a magnitude of up to 2m were observed through satellite images. To the north east of Gölbaşı, a secondary east-west fault segment was identified. Close to the start of this segment, multiple parallel cracks were observed, at a steep angle to the secondary rupture. These cracks could have also been affected by spreading due to the vicinity of the site to a lake. Some characteristic photos along one of the observed cracks are shown in Figure 2. Based on privately provided borehole data, the first 20m from the surface in this location is made up of a mixture of gravelly sandy clay. By inspection and discussion with locals, all structures shown in Figure 2 had stiff raft foundations. The surface feature of Figure 2 was observed approaching a cluster of buildings through the shallow canal and road of Figure

2a. It then continued between two adjacent structures shown in Figure 2b, forcing a gap of 0.67m to open between them. Avoiding going through foundations, it continued past more buildings, damaging only lightweight structural components as shown in Figure 2c. Finally, in Figure 2d, the crack is seen diverting around the corner of a foundation, before continuing further. The kinematic constraint and increased stress imposed by the foundations along the inspected crack seem to have forced the surface feature to divert around the foundations of buildings, rather than go through them. As a result of the crack divergence, mostly rigid body displacements occurred, with structural damage remaining limited.

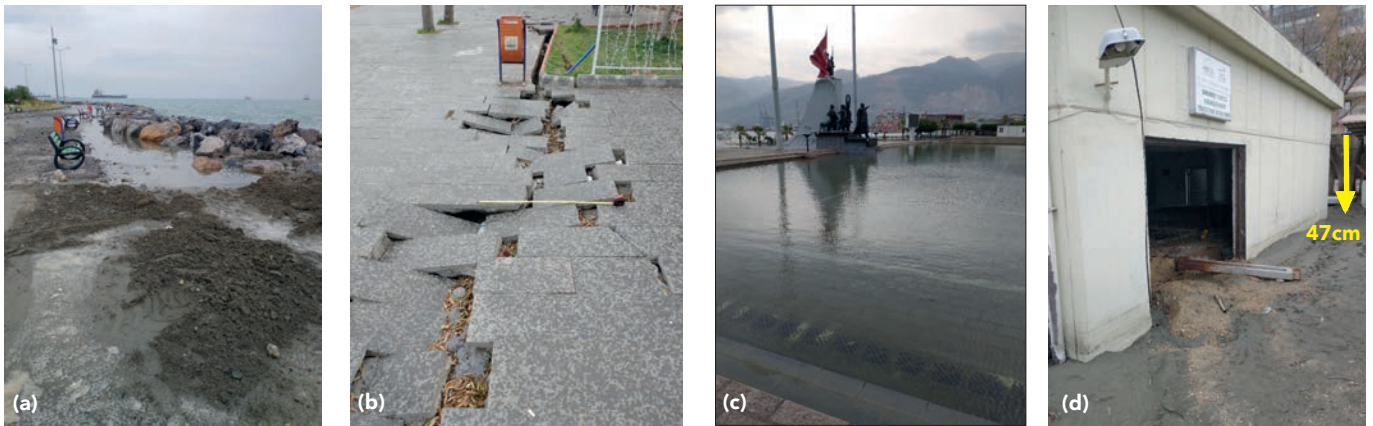
In İskenderun, most of the seafront displayed several signs of liquefaction, including ejected sandy material, lateral spreading cracks and subsidence. The boulder seawall was displaced towards the sea and settlement was observed behind it, with ejected sandy material visible in some locations (Figure 3a). Sand ejecta along the Atatürk Boulevard park indicated widespread liquefaction. Lateral spreading cracks were visible throughout the inspected waterfront, with an average cumulative displacement towards the sea of more than 40cm (Figure 3b). Significant subsidence was observed in the districts of Yenişehir and Çay. Large parts of Atatürk Boulevard and its surrounding locations were under sea level at the time of inspection, including the İskenderun Anıt Meydanı square shown in Figure 3c. Settlement of up to 47cm was observed for a single-storey water management building within the liquefied zone at the seafront of Çay district (Figure 3d).

Figure 3 (above): Liquefaction and subsidence in İskenderun

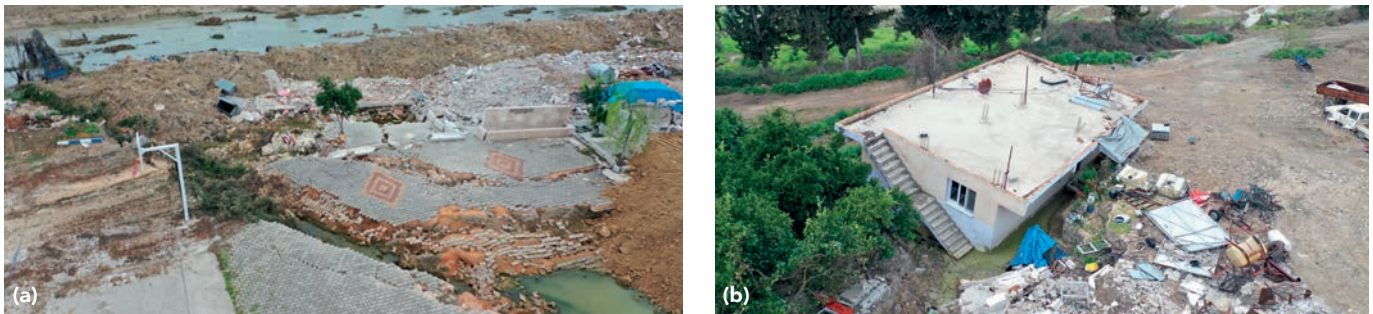
Widespread liquefaction was also identified all along the Orontes River, north east of Antakya. Two examples close to the village of Demirköprü are shown in Figure 4. Lateral spreading towards the Orontes was observed close to the historic masonry bridge and the school of Demirköprü, the yard of which is shown in Figure 4a. Ejected material was seen covering large parts of the surface around the Orontes river, to the west of

Figure 4 (above): Liquefaction and subsidence in İskenderun

Demirköprü. A shallow-founded structure within that zone is shown in Figure 4b, which experienced a settlement of 1.8m and rotation of 14° along its transverse direction, with no rotation measured along its longitudinal plane. A discussion with the owner indicated that the building had a reinforced concrete raft foundation. The side of the building away from the river settled more, indicating a deep scoop mechanism that encompassed the foundation. In the town of Gölbaşı, liquefaction within a part of the town was observed. The majority of the affected structures were founded on stiff raft foundations and experienced settlement of more than 1m (for example, Figure 5a) and in cases with a high aspect ratio, also significant tilting (for example, Figure 5b). Limited structural damage indicated a rigid body response for buildings, facilitated by the raft foundations and the soil softening due to liquefaction. Liquefaction in Gölbaşı affected structures within an urban setting, where structure-soil-structure interaction effects cannot be neglected (Figure 5c).

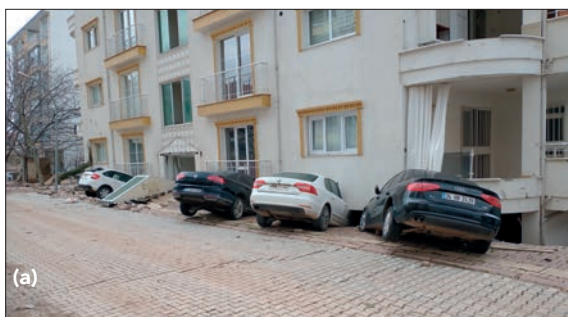
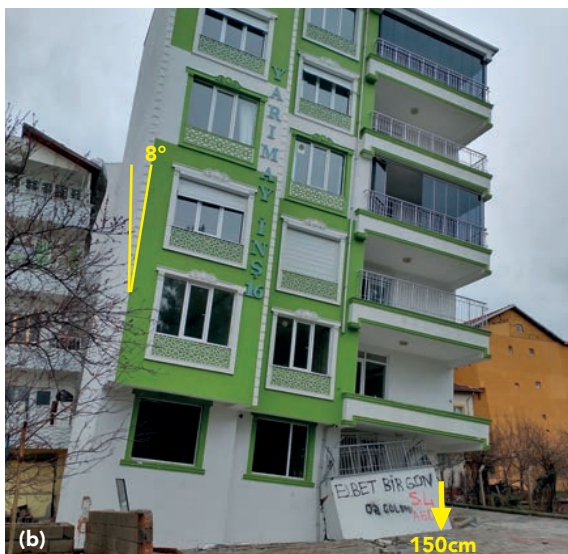
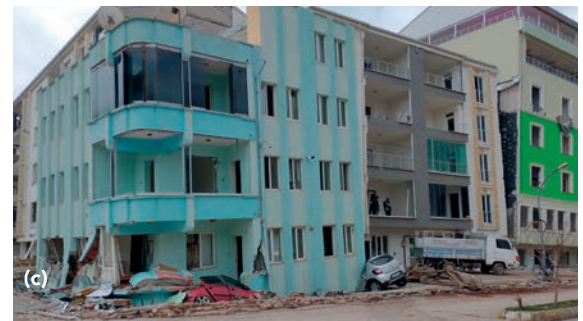
Figure 5 (left and right): Liquefaction-related failures in Gölbaşı

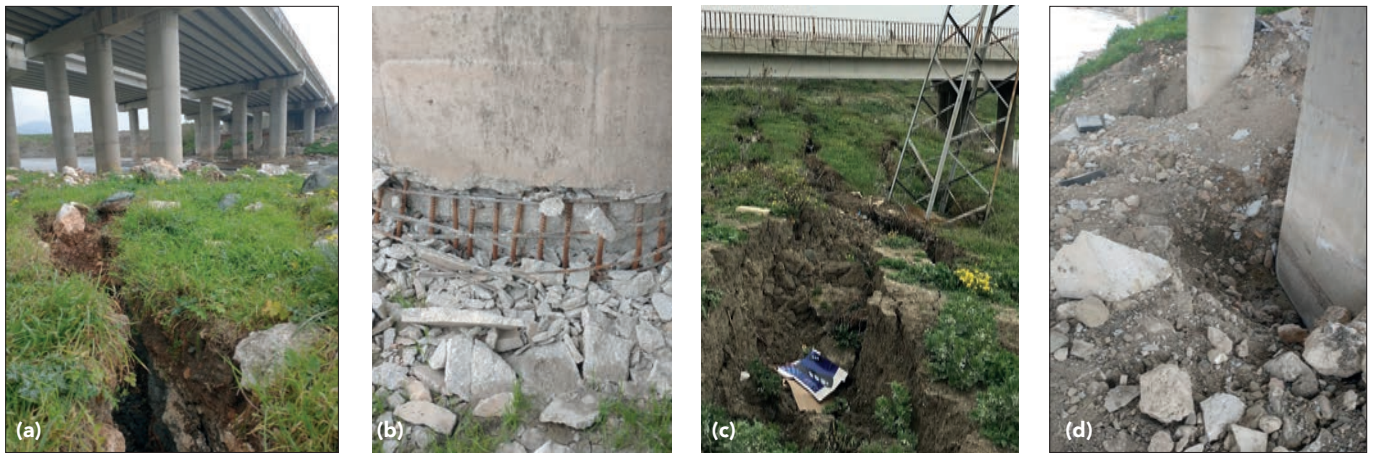
Figure 6: Hatay stadium bridge inspection

The Hatay stadium bridge is a dual, five span beam bridge. Each span has a length of 27m. At the time of inspection, the bridge was closed due to heavy damage. Spreading cracks were observed on the western bank, with gaps up to 40cm (Figure 6a). The surface soil included fine grained, plastic material along with a proportion of gravel. No ejected material was visible. Pillars on the west bank rotated by up to 3.5°, with the foundations moving towards the river while the supporting beams impeded movement at their top. As a result, plastic hinges formed at the connections of pillars with the foundations (Figure 6b). On the eastern bank, which had a steeper slope, a slope stability failure was observed (Figure 6c), with the displacing soil

pushing the pillars on that side and creating a “shadow” effect behind them (Figure 6d).

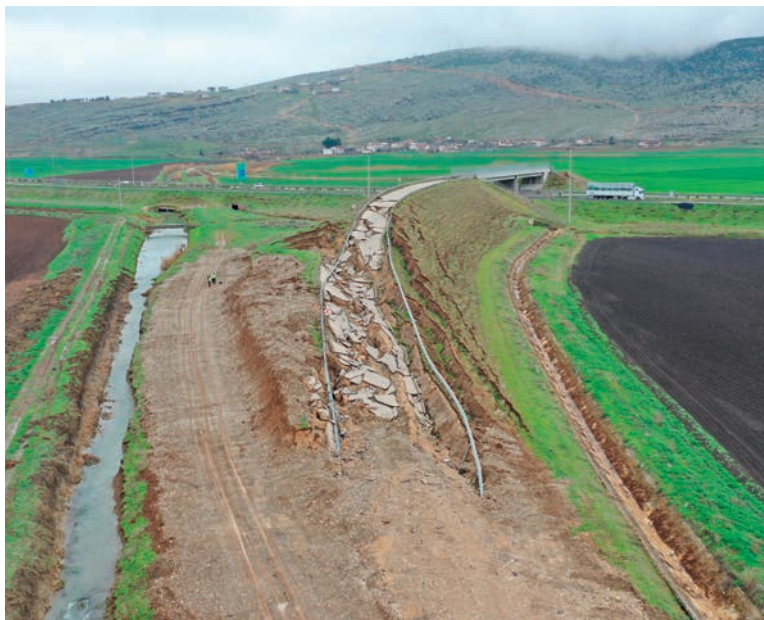
Figure 7: Embankment between the villages of Evri and Çöçelli

Finally, a failed approach embankment leading to an overpass bridge between Evri and Çöçelli was inspected (Figure 7). Longitudinal surface cracks in flat areas on both sides of the overpass bridge indicated a weak foundation soil. A hand held shear vane used on the surface layer verified its very low strength, giving 14kPa average peak shear strength and 3.5kPa average residual shear strength. Drone images revealed an extensive slope stability failure, with an extensive shear surface likely formed, passing through the soft soil below the embankment. The presence of a shallow canal facilitated the triggering of the failure mechanism towards one side by introducing an asymmetry. The displacements imposed by the failure mechanism were visible as a narrowing of the canal during the inspection.
