Ref : EUCL-IBO-TR-7-007  
Issue : 1.0  
Date: 09/06/2021  
Page: 1/37

<b>TITLE:</b>	<b>Test Report of NISP dedicated test activities during the CSL campaign - DCU-SCE Communication issue</b>		
<b>Date:</b>	09/06/2021	<b>Issue:</b>	1.0
<b>Reference:</b>	EUCL-IBO-TR-7-007		
<b>Custodian:</b>	Eduardo Medinaceli

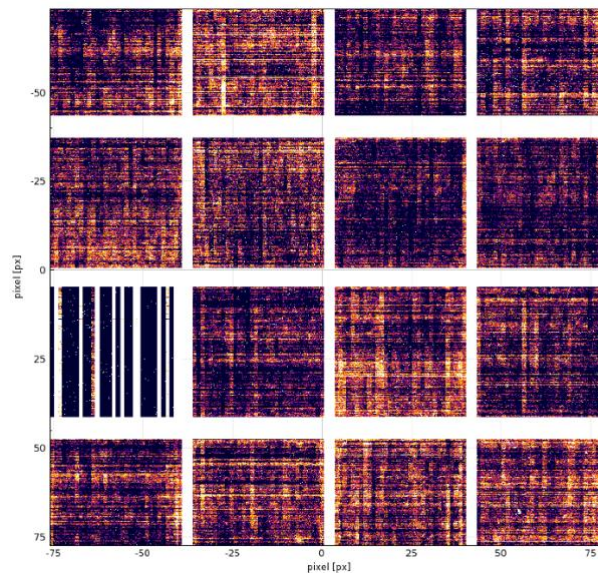
Then, during the second test run an artifact was seen only in detector SCS#31 (detector SCS#22 was recovered from the image quality point of view) as shown below.

'Artifacts' are related to high dishomogeneities between readout channels, that vary from one acquisition to another (no systematic repetitions has been done, but a single case is presented here). By comparing the reference pixels signal from two full Raw Lines of detector SCS#31 was concluded that the signal level (ref pxs) was homogeneous in both images. The signal compatibility also applies to SCS#22 even if the 'artifact' in the second case disappeared during the second MACC. Below, are shown the two consecutive acquisitions taken with SCS#22 (on the left with the 'image artifact' and at the center without it); on the right of

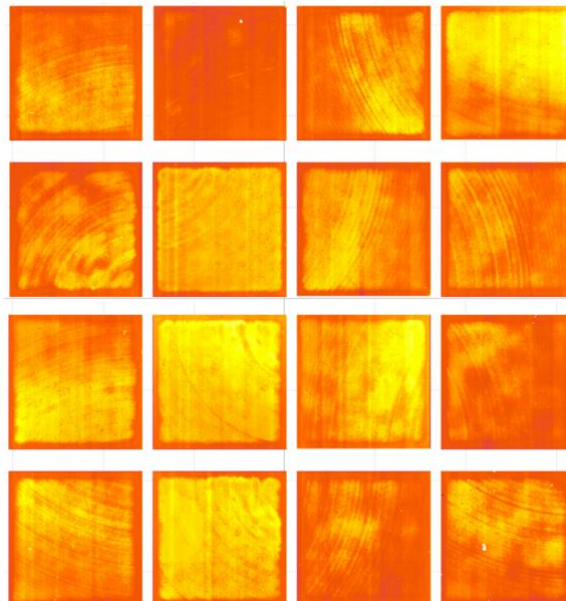
Again in this case the same kind of errors were reported by the DCUs but without artifacts in the images as shown below.

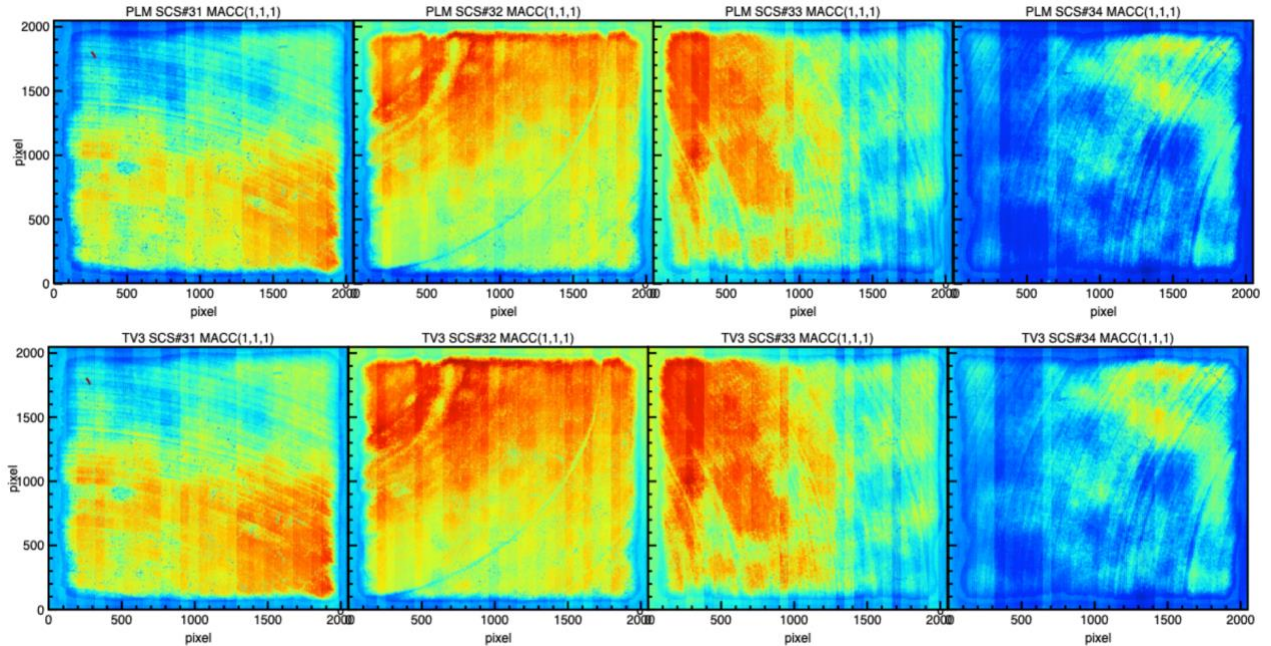
For example, below are show images from detectors SCS#31 to SCS#34 (top row), and for comparison are shown the images of the same detectors taken during TV3@LAM (bottom row), which by a visual inspection are compatible.

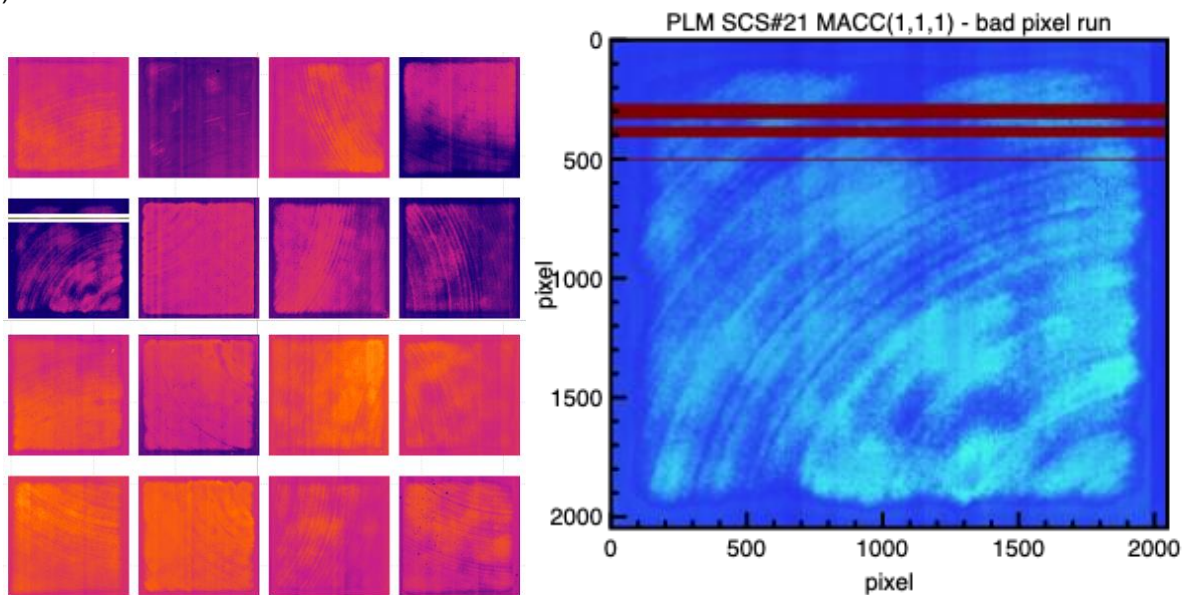
By checking the image it was verified that some lines were not transmitted (compatible with the DCU error code); also SCE telemetry recorded the same line errors in the ErrorTable.

The signal of the entire FPA is represented on the left-side of the following display; on the right is shown the image of detector SCS#21 (with a different color scale) with the line transmission errors (indicated with dark red horizontal lines).

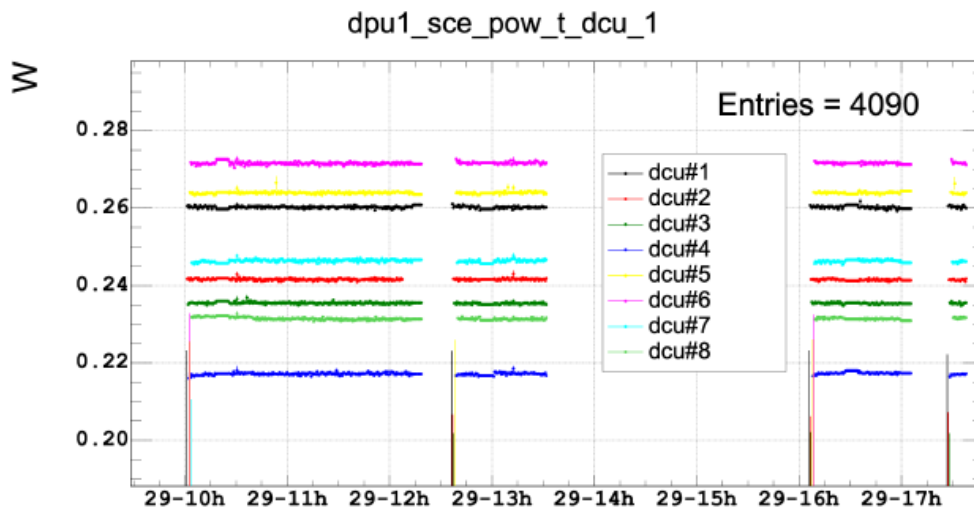
ASIC's power consumption never shows anomalies before, and while starting the acquisitions. For example, in the next figure are plotted SCE's total power for DPU1; to be noticed that even when SCEs enters in the "non-nominal" state a power drop is not seen. No power reduction is also evident in DCU power lines nor in the DPU main power supply.

SCE's total power down for DPU1, no abnormal power consumption was detected.

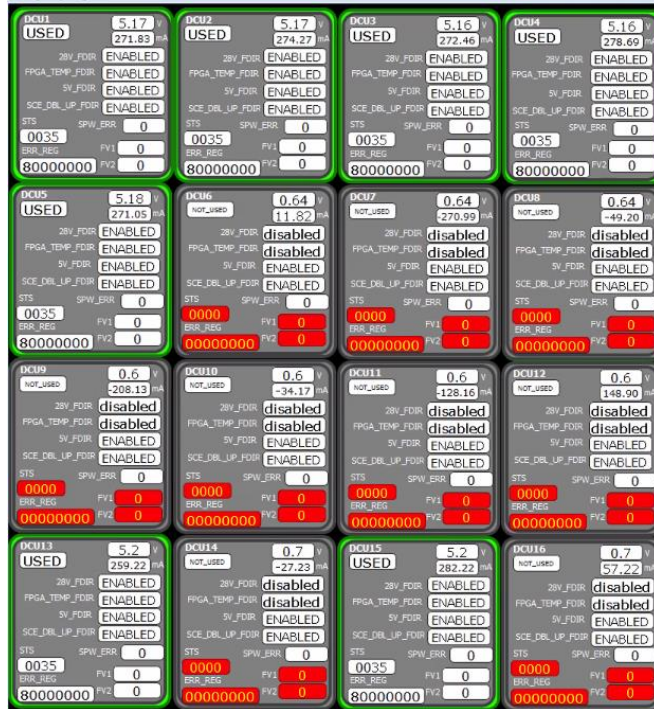
We had a subset of detector chains (DCU-ASIC) showed below that never experience “failures” during acquisitions – green boxes highlight the 7 out of the 16 detector chains working nominally, while the ones with red values are the

ones kept powered down. Using this FPA configuration middle long-term stability has been tested by performing several broadcast acquisitions. We acquired short MACC(1,1,1) – MACC(3,2,1) and several nominal MACC(15,16,11) and MACC(4,16,11) consecutively without having problems.

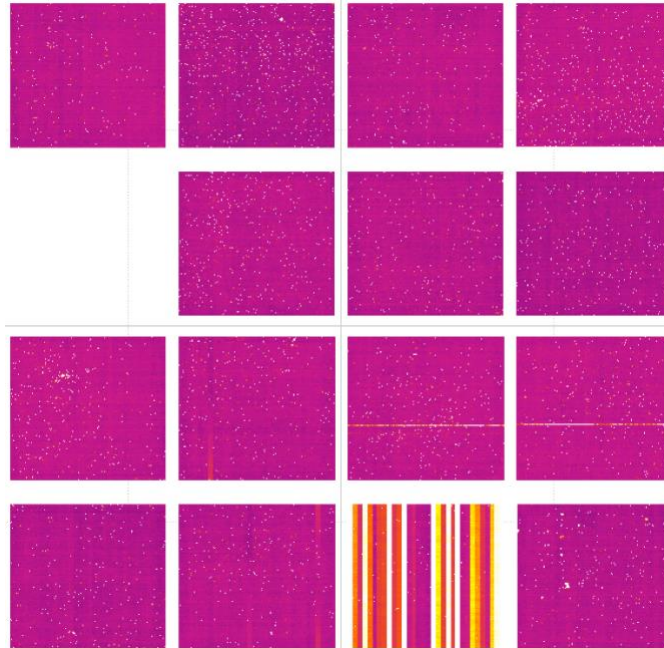
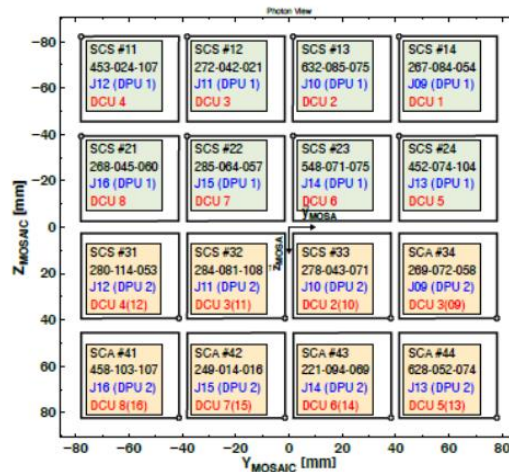
The image below (left) shows the data acquired during the 1<sup>st</sup> exposure (errors and artifacts can be seen in the plot), DPU1-DCU8 failed to transmit the data due to the SCE line errors. (On the right is the map of the DCU/SCE IDs).

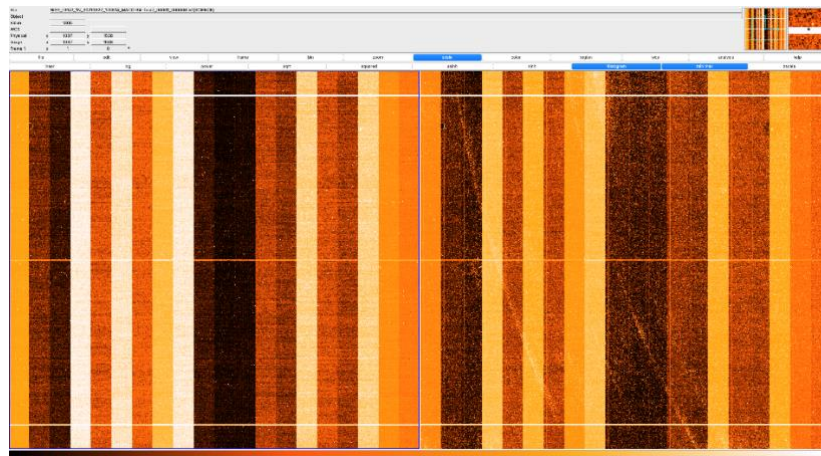
SCE’s telemetry is not available just after the start of the MACC acquisition. In some cases when the DCU signal a transmission error, in the image can be seen “artifacts”, for example lines with non-nominal values as:

Images from two different detectors showing “horizontal lines” (artifacts) in the same rows.

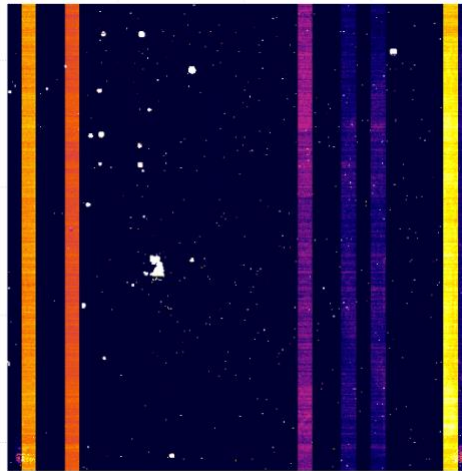
This kind of “strange” lines were also found in the reference pixels. In these cases, the reference pixel correction performed by the DPU-ASW creates an artifact showing channel-to-channel patterns in the image, like:

Vertical structure induced by the reference pixel correction when a non-nominal row of reference pixel is acquired. This image was acquired at the DPU's lowest operative temperature.

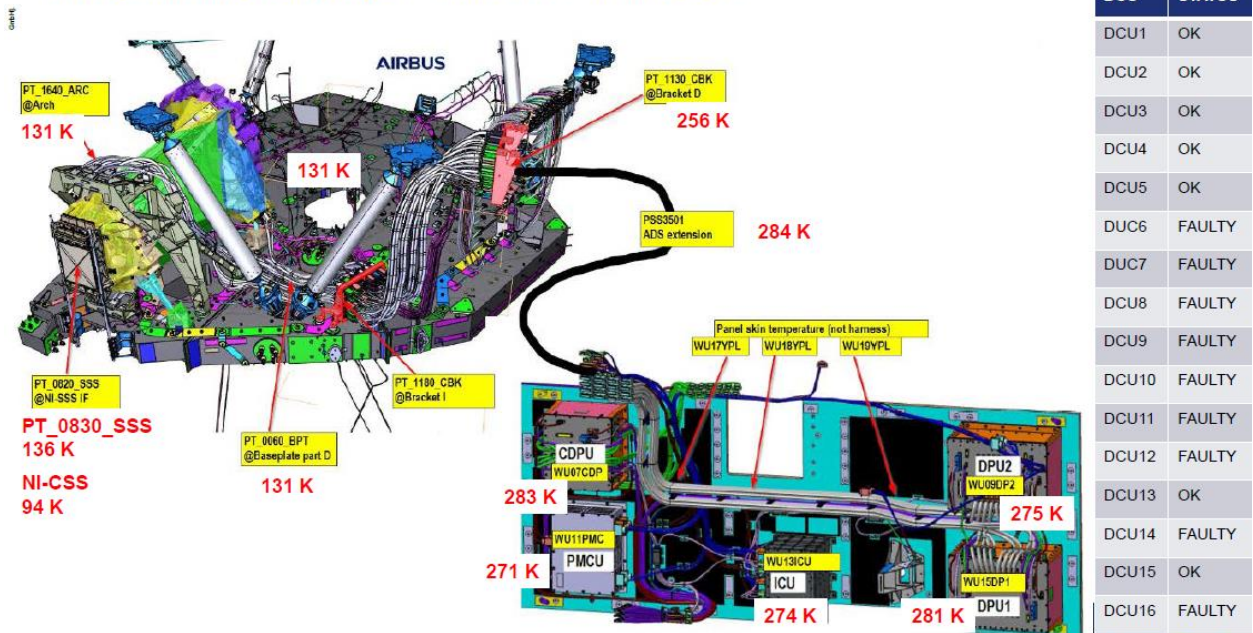
## First Occurrence: 29/05/2021 – 08:30 UTC – PHASE 50c

Confidential	
DCU	STATUS
DCU1	OK
DCU2	OK
DCU3	OK
DCU4	OK
DCU5	OK
DUC6	FAULTY
DUC7	FAULTY
DCU8	FAULTY
DCU9	FAULTY
DCU10	FAULTY
DCU11	FAULTY
DCU12	FAULTY
DCU13	OK
DCU14	FAULTY
DCU15	OK
DCU16	FAULTY

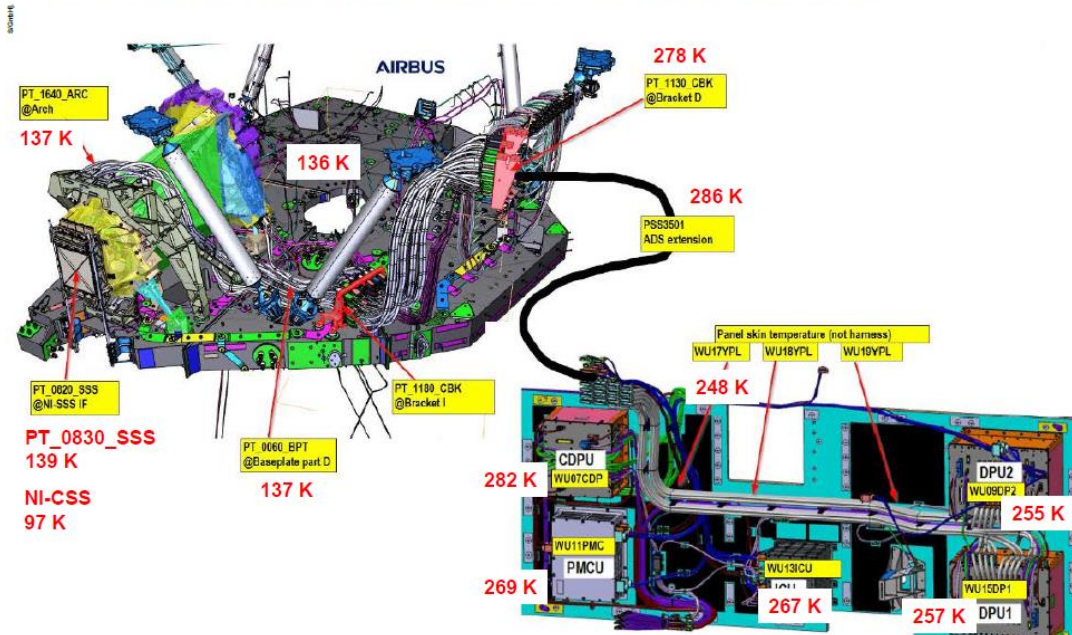
## First Occurrence: 29/06/2021 – 11:10 UTC – PHASE 61 – (Test#08)

DCU	STATUS
DCU1	OK
DCU2	FAULTY
DCU3	OK
DCU4	FAULTY
DCU5	OK
DUC6	FAULTY
DUC7	FAULTY
DCU8	FAULTY
DCU9	FAULTY
DCU10	FAULTY
DCU11	FAULTY
DCU12	FAULTY
DCU13	FAULTY
DCU14	FAULTY
DCU15	OK
DCU16	FAULTY

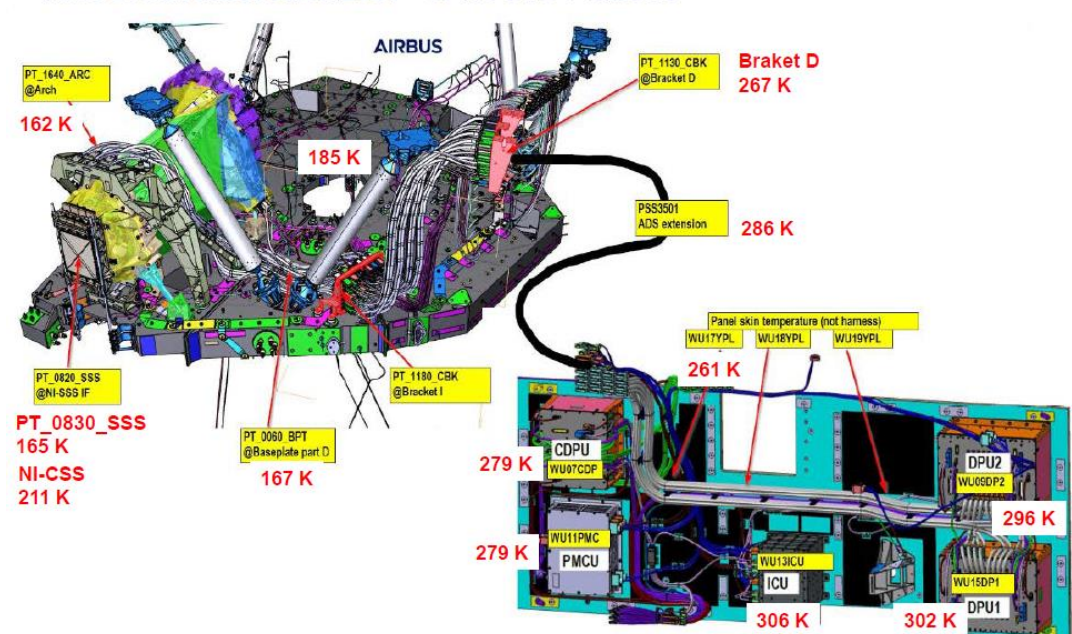
## First Occurrence: 02/07/2021 – 07:46 UTC Phase 70

DCU	STATUS
DCU1	OK
DCU2	OK
DCU3	OK
DCU4	OK
DCU5	OK
DUC6	OK
DUC7	OK
DCU8	FAULTY
DCU9	FAULTY
DCU10	OK
DCU11	FAULTY
DCU12	OK
DCU13	OK
DCU14	OK
DCU15	OK
DCU16	OK

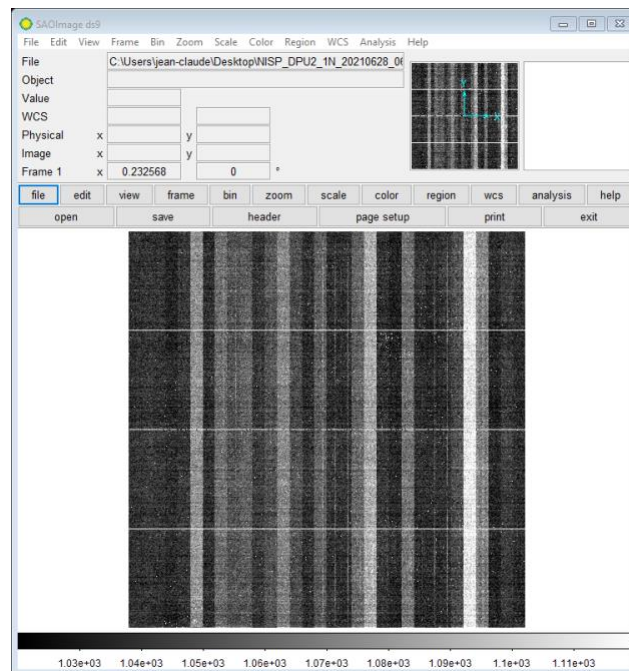
- Only in 6 out of the 10 stable DCUs does not show an error during the 1<sup>st</sup> exposure, indicating a "degradation" of a stable initial configuration (of 10 DCUs) for the engineering raw mode data acquisition. Several images were showing "non-nominal rows" (artifacts), and in some case multiple ones, for example on data from DCU4(12) are present 3 lines:

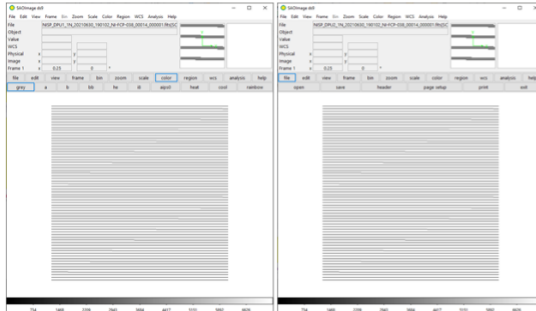
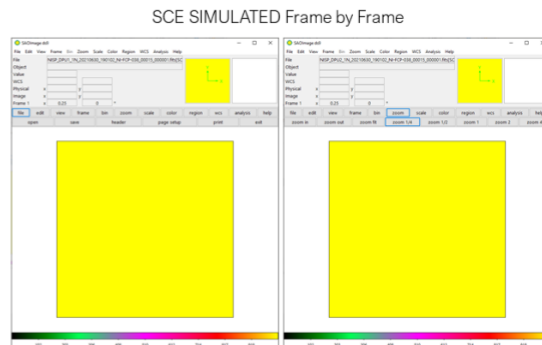
SCE SIMULATED Px by Px

all images OK,  
but 2<sup>nd</sup> exposure not executed in  
both OK and NOT OK DCUs

Simulated Images for the 1<sup>st</sup> EXP for both (OK and not OK) DCUs showing nominal signal; on top results using a simulated image generated Px by Px, and on the bottom generated frame by frame.

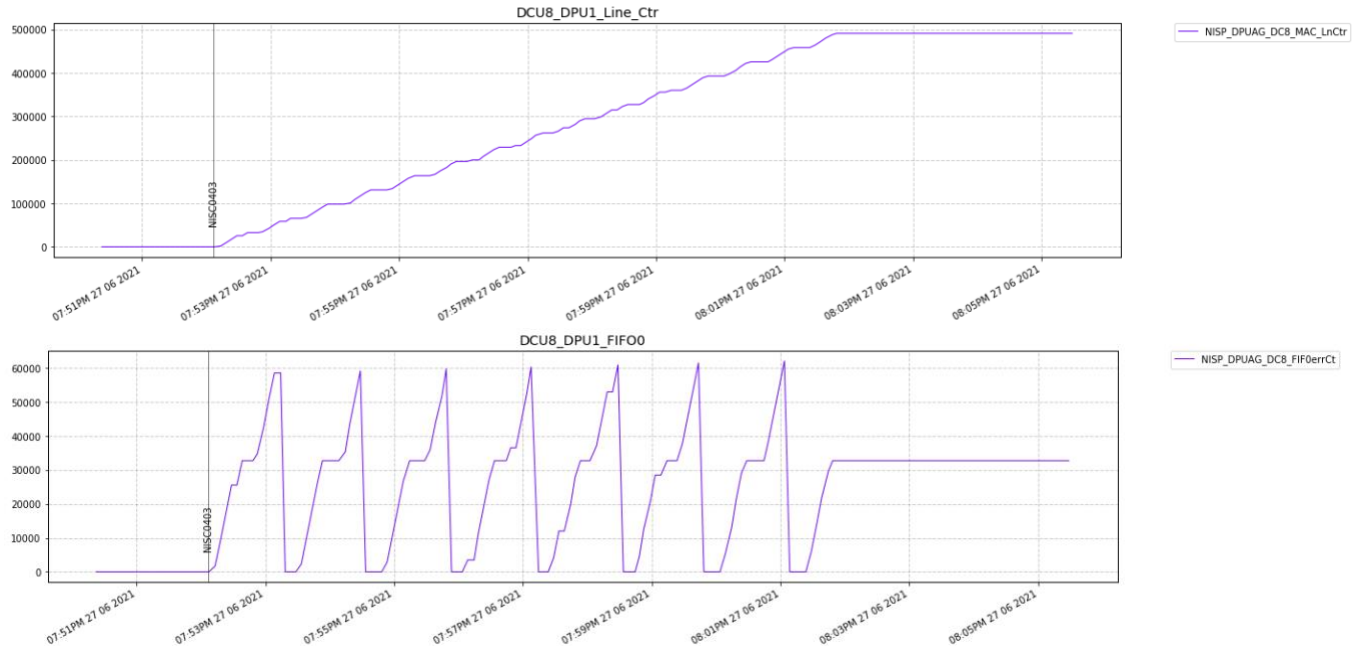
This DCU failed to perform a second consecutive exposure; even if the above condition showing a wrong communication using FIFO\_0 was “recovered” using FIFO\_1 (no errors related to FIFO\_1 signalled by the DCU).

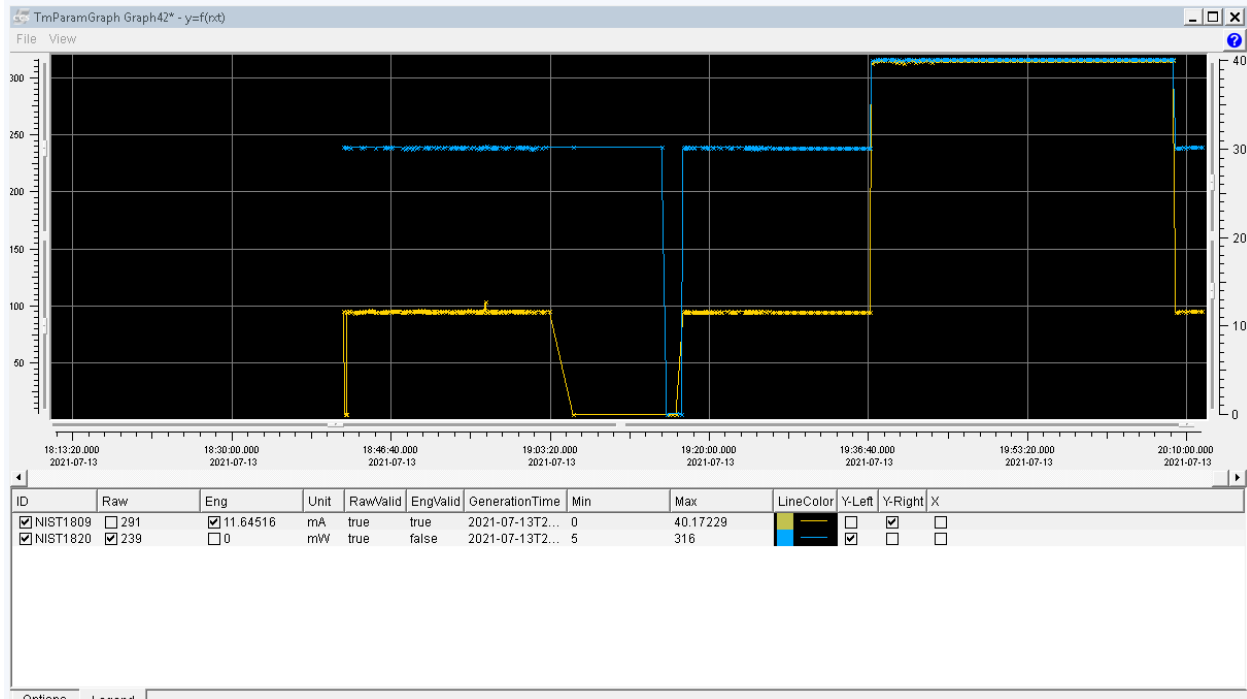
To test the state of the SCE a MEM DUMP (which implements a SCE read instruction) was done without success – due to the so-called 'loss of communication condition'. Nevertheless, a second SCE write operation was done successfully executing DPU-ASW command SCE\_Awake. This last command restarts the ASIC firmware by writing at register address = 0x6903 the value = 0x1900; and as a consequence, the current decreases to the nominal value – see Figure 1.

Fig. 1, NISP (DCU) telemetry showing the increase at around 19:36:40.0 and successive decrease at around 20:20:00.0 of the V2P5\_V current - NIST1809 (yellow) and total power – NIST1820 (blue), associated to the execution of SCE\_CONFIG and SCE\_AWAKE commands respectively.

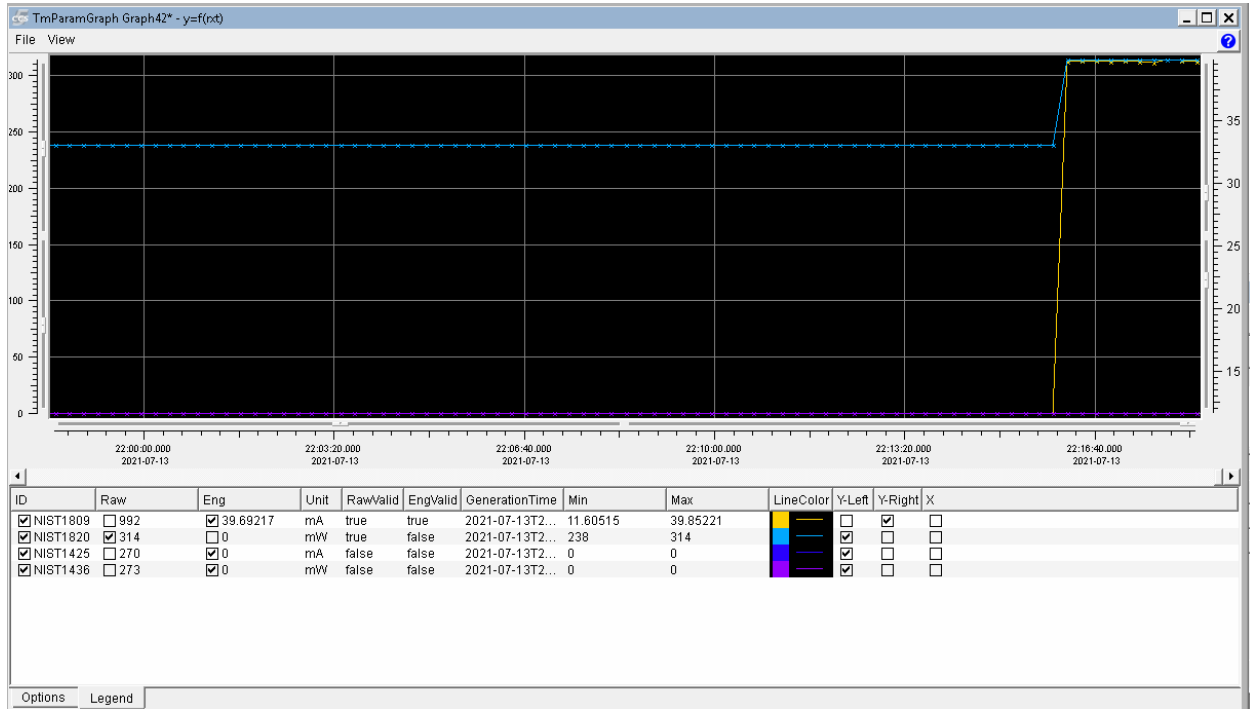
Fig. 2, NISP (DCU) telemetry showing the increase at around 22:16:40.0 of the V2P5\_V current - NIST1809 (yellow) and total power – NIST1820 (blue), associated to the execution of SCE write executed with a low-level access.
