NONDESTRUCTIVE EVALUATION OF METAL MATRIX COMPOSITES

Scott W. Schramm and Isaac Daniel

IIT Research Institute
10 West 35th Street
Chicago, IL 60620

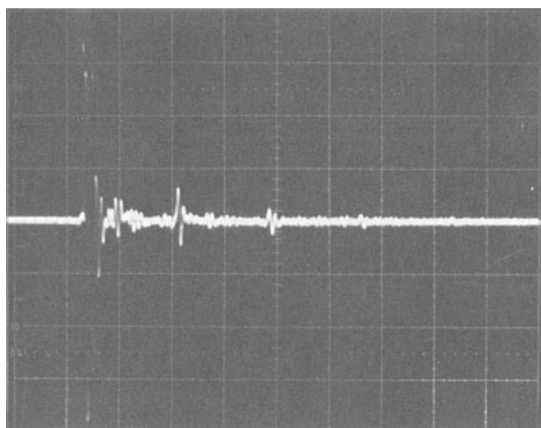
Fig. 1. Ultrasonic attenuation record for FP/Mg specimen without intentional flaws.

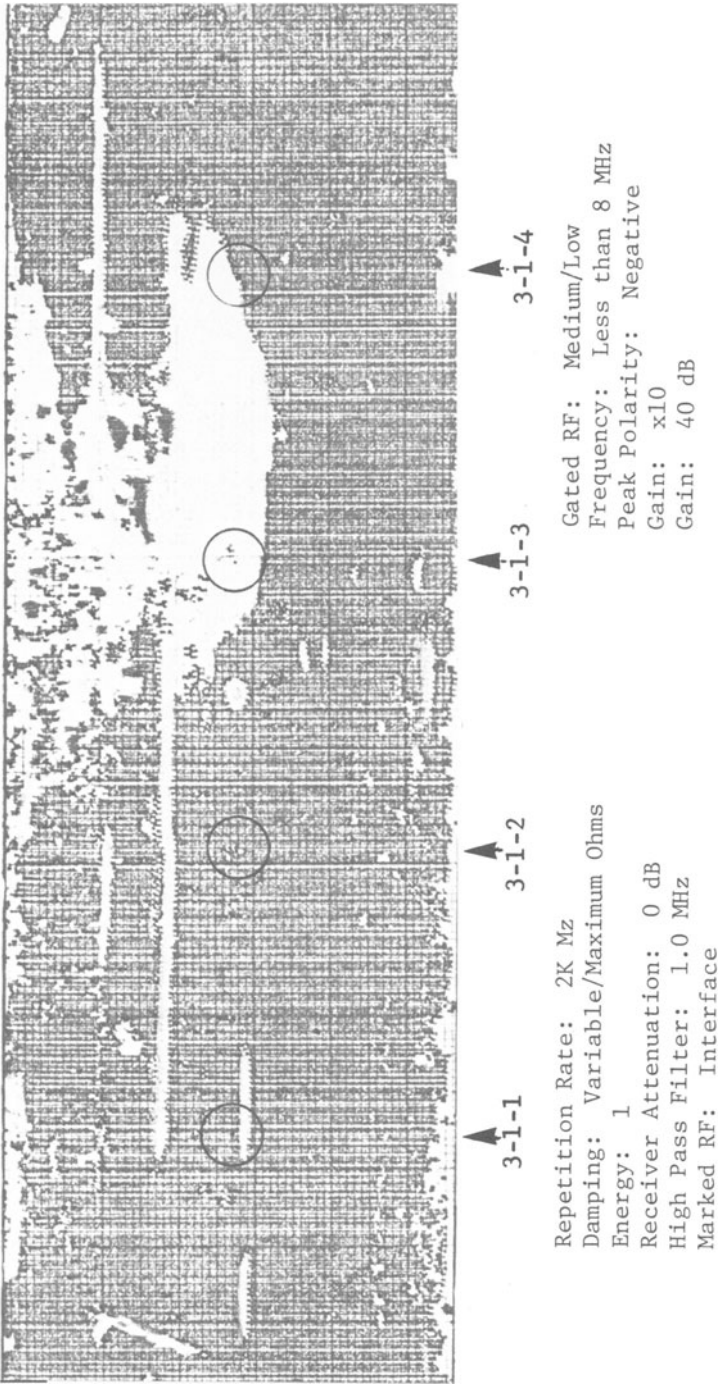
Figures 2 and 3 are pen-lift and analog C-scans, respectively, of Specimen 3-1. Both C-scans were generated using a 15 MHz immersion, compression wave transducer operated in the pulse-echo mode with the specimen held in the special fixture. Both C-scans show a well-defined area of apparently flawed material involving approximately 20% of the specimen. The narrow bands of apparent damage running parallel to the fiber direction were identified as surface scratches by A-scan interpretation and visual inspection.

For Specimen 3-1, ultrasonic inspection, pen-lift/analog C-scan and A-scan photographs gave an indication of the presence of an area of porosity involving up to 6 of the 8 plies of the specimen.

Of particular interest for this specimen are the wave velocities at the four inspection locations shown on Figure 2 (3-1-1 through 3-1-4) and inspection location 15 from Table 1. Inspection locations 3-1-1 through 3-1-4 correspond to locations 4, 8, 12, and 16 of Table 1.

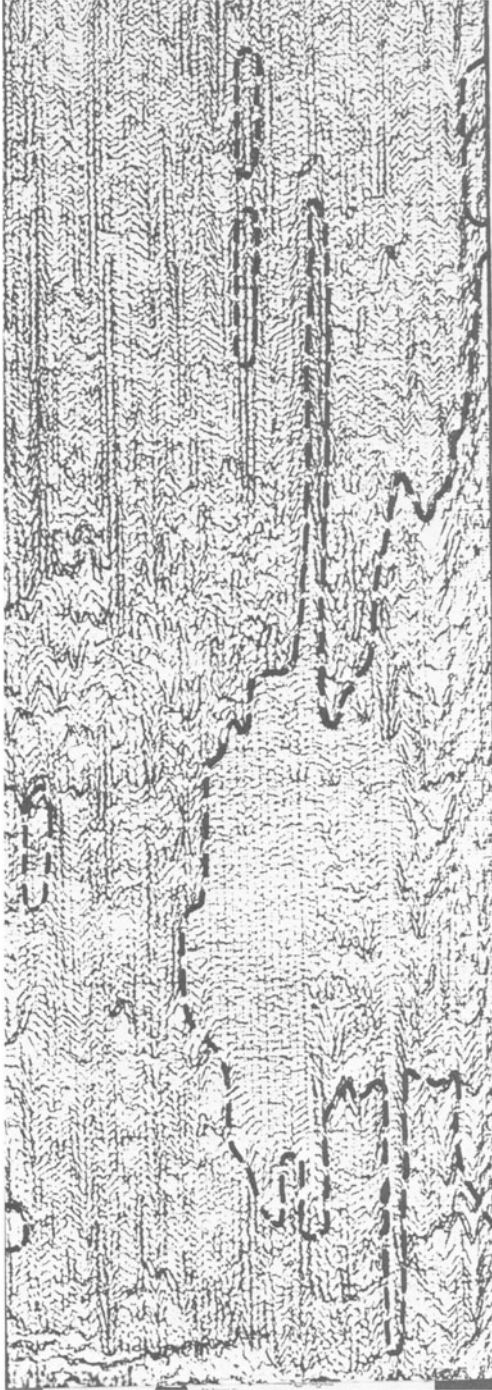
Figure 3. Analog C-Scan of FP/Mg Specimen 3-1 (porosity),
 15 MHz transducer in pulse-echo mode.

The material attenuation coefficients in Table 2 show good correlation with one another and correspond very well with the C-scans (Figure 2 and 3). Inversely to the wave propagation velocities of the preceding subsection, the maximum attenuation values are seen at inspection location 3-1-3 (inspection area apparently totally flawed), and the minimum attenuation values at inspection location 3-1-2 (inspection area apparently totally unflawed). Again, inspection locations 3-1-1 and 3-1-4 have attenuation values between the extremes of inspection locations 3-1-2 and 3-1-3, which indicated relative percentages of apparent damage.

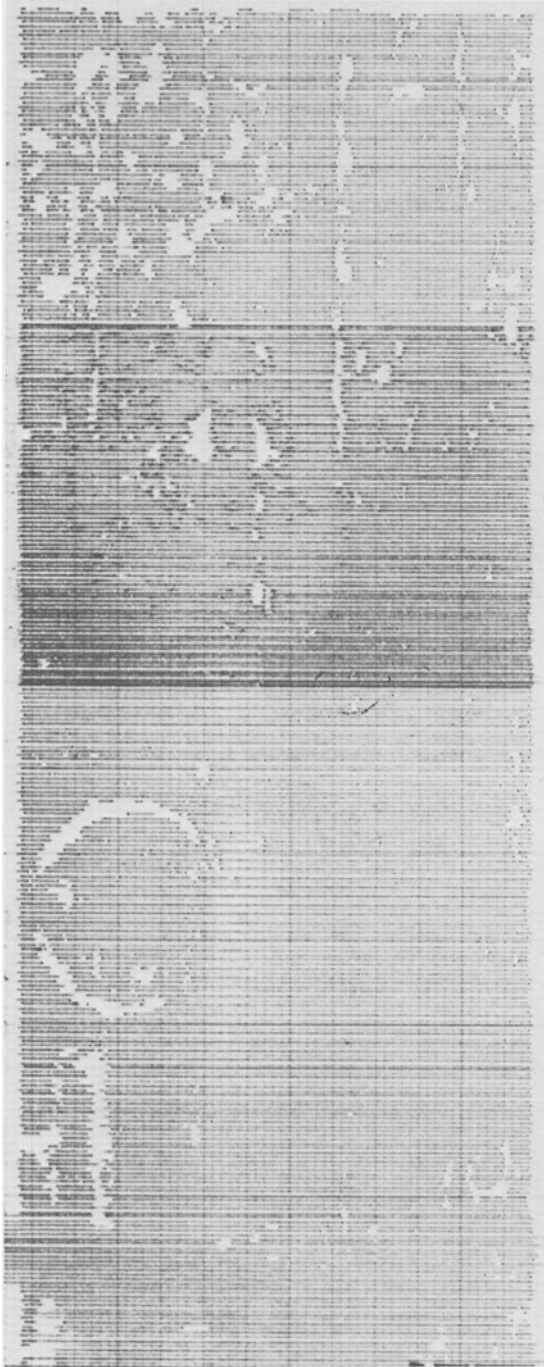
Figures 4 and 5 are pen-lift and analog C-scans, respectively, of Specimen 6-2. Both C-scans were generated using a 15 MHz immersion, compression wave transducer operated in the pulse-echo mode with the specimen held in the special fixture. Both the pen-lift and analog C-scan clearly shows the location and extent of the circular area of nonuniform fiber distribution. The circular area is at the mid-length of the specimen. It is towards the left side of the specimen in Figure 4 because the left edge (approximately 20% of the scan length) was inadvertently cropped off before mounting. The additional areas of apparently flawed material on the two C-scans were determined to be surface irregularities by visual inspection and A-scan interpretation.

Figure 4. Pen-lift C-scan of FP/Mg Specimen 6-2 (nonuniform fiber distribution), 15 MHz transducer in pulse-echo mode.

For Specimen 6-2, ultrasonic inspection gives a representative indication as to the presence and definition of areas of non-uniform fiber distribution.

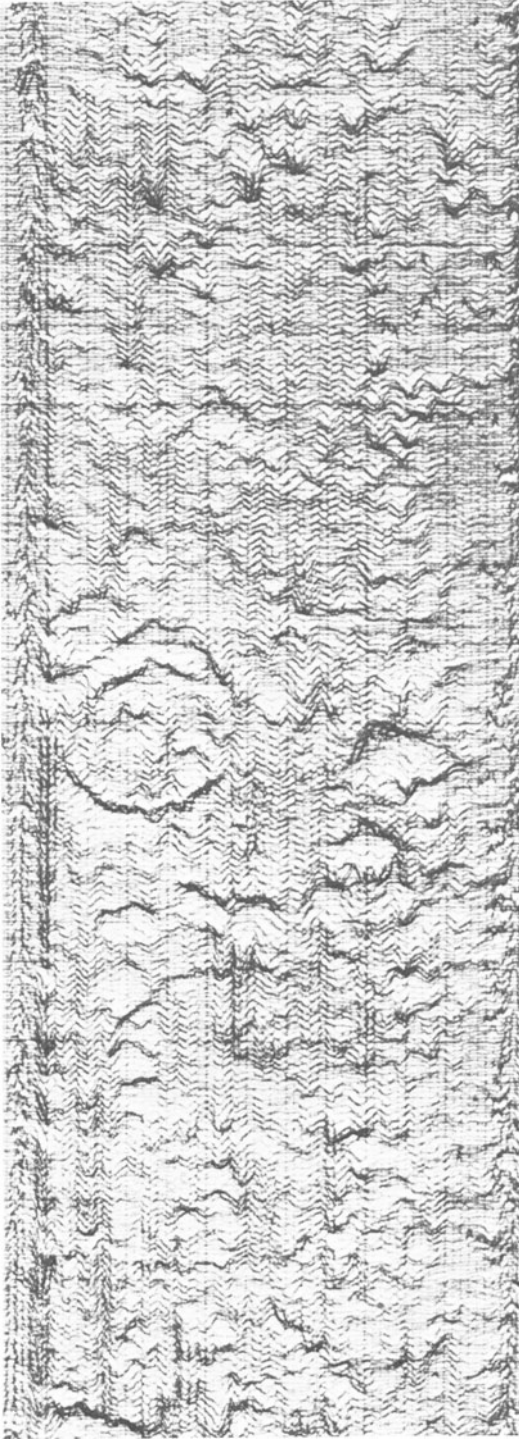
Figure 5. Analog C-scan of FP/Mg Specimen 6-2 (nonuniform fiber distribution), 15 MHz transducer in pulse-echo mode.

The wave propagation velocities for the five inspection locations (6-2-10 through 6-2-14) within the area of nonuniform fiber distribution as indicated by the C-scans (Figures 4 and 5) show a moderate decrease from that within the areas of no apparent material defect. The decrease of the wave propagation is a direct function of the change in composition of the material in that area.

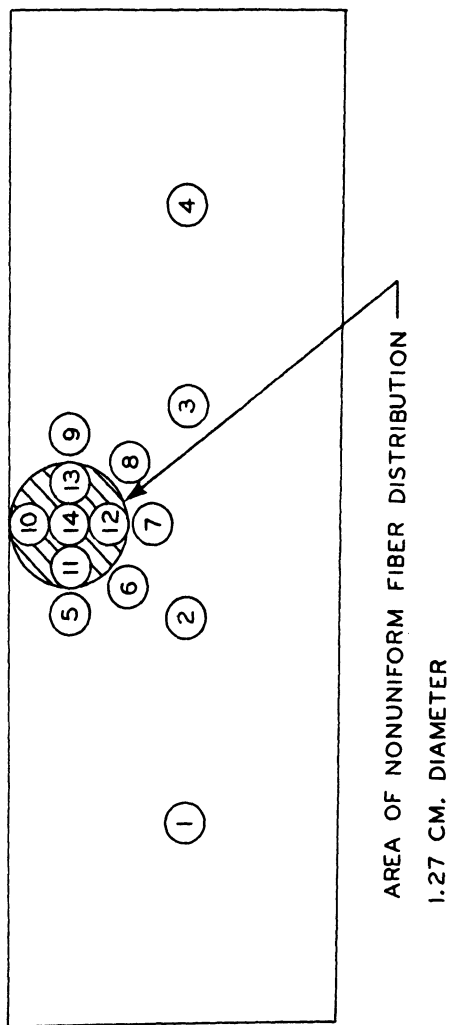
Figure 6 shows the inspection locations on Specimen 6-2 where wave propagation velocity measurements were taken. Table 3 shows the wave propagation velocities for the 14 inspection locations shown in Figure 6 and the average wave propagation velocity of the first nine measurements. The average wave propagation velocity for Specimen 6-2 (for the unflawed locations) is within 6% of the theoretical value of 6119 ms^{-1} and within 1% of the empirical average of 6466 ms^{-1} for Specimen 1-1. As a comparison, the average wave propagation velocity for 20 inspection locations for Specimen 6-1 was 6466 ms^{-1} which is identical to the empirical average for Specimen 1-1.

Figure 6. Wave propagation velocity inspection locations for FP/Mg Specimen 6-2 (nonuniform fiber distribution).

The material attenuation coefficient at inspection location 6-2-14 (within the area of nonuniform fiber distribution) is appreciably higher than those indicated for the other locations. This would be expected at an area of nonuniform fiber distribution because that type of defect causes a decrease in both local density and local modulus which increases the material wave attenuation coefficient. For specimen 6-2, wave attenuation coefficients give an indication of the presence of nonuniform fiber distribution.
