## NDE OF CORROSION AND DISBONDING ON AIRCRAFT USING THERMAL WAVE IMAGING

Xiaoyan Han, L.D. Favro, Tasdiq Ahmed, Zhong Ouyang, Li Wang,  
Xun Wang, P.K. Kuo and R.L. Thomas

Department of Physics and Institute for Manufacturing Research  
Wayne State University, Detroit, MI 48202, USA

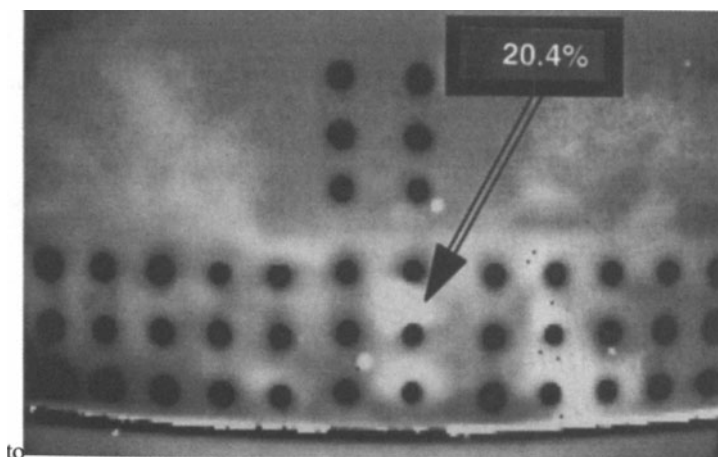
One of the test objects in the AANC "library" is a Boeing 737 testbed, which is available for use in developing NDI methodologies. In Fig. 2 we show a thermal wave image from a region of lap splice on this testbed - a target which is rather more complicated than the single fuselage skin just above it. The number (20.4%) which appears in Fig. 2 is the result of applying the quantitative corrosion thinning algorithm [2] to the bright region indicated by the arrow. Because of the presence of the fasteners (heat sinks - black) and the second layer of metal involved in the lap splice construction, it is not clear that this algorithm should work without applying some correction factors relative to the situation for a region of single fuselage skin. Nevertheless, following our measurement, shown in Fig. 2, one of the AANC staff members utilized a standard eddy current corrosion thinning measurement instrument and indicated that the corrosion was approximately 20%. Although laboratory studies are still in progress, we find that the thermal wave estimates in such situations are likely to be somewhat less than the actual corrosion thinning, and somewhat dependent on the lateral size of the region of corrosion, and the thickness of the layer of paint on the outside of the aircraft (unless it is very small compared to the skin thickness).

Fig. 2 Thermal wave image of a region of corroded (about 20%) lapsplice on the B737 testbed aircraft in the FAA's Aging Aircraft NDI Validation Center (AANC). The estimate (20.4%) is obtained from the thermal wave imaging corrosion analysis algorithm, known to be accurate for single skins [1], but likely to underestimate the corrosion for small lateral sizes of corrosion and for regions with thick paint.

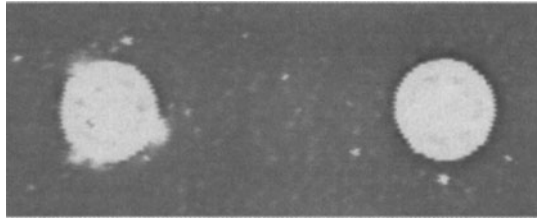
A second example of aircraft corrosion is illustrated in Fig. 3, which shows a single thermal wave image of two adjacent steel fasteners in a wing skin sectioned from an Air Force KC-135 aircraft. Because of the contact between the dissimilar metals (Steel/Al), the interface region in the countersink surface of the aluminum wing skin is susceptible to pitting corrosion, which in some cases, progresses laterally out from the countersink in the form of intergranular corrosion cracking. In a test program conducted by ARINC for the USAF, we have applied thermal wave imaging to 80 such fasteners in both KC-135 and B-52 wing skins. We succeeded in identifying 87.5% of the fasteners with confirmed intergranular corrosion (some of it quite minor, as seen in the metallographic optical imaging sections following the test), with zero false calls. In Fig. 3, two thermal wave images from this test are displayed, the left showing corrosion, the right showing uncorroded material.

Fig. 3 Thermal wave image of two adjacent steel fasteners in a wing skin sectioned from an Air Force KC-135 aircraft. The left fastener shows several regions of intergranular corrosion, extending laterally from the top of the fastener head which "shadows" the corrosion. The indistinct nature of the thermal wave reflections from the lateral subsurface corrosion is typical of the thermal blurring expected from subsurface defect scattering.

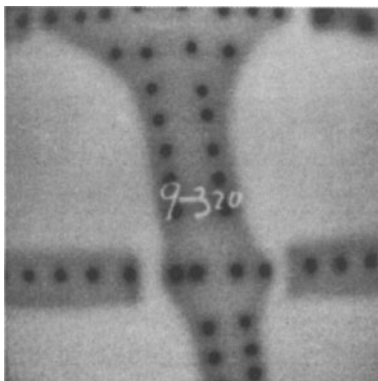
Fig. 4 (a) Thermal wave image of a well-bonded region of subsurface doubler from Section 41 of a B747 aircraft.

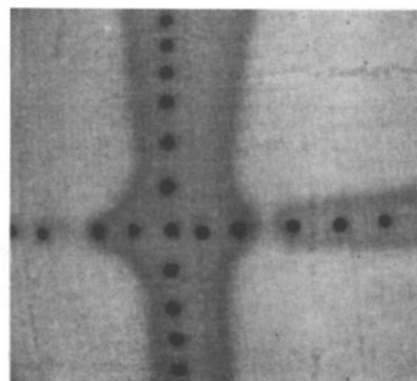
Fig. 4 (b) Thermal wave image of a disbanded region (left/center of the image) of subsurface doubler from Section 41 of another B747 aircraft.

from the airline and the manufacturer. The two methods agreed throughout the tests with one exception. One region, initially found to be disbanded by traditional testing, seemed well bonded thermally. Re-inspection by the manufacturer/airline confirmed the conclusion of the thermal wave imaging inspection.
