**Management of water and backfill characteristics for improved bridge
approach performance**

Mohamed Magdi Mekkawy

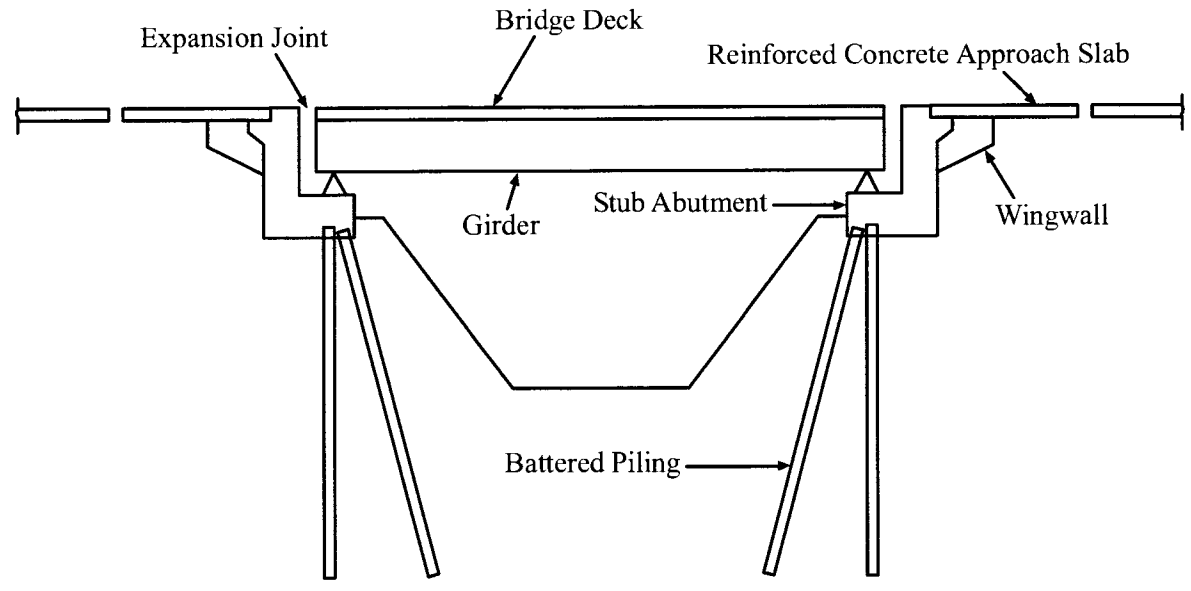
Figure 2.2 - A Simplified Cross Section of a Non-Integral Abutment Bridge (Greimann *et al.* 1987)

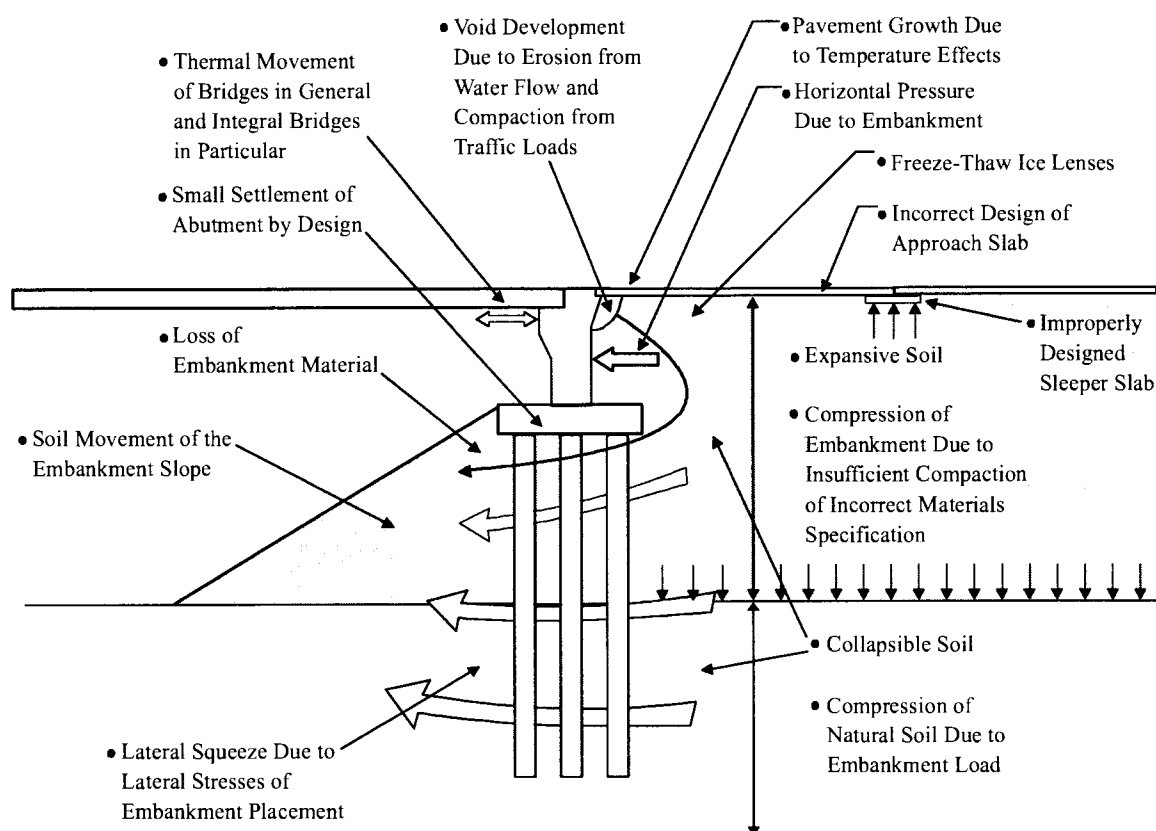
Figure 2.4 - Problems Leading To the Development of the Bump (Briaud *et al.* 1997)

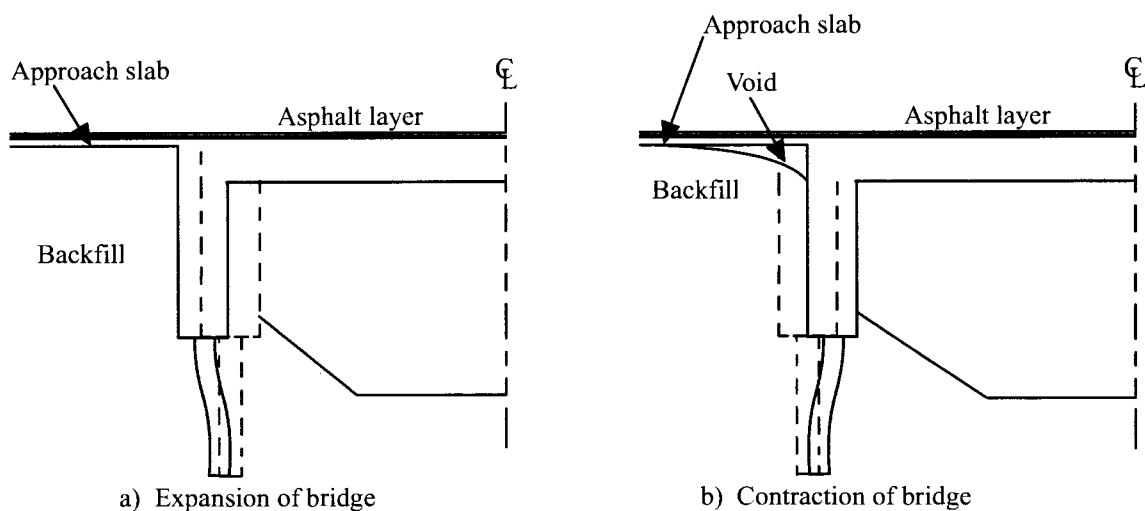
Figure 2.5 - Movement of Bridge Structure with Temperature (Arsoy *et al.* 1999)

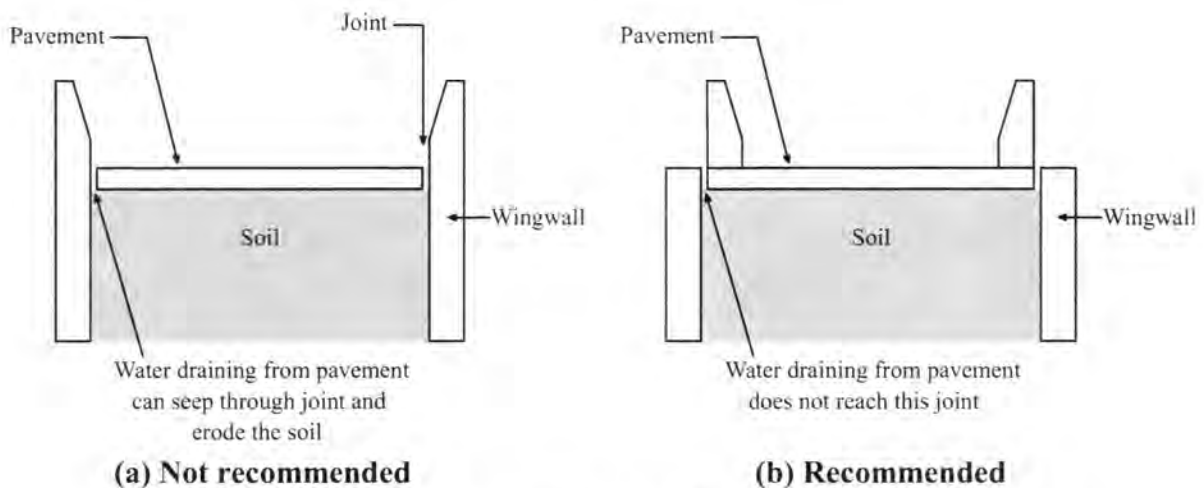
Figure 2.10 - Recommended Wingwall Detail (Briaud *et al.* 1997)

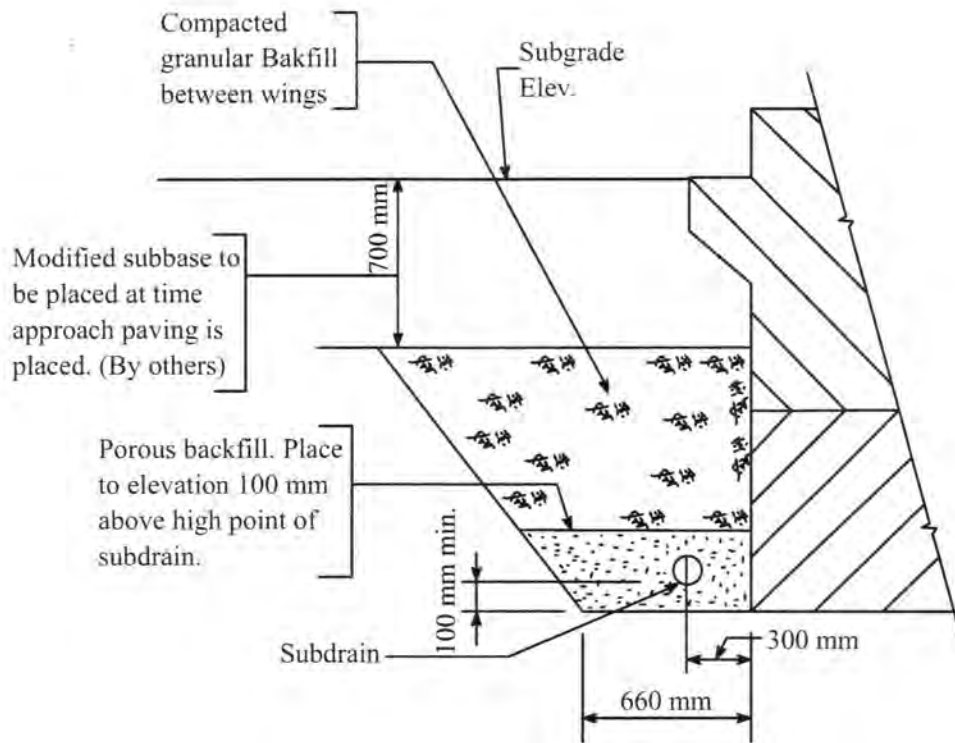
Figure 2.11 - Porous Fill Surrounding Subdrain (Iowa DOT 2004)

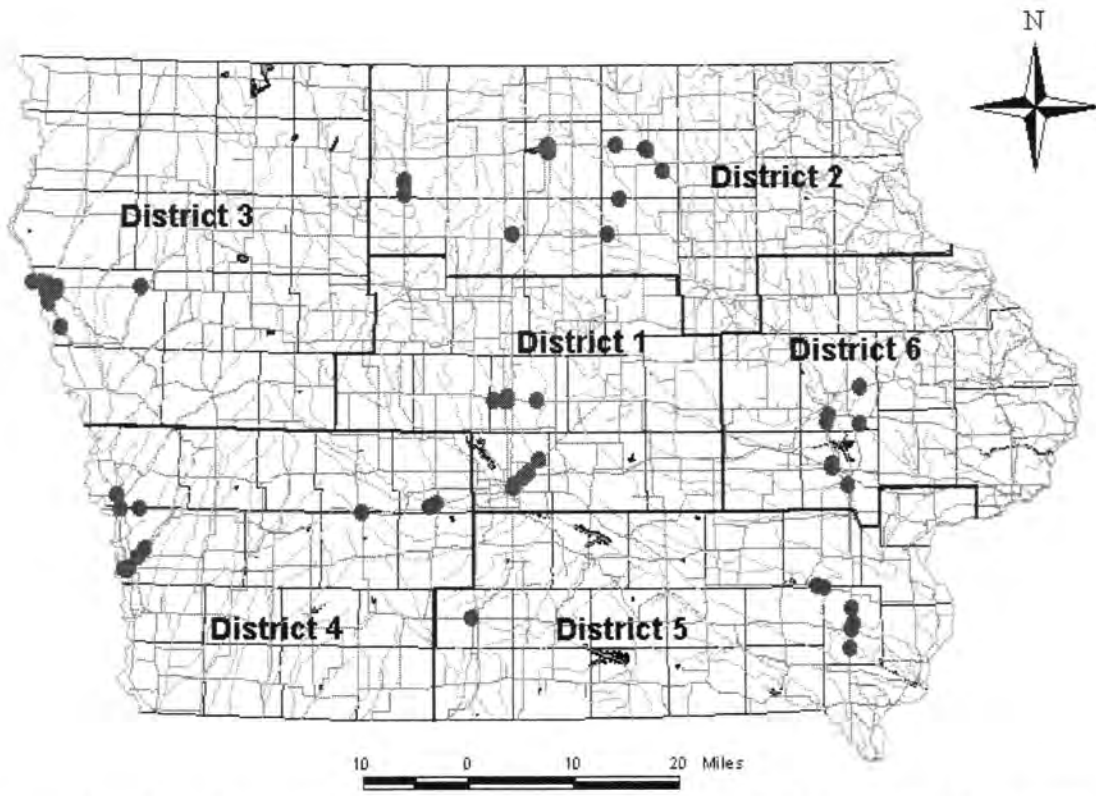
Figure 3.1 - Iowa Map with the Location of the Inspected Bridges at All Iowa Districts

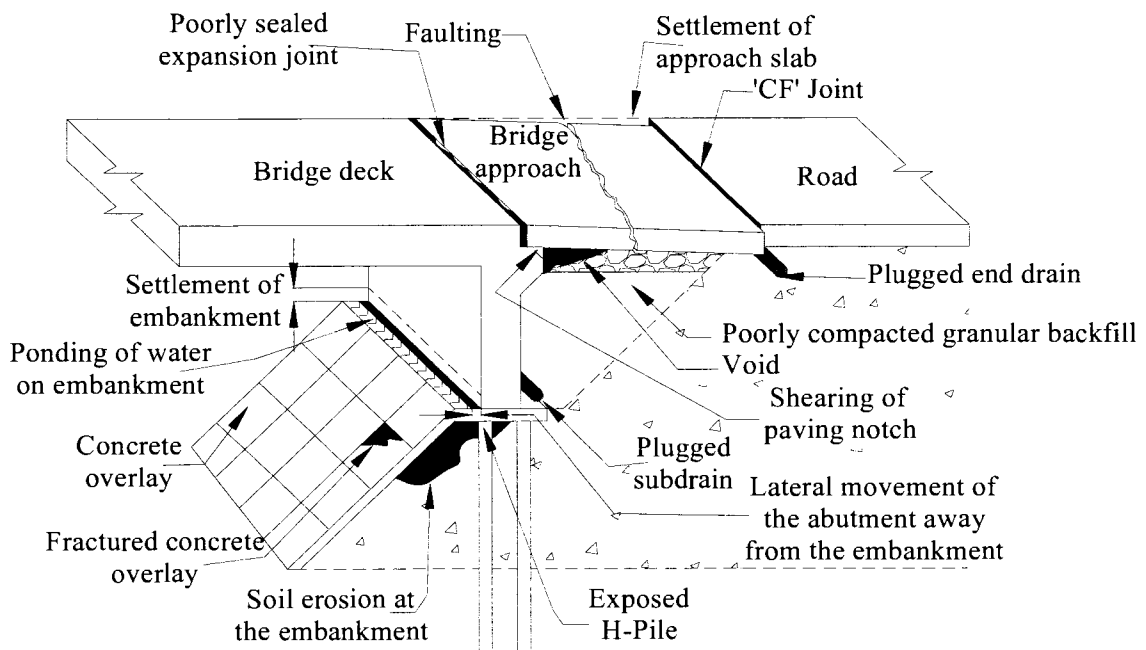
Figure 3.3 - Schematic Summarizing the Frequent Problems Observed at the Investigated Bridges

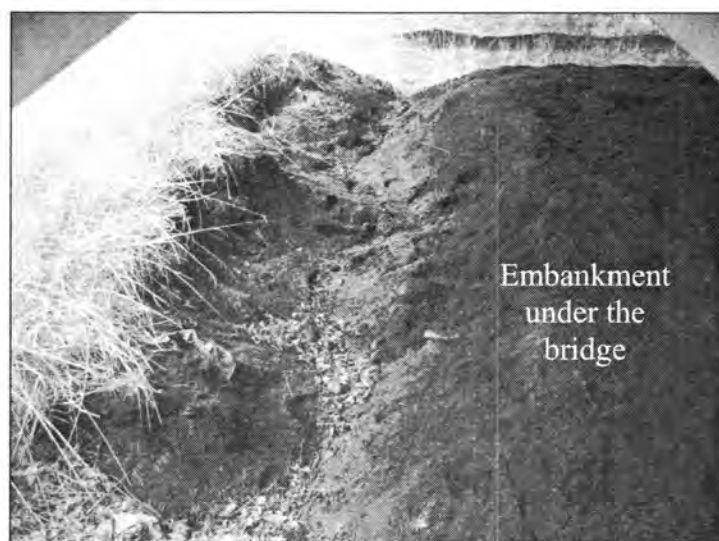
Figure 3.4 - Soil Erosion of the Bridge Embankment (Bridge at U.S. 65 over South Skunk River - South End of NBL)

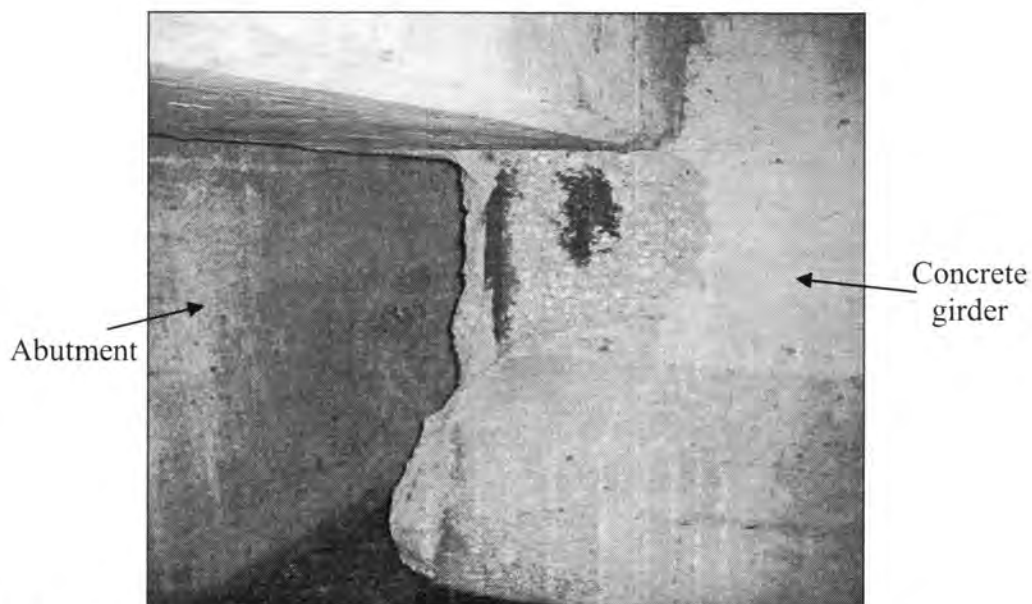
Figure 3.5 - Deterioration of Concrete with Visible Steel Reinforcement (Bridge at U.S. 65 over South Skunk River - South End NBL)

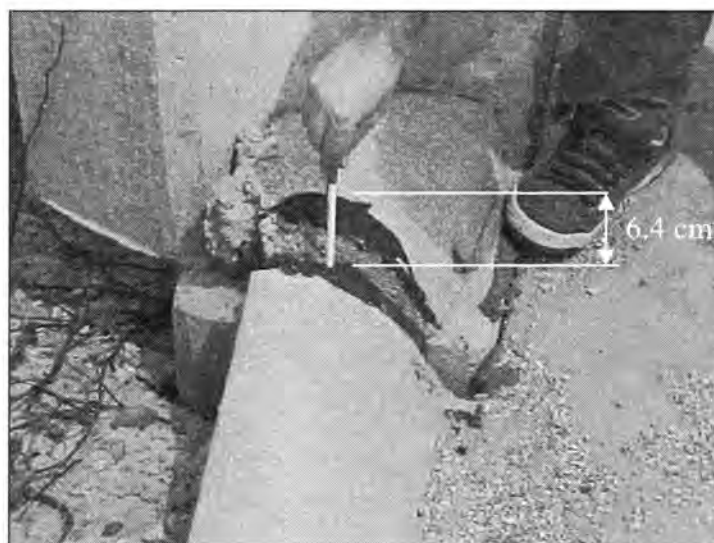
**Figure 3.6 - Differential Settlement between the Bridge Deck and the Approach Slab
(Bridge at U.S. 65 over South Skunk River - South End SBL)**

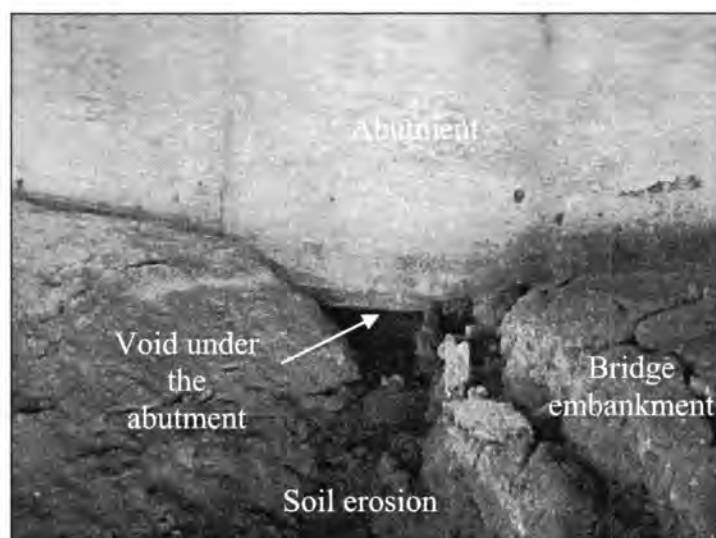
Figure 3.10 - Erosion of Soil Under the Bridge Abutment (Bridge at U.S. 65 over Rail Road - North End of NBL)

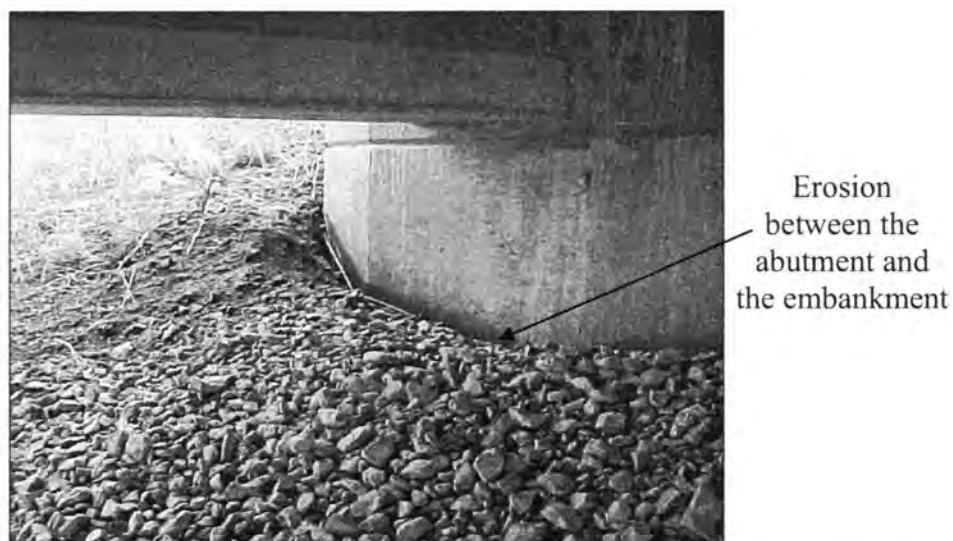
Figure 3.15 - Aggregate Used as Slope Protection at the Bridge Embankment (Bridge at U.S. 65 Crossing Pleasant Hill Road)

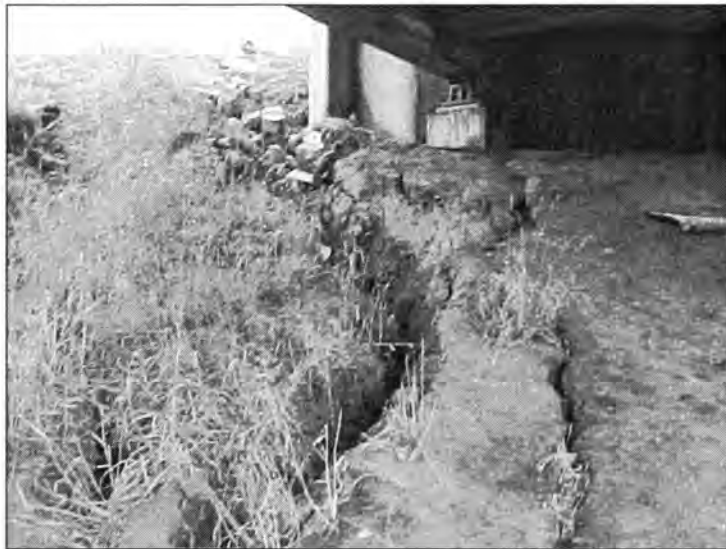
Figure 3.17 - Soil Erosion of the Bridge Embankment (Bridge No. 8556.8L030)

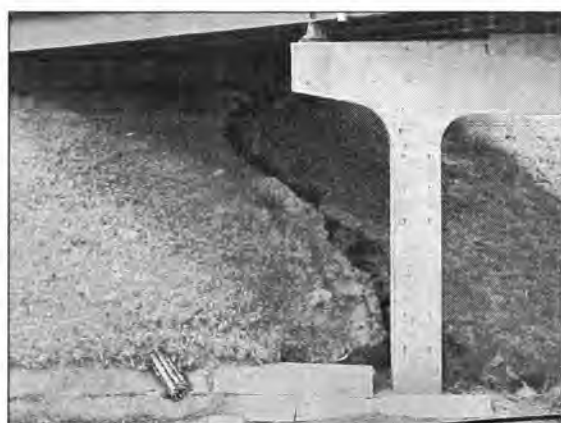
This bridge has non-integral abutments and steel girders. Significant erosion was observed under the bridge at both the east and the west bounds as shown in Figure 3.18. However, the approach slab appeared to be in a good condition.

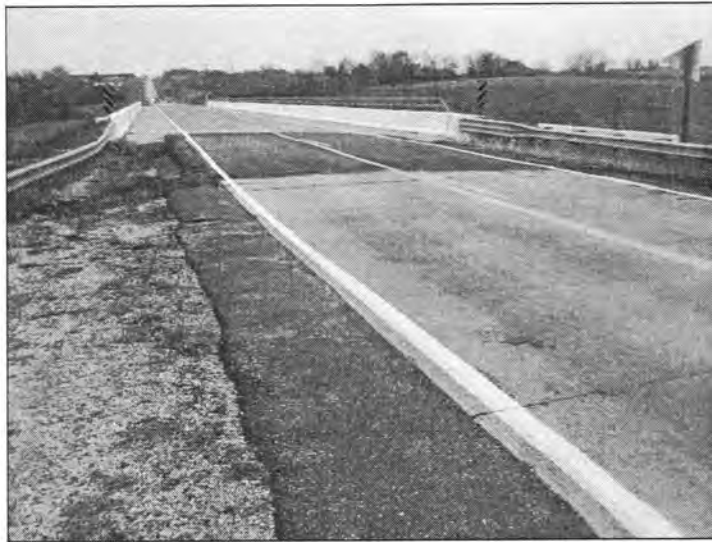
Figure 3.19 - Recently Placed Asphalt Overlay at the Bridge Approach (Bridge Carrying 72nd St. over I-35 - East End)

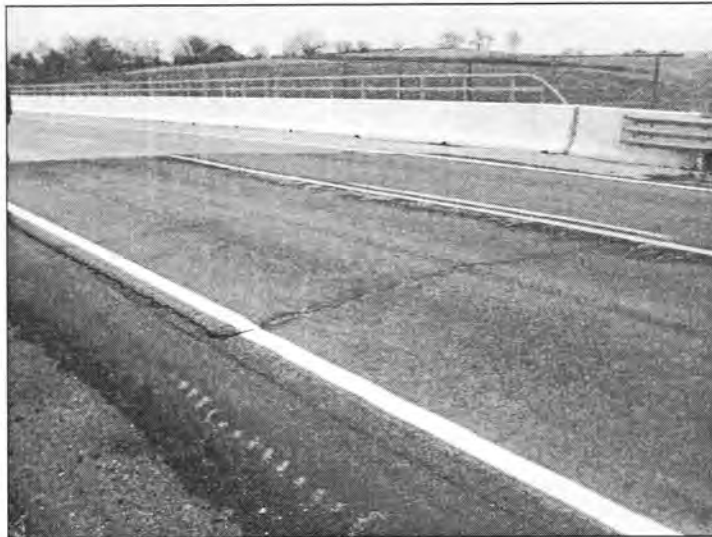
Figure 3.20 - Cracking of the Asphalt Overlay (Bridge Carrying 72nd St. over I-35 - East End)

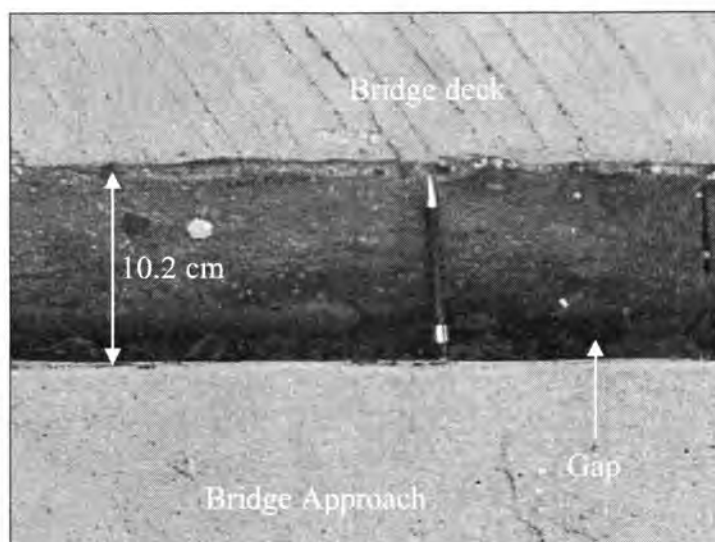
Figure 3.21 - Poorly Sealed Expansion Joint (Bridge Carrying 72nd St. over I-35 - East End)

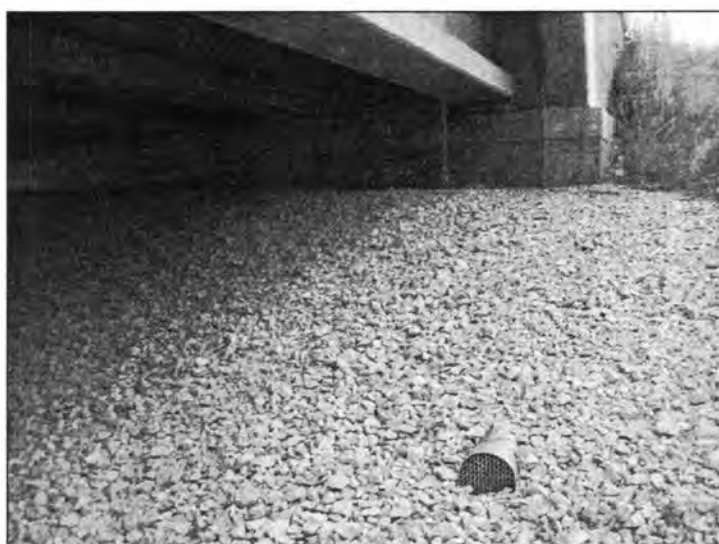
Figure 3.22 - Aggregate Used as a Slope Protection at the Bridge Embankment (Bridge Carrying 72nd St. over I-35)

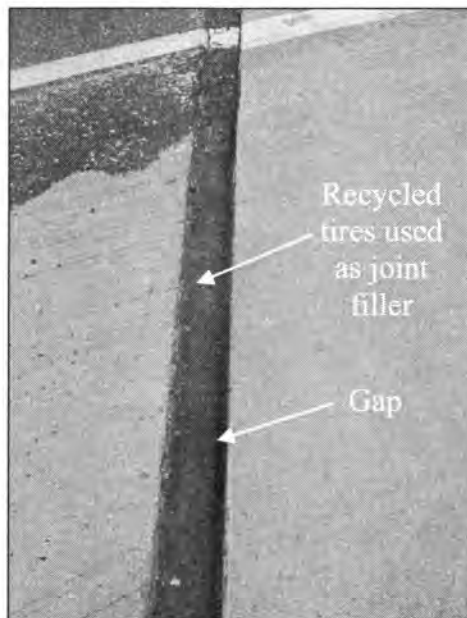
Figure 3.23 - Poorly Sealed Expansion Joint (Bridge Carrying 72nd St. over I-35 - East End)

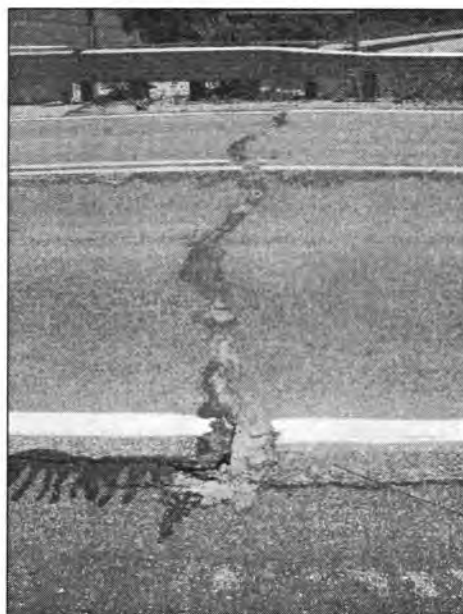
Figure 3.24 - Transverse Cracks of Recently Resurfaced Approach Slab (Bridge Carrying 72nd St. over I-35 - East End)

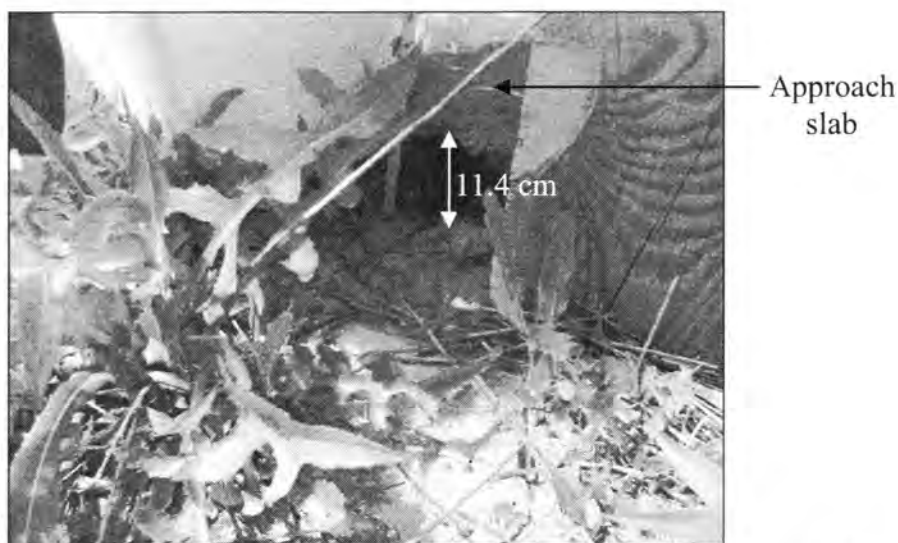
Figure 3.25 - Void Developed Under the Approach Slab (Bridge Carrying 72nd St. over I-35 - West End)

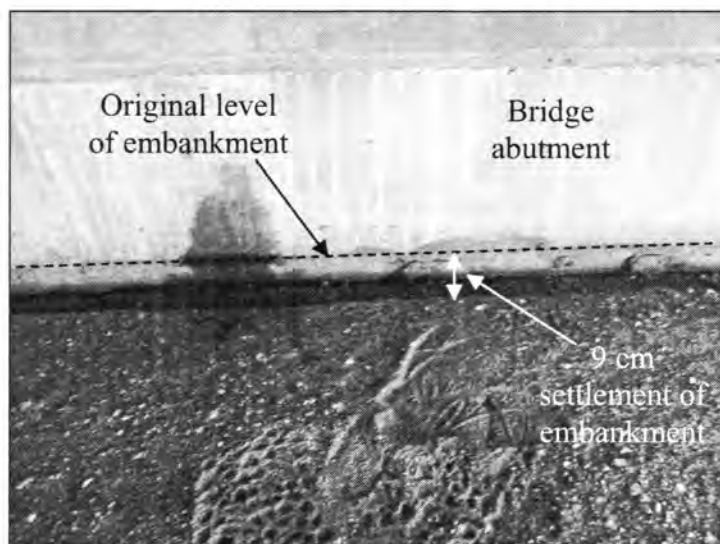
Figure 3.28 - Settlement of the Embankment under the Bridge and a Gap between the Abutment and the Bridge Embankment (Bridge Carrying 160 over I-35 - East End WBL)

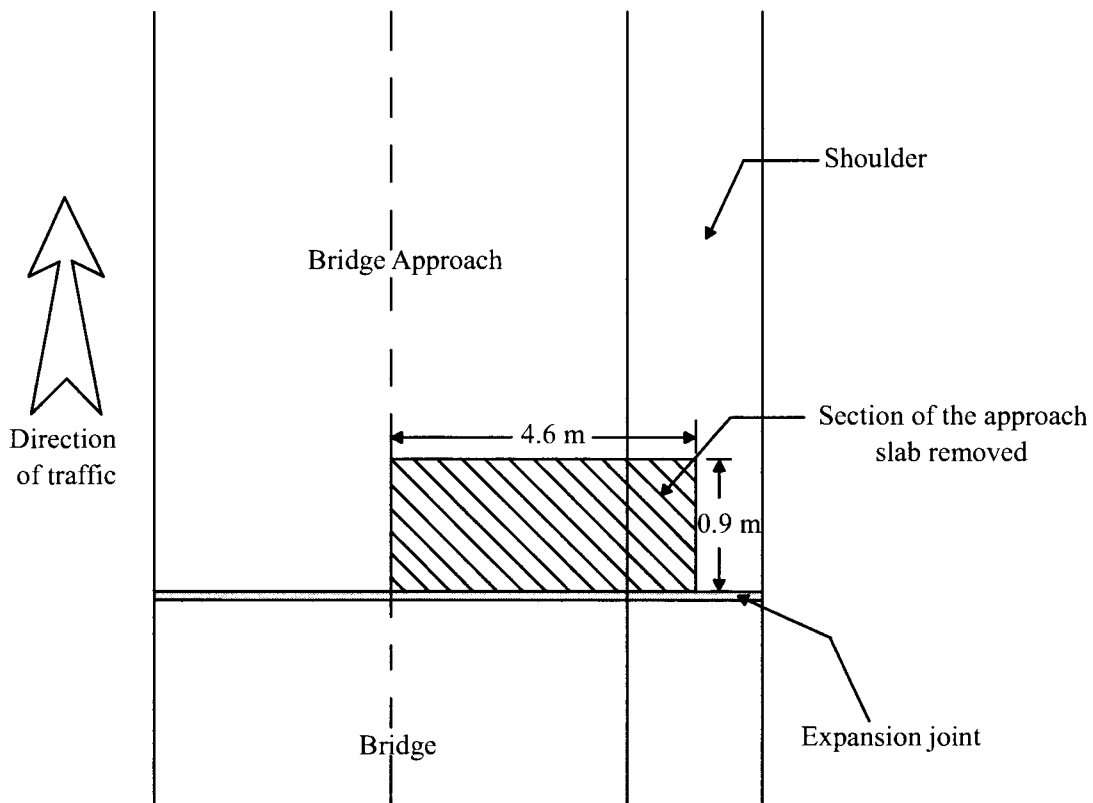
Figure 3.29 - Plan View of the Bridge with the Location of Removed Approach Slab Section for Inspection (Bridge Carrying 160 over I-35)

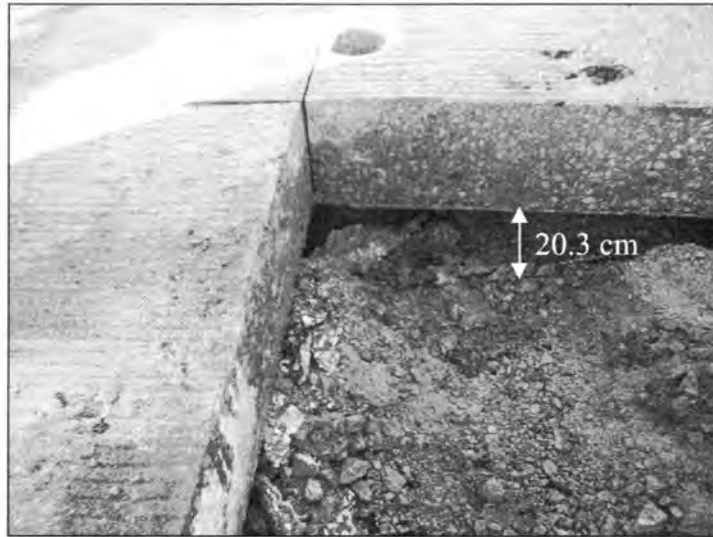
Figure 3.32 - Void Observed under the Approach slab (Bridge Carrying 160 over I-35)

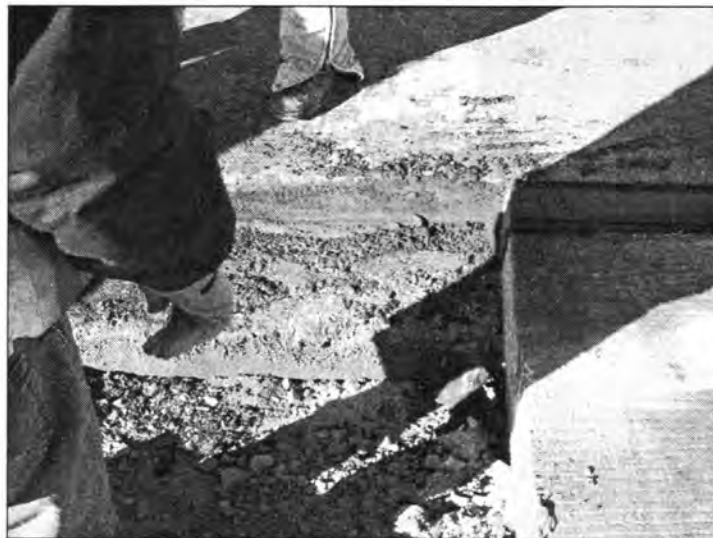
Figure 3.33 - Layer of Crushed Aggregate Covering the Paving Notch (Bridge Carrying 160 over I-35)

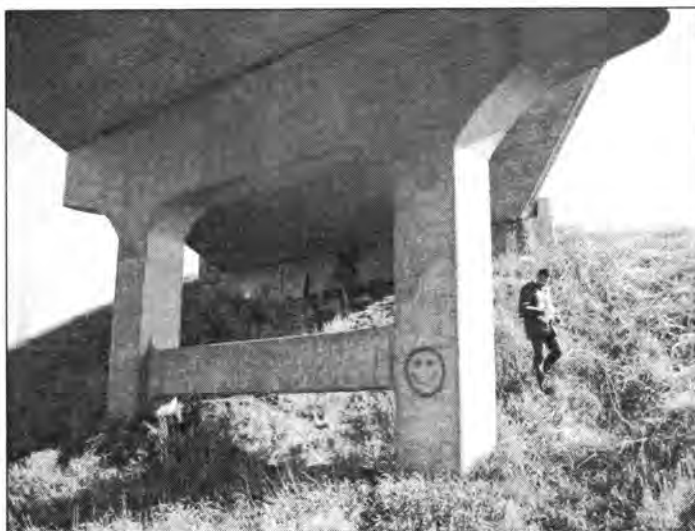
Figure 3.36 - Concrete Bridge with Deep Slab and No Girders (Bridge No. 1270.2S014)

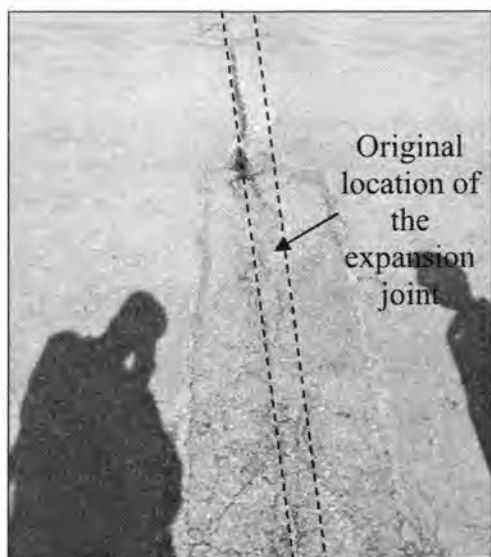
Figure 3.38 - Cracked Asphalt Patch at the Expansion Joint (Bridge No. 1270.2S014)

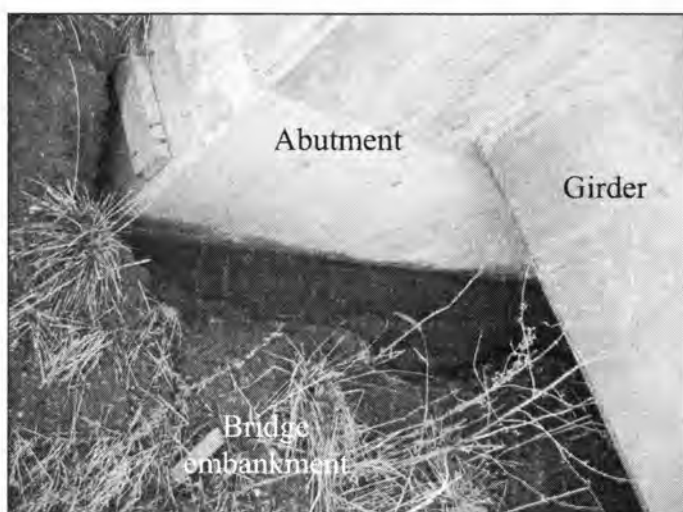
Figure 3.39 - Water Ponding on the Embankment under the Bridge (Bridge No. 1270.2S014)

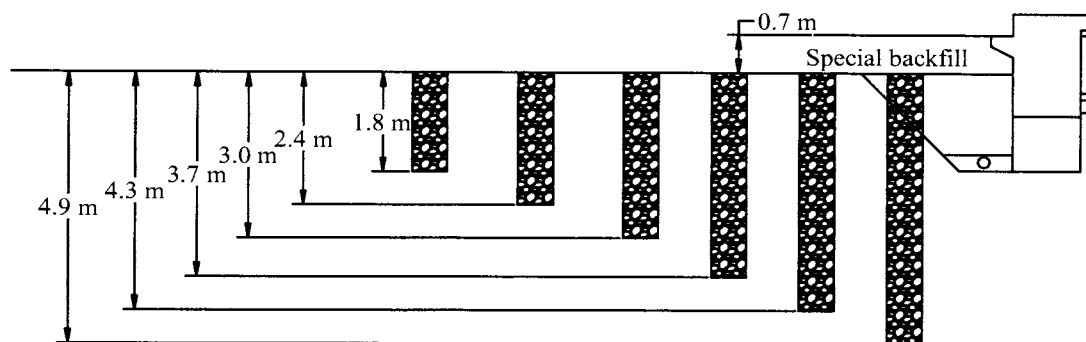
Figure 3.40 - Profile of Geopier Elements Supporting Bridge Approach (White *et al.* 2003)

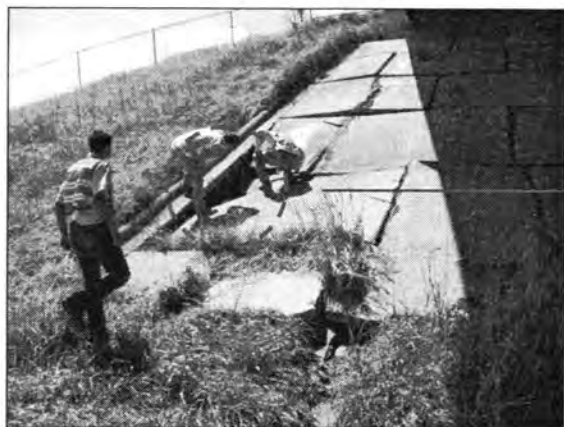
(a) Damaged Slope Protection

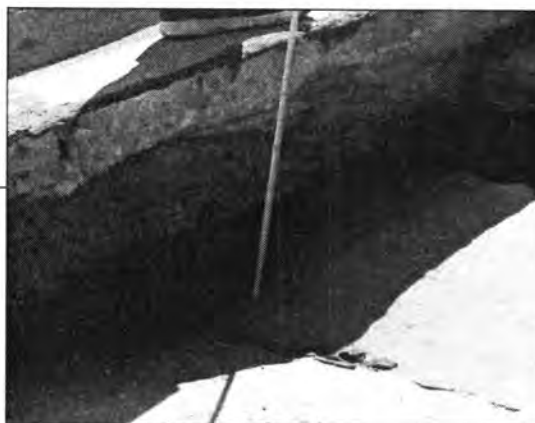
(b) Closer Image of the Damaged Concrete

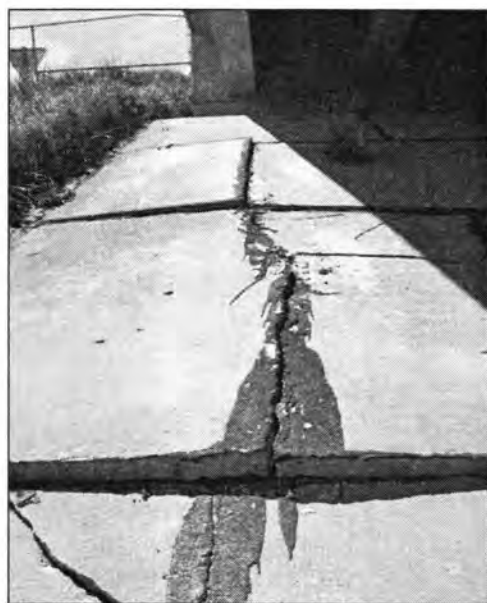
Figure 3. 46 - Fractured Concrete Slope Protection (Bridge No. 1793.6R035)

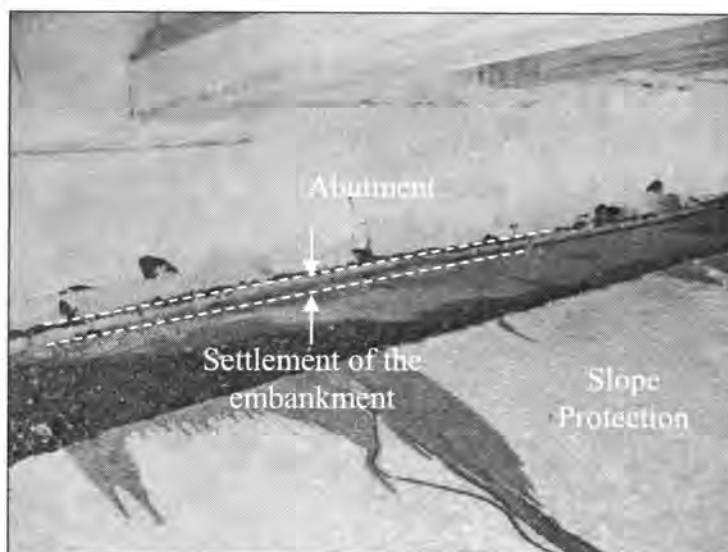
Figure 3. 47 - Settlement of the Bridge Embankment and a Gap between the Embankment and the Abutment (Bridge No. 1793.6R035)

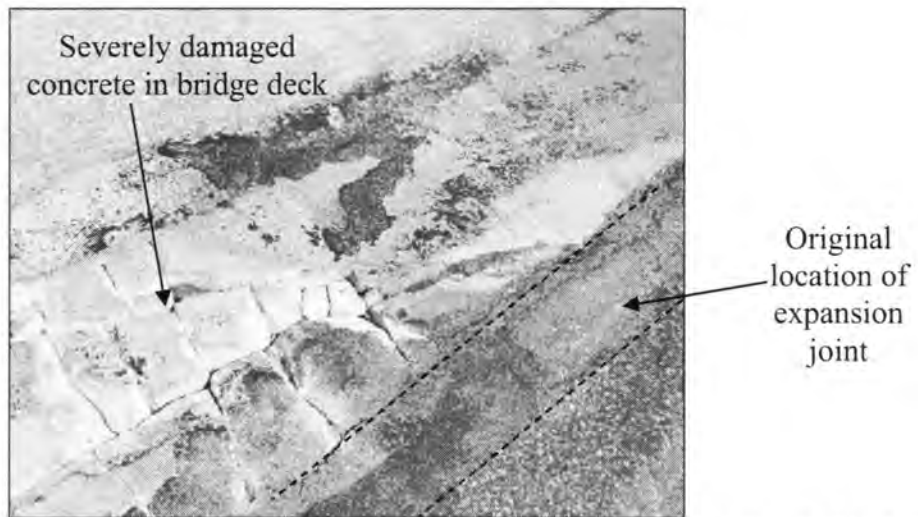
Figure 3. 48 - Bridge Deck Damage was suspected to be a Result of Grouting behind the Bridge Abutment (Bridge No. 5596.2S169)

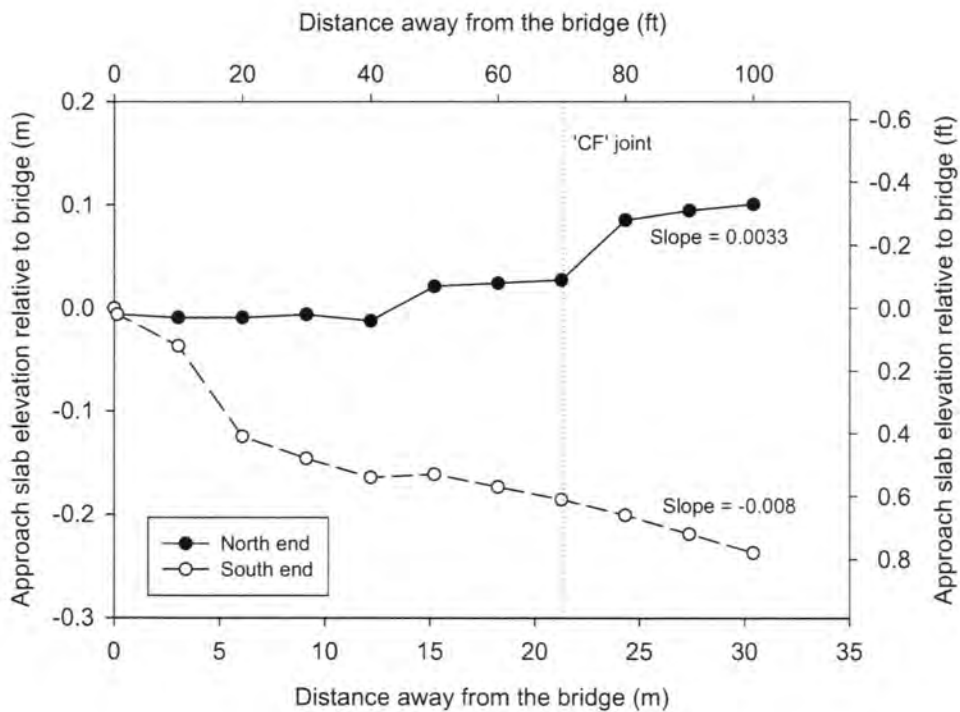
Figure 3. 49 - Elevation of Approach Slabs Relative to the Bridge (Bridge No. 5596.2S169)

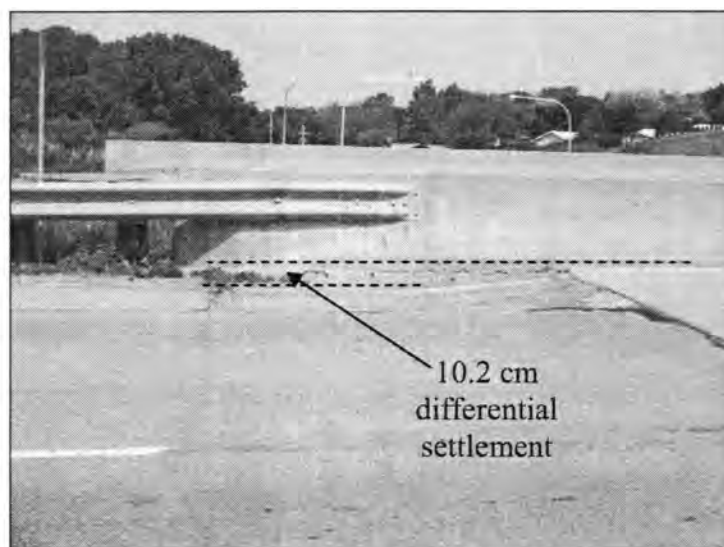
**Figure 3.51 - Differential Settlement between the Bridge Deck and the Approach Slab
(Bridge No. 9702.9)**

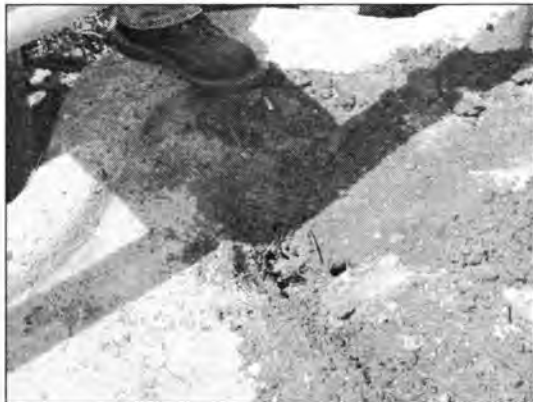
**(a) Bridge End Drain
Blocked by Debris**

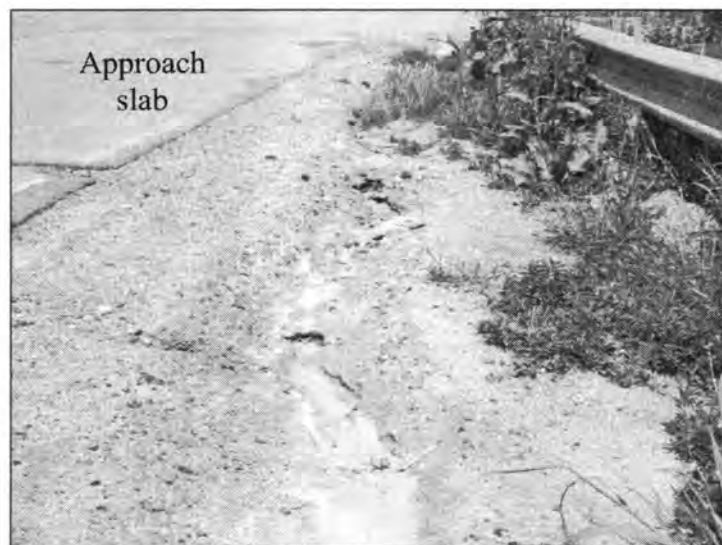
Figure 3.55 - Erosion Caused by Runoff Water at the Approach Slab Shoulder (Bridge No. 982.9)

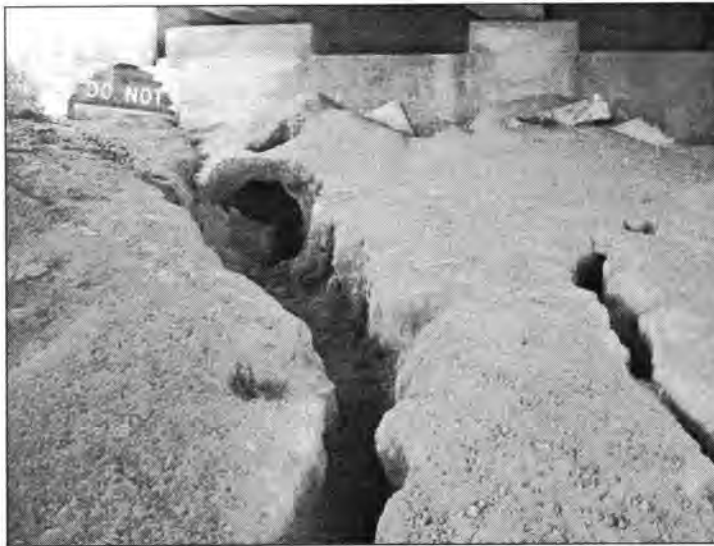
Figure 3.56 - Severe Erosion under the Bridge (Bridge No. 982.9)

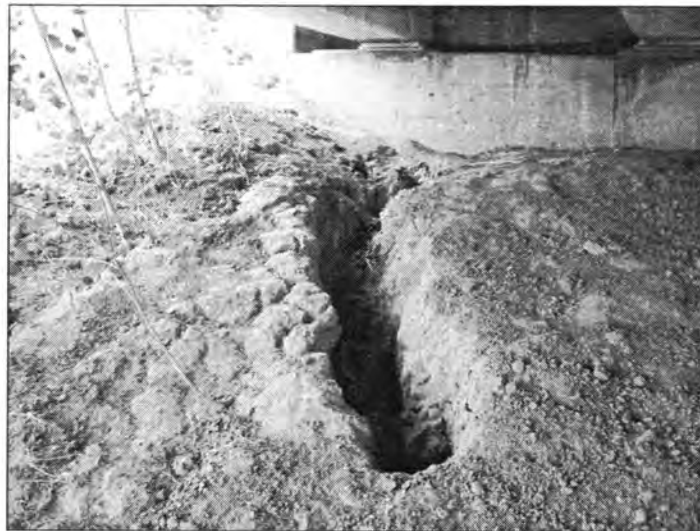
Figure 3.57 - Soil Erosion of the Bridge Embankment (Bridge No. 99)

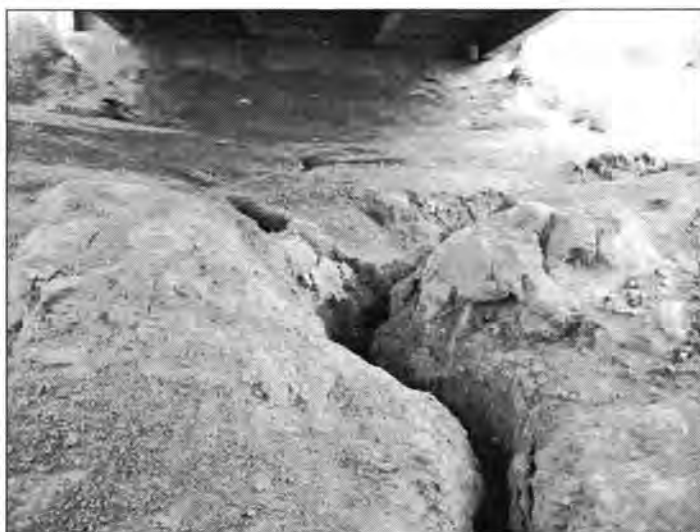
Figure 3. 59 - Soil Erosion of the Embankment under the Bridge (Bridge at U.S. 20 over West Fork Little Sioux River)

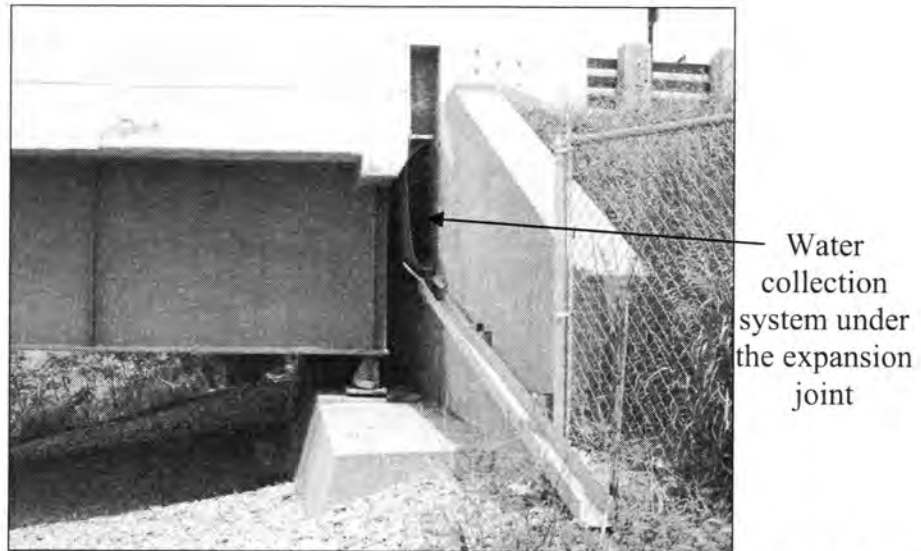
Figure 3.60 - Distinctive Drainage Design at the End of the Bridge (I-29 Border Bridge)

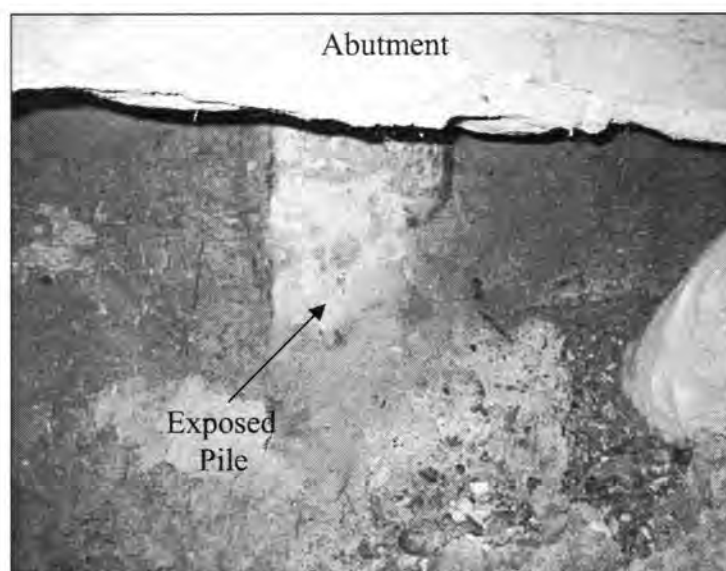
Figure 3.61 - Exposed H-pile Caused by Soil Erosion under the Abutment (Bridge No. 786.3R080)

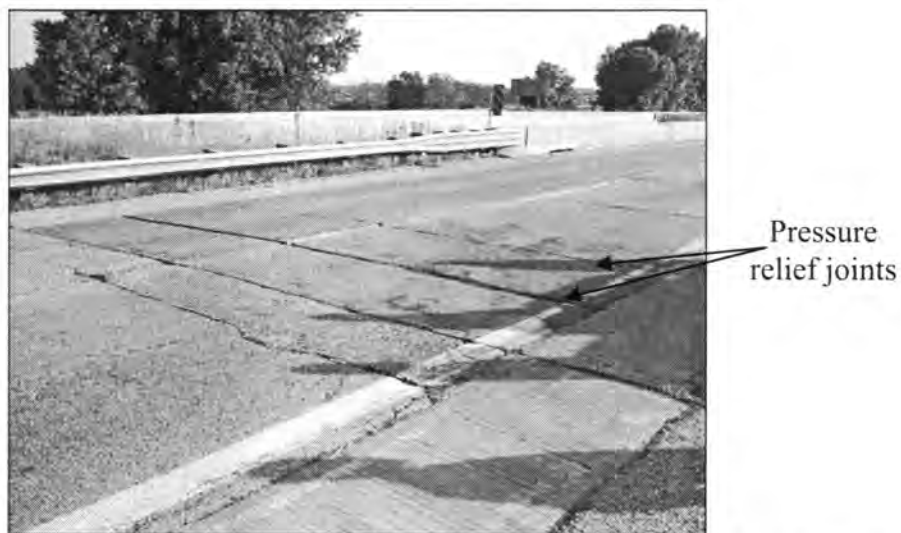
Figure 3.62 - Pressure Relief Joint Made by Cutting the Approach Slab (Bridge No. 786.8R080)

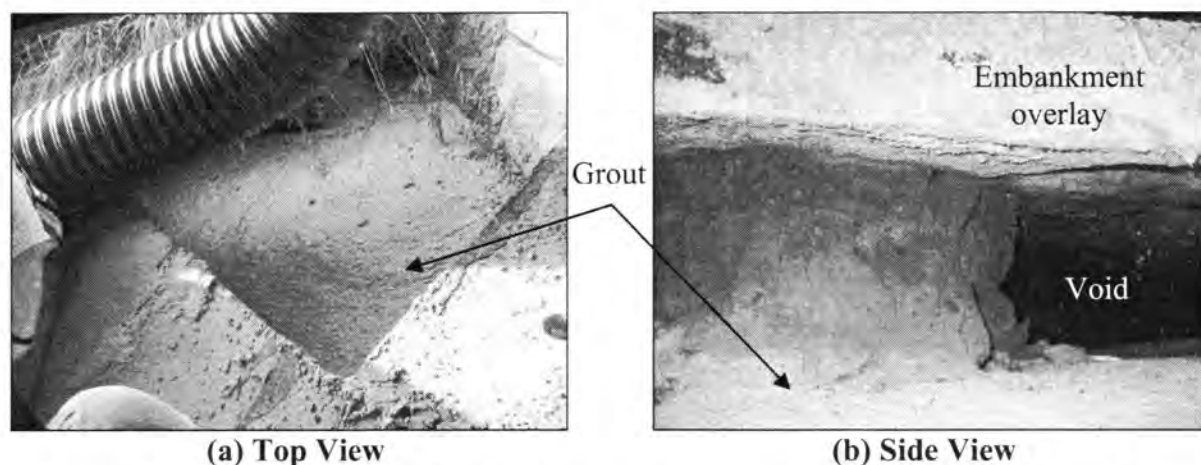
Figure 3.63- Grout Pumped under the Slope Protection to Fill the Void Caused by Erosion (Bridge No. 786.8R080)

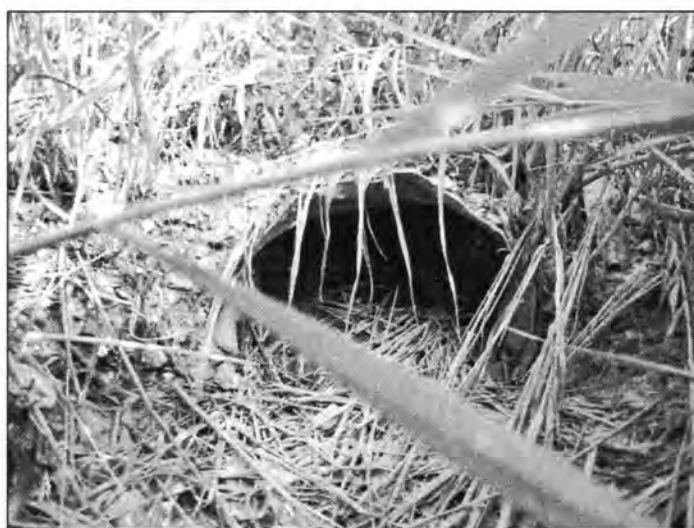
Figure 3.64 - End Drain Plugged with Soil (Bridge No. 786.8R080)

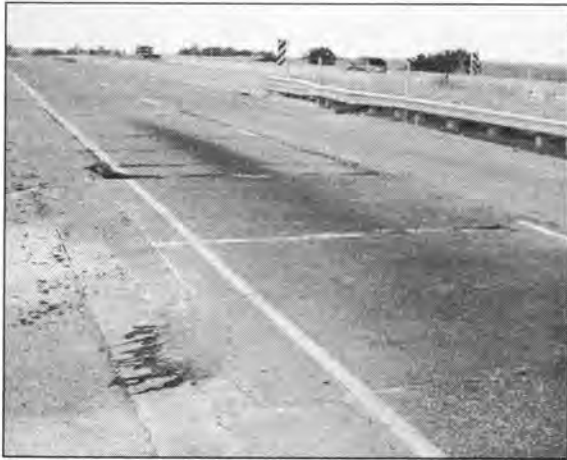
(a) Cracked Approach Slab Panels

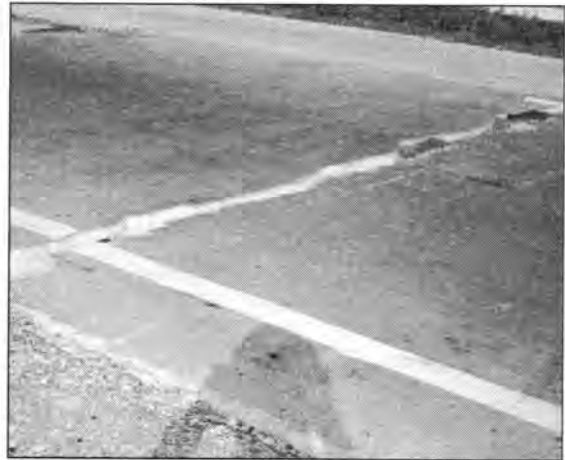
(b) Closer Image of Faulted Approach Slab

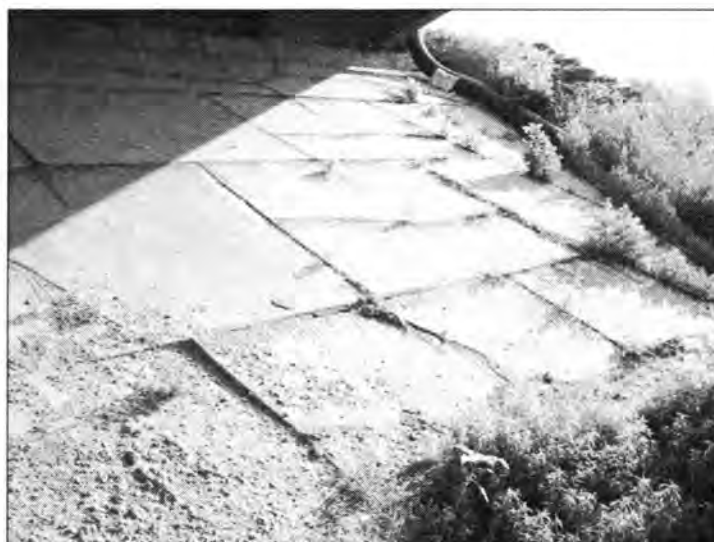
Figure 3.67 - Cracking of Concrete Slope Protection (Bridge No. 788.5R080)
