**Management of water and backfill characteristics for improved bridge
approach performance**

Mohamed Magdi Mekkawy

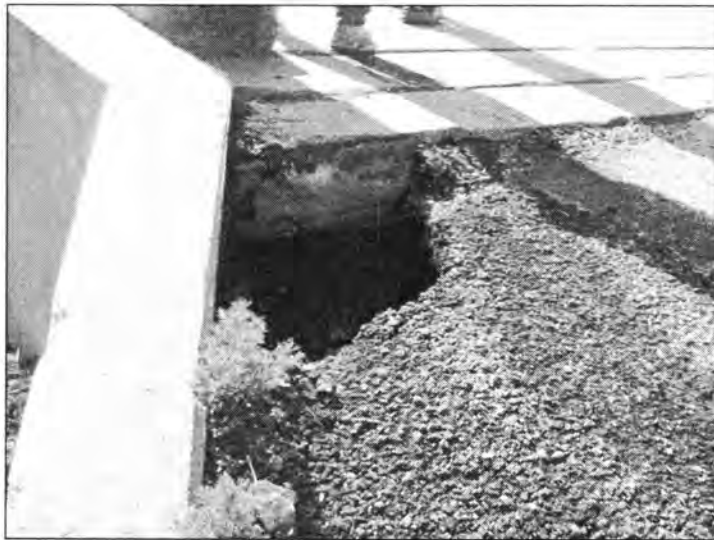
Figure 3.68 - Failure at the Approach Slab Shoulder (Bridge No. 7821.1L680 - WBL)

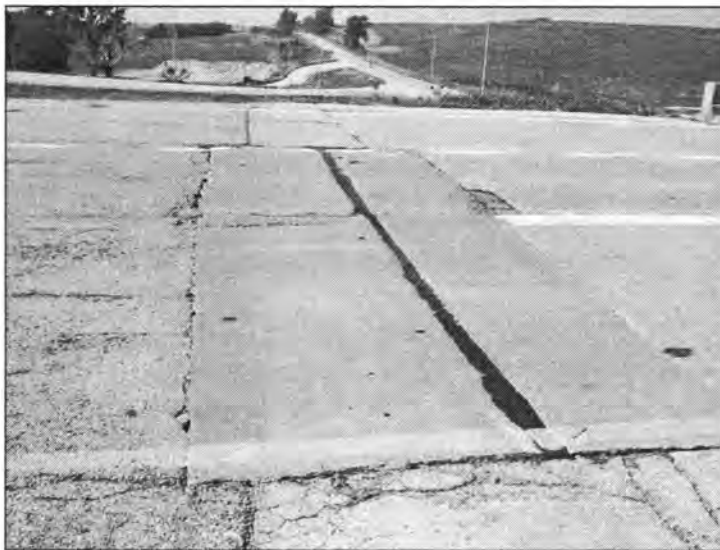
Figure 3.69 - Various Cracking at the Bridge Approach (Bridge No. 7821.1L680 - EBL)

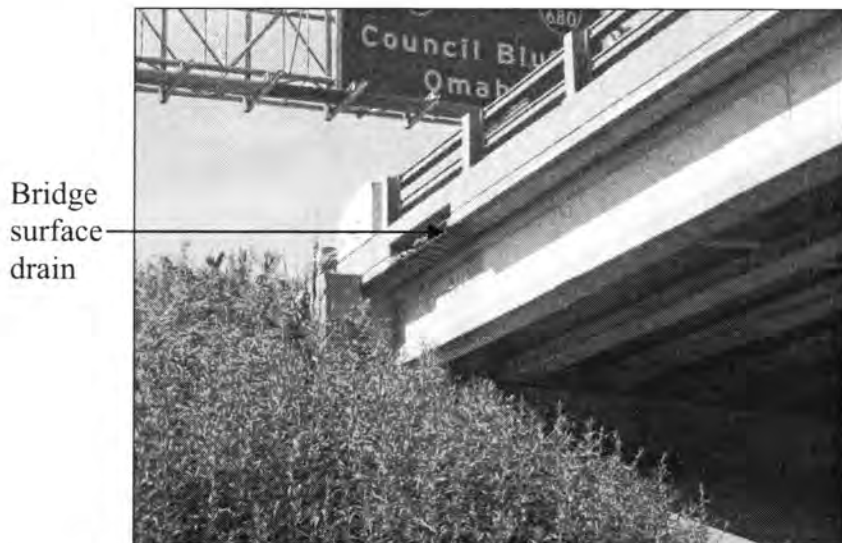
Figure 3.70 - Surface Drain of the Bridge Deck Allowing Water to fall on the Embankment (Bridge No. 78071.5R29)

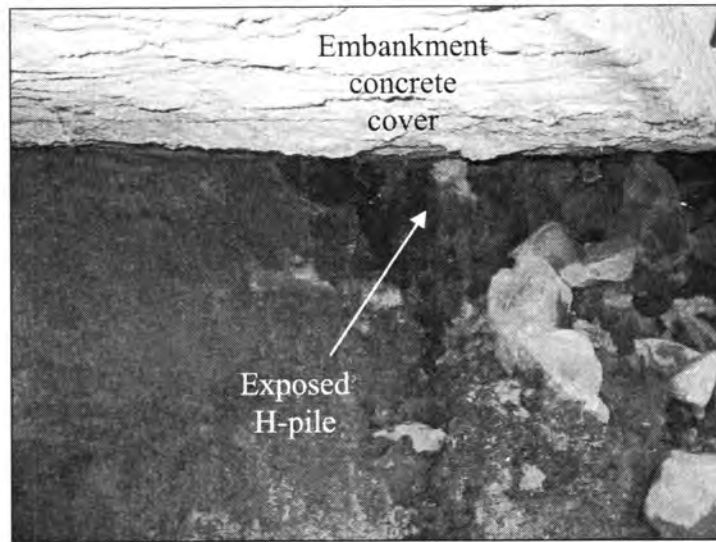
Figure 3.72 - Exposed H-pile (Bridge No. 78071.5R29)

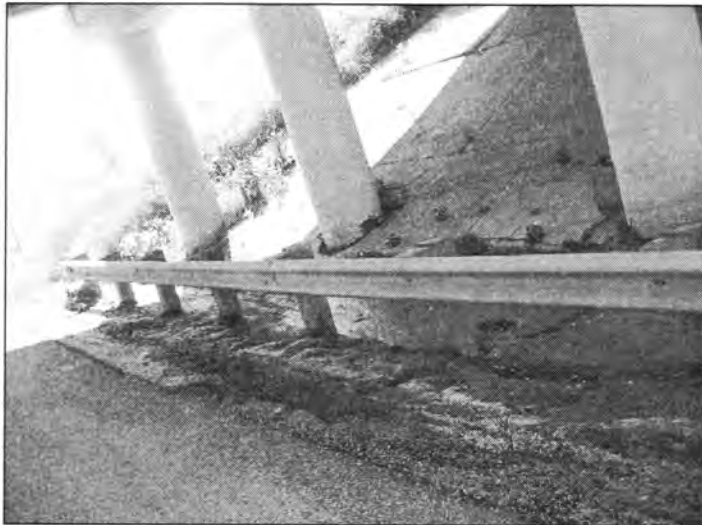
Figure 3.74 - Water Observed at the Bottom of the Embankment (Bridge No. 78071.5R29)

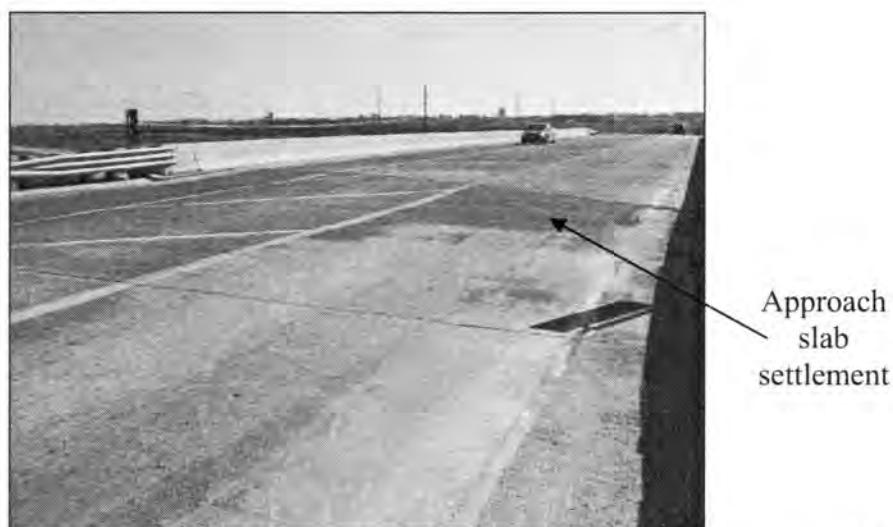
Figure 3. 75 - Settlement of the Approach Slab (Bridge at Clay St. Crossing I-35)

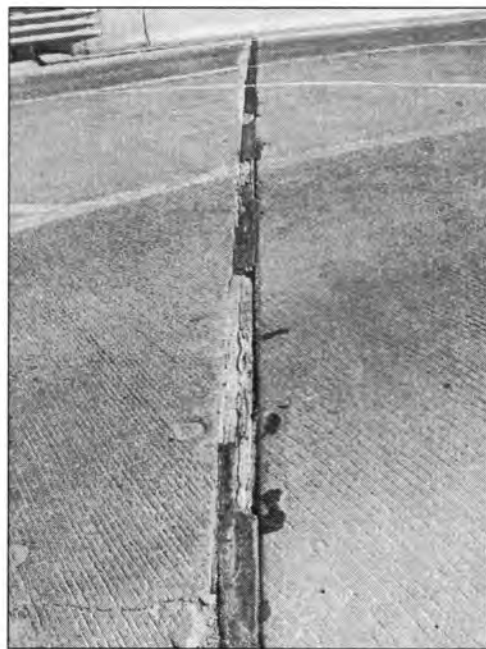
Figure 3.77 - Deteriorated Expansion Joint Sealer (Bridge at Clay St. Crossing I-35)

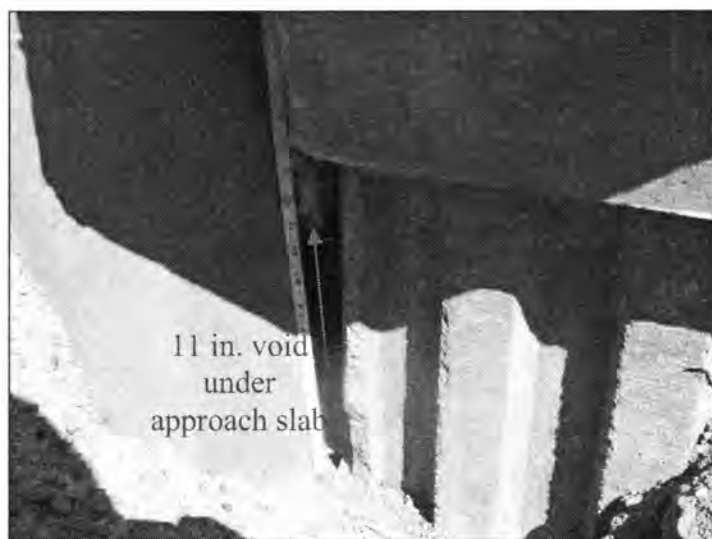
Figure 3.78 - Void Developed under Approach Slab (Bridge at Clay St. Crossing I-35)

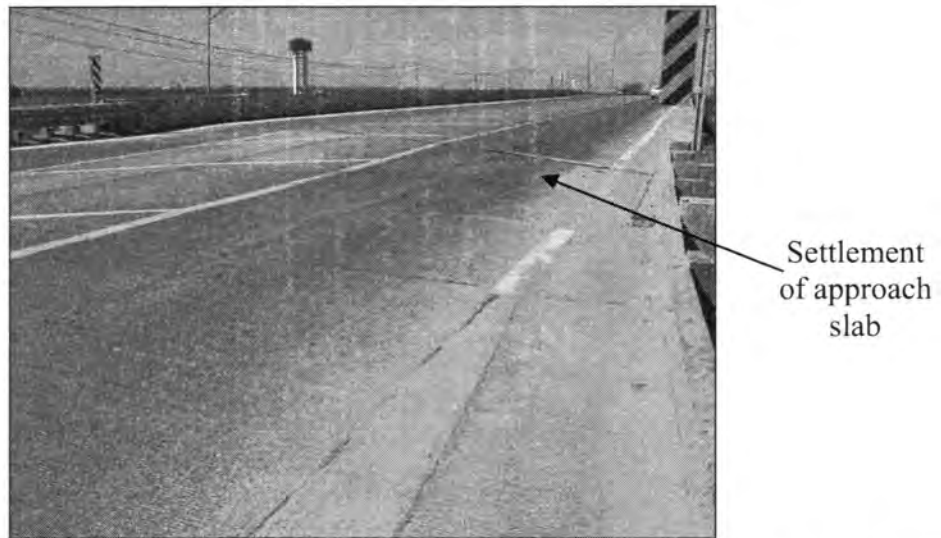
Figure 3.79 - Differential Settlement at the Bridge Approach (Bridge at Clay St. Crossing I-35 - East End)

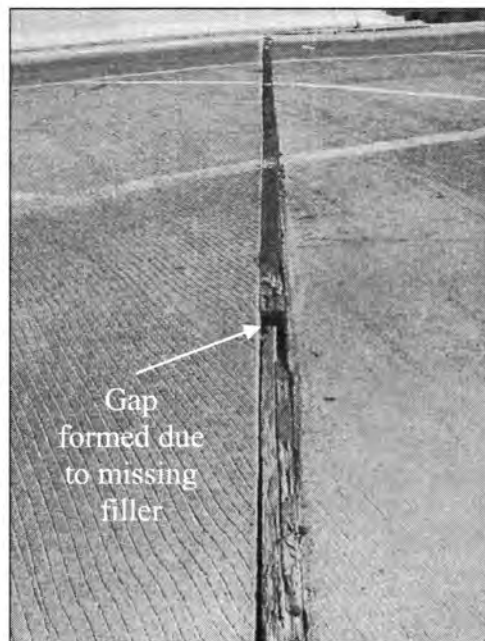
Figure 3.80 - Missing and Deteriorated Filler Material at the Expansion Joint (Bridge at Clay St. Crossing I-35 - East End)

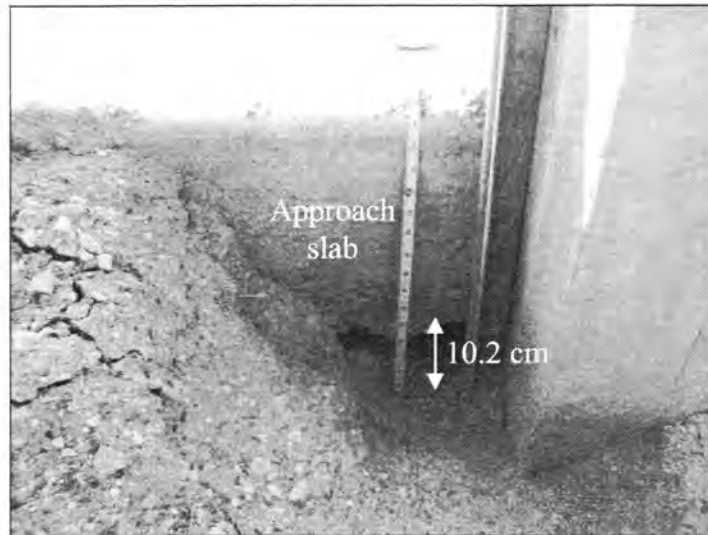
Figure 3.81 - Void Developed under the Approach Slab (Bridge at Clay St. Crossing I-35 - East End)

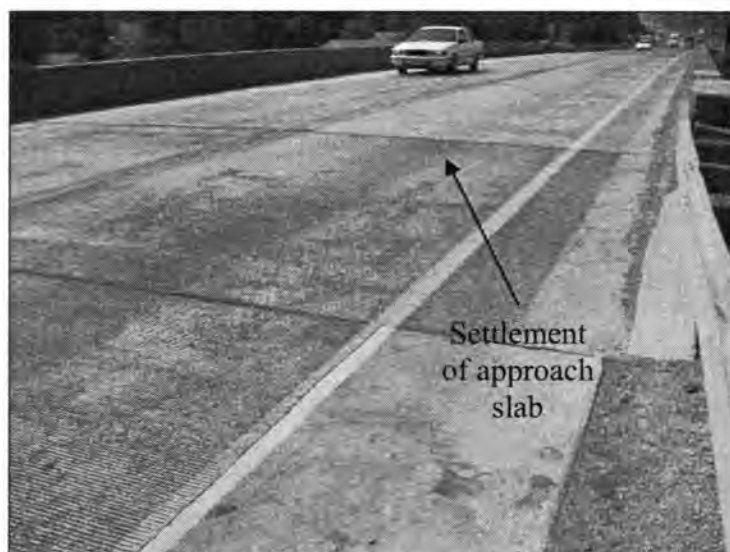
Figure 3.83 - Differential Settlement at Recently Replaced Bridge Approach (Bridge at Old U.S. 218 Crossing Henry St.)

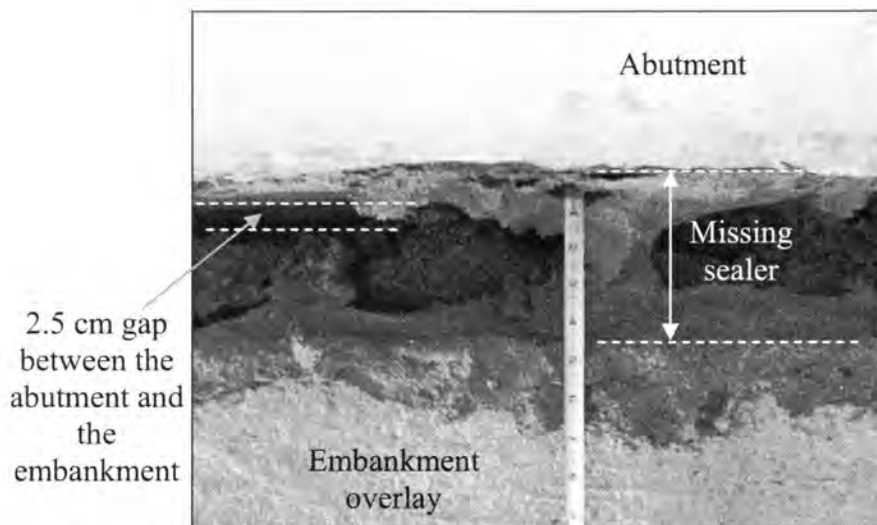
Figure 3.84 - Lateral Movement of the Abutment (Bridge at Old U.S. 218 Crossing Henry St.)

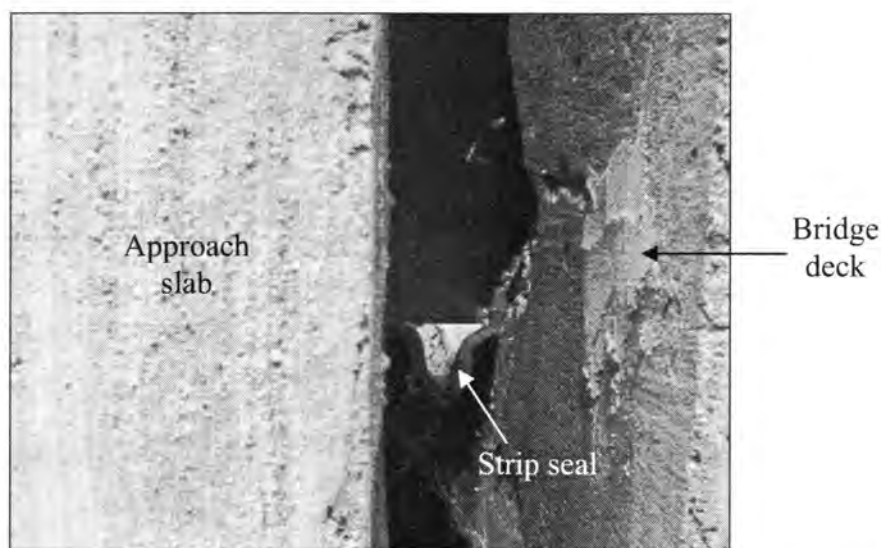
Figure 3. 86 - Side View of the Strip Seal which was Cut Short (Bridge at U.S. 218 over South Skunk River - South End of SBL)

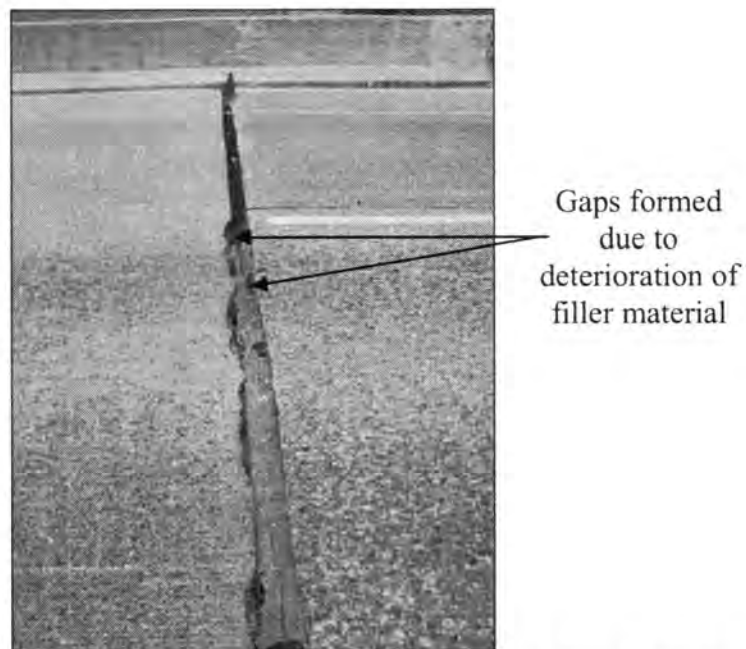
Figure 3.89 - Deteriorated Flexible Foam which was used as Joint Filler (Bridge at U.S. 218 - North End of NBL)

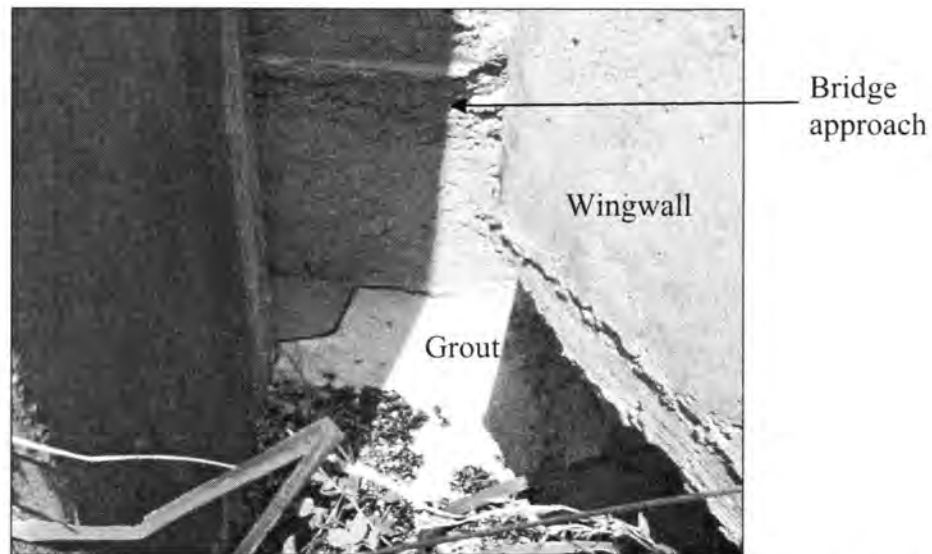
Figure 3.90 - Grouting Under the Approach Slab (Bridge at U.S. 218 - South End of NBL)

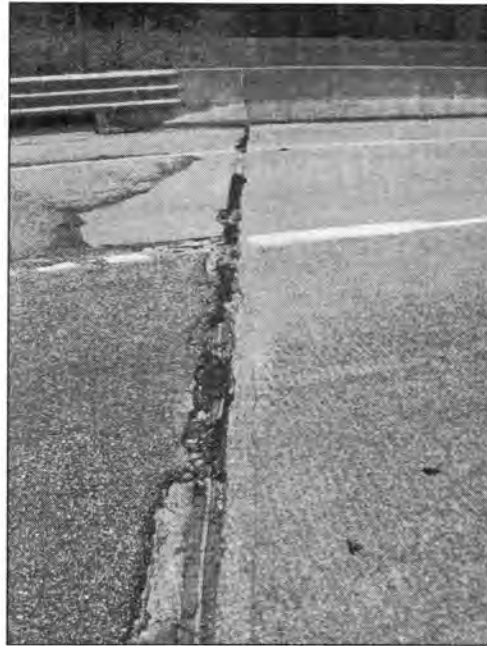
Figure 3.91 - Poorly Resurfaced Approach Slab (Bridge No. 9266.2R - West End of WBL)

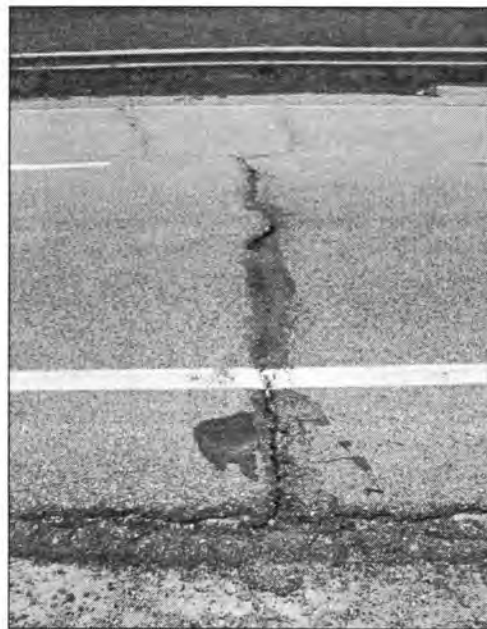
Figure 3.92 - Transverse Cracking of the Asphalt Overlay (Bridge No. 9266.2R - West End of WBL)

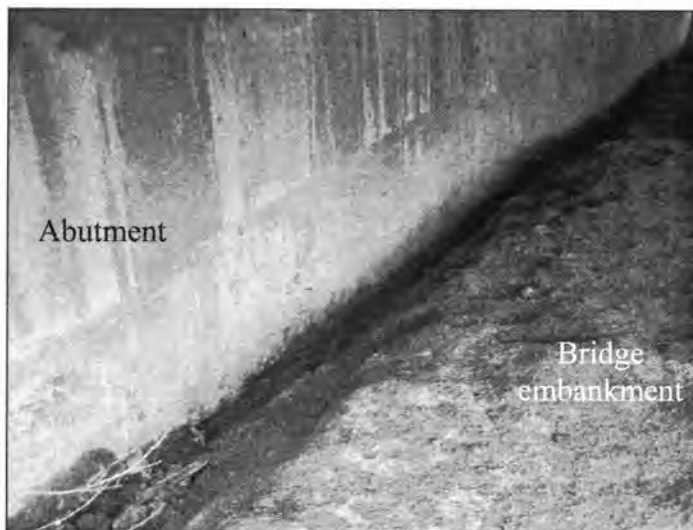
Figure 3.93 - Erosion of the Embankment Soil (Bridge No. 9266.2R - West End of WBL)

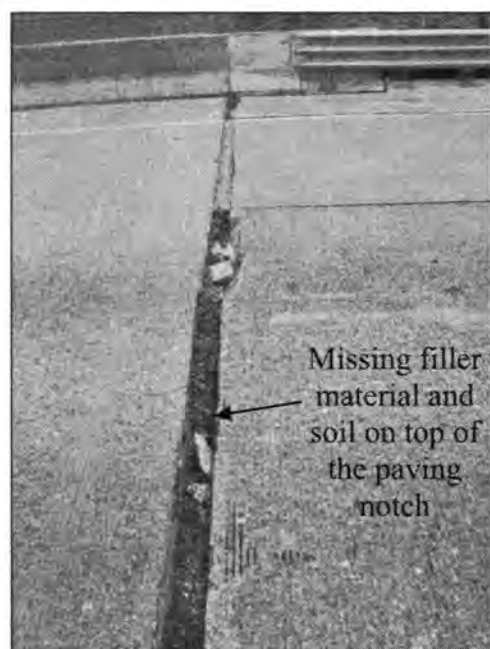
Figure 3.95 - Missing Filler Material Exposing the Pavement Notch (Bridge No. 9265.6L - East End of WBL)

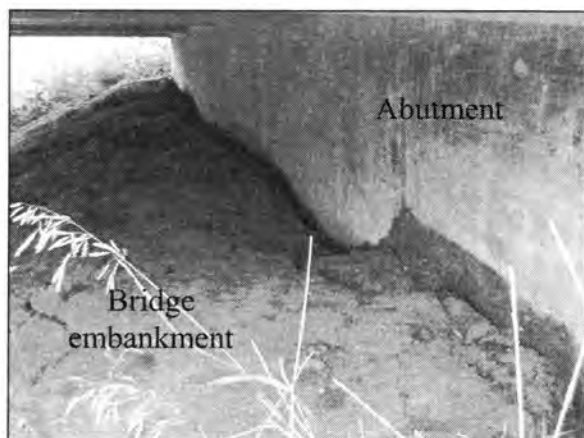
(a) Erosion at the Bridge Embankment

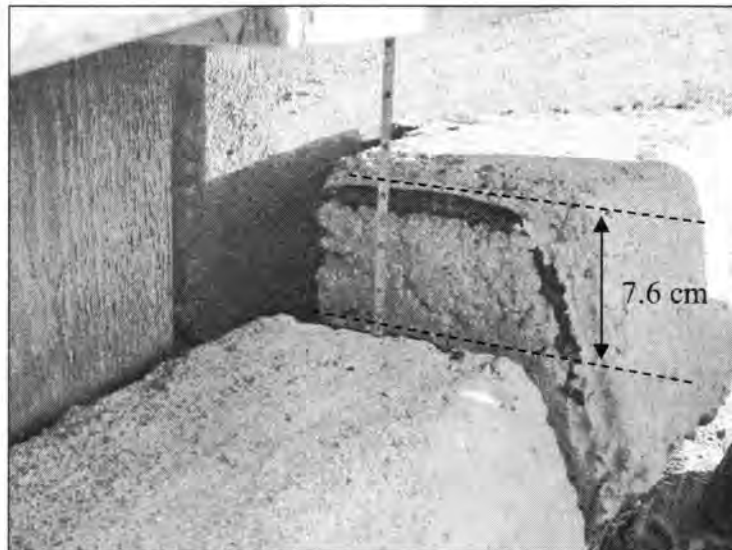
Figure 3.97 - Differential Settlement at the Bridge Approach (Bridge No. 574.2S001 - SBL)

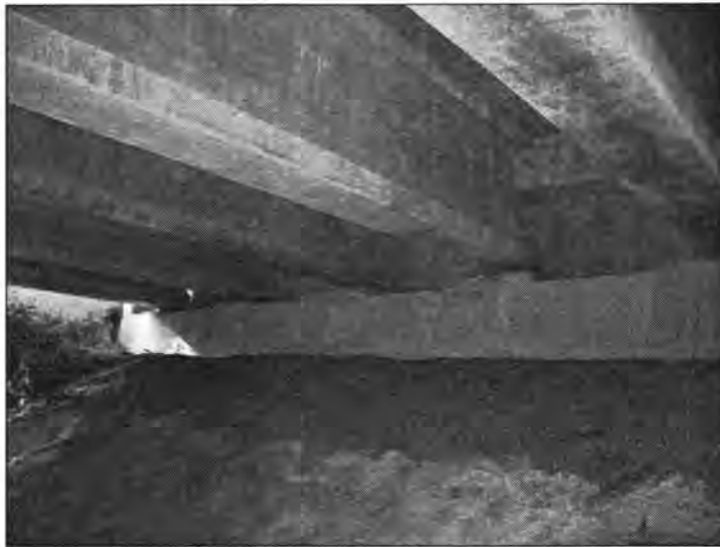
Figure 3.98 - Wet Loess Soil Observed at the Bridge Embankment (Bridge No. 574.2S001)

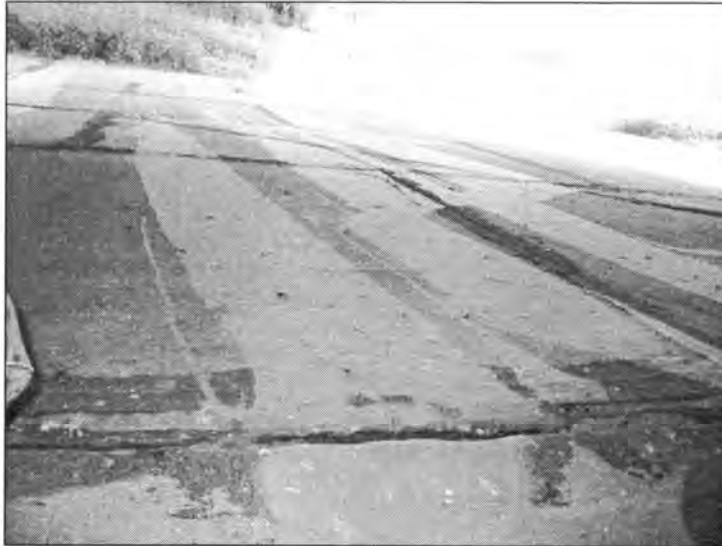
Figure 3.99 - Grout Seeping from under the Concrete Cover (Bridge No. 574.2S001)

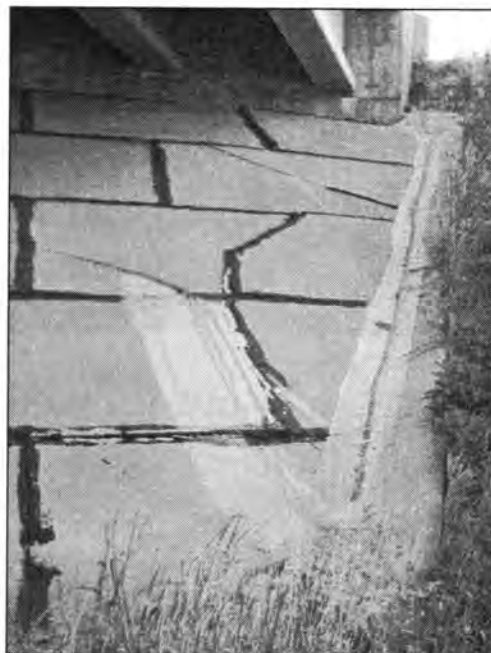
Figure 3.106 - Cracking of the Slope Protection (Bridge No. 574.2S001)

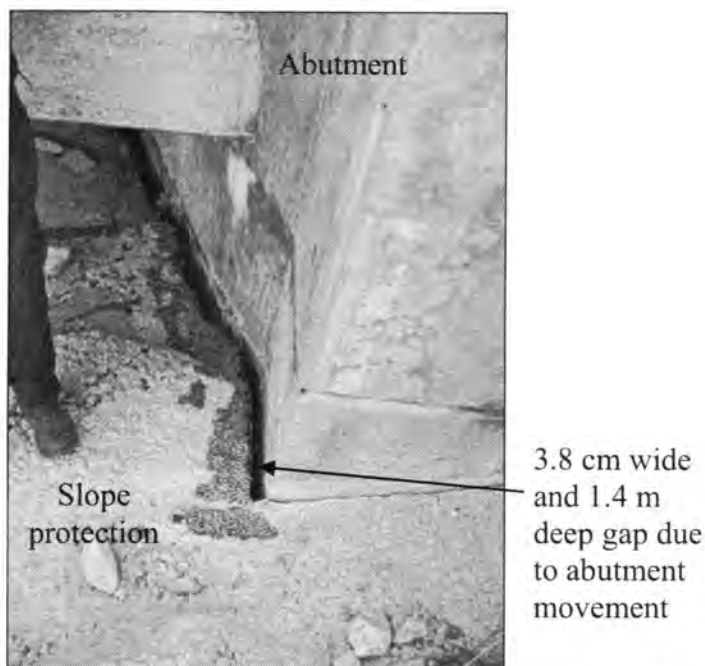
Figure 3.107 - Lateral Movement of the Abutment Away from the Bridge Embankment (Bridge No. 574.2S001)

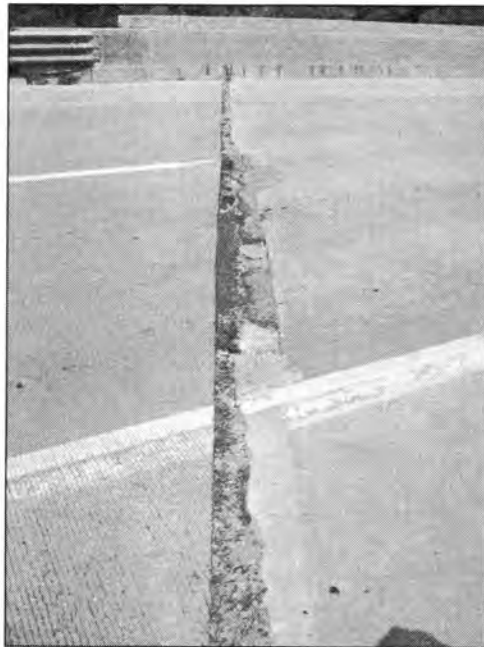
Figure 3.108 - Concrete Spalling and Cracking at the Expansion Joint (Bridge No. 5200.5R380)

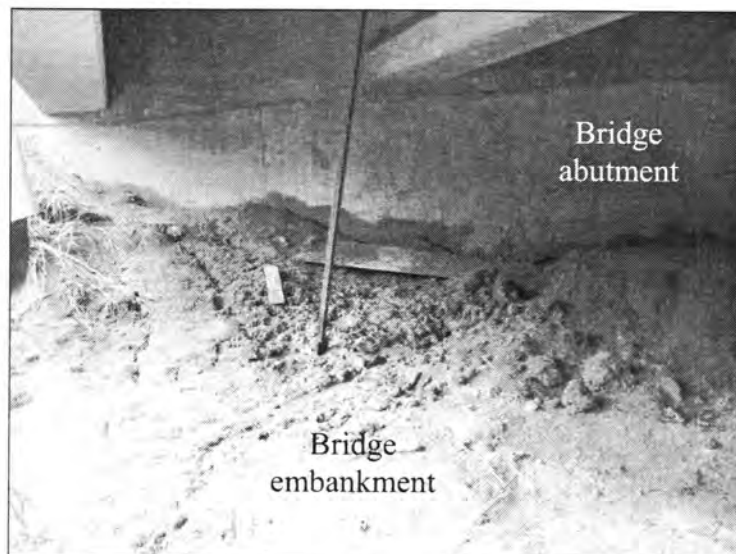
Figure 3.109 - Soil Erosion of the Bridge Embankment (Bridge No. 5200.5R380)

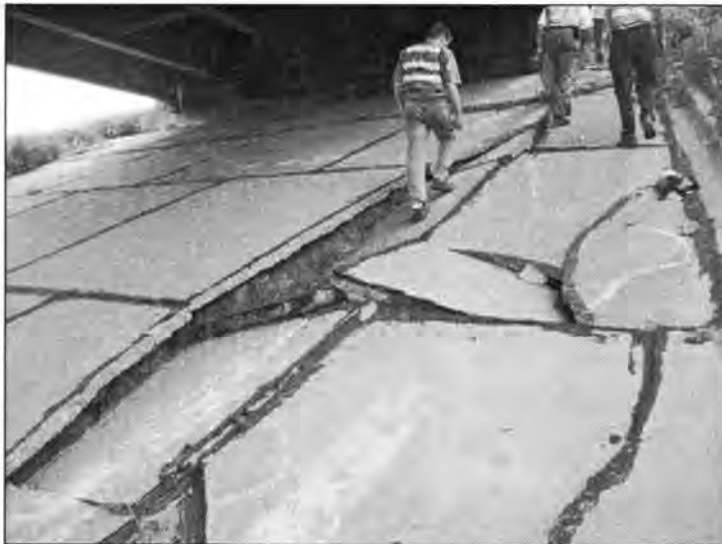
Figure 3.112 - Severe Damage of Concrete Slope Protection Due to Erosion (Bridge No. 5200.8R380)

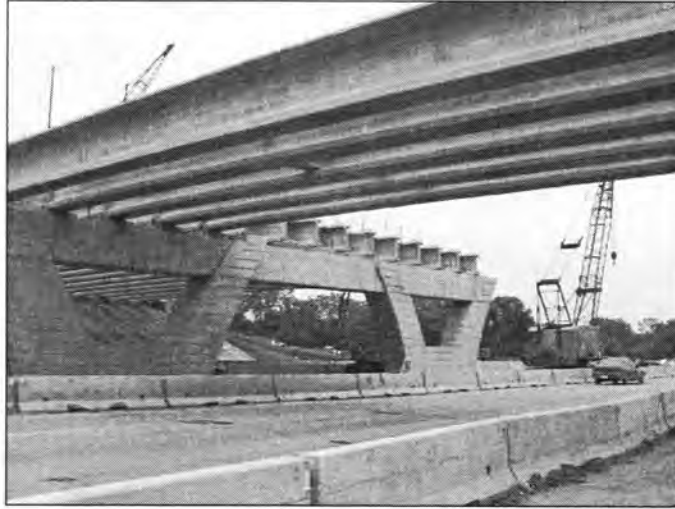
Figure 3.118 - Girders under Construction (35th Street over I-235 - NBL)

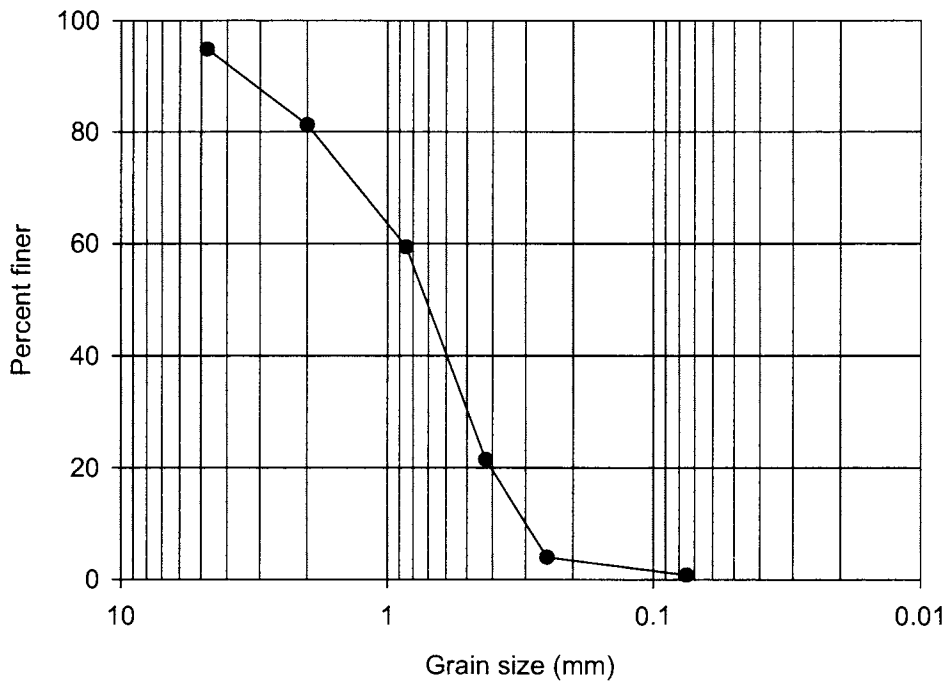
Figure 3.124 - Gradation of Granular Backfill Material used at the North End; Classified as SP (35th Street over I-235)

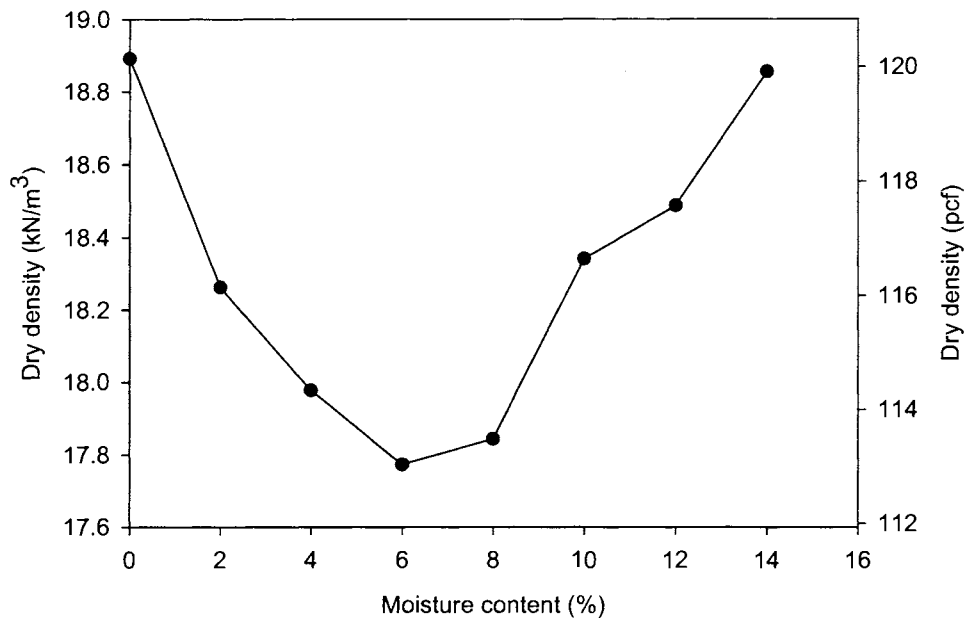
Figure 3.126 - Dry Density–Moisture Content Relationship of Granular Backfill used at the North End (35th Street over I-235)

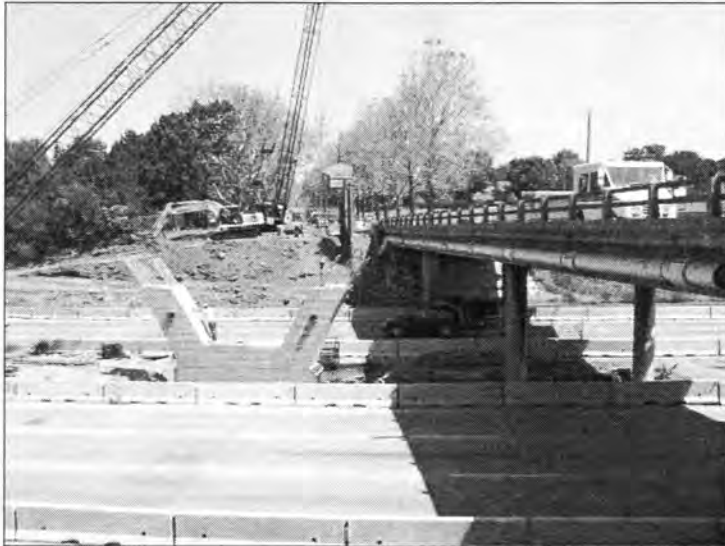
Figure 3.127 - Construction of the New North Bound Lane Bridge (Polk Blvd. Bridge)

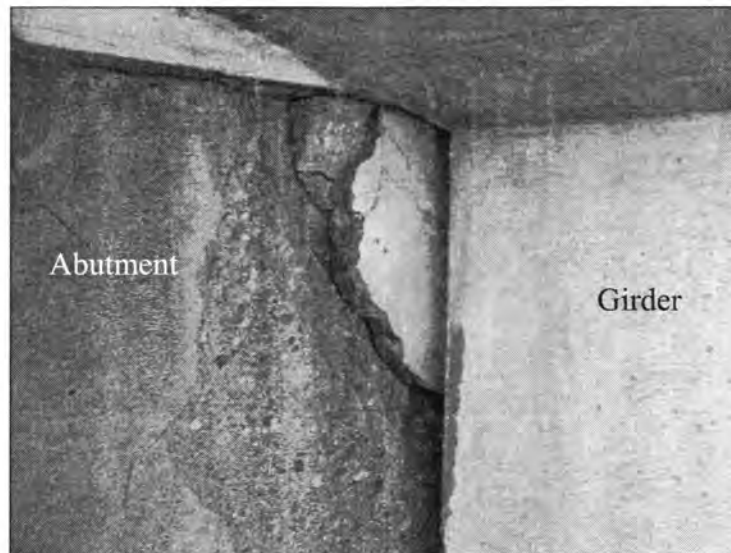
Figure 3.129 - Concrete Spalling at the Abutment (Polk Blvd. Bridge - SBL)

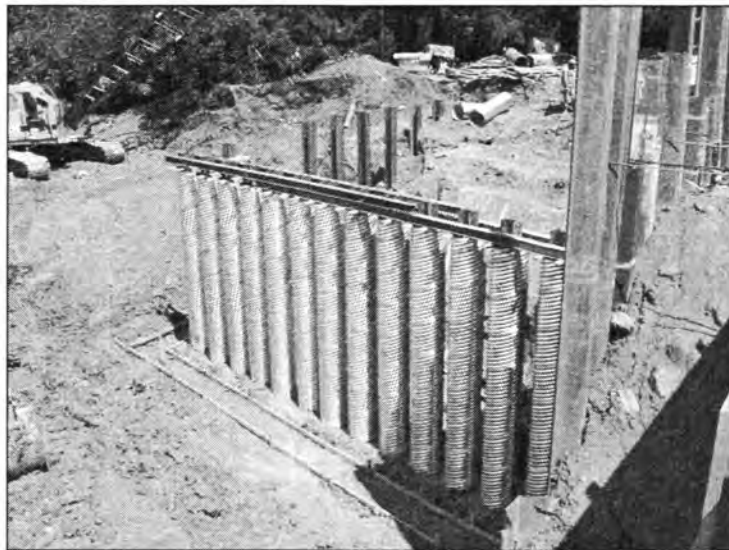
Figure 3.130 - Installation of H-Piles (Polk Blvd. Bridge - North End of NBL)

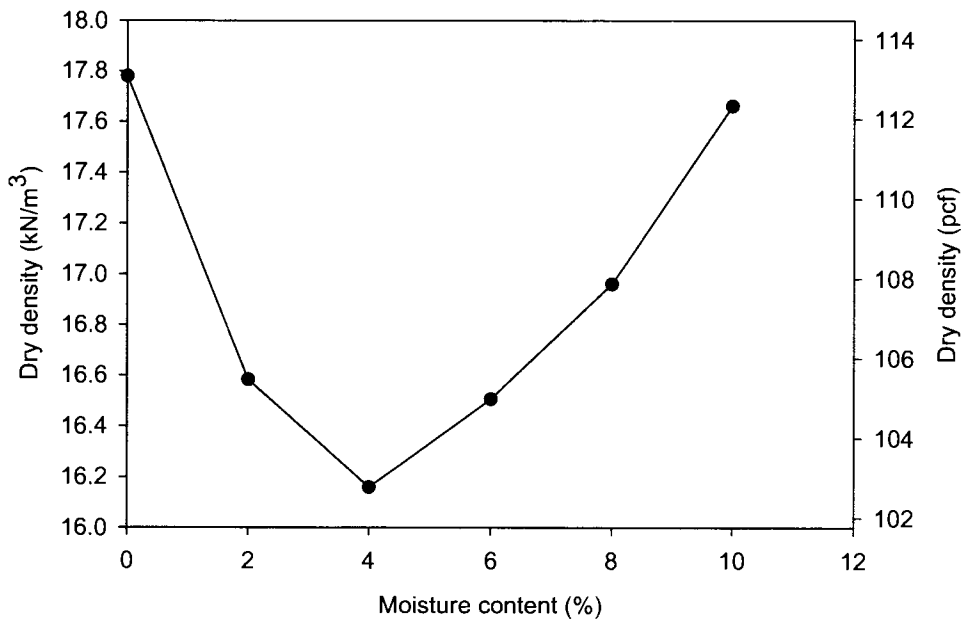
Figure 3.140. Dry Density - Moisture Relationship for Backfill Material (Polk Blvd. Bridge)

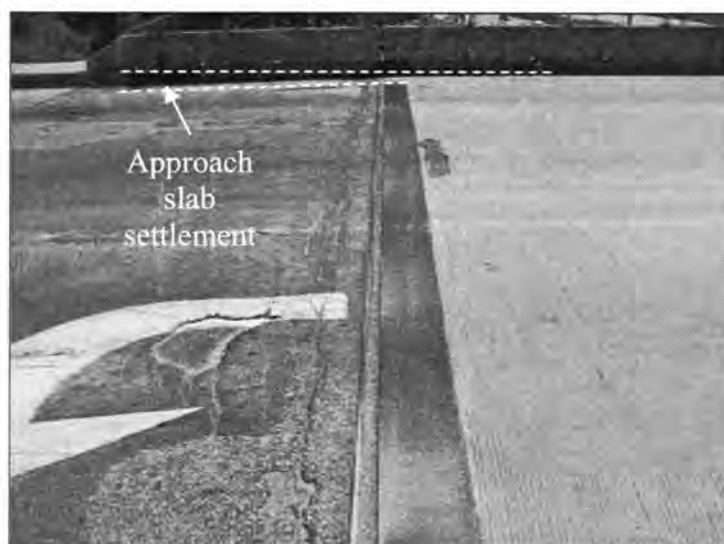
Figure 3.141 - Cracks at Asphalt Approach Slab with Visible Differential Settlement (19th Street Bridge)

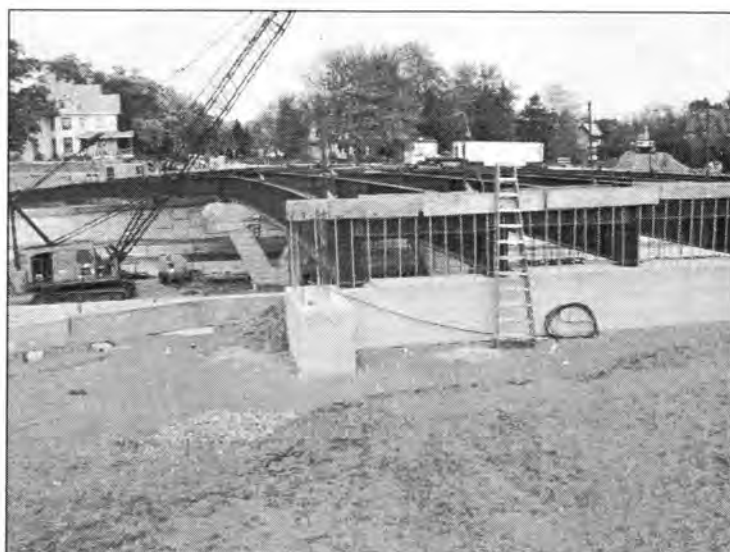
Figure 3.142 - Construction of Steel Girders and Backwall (19th Street Bridge)

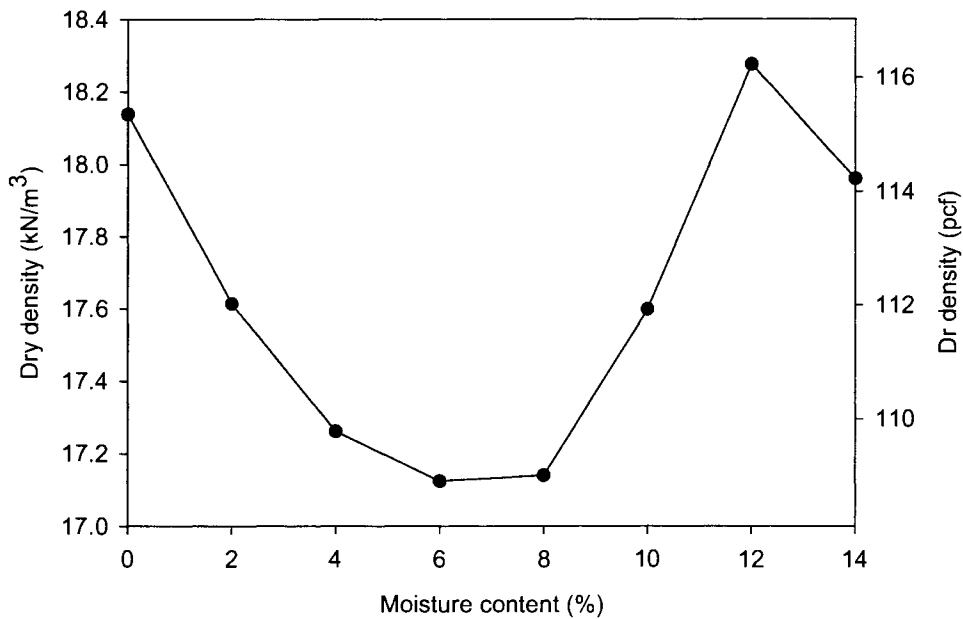
Figure 3.144 - Dry Density – Moisture Relationship for Granular Backfill (19th Street Bridge)

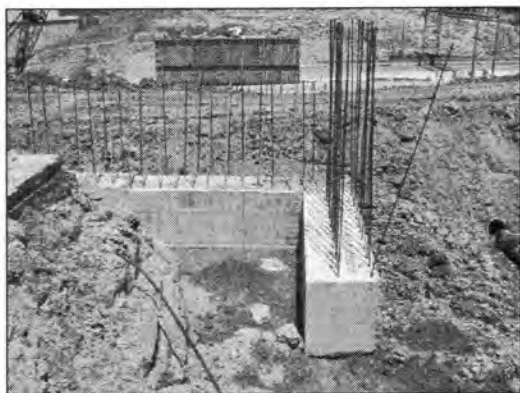
(a) Backwall construction

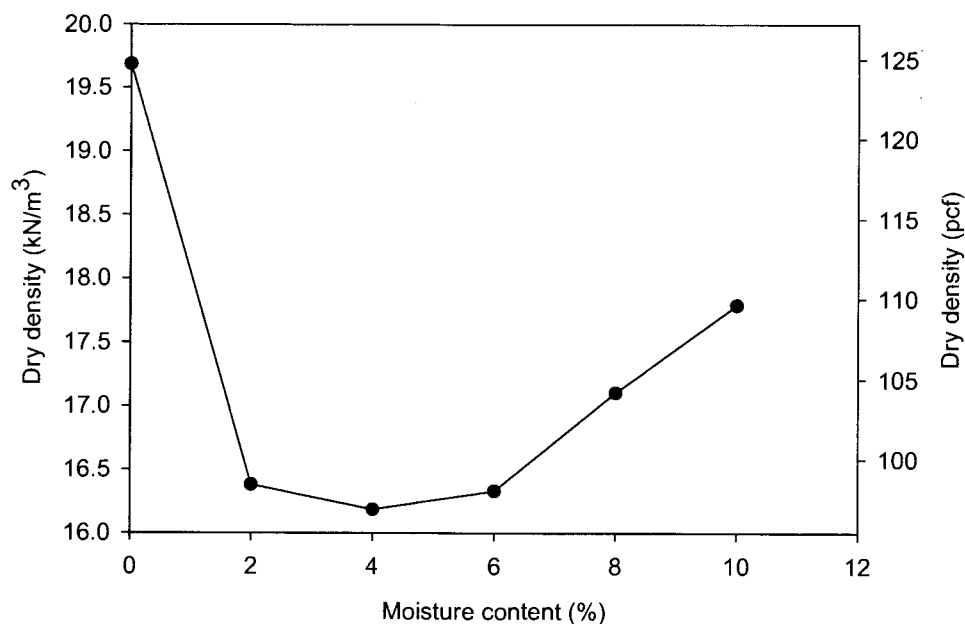
Figure 3.152 - Dry Density–Moisture Content Relationship for Granular Backfill (East 12th Street Bridge)

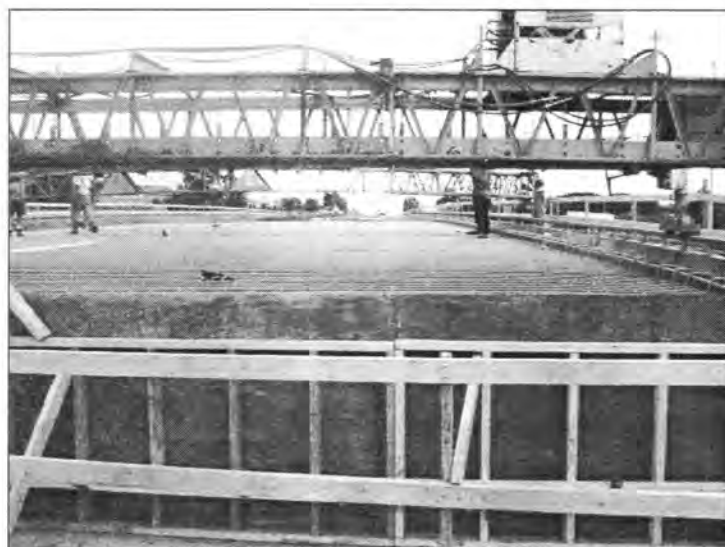
Figure 3.153 - Construction of Bridge Deck (Euclid Avenue Bridge)

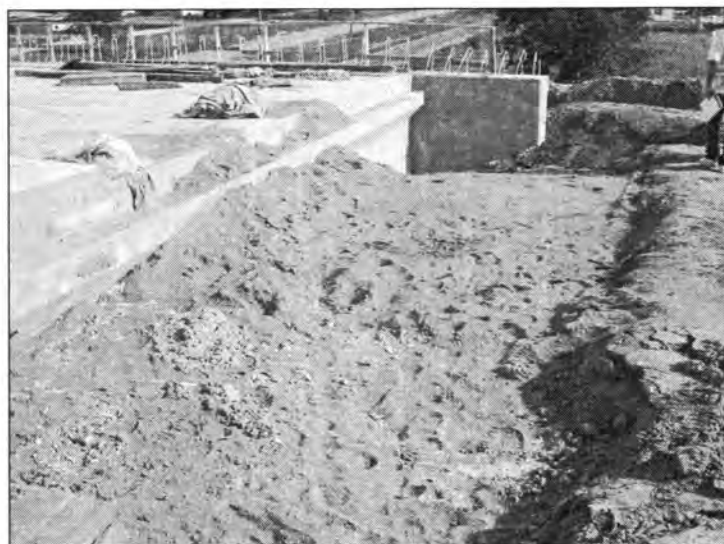
Figure 3.163 - Poorly Placed Granular Backfill (Bridge over Union Pacific Railroad)

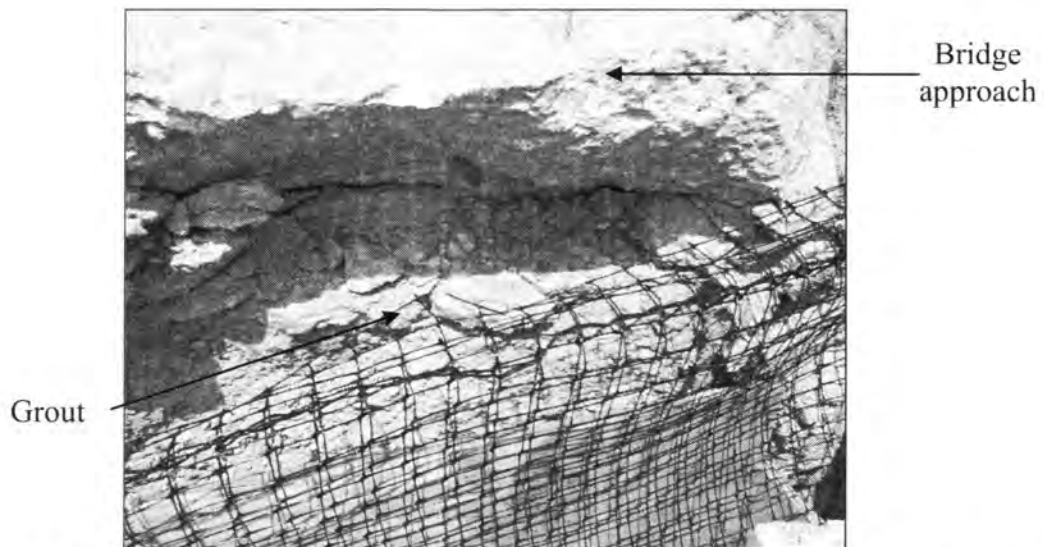
Figure 3.169 - Grout Pumped under Existing Approach Slab (Bridge at U.S. 218 Crossing Rail Road - South End of SBL)

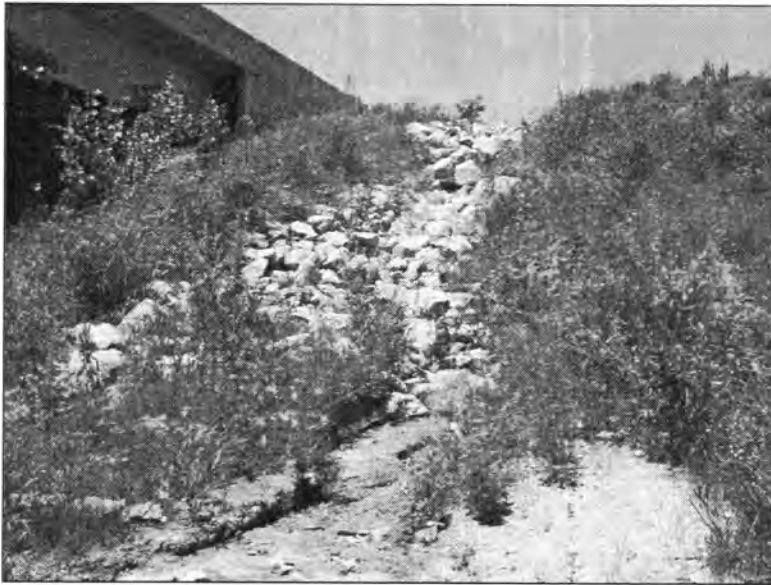
Figure 3. 172 - Rocks Placed at the Abutment Side to Prevent Erosion (Bridge No. 76.8065 - North End of NBL)

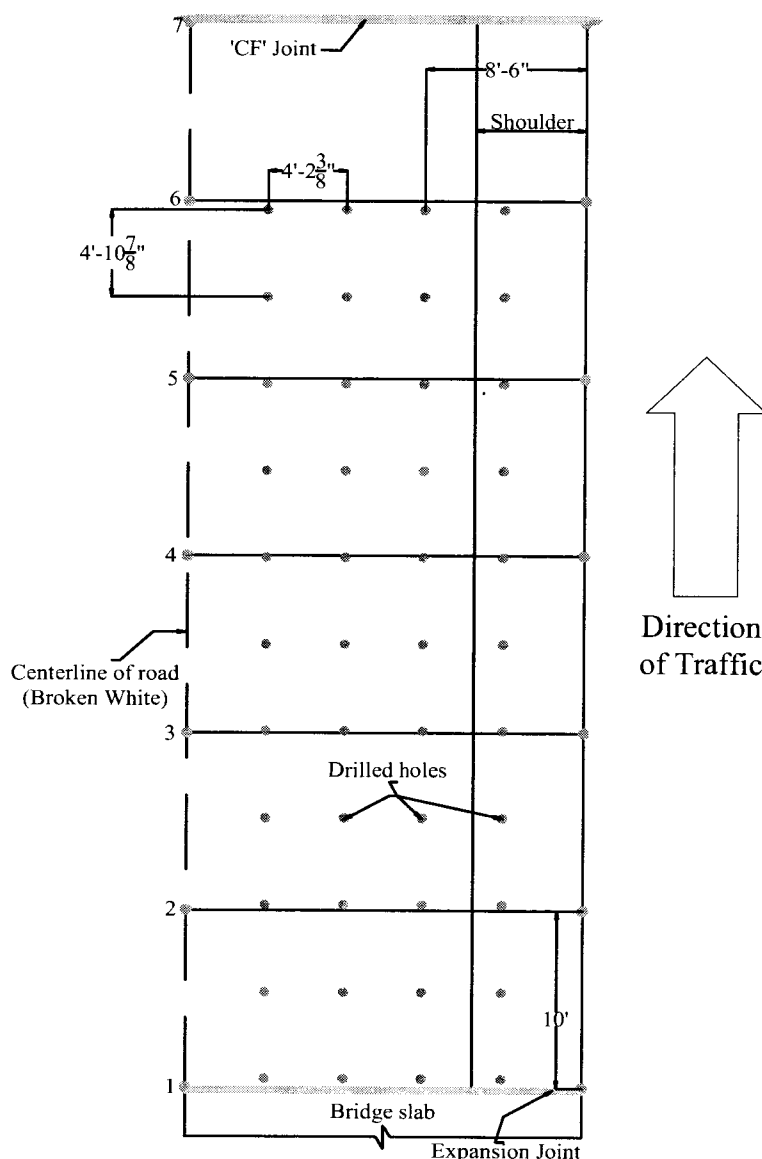
Figure 3.177 - Location of Holes Drilled on the Bridge Approach Slab (Bridge No. 76.8065)

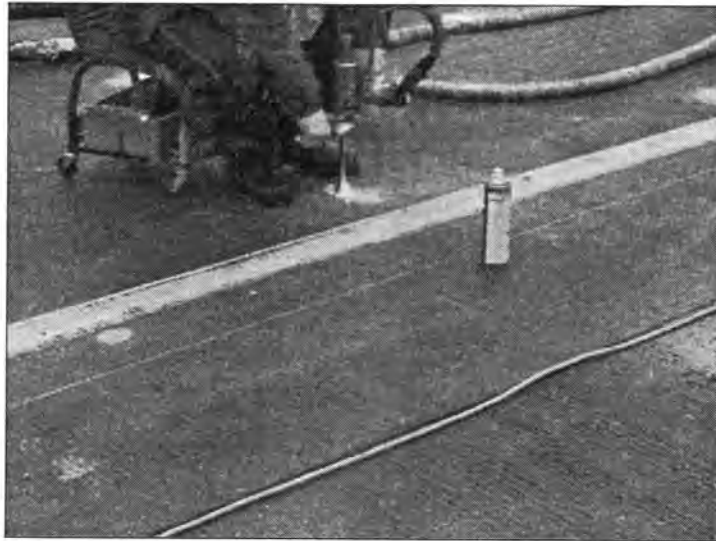
Figure 3.182 - Steady Injection until Material Leaks Out of Hole (Bridge no. 76.8065)

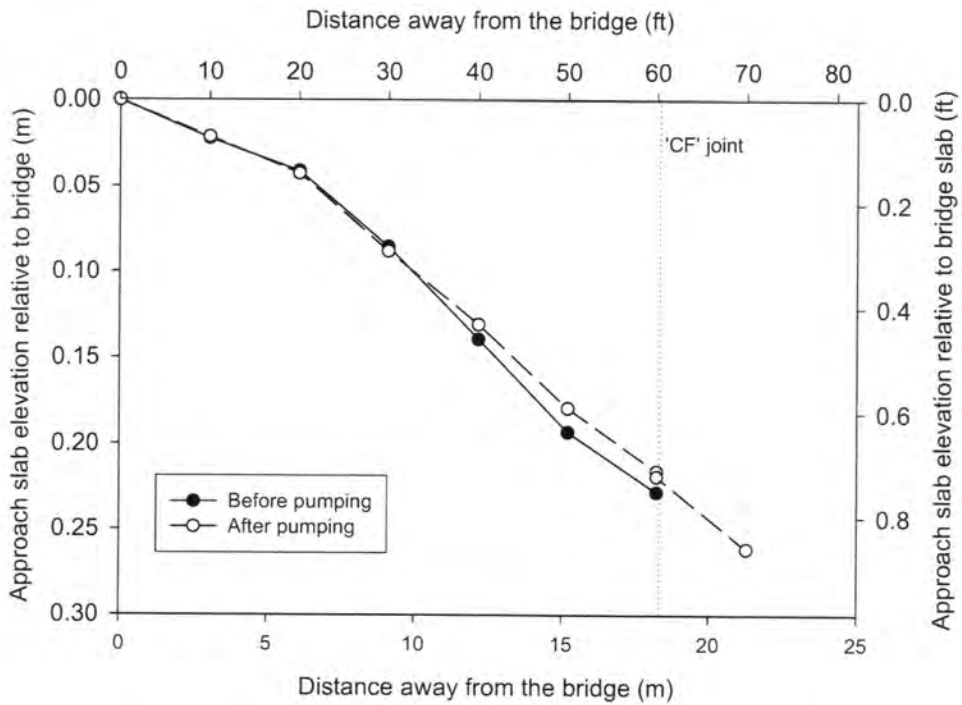
Figure 3.183 - Elevation of Approach Slab Relative to the Bridge before and after Injecting the Polyurethane (Bridge No. 76.8065)

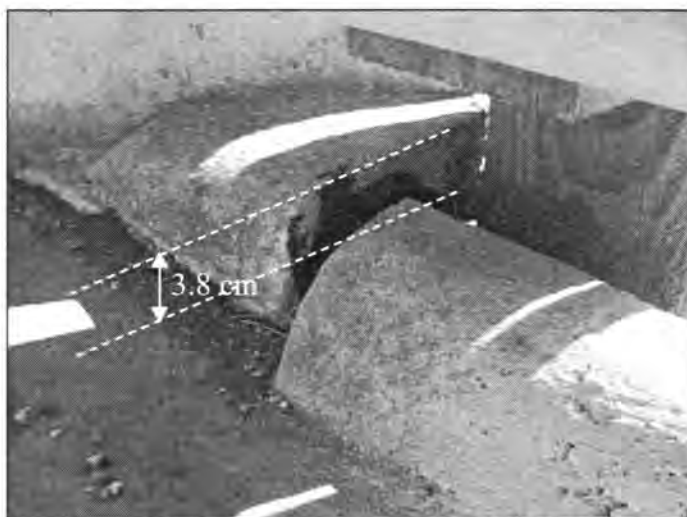
Figure 3.184 - Differential Settlement between the Bridge Approach and the Approach Slab (Bridge No. 1783.6018 - West End of EBL)

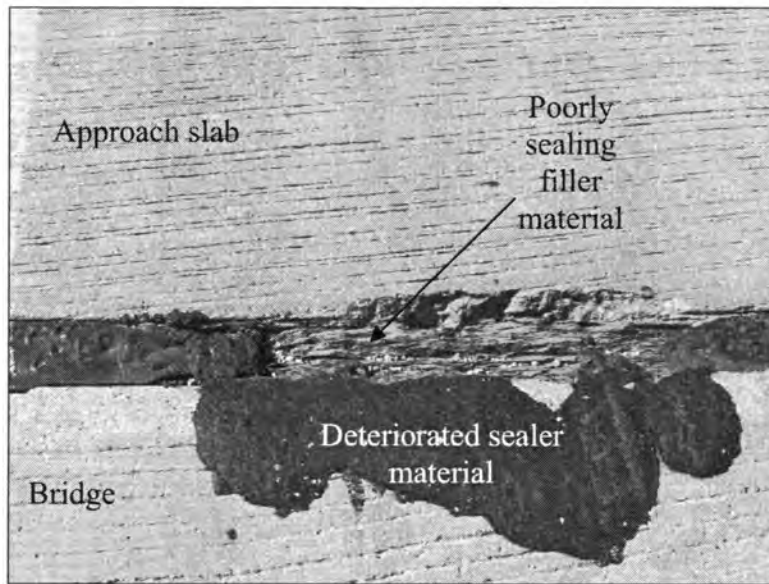
Figure 3.185 - Deterioration of the Expansion Joint Sealer Exposing the Poorly Sealing Filler Material (Bridge No. 1783.6018 - West End of EBL)

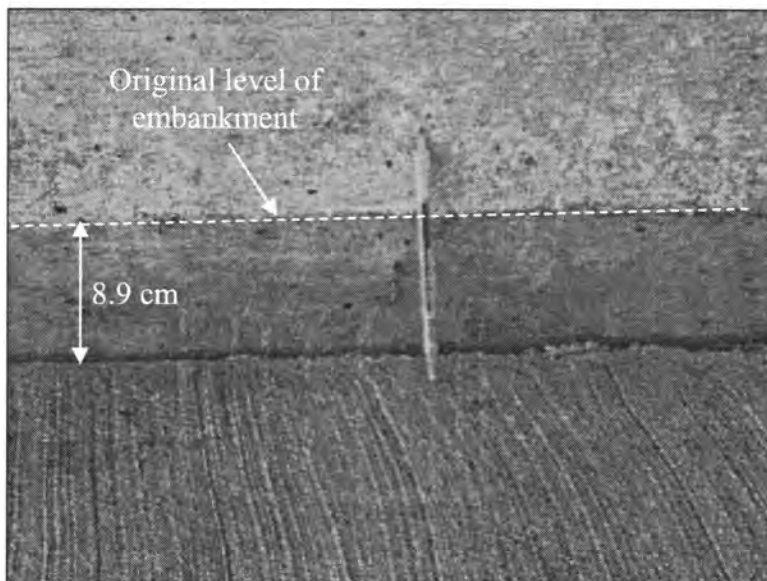
Figure 3.186 - Settlement of the Bridge Embankment (Bridge No. 1783.6018 - West End of EBL)
