**Management of water and backfill characteristics for improved bridge
approach performance**

Mohamed Magdi Mekkawy

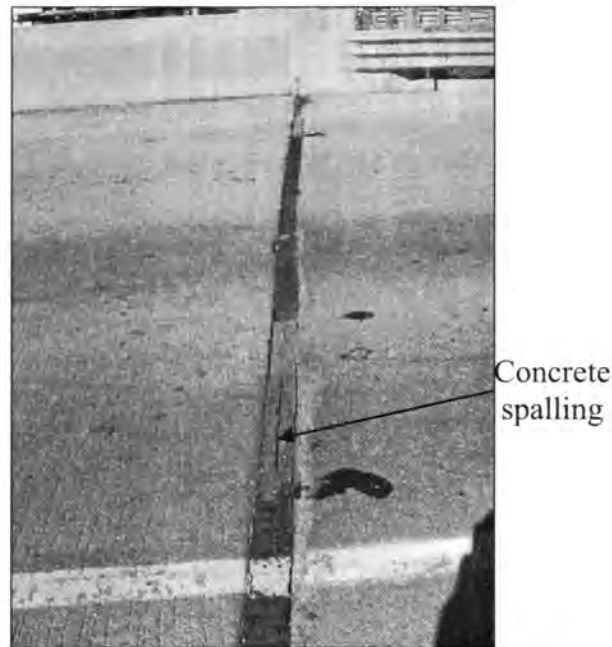
Figure 3.189 - Poorly Sealed Expansion Joint with Concrete Spalling (Bridge No. 1783.6018 - East End of EBL)

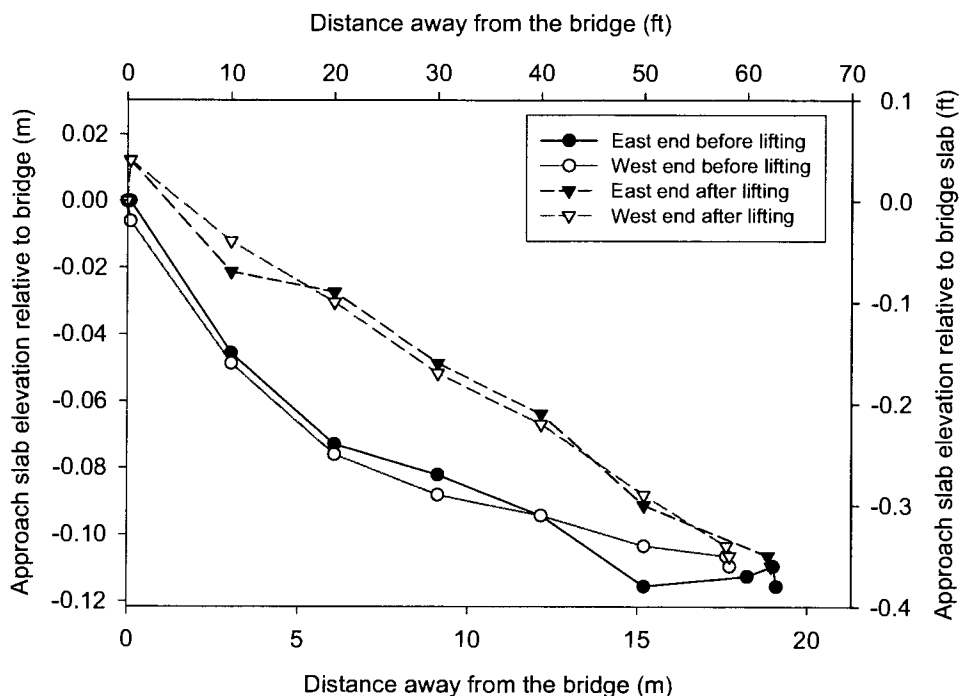
Figure 3.190 - Approach Slabs Elevations before and after Injecting the Expansive Polyurethane (Bridge No. 1783.6018 - EBL)

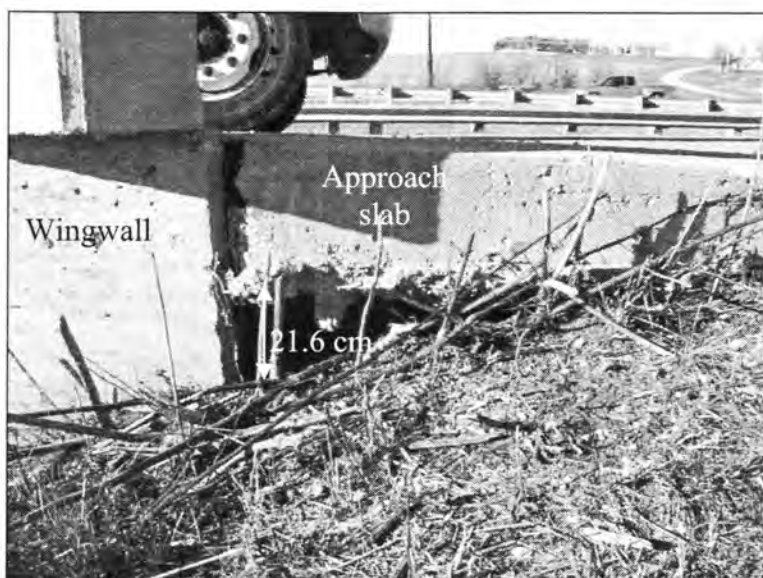
Figure 3.191 - Void under the Approach Slab (Bridge No. 7773.0R065 - North End of SBL)

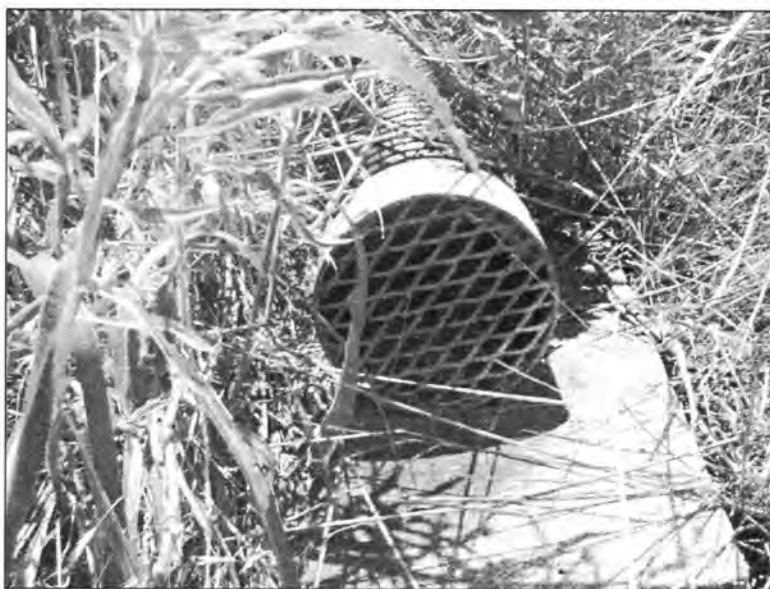
Figure 3.194 - End Drain in a Satisfactory Condition (Bridge No. 7773.0R065 - South End of SBL)

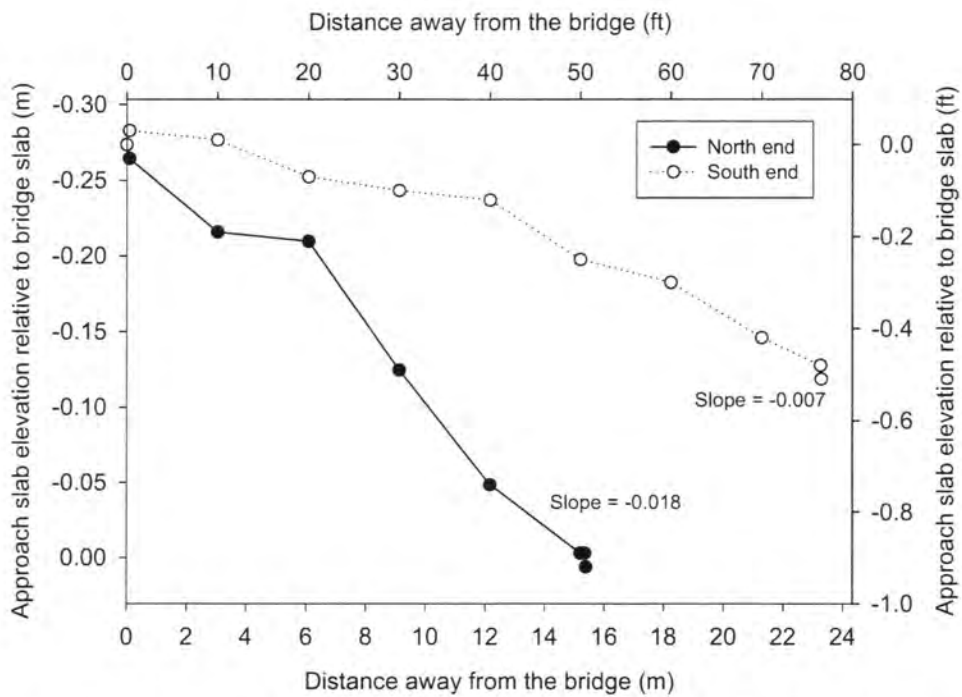
Figure 3.195 - Profiles of the Approach Slab Relative to Bridge Deck (Bridge No. 7773.0R065 - SBL)

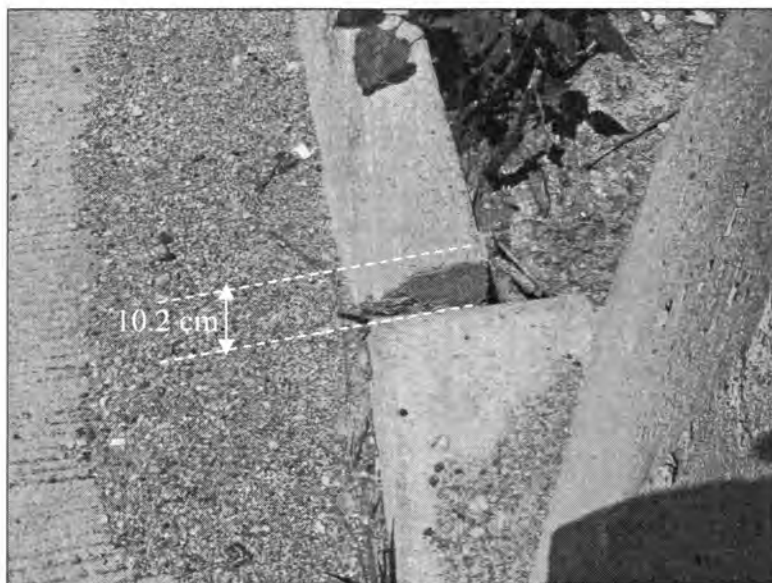
Figure 3.202 - Differential Settlement at the Bridge Approach (Bridge No. 7777.0R065 - North End of NBL)

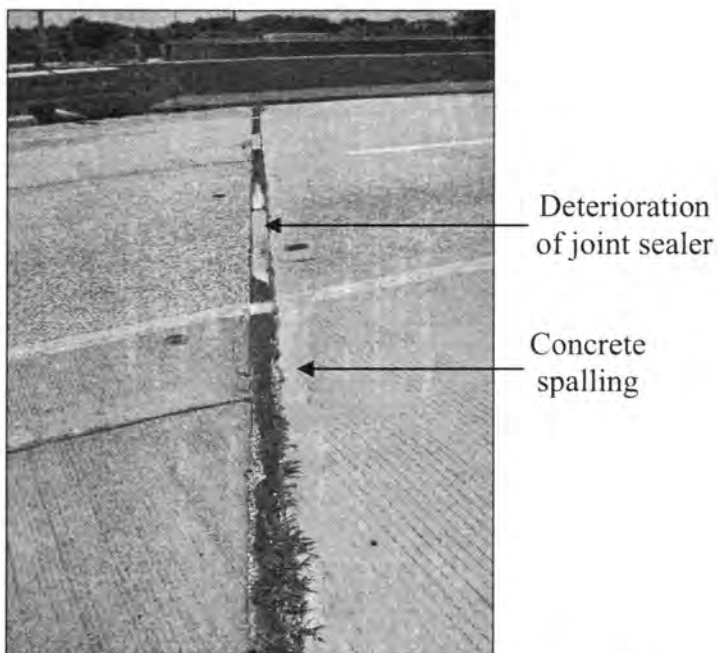
Figure 3.206 - Deteriorated Joint Sealer (Bridge No. 7777.0R065 - South End of NBL)

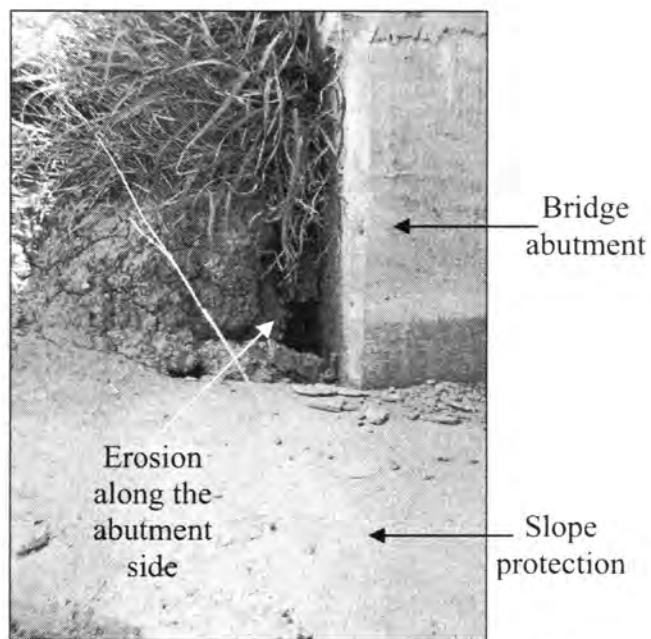
Figure 3.207 - Erosion Along the Abutment Sides (Bridge No. 7777.0R065 - South End of NBL)

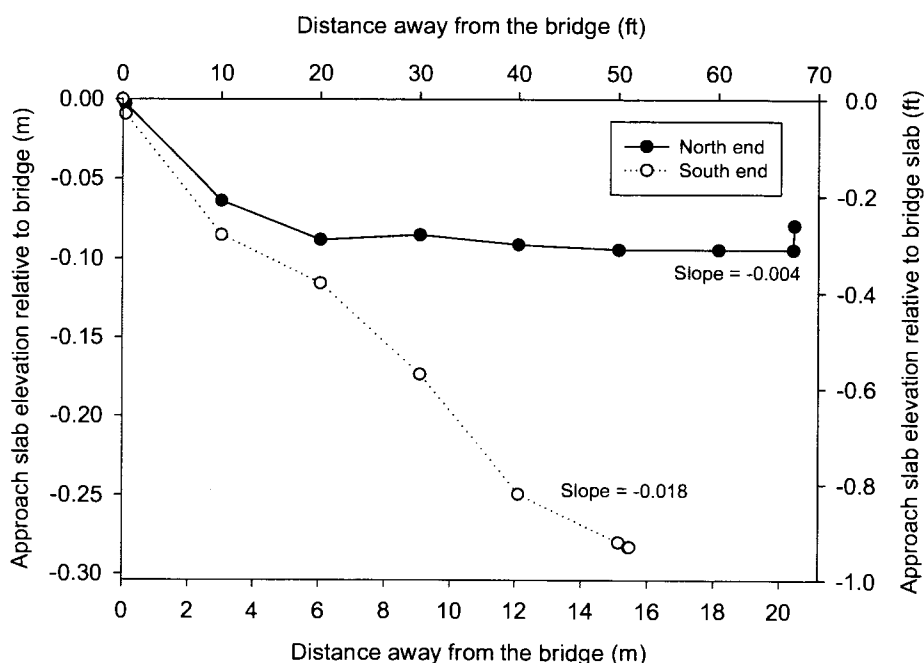
Figure 3.210 - Profile of the Bridge Approach Relative to the Bridge Deck (Bridge No. 7777.0R065 - NBL)

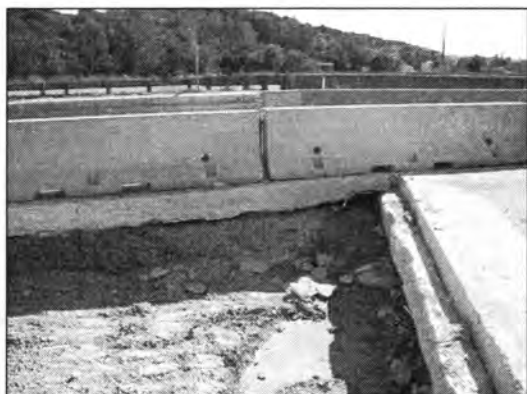
(a) North End Approach Slab

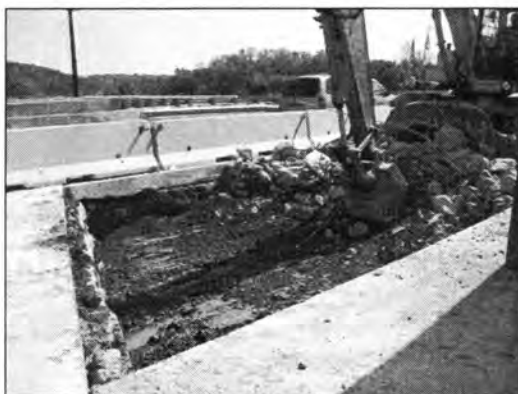
(b) South End Approach Slab

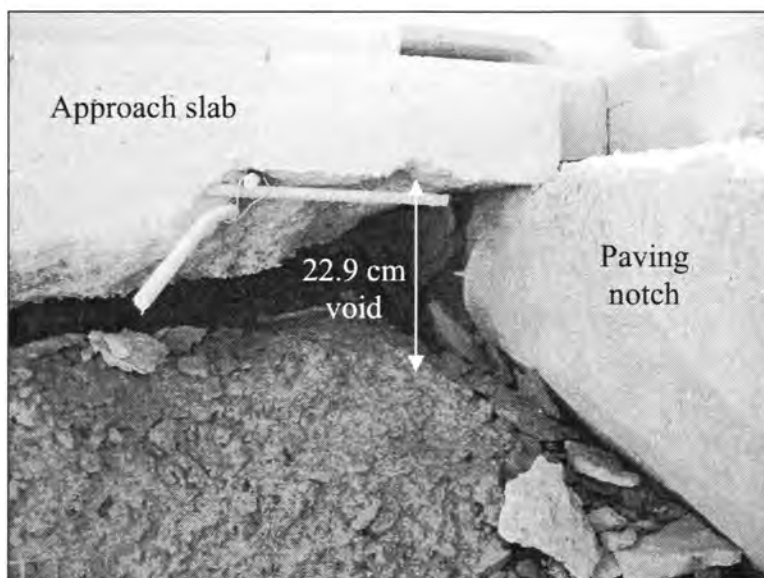
Figure 3.212 - A Void Developed under the Left Lane Approach Slab (Bridge No. 7777.0R065 - North End of SBL)

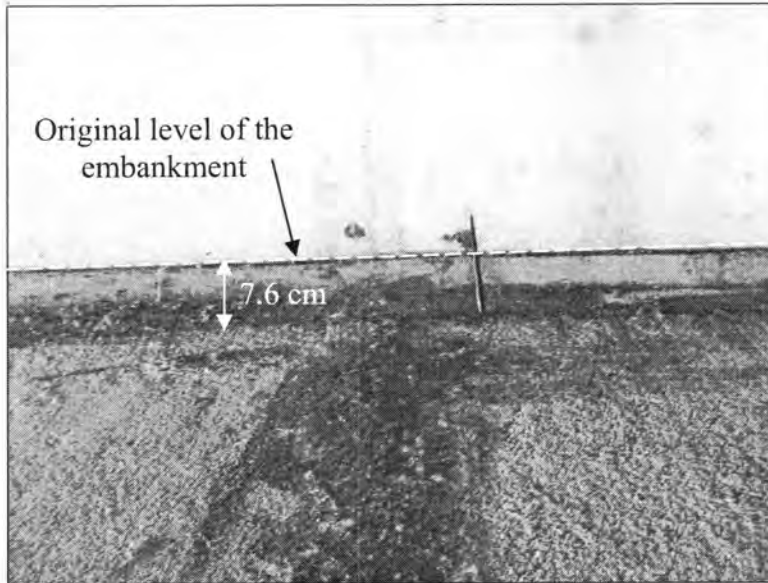
Figure 3.220 - Settlement of the Bridge Embankment (Bridge No. 7778.1065 - North End of NBL)

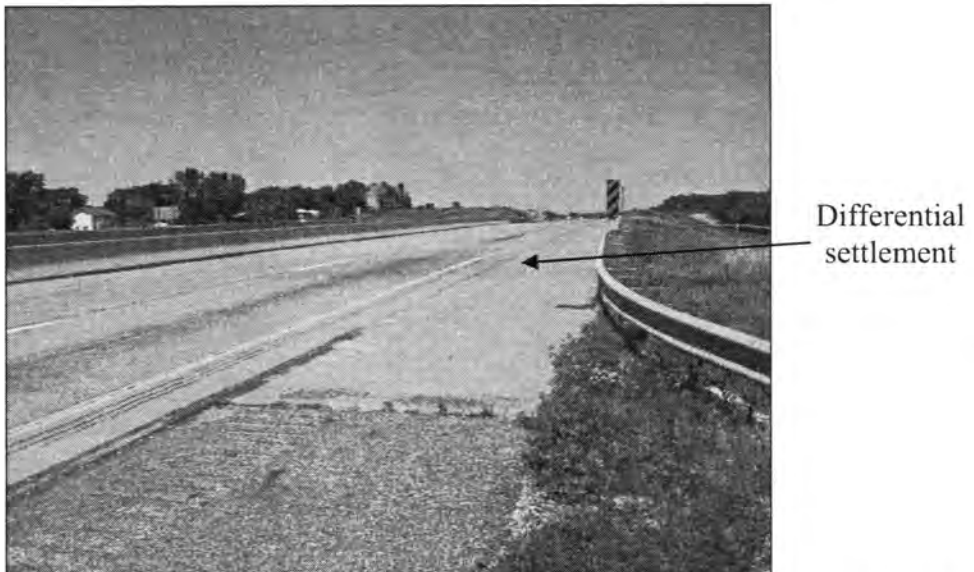
Figure 3. 221 - Differential Settlement of the Approach Slab (Bridge No. 7778.1065 - North End of SBL)

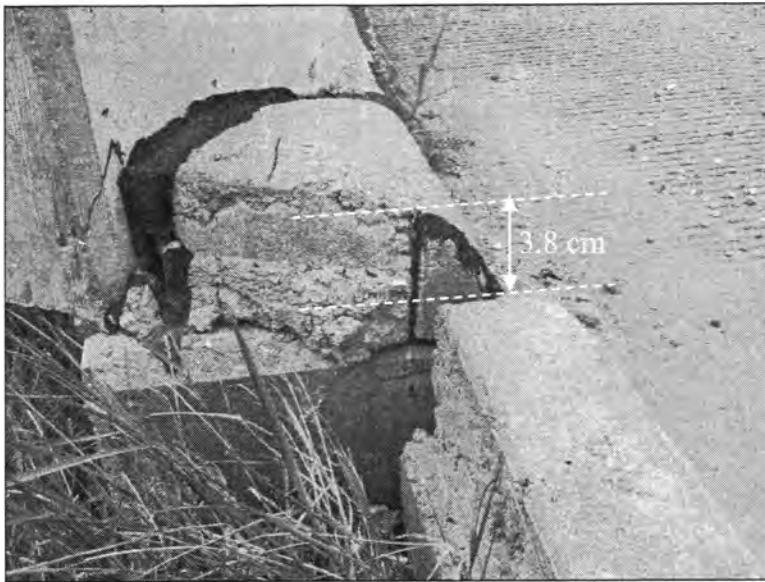
Figure 3.227 - Differential Settlement between the Bridge Deck and the Bridge Approach (Bridge No. 7779.0065 - North End of NBL)

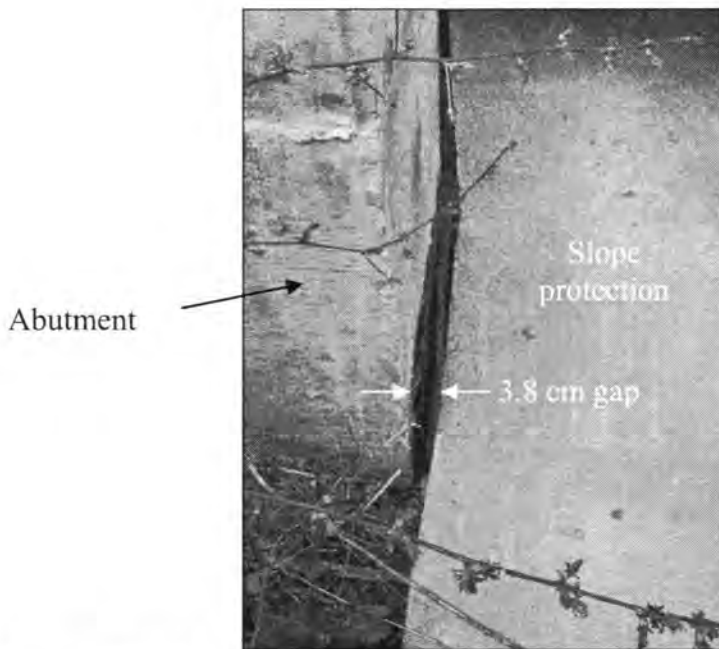
Figure 3.229 - Lateral Movement of the Abutment Away from the Bridge Embankment forming a Gap (Bridge No. 7779.0065 - South End of NBL)

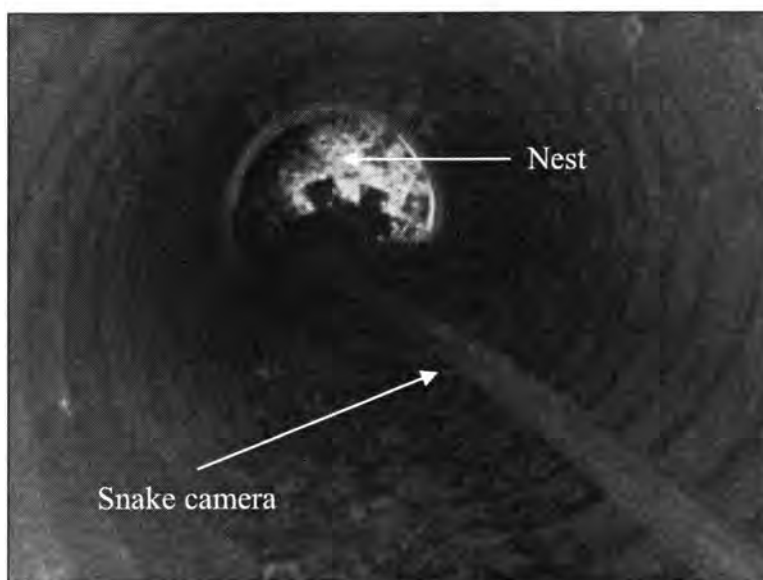
Figure 3.230 - Rodent Nest blocking the Subdrain at 1.5 m from the Outlet (Bridge No. 7779.0065)

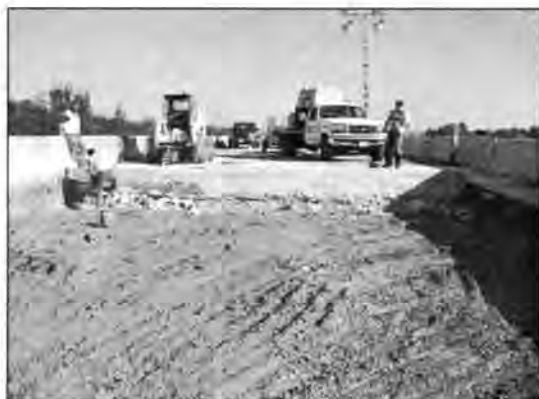
(a) Replaced Approach Slab

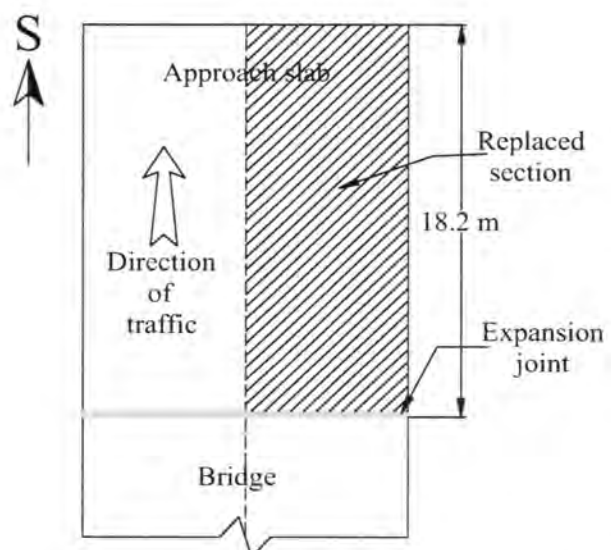
(b) Schematic of the Replaced Section

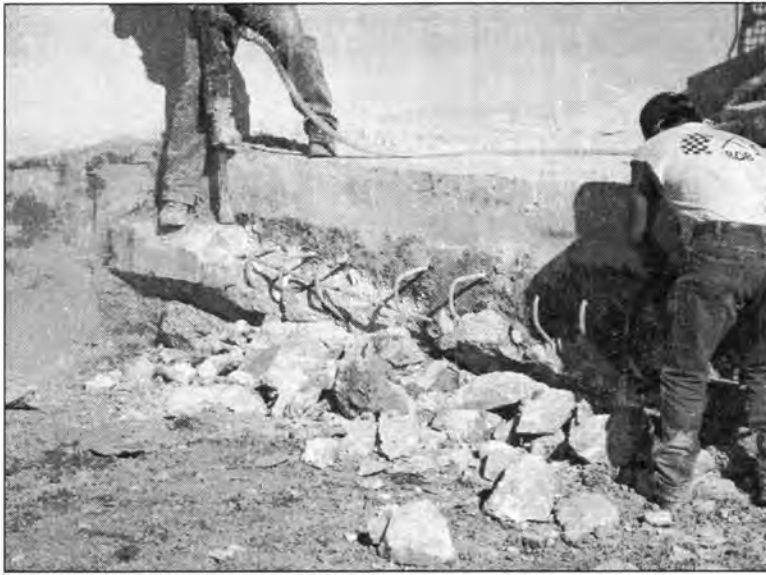
Figure 3.233 - Tearing Down the Old Pavement Notch (Bridge No. 7779.0065 - South End of SBL)

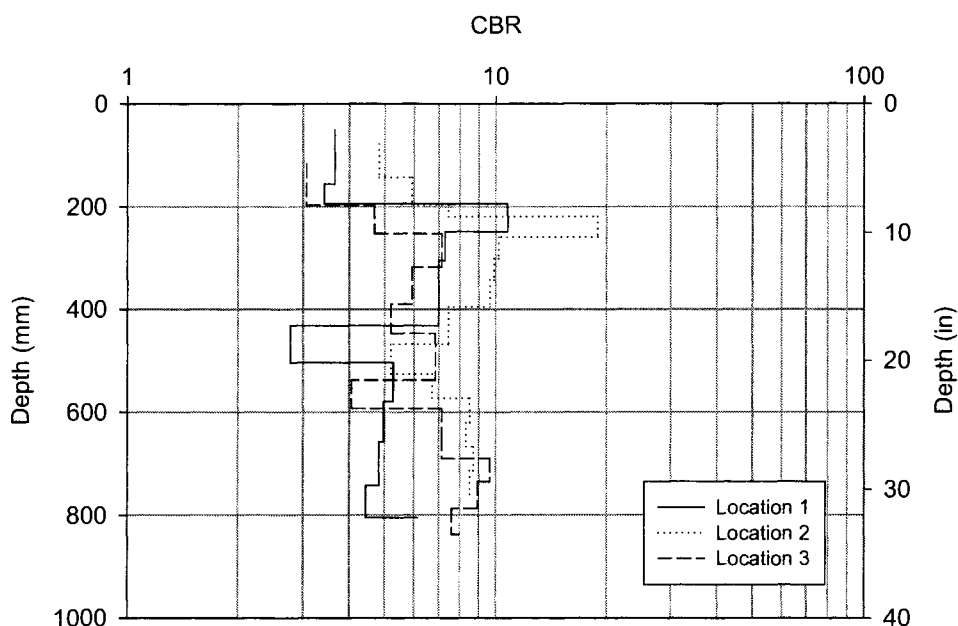
Figure 3.237 - Results of DCP Test Conducted on Special Backfill Material after Replacement (Bridge No. 7779.0065 - South End of SBL)

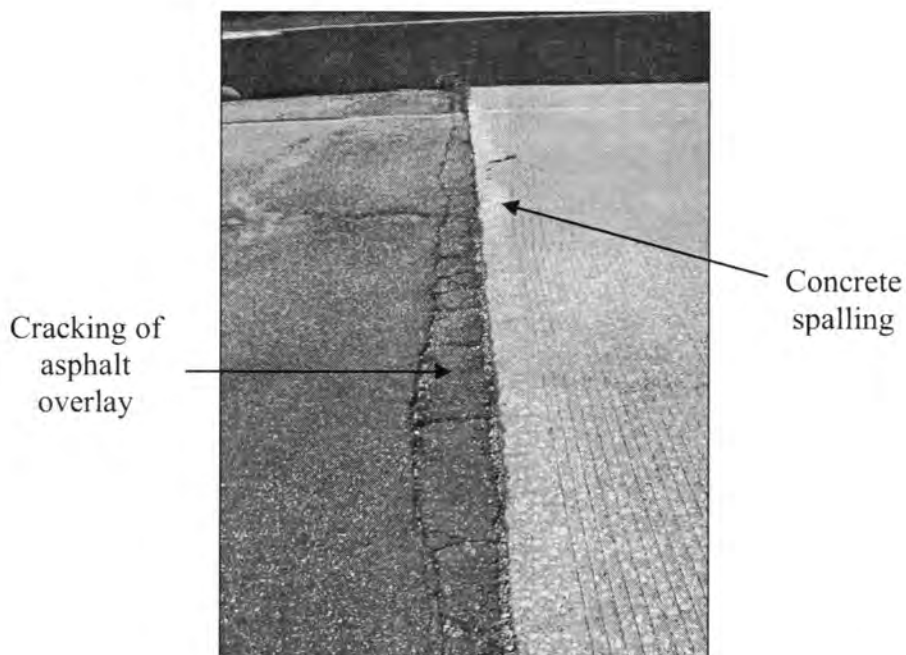
Figure 3.239 - Concrete Spalling and Cracking of Asphalt Overlay at the Expansion Joint (Bridge No. 7779.4065 - South End of NBL)

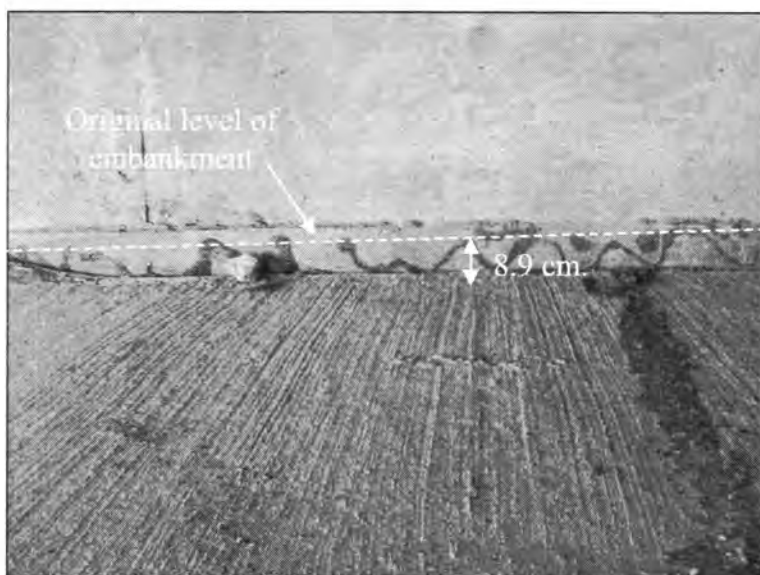
Figure 3.240 - Settlement of the Bridge Embankment (Bridge No. 7779.4065 - South End of NBL)

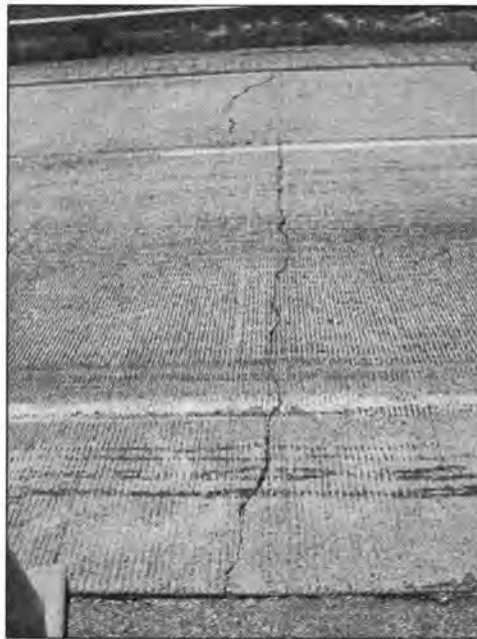
Figure 3.247 - Transverse Cracks at the Bridge Approach (Bridge No. 80.8R065)

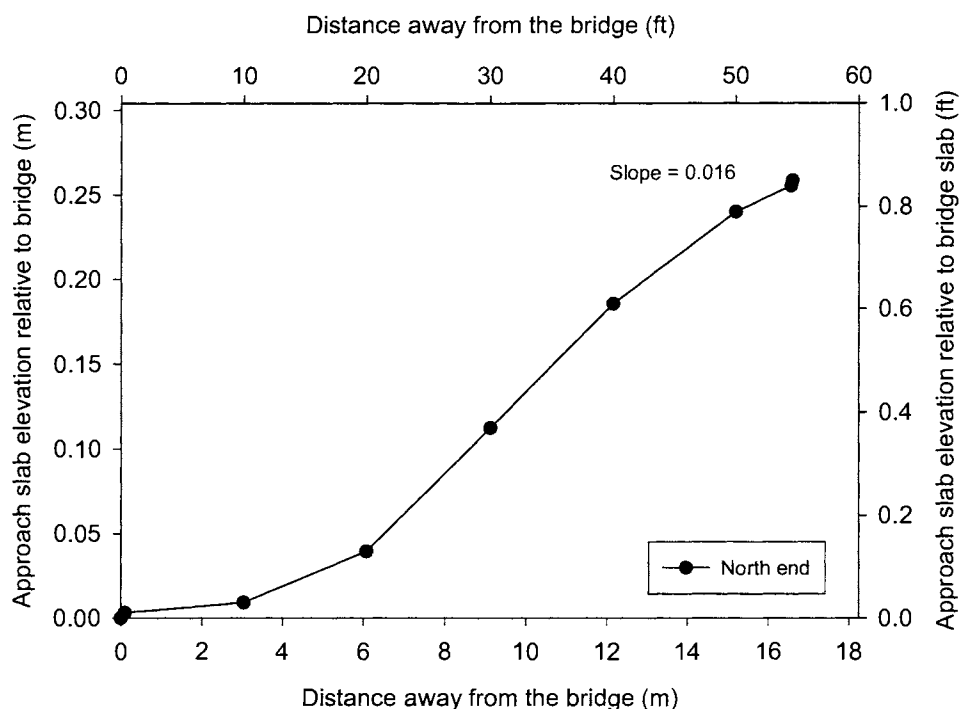
Figure 3.248 - Profile of the Bridge Approach Relative to the Bridge Deck (Bridge No. 80.8R065 - North End of NBL)

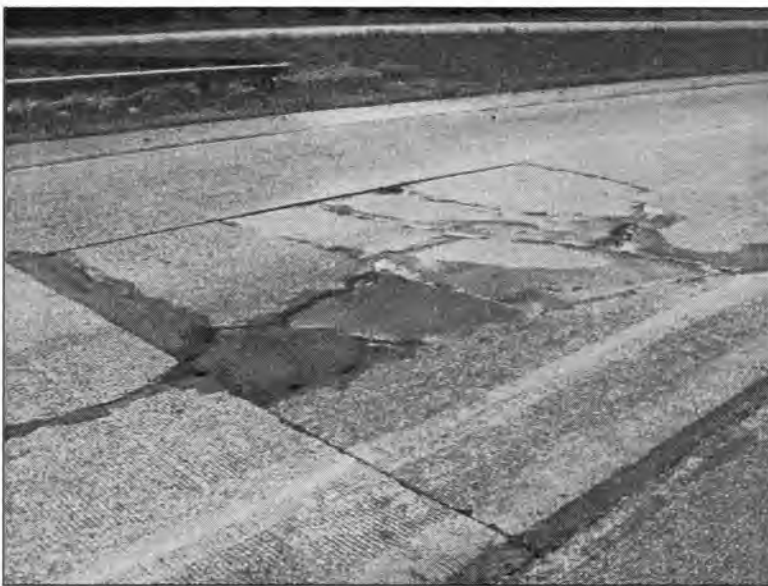
Figure 3.249 - Severe Cracking at the Bridge Approach Pavement (Bridge No. 7781.2065 - North End of NBL)

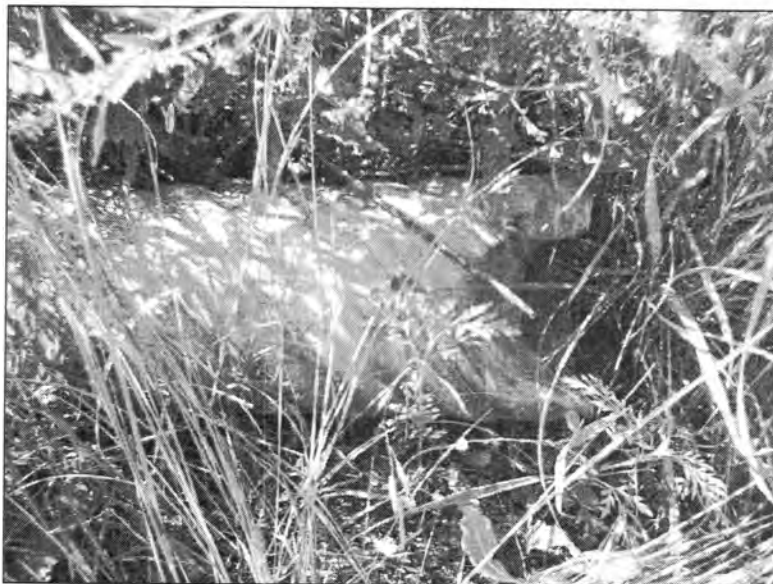
Figure 3.250 - Damaged End Drain Outlet (Bridge No. 7781.2065 - North End of NBL)

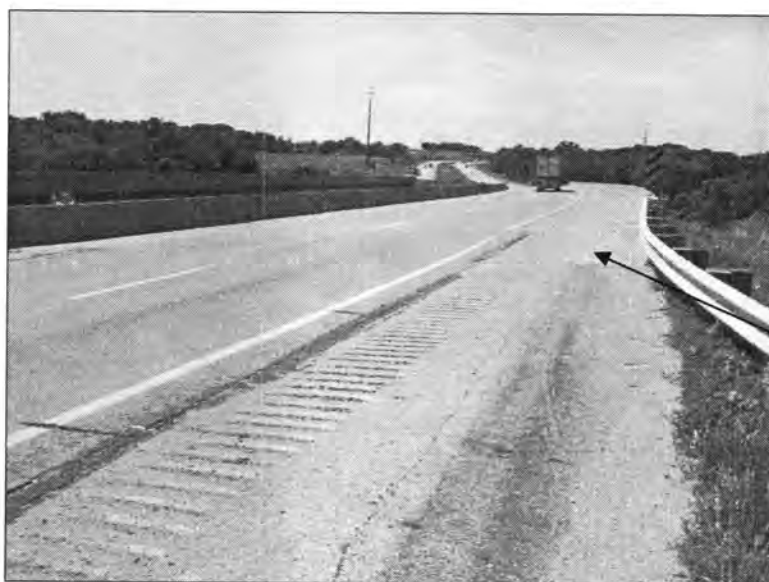
Differential settlement

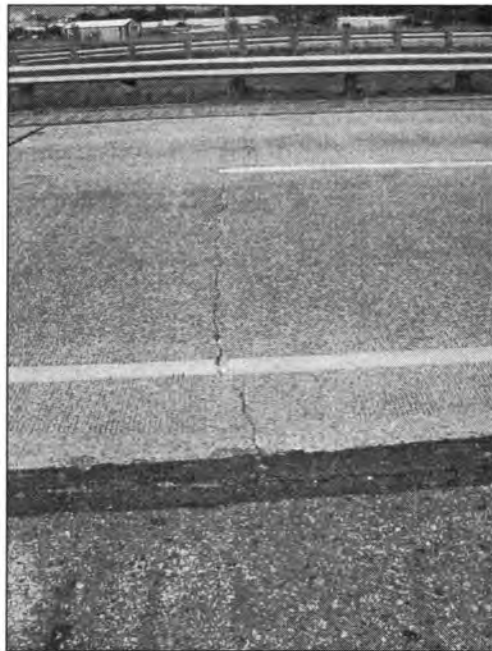
Figure 3.259 - Transverse Cracking at the Bridge Approach (Bridge No. 7782.8L065 - North End of SBL)

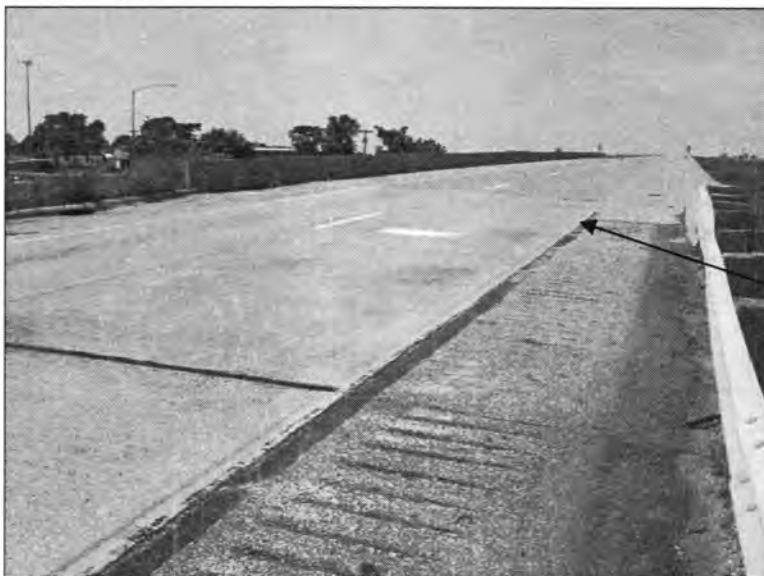
Approach
slab
settlement

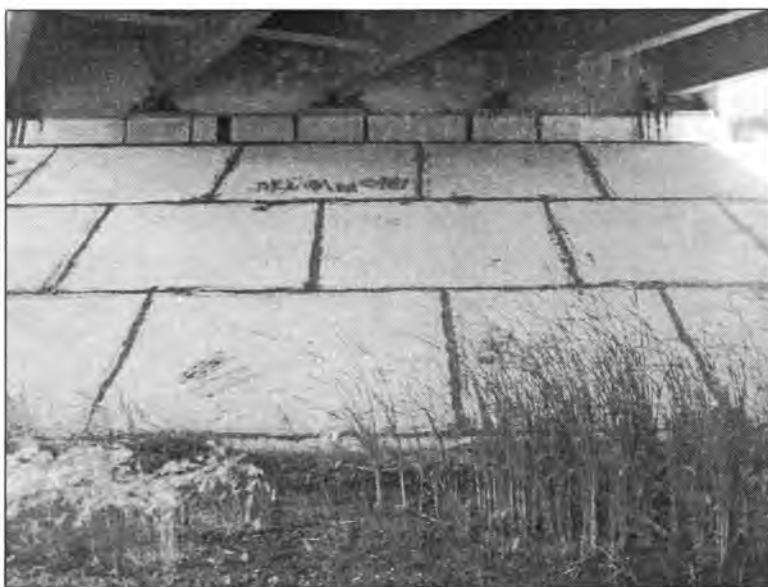
Figure 3.261 - Bridge Embankment in a Satisfactory Condition (Bridge No. 7782.8L065)

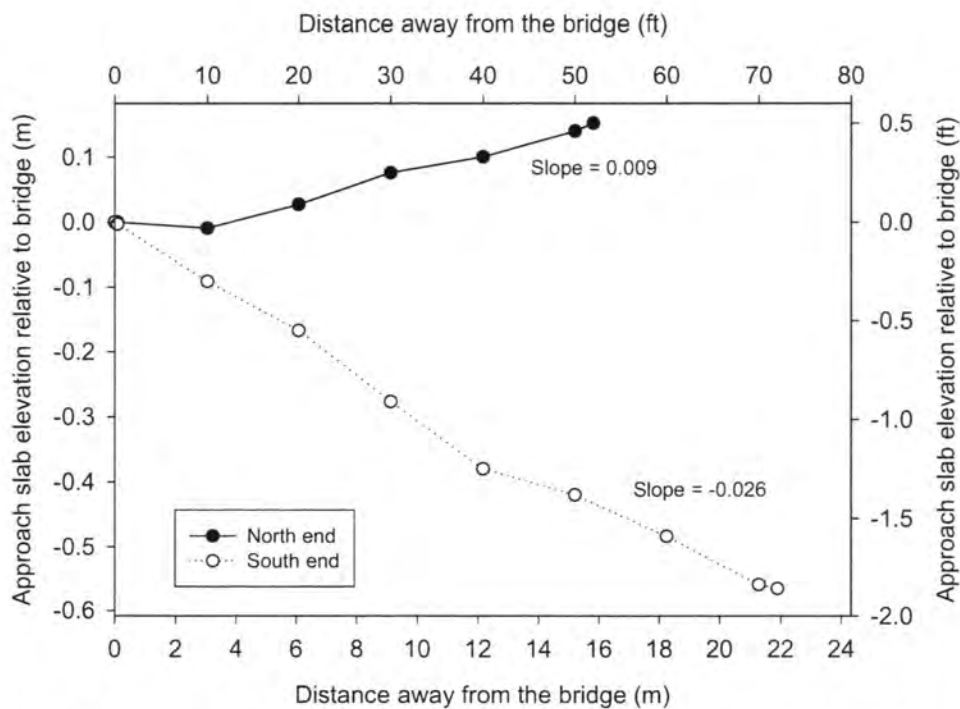
Figure 3.262 - Profile of the Bridge Approach Relative to the Bridge Deck (Bridge No. 7782.8L065 - SBL)

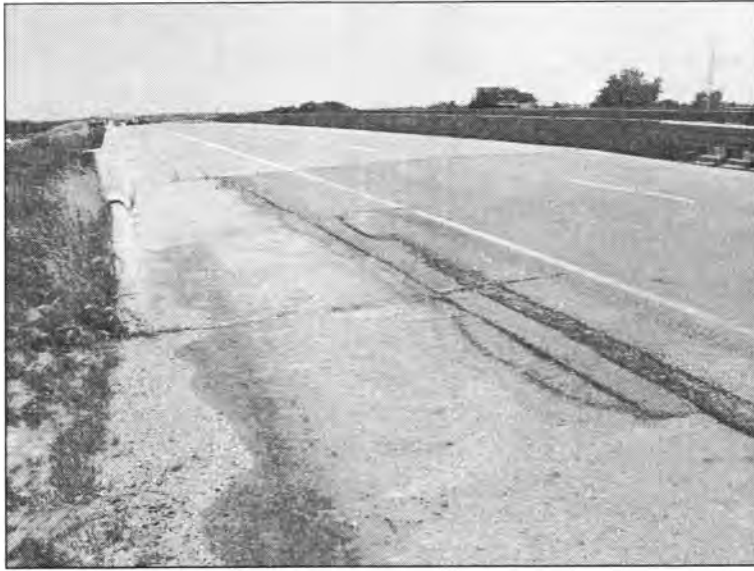
Figure 3.263 - Asphalt Overlay Placed Over the Approach Slab to Compensate for the Differential Settlement (Bridge No. 7783.1065 - North of End NBL)

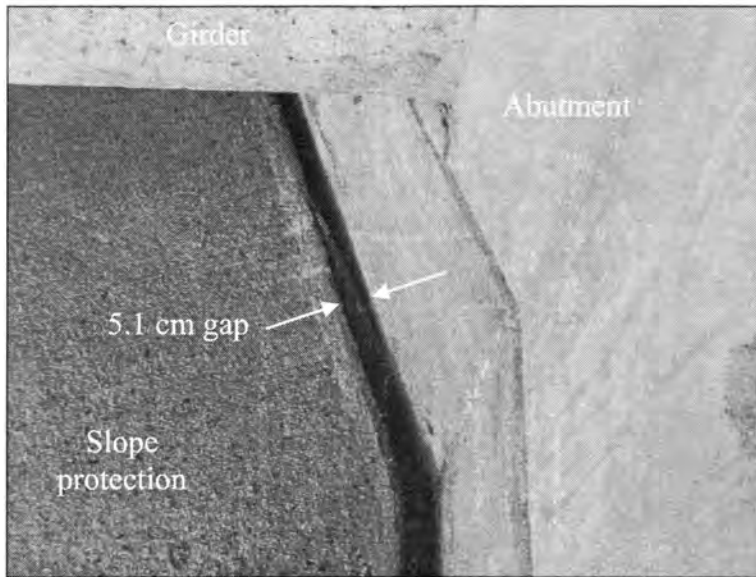
Figure 3.265 - Lateral Movement of the Abutment Away from the Bridge Embankment Caused by Expansion of the Bridge Structure (Bridge No. 7783.1065 - North End of NBL)

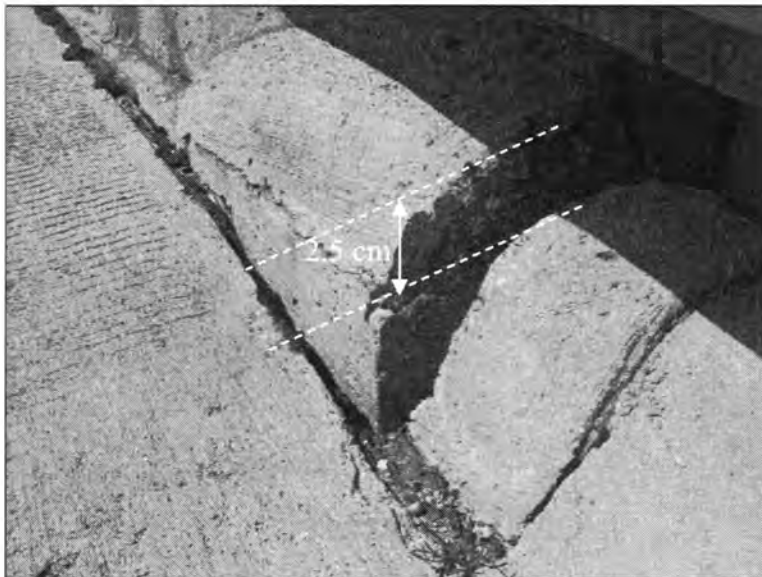
Figure 3.266 - Differential Settlement at the Bridge Approach (Bridge No. 7783.1065 - South End of NBL)

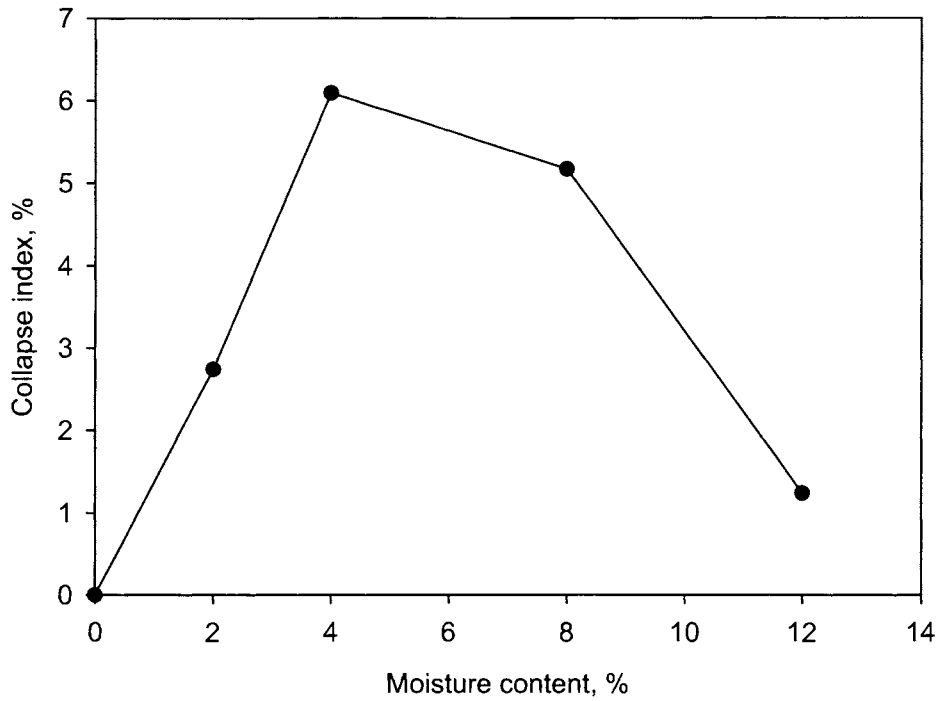
Figure 3.273 - Collapse Index – Moisture Content Relationship for Granular Backfill Material

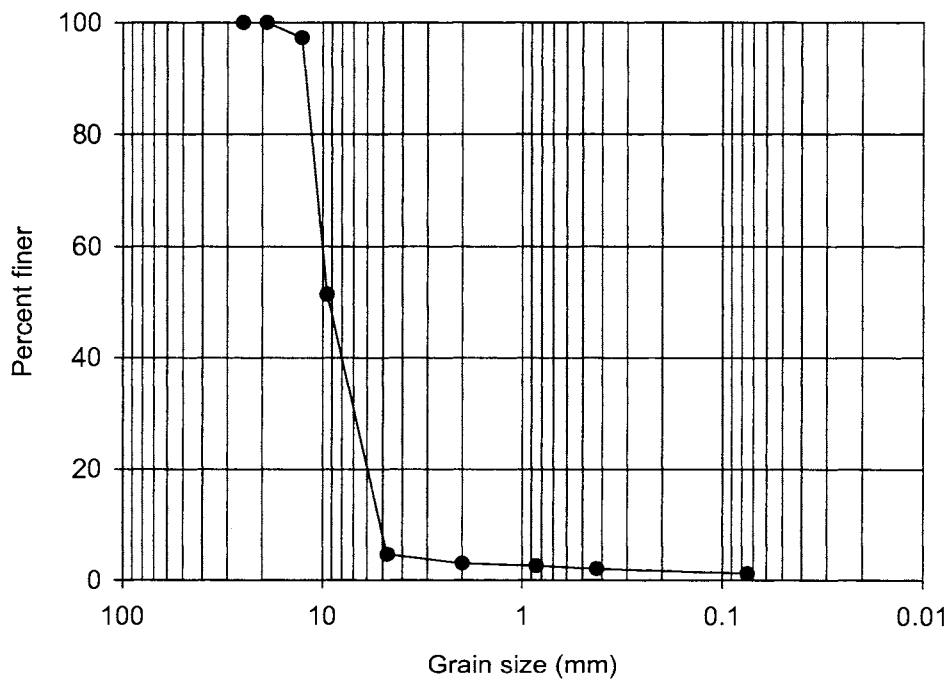
Figure 3. 274 - Grain Size Distribution for Porous Backfill

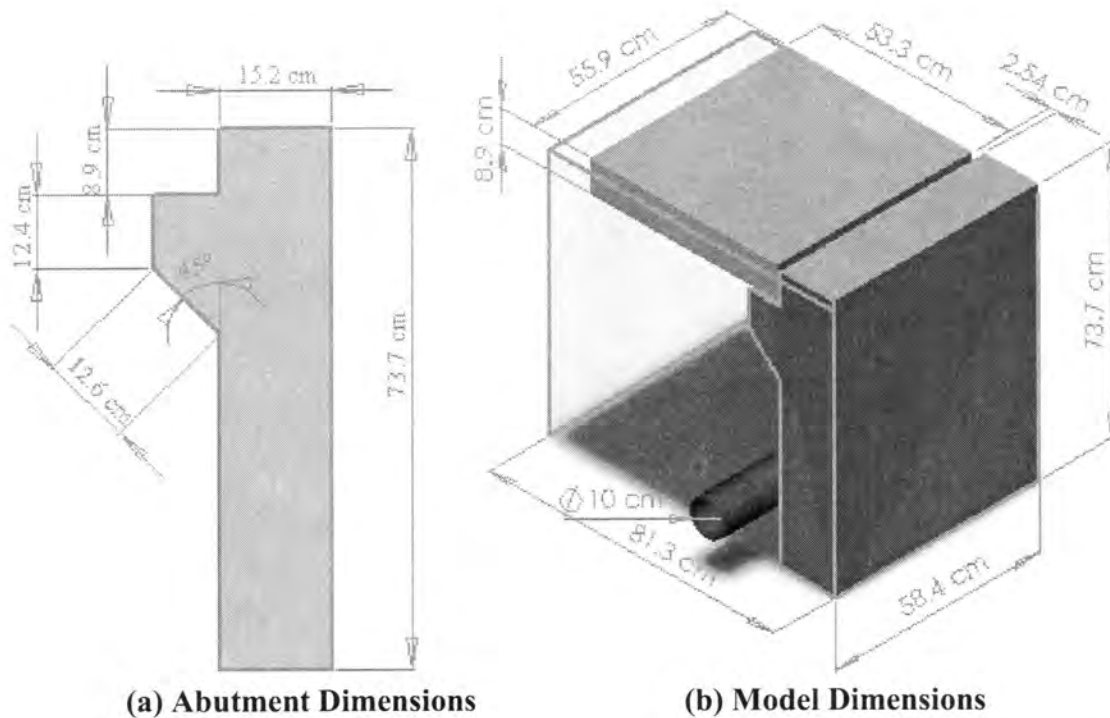
Figure 3.279 - Schematic for the Constructed Water Management Bridge Approach Model

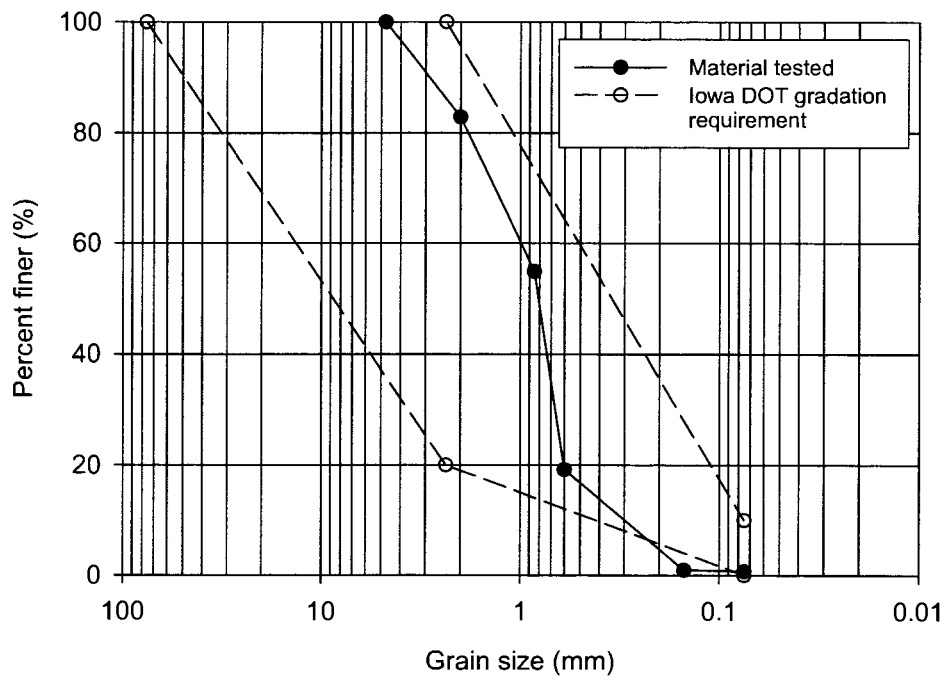
Figure 3.281 - Grain Size Distribution for Granular Backfill

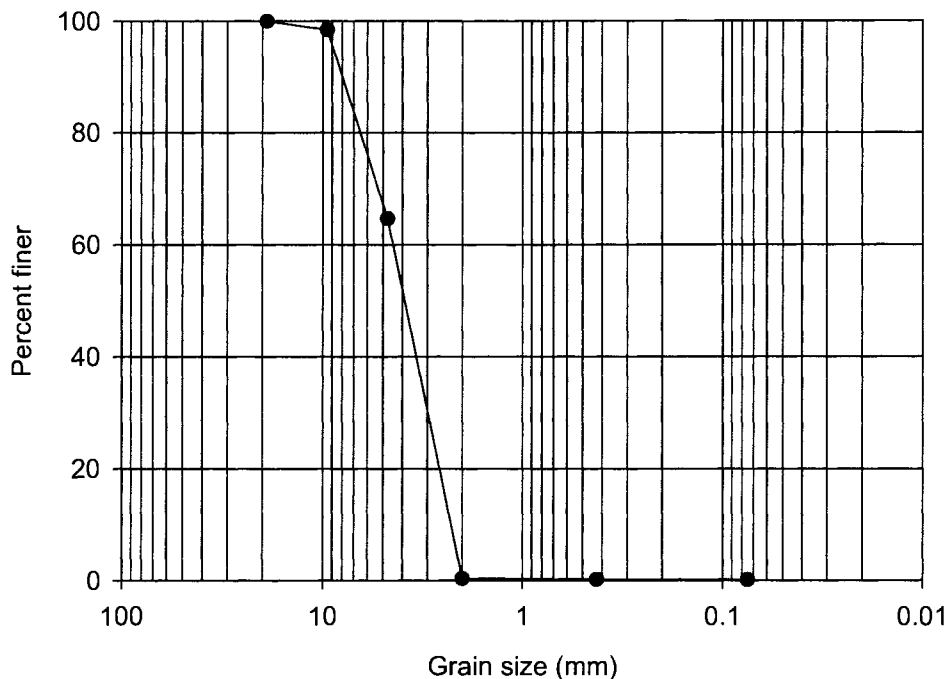
Figure 3.284 - Grain Size Distribution for Tire Chips

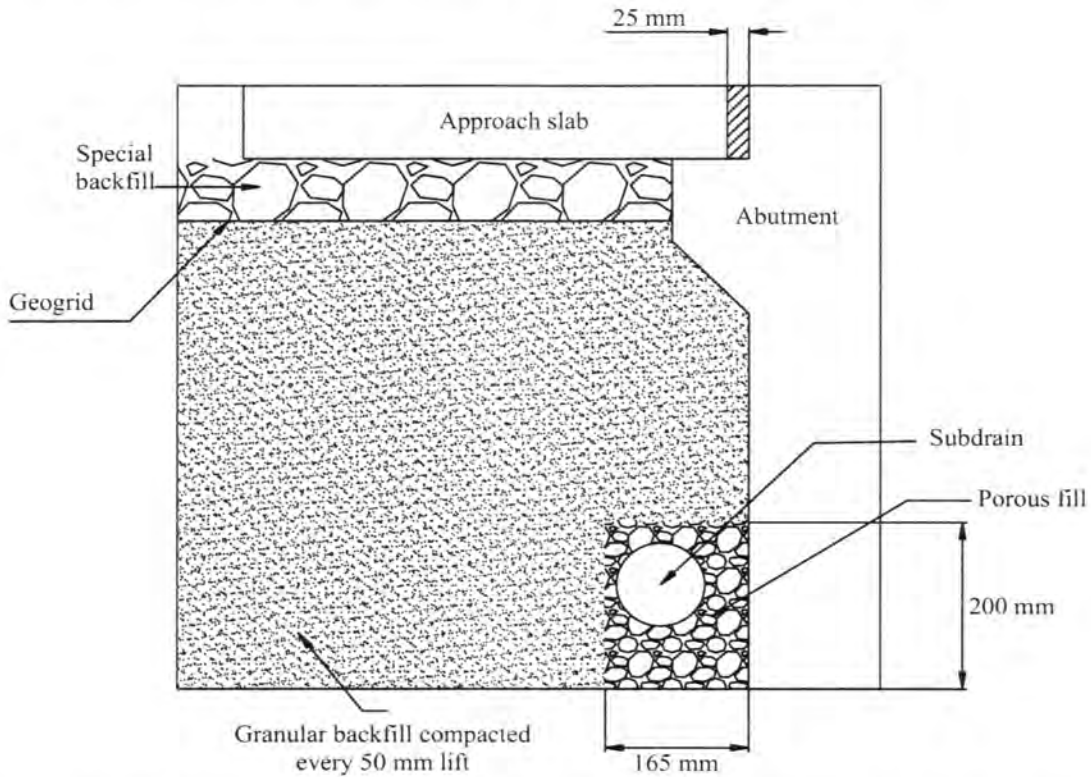
Figure 3.285 - Schematic Diagram of Test 1 Representing Iowa DOT Current Design

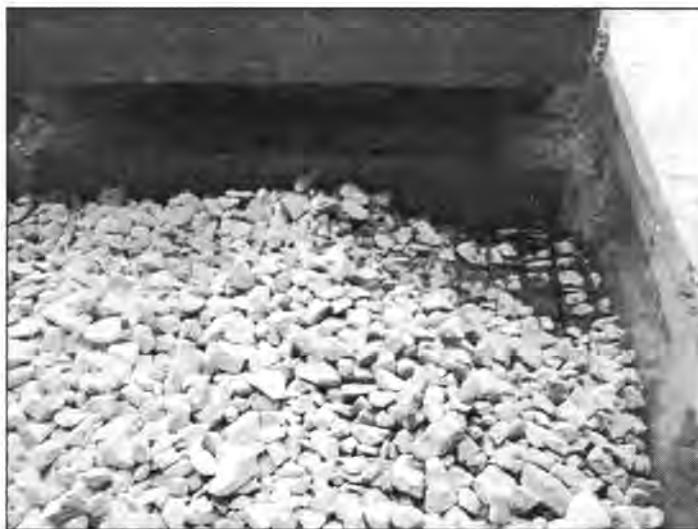
Figure 3.286 - Geogrid Placed under Special Backfill

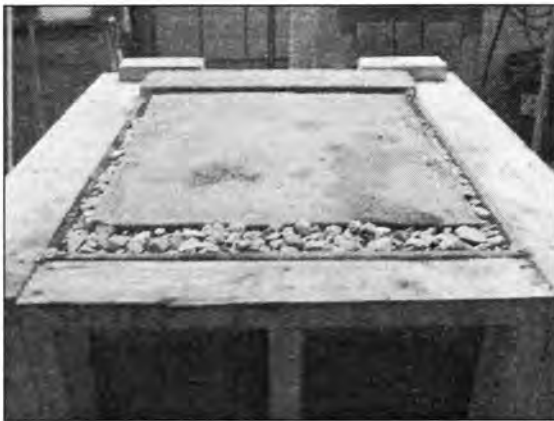
Backfill type	Granular backfill with porous fill around subdrain and special backfill under the approach slab
Moisture content	3.0 %
Compaction	By tamper every 50 mm lift
Settlement (cm)	Left side: 5.1 cm
	Right side: 3.8 cm
Void (cm)	Left side: 11.4 cm deep at the abutment face and extending 21.6 cm under the approach slab
	Right side: 8.9 cm deep at the abutment face and extending 22.9 cm under the approach slab
Maximum steady state flow (cm ³ /sec)	32.0
Time for water to drain (min)	10

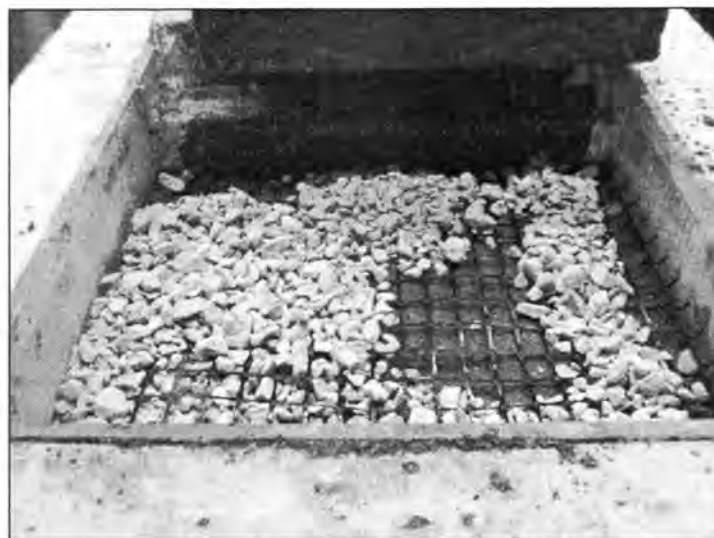
Figure 3.289 - Placing Special Backfill over Geogrid

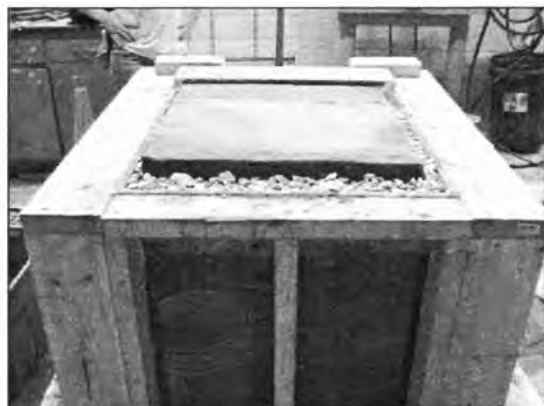
Backfill type	Granular backfill with porous fill around the subdrain and special backfill under the approach slab
Moisture content	12.6 %
Compaction	By tamper every 50 mm lift
Settlement (cm)	No settlement
Void (cm)	None
Maximum steady state flow (cm ³ /sec)	31
Time for water to drain (min)	12

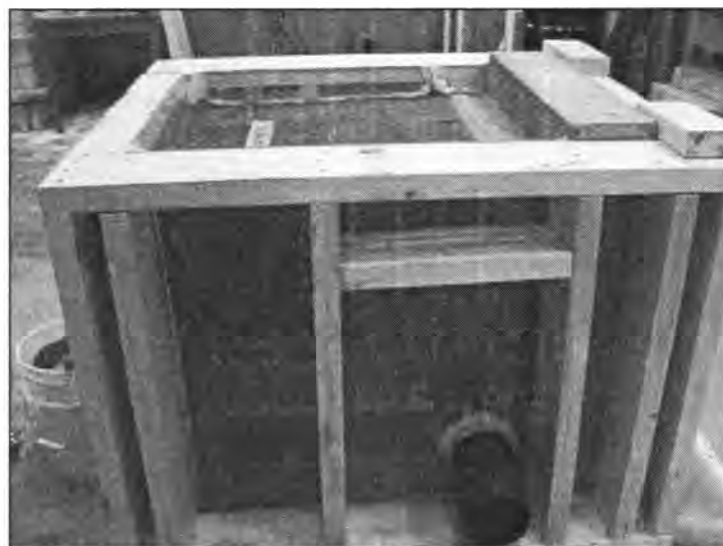
Figure 3.292 - Granular Backfill Placed behind the Abutment
