**Management of water and backfill characteristics for improved bridge
approach performance**

Mohamed Magdi Mekkawy

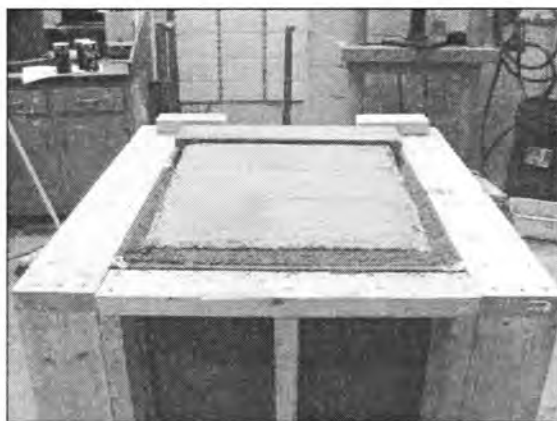
Backfill type	Granular
Moisture content	3.0 %
Compaction	By own weight
Settlement (cm)	Left side: 4.4 cm
	Right side: 5.7 cm
Void (cm)	Left side: 10.2 cm deep at the abutment face and extending 11.4 cm under the approach slab
	Right side: 8.3 cm deep at the abutment face and extending 11.4 cm under the approach slab
Maximum steady state flow (cm ³ /sec)	33.5
Time for water to drain (min)	10

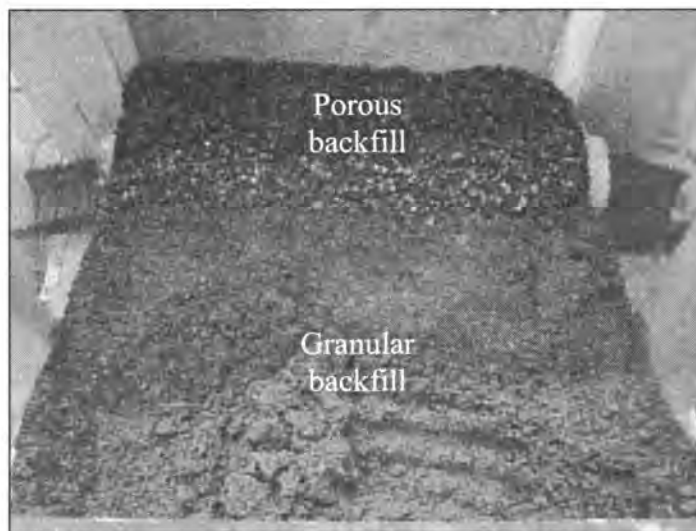
Figure 3.295 - Porous Fill Placed Around the Subdrain

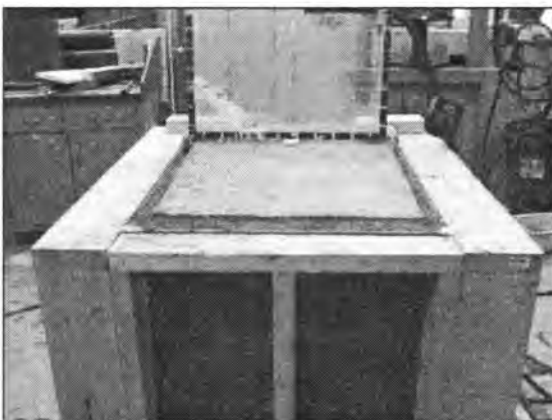
Backfill type	Granular with porous fill around subdrain
Moisture content	5.45 %
Compaction	By own weight
Settlement (cm)	Left side: 5.1 cm
	Right side: 5.7 cm
Void (cm)	Left side: 5.1 cm deep at the abutment face and extending 25.4 cm under the approach slab
	Right side: 5.1 cm deep at the abutment face and extending 7.6 cm under the approach slab
Maximum steady state flow (cm ³ /sec)	67.0
Time for water to drain (min)	11

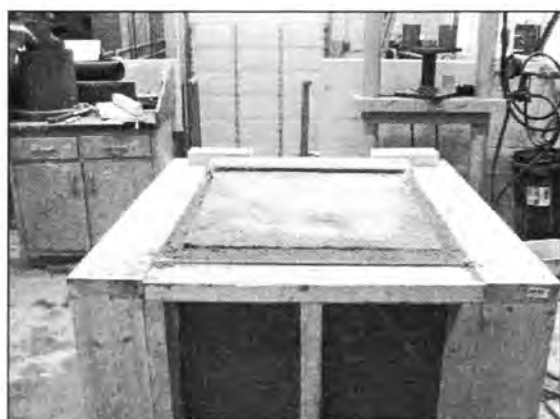
Backfill type	Granular with porous fill around subdrain wrapped with geotextiles
Moisture content	4.8 %
Compaction	By own weight
Settlement (cm)	Left side: 5.1 cm
	Right side: 4.4 cm
Void (cm)	Left side: 6.4 cm deep at the abutment face and extending 22.9 cm under the approach slab
	Right side: 4.44 cm deep at the abutment face and extending 21.6 cm under the approach slab
Maximum steady state flow (cm ³ /sec)	82.0
Time for water to drain (min)	10

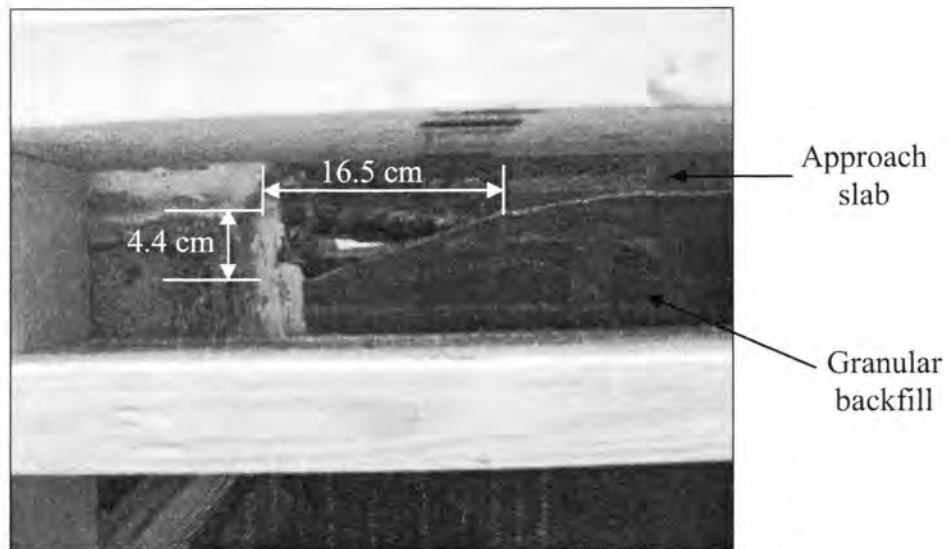
Figure 3.304 - A Void Developed under the Approach Slab Due to Soil Collapse

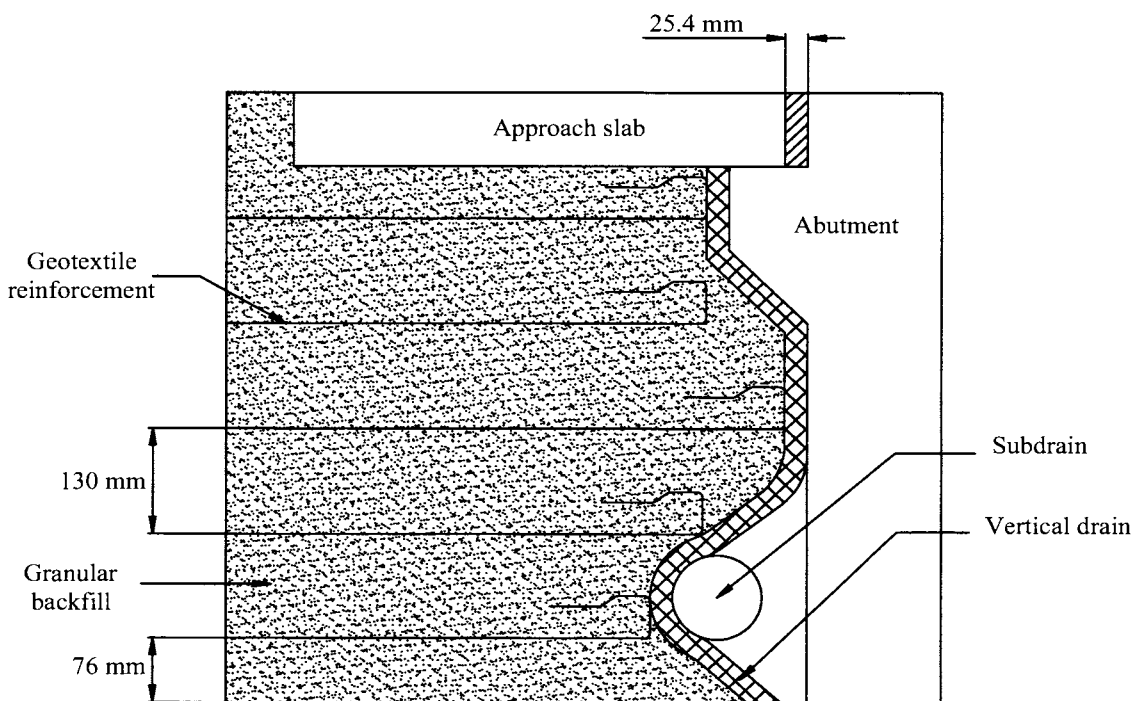
Figure 3.306 - Schematic of Test 7 Drainage Details

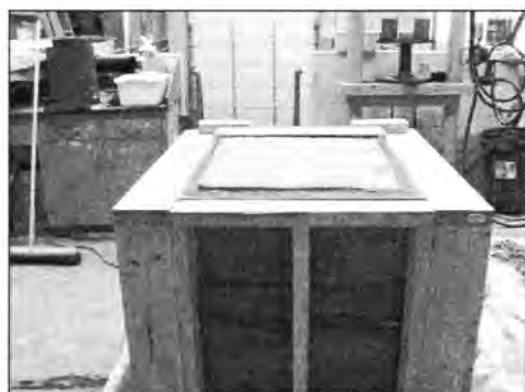
Backfill type	Reinforced granular backfill with vertical drainage
Moisture content	4.2 %
Compaction	By own weight
Settlement (cm)	Left side: 5.1 cm
	Right side: 5.4 cm
Void (cm)	Left side: 12.7 cm deep at the abutment face and extending 24.1 cm under the approach slab
	Right side: 13.9 cm deep at the abutment face and extending 16.5 cm under the approach slab
Maximum steady state flow (cm ³ /sec)	222
Time for water to drain (min)	4

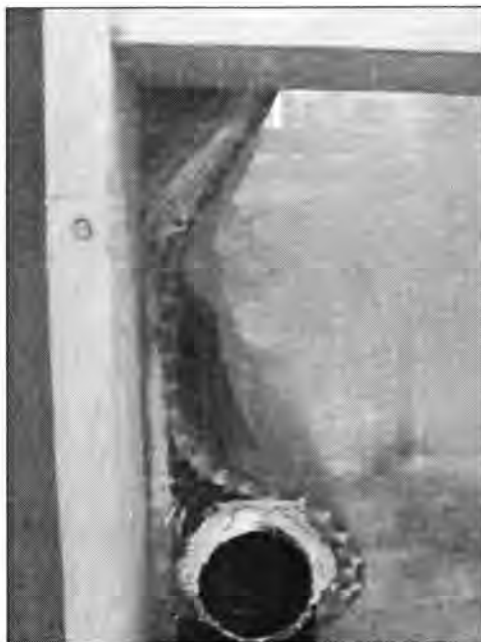
Figure 3.311 - Attaching the Geocomposite Drain to the Abutment

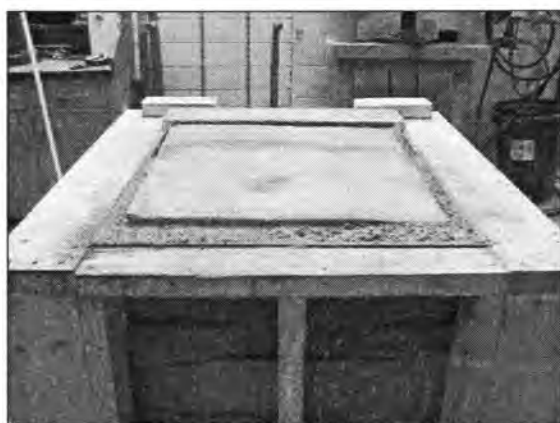
Backfill type	Reinforced granular backfill
Moisture content	3.7 %
Compaction	By own weight
Settlement (cm)	Left side: 5.7 cm
	Right side: 6.4 cm
Void (cm)	Left side: 3.8 cm deep at the abutment face and extending 10.2 cm under the approach slab
	Right side: 3.8 cm deep at the abutment face and extending 11.4 cm under the approach slab
Maximum steady state flow (cm ³ /sec)	383
Time for water to drain (min)	1

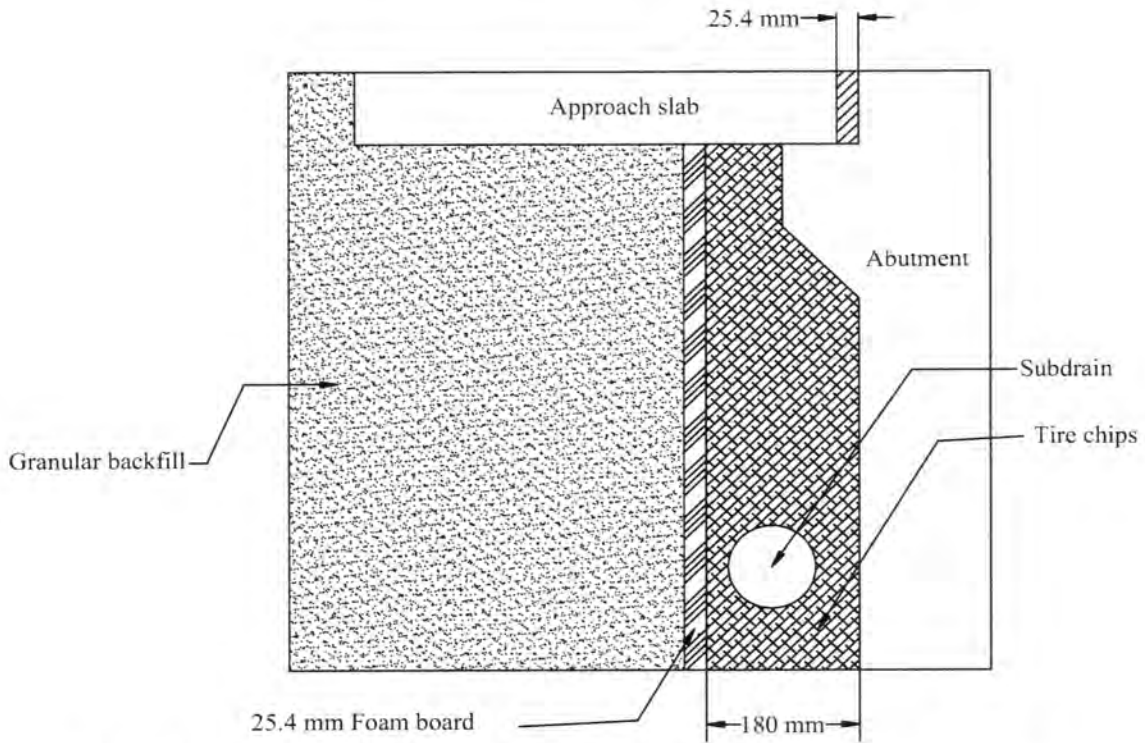
Figure 3.315 - Schematic of Test 9; Using Tire Chips behind the Abutment

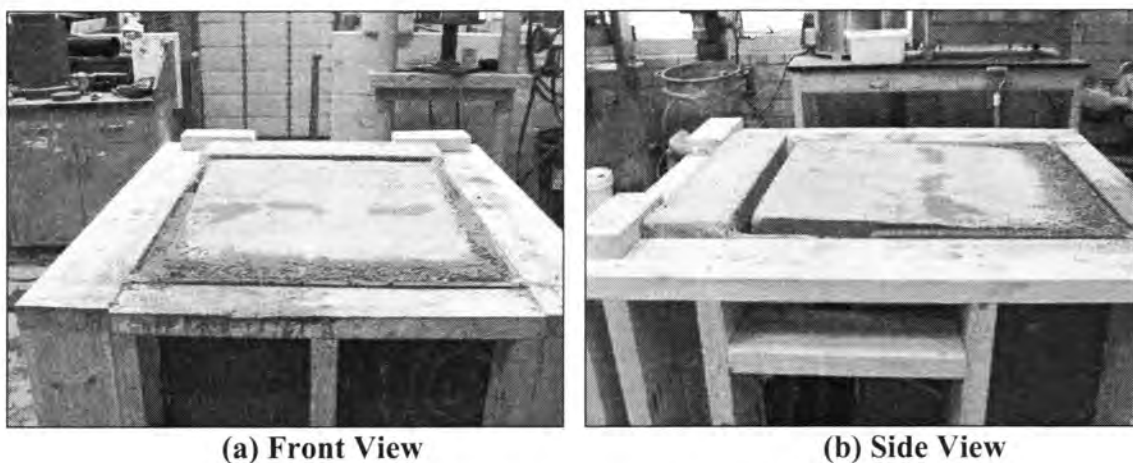
Figure 3.317 - Position of Approach Slab before Test 9

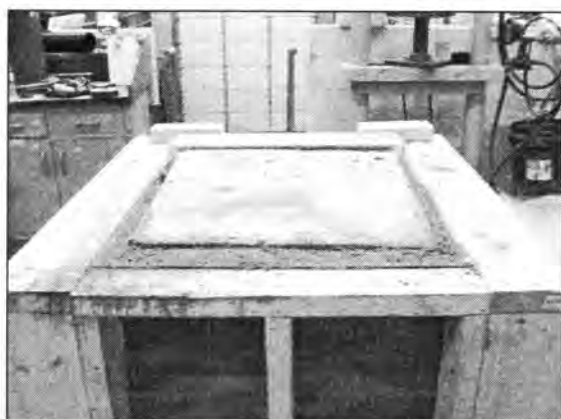
Backfill type	Reinforced granular backfill with tire chips as drainable material
Moisture content	4.04 %
Compaction	By own weight
Settlement (cm)	Left side: 2.5 cm
	Right side: 3.2 cm
Void (cm)	None
Maximum steady state flow (cm ³ /sec)	554
Time for water to drain (min)	1

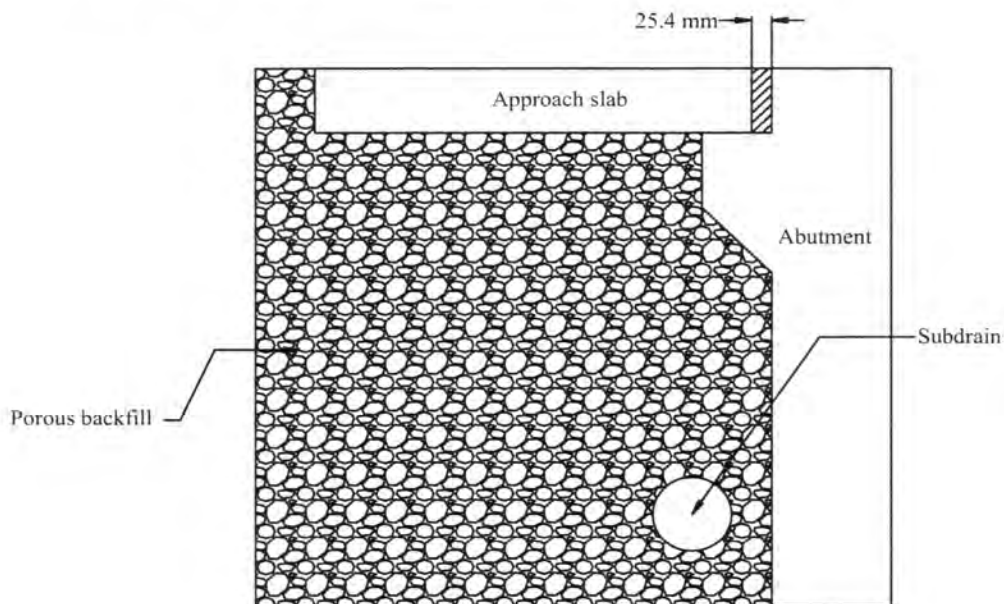
**Figure 3.323 - Drainage Detail for Test 11**

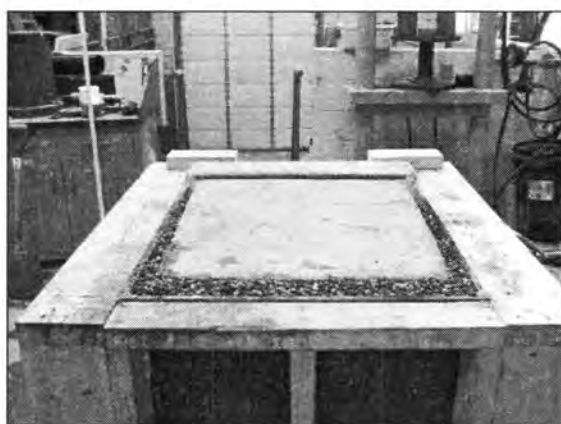
Backfill type	Porous fill
Moisture content	4.59 %
Compaction	By own weight
Settlement (cm)	No settlement
Void (cm)	None
Maximum steady state flow (cm ³ /sec)	92.0
Time for water to drain (min)	4

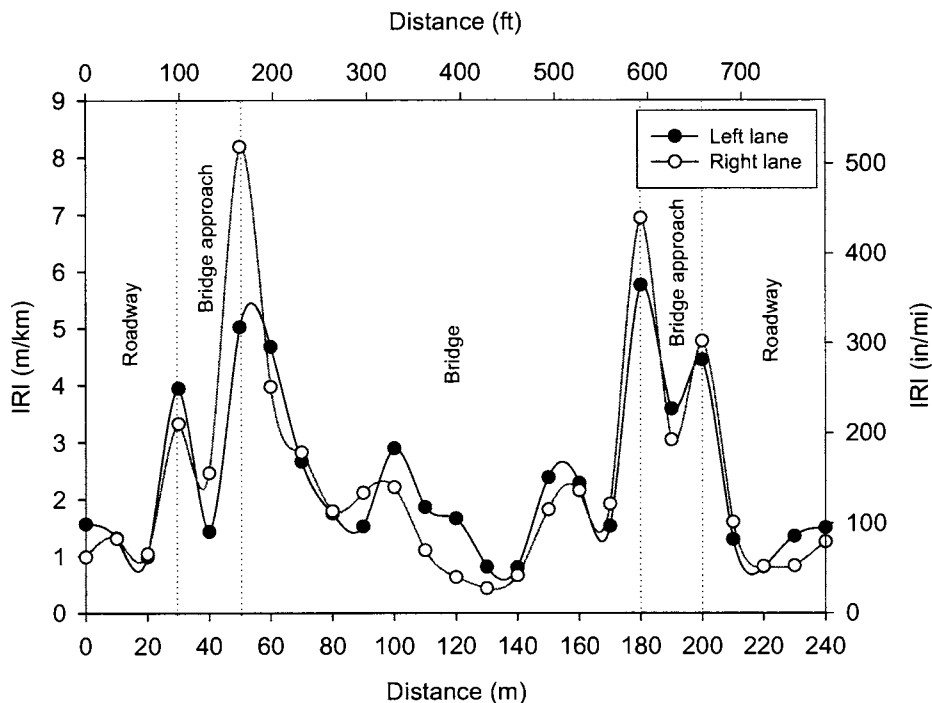
Figure 3.327 - IRI Graph (Bridge No. 7777.0065 SBL)

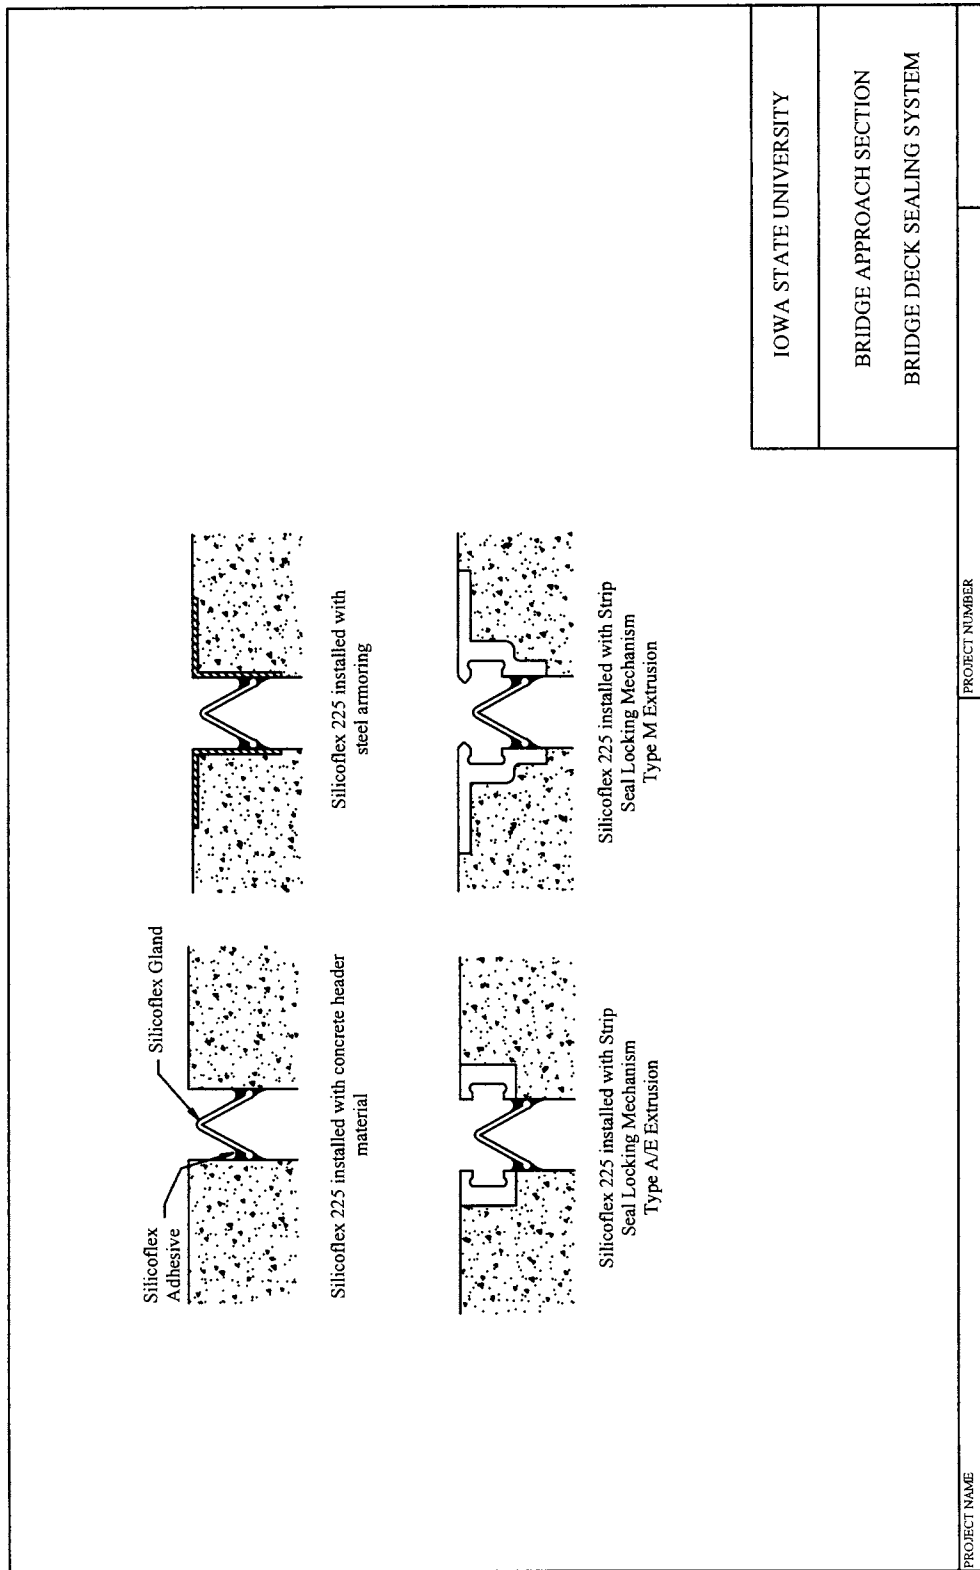
Figure 5.1 - V-shaped Rubber Gland Joint Sealing System

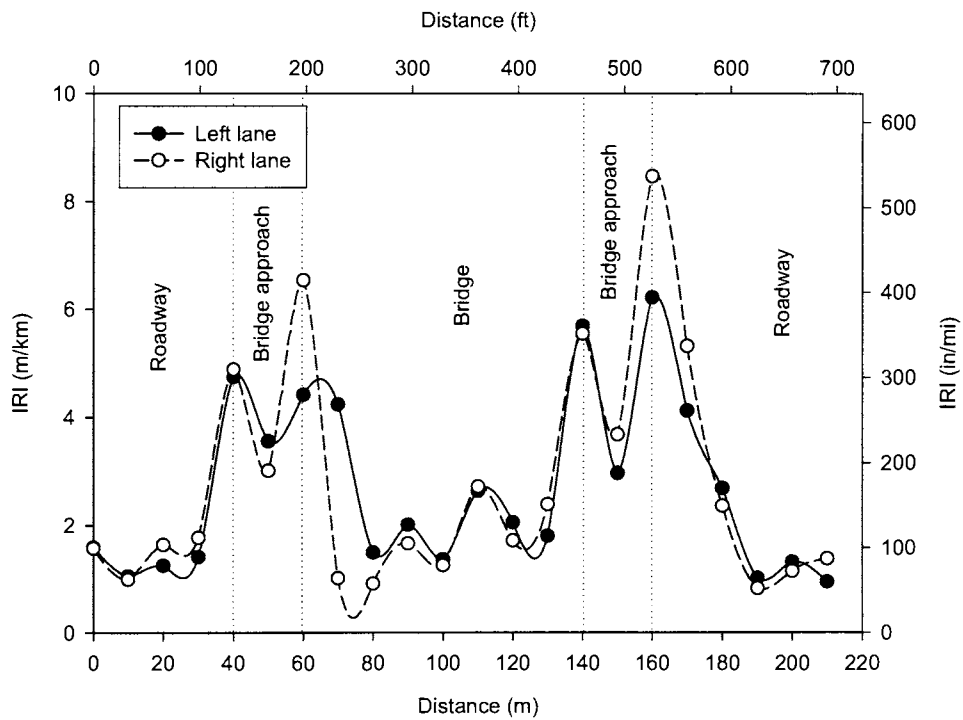
Figure B1 - IRI graph (Bridge No. 7773.0065 - SBL)
