Three different reasons for surface damages of glasses after machine dishwashing

Chun Wang, Georg Krausch and Markus Decker

A variety of glass cups has been investigated after treatment in a machine dishwasher. Three types of surface damages were found.

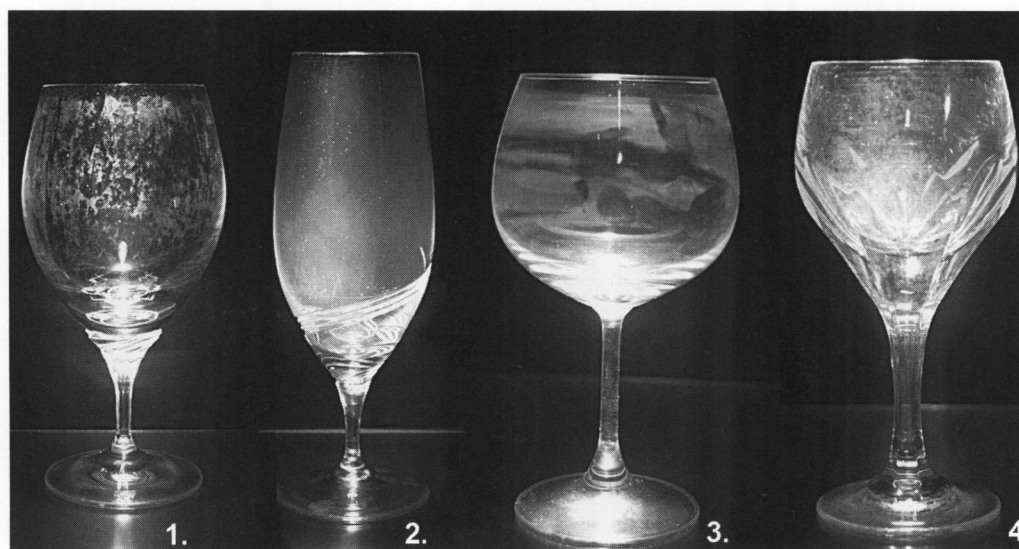
Figure 1. Four surface damaged wine glass cups after machine dishwashing. Cup 1: shows a continuous matt area and brilliant spots, cup 2: appears foggy all over, cup 3: displays sheet clouds on the outside, cup 4: has an additional golden layer on the inner surface.

Figure 1 presents four glass cups damaged on the entire surface. Cup 1 shows a continuous matt area and brilliant spots. Cup 2 appears foggy all over. Cup 3 displays sheet wave clouding on the outside. Cup 4 has an additional golden layer on the inner surface. FE-SEM and AFM images were taken at different parts of the cups and revealed different damage patterns after dishwashing, which will be discussed individually.

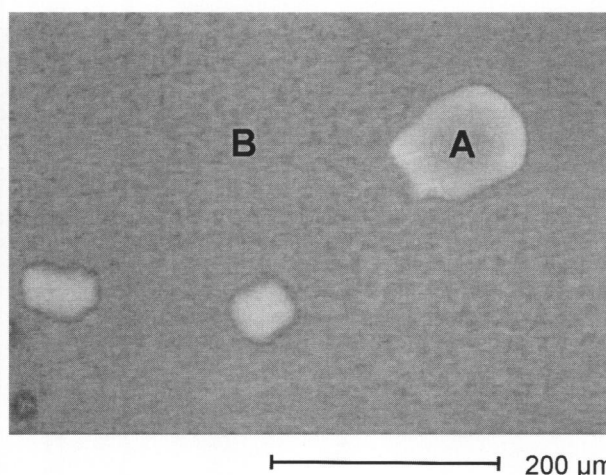
Figure 2. Optical microscope image of cup 1 of the outer surface showing the smooth brighter spots (A) and darker continuous matt area (B).

Figure 2 is an optical microscope image of the outer surface of cup 1. The smooth brighter spot (A) and the darker con-

tinuous matt area (B) were examined further by AFM. The height mode AFM image on the brighter spot (A) reveals droplet traces after dishwashing. This area is relatively smooth with a lower root mean square (rms) roughness value of 0.83 nm measured on a $(5 \times 5) \mu\text{m}^2$ image, in spite of the large undulation on the surface. The AFM image of the continuous area (B) shows a granular structure. This area is rougher than spot (A) with a higher rms roughness value of 1.4 nm ($(5 \times 5) \mu\text{m}^2$ image). The two different areas are clearly different in their features.

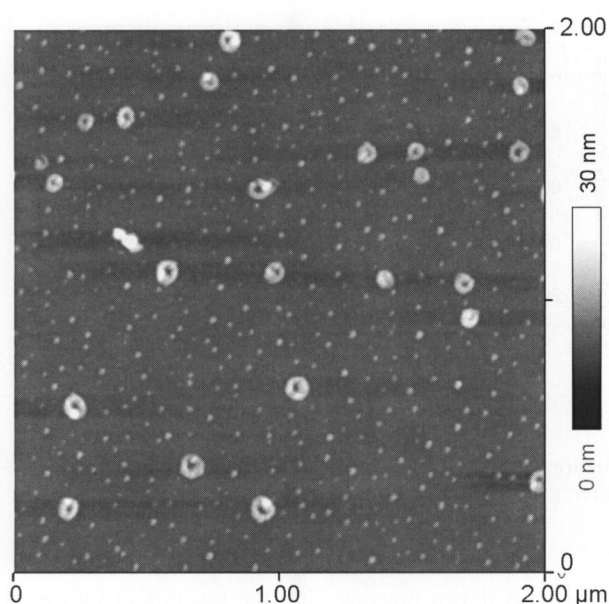
Figure 3. AFM image on the inside of a virgin wine cup (no photo) exposed to air for 10 d, showing the corrosion droplets.

To realize what happens after washing, it is necessary to study the virgin glass surface. Figure 3 shows an AFM image of the inside of a wine cup (no photo) exposed to air for 10 d. The cups were produced by blowing a piece of molten glass into a mould. Then the blow-cap was cut off and the sharp edge was remolten. The inside of the cup usually lacks any defects functioning as an ideal of the surface helping to explore the nature of glass. Figure 3 reveals that there are minor droplets on the glass surface in addition to the larger visible droplets. It was observed also that washed off droplets leave etched traces on the glass surface. Such corrosion droplets and their etching behaviour on glass skin were studied previously [22 and 23]. The AFM investigation on the washed atmosphere side of float glass [23] revealed the same pattern as observed by us. It can be concluded that the brighter spot (A) on cup 1 is the original glass surface whereas the matt area (B) with the granular pattern reveals the inner structure of the glass after the glass skin had been eroded. The granular pattern has also been observed on many other glass fracture surfaces [16 and 17]. Hence the results obtained from cup 1 indicate the existence of a glass skin as proposed earlier [22]. The glass skin can protect the glass against attacks from the corrosive media and can also result in inhomogeneous corrosion appearance if previously injured [22 and 23]. During production the outer surface of the wine cup contacts the metal mould. The process comes along with inhomogeneous stress and temperature distributions on the glass surface, which probably results in inhomogeneous migration of the ions onto

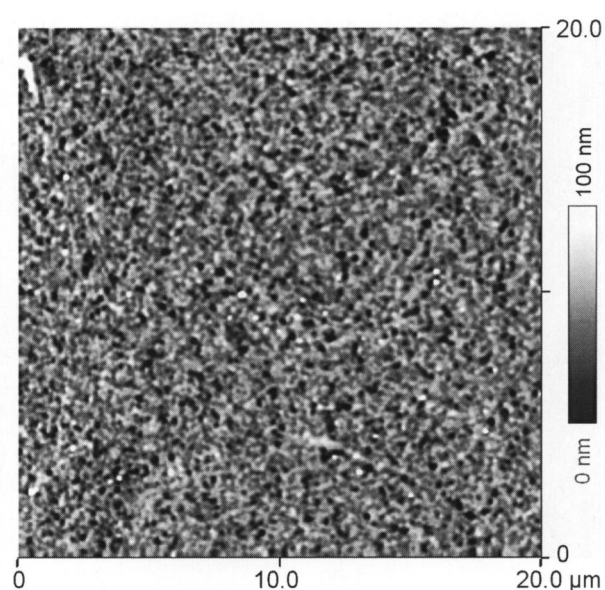
Figure 4. AFM image of the inside of cup 2 polished with acid during the final manufacturing process.

Cup 2 looks as if uniformly corroded. It was polished with acid to remove unevenness on the surface during the final manufacturing process remarkably eroding the protective glass skin. The exposed surface should be structured the same as in bulk. The AFM studies on both sides of cup 2 revealed the same porous features, see for example in figure 4 showing the inside of cup 2. This indicates that the glass surfaces on the inside and on the outside both faced the same primordial conditions and were equally corroded by washing. The rms roughness values of both sides are almost the same (7.21 nm and 7.04 nm, respectively). The porous structure in figure 4 consists of holes of about $1 \mu\text{m}$ in size. Those holes are responsible for the presence of the foggy appearance of cup 2. At higher magnification the constructive units of the surface revealed by AFM are detected as granules of 20 to 30 nm in diameter (not shown here).

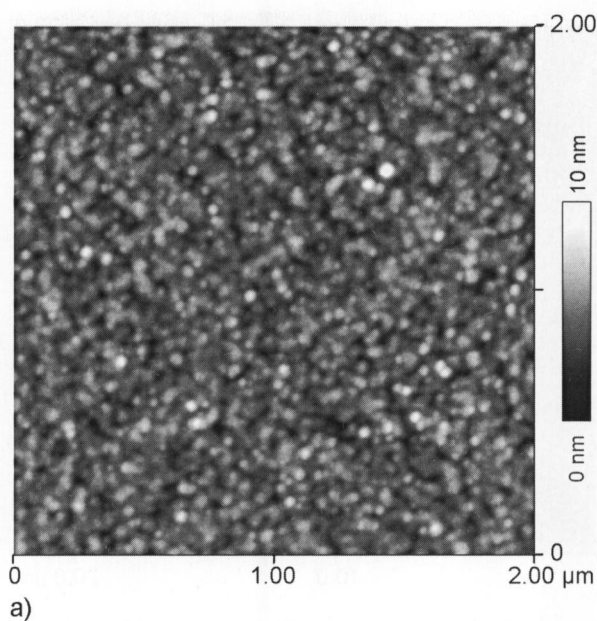
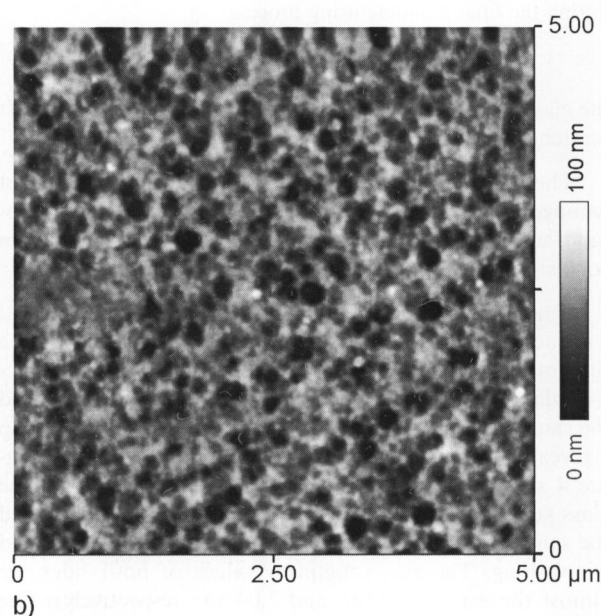
In order to obtain a general evolutionary concept on glass corrosion in the case of dishwashing, numerous glasswares (no photos) were examined by AFM of the inner surface at different washing stages. After 100 washing cycles the glass is still transparent and shining, but the AFM image (figure 5a) reveals a homogeneous granular structure and the surface already lacks its protective glass skin. The higher resolution AFM image (not shown here) indicates that the granules are sized 20 to 30 nm. In spite of the homogenous feature of this sample, the roughness value is 1.45 nm, i. e. larger than that of glass skin. With increased number of washing cycles the release of group of granules from the glass is induced. After 1000 washing cycles the glassware is visibly cloudy. The AFM image in figure 5b shows a honeycomb pattern. The roughness value abruptly increases up to 11.70 nm. Holes of about 600 nm in size scatter the light,

Figures 5a and b. AFM images of the inner surfaces of various wine cups (no photos) at different washing stages; a) at the earlier stage after 100 cycles, the glass looks still transparent, and b) at the damaged final stage after 1000 cycles, the glass appears cloudy.

also mentioned in [4]. It needs to be noticed that the two AFM images are presented on two different height scales (10 and 100 nm). If they are treated on the same height scales, figure 5a shows a rather flat surface, figure 5b shows a rather rough one with holes of various sizes resembling a honeycomb.

For the very first time we found that the glass is not eroded uniformly as described in [2], but dissolved in pieces during dishwashing, which results both in morphological changes and weight loss. Therefore the clouding mechanisms of glassware need to be reconsidered. Leaching of ions and dissolving of glass network are commonly accepted to be the main clouding process. The SNMS investigation

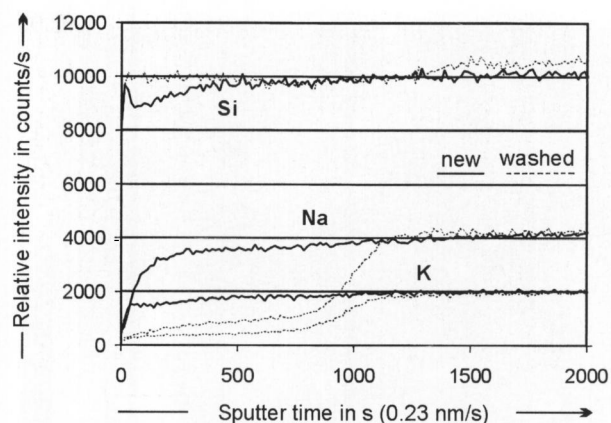
Figure 6. SNMS depth profiles of a new cup surface and of one after a short washing time (100 cycles).

in figure 6 shows, however, that the leaching of ions does not directly relate to the cloudy appearance. After a short washing time (100 cycles) Na^+ and K^+ ions had heavily been leached out and had left a 200 nm ion-poor near surface region. Meanwhile the silicon concentration remained almost unchanged before and after washing. We observed that the glass is still far from visible clouding after 100 washing cycles. In other words ion leaching plays only a minor role in this process. As soon as the cross linkages around the granules have been broken, the glass could turn cloudy. The notion of density fluctuations in the liquid glass would best explain our observations concluding that glass is composed of both higher density granules and lower density linkages. A detailed discussion of such a long range granular structure is beyond the scope of this paper and will be published later.

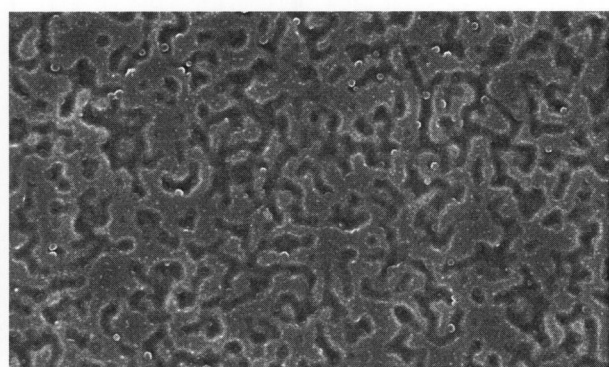
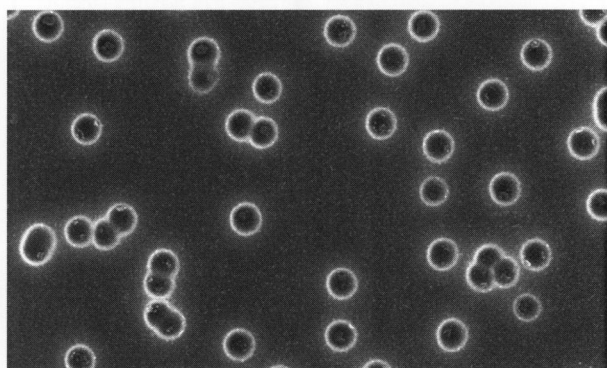
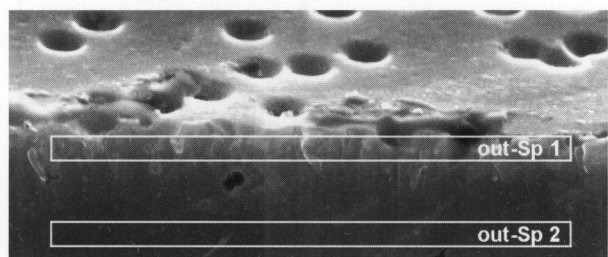
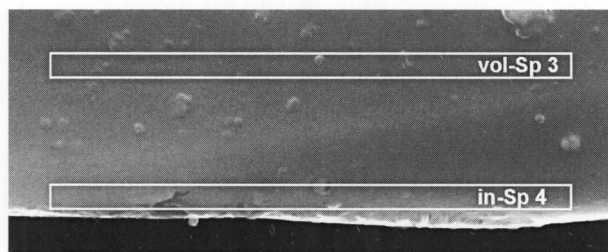
Figures 7a to d. FE-SEM images of cup 3; a) on the surface area showing bi-continuous phase separation pattern, b) on the surface area showing isolated sphere phase separation pattern, c) on the fracture near the outer surface, d) on the fracture near the inner surface. The frames inserted in 7c and d indicate the EDX analysing areas.

Cup 3 was examined in various regions. It was ascertained that the inside and the bottom of the outside do not bear any damage at all whereas major parts of the outside reveal various damage patterns depending on the specific zone. Figures 7a and b are examples showing a bi-continuous domain pattern (figure 7a) and an isolated sphere domain pattern (figure 7b). The measurements on the fracture confirmed that the patterns were formed by a dissolved phase and a continuous matrix phase as shown in figure 7c. The inside remained unaffected (figure 7d). AFM images of the outer surface confirm further that the dissolved phase ap-

pears as grooves and holes on the surface (not shown here). The EDX analysis indicates that the lost phase is the Pb-rich phase since Pb is much rarer around the damaged outer surface (out-Sp 1; table 1) than elsewhere. The flame treatment to round-melt the sharp edge might very well sign responsible for this effect as was the case in our previous studies [1]. The spreading of the flame all over the entire surface is probably due to the specific round shape of the glass since the same damaged pattern was observed on glass with the same shape like cup 3 as reported in literature [4]. The contour of the glass may lead the flame (600 to 2000 °C) to flow towards the bottom instead of being limited to the rim. The glass surface is obviously exposed to different temperature regimes when in contact with the flame. Subsequently, different phase separation patterns are established. However, not every single round cup is affected, there are certainly other deviations contributing during the production process at the rounding stage, such as wind, vibration, etc. This sort of damage merely occurred occasionally, yet is observed much earlier (already after 100 cycles) than with cup 1 and cup 2. These defects are due to manufacturing. Washing only makes them visible. Initially the phase separated surface was covered by a denser SiO₂ skin [23]. The refractive indexes of the Pb-rich phase and the SiO₂-rich matrix remained insignificant and would not cause light scattering. After the glass skin had been eroded, the Pb-rich phase was dissolved. The surface would scatter light as soon as the size of the dissolved phase exceeded the half of the light wavelength. In order to ascertain the real features of the cloudy area AFM and FE-SEM measurements were carried out on the surface as well as on the fracture surface. When the cloudy glass was studied only with SEM, it became difficult to distinguish the elevated from the depressed parts [2]. Phase separation remained too insignificant a phenomenon as to enable any definite conclusions.

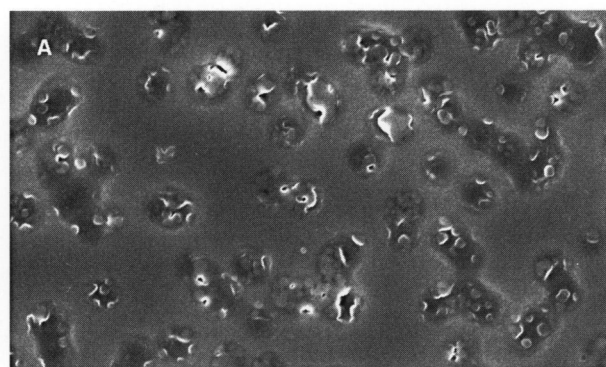
Figure 8. FE-SEM images of cup 3; enlarged image of the fingerprints on a contacting line.

Further useful pieces of information were obtained on cup 3. There were fingerprints on the glass surface. They became visible only after the cloudy damage appeared. They could not be removed by acetone or any other fat-soluble organic substances. The FE-SEM and AFM investigations showed that the lines of the hand impressed on the glass consist of thin layers covering the Pb-rich domains (figure 8). The EDX analysis indicates that there is an additional NaCl composition there. The NaCl salt possibly reacts or mix-crystallizes with the SiO₂-rich glass skin, thus prolonging the lifetime of the skin. After the neighbouring Pb-rich phase had been dissolved the fingerprints on the glass manifested themselves. It is a coincidental result which offers a method to increase the resistance of glass to corrosion. Recently, it was demonstrated [27] that if a new glass surface was treated with AlCl₃ salt the lifetime could be prolonged. This may follow the same mechanisms as as-

sumed here, which means that enhancing the glass skin is another very useful method for improving dishwashing resistance of glasses.

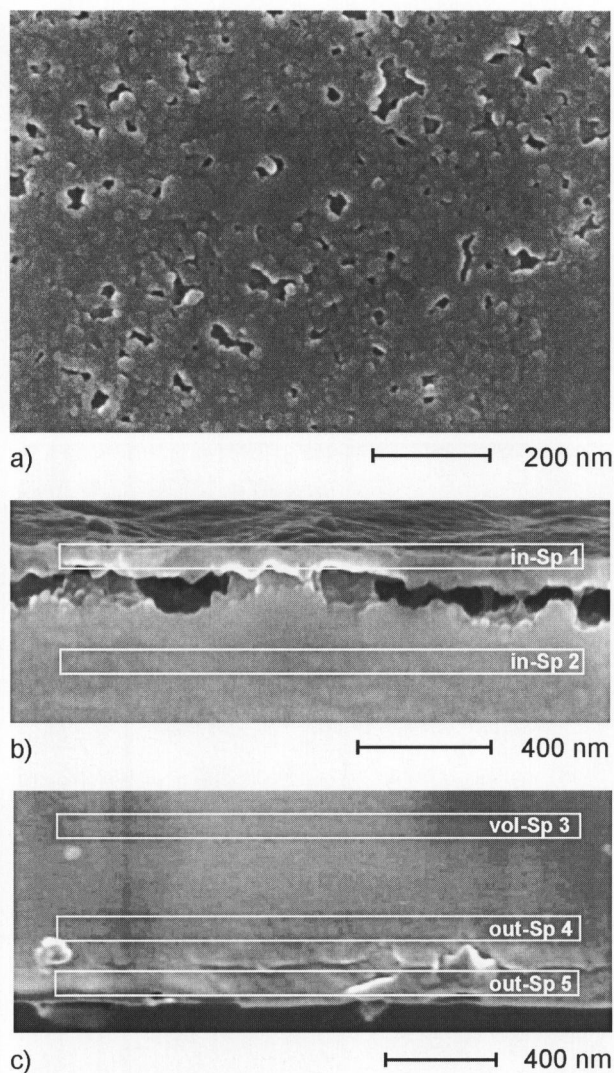
Figures 9a to c. FE-SEM images of cup 4; a) inner surface, b) fracture near the inner surface, c) fracture near the outer surface. The frames inserted in figures b and c indicate the EDX analysing areas.

Cup 4 shows a golden film on the inner surface. In most cases the additional golden hard layer was built by lime from hard water. It consists mainly of CaCO₃ and can be removed by acetic acid or citric acid. A piece of cup 4 was accordingly treated and cleaned with an ultrasonic bath at 60 °C for 1 h. The golden film, however, remained. AFM examinations helped to characterize the cup. They revealed granular patterns (rms roughness = 1.4 nm) and honeycomb patterns (rms roughness = 12.2 nm) on the outside as well as flock pieces (rms roughness = 21.5 nm) on the inside. Thus it follows that the outside is still glass surface and the inside is covered with a layer. In order to understand the damage better FE-SEM investigation was carried out on the inner

surface as well as the fracture surface of cup 4. The FE-SEM images show that the golden film covers the entire inner surface but is not watertight (figure 9a). When viewed on the fracture the additional film was seen more clearly. It is about 80 nm thick and the glass underneath is heavily corroded (figure 9b). The other side shows a lower density band of about 150 to 200 nm in width (figure 9c), which is typical of water corrosion [25]. The EDX values are given in table 2. Since the electron beam is larger than the analyzed area the results can only be considered as semi-quantitative. There is more carbon on the golden film than elsewhere on the cup, whereas there is less silica. Additionally, the calcium in the film is insignificant, so a lime film could not be formed. Note the film is merely on the inside. Conclusively, the golden film might be formed by the reaction of organic substances in drinks with the glass surface [26]. If the complex building is used as a protecting coating layer against the attack of water, it must be considered whether the layer is tight or not. In the case of cup 4 the layer is not watertight and can not block water corrosion. On the contrary the inside was corroded much more severely than the uncoated outside. The analysis therefore recommends avoiding useless or contra productive coating processes.
