Condition assessment of the northern climatic research house at the USDA forest service forest products laboratory

Tanaya Johnson

A Thesis

December 2023

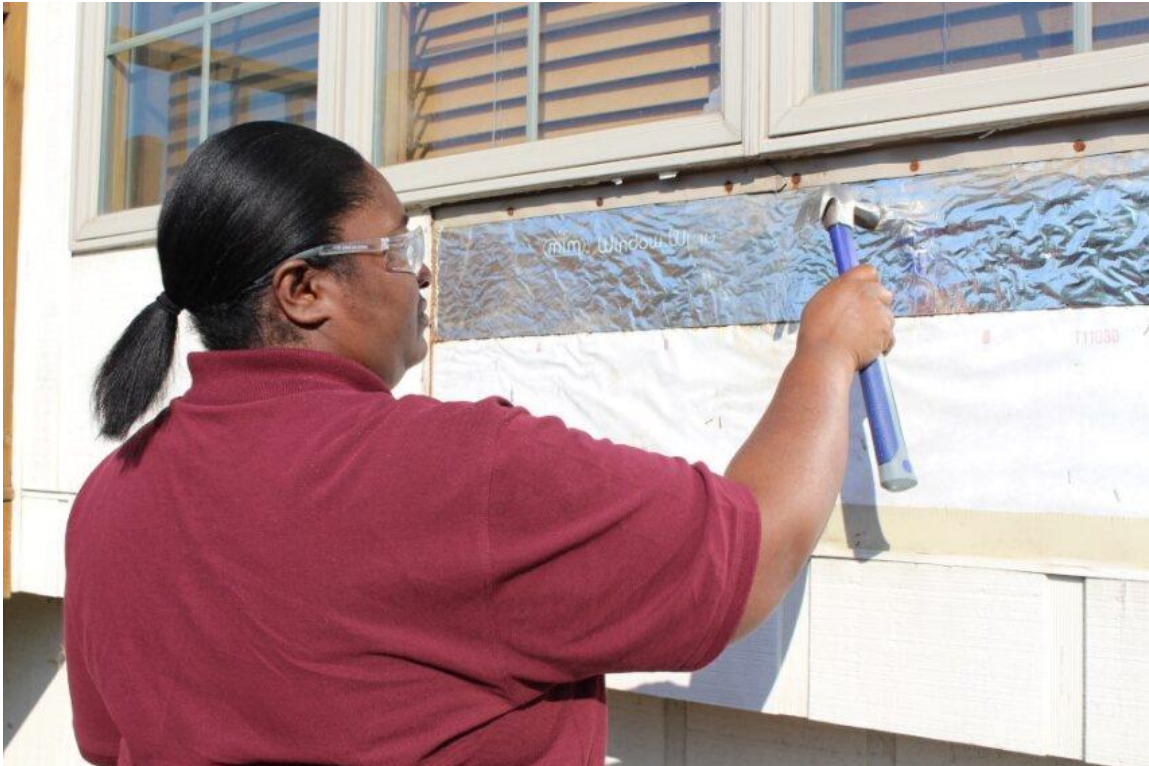
The exterior of the house was inspected by removing the siding from the house to see if there was any decay under the T1-11 siding (Figure 1). The house wraps and flashing beneath the siding appeared intact and functional. The sheathing was probed by striking a hammer to the area under the siding to prove that the area was intact and functional. The sheathing appeared intact based on the hammer's sound and return bounce upon striking. Since the sheathing appeared intact and not decayed, it was assumed that the wall framing beneath the sheathing in this area was also intact and not decayed. The siding in other areas where utilities were attached

Figure 1 This image is illustrating the student using a hammer gently striking silver area which is the sheath underneath the siding of the house to determine if moisture is present.

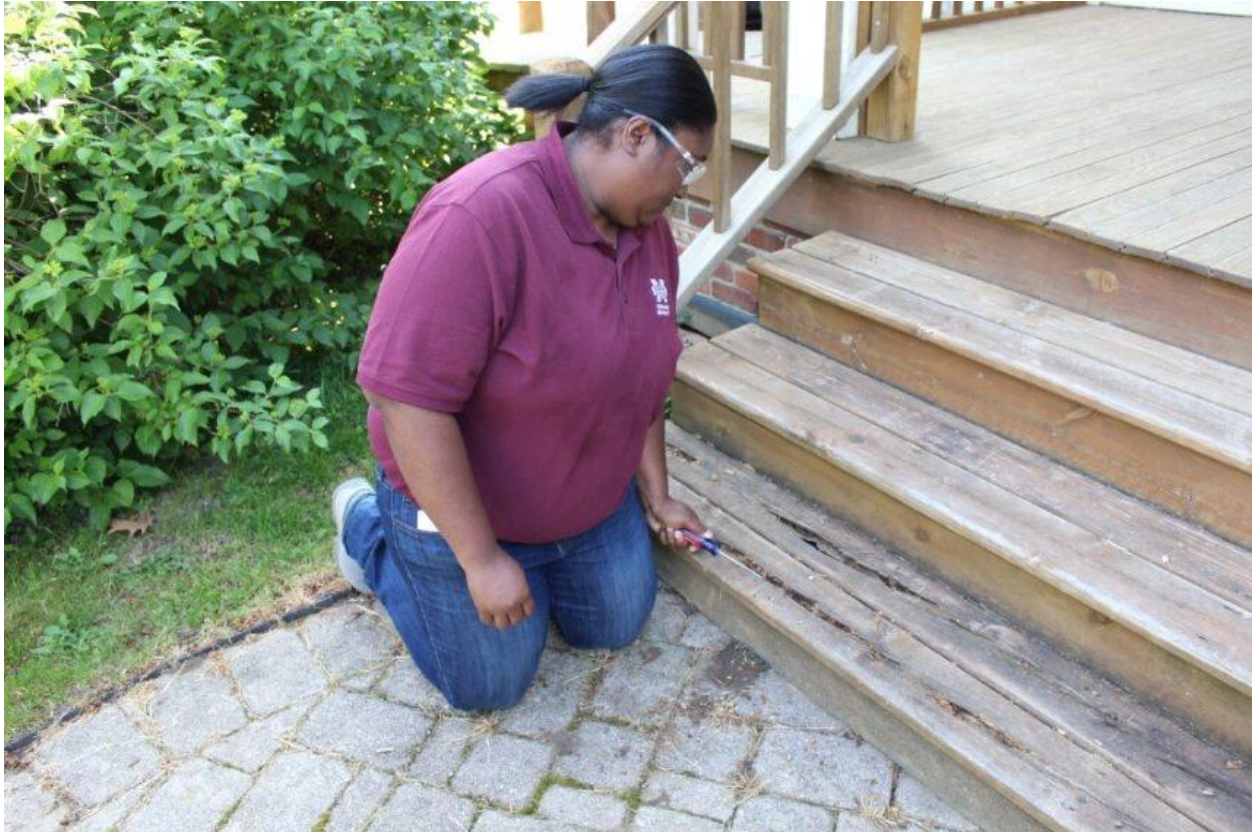
The exterior of the porch step was probed with a screwdriver (Figure 2) in where the railing leading to the porch. The bottom of the post appeared to be connected to the stair stringer with screws. The porch flooring near the top of the steps has become unfastened due to the fastener corrosion and rust. The ceiling of the same porch tongue and groove indicated that the porch takes on moisture.

Figure 2 The student is kneeling down to insert a screwdriver into the front porch steps to measure the dept of decay.

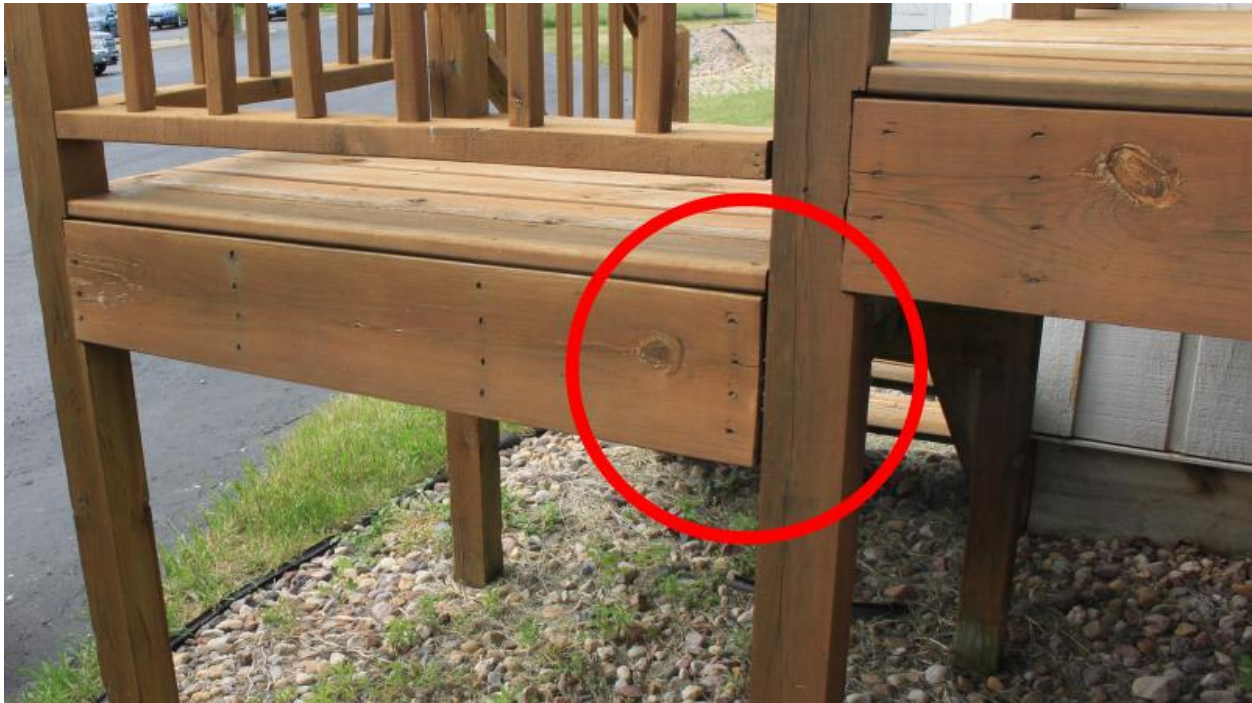
The back-entrance stoop, leading into the kitchen, is cause for imminent concern. The back deck presents some wood decay. The joists are connected to the joist box (also called rim joist) with appropriate hangers. The joist box, which carries the load of the joists is not well connected to the support post. This joist box to post connection system is not sufficient (Figure 3).

Figure 3 The circled image is the joist box and the rail. The circle is showing how the Joist box to rail connection is showing insufficient fixity.

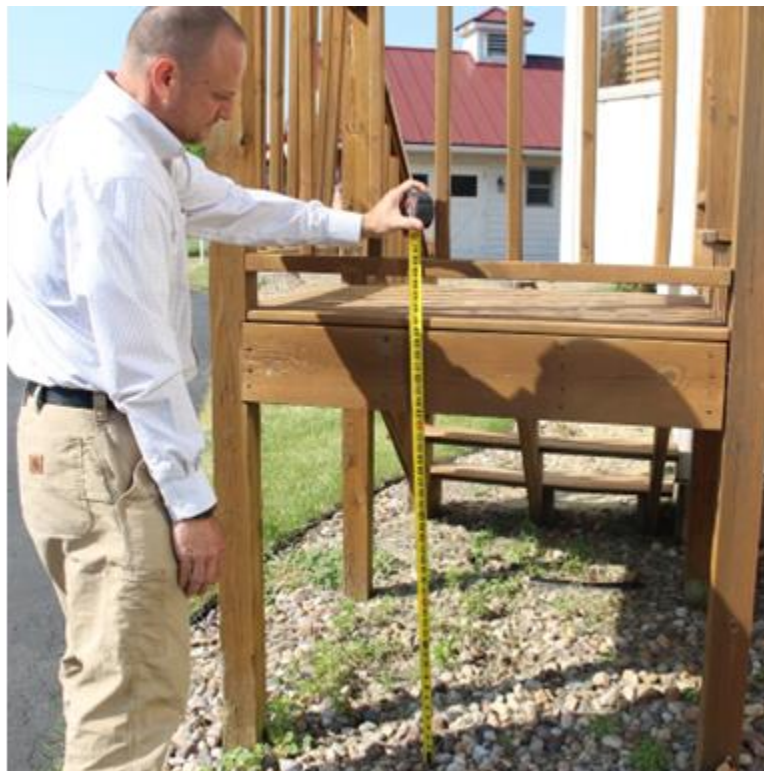
For safety, rail and guard systems are required on decks that are 30 inches or more off the ground. Rail and guard systems are supposed to resist a 200-pound lateral load applied at any location (International Residential Code, 2018 – Section R312, R312.1.1). In this case, the deck height is 41 inches (Figure 4). In addition, the rail-to-post connections have completely failed in several locations (Figure 5 a-b). This failure renders the guard system unable to resist any loading. It appears that the rail-to-post connections were initially and inadequately connected with non-structural #4 or #6 finish nails. This connection detail likely contributed to guard system failure. It is recommended that this stair / stoop structure be immediately and actively closed to prevent any use, until it can be replaced.

Figure 4 Dr. Shmulsky is measuring the deck height to ensure it is up to code with the International Residential Code.

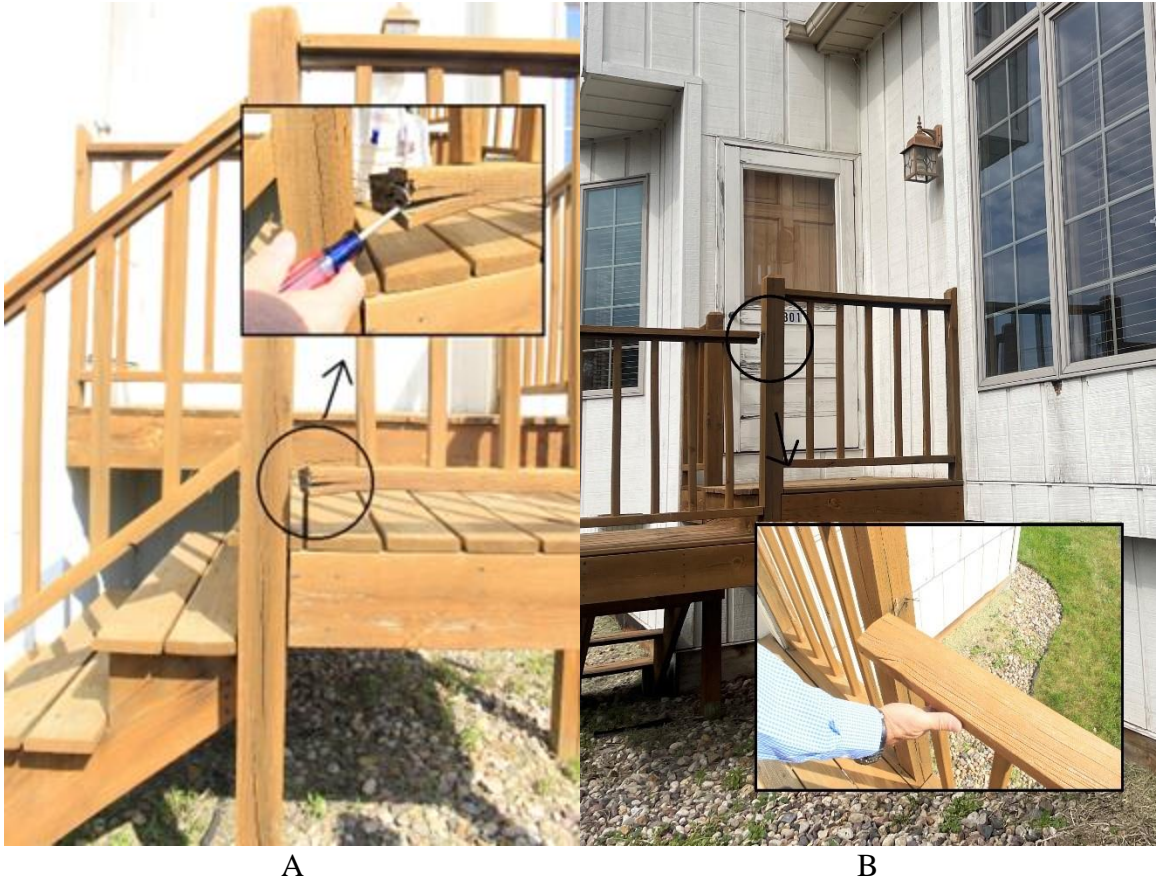
Figure 5 A and B, the images are of the back deck, and it shows the problematic areas. Images of the rail-to-post connects have completely failed in the highlighted location.

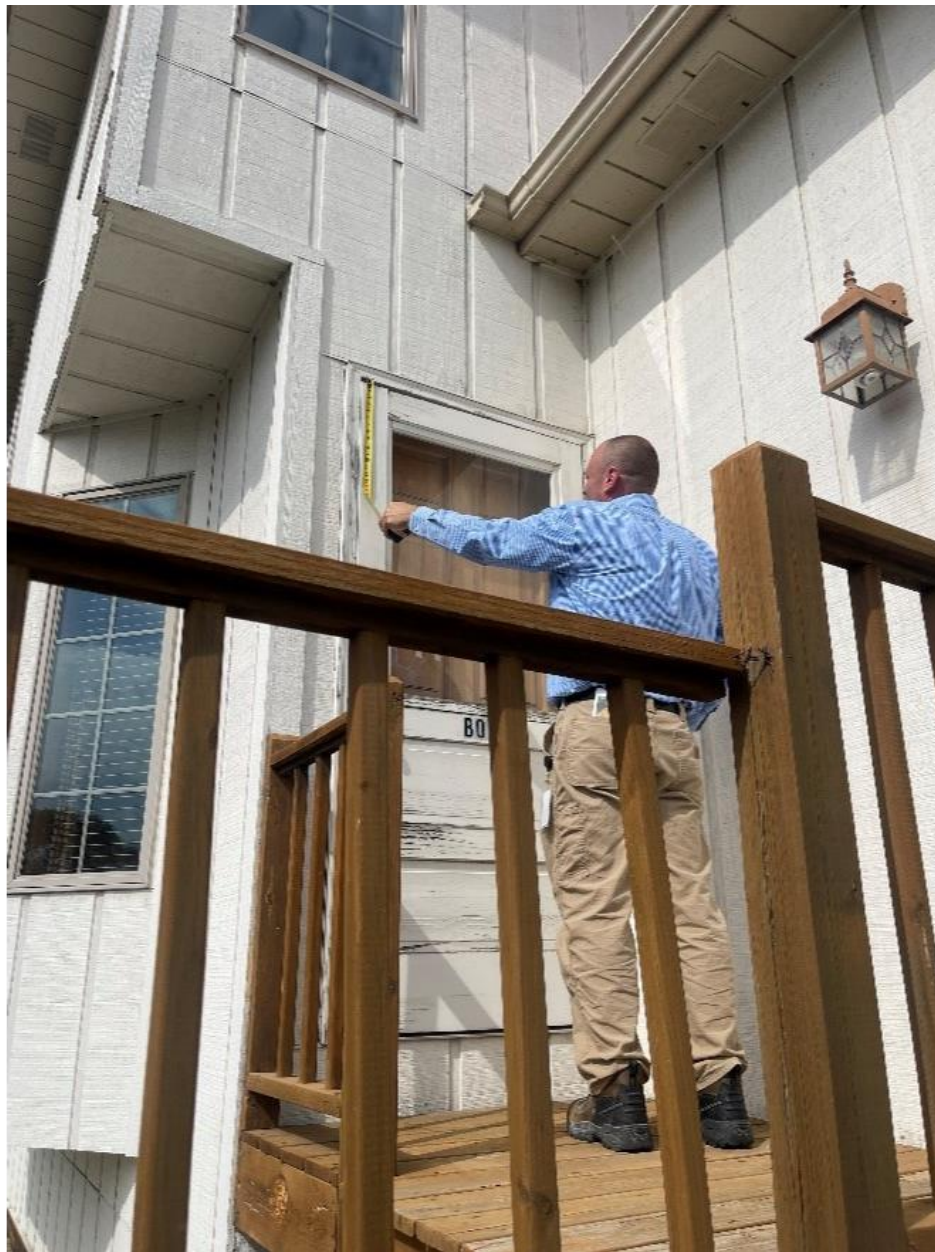
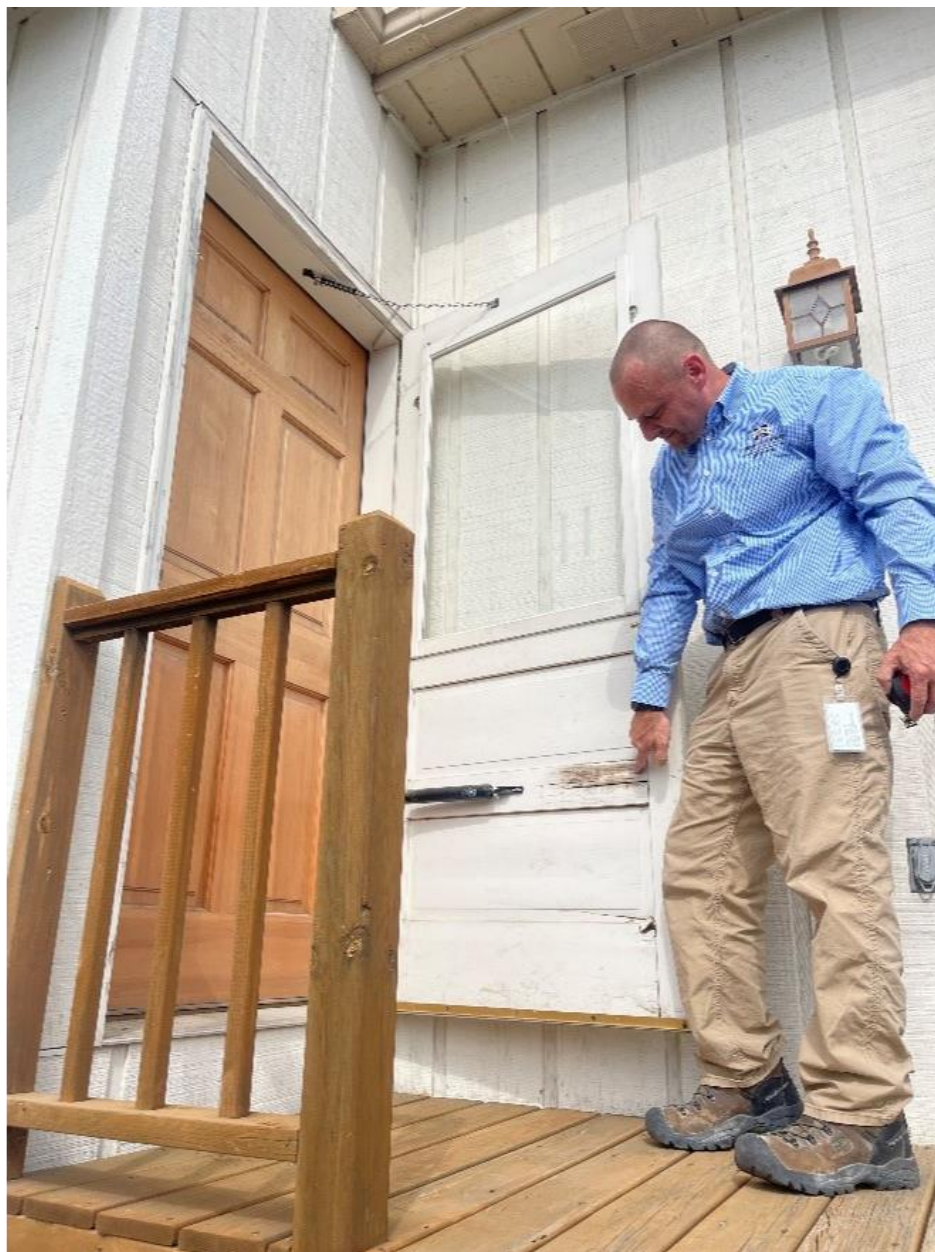
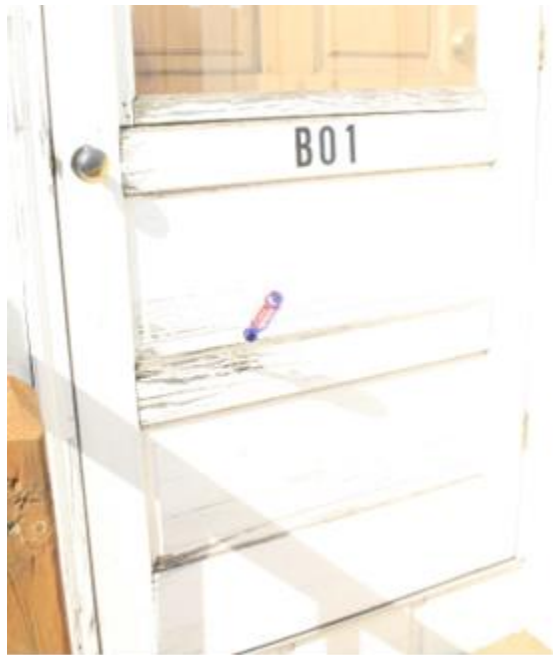
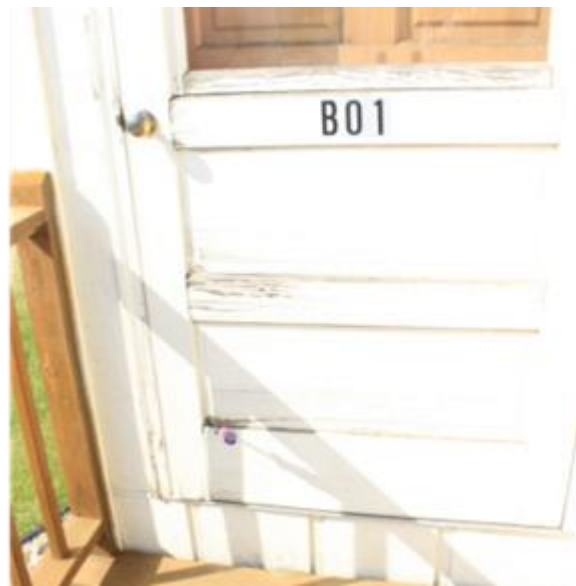
Also, the storm door leading from the kitchen to the stoop has deteriorated beyond repair (Figure 6, a-d). In its current state it is not functioning as needed, that is, as a means of preventing water infiltration into the structure. Replacement or removal of the storm door appears to be the only options to restore its intended functions of energy savings and protection from water intrusion.

Figure 6 A through D, Images of figures A through D shows images of the damaged storm door from the back deck. The images show that the door is severely deteriorated.

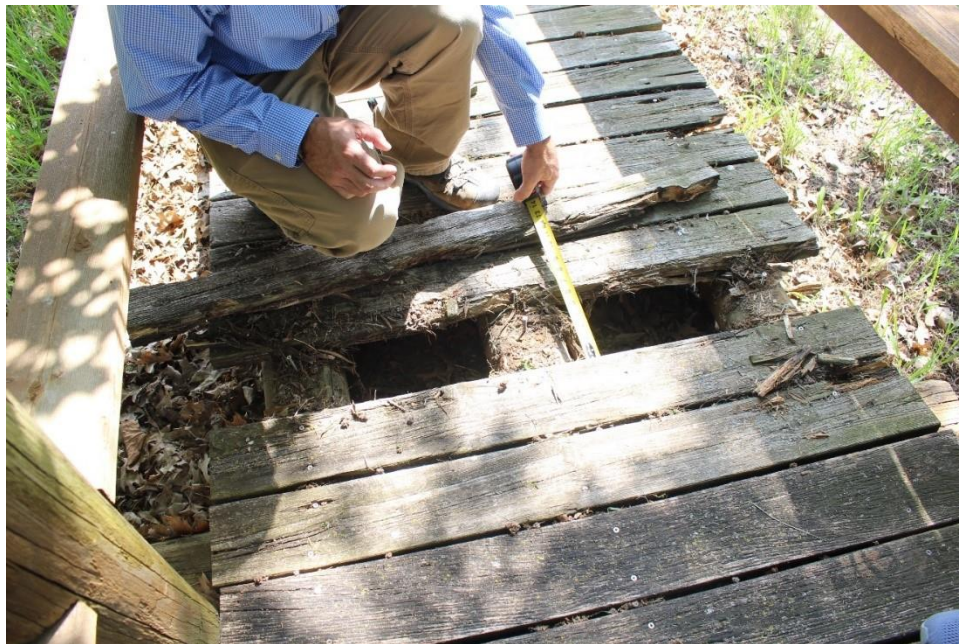
The accessibility ramp is severely deteriorated. The structural posts, carrying beams, deck boards, and rails are all deteriorated to some degree. Some of the deck boards have deteriorated to the extent that they can be removed by hand and are at risk of bending failure (Figure 7). Many of the structural posts are decayed at their cores and hollowed out to the extent that they do not securely hold the rails. In many cases the rails can be lifted off the posts (Figure 8, a-d). The rails were let-in to the posts by mortise and tenon type construction. The mortise pockets appear to have served as water traps. As a result, the tops of the posts are severely decayed to a depth of approximately 12-inches or more. As such, the posts are no longer able to hold or remain fixed to the handrails. In many cases the handrail boards are also decayed particularly at the end. Some of the support cross beams that are affixed to the posts and support the deck framing, are severely deteriorated in their cores (Figure 9).

Figure 7 Dr. Shmulsky is measuring the deteriorated area with a tape measurer to get the width of the deteriorated deck that was removed. Some of the deck could be removed without effort as illustrated in the image above.

In sum the posts, carrying beams, decking, and handrails are severely decayed and need immediate replacement. Because many of the deck boards, many of the support beams, the structural posts, and the handrails are severely deteriorated, the structure must be closed and actively blocked. Two of the three entrance points to the ramp (that is the two along the paved driveway are posted “closed” and blocked with rope in (Figure 10). One of the three entrance points to the ramp, that is the location where the ramp connects to the front porch, is open (Figure 11). This entrance point must also be actively blocked and posted as closed to prevent pedestrian access to the ramp.

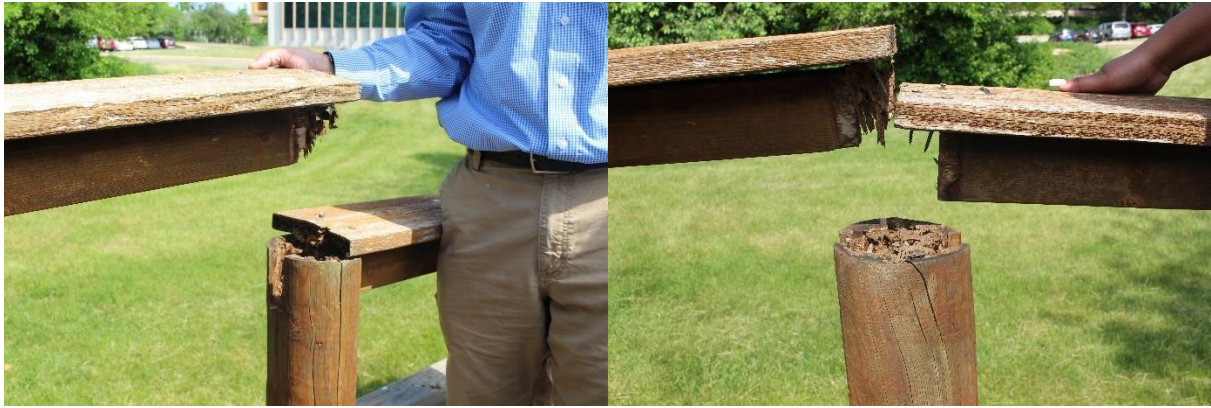
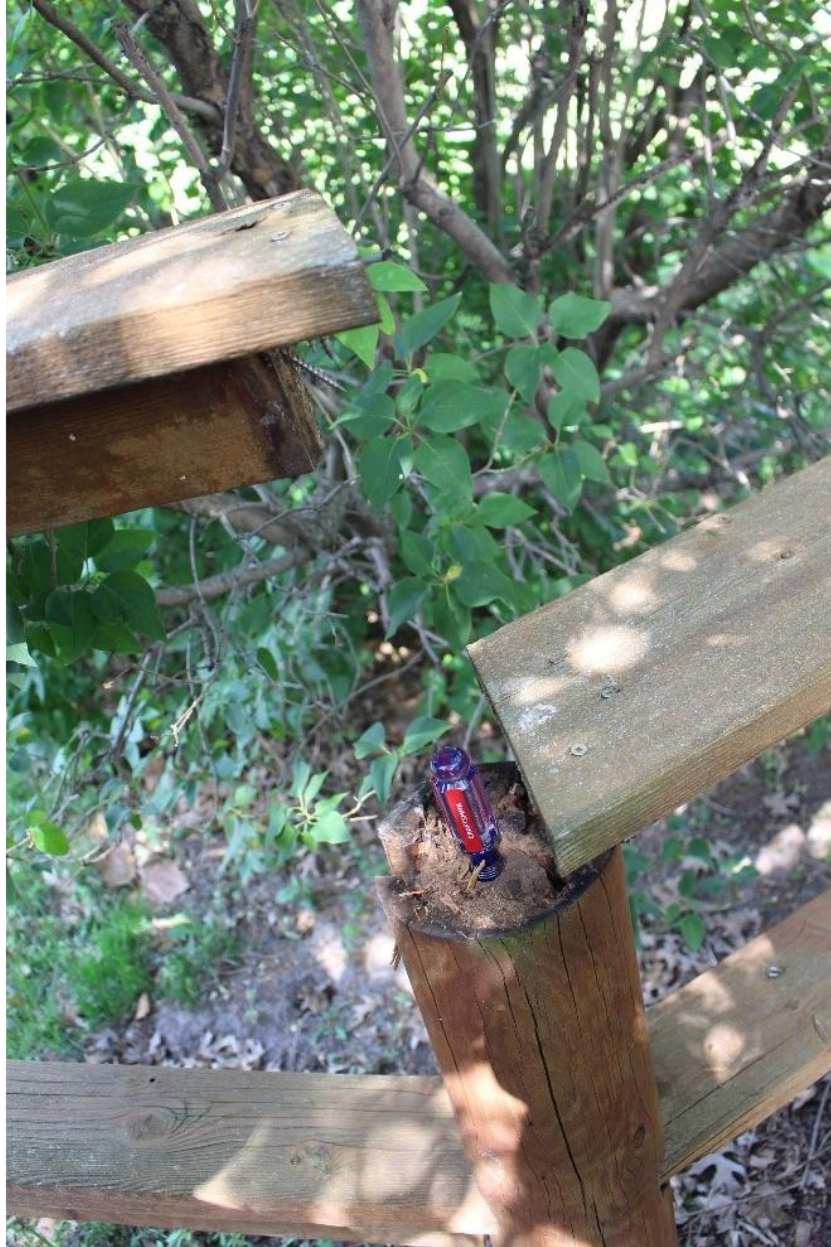
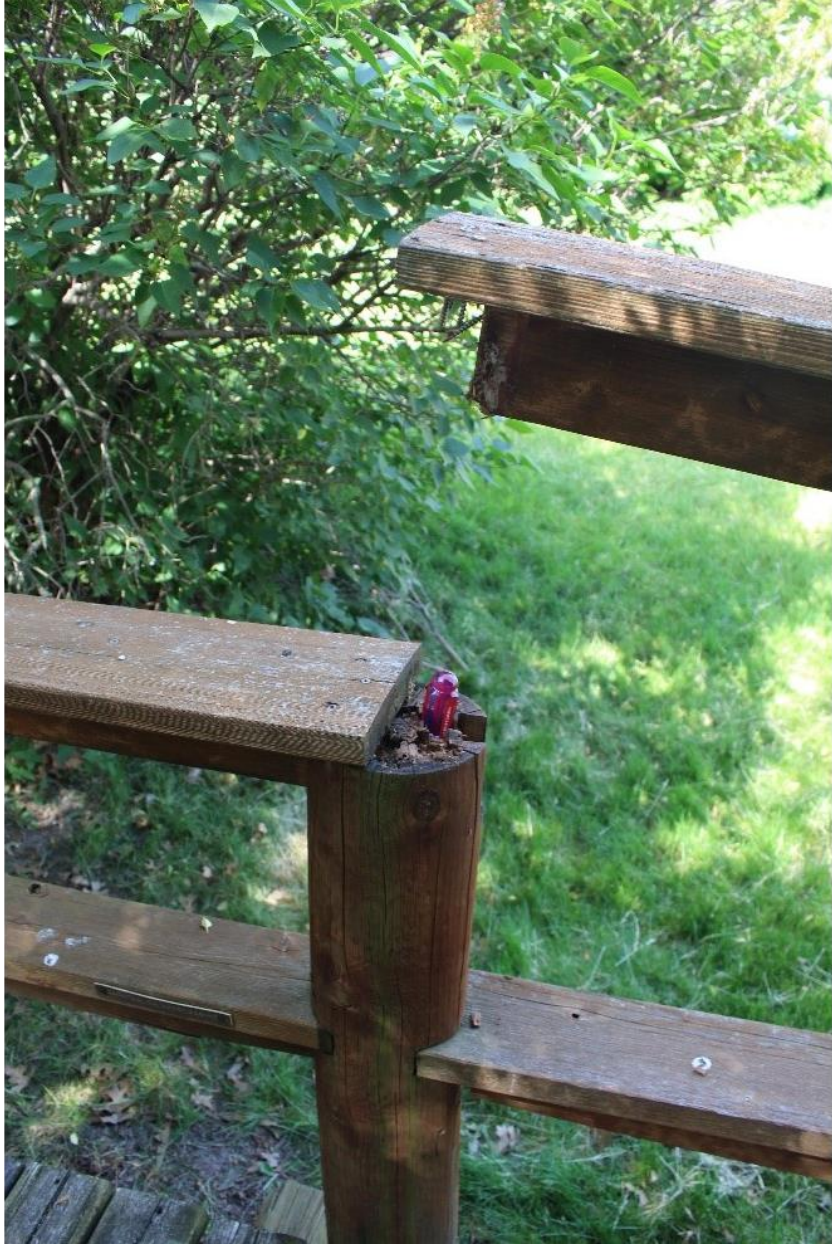
Figure 8 A through D, Deteriorated rail-to-post was severely decayed and the rail can be removed from the post and the post was also decayed. When probing the post with a screwdriver, the screwdriver went in the post without much effort.

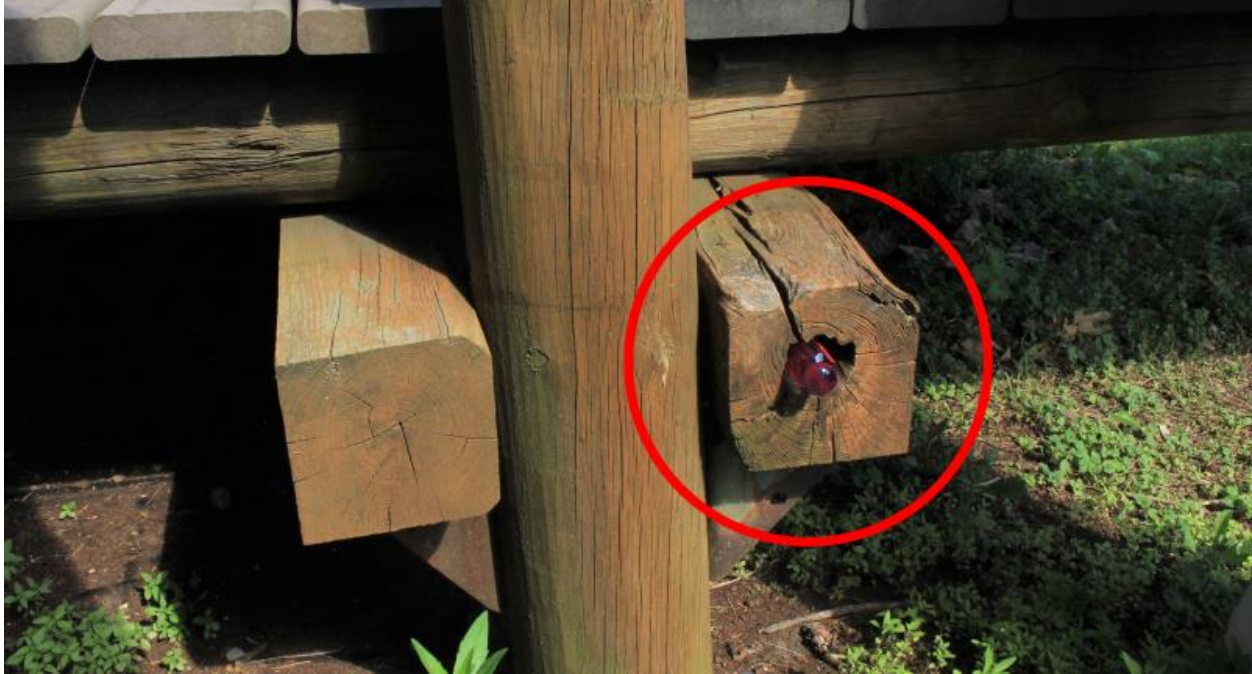
Figure 9 The image shows advanced decay in carrying beams which support the floor frame of the accessibility ramp. The screwdriver is in the decayed area in the carrying beam, the image shows dept of decay.

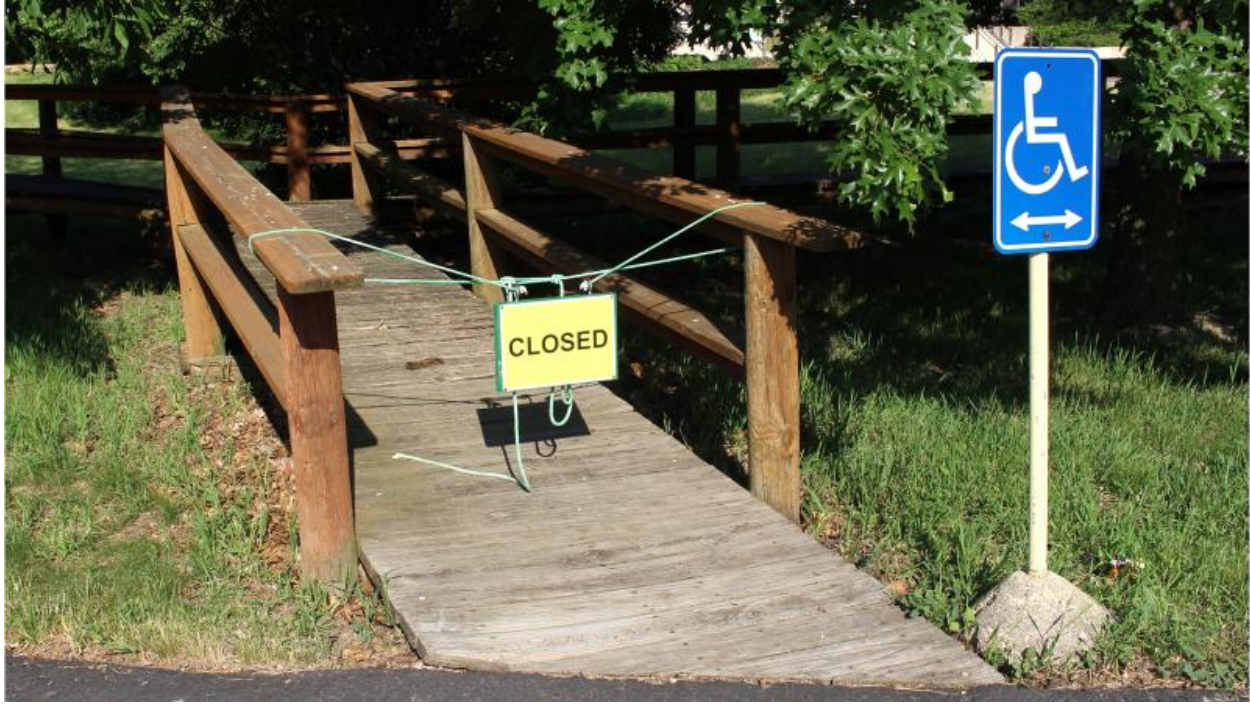
Figure 10 The image is one of the entrance ways to the accessibility ramp and its exemplar “Closed” sign and rope barricade at one of three entrance points to the accessibility ramp.

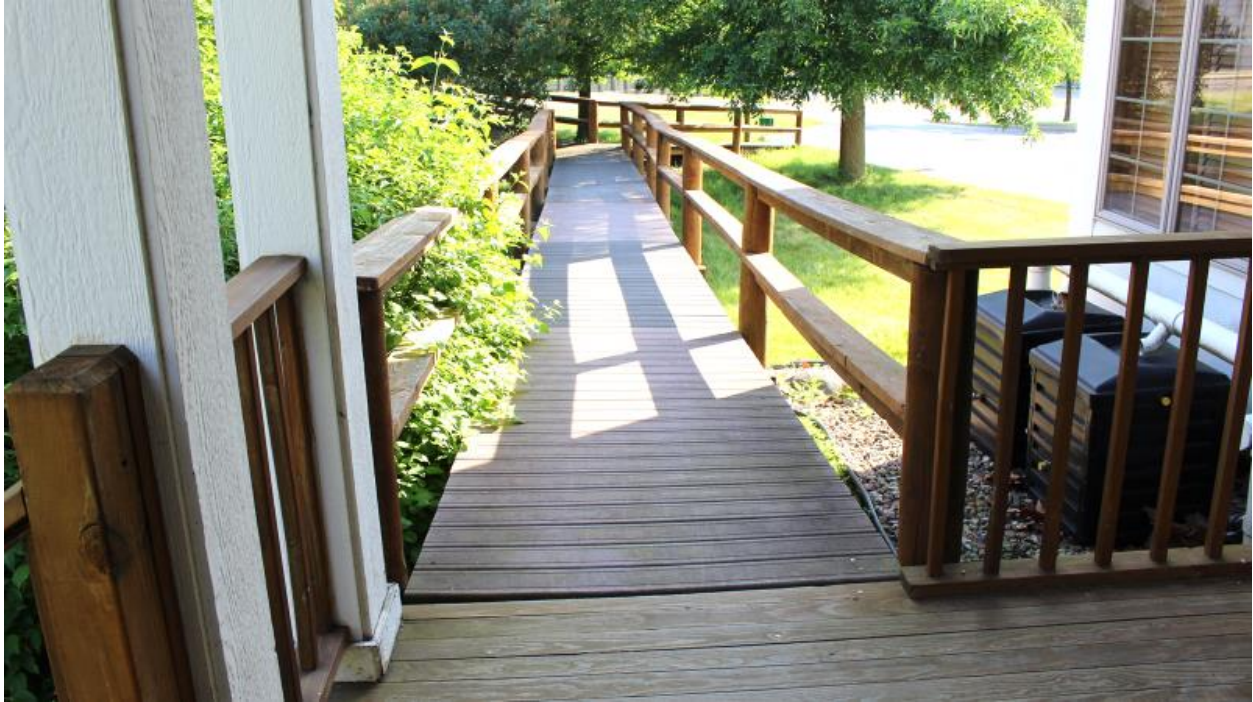
Figure 11 This image of the accessibility ramp from the front porch view. The images shows that the area should have a closed sign as in figure 10.

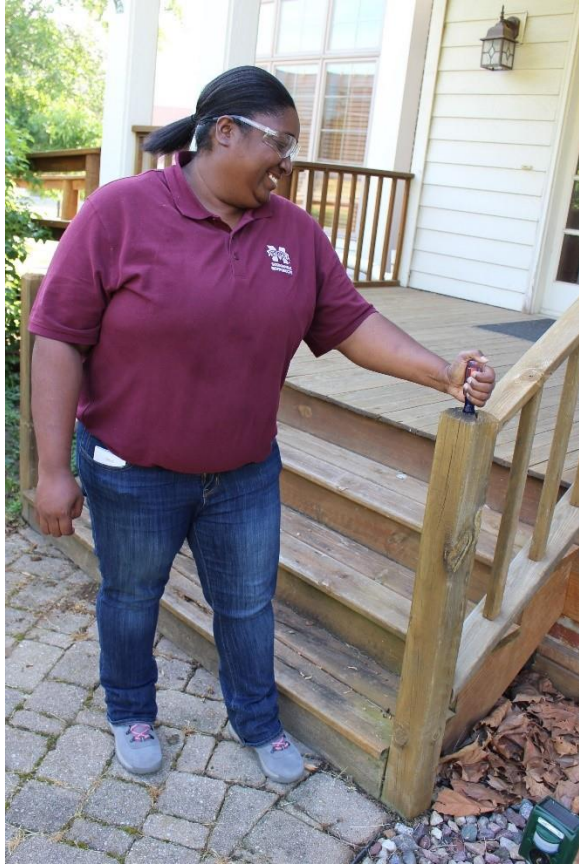
The front entrance deck rail posts have decayed. A screwdriver was inserted into the top of the post to probe the extent of the decay (Figure 12). The bottom of the post appeared to be connected to the stair stringer with screws. This method of post fixity is not considered sufficient to provide the 200-pound resistance as required by the building code (International Residential Code, 2018 – Section R312, R312.1.1). The stair treads were decayed. Screw drivers were inserted into the decayed portions to probe the extent of the deterioration (Figure 13 a and b). The porch flooring near the top of the steps has become unfastened due to fastener corrosion and rust and post trim showing signs of deterioration (Figure 14 and 15). It is recommended that the porch steps, posts, rail, and guards, be replaced and the porch decking be refastened or repaired as necessary. Ceiling tongue and groove indicated that the porch takes on moisture (Figure 16).

Figure 12 The student is inserting a flat head screwdriver into the post to indicate decay is present in the structure.

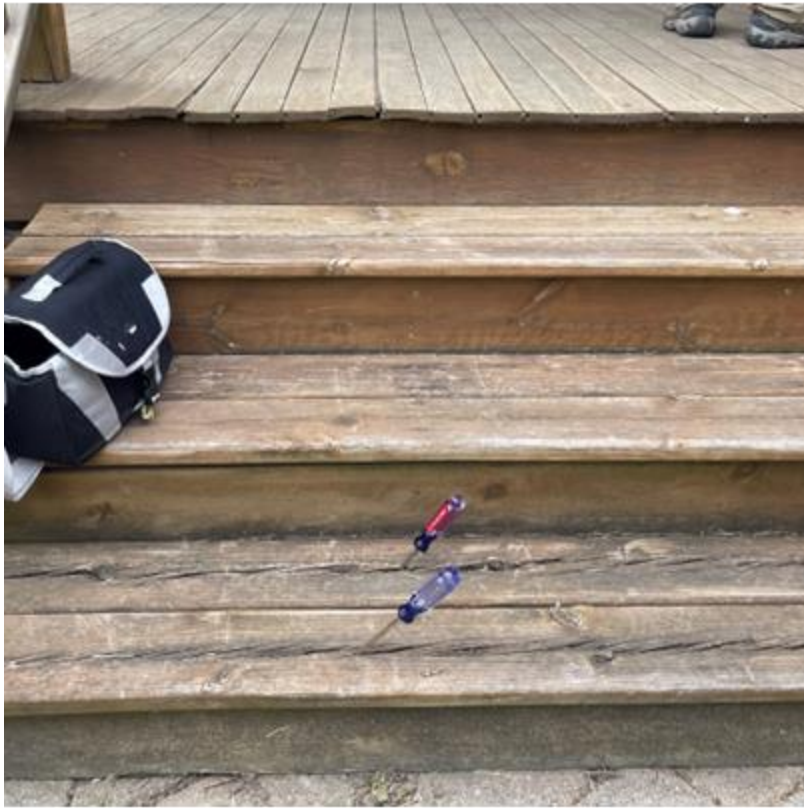
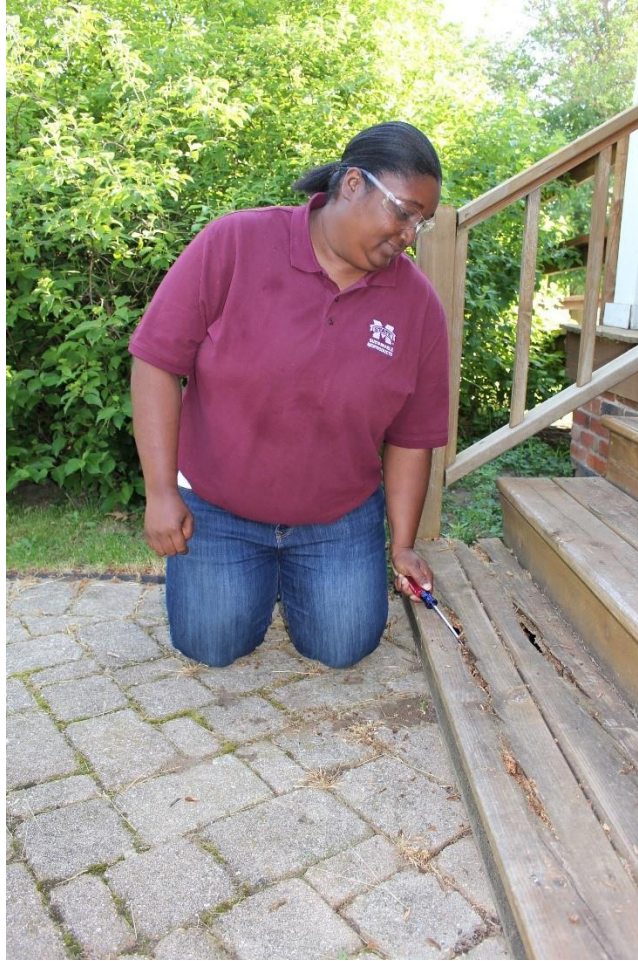
Figure 13 A and B, in image A screwdrivers were inserted into the decayed portions to probe the extent of the deterioration, however, in image B, students kneeling to insert screwdriver into the front porch step. The screwdriver was inserted into the decayed portion to probe the extent of the deterioration.

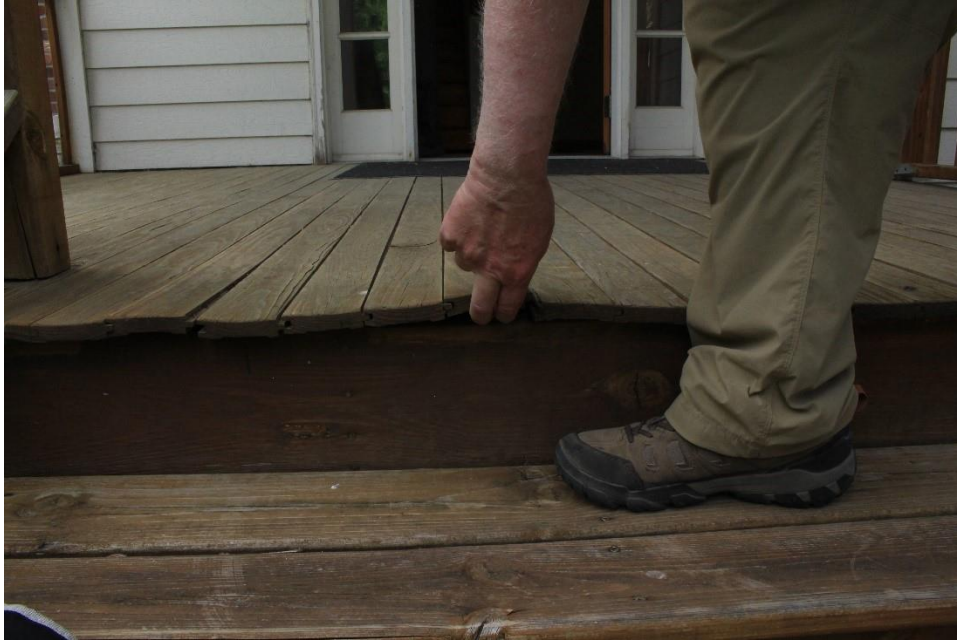
Figure 14 Dr. Ross is bending over to show where the front porch can be lifted, therefore, the porch flooring near the top of the steps has become unfastened due to fastener corrosion.

It is noteworthy that with the entrance ramp closed due to major deterioration failure, the decay and failure of the front posts and treads, and the immediate need to close the rear steps and stoop due to fastener and other failure, at present there is no safe means of entering or exiting the building. The guard and railing system at the front porch is fastened with small (approximately 4d) finish nails, like the back stoop. This fastening system is inadequate and should be replaced.

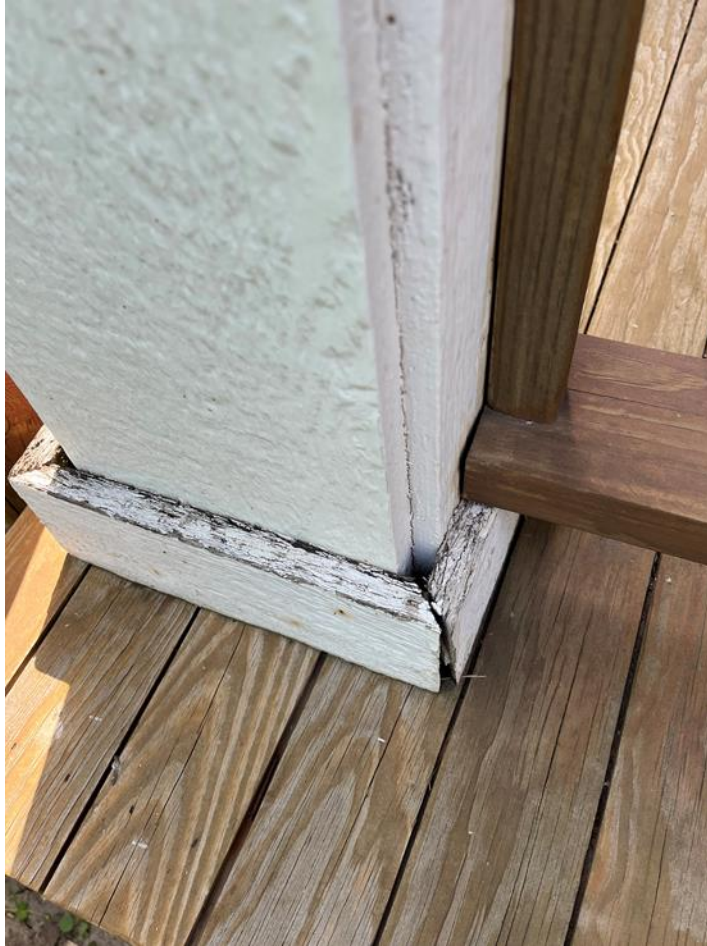
Figure 15 The image is still of the front porch entrance and the post trim showing signs of deterioration.

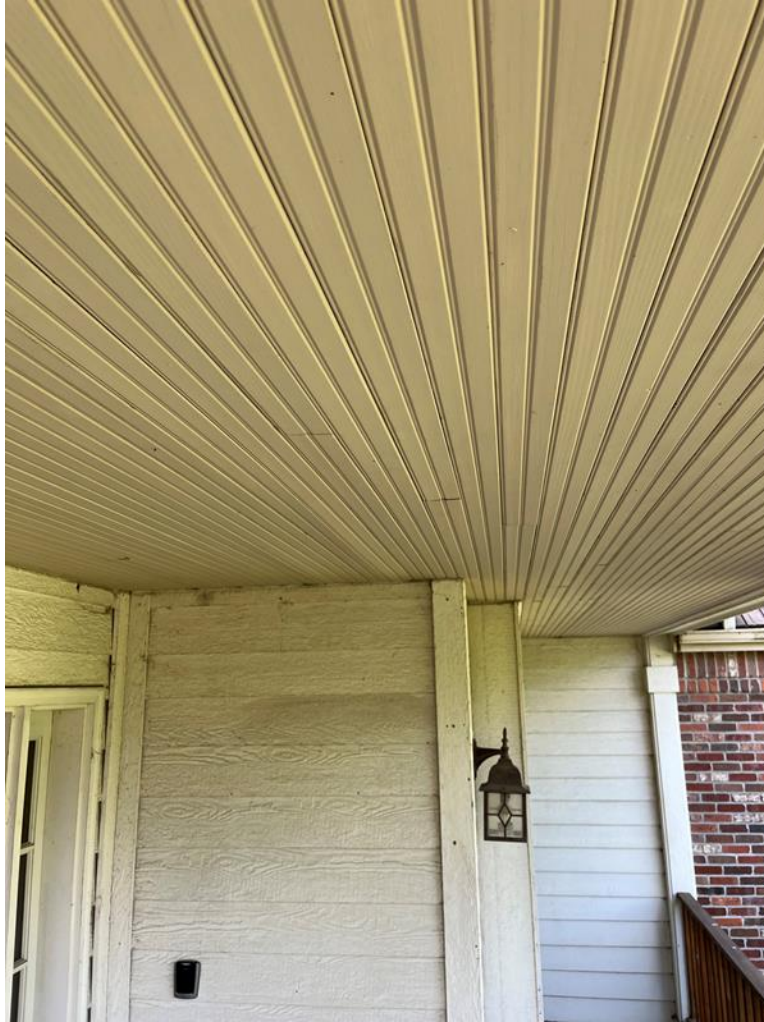
Figure 16 The image is of the front porch ceiling, and the photo depicts tongue and groove ceiling swelling indicating moisture issues.

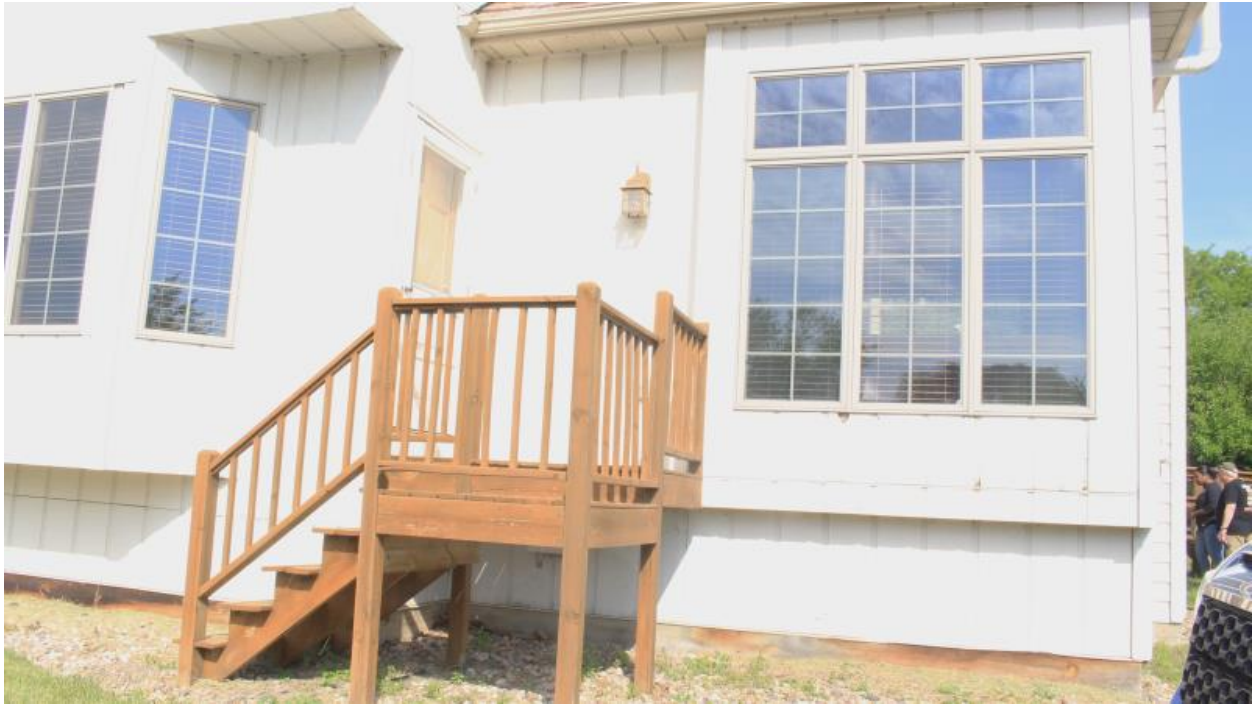
Most of the siding (cladding) on the house is Texture 1-11 (also known as T1-11) plywood. There is also an 8-inch-wide oriented strand board lap siding as well as stucco and brick veneer in small areas and on some wall portions. The T1-11 siding is failing due to decay in places along the Southeast and Southwest sides of the house. The worst location is in the vicinity of the dining room, particularly near the triple-mullion dining room window (Figure 17 and 18). The siding under and around said window needs replacement. In other places the siding is beginning to rot, particularly at the lowermost edges of the various T1-11 panels. These bottom edges often become water traps which do not readily drain and dry. There is decay in the vicinity of an electrical conduit/LB conduit body penetration on one of the Southwest walls. Some of this decay may be accelerated because there is a large tree located near the exterior siding (Figure 19). The proximity of the tree to the siding prevents and/or retards redrying of the siding after rain events. As such, the walls remain wet longer than otherwise possible thereby accelerating decay.

Figure 17 The image is the back deck of the demo house where the T1-11 siding is mostly located on the house and the image shows signs of decay and missing pieces of the siding.

Should the structure be kept then repair and replacement of the siding is in order.

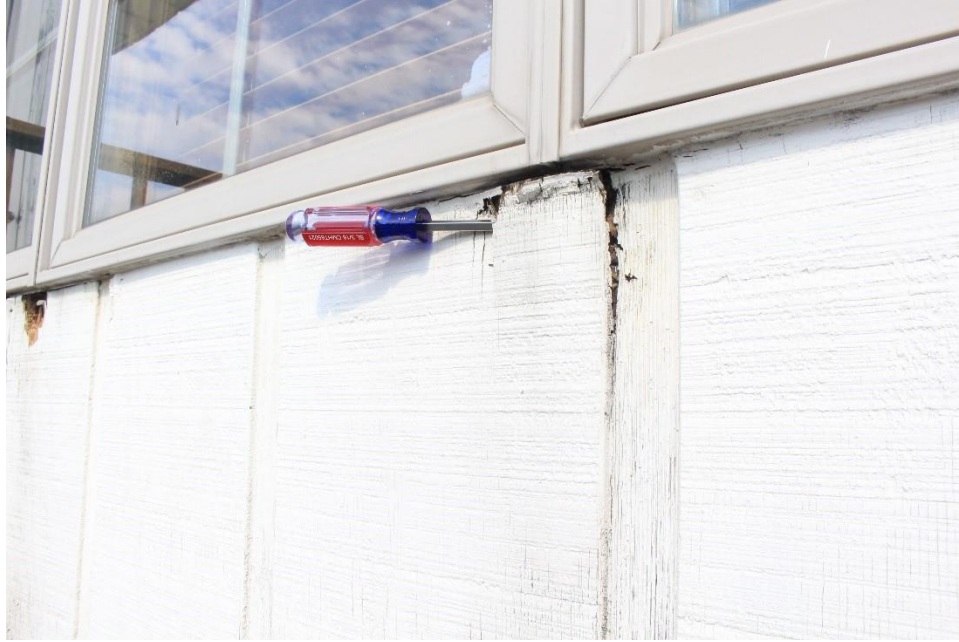
Figure 18 This image is a closer look at the siding and the siding is deteriorating beneath the vicinity of the triple mullion dining room window. The screwdriver is inserted in the decayed area to indicate that the area is deteriorating.

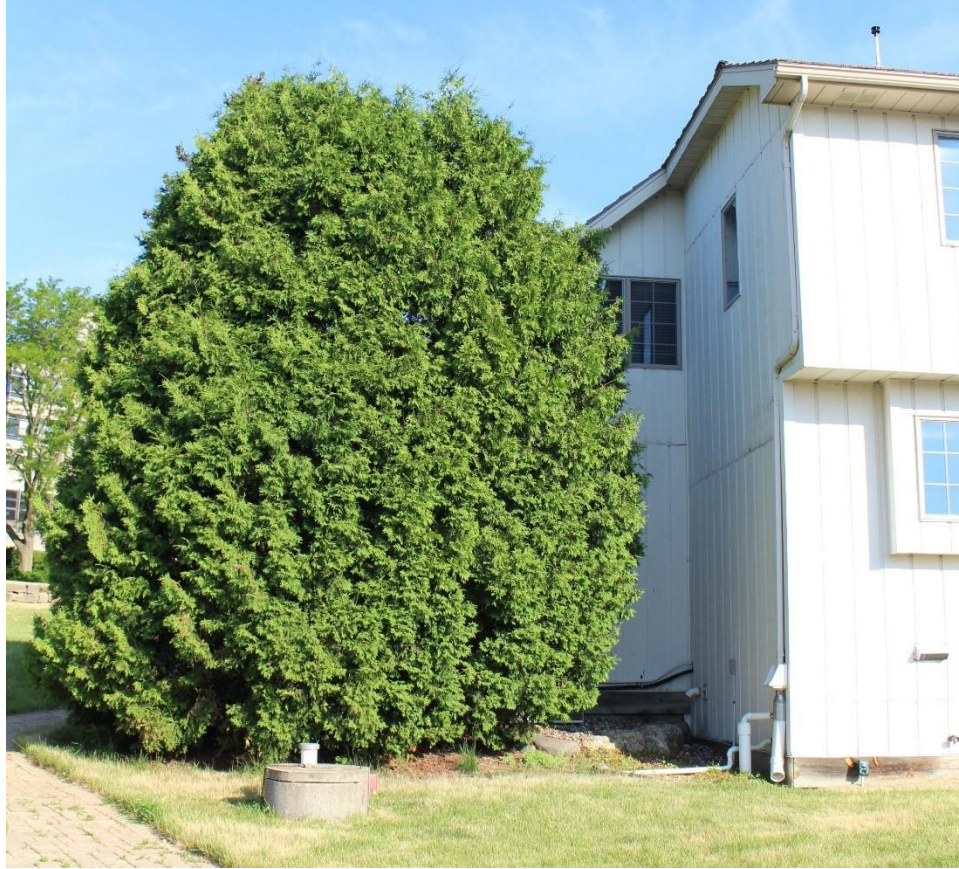
Figure 19 This image is a large cedar tree near the house, which is located on the Southwest side of the house where decay may be accelerated because of the tree due to the fact that there's not enough sunlight which means more moisture is acceptable in this area.
