Condition assessment of the northern climatic research house at the USDA forest service forest products laboratory

Tanaya Johnson

A Thesis

December 2023

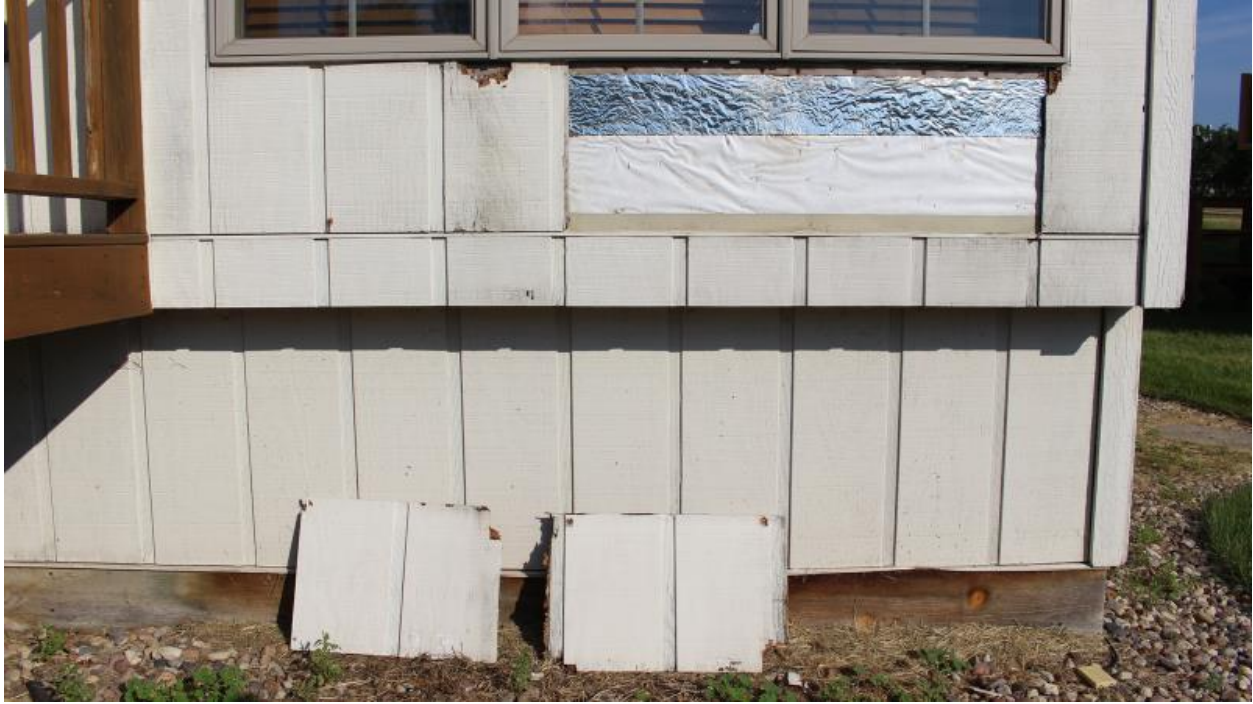
During the inspection, an approximate 18 × 48-inch section of T1-11 siding was removed from under the dining room triple mullion window unit (Figure 20). The house wraps and flashing beneath the siding appeared intact and functional. The sheathing was probed by striking it with a hammer (Figure 21). The sheathing appeared intact based on the hammer's sound and return bounce upon striking. Because the sheathing appeared intact and not decayed, it is assumed that the wall framing beneath the sheathing in this area is also intact and not decayed.

Figure 20 This image shows the section of T1-11 siding removed beneath the triple mullion dining room window to prepare to test the silver area to indicating if moisture is present behind the siding.

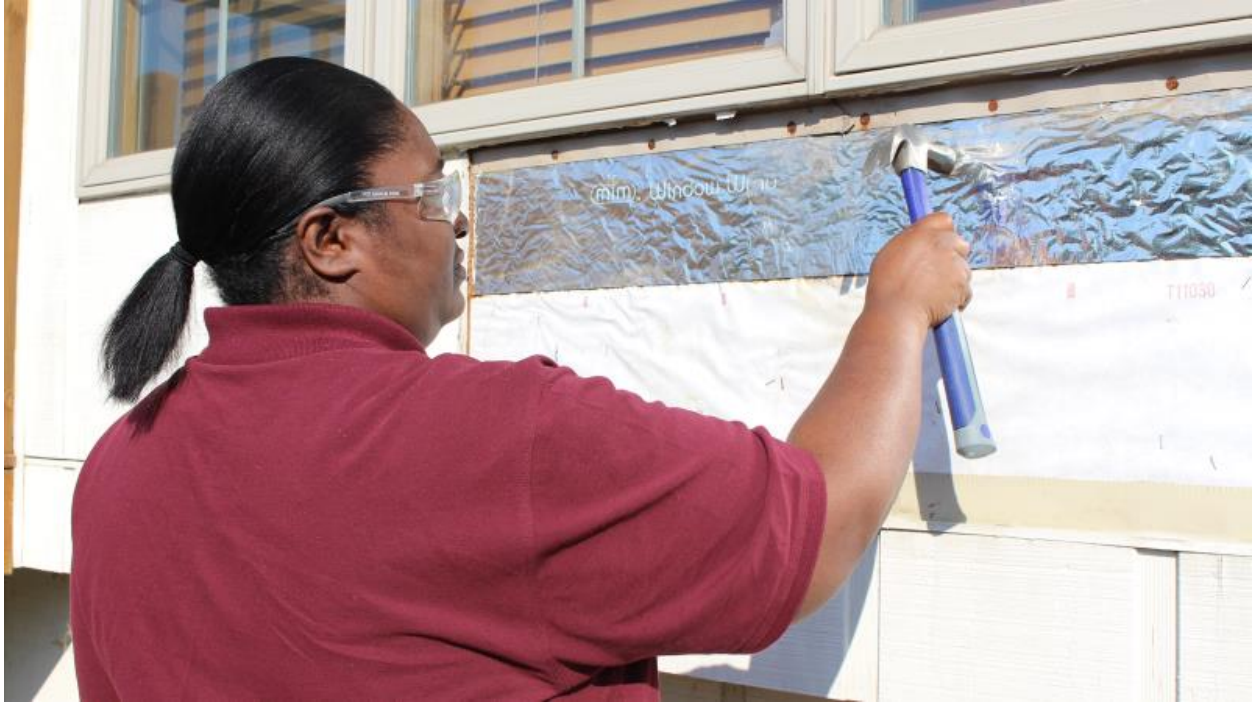
Figure 21 This image is illustrating the student using a hammer gently striking silver area underneath the side to determine if moisture is present.

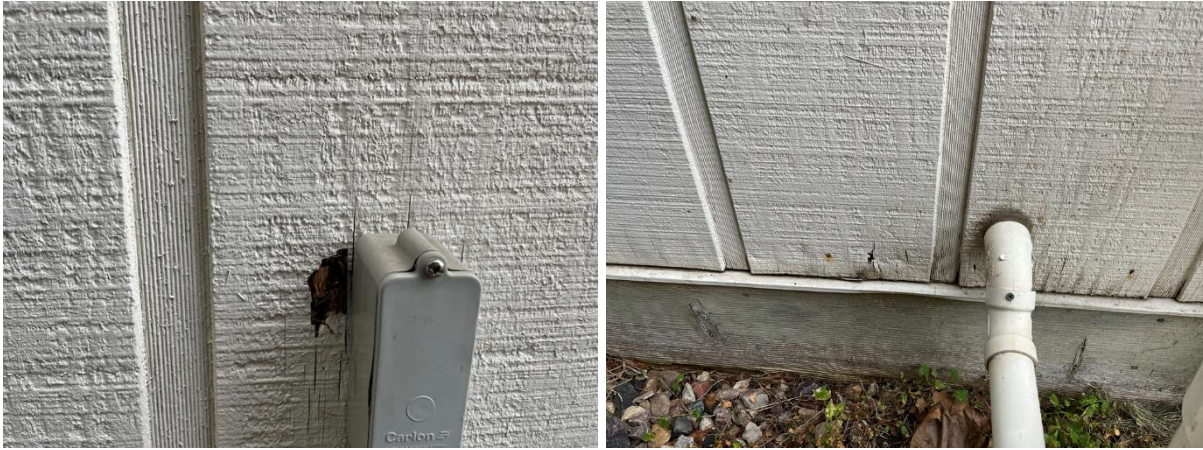
Siding in other areas where utilities are attached are showing similar signs of decay (Figure 22) and some trim boards are showing signs of decay due to failure of paint (Figure 23).

Figure 22 The photograph is of the areas where utilities are attached and show similar signs of decay.

Should the structure be kept then repair and replacement of the siding is in order.

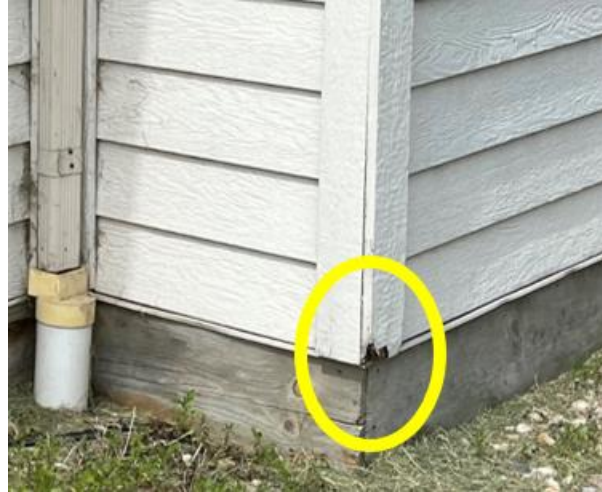
Figure 23 The image is of the trim boards of the house and the trim boards around the house are showing signs of decay due to failure of paint.

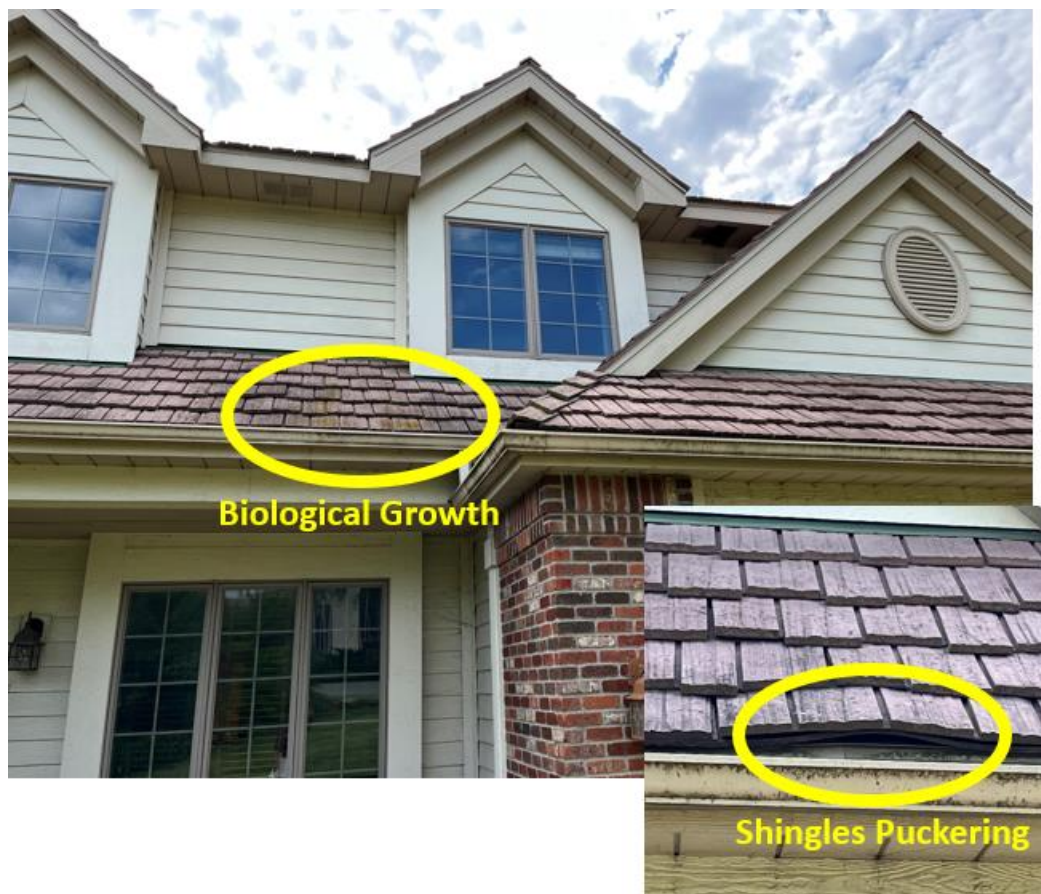
The roof shingles appear to be hand-split cedar shakes but are actually a wood-plastic composite material made from wood recycled plastic milk containers. From the exterior, it is noted that the roof shingles are puckering (also known as buckling or lifting) in many areas. To the assessors' knowledge, the shingles are composite. Densified and compressed composites swell when exposed to moisture over prolonged periods. This swelling causes adjacent shingles to push on each other and ultimately lift off the roof structure. On the front side of the house, over the garage door and over the porch entry, it appears that both the shingles and the roof sheathing are lifting off the roof framing. The shingles are showing signs of biological growth,

this is an indication of water being held on the surface of the shingles (Figure 24). As the shingles pucker and lift / separate off the roof, their ability to resist wind and shed wind driven rain decreases. Similarly, when roof sheathing swells and lifts off the roof framing, it loses its ability to shed wind-driven rain. The intrusion of said rain then ultimately leads to deterioration within wood framing. Additionally, water damage is noted in the main stairwell between the first and second floors. This is noted as a small blackish colored hole at the top of the stairwell ceiling, with rust colored splash marks beneath said hole. This moisture intrusion appears to be coming from a hole or penetration in the roof.

Figure 24 The image is of the roof shingles and the shingles showing signs of weathering. Biological growth and puckering can be seen on the shingles of the roof.

During the condition assessment no shingles were removed for inspection of the roof sheathing and truss/rafter roof framing. Additionally, from the attic, the roof framing and sheathing at the eaves, over the garage, and elsewhere were inaccessible. As such, given the appearance of the puckered shingles and swelled sheathing, one must assume that there is some level of water-intrusion related damage to the sheathing and framing. As such, repair and replacement of at least a portion of the roof sheathing and framing should be included in any type of roof repair cost estimation.

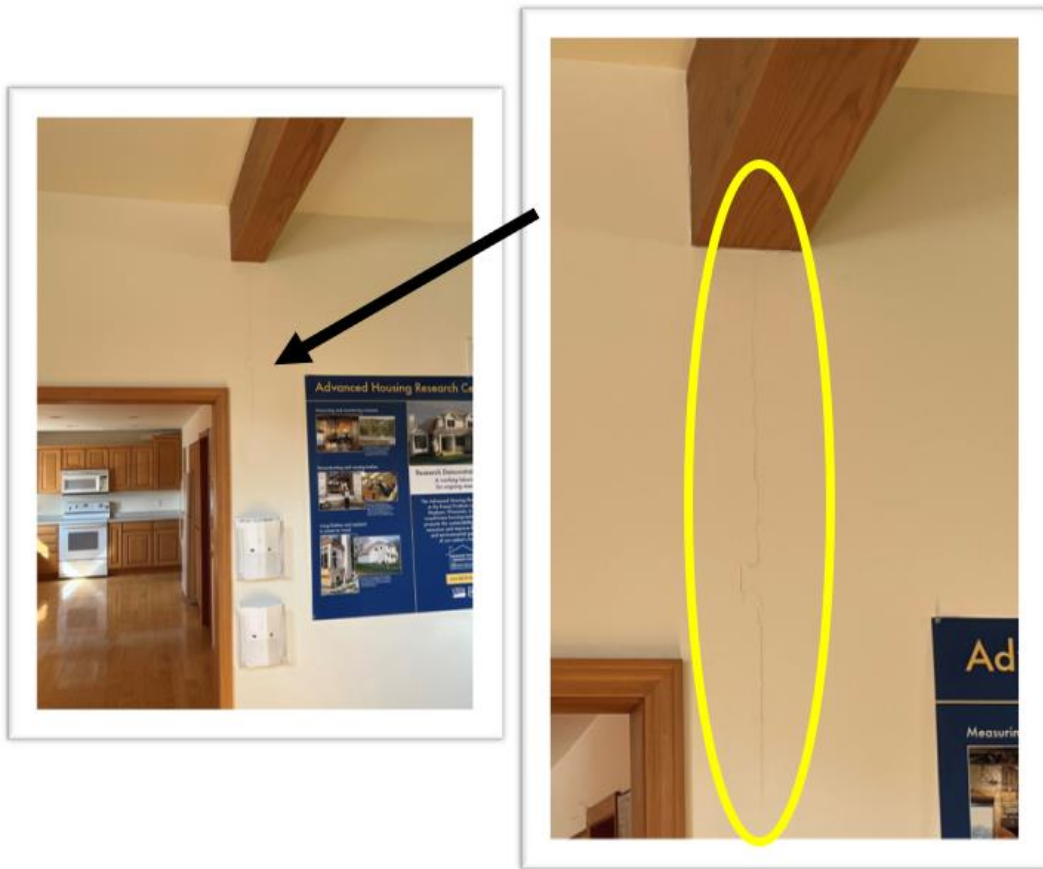
Other issues may be with the soil around the house's foundation. Signs of fracture or buckling of the dry wall can be seen in (Figure 25). A corresponding un-leveling in the basement could explain the buckling of drywall. Deconstruction of the basement floor would be needed to investigate the issue. This may be from soil erosion from rain and moisture. Soil erosion can be seen in front of the garage (Figure 26). A possible contributor to the foundation / soil settling issues is the disconnected downspout. The downspout is located at the front of the house, near the location where the accessibility ramp connects to the porch. The downspout is supposed to be connected to a water collection and drainage device. The downspout is however disconnected.

Figure 25 A fracture or buckling of sheet rock in the great room and the right-side header inside the great room shows fracture or buckling in the drywall above the door opening.

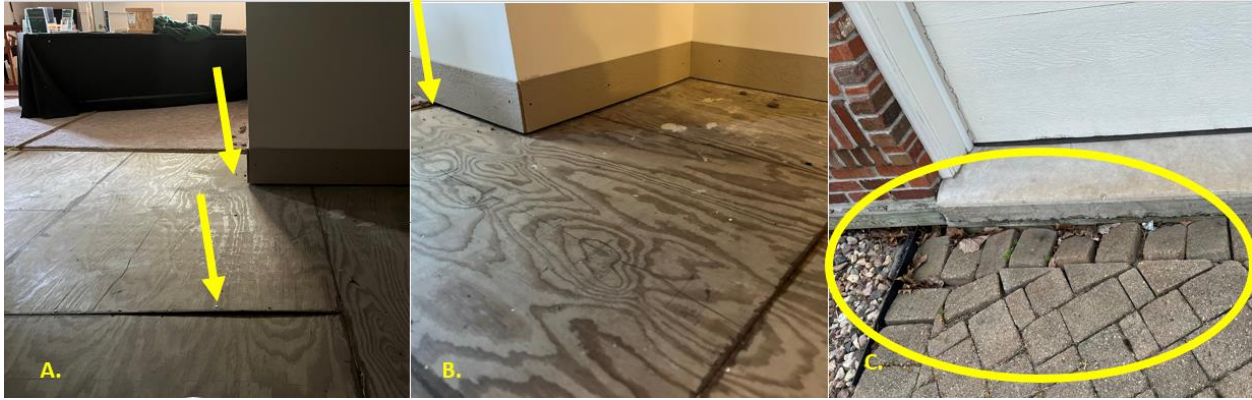
Figure 26 These images show signs of settling in the foundation, photo located in the southwest portion of the basement and top left photo in front of the carport. The treated plywood foundation shows un-leveling underneath the flooring.

permanent wood foundation, including removal of a portion of the basement flooring and wall coverings to access the treated wood framing is recommended.
