Behavior of hydropower plant "La Yesca" Mexico, after two year of built

This paper presents the program instrumentation, monitoring and performance of Hydropower Plant "La Yesca", which is a concrete face rockfill dam, with 207,5 m high (inaugurated on November 6, 2012). During de filling of the reservoir, high leaks where measured on the drainage gallery of the curtain and on the injection and drainage galleries, particularly on the right bank. To reduce the anomalous seepage in the galleries a series of studies were done to define the source of the leaks and implement corrective measures. Currently the embankments of the dam and the concrete face show a good behavior. They present less than 20 cm of maximum settlement from the reservoir filling and two years

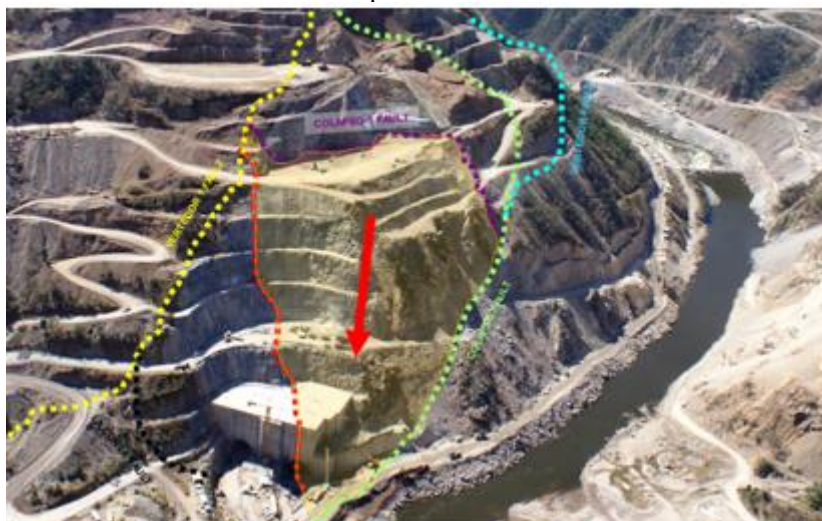
Figure 3. Block in unstable left margin faults delimited Collapse, Collapse 1 Collapse 2 and the granitic dike entrance portal diversion tunnels

In October 2007, excavations began to build open portals of the tunnels that were used to divert the Santiago River then late February and early March 2008, excavations began underground entrance gates of the two tunnels, the portals of a tunnel out and cruise, respectively. The volumes of surface excavations entry portals were the order of 400 000 m³. This caused the slope of the left bank lost support, which combined with the vibrations induced by blasting rock for underground excavations, restarted a movement of a large block of rock through a preexisting fault plane consists of a clay layer with a thickness of 10 to 80 cm.

The instrumentation of the rock block revealed that reactivation of motion displacement reached speeds of up to 9 mm/day in its critical stages, between the months of June and July 2008, therefore the “CFE”, conducted during 2009 execution a series of activities to evaluate and analyze the stability of the area mentioned. These studies allowed defining the boundaries of the unstable block bounded by faults being Collapse, Collapse 1 and Collapse 2, with an area of involvement involving Diversion Tunnels, an area of the plinth and the final closing port (Figure 3).

Due of damages caused by the unstable block, the dam axis turned 12 degrees to the left bank downstream, thus eliminating this problem partially, being to ensure the stability of the rock block during construction and service life of the dam, which led to the design and construction of some stabilization works.

The stability analysis showed that rock block to ensure minimum safety factors of the work under different conditions of actions would be subject to the dam, first during its construction and later in its life, it was necessary to implement various works of stabilization [1]. As a first measure withdrew a significant amount of material in the upper part of the block, in stages, of the order of 1 550 000 m³. Additionally we constructed a concrete monolith at the foot of the rock block to support it, which represented a volume of 110 000 m³. The impact of each of these works in the stability of the block is shown in Figure 4, with a speed of movement at the beginning of this of 117,4 mm/month to 6,5 mm/month at the end of the first stage material removal at the top of the block. Subsequent stages of excavation and construction of the monolith reduced movement speed values on the order of 1 mm/month, with an outspoken tendency to stabilization.

Due the rapid drawdown, water levels in the dam and the seismic stability conditions in the rock block were critical. It was necessary to design and construct additional stabilization works as the case of a wall formed by six plain concrete piers 9 m diameter each one and varying depths between 60 and 85 m (Figures 5 and 12), which crossed the fault Collapse and were embedded in the underlying bedrock. Additionally, diversion tunnels were filled with reinforced concrete in a certain length (190 m in the tunnel 1 and 175 m in the tunnel 2), at its intersection with environment collapse failure, to make them work as a large anchor (Figures 5 and 12).

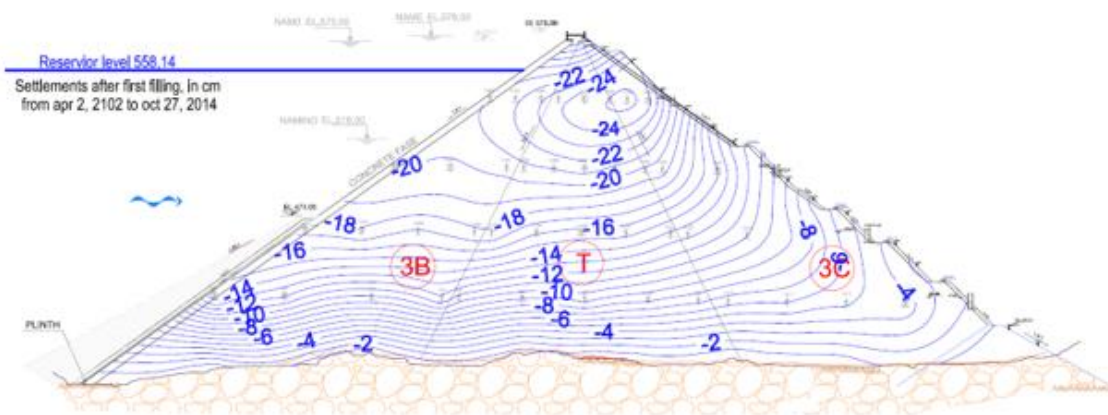
Figure 8. Contours of settlements in the maximum section (L-21) of the rockfill during the filling of the reservoir and the two years of operation.

Figure 8 shows contours of the settlements measured of the embankment during the filling of the reservoir and the two years of operation.

It also notes that the settlements in the 3B and T materials are not very different due to their similar characteristics deformability and increased confinement of the material T. The calculated values of modules deformability at the end of construction for 3B material, T and 3C, were 174 MPa, 164 MPa and 92 MPa, respectively.

The influence of increased deformability of the material 3C and push the reservoir is only appreciated in the upper third of the rockfill, where settlements reach just over 24 cm.

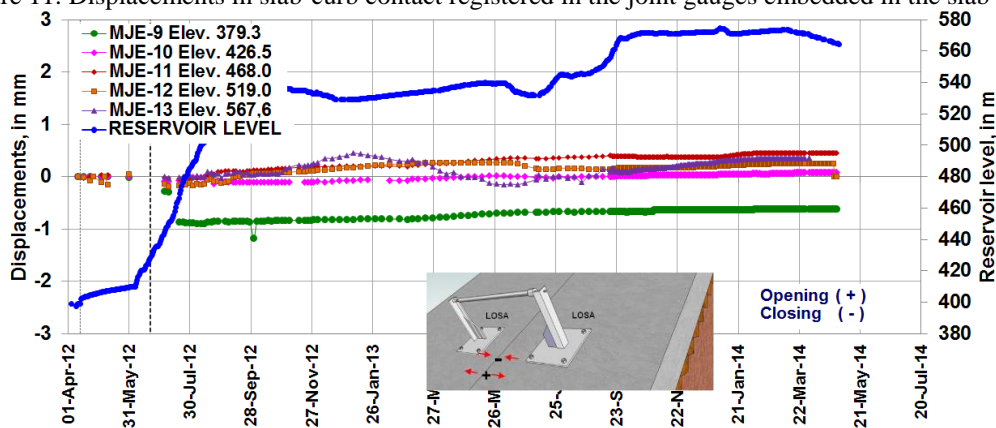
Figure 11. Displacements in slab-curb contact registered in the joint gauges embedded in the slab L-20.

Electric seal meters were installed to know the interaction between slab-curb; these were embedded along the slab L-20 (MJE-9 to MJE-13), which do not show relative displacement due to the hydraulic head. The observed decrease in the MJT-13 (Figure 11) installed to the elevation 567.58 m is mainly associated to room temperature, when the reservoir level is below the instrument.

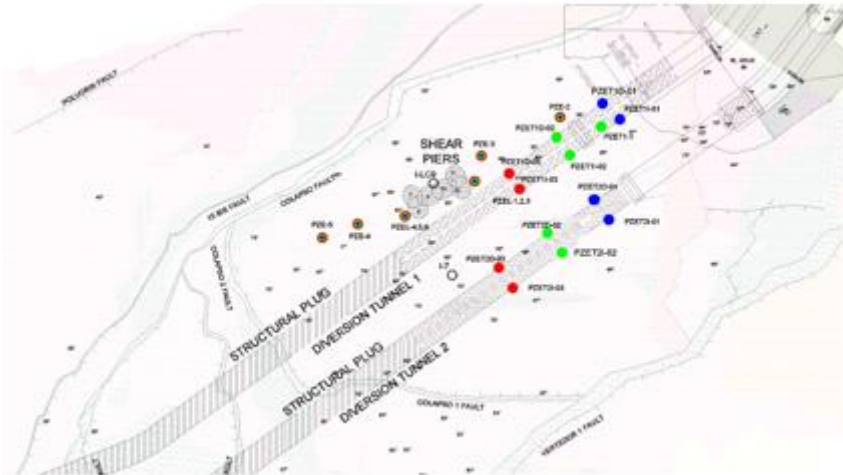
Figure 12. Locating electrical extensometers at anchor-plug 1.

Piezometers installed in the vicinity of the diversion tunnel 1 (Figure 12) near the slope of the stabilized zone show slightly lower pressures at reservoir level; regardless of whether they were placed under, on or above of the “Collapse” fail and ascended gradually as the reservoir did. Due to the high permeability of the rock in the vicinity of the Collapse fault, the piezometers response is immediate to reservoir level changes, regardless of location.

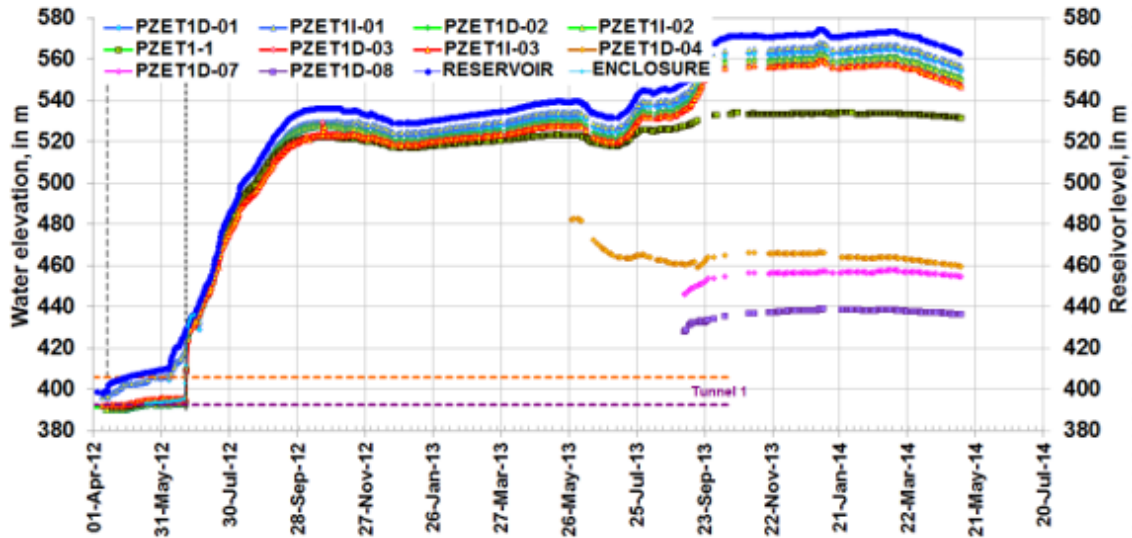
Figure 13. Water elevation recorded in electrical piezometers installed in the tunnel 1

Leaks in the structural plug of the diversion tunnel 1, decreased from 125 to 12,8 l/s at the end of the injection contact; besides, these increased as the reservoir did (January 2013), reaching 28,4 l/s in May 2014, for a reservoir elevation of 557 m. In the diversion tunnel 2, the injections decreased the flow from 148,3 to 1,3 l/s and this rate remained almost constant with time.

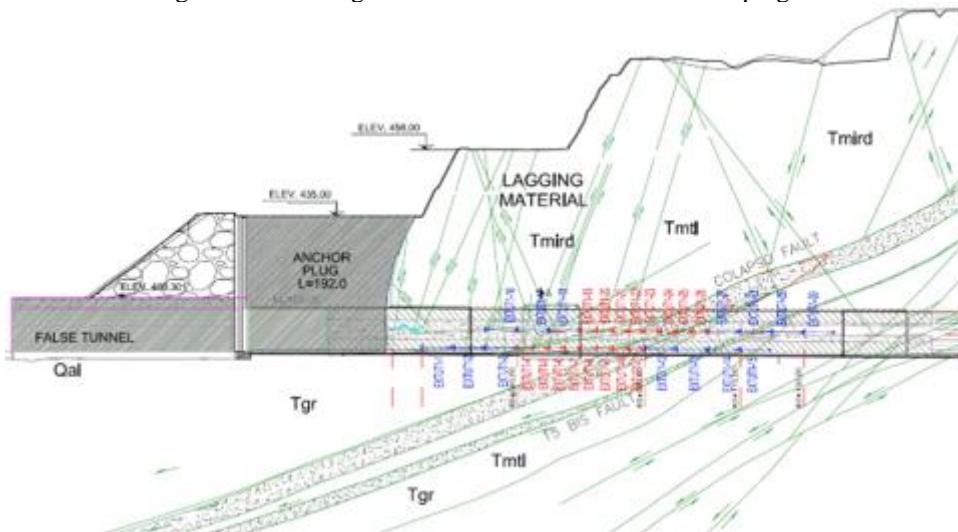
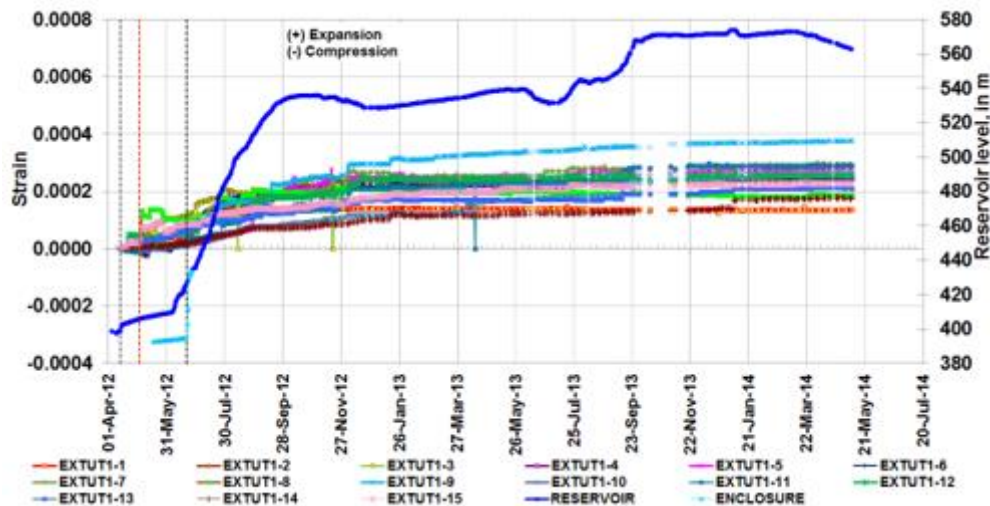
Figure 14. Locating electrical extensometers at anchor-plug 1

No evidence of movement in the structural plugs at the junction with the trace of the fault Collapse, as recorded by the electrical strain gauges. The unit relative strain between the upper and lower bed diversion tunnel 1 is of the order of 0,0004 and is not indicative of movement of the rock mass by the failure; increases are associated with the thermal effect of the setting of concrete and grouting work on consolidation and structural closures. The main deformation increases plug diversion tunnel 2 due to the temperature variation by the setting of concrete and rock saturation; from December 2012, there are no significant displacements.

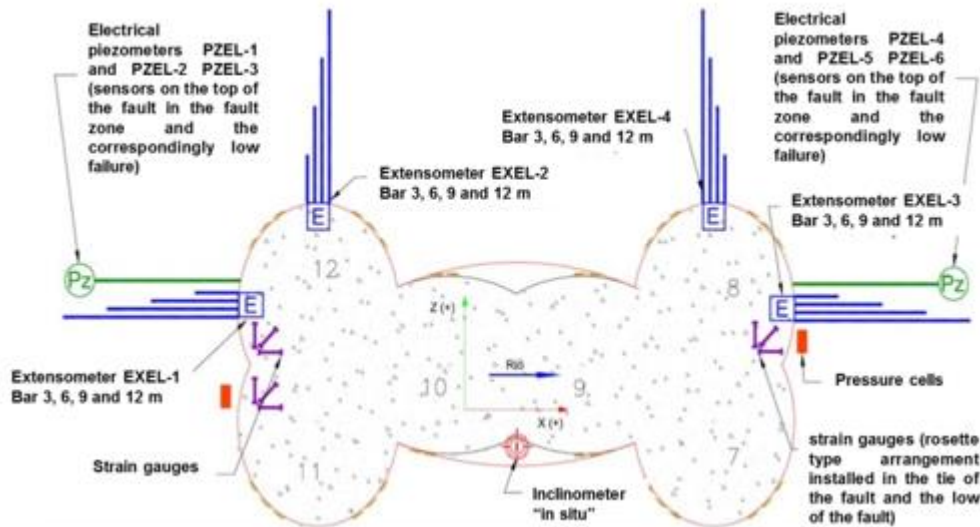
Figure 16. Measuring instruments installed in the shear-piers

in the pressure cells reflect the effect of the saturation of the rock, the recorded values are related to the hydrostatic pressure of the reservoir level and varies according this does.

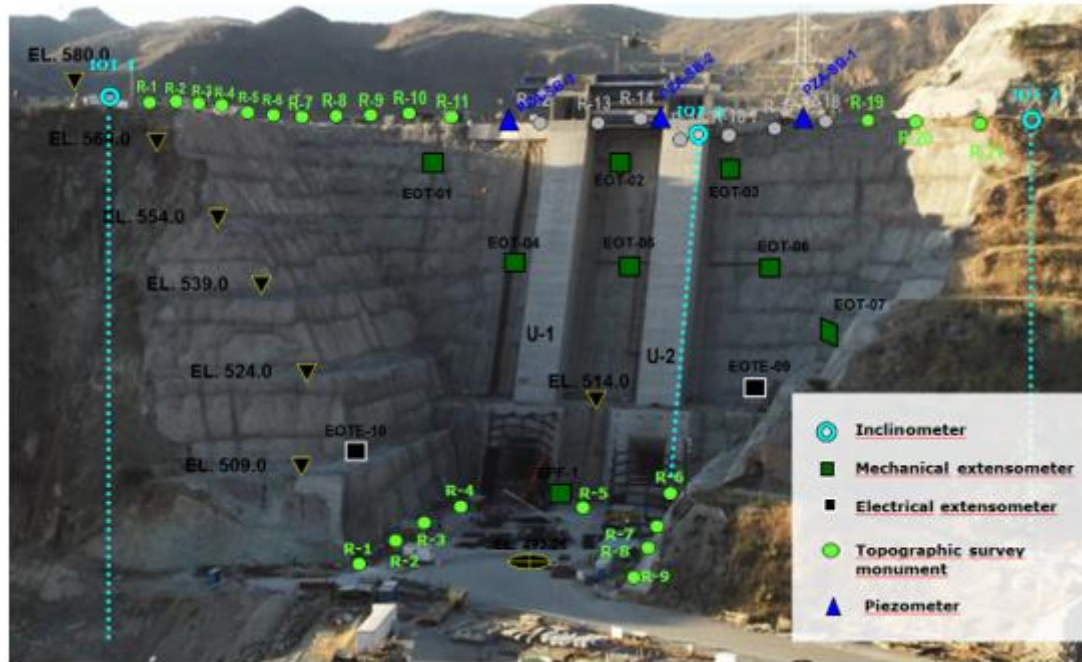
Figure 17. Instrumentation on the slopes of the intake structure

The piezometers installed in the zone of the intake structure show variations associated with rainfall and reservoir level. The PZA-SB-3b (Figure 17) reacts quickly to fluctuations in the hydraulic head because approximately to the elevation of the bulb is the cracking that was generated during the screen injections made from the platform located at elevation 580 m.

There are no major displacements in extensometers installed on the U-1 unit with respect to the U-2, nor between the intake structure platform and surrounding area of pressure pipes of both units. The displacements accumulated from April 2012 to date are less than 2 mm.

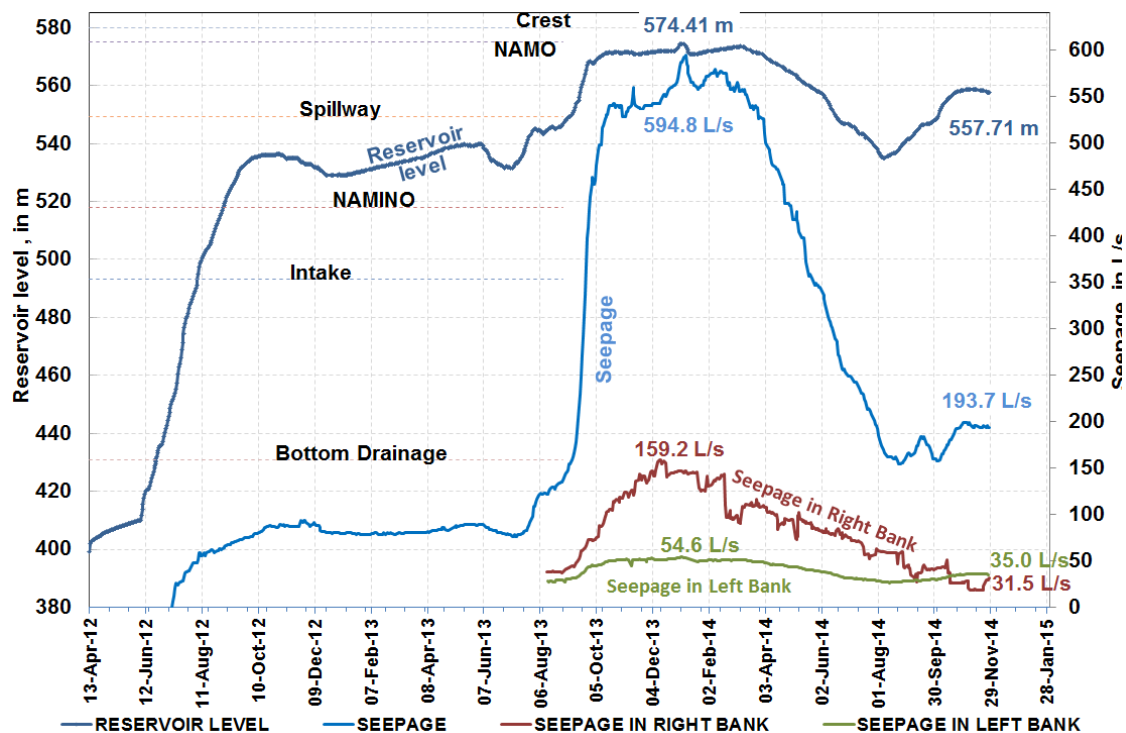
Figure 18. Evolution of the leaks with the reservoir level in the drainage galleries GD-1 to GD-4 and the bottom of the curtain.

On April 13, 2012, the diversion tunnel gate 2 was closed, that stated the reservoir filling. This filling is made progressively reaching NAMINO (El. 518 m) in early September of the same year; a month and a half after the elevation 540, the maximum progressive filling level, is reached. From November 2012 to end of July 2013 the water level fluctuated between elevations 530 and 540 m. During this time, the leaks in the gallery at the bottom of the curtain and drainage galleries were maintained with relatively small discharge; total discharge of the order of 80 l/s (Figure 18).

In late July and early October 2013 the water level rose rapidly allowing to do performance testing of the spillway. During the months of September and October 2013 leaks at the bottom of the curtain markedly increased in 400 l/s, for a total flow of 540 l/s. This anomalous behavior was also observed in the galleries on the right bank, however, in the galleries on the left margin and diversion tunnels did not show this phenomenon.

It should be noted that due to the motion that was presented on the left bank during excavations of the portals of the diversion tunnels, it was necessary to turn the axis of the curtain, which caused the tympanum of the gallery GD-2 stay with low coverage, of the order of 10 m, with respect to the plinth. This lack of coverage and quality of the rock in this area could explain the fact that when the reservoir reached elevation 540 m, appeared on the gallery covering GD-2, near tympanum, two fissures, which contributed significant leaks in the order 45 l/s. As a remedial measure, a concrete plugs 30 m long was constructed, leaving a length of 15 m accessible for injections seal from the inside.

To reduce seepage measured to values that do not constitute a risk to the security of HP, a series of studies to determine the causes of the observed phenomenon and implement corrective actions were initiated [2].
