Path of Knowledge for the Assessment of Structural Safety of the Pisan Tower of the Royal Palace of Palermo in Italy

Abstract: This paper presents the path of knowledge developed for assessing the structural safety of the Norman-age Pisan Tower, which is mostly incorporated into the Royal Palace in Palermo, Italy. Historical, geomatic, and mechanical investigations were conducted and the most relevant results are herein collected and presented. The research path was addressed to specific tasks: identification of the building, geometric surveys, recognition of the sequence of phases of building transformation, detection of the components of the load-bearing structure, structural diagnostic surveys, and investigation of the subsoil and foundations. The explicit vulnerabilities found were mostly confined to the Piazza library floor, while implicit vulnerabilities were identified in the presence of false walls and in high loads and fillings on the vaults of the last levels. The results of the analyses allowed the individuation of the confidence factors to use in structural analysis models aimed at the assessment of the seismic safety of the building.

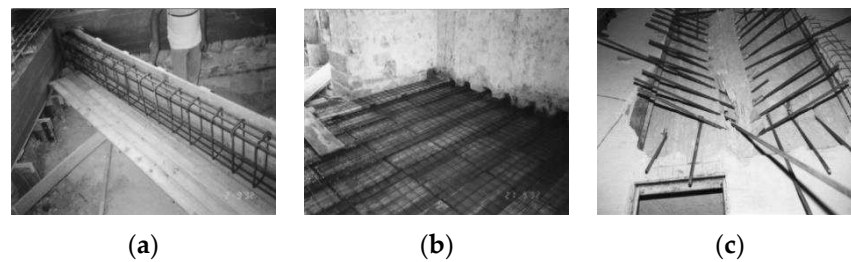
Boscarino and Cottone's intervention in the 1990s was performed after the damage due to the 1968 earthquake. In particular, the floor of the President's Room is still severely damaged, as well as the room with the Piazzesi Library, which is even more damaged, with a strongly cracked vault, shored up in a currently visible safety intervention, which should have been provisional.

In 1985, almost 20 years after the earthquake, the general study realized by S. Boscarino highlighted the "...precarious conditions of most rooms, with instability phenomena on floors and roofs, and of poor roof coverings and windows..." (*Consolidamento, restauro e sistemazione dei locali dell'Osservatorio Astronomico nel Palazzo dei Normanni*, Palermo, 1985, published by the Technical Bureau of the University of Palermo, in Italian), and proposed a restoration intervention for the severe state of decay, which resulted in the "Extraordinary maintenance project for the rooms of the G.S. Vaiana Astronomical Observatory in the Norman Palace in Palermo" by A. Cottone. The intervention restored the state to that at the time of the construction of the Observatory by eliminating the partition walls that divided the gallery; only the scissors ladder differed, as it was realized anew in steel inside the residual cavity between the wall of the room and the transfer wall of 1865. The intervention involved the two floors at 37 and 40 m, respectively, which corresponded to the spring line and the roof covering of the gallery. At the level of the spring line of the gallery, two slab spans were realized externally, above the vaults, with steel profiles and hollow flooring blocks, sustained by rim joists and by a diagonal crossbeam (Figure 11a,b). On the other hand, the central vault was simply reinforced on the extrados through the insertion of metal dowels and the addition of reinforced concrete to support the reticular steel column which sustains

Figure 11. Details of the execution of the Boscarino–Cottone intervention (1990s): (a,b) photos related to the floor slab of the room on the left of the gallery, showing the diagonal crossbeam and the electro-welded mesh above hollow blocks; (c) reinforcement of the central vault for the sustainment of the steel reticular column which supports Mertz's equatorial telescope.

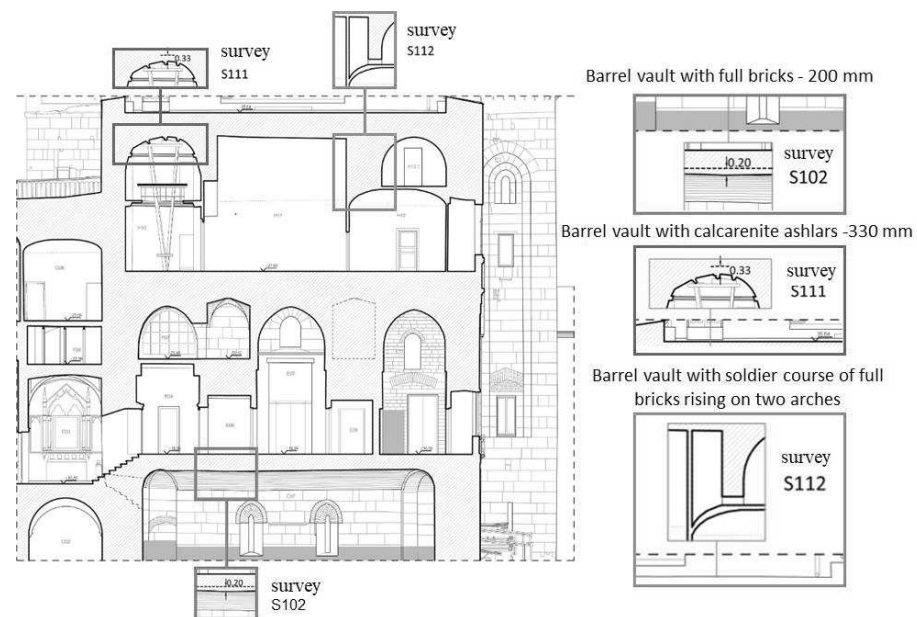
The results of these integrative surveys allowed the determination of both qualitative and quantitative data. In particular, a mostly incoherent infill was found above the vaults, in the northwest corner of the ambulatory surrounding the Treasure Room, also called the Mint Hall (sample S103), in correspondence with an edge of the interior wall of the south

Figure 13. Results of endoscopic surveys S102, S111, and S112.

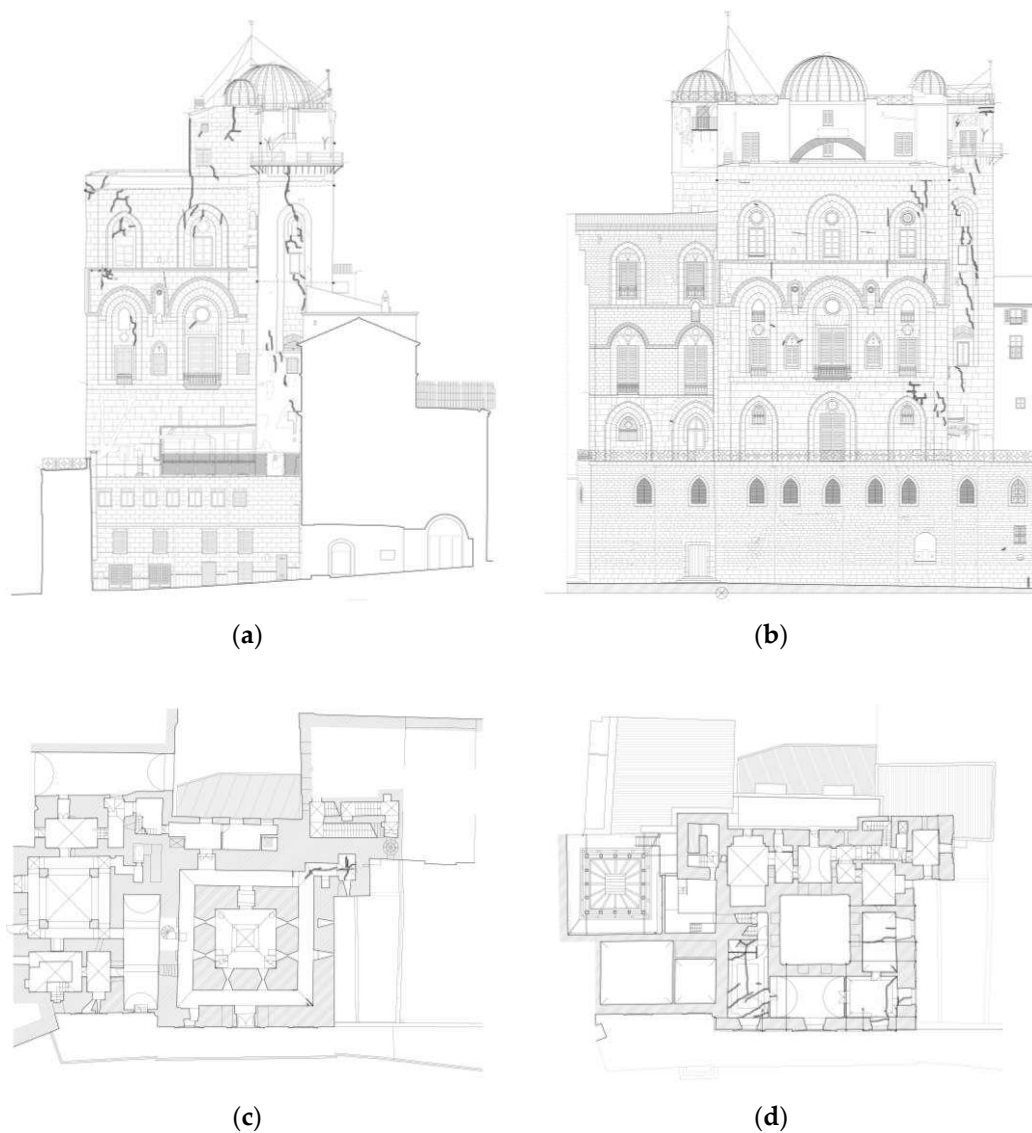
During the long life of the Royal Palace, many significant seismic events have occurred, and these have produced damage, which has been documented since 1693 [22] because of the various architectural modifications and the proximity of the Kemonia creek, which had a higher flow at that time. In particular, the Pisan Tower suffered significant damage during the 1968 earthquake, leading to the unavailability of some rooms on the level of the Observatory, with severe cracks in the vault of the Piazzzi Library, which is currently still shored up for safety reasons. Comparison should be made of the current crack pattern—possibly worsened by the recent earthquake on 6 September 2002—with surveys of previous cracks; however, there was no available documentation for this purpose. Figure 14 shows some of the technical drawings by Officina per le Arti Opera, which illustrate the crack patterns.

Figure 14. Crack patterns (in red) and steel ties (in blue) (from the drawings of the Officina per le Arti Opera company): (a) on the north side; (b) on the east side; (c) on the floor plan at the height of 13.00 m; (d) on the floor plan at the height of 28.70 m.

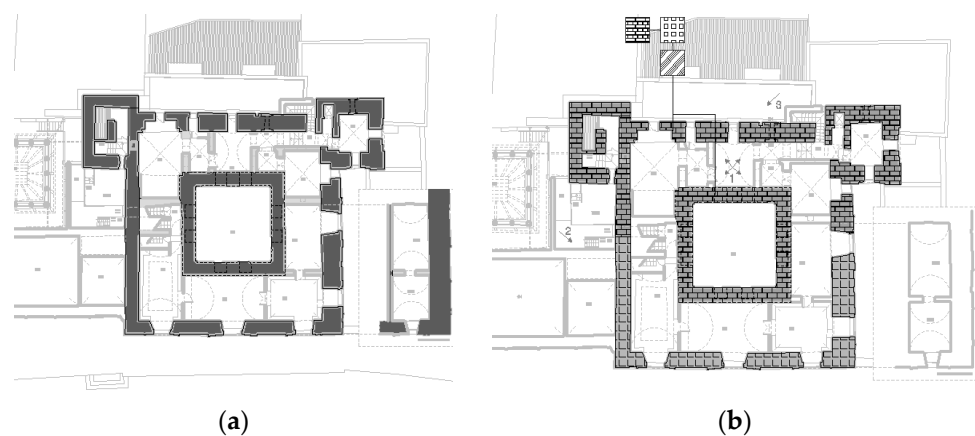
At the level of the Piazzini Library (level H), which hosts rooms of both the Astronomical Observatory and the ARS, the load-bearing structure provides the layout with concentric quadrilaterals (Figure 21a). The compactness and rigidity of the system are notably reduced by the narrow width of the walls, and by the numerous openings. As discussed in the previous paragraphs, the east side of the Tower probably represents an addition from the period of the Spanish Viceroyalty. Hence, techniques and materials differ significantly from the Norman construction (Figure 21b). This circumstance was also confirmed by the mechanical characteristics surveyed in the Spanish masonry, which was characterized by low values of compression strength as compared to those of the Norman masonry and to the suggested values for masonry walls in soft stone ashlars. These intrinsic flaws in the masonry, together with the presence of many transfer walls between the two squares in the load-bearing structure of the Tower, have certainly led to a relevant vulnerability. The effects of the 1968 earthquake and the constant and abundant infiltrations from the terrace of the upper level have produced several instability phenomena, including diffuse—and worrisome—cracks in both vertical and horizontal structural components. Following these damages, the rooms of the Observatory were shored up and made inaccessible. The cracks in the floor slabs are often extended in the walls, hence disrupting the wall structure and leading to additional vulnerability.

Figure 21. Identification of the structure of the Tower on level H (height 28.70 m): (a) hypothesized vertical load-bearing structure; (b) hypothesized materials.

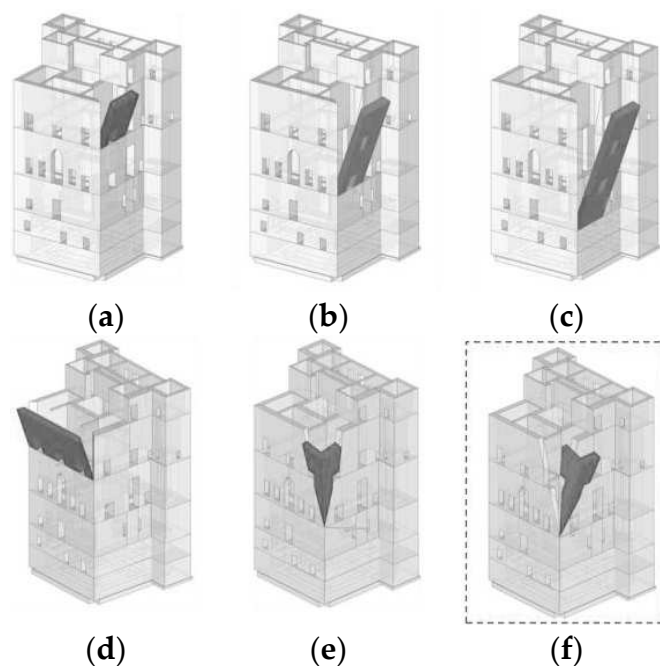
Figure 29. Axonometric views of the theoretical local collapse mechanisms: (a–c) rotation of the north wall at different levels; (d) rotation of the east wall; (e) rotation of the north-east corner area; (f) most probable simple overturning of the north wall (angle $\gamma = 0$) and a portion of masonry in the east wall.

The obtained results show that the most likely failure mechanism involves the simple overturning of the north wall (angle $\gamma = 0$) and a portion of masonry in the east wall.
