Study on deformation characteristics of underground pipeline corridors and uneven settlement factors of foundations in sandy chalky soil layer

2 Overview of the pipeline corridor project

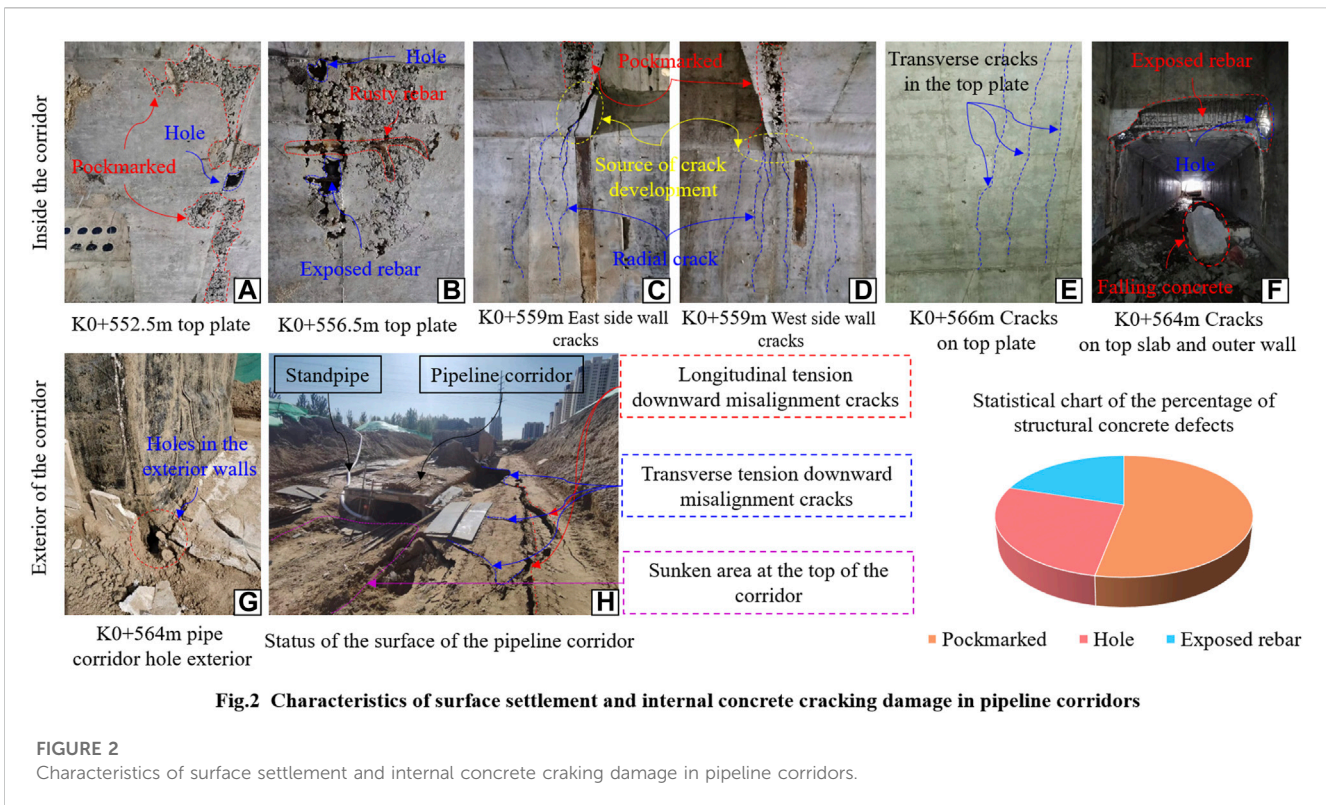
FIGURE 2

manifested in the exposed tendons, pockmarks and holes. Figure 2A, B shows the exposed reinforcement, pockmarked surface and hole defects existing in the roof slab of the pipe corridor at K0+552.5 m and K0+556.5 m. This defects and damage left by the concrete casting will promote the subsequent deformation of the concrete construction damage, in the subsequent uneven settlement, these defects at the hidden danger will be amplified, will be the first in these defective parts of the cracking damage, which evolved to the destruction of the concrete structure as a whole. Such defects and damages left due to concrete pouring belong to the congenital influences on the structural deformation of the pipe corridor.

The corridor experienced uneven settlement around the corridor after two heavy rainfall events. Uneven settlement of the foundation leads to unbalanced stress in the corridor structure, and stress concentration occurs at the corridor's variable cross-section due to the change in cross-sectional area, resulting in tension cracks. There are three cracks in the structure of the pipe corridor, the first crack is located in the east and west sides of the outer wall at K0+559m, the source of cracking is located in the concrete surface, and the cracks are radial expansion from the concrete surface. At K0+559 m there are 7 cracks in the west wall with a maximum crack width of 11.5 mm (shown in Figure 2C) and 5 cracks in the east wall with a maximum crack width of 13.3 mm (shown in Figure 2D). The second crack was located on the top slab at K0+566m, with five cracks distributed transversely and the maximum crack width of 1.24 mm (shown in Figure 2E). The third crack was located in the top slab and exterior wall at K0+564m, where a crack penetrated in the top slab causing the concrete to fall off (shown in Figure 2F) and a hole in the waterproofing layer of the exterior wall (shown in Figure 2G). It can be seen that the uneven settlement of the foundation of the corridor makes the

Characteristics of surface settlement and internal concrete cracking damage in pipeline corridors.

defects of the concrete structure amplified, and the cracks start to sprout from the concrete defects, and expand through under the action of further uneven settlement, leading to structural cracking and damage.

Analyzing the cracking damage characteristics of the pipeline corridor, it is found that the cracks on the concrete structure are mainly sprouted from the exposed reinforcement and pockmarks at the gestation, and penetrate into each other between the concrete holes, and eventually form macroscopic penetrating cracks. It can be seen that inhomogeneous settlement is the main driving factor leading to cracking damage, and original defects in concrete are the main contributing factors leading to cracking damage in concrete structures.

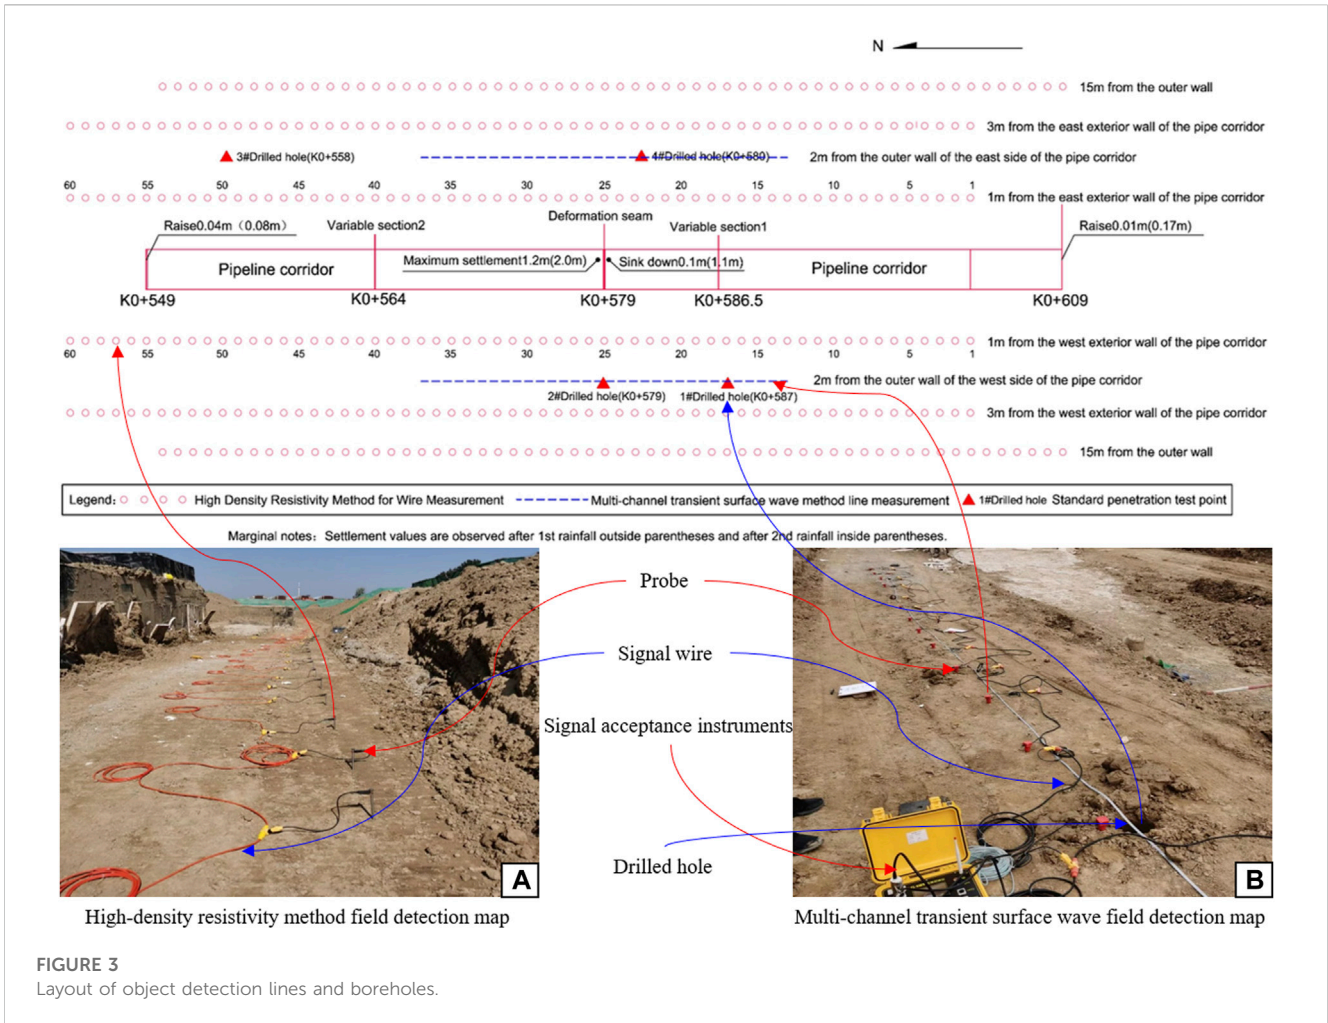
In order to investigate the reasons for the uneven settlement of the foundation of the corridor, the high-density resistivity method was used around the corridor to carry out probing on both sides of the corridor and to investigate the physical characteristics of the foundation soil under the corridor. Six measurement lines were arranged on both sides of the pipeline corridor, the lines were 1.0m, 3.0m and 15.0 m away from the outer wall (the distribution of the lines is shown in Figure 3), the spacing of the measurement points was 1.0 m, and the length of the lines was 60 m, and the dipole-dipole device (the on-site arrangement is shown in Figure 3A). The average ground elevation of the 1.0 m measuring line from the outer

wall and the 3.0 m measuring line from the outer wall is 18.4m, and the 25# probing point corresponds to its maximum settlement, while the average ground elevation of the 15.0 m measuring line from the outer wall is about 21.4 m, and the 31# probing point corresponds to its maximum settlement.

the wave velocity of the soil layer below the top plate of the pipeline corridor in the range of 15.0 m, the layout of the measurement line as shown in Figure 3, the distribution of the field detection points as shown in Figure 3B.

and hole 4 located in the east side of the pile No. K0+580. In the area where no abnormality is found, 3# holes (east side pile No. K0+558) are arranged as comparison holes, which are 2.0 m away from the outer walls on both sides of the pipeline corridor, and the arrangement of the holes is shown in Figure 3.

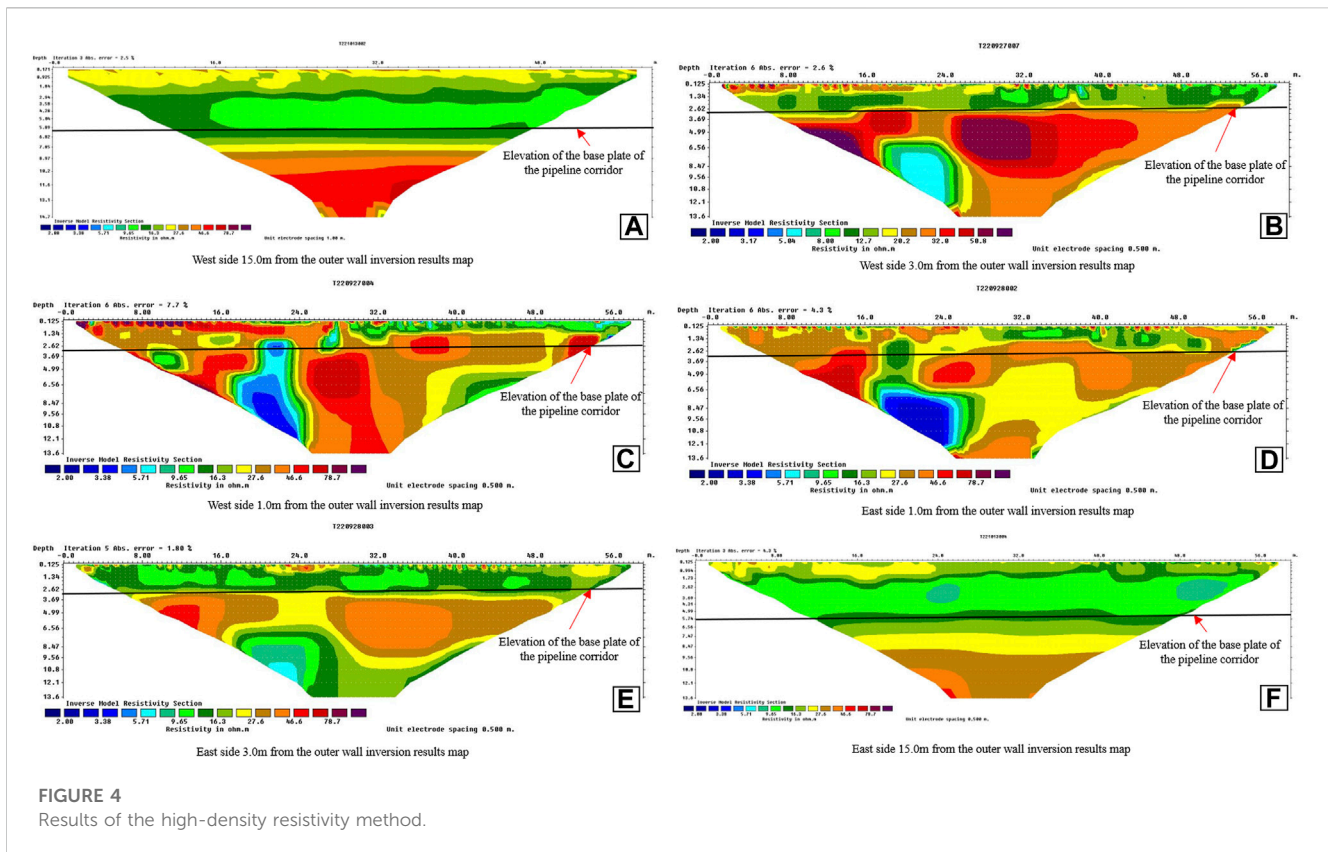
FIGURE 4
Results of the high-density resistivity method.

The data collected by the high-density resistivity method were inverted and analyzed, and Figure 4 shows a cloud map of the results of the inversion analysis for the six survey lines. The analysis results based on the cloud map show that: 1) along the pipeline corridor direction, pile number K0+578~K0+586.5 section, there is an obvious low-resistance area below the bottom plate of the pipeline corridor, the resistivity value is $\leq 8.0 \Omega\text{-m}$, and initially determined to be the distribution of water-rich and sparse bodies, and the distribution range is shown in Table 1. Water-rich body area due to K0 + 609 south side of the pit pumping and other local hydraulic effects, resulting

in the weakening of the soil structure, strength is further reduced, the engineering properties of the soil body deteriorated, endangering the safety of the upper corridor. The hydraulic action triggered by pumping leads to the removal of soil particles from the upper part of the water-rich body, which gradually develops into a cavity and leads to the sinking of the pipe corridor. 2) In the direction of the vertical pipeline corridor axis, it can be seen from [Figures 4B–E](#) that the distribution range of the low resistance area is slightly expanded from west to east. As can be seen from [Figures 4A, F](#), the farther away from the centerline of the corridor, the soil below the bottom plate of the corridor as a whole shows that the resistivity of the east side is significantly lower than that of the west side in the same depth range, indicating that the water content of the soil on the east side is significantly higher than that on the west side.

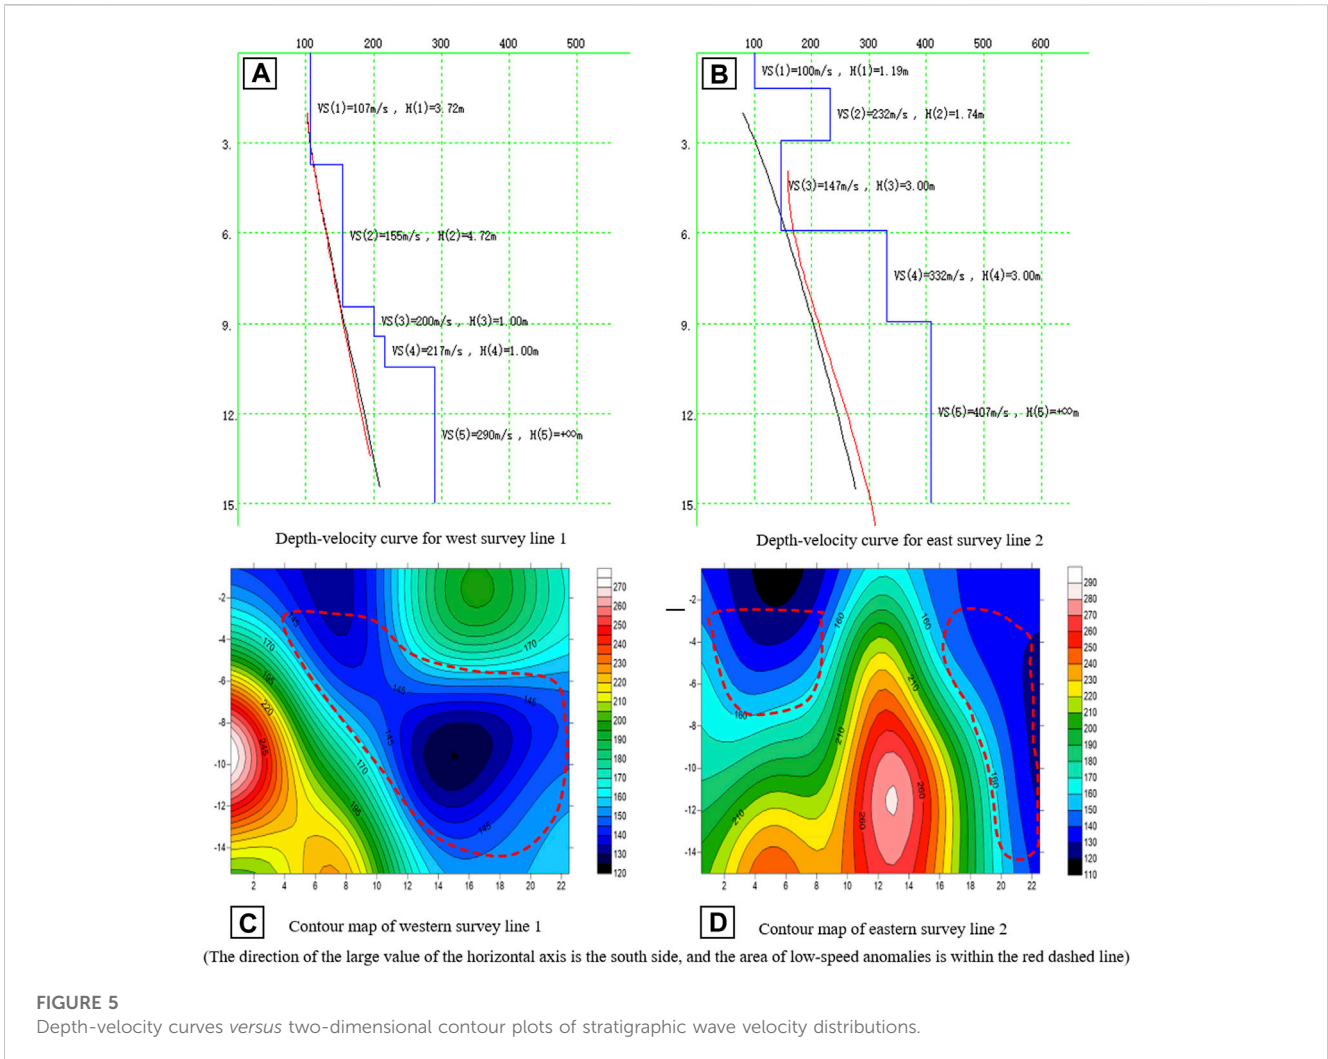
Multi-channel transient surface wave exploration data processing and interpretation are processed by special software, after filtering and de-noising, multi-gun superposition, FK frequency spectrum analysis, frequency dispersion curve extraction, and obtaining V-H velocity depth curves to invert the stratigraphic wave velocity distribution. [Figures 5A, B](#) show the depth-velocity curves after data processing, and [Figures 5C, D](#) show two-dimensional contour plots of the stratigraphic wave velocity distribution after integrated inversion. Analyzing the change characteristics of the V-H velocity curve, it is found that the wave velocity of the soil layer in the range of 3.0 m below the bottom plate on the east side of the pipeline corridor decreases

sharply, the shear wave velocity V_s decreases from 232 m/s to 147 m/s, and the slope of the dispersion curve changes significantly, and the presence of sparsity is suspected in the range of this depth. The wave velocity value of the soil layer in the range of 5.5 m below the bottom plate of the pipeline corridor on the west side is 155 m/s, and the wave velocity value is obviously low, indicating that there is a suspected loose body.

The wave velocity contour map shows that there exists a low wave velocity zone with gradually increasing depth and width in the west side of the pipeline corridor at pile number K0+572~K0+590 (horizontal coordinates 4–22), and the depth range is from 0.0 m below the bottom plate to a maximum depth of 12.0 m (red dashed area in Figure 5C). There are two main low-wave velocity areas on the east side of the pipeline corridor (red dashed area in Figure 5D), one of which is pile number K0+568~K0+577 (horizontal coordinates 0–9), with a depth range of 0.0–5.0 m below the bottom plate of the pipeline corridor. The other one is pile number K0+584~K0+590 (horizontal coordinates 16–22), and the depth range is 0.0–12.0 m below the bottom plate of the pipe corridor. These two low-wave velocity areas are suspected to be sparsely populated.

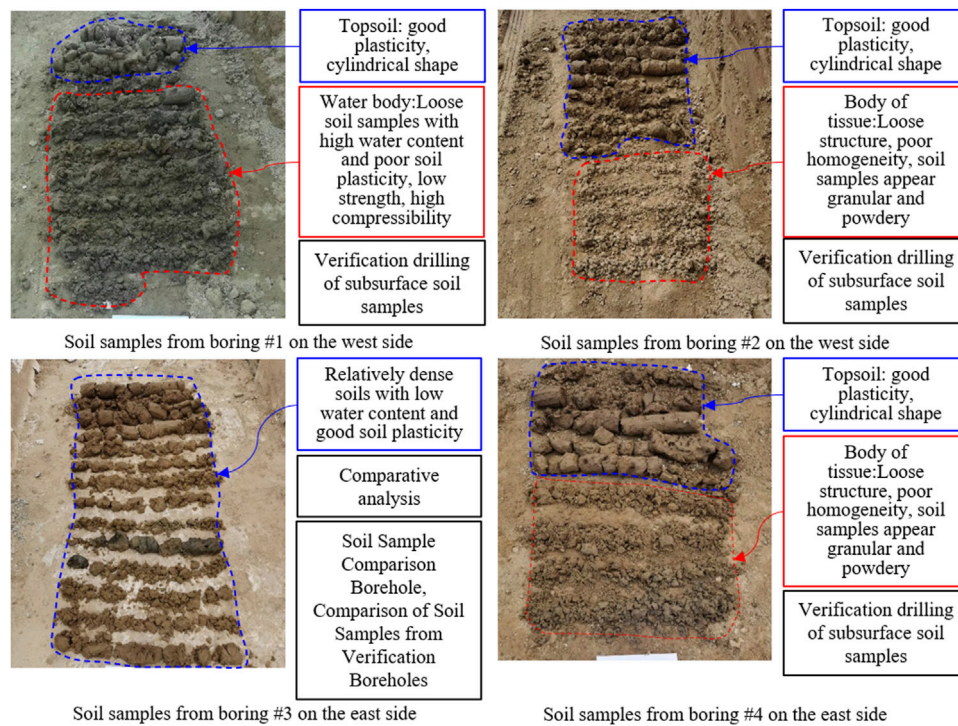
FIGURE 6
Photographs of soil samples from verification and comparison borings.

than the other areas where no anomalies were found. Figure 6A, B, D show sample soils from verification holes 1#, 2#, and 4#, respectively, and Figure 6C shows sample soils from comparison hole 3#. Based on the analysis of the soil samples taken from each of the boreholes in Figure 6, the samples from

verification boreholes 1#, 2# and 4# have loose soil and high water content, while the sample from comparison borehole 3 has relatively dense soil and low water content. Figure 6 shows photographs of soil samples from the four borings at the site, and Table 2 shows the results of the standard penetration tests.

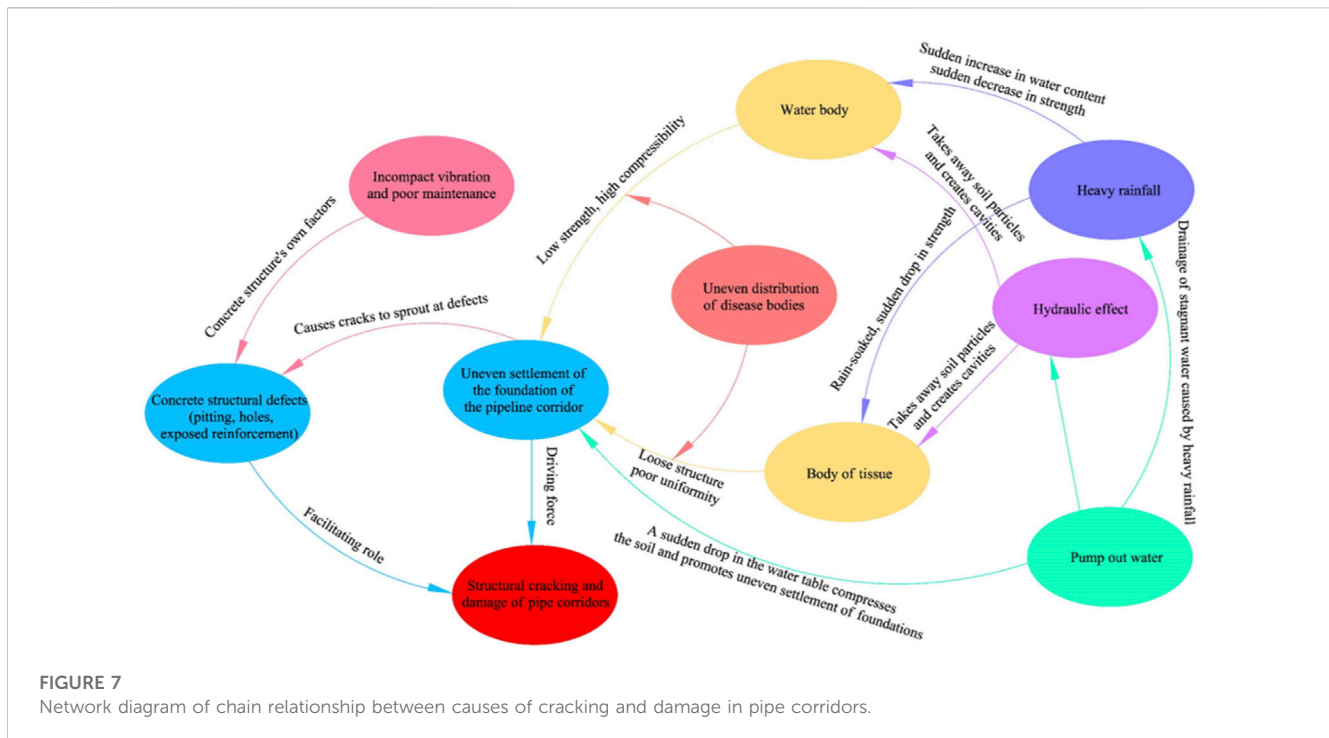
Uneven settlement of the foundation becomes the main driving factor for the cracking and deformation of the pipe corridor structure, and the factors leading to the uneven settlement of the foundation are the fundamental factors for the cracking and damage of the pipe corridor. By means of physical exploration to explore the reasons for the uneven settlement of the foundation of the pipe corridor, the results show that the pipe corridor pile number K0+568 ~ K0+590 section of the bottom plate below the depth range of 0.0 m~12.0 m, the foundation holding layer is suspected to exist in

the water-rich body, sparse body, at the same time in the pile number K0+564, K0 + 566, K0 + 559, the pipe corridor due to the uneven settlement of the foundation to produce serious damage. In order to further verify the reliability of the results of the physical exploration, three verification holes and one comparison hole were excavated within the uneven settlement range of the pipeline corridor, and the distribution of loose bodies within the depth range of the 1#, 2# and 4# verification holes exposed basically coincided with the results of the inversion of the two physical exploration methods. By analyzing the results of physical exploration and verification of soil extraction, it was found that the main reasons leading to the uneven settlement of the foundation are the following 3 points.

- (1) Several spars and water-rich bodies exist in the depth range of 0–12.0 m below the base plate of the pipeline corridor in this section. Loose bodies are characterized by loose structure and poor homogeneity, and water-rich bodies are characterized by high water content, low strength and high compressibility. Heavy rainfall led to a sudden increase in the water content of the soil around the corridor, the strength of the loose body was significantly reduced by rainwater soaking, the water content of the water-rich body further increased, the strength of the further reduction of its compression at the same time increased. Due to the uneven distribution of loose and water-rich bodies below the subgrade of the corridor, this leads to an uneven settlement of the soil layer below the subgrade. This is the stratigraphic condition in which uneven settlement occurs in the pipeline corridor.

- (2) The pumping of water after heavy rainfall caused a rapid decline in the water table, the effective stress of the foundation soil below the base plate of the corridor increased, soil compression occurred, and further contributed to the uneven settlement of

- the foundation, which is also an important causative factor for the aggravation of the uneven settlement of the foundation.
- (3) The pumping operation also triggered localized hydraulic action, and such underground diseased bodies as loose bodies and water-rich bodies were weakened by localized hydraulic action, the soil structure was weakened, the strength was reduced, and the bearing capacity of foundations was decreased. The hydraulic action takes away the soil particles within the loose body and water-rich body, leading to the development of the loose body and water-rich body into a cavity and accelerating the rate of settlement.

- (4) The cross-section area of the pipe corridor structure is changing, and under the effect of uneven settlement, the junction of the cross-section change will have a significant stress concentration phenomenon, which will lead to the cracking damage of the pipe corridor structure.

Combined with the analysis of the actual situation on the site, the first time after the rain pumping caused uneven settlement, K0 + 579 position deformation joints staggered, the corridor substrate soil extrusion, surging into the interior of the corridor. The second pumping location at K0+579 deformation seam caused the loss of powdered soil in the holding layer of the base of the pipe corridor, destroying the soil structure of the base and increasing the sinking of the pipe corridor at both ends of the deformation seam.
