Slope stability problems in Denmark - a joke or dire reality?

J.S. Steenfelt,
COWI A/S, Kongens Lyngby, Denmark; jos@cowi.dk

ABSTRACT: Contrary to common belief, even Denmark suffers slope failures in natural and man-made slopes. In a majority of the failures water is the catalyst combined with oversight or neglect of fundamental soil mechanics principles. The paper describes three cases of slope failures, two natural and one man-made, and the subsequent forensic geotechnical engineering investigations and remediation.

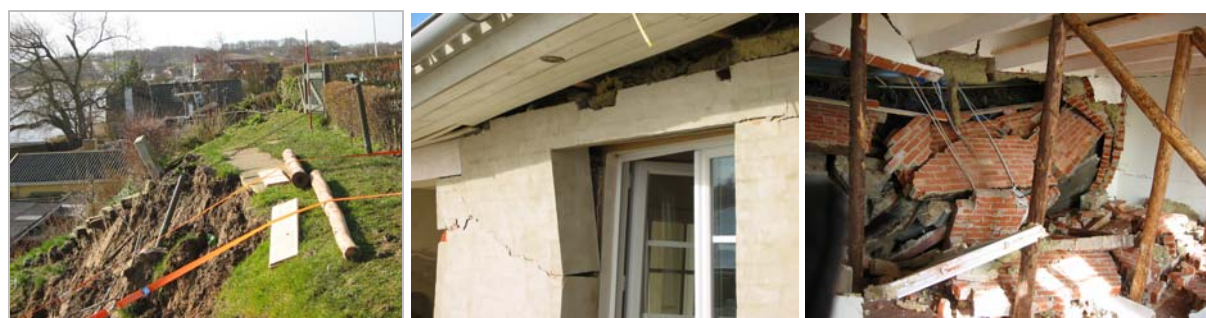
The case histories amply demonstrate that our capabilities in terms of testing do not always meet our expectations. But back-calculation based on well-winnowed experience proved to be invaluable, hence re-iterating the need for case histories in geotechnical engineering. Even smaller slope failures carry loud messages as seen from Figure 1.

Figure 1. Dire reality of a minor slope failure leading to total demolition of a one-family house in Denmark

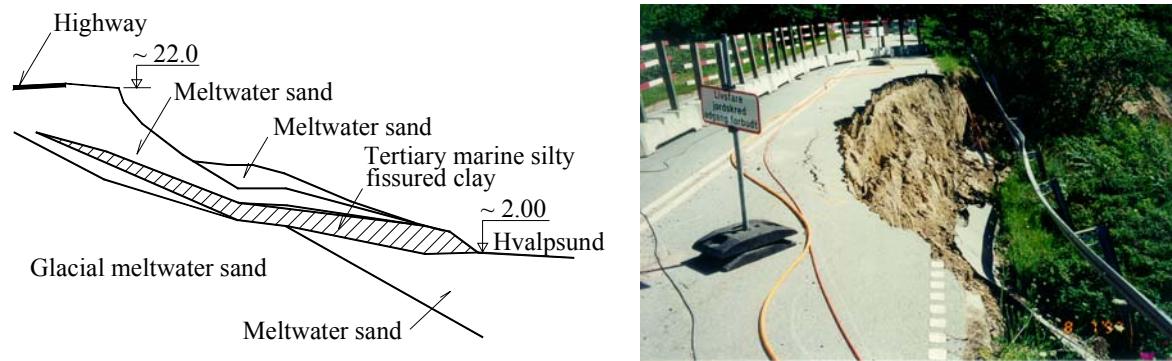
Figure 2. (a) Cross section at slope at Sundsøre prior to failure; (b) Second failure involving half the highway

Geotechnical borings in the slope revealed rather complicated slope geology. One boring at the crown showed 1.0 m of leached, glacial clay till above 6.5 m of glacial meltwater sand with grain sizes and gravel contents increasing with depth. This was underlain by some 2 m thick wedge of Tertiary, marine silty fissured clay. Below the Tertiary clay, glacial fine to coarse meltwater sand was found to a depth of 14.5 m below the crown. The borings carried out down the slope confirmed the presence of a floe of Tertiary clay, wedged at an angle along and across the slope profile. A cross section of the slope appears from Figure 2.

Based on the site investigation and a preliminary assessment of strength parameters and ground water conditions it was found that the factor of safety for the slope was below the requirements of the Danish Code DS 415 (1984). For safety reasons half the highway was therefore blocked pending remediation work on the slope.

A solution involving a decrease of slope angle was not considered feasible, and hence the road authorities decided to permanently change the alignment of the road away from the slope. The wisdom of the decision was borne out by a new slope failure taking place shortly after the decision and without warning. Half the highway disappeared over a length of about 100 m (cf. Figure 2b).

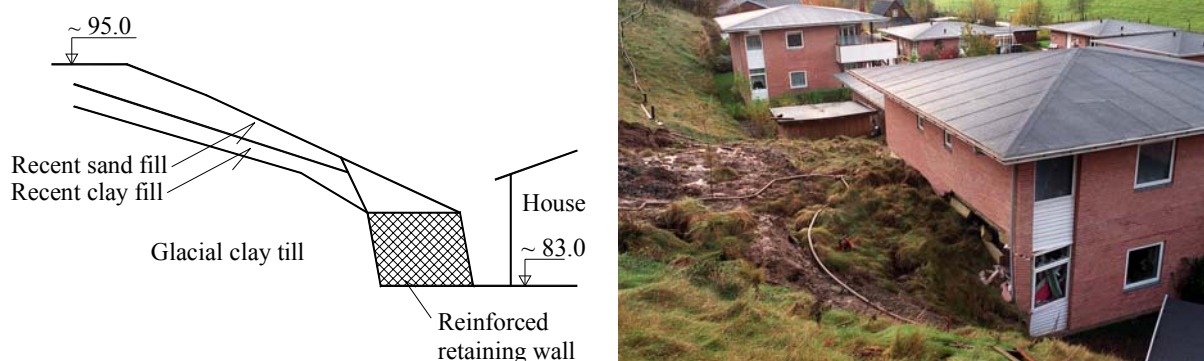
The slope at the residential area "Høgsholtparken" is situated in the northern part of Vejle in eastern Jutland. The slope was about 12-15 m high and to accommodate a series of new domestic houses, up to 16 m of the slope was removed at the bottom of the slope (cf. Figure 3a).

The slope could not be cut back due to a series of existing apartment buildings close to the crown of the slope. Hence, an up to five m high reinforced sand retaining wall was established at the base of the slope with the new houses as close as 2 m away. However, the reinforced slope was not stable, and over a period of time a series of smaller slope failures took place up to October 1998, where the gable on one of the houses collapsed due to a major, sudden slide (fortunately without any bodily harm to the inhabitants), as seen in Figure 3b.

The forensic investigation with geotechnical borings carried out in the slope showed recent sand and clay fill deposits (or solifluction deposits) to a depth of some 1-3 m below the surface. This was underlain by rather plastic glacial clay till to a depth of 12 m below the surface. Glacially, fine to medium meltwater sand was found 12 to 15 m below ground surface (end of borings). The clay till deposit was interlaced with thin horizons of medium to coarse sand till. The primary groundwater table was found to be well under the level of the foot of the slope. A cross section with interpreted soil boundaries is shown in Figure 3a.

Figure 3. (a) Interpreted soil boundaries for slope at "Høgsholtparken"; (b) Damage from the slope failure

The reason for the failure was clearly a build-up of pore pressure during heavy rainfalls in the interface between the top deposits (of sandy, gravelly, fill and clay) and the underlying clay till in combination with an inadequate soil reinforced retaining wall at the foot of the slope.

- A traditional Danish solution with a tied back sheet pile wall at the top of the slope (retaining the crown of the slope) allowing a reduction of slope angle
- Soil nailing of the existing slope maintaining the slope angle. This solution invites itself, as the very competent clay till is at shallow depth

Although the soil nailing solution was technically feasible the (Danish) traditional solution, with a sheet pile wall at the top, was preferred as this allowed a transparent pricing of the remediation works.

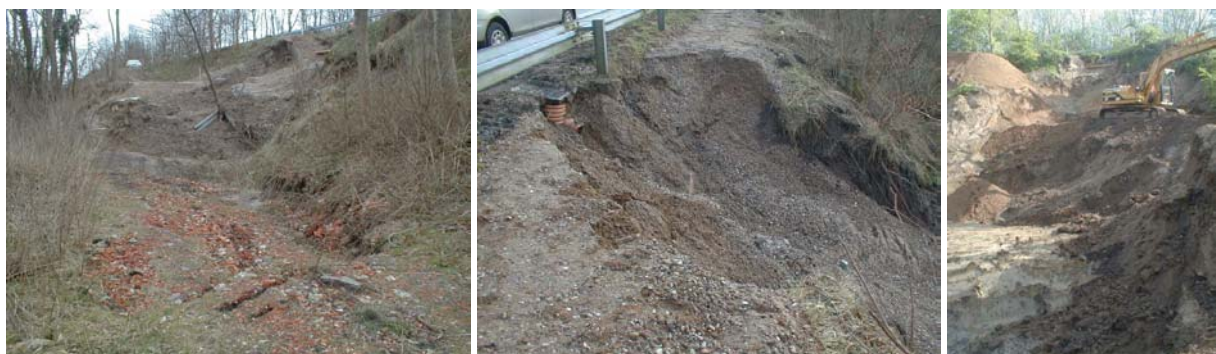
A minor slope at the top of a 15 m high slope along Highway 519 in the southern part of Jutland took place in February 2002. As seen on Figure 4 the bicycle lane disappeared over a length of some five metres causing major concern for the safety of the highway. In the failure escarpment water was visibly seeping from the soil layers below the road. At the foot of the slope some failures had taken place too, and the immediate reaction was that failures in clay deposits due to dead elm trees (caused by elm disease) might be the main reason for the slope failure.

Figure 4. (a) Slide failure blocking private road; (b) The missing bicycle lane; (c) The hunt for Tertiary clay floes

The geology on site is rather chaotic, due to the ice movements during the latest glaciation (responsible for the attractive, highly undulating landscape). Thus, fat Tertiary clay deposits of varying thickness may be interbedded in glacial sand and gravel deposits. Due to very difficult access conditions because of the failure, only two borings were carried out, one at the top of the slope and one halfway down. The top boring indicated plastic Tertiary clay at the top of the slope underlain by glacially deposited sand. The midway boring indicated sand only and could not contribute to a plausible explanation of the failure. However, the presence of Tertiary clay and sand combined with excess water from rainfall and possibly defunct drain systems along the highway seemed the most likely explanation (notice exposed sewage discharge pipe on Figure 4b).

A rather untraditional and proactive approach was used in the remediation. In a very co-operative spirit between Road Authorities, geotechnical consultant and contractor, remediation was carried out by trial and error. The premise was that removal of the fat Tertiary clay floes and an effective drainage of water from the top of the road to the foot of the slope was the cure.

Where the clay could not be removed it was perforated and the holes filled with sand to prevent future pore pressure build-up to take place. The excavated clay was placed at an inclination of 1:15 at the foot of the slope using a total of 5000 m³ of sand as replacement in the slope at an inclination of 1:2.2 and with re-establishment of the 3 m wide private road approximately at mid-height. To further reduce the risk of future failures, the existing sewage line from the road was connected to two sets of four metre deep, one meter diameter drainage wells down the slope.
