Engineering Failure Analysis 9 (2002) 495–509

Failures by SCC in buried pipelines

Until a few years ago there had been no record of stress corrosion cracking (SCC) as a main cause of failures in Argentine pipelines, but as the pipeline system became of a certain age this mechanism started to have an important impact on reliability. This study analyzes three blowouts attributed to high pH SCC in different oil and natural gas transmission pipelines, which occurred by the sudden propagation of longitudinal cracks at the outer surface of the pipes. © 2002 Elsevier Science Ltd. All rights reserved.

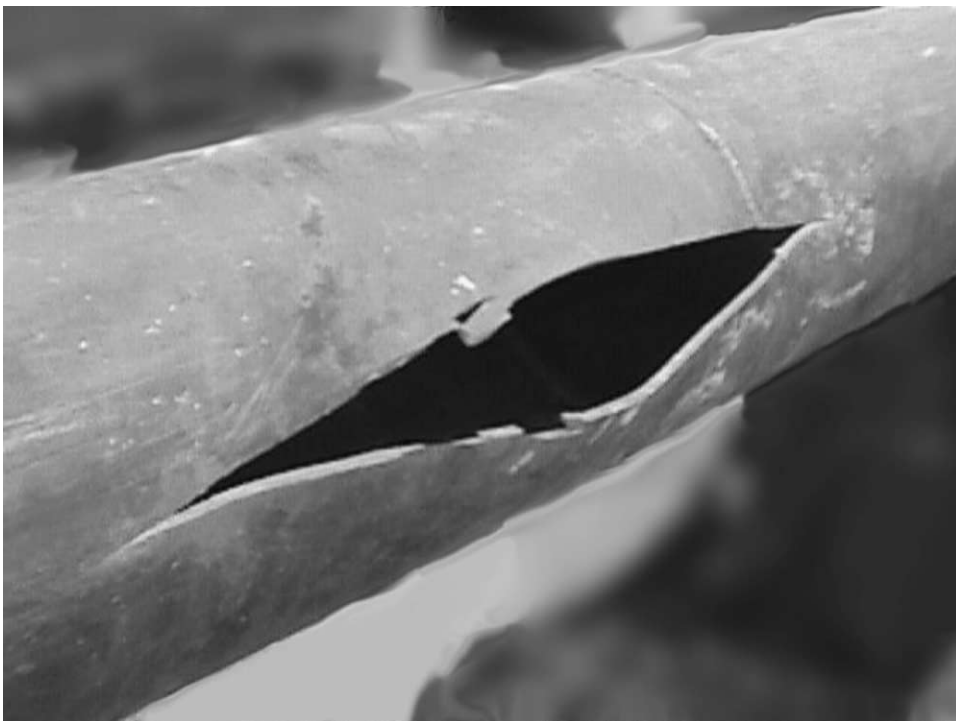
Fig. 1 shows the visual aspect of this failure. The blowout occurred near the pump station, by the sudden propagation of a longitudinal crack along the longitudinal ERW weld material. The crack ran near the tube to tube circumferential weld. Total length of the fracture was 720 mm and involved two pipes, running through the circumferential weld. Pipe coating was lost during the blowout and the following fire. No metal loss due to corrosion was observed. A careful observation of the fracture surface using a low magnification stereo microscope allowed one to identify two kinds of propagation: at the extremes of the fracture, propagation is characteristic of mode I, driven by the tensile hoop stress, with chevron marks pointing to the center. In the center, irregularly stepped propagation is observed, with clear evidence of coalescence of longitudinally oriented parallel defects. Fig. 2 shows this type of irregular propagation parallel to the main fracture propagation and an open secondary crack. Low magnification fractographic observations show a thin black film covering the parallel initial defects.

Fig. 1. Visual aspect of the SCC failure in a 14 inch ERW oil pipeline. (Failure case 1.)

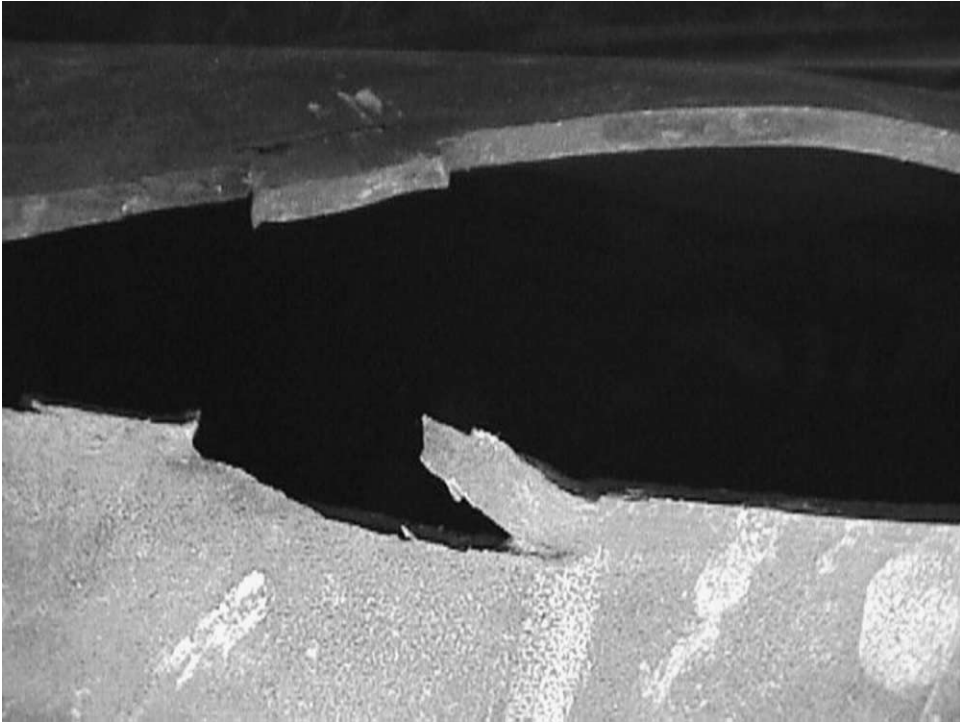
Fig. 2. Irregular propagation at the origin of the failure in the oil pipeline.

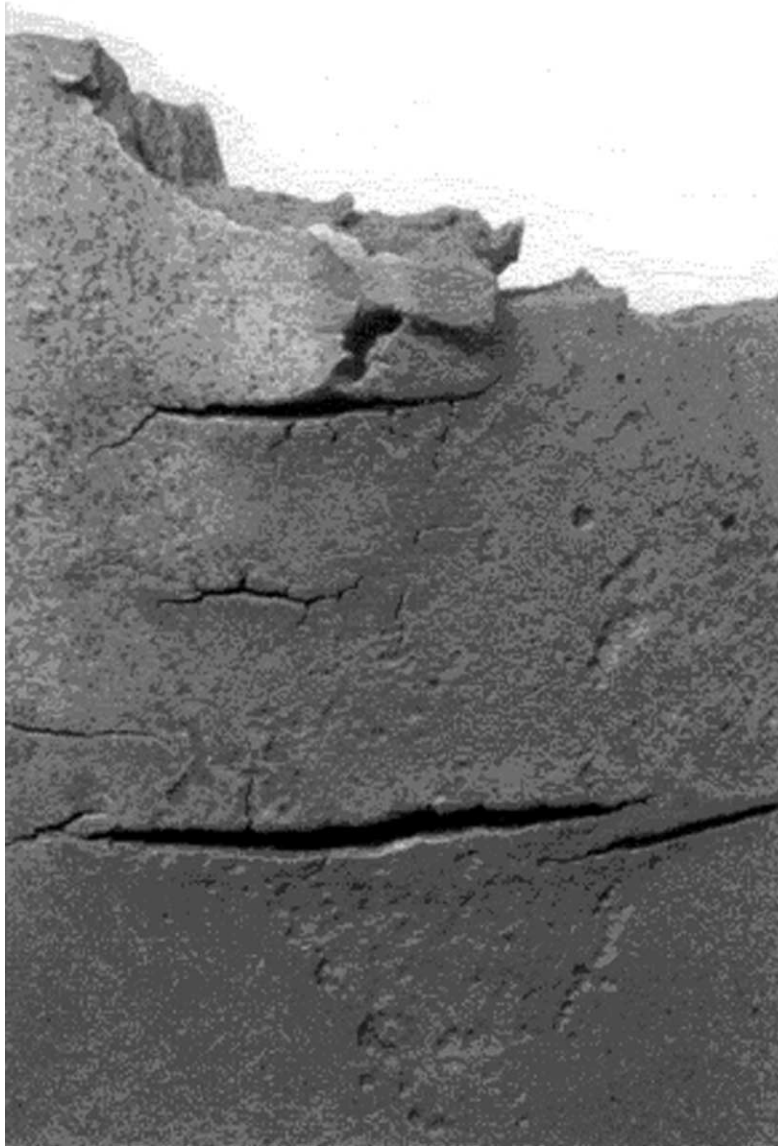
Fig. 3. Secondary cracks close to the main fracture in a 24 inch gas pipeline failed near a compressor station. (Failure case 2, $\times 20$.)

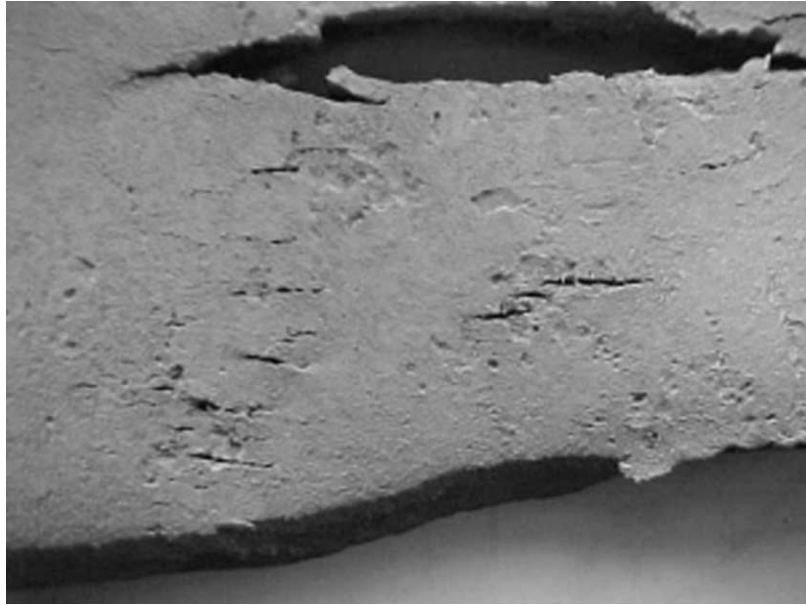
Fig. 4. Secondary cracks found by magnetic particle inspection in failure case 2.

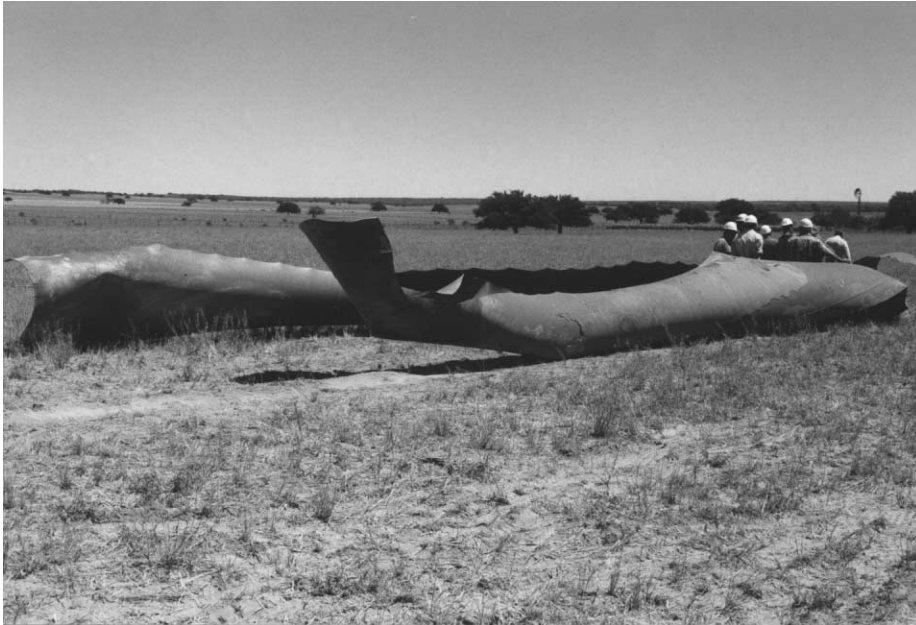
Fig. 5 shows the general characteristics of the failed portion of the pipe. The primary fracture is parallel to the longitudinal axis of the pipe. Total length of the fracture was 38 m. The length of the crack is related to the large compressibility of the transported fluid and the relatively high crack propagation rate. A

Fig. 5. Failure in a natural gas pipeline, 23 km downstream from the closest compressor station. (Failure case 3.)

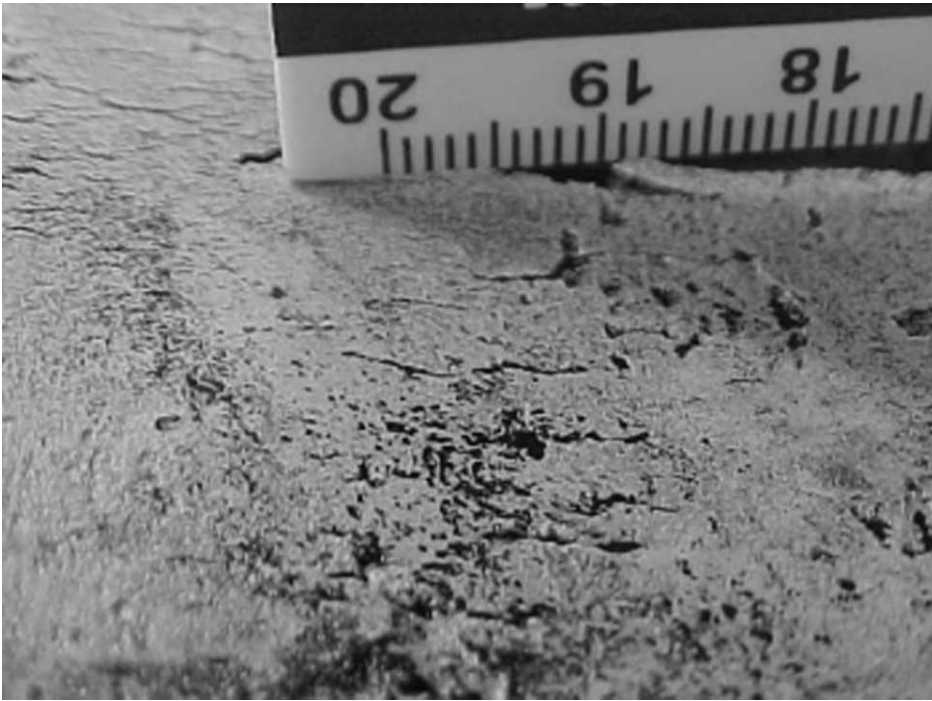
relatively large number of secondary cracks in the vicinity of the fracture origin were found by magnetic particle inspection, some of them are shown in Fig. 6 ($\times 3$). Fig. 7 shows a low magnification fractographic section of the failure origin. Again a thin black film was found covering the parallel initial defects. Fig. 8 ($\times 500$) shows the same portion of the pipe when observed in the SEM at higher magnification. A clear intergranular crack path can be seen. Disbonded coating was found in a nearby region downstream of the failure site. The pH of the electrolyte trapped in the gap beneath the disbonded coating was measured using Litmus paper. Values of pH ranged between 8 and 9.

Fig. 6. Secondary cracks found by magnetic particle inspection in failure case 3 ($\times 3$).

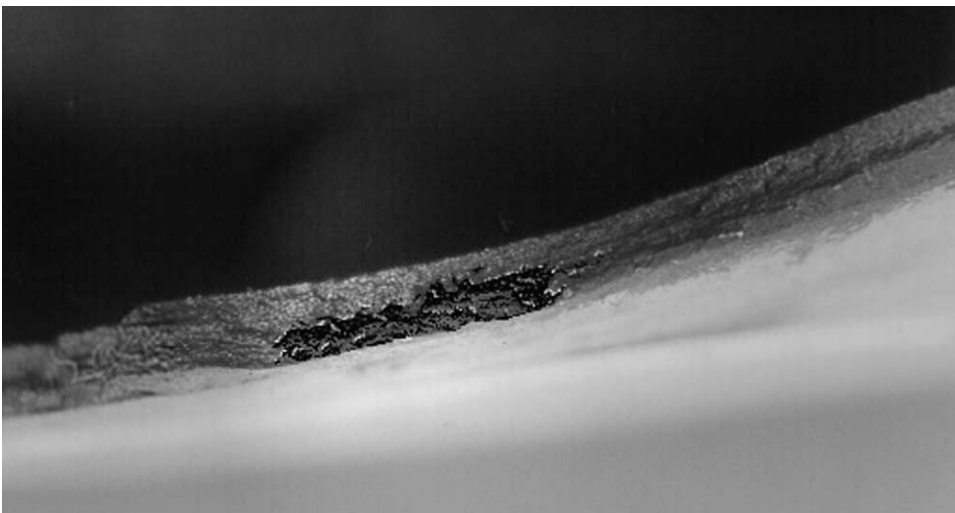
Fig. 7. Fractographic section of failure origin showing black films.

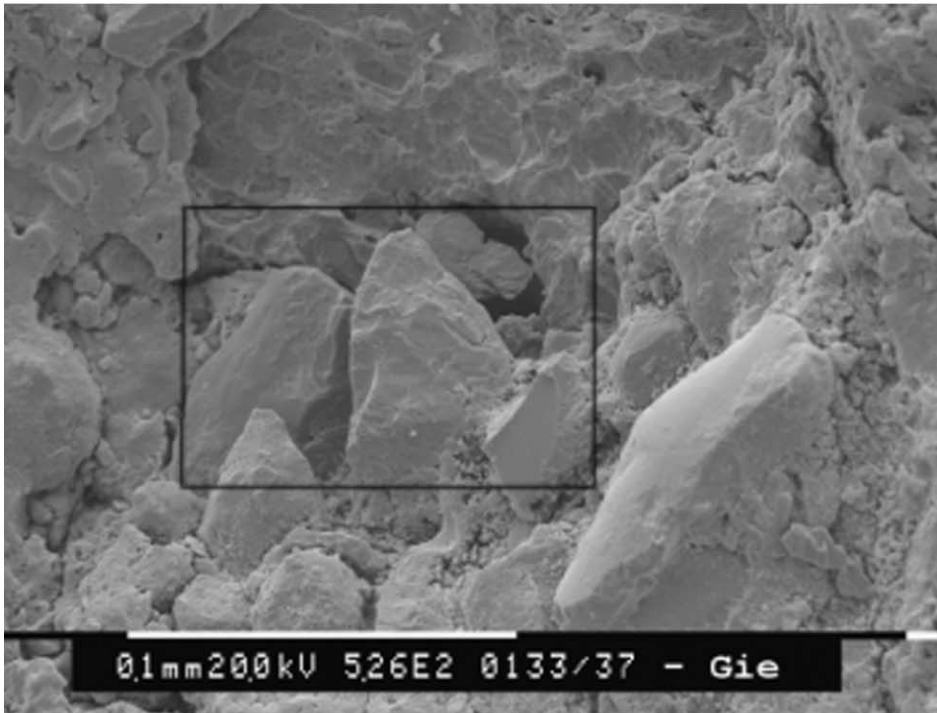
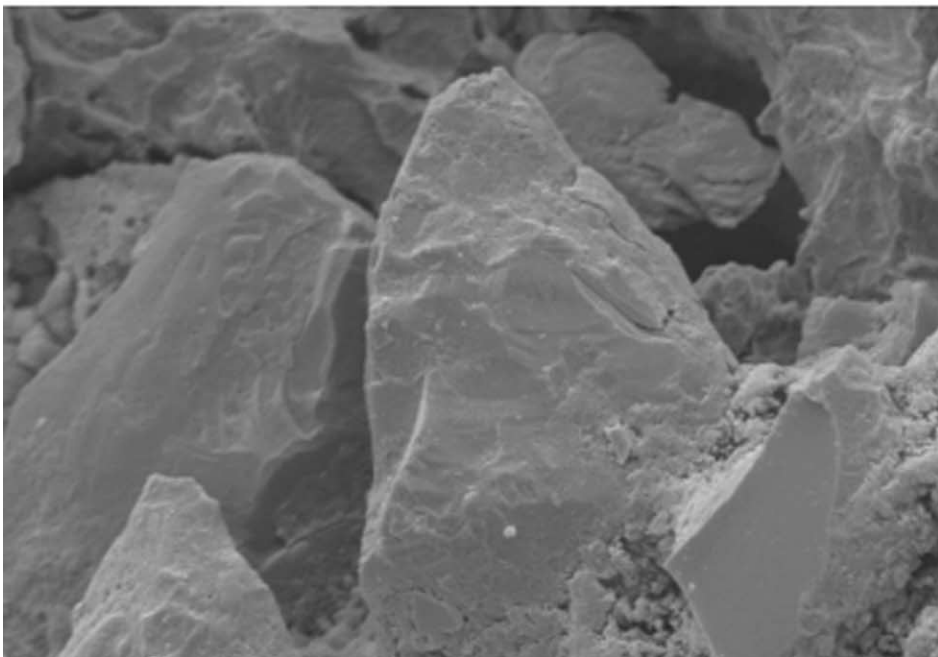
Fig. 8. SEM micrograph showing an intergranular crack path typical of SCC ($\times 500$).

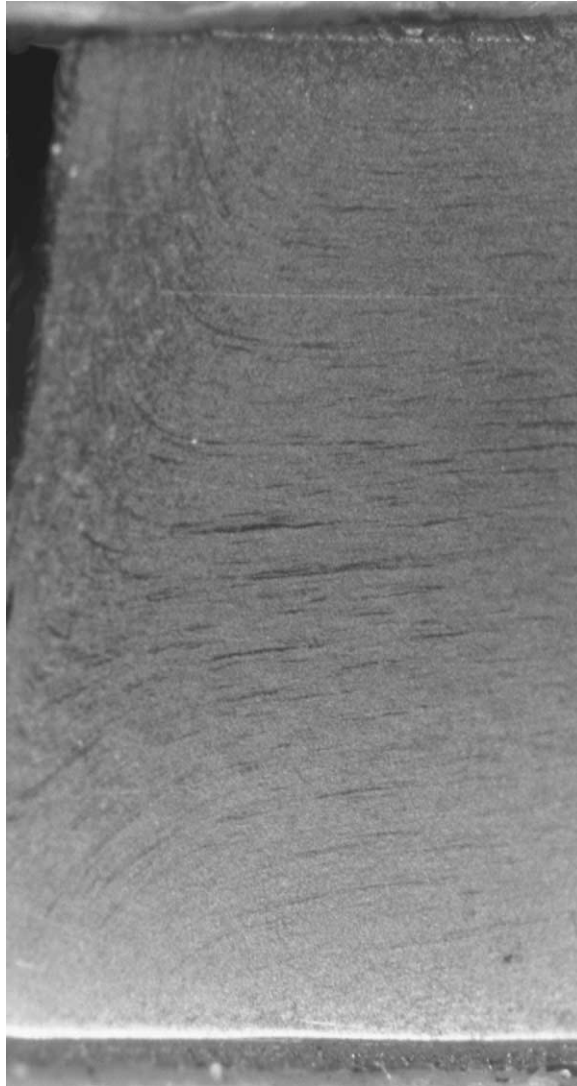
Metallographic samples of cross sections at the fracture origin of each of the failures were prepared for microstructural examination to determine the nature of the cracking and to determine the morphology of the cracks. Fig. 9 ($\times 20$) (case 1) shows typical microstructures of base metal (right) and weld metal (left) for the oil ERW pipe. The external pipe surface runs horizontal in the upper part of the photograph. Note

the severe microstructural banding of base metal, running parallel to the pipe surfaces. This banding is typical of pipes, and is due to the lamination process during the fabrication of the tube from plate material. A large number of inclusions are present in the material, which are also aligned. Some of these inclusions are very long and shallow. Elongated type II MnS and planar arrays of oxides or complex oxy-sulphite

Fig. 9. Typical microstructures of base and weld metals in the oil ERW pipe.

inclusions might act as preferential sites for initiation of surface cracks or propagation of pre-existing defects. Also in this region are small defects of lack of fusion, with caught non metallic inclusions, located in the highly deformed weld area. They present plane or curved surfaces, with small protuberances in the ends. Maximum depths and lengths measured are less than 0.5 mm, while most defects are about 0.25 mm. Base materials of the two gas pipelines also show the banded microstructure typical of API 5 L steels.

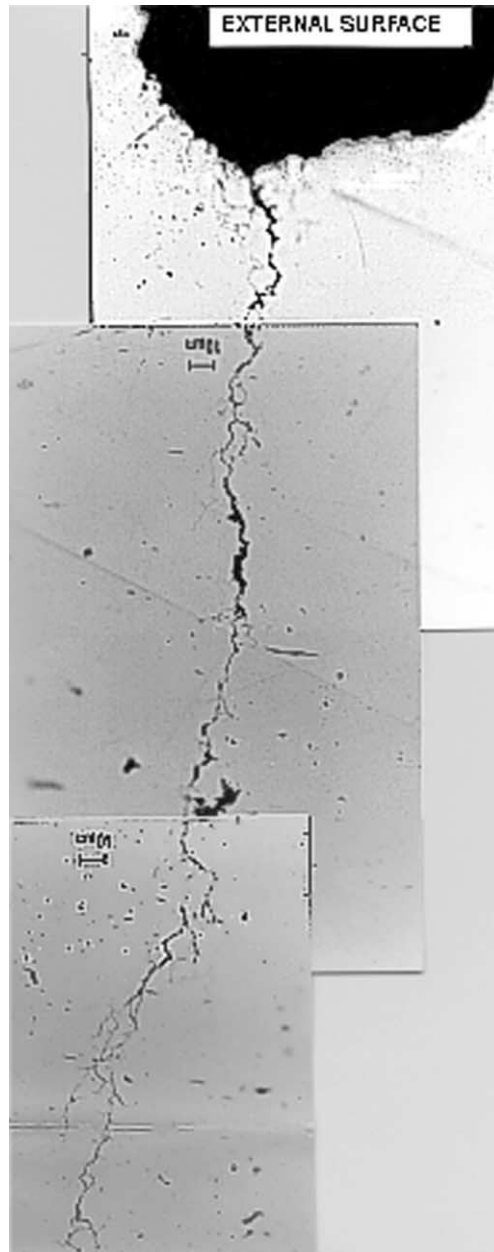
Fig. 10 (case 2) shows the through wall aspect of one of the defects in base metal. It can be seen that the cracks are mainly intergranular and branched, initiating from the outer surface. Several secondary longitudinal cracks from each case were selected for additional examination. Each crack was cut completely from the pipe. A second cut was made perpendicular to the cracks. One half of the secondary longitudinal cracks was metallographically mounted, polished and etched in NITAL. The second half was broken open at cryogenic temperatures. One fracture surface (1/4 of the piece) was cleaned for SEM (scanning electron

Fig. 10. Typical through wall aspect of one of the cracks in base metal ($\times 300$).

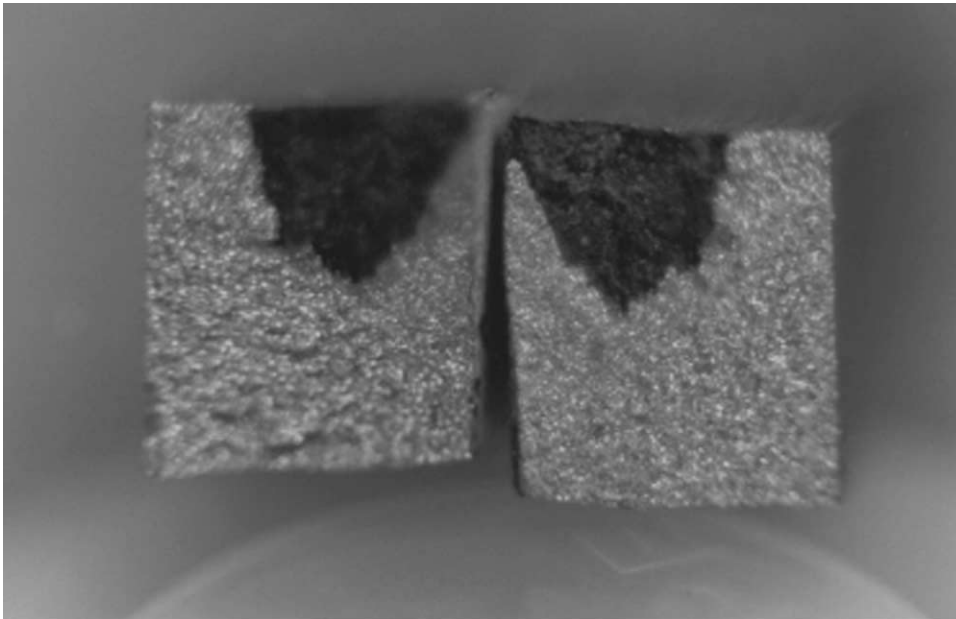
microscopy) examination. The other fracture surface was optically photographed. Fig. 11 shows one of the analyzed specimens, a rather uncommon, semielliptical form of the secondary cracks can be observed.

Fig. 11. Secondary crack morphology after being broken at cryogenic temperatures ($\times 5$).

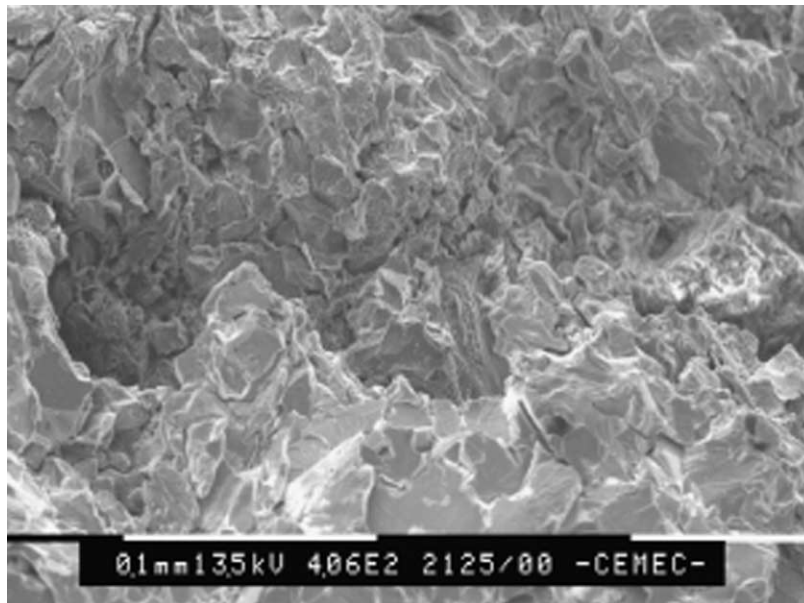
SEM observation of non-gold plated specimens was carried out. Special attention was given to the bottom portion of the preexisting in service cracks, near the recently created cleavage fractures. Fig. 12 ($\times 300$) shows the interface between the crack tip and the cleavage surface. Fig. 13 ($\times 1000$) shows at larger mag-

Fig. 12. Crack tip of secondary crack ($\times 300$).

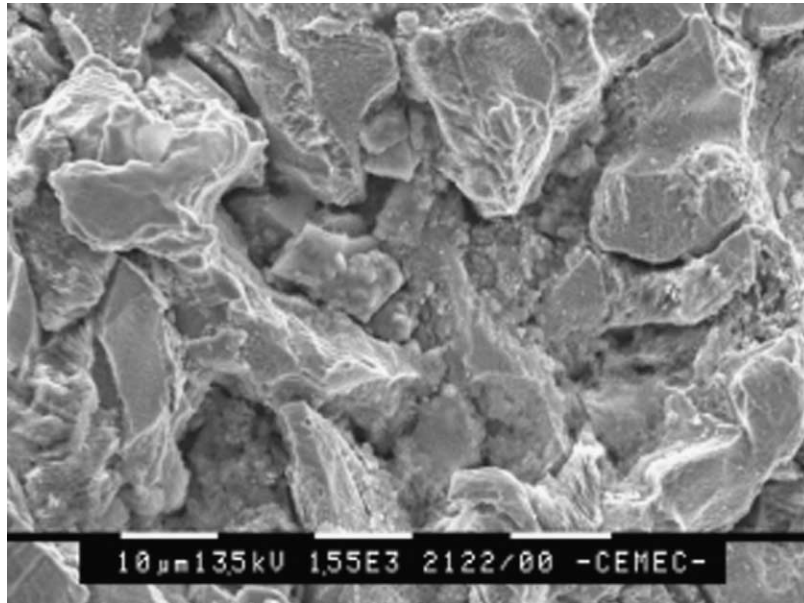
nifications the upper part of Fig. 12, where the intergranular character of the surface of the preexisting longitudinal crack is clearly identified

Fig. 13. Intergranular path of secondary crack ($\times 1000$).
