EVALUATION OF THE J. FRIEMEL #1 VERTICAL WELL
TESTS, DEAF SMITH COUNTY, PALO DURO BASIN,
TEXAS PANHANDLE

D. Anderson Smith

Prepared for the
U.S. Department of Energy
Office of Nuclear Waste Isolation
under contract no. DE-AC-97-83WM46615

Bureau of Economic Geology
W.L. Fisher, Director
The University of Texas at Austin
University Station, P.O. Box X
Austin, Texas 78713

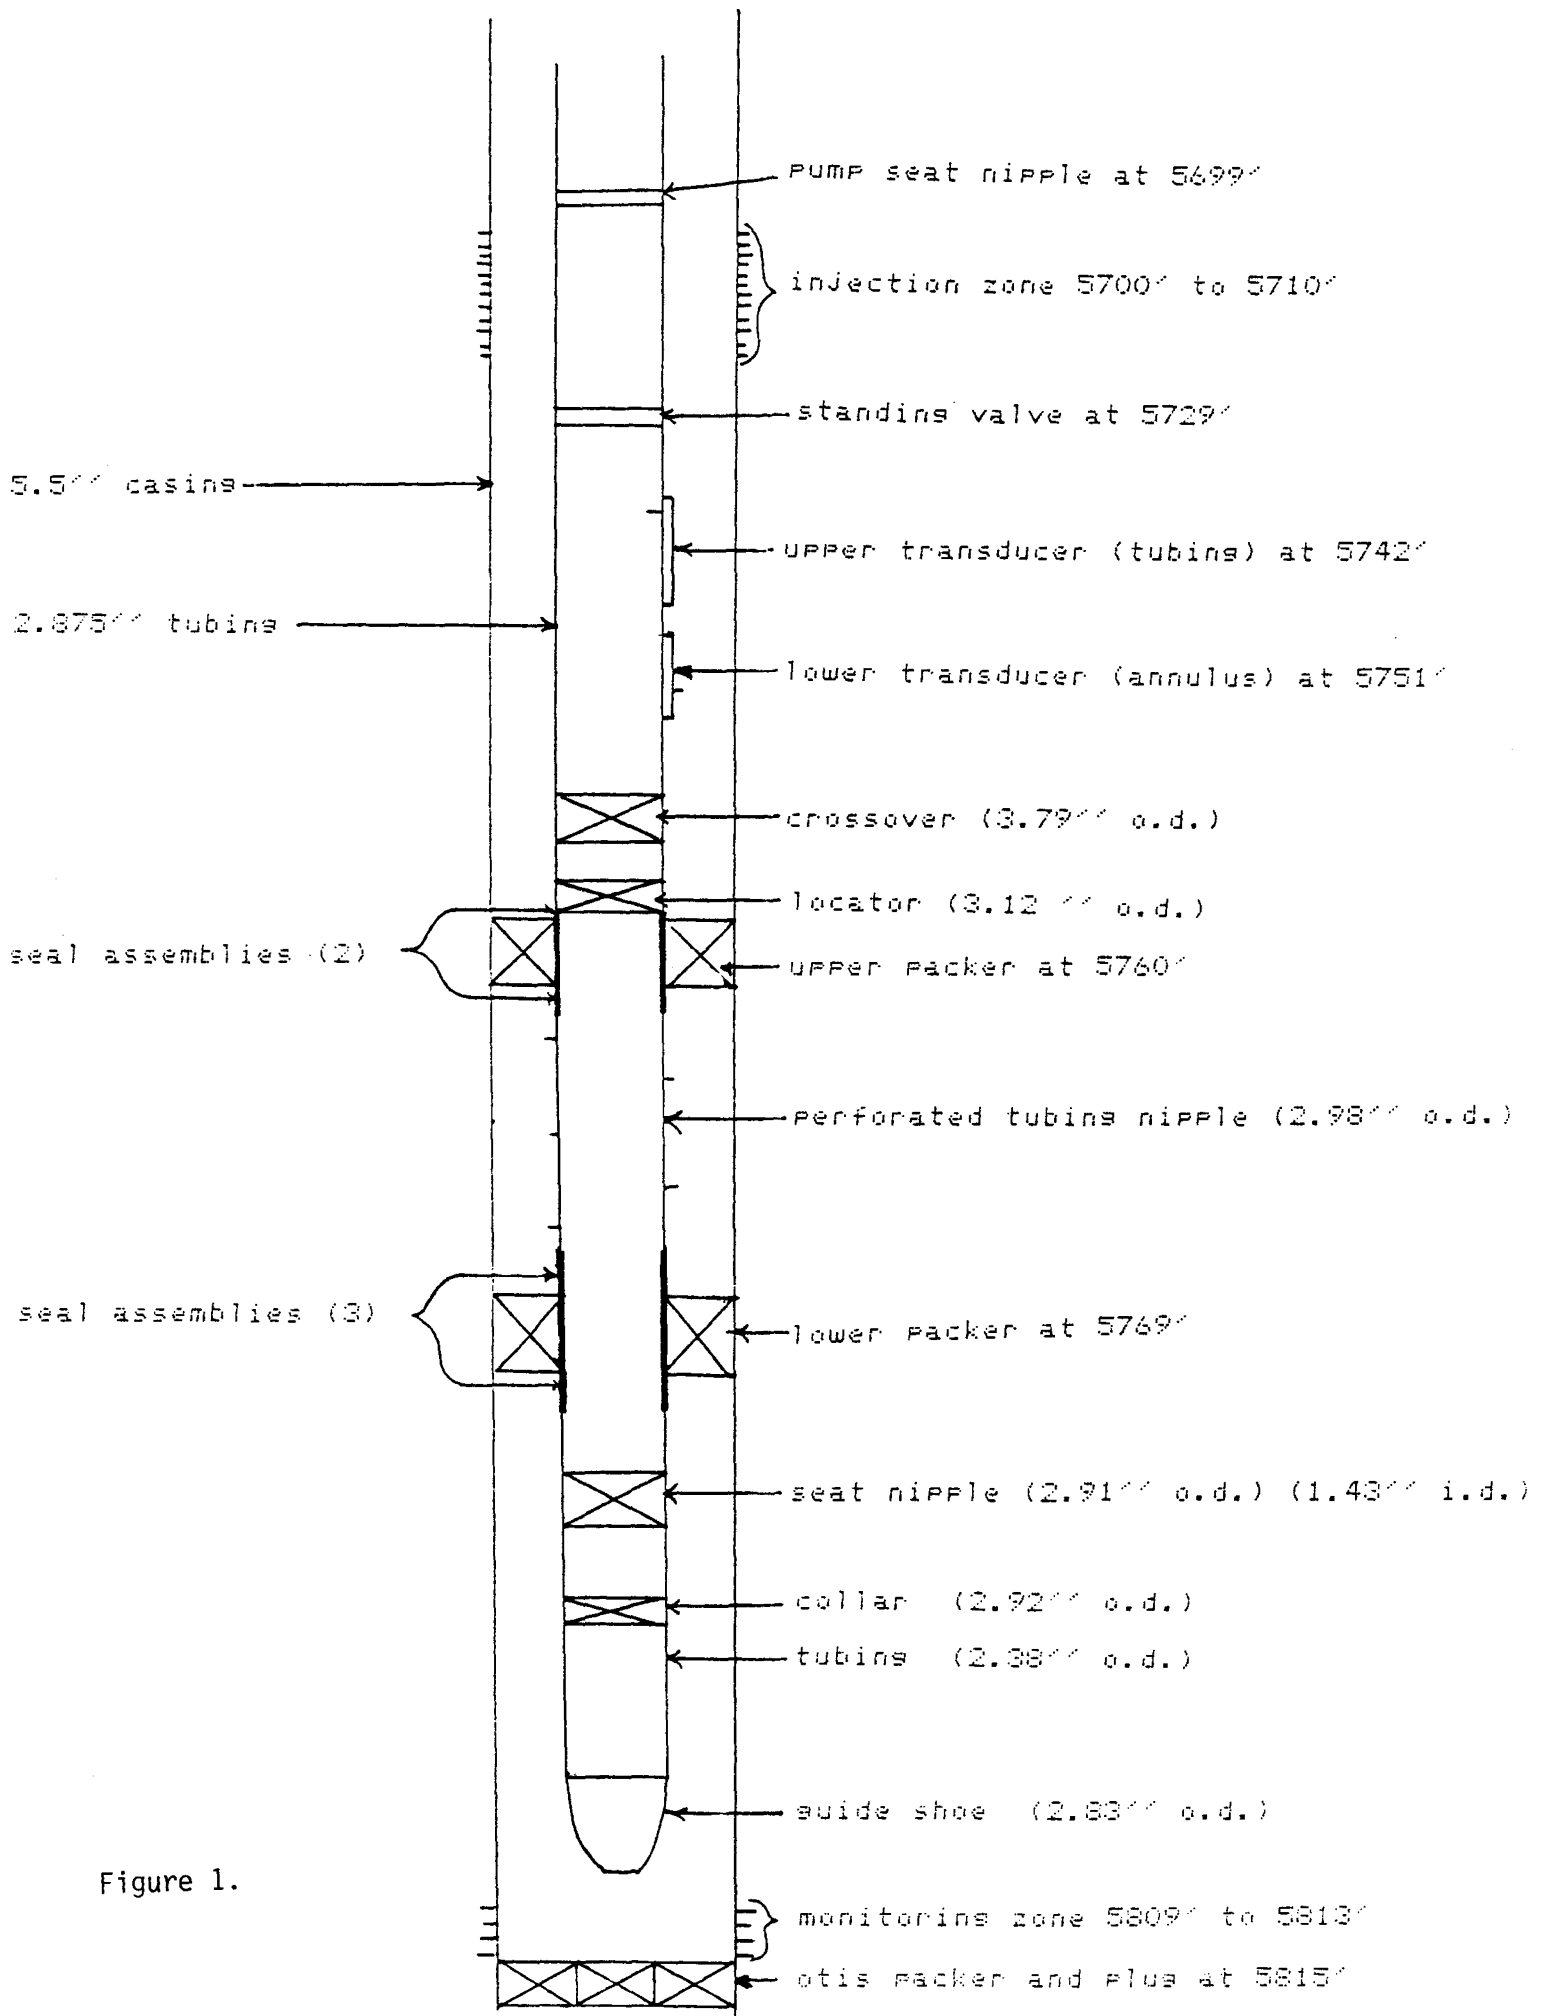
Figure 1.

Figure 1 shows the final test tool as it was installed in the well. There were two packers permanently installed in the well between the two perforated intervals. Seal assemblies were spaced in the tubing string such that they would seat into the two packers simultaneously. A perforated length of tubing was positioned between the two seal assemblies and thus between the two packers. A seat nipple was positioned below the lowermost seal assembly, so that a plug set into the nipple would isolate the tubing from the lowermost perforated zone. With the plug in place the tubing is in communication with the interval between the packers through the perforated length of tubing, but is isolated from both perforated casing zones. The tubing can then be pressured up to a pressure high enough to document that the packers are not leaking. After the packers are successfully tested, then the plug can be removed, restoring communication from the tubing to the lowermost perforated zone.

There were two transducers mounted on the tubing string, one ported to the tubing to monitor the lower perforated zone (monitor zone) and one ported to the annulus to monitor pressure in the upper perforated zone (injection zone).

A standing valve was located in the tubing string above the transducer carrier to allow the monitor zone to be shut in. A pump seat nipple was located above the standing valve to allow a sucker rod pump to be used to pump from the monitor zone.

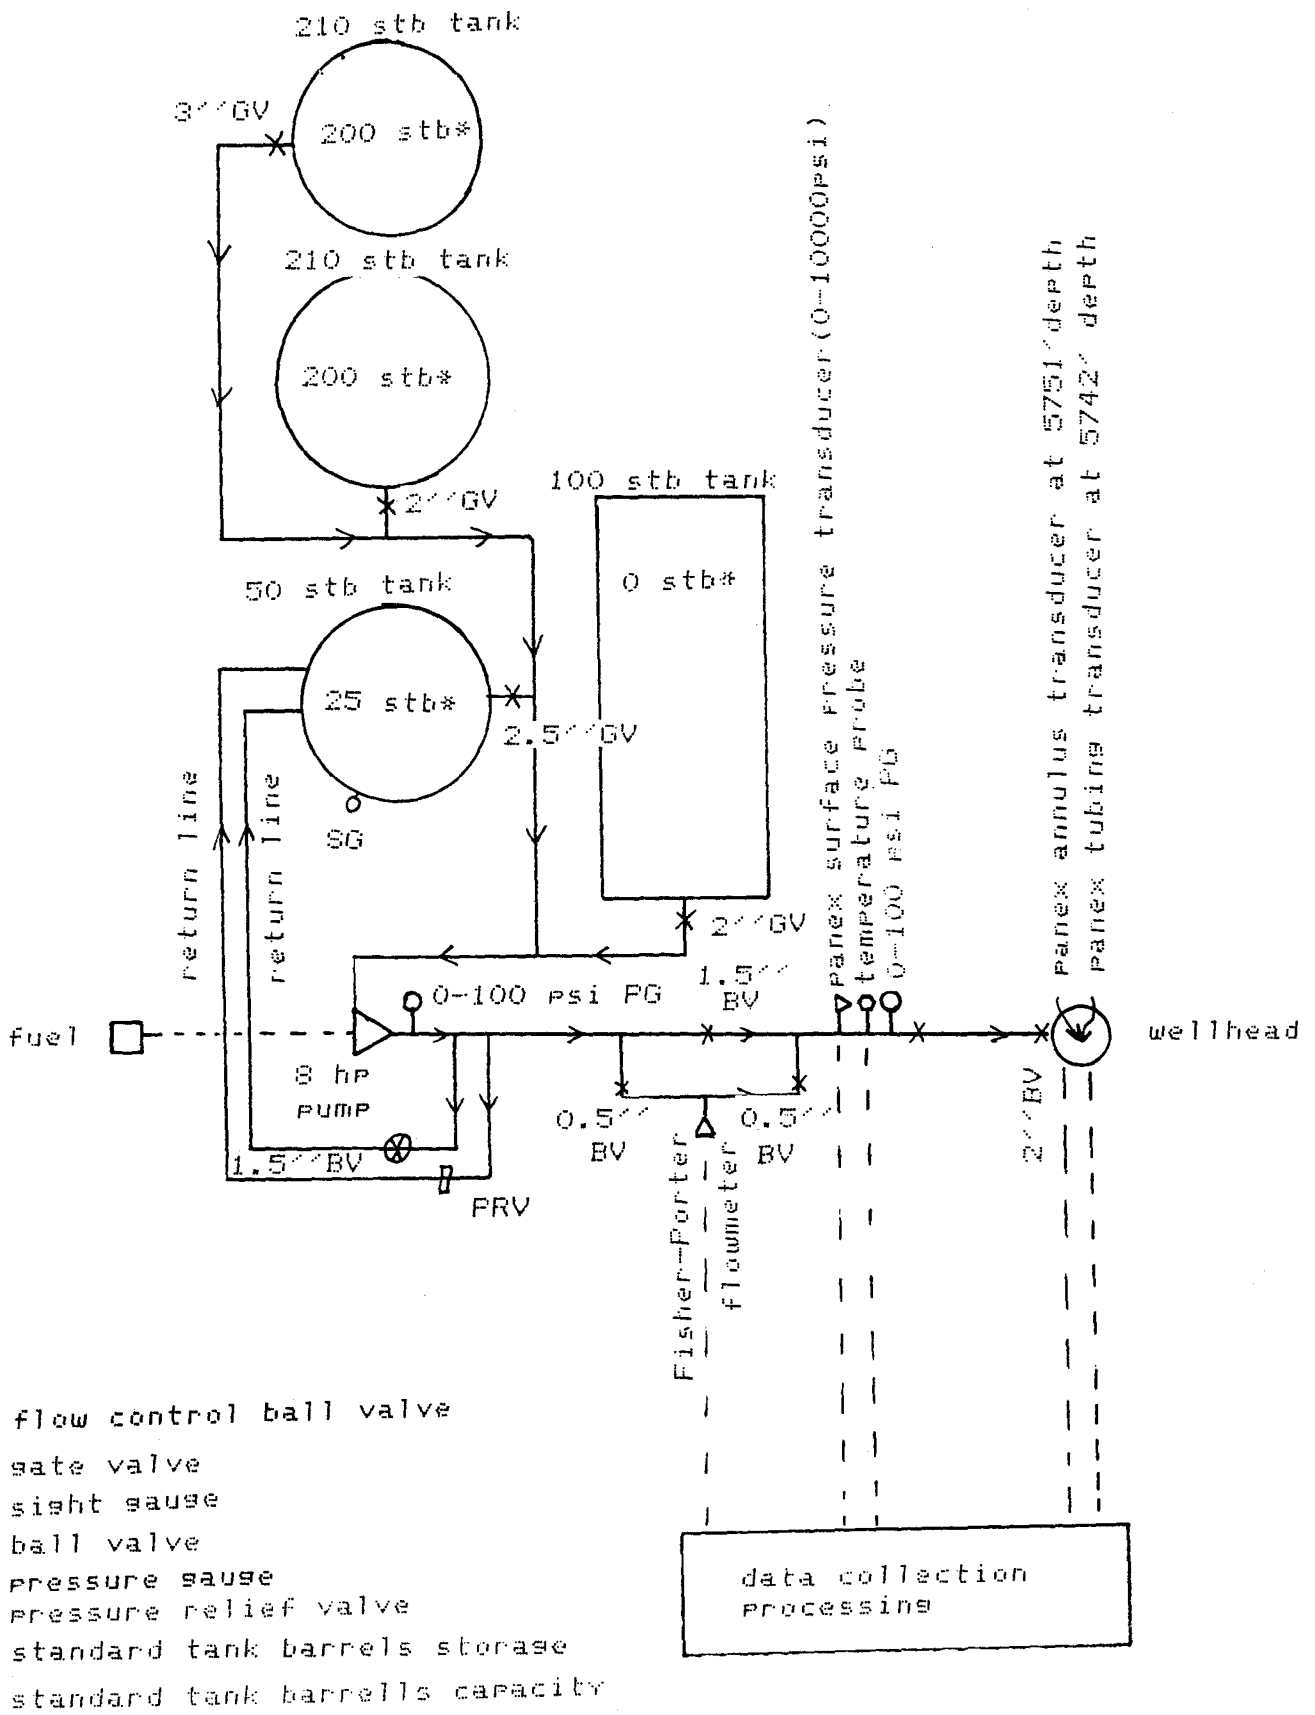
FIGURE 2 VERTICAL WELL TEST SURFACE SCHEMATIC

The surface equipment design is illustrated in figure 2. Four tanks holding a total of 425 barrels of brine were each connected to the injection pump by 2-inch PVC pipe. Each tank was equipped with a valve so that injection could be from any combination of the tanks. The small 50-barrel tank was fitted with a manometer-type sight gauge for measuring fluid level in the tank. The injection pump is an 8-horsepower gasoline engine pump. Pressure in the injection line is regulated by two return lines from the injection line to the 50-barrel tank. On the primary return line, a 1-1/2-inch ball valve can be partially opened to adjust the amount of flow bypassing the injection line and returning to the 50-barrel tank. The secondary return line is equipped with a pressure relief valve which can be adjusted to open at a specified pressure. The system was designed to allow the pressure to be adjusted by the primary return line valve and regulated by the secondary return line pressure relief valve.

On the wellhead side of the injection pump, the injection line consisted of a primary injection line of 1-1/2-inch galvanized pipe, which could be

closed by a ball valve, and a 1/2-inch secondary line containing a Fisher-Porter flow meter. The 1-1/2-inch line was to be used to fill the annulus at a high flow rate. When the annulus was filled, the 1-1/2-inch line was to be closed and the 1/2-inch line opened so that the flow rate could be monitored by the flow meter. The Fisher-Porter flow meter scale was adjusted to read from 0.3 gallons per minute to 10.0 gallons per minute. Pressure, temperature, and flow rate were to be measured in the injection line on the wellhead side of the two injection lines, so that the pressure and temperature of the fluids being injected could be measured, and the actual amount of injection could be measured and recorded.
