Seismic upgrading of cultural heritage – A case study using an educational building in Croatia from the historicism style

Antonela Moretić^a, Mislav Stepinac^{a,*}, Paulo B. Lourenço^b

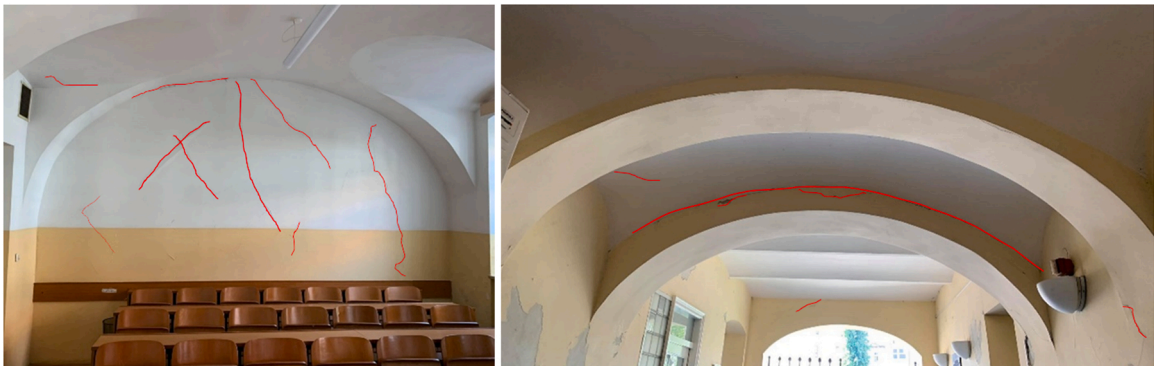
Fig. 6. Characteristic cracks, marked with a red line (photo credit: Mislav Stepinac).

A few months later, a detailed examination was performed [14,15]. The flowchart of the performed activities is shown in Fig. 7. It was found that the cracks on the walls of the central staircase core coincide from the outside and inside, which indicates that the cracks are not superficial. The walls of the central core extend through the entire height of the building without any lateral restraints, and are weakened by openings, so they are considered to be the most critical part of the building. Cracks in the transverse walls of central core indicate possible out-of-plane failure of the mechanism. Shear strength testing of masonry were performed [14,15] using a hydraulic jack (Fig. 8). Visual inspection followed by in-situ examinations is explained in detail in [11]. It revealed that the masonry was in a good condition. Archival documentation was insufficient for geometry assessment. Photogrammetry was used to assess the true geometry of the building (Fig. 9) [16–18]. DJI Mavic 2 pro drone was used to take photos. Altogether, 87 photos were taken and the basic model was made in Agisoft Metashape software [19]. The full assessment of the presented case study was elaborated more in the detail in [11].

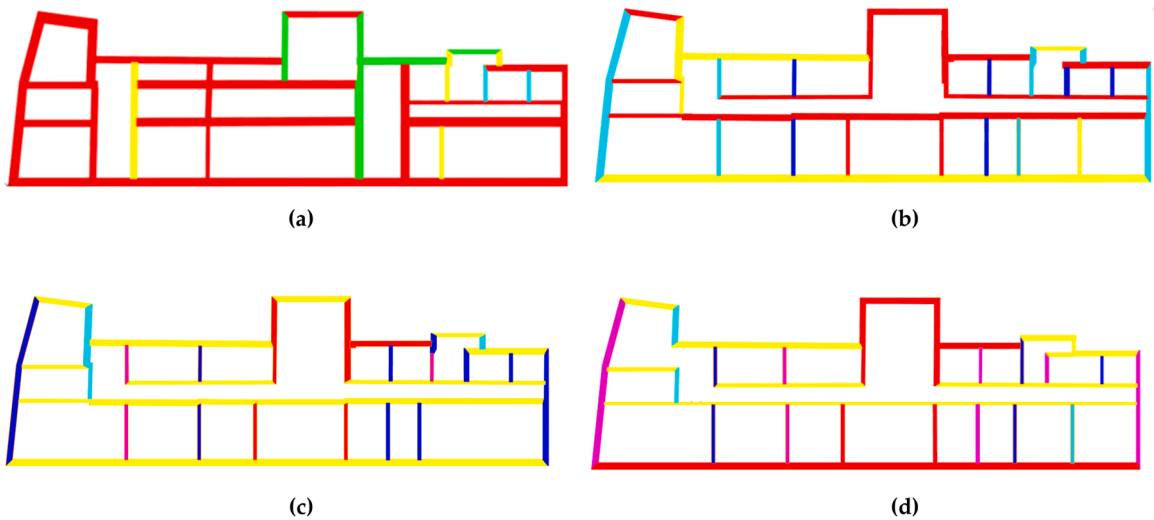
Fig. 11. FRCM system (a) ground floor plan (b) first floor plan (c) second floor plan (d) attic floor plan.

is not necessary to strengthen each element equally, nor is it economical. Masonry characteristics are shown in Table 3. For the first variant, the FRCM composite with aramid fibers was placed on both faces of the walls, 3 layers were used (Table 4, Fig. 11). FRCM with aramid fabric was used because it is common to use it in Croatia due to availability by the producers. FRCM-matrix was taken as it defined in the Italian code. The procedure was performed iteratively, the initial strengthening concept was corrected according to the

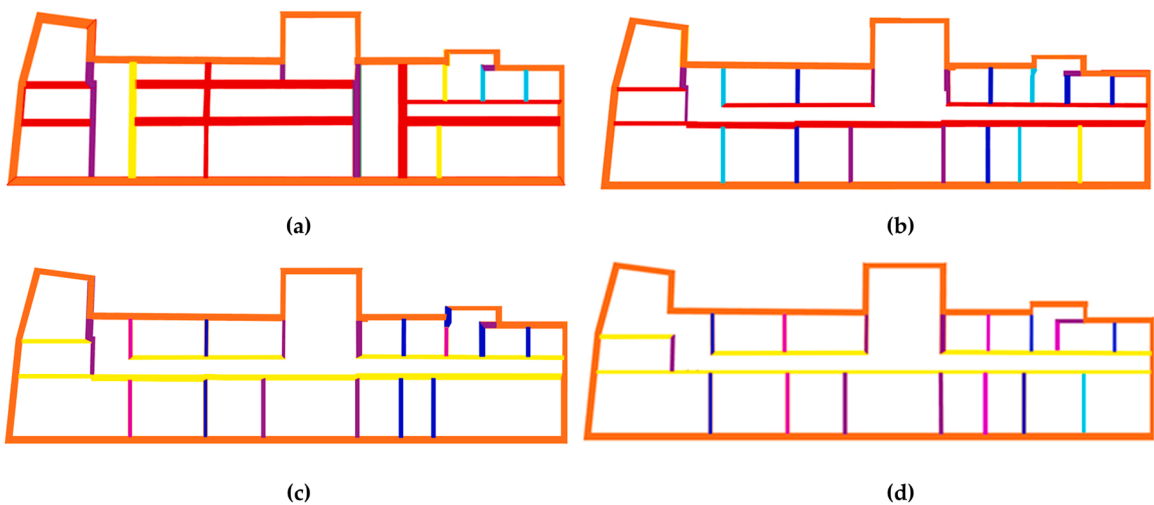
Fig. 12. Combination of FRCM system and shotcrete (a) ground floor plan (b) first floor plan (c) second floor plan (d) attic floor plan.

In the last and third variant, a combination of shotcrete and FRCM system was used (Table 5, Fig. 12). The shotcrete was used on the façade walls and stairwell walls, while the FRCM system was used on the remaining interior walls. Reinforcement meshes Q503 were used for shotcrete application. On the façade walls, they are placed only on the inner face. On the inner walls of the central core and wings, the shotcrete is placed on both faces, because according to the calculations, they are the most critical parts of the building, and it is impossible to strengthen them on one side only. As for FRCM, five different systems were used. The composite is placed on both faces of the walls.

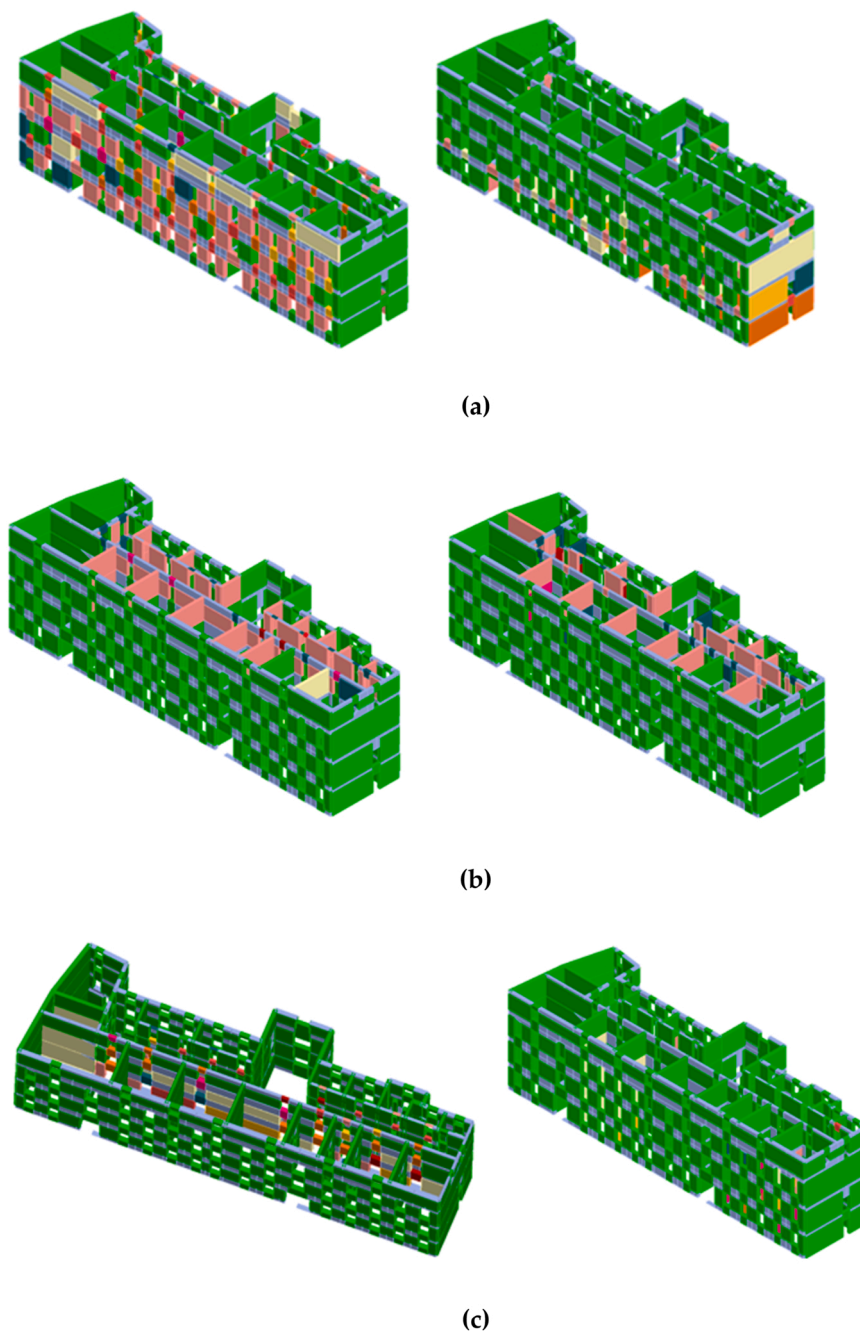
Fig. 16. Damage visualization for the most critical analysis in x (left) and y direction (right) (a) model strengthened by the FRCM system (b) model strengthened by shotcrete (c) model strengthened by FRCM systems and shotcrete.
