Rising damp, a reoccurring problem in basements

a case study with different attempts to stop the moisture

Rising damp, a reoccurring problem in basements – a case study with different attempts to stop the moisture

Eva. B. Møller, Ph.D. ¹
Birgit Olsen, MSc. ²

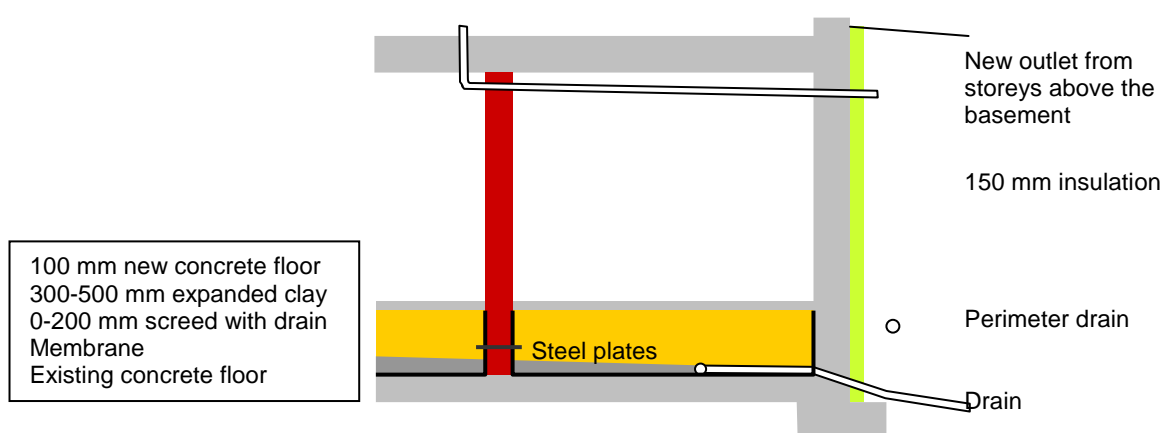
FIG. 1. Schematic drawing of remedies to reduce moisture transport into the basement. Originally the membrane was planned to be continuous e.g. under the internal walls, but this was later changed by the contractor. Instead steel plates were pressed through the walls, and the membrane was continued on the wall.

- *New floors.* Although the concrete floor was placed on sand, the moisture content, indicating that capillary suction was possible through the sand and concrete. As the ceiling height in the basement was 3.28 m, it was possible to raise the floor and create a double construction by placing a new floor at a higher level. The area between the two floors was drained. To stop rising damp through the floor a liquid membrane was applied on the original floor.

- *Steel plates and injections.* To stop the rising damp in the internal brick walls it was planned to use the liquid membrane, removing 2 courses of the brick wall approximately 1 m at the time. This was difficult and time consuming. Instead the contractor chose to force overlapping steel plates through a horizontal joint where they acted as a capillary suction barrier. Where it was impossible to place steel plates e.g. because of downpipes in the walls, it was planned to inject the area of the wall with a capillary blocking mortar, however, this was never done.

- *Outer walls.* The concrete walls were un-insulated and the drainage defective. Therefore, perimeter drain and 150 mm external insulation (EPS) were added to the walls. Pumps to insure the drainage was effective were also installed. The pumps were provided with an alarm system, telling the caretaker when the system had fall outs.

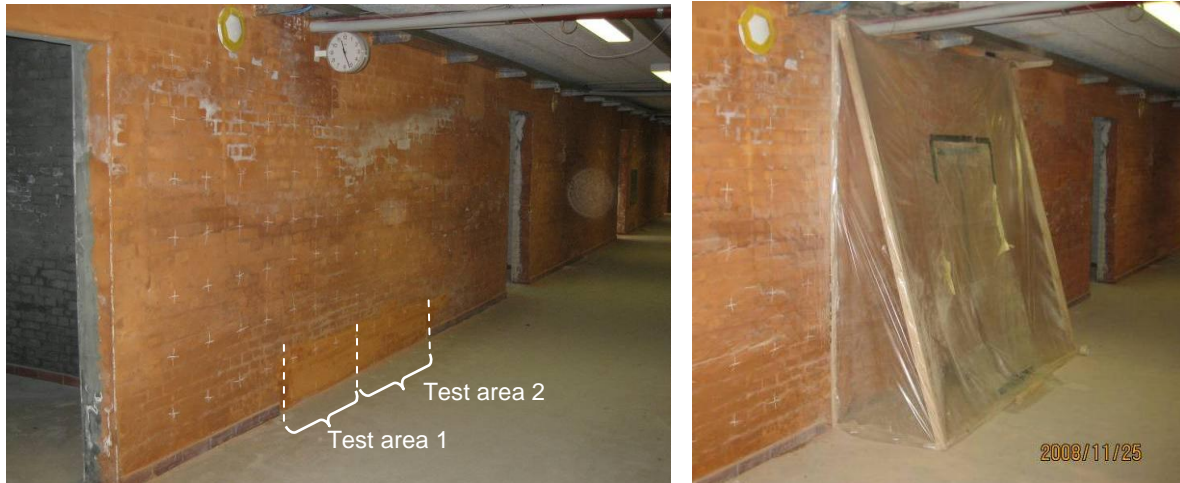
As the dispute went on, the internal walls showed signs of high moisture content; the fringe of capillary suction was very visible where the plasterwork was coloured, see FIG. 2 (left), parts of the plasterwork also was loosened by the salt formation at the fringe (efflorescence).

FIG. 2. Examples of moist internal walls in the basement. Left: Visible moisture signs (efflorescence) and the two test areas. Right: Forced drying under a tent.

Therefore, the basement was ventilated and heated to reduce the relative humidity of the air. The development of the moisture content was followed and new renovation proposals tested.

After the test renovations were performed, the wall was left to dry naturally, but with heating and enhanced ventilation in the basement. Approximately four years after the second test was performed the moisture content in the wall was measured by a nuclear moisture density gauge, see FIG. 4. As the measurements showed very little difference to moisture content in the parts of the walls where no test renovations were performed, forced drying was installed. To reduce the drying costs the two test areas were covered by a small tent, see FIG. 2. Moisture measurements were continued after the forced drying was stopped.

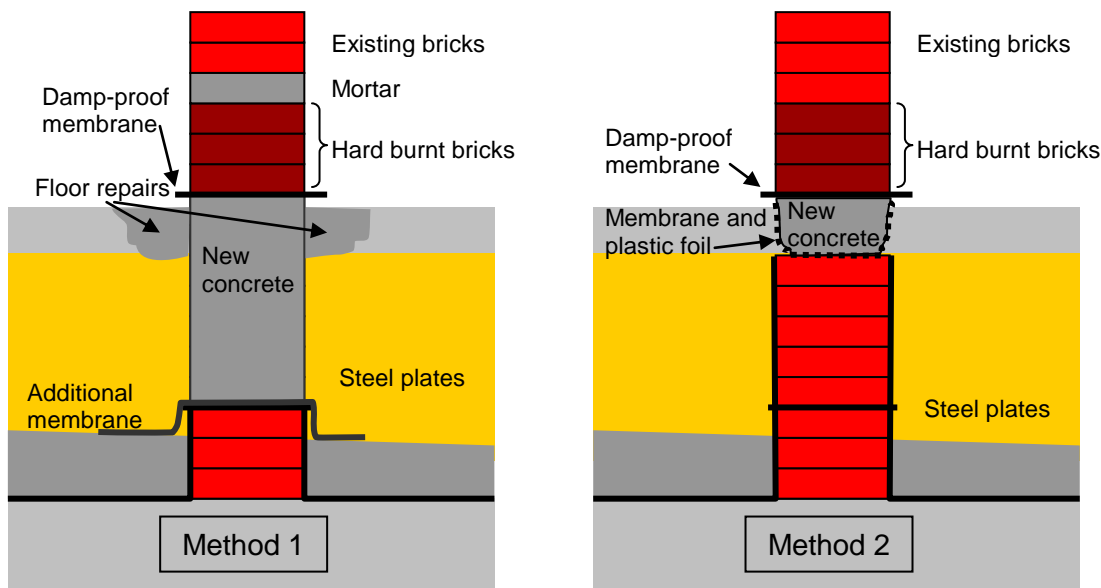
FIG. 3. First method to avoid moisture transport in internal walls, ten courses of bricks had to be replaced in this solution (left). In the second method the concrete floor was untouched and only five courses had to be removed (right).

were performed. Different solutions were tried; the first was regarded more safe than the second but also more expensive. Both solutions are presented in FIG. 3.

As both methods included removal of bricks, it was not possible to renovate the whole wall at once, but the wall had to be divided in bits, making it possible to have a gap of maximum 1 m and solid wall on both sides of the gap. Theoretically every other meter of wall could be renovated at the same time. When the gap was closed, the adjacent wall piece could be renovated. However, a part of the wall had to be left open between the two similar work processes, as the liquid membrane had to overlap.

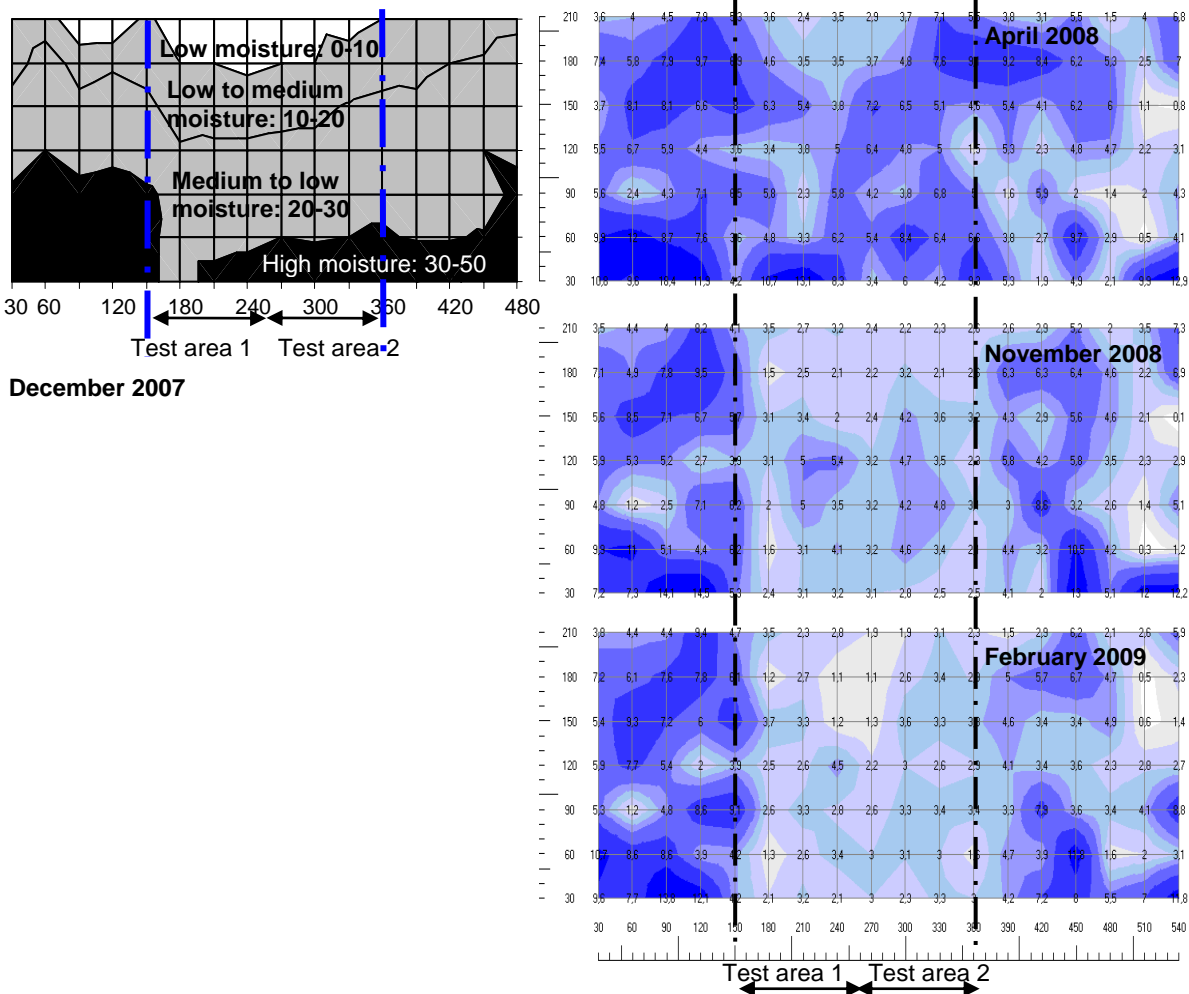
Measurements with nuclear moisture density gauge are shown in FIG. 5. The measurements are shown as numbers that resembles the moisture content; high numbers indicates high moisture content. The measurements were performed in December 2007, 4½ years after the two tests were performed; e.g. rising damp was blocked horizontally but not vertically. The basement was heated and ventilated during this period. Moisture content in brick and mortar was determined by weight to 21 % in brick and 6 % in mortar in an area where the nuclear moisture density gauge showed high moisture content.

The microwave moisture measurements were introduced when the test areas were separated from the untreated wall and the drying was forced. The results are shown in FIG. 5.

FIG. 5. Moisture measurements with nuclear moisture density gauge with numbers resembling the moisture content (left). Microwave moisture measurements (in weight % of bricks) (right); when the test areas were separated from the rest of the wall and forced drying activated (April 2008) and after (November 2008 and February 2009). The measurements after the forced drying was stopped (February 2009) did not show significant changes and were similar to those from February 2009.

Like the measurements with nuclear moisture density gauge the first microwave moisture measurements showed that there was only little difference in the moisture distribution in test area compared to the untreated parts. The lower parts were moister than the upper parts although the image was more blurred, with some wet areas higher up in the wall. It seems more likely that the walls are moister at the bottom than at the top, as the measurements with nuclear moisture density gauge showed (FIG. 5 left), than a random distribution as the microwave moisture measurements showed (FIG. 5 right).

After the moisture content in the test area had stabilised (after less than a year, cf. FIG. 5), the forced drying was stopped, and microwave moisture measurements continued. The moisture distribution did not change after the forced drying had stopped. Therefore, rising damp in the internal walls had stopped; the tests were successful. As a result the second test solution is now being applied to all the internal walls. After a drying period the moisture content will be checked with microwave moisture measurements combined with moisture measurements by weight.
