## **Assessment of pre-fabricated bathrooms from the 1990s**

Morelli, Martin; Brandt, Erik

1st International Symposium on Building Pathology (ISBP 2015)

2015

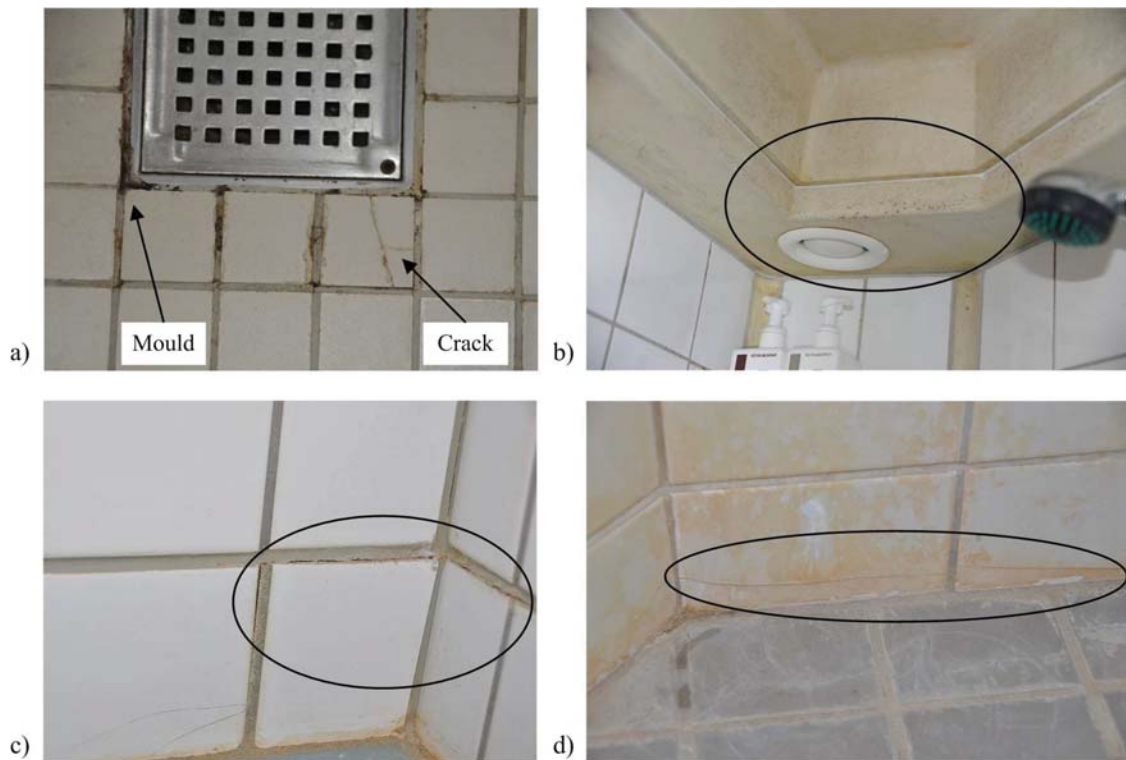
The inspections lead to the conclusion that in general the conditions of the bathrooms were good e.g. all bathrooms had a basin and shower unit without moisture sensitive materials. However, the resilient silicone sealants were often attacked by mould especially in the wet zone, loss of adherence and cracks, as shown in Figs 6a and 6c. Mould growth was also detected in the ceiling and mortar joints in

the wall of one bathroom as shown in Fig 6b. The mechanical ventilation was judged very low in this particular bathroom contrary to many other bathrooms. Other failures registered in the wet zone were holes that were not repaired after removal of hooks etc. Cracked tiles were registered close to the gully (Fig 6a) and for the heavy-weight assembly kit with fibre reinforced concrete bottom on the wall about 30 mm above the floor (Fig 6d). This bathroom floor was constructed with a small plinth and the cracks were observed at different locations in each bathroom.

**Figure 6.** a) Black discolouration in resilient silicone sealant around floor gully due to extensive mould growth; and cracks in tiles on floor. b) Mould growth in a ceiling made from fibre reinforced concrete due to low ventilation (high relative humidity). c) Loss of adherence and crack in resilient silicone sealant. d) Cracks in wall tiles in the height of the plinth.

Perhaps the most critical failure was registered in the heavy-weight assembly kit of fibre reinforced concrete bottom with a plinth. As the crack was observed on different walls but in the same height in

the three inspected bathrooms, the crack might be related to the plinth on the bottom element (Figs. 4b and 6c). However, the cracks could also be related to movement in the building. As no destructive inspections were conducted, the correct reason for the crack cannot be stated.

In general the quality of the bathrooms is high considering their age of 15-20 years. Many of the failures registered could have been avoided with increased maintenance, e.g. replacement of tiles with cracks and silicone sealant with mould growth. One reason for the high quality of the bathrooms relates to their layout, where the wet zone is separated from critical assemblies and moisture sensitive materials such as wooden panels are kept in the moist zone. The influence of mechanical ventilation is important to the indoor environment in these small bathrooms without venting opportunities to the outside. This is assessed to be the reason for mould growth in the ceiling of one bathroom with reduced ventilation as compared to the other bathrooms. Again this might be related to the occupant's ability of maintaining the bathroom and the ventilation system i.e. the fan.
