Publication date: 2015

# Vibration-based damage identification in wind turbine blades

Experiments were conducted with a Vestas V27 wind turbine, situated at DTU Wind Energy in Roskilde, Denmark. Fig. 1 depicts the experimental setup in which one blade was instrumented. The turbine was analyzed in four states; namely, the healthy state and three damaged ones with, respectively, a 15 cm, 30 cm, and 45 cm trailing edge crack in the instrumented blade. The experiments were conducted from October 2014 to January 2015 to capture the effects of environmental variability.

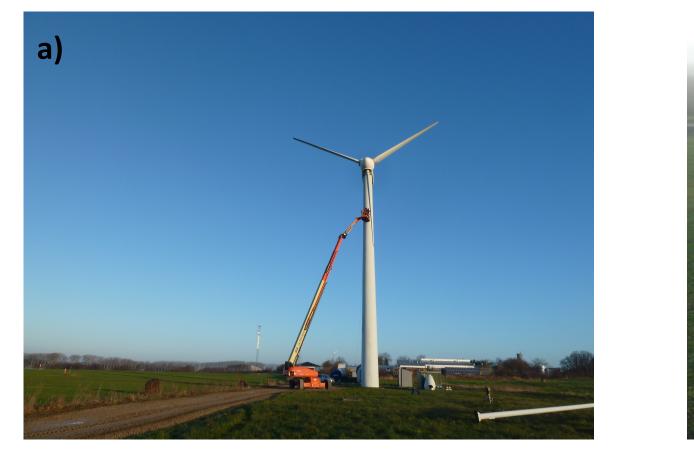
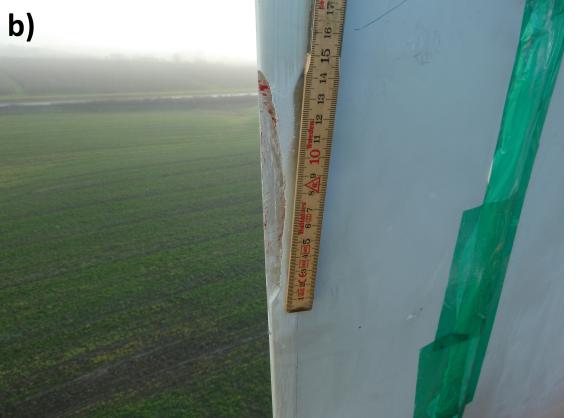
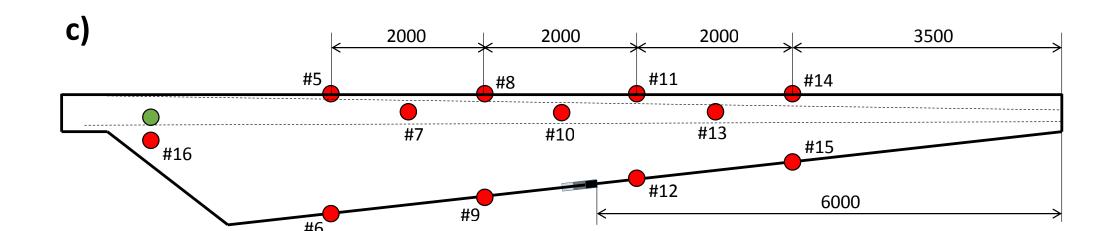
**Fig. 1:** a) Equipped Vestas V27 turbine. b) 15 cm crack. c) Sketch of instrumented blade with actuator (green dot), accelerometer (red dots), and damage (hatched boxes) locations.

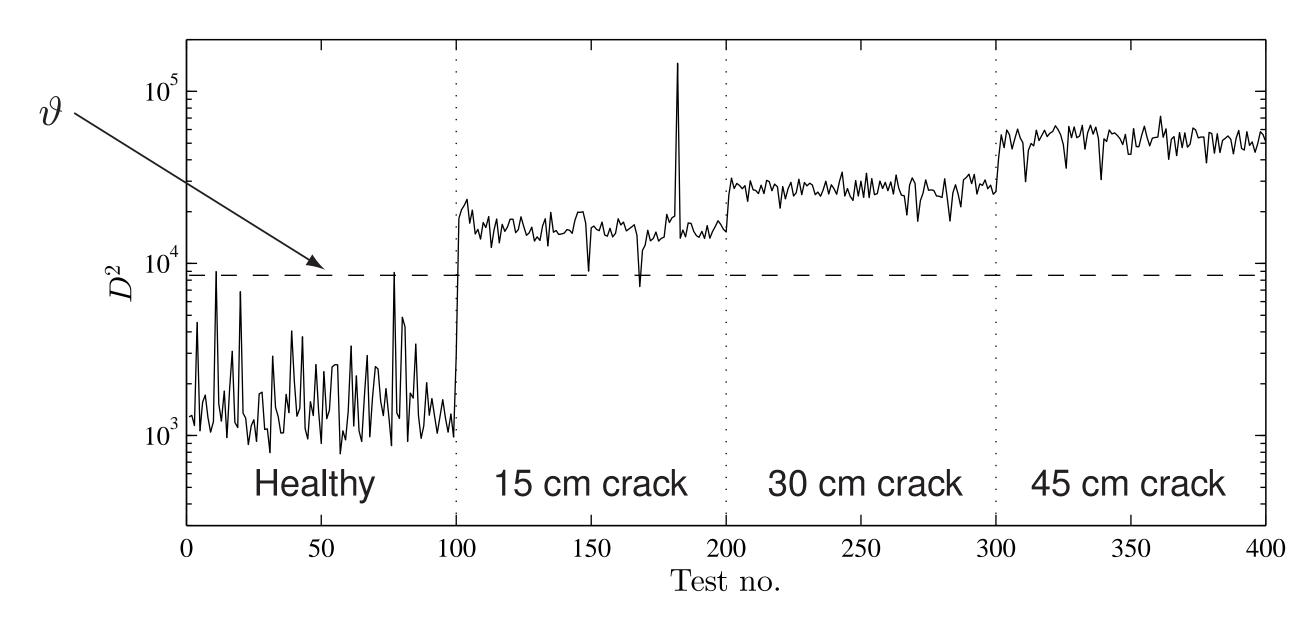
**Fig. 2:** Damage detection in V27 blade during operation at 43 RPM.

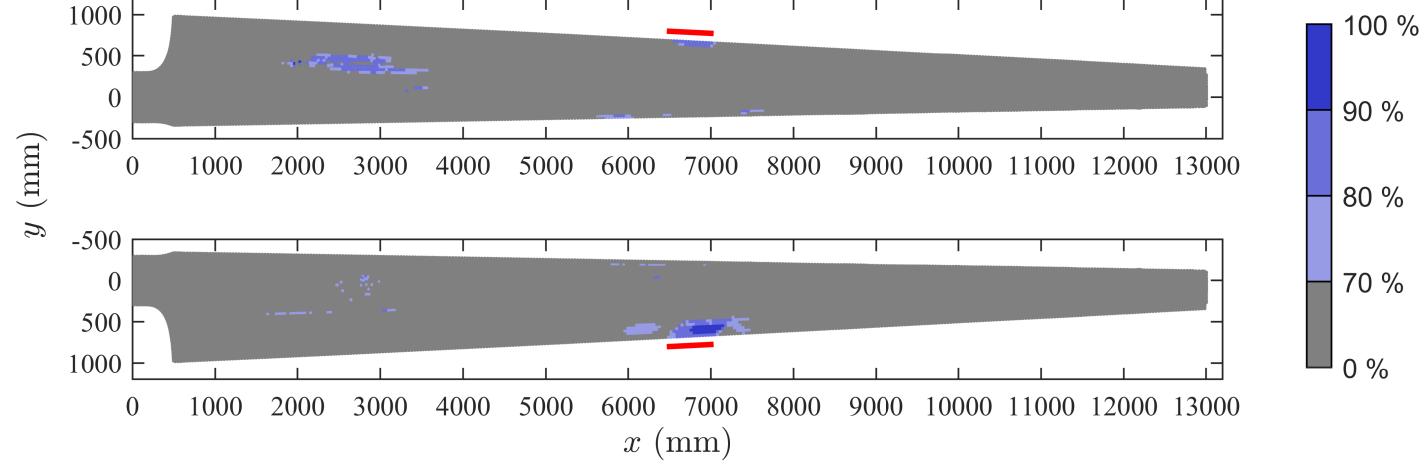
Fig. 3: Localization and assessment of 45 cm crack in idle-conditioned V27 blade. The percentage scale indicates how many times each element has been classified as damaged. The red lines mark the damage location.
