MSE Walls Retrofit

Design and Construction

110th Annual Road School 2024

B-43196 (40 MSE Wall Repair Statewide INDOT) Project Development Process for IDIQ MSE Wall Rehabilitation Projects

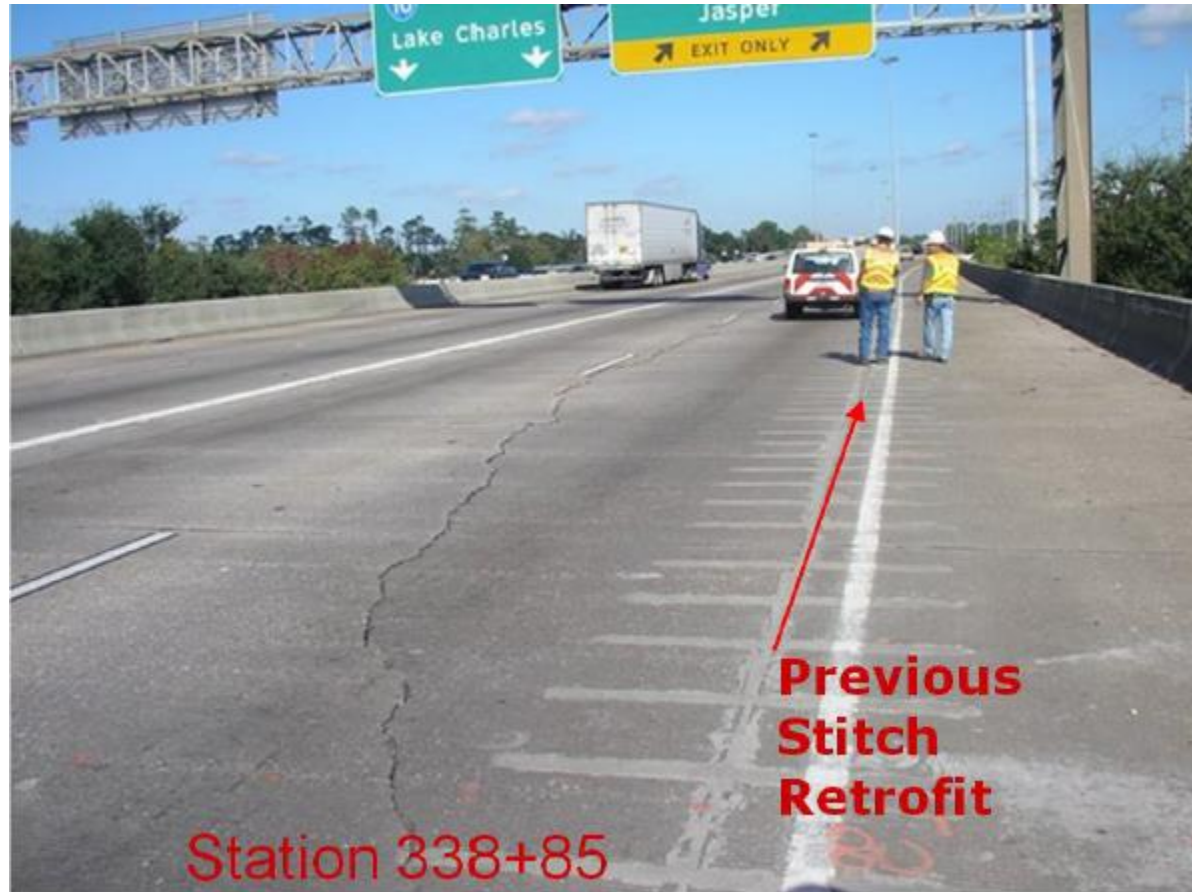
Retrofit that did not Work I-10

The separation ran about 100 ft long and up to 3 inches wide. Cracking was also observed at the connection between the coping/barrier and the MSE wall panels. To prevent the propagation of the settlement and further separation, a retrofit measure was taken by **dowelling the shoulder to the adjacent travel lanes**. After the retrofit, **cracks appeared in the same travel lanes again, but were shifted toward the centerline of the roadway**

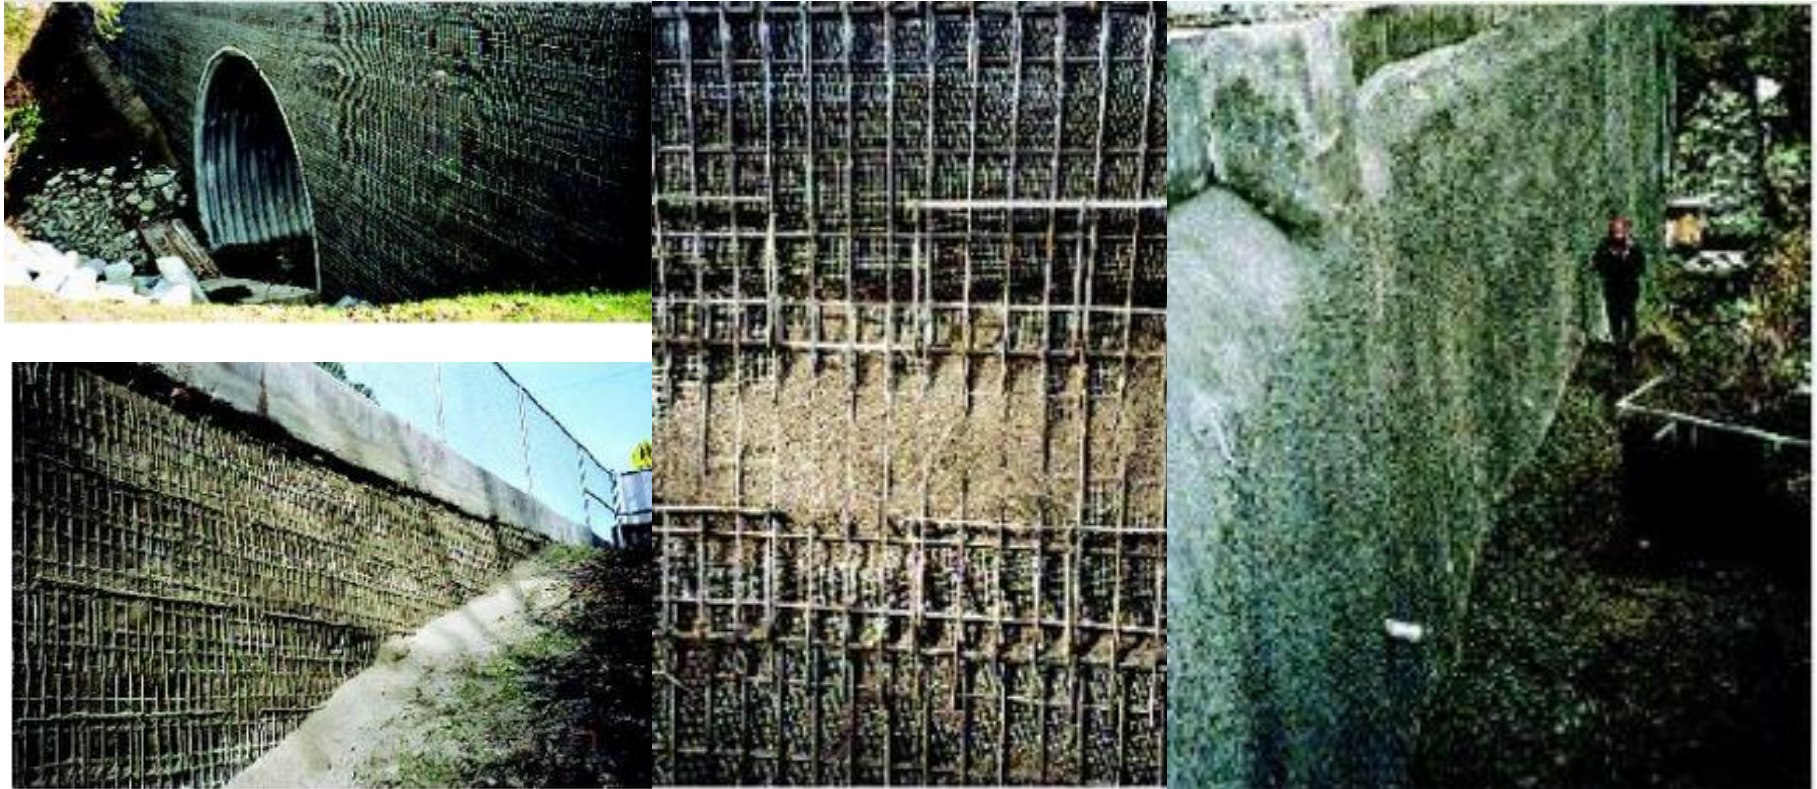
Shotcrete Retrofit of MSE Wall

British Columbia, Canada, the MSE wall was 26 ft high and 230 ft long, the backfill is fine dredged river sand

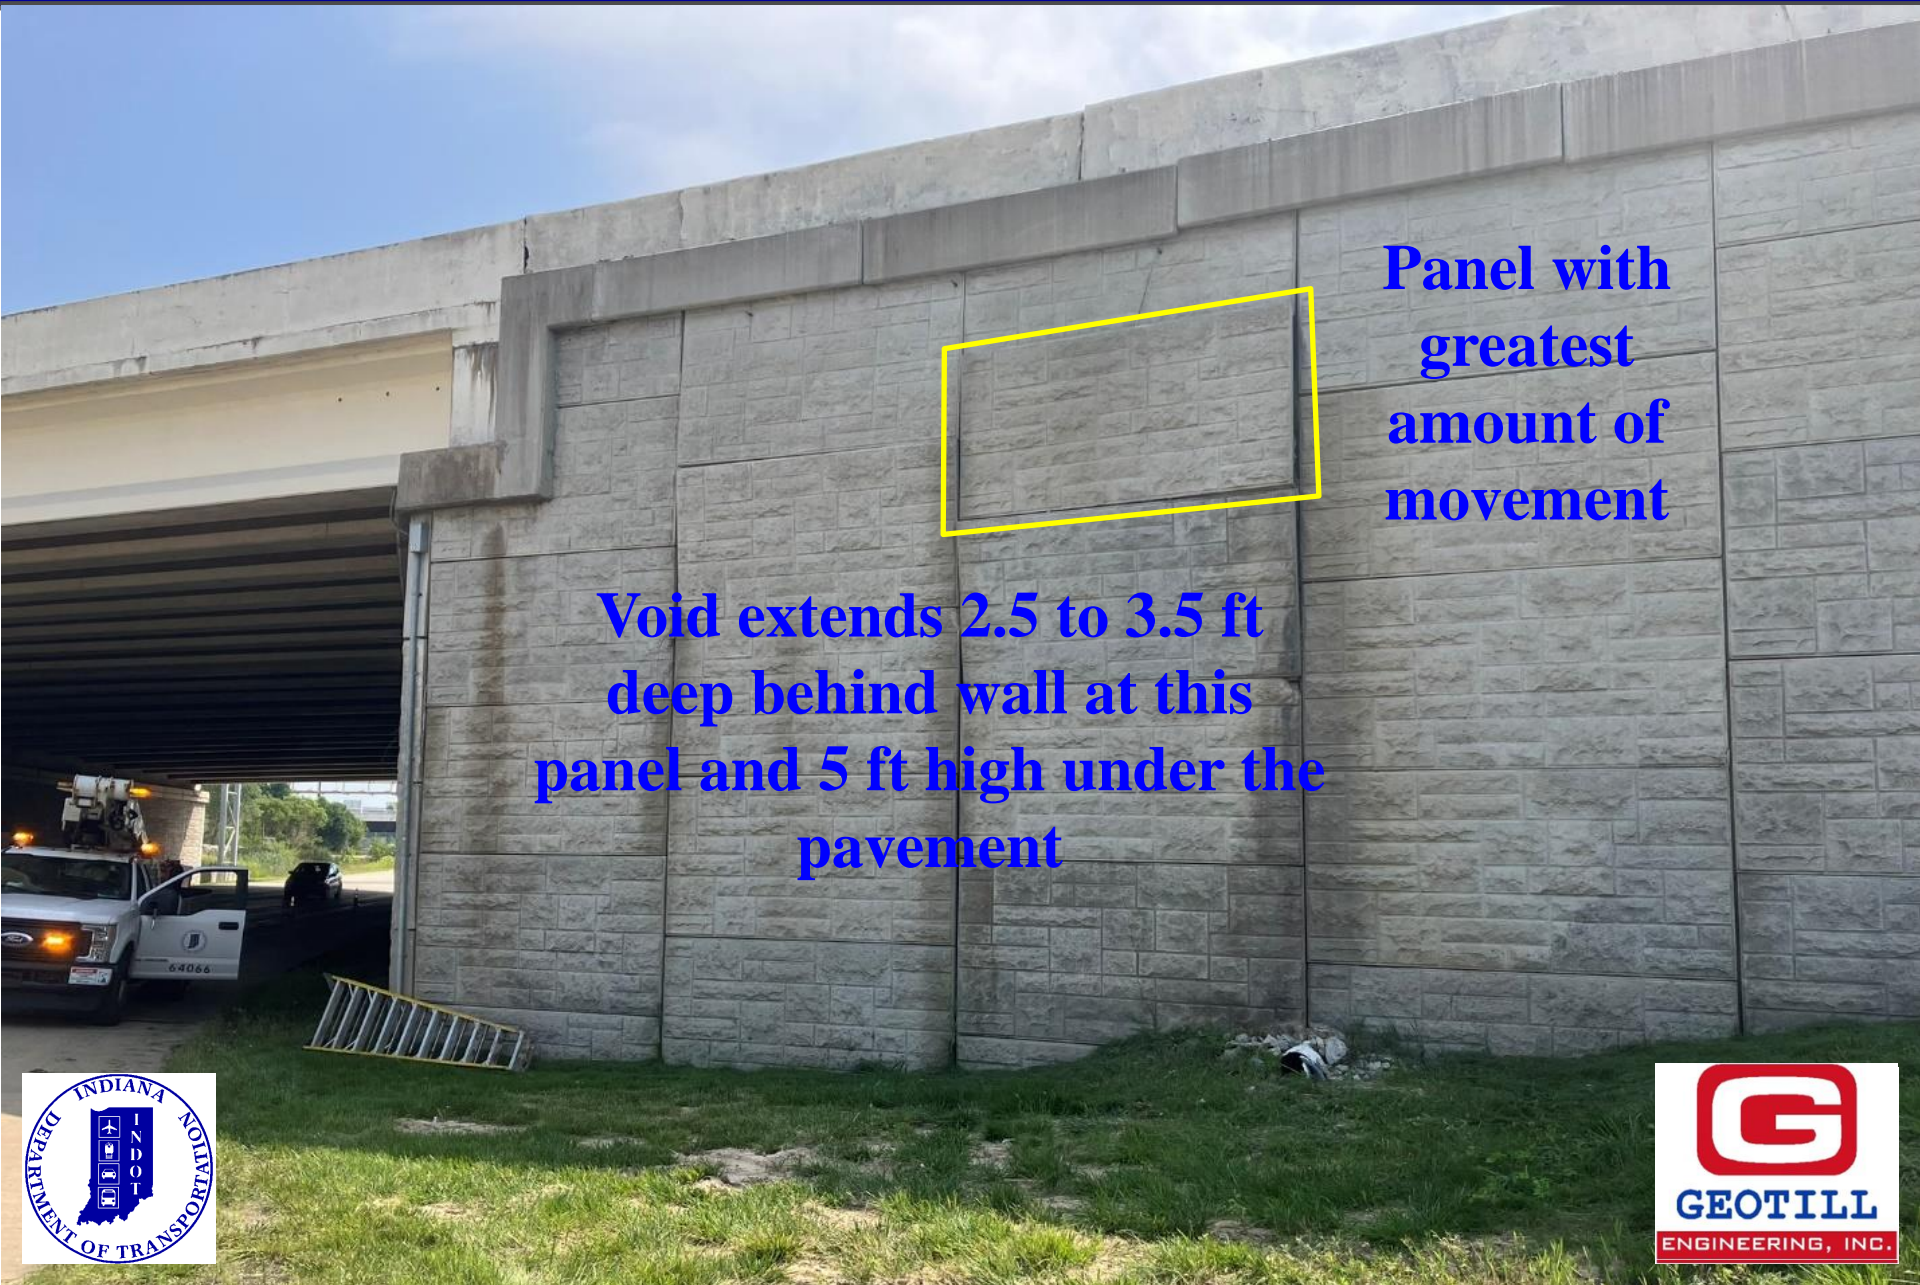
Moved Panels

Broken Pavement

Cracks

Gap

**Panel with
greatest
amount of
movement**

**Void extends 2.5 to 3.5 ft
deep behind wall at this
panel and 5 ft high under the
pavement**

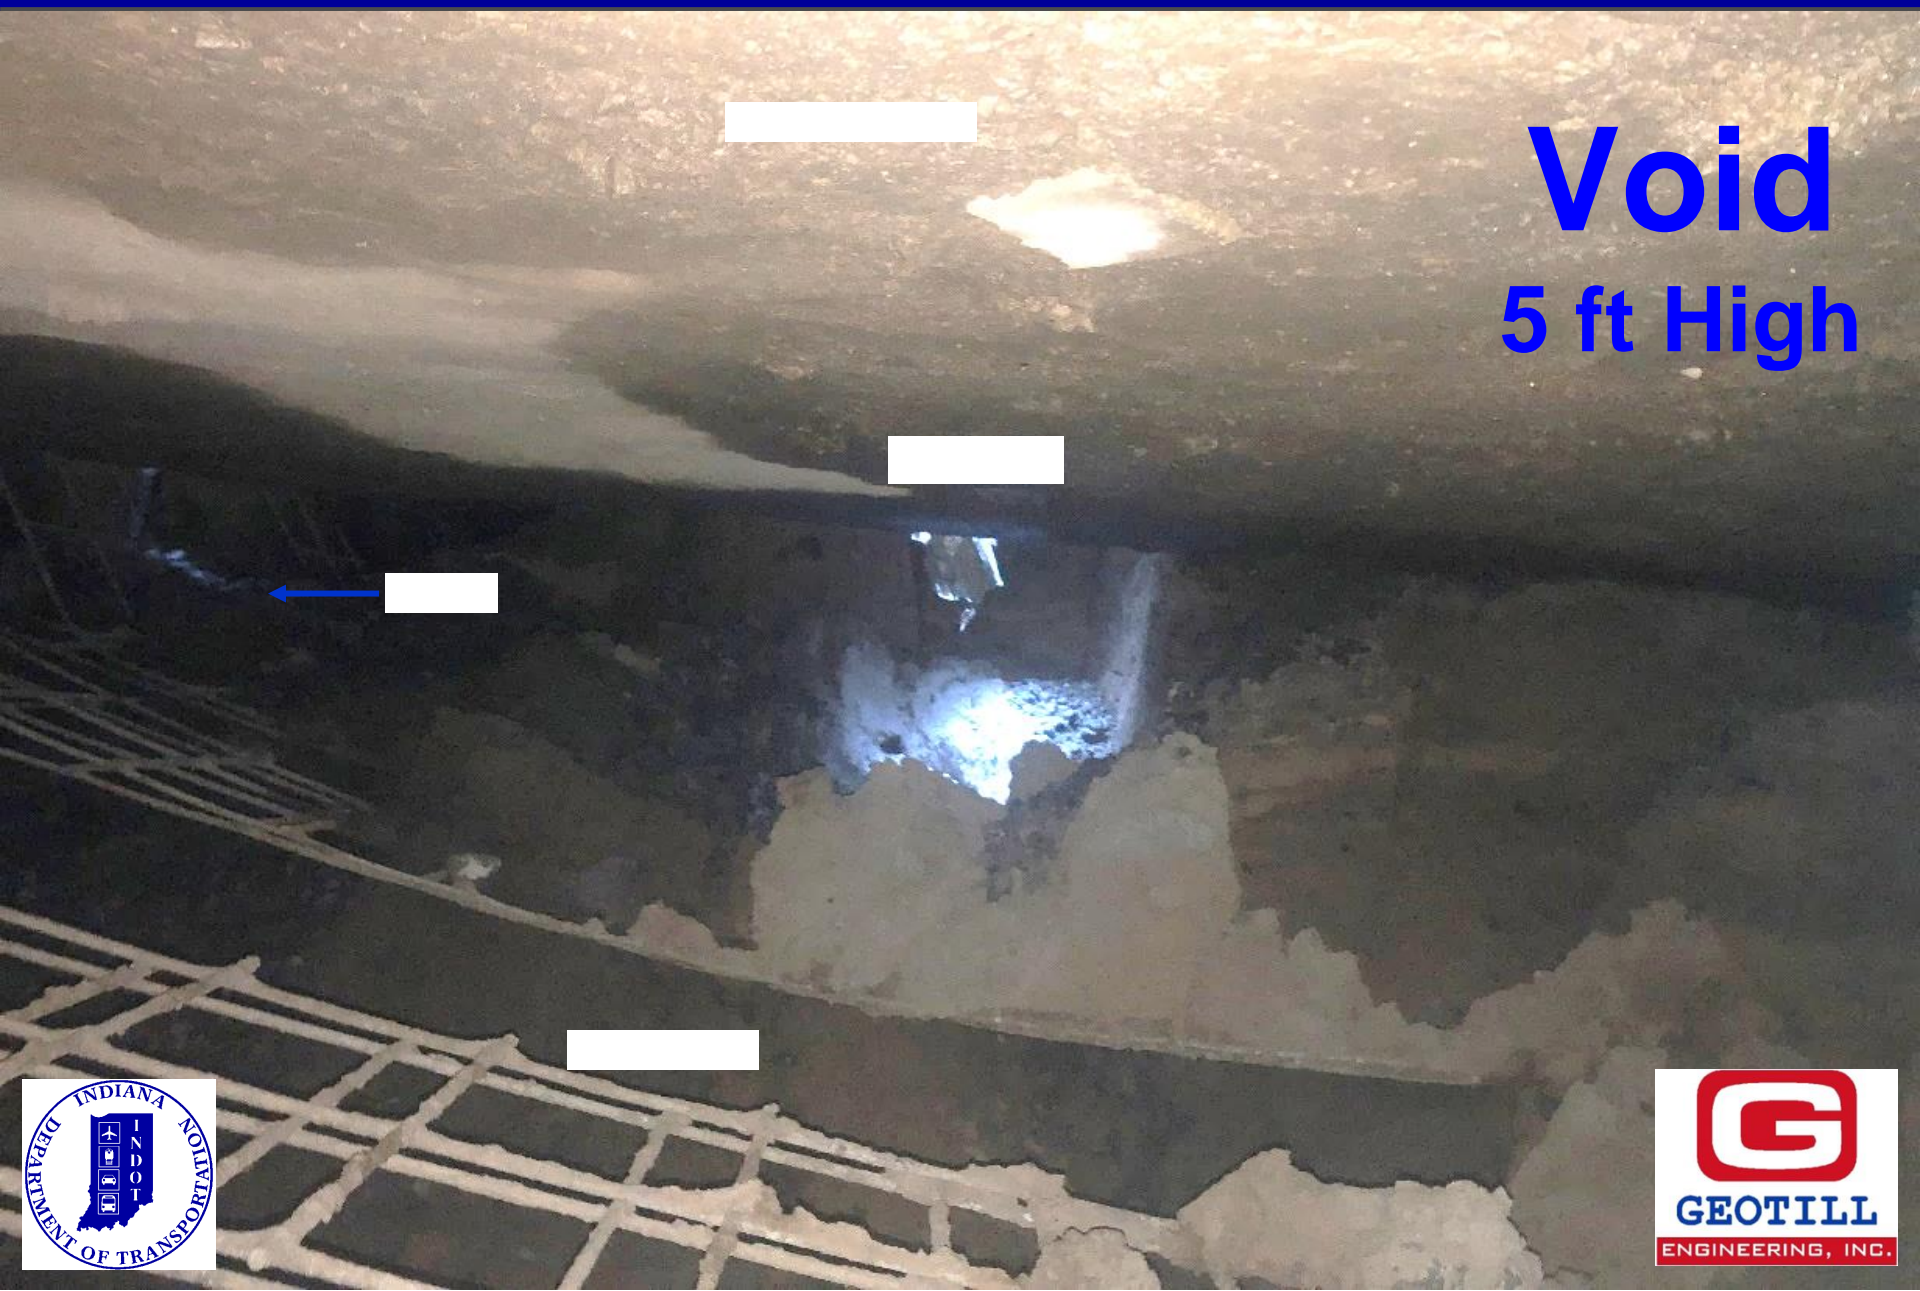
Void
5 ft High

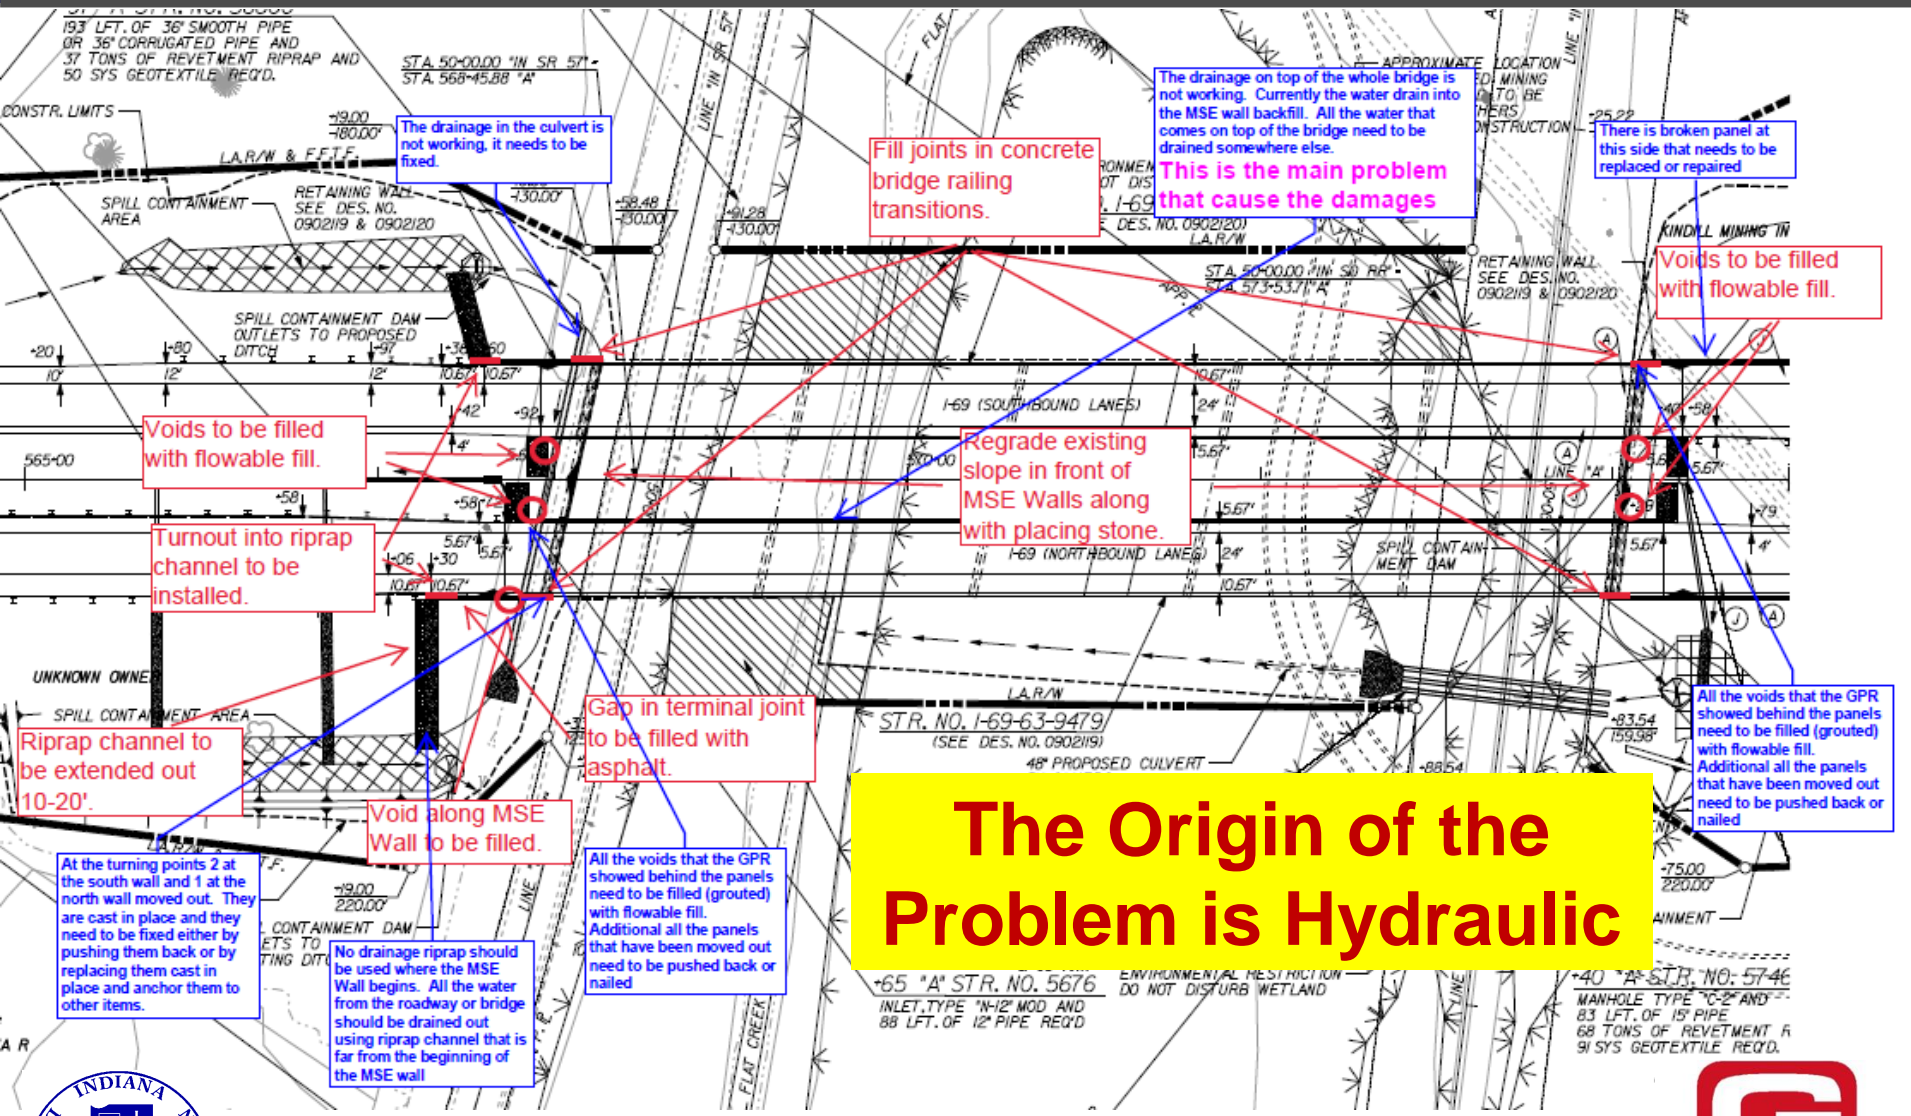
The Origin of the Problem is Hydraulic

Retrofit Recommendation

Since the origin of the problem is Hydraulic, permanent repair is scheduled to be done by the summer of 2024. The permanent repair will involve replacing the bridge approaches and installing a new drain system that can handle the amount of water that come on the top of the bridge.

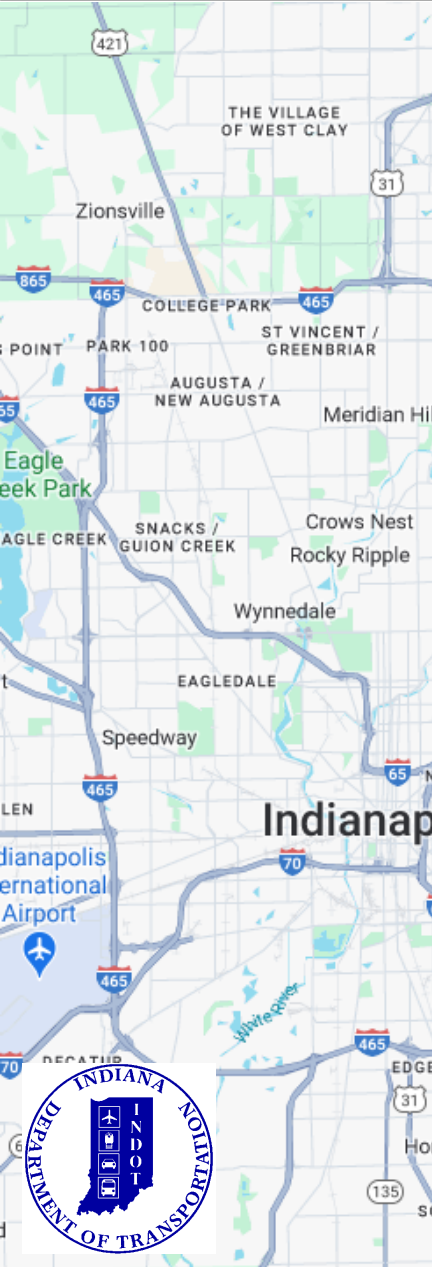
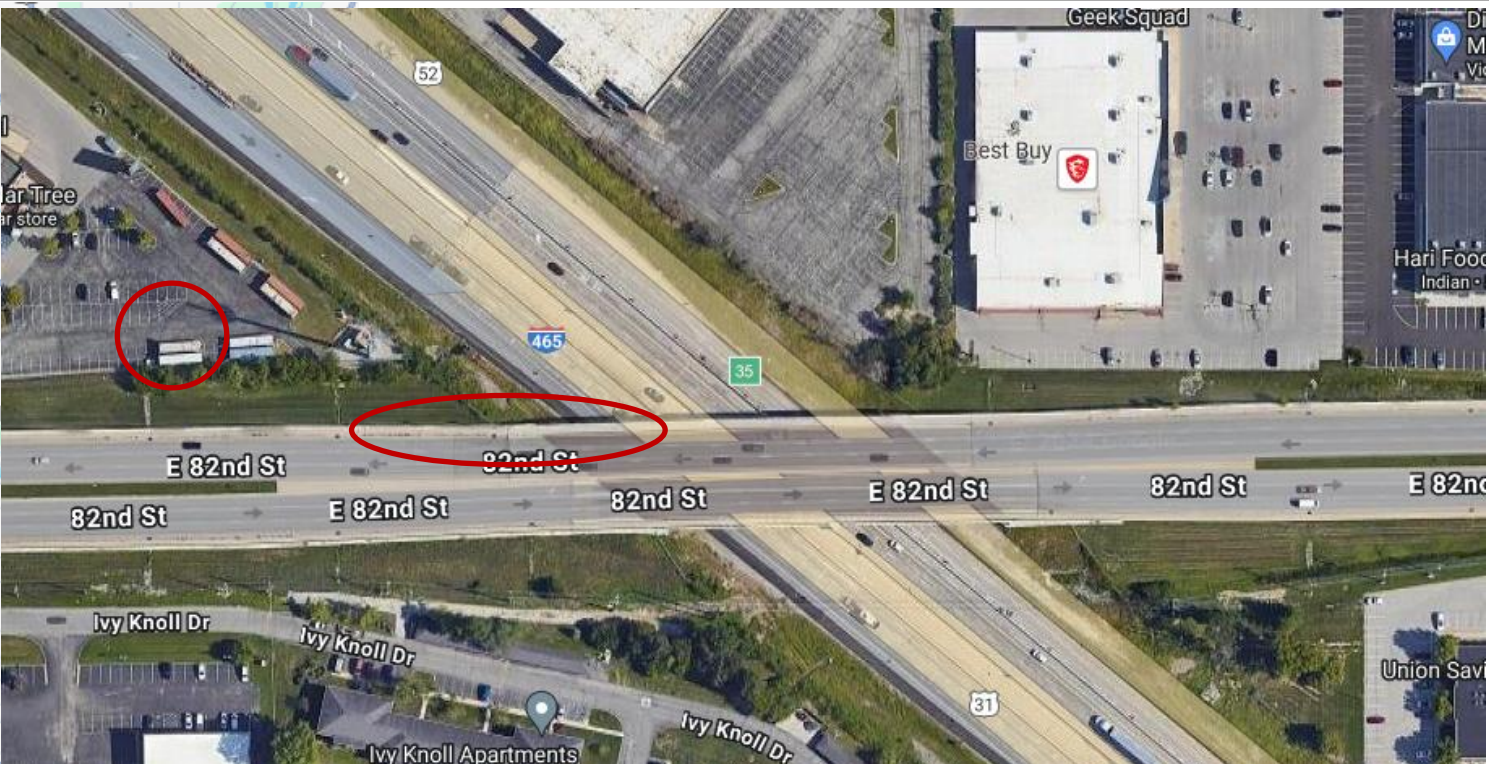
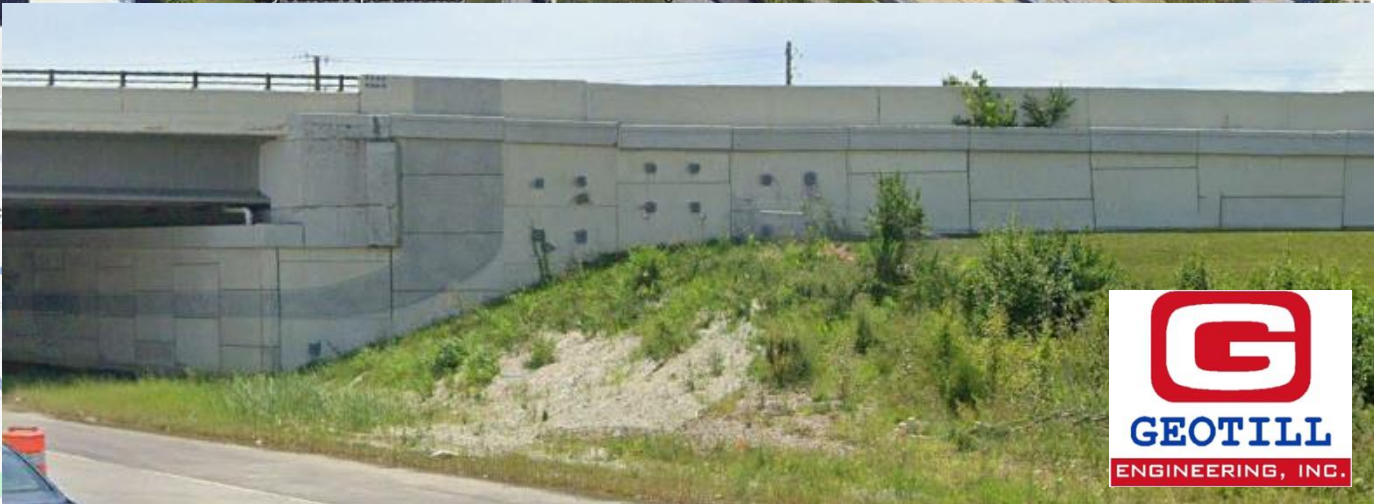
Issues Observed

- **Backfill leak from Northwest side.**
- **Broken CIP copings.**
- **Some bulging panels.**
- **Pavement issues probably voids.**
- **Widen and tighten panel gaps, possibly because of settlement.**
- **Some blocked underdrain**

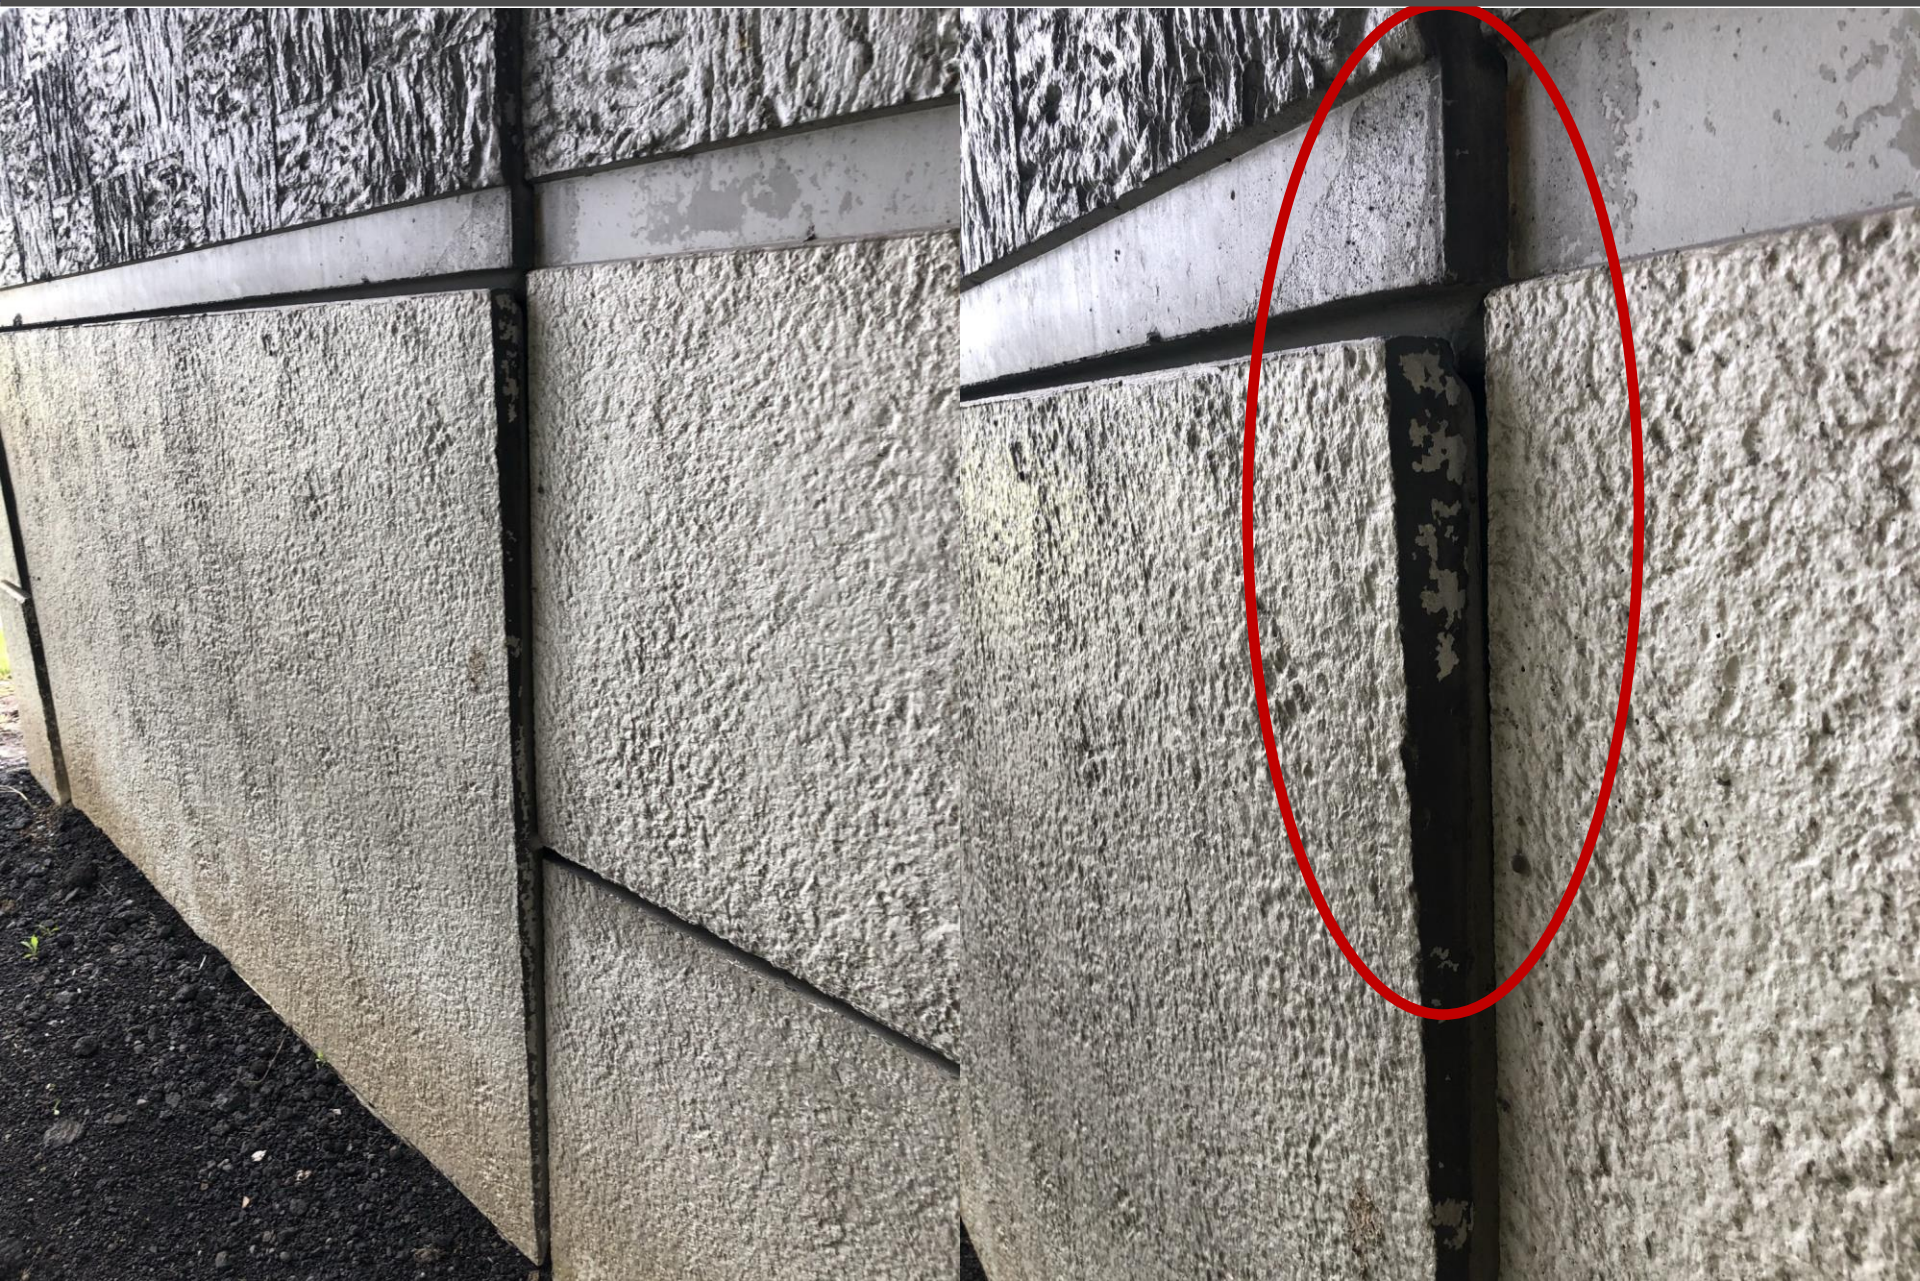
The main problem for this location is that the **drainage** system is not able to drain all the water away from the MSE walls. The water seeps through the damaged expansion joints and some manholes and then seep on top of the MSE walls especially at the northwest wall. In addition, to the known **connections** problems that Tricon MSE Wall system has.

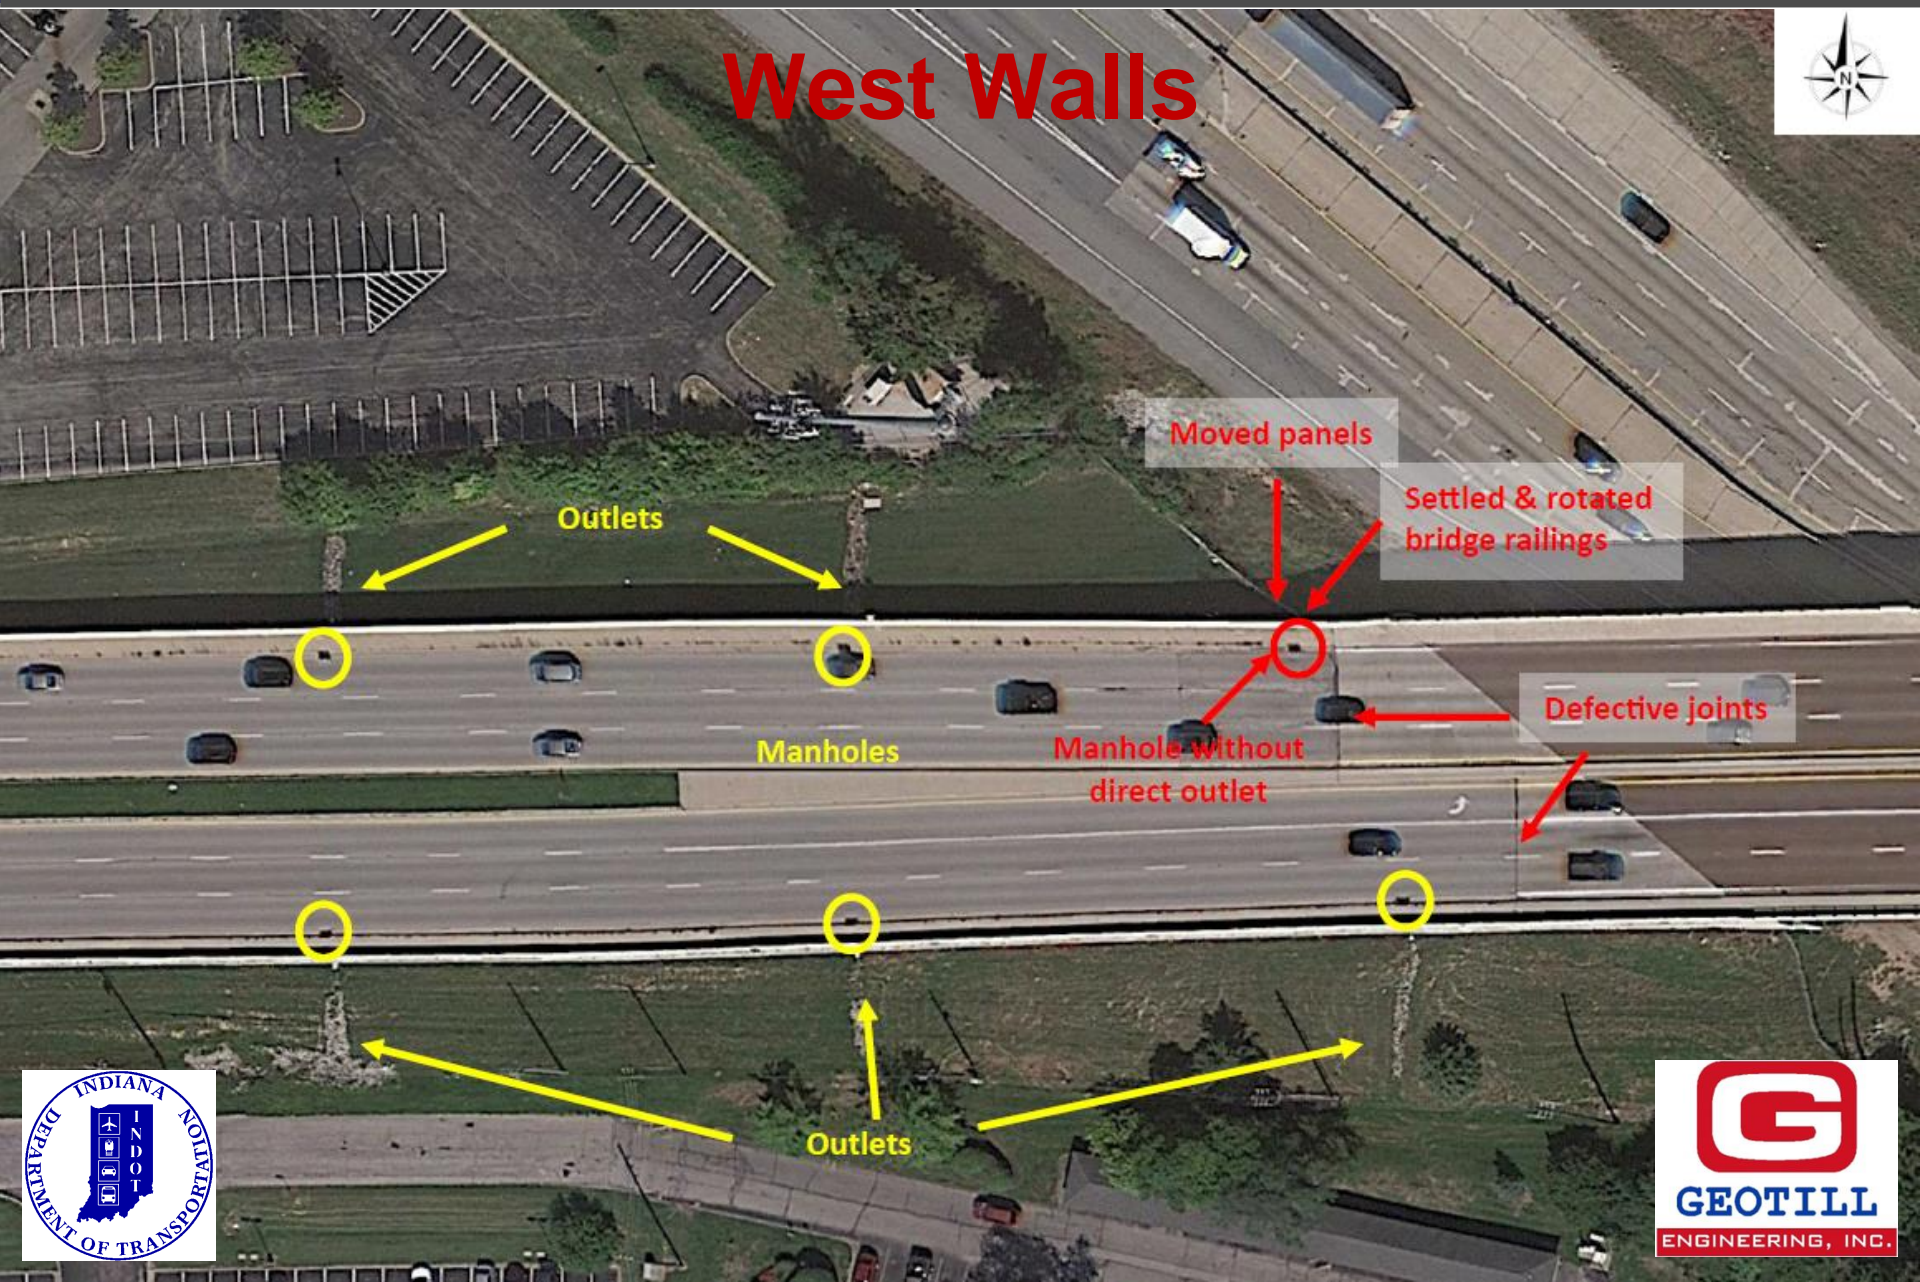
West Walls

Moved panels

Settled & rotated
bridge railings

Defective joints

Manhole without
direct outlet

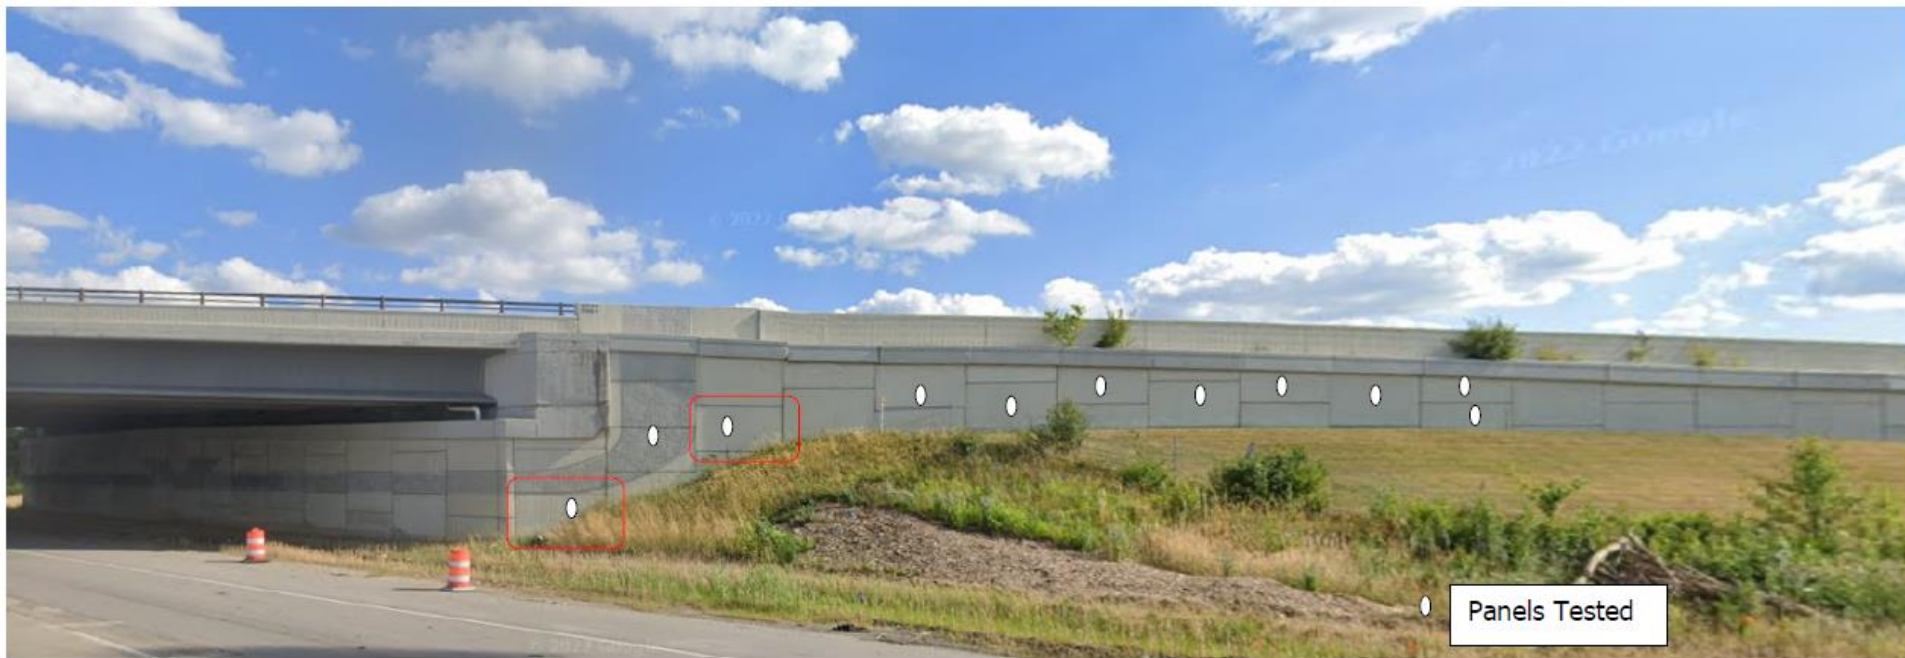
Image showing the wing wall and panels with air gap GPR signatures (red).

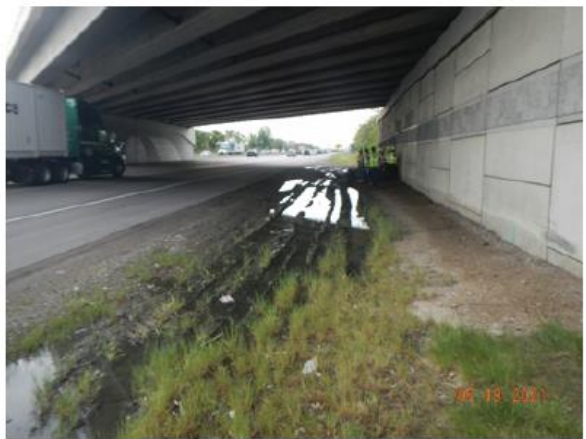
Abutment 3: Northeast Corner

Abutment 1: Standing water due to inadequate drainage

Extend Drains to nearest ditch

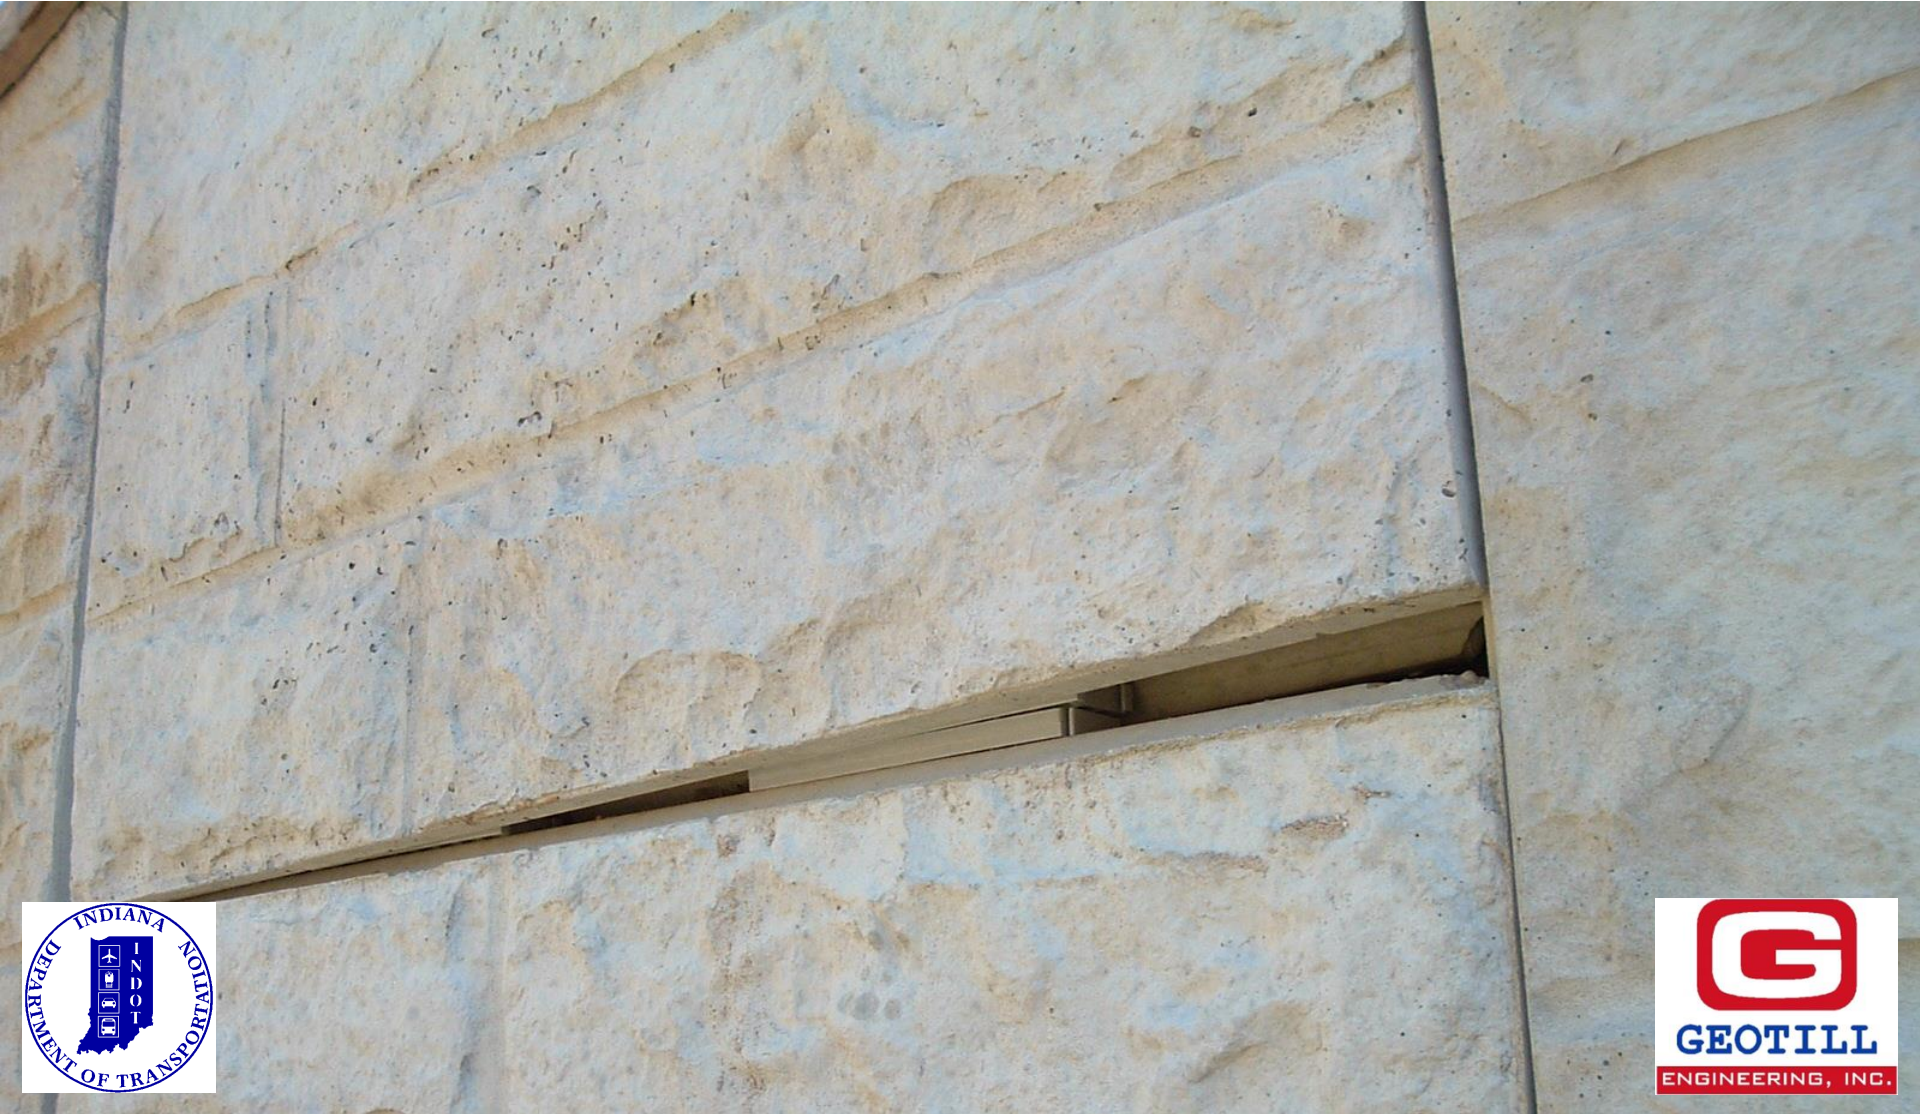
Settlement of Panels
