MSE Walls Retrofit

Design and Construction

110th Annual Road School 2024

B-43196 (40 MSE Wall Repair Statewide INDOT) Project Development Process for IDIQ MSE Wall Rehabilitation Projects

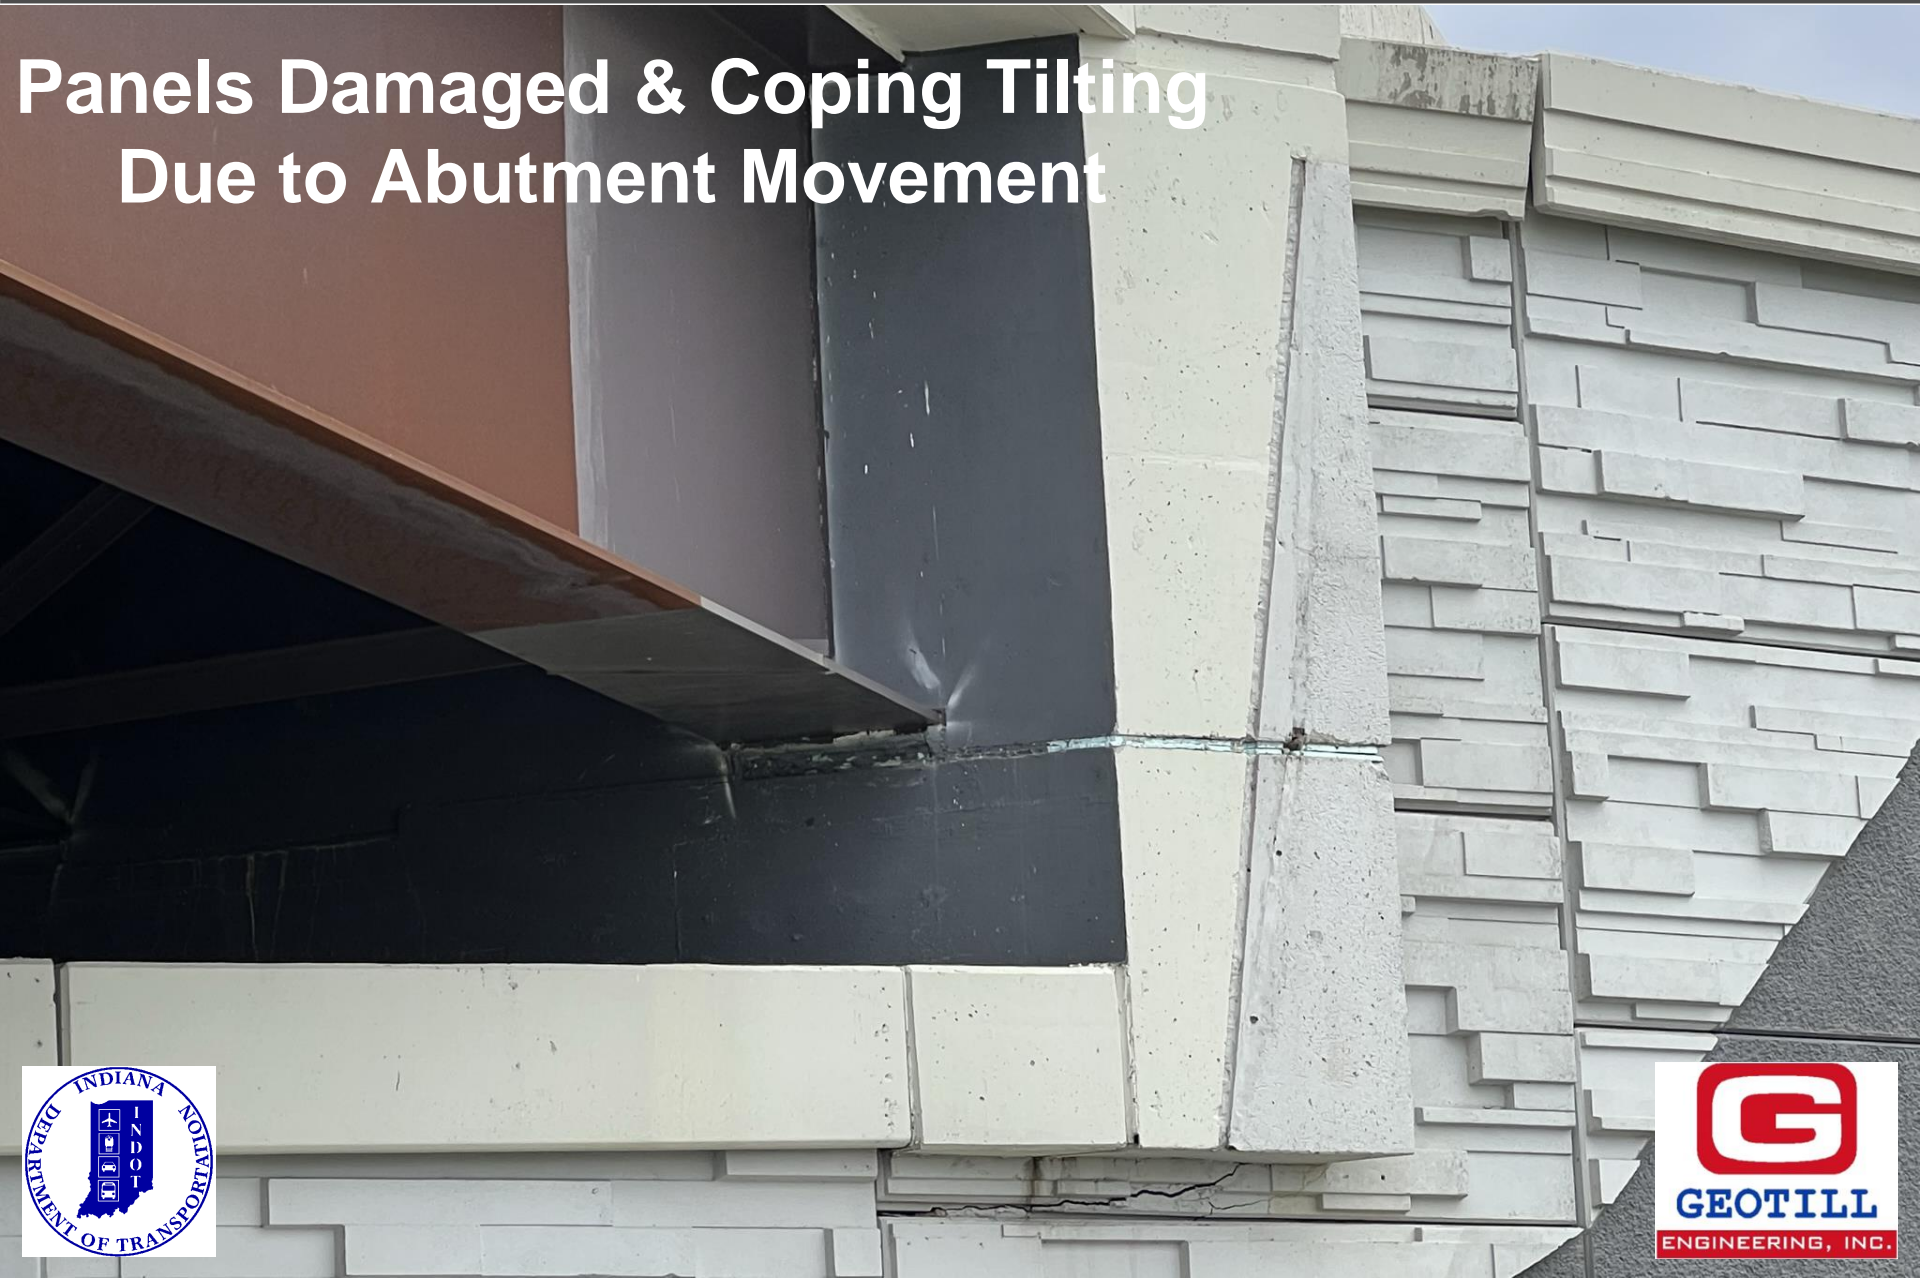
**Panels Damaged & Coping Tilting
Due to Abutment Movement**

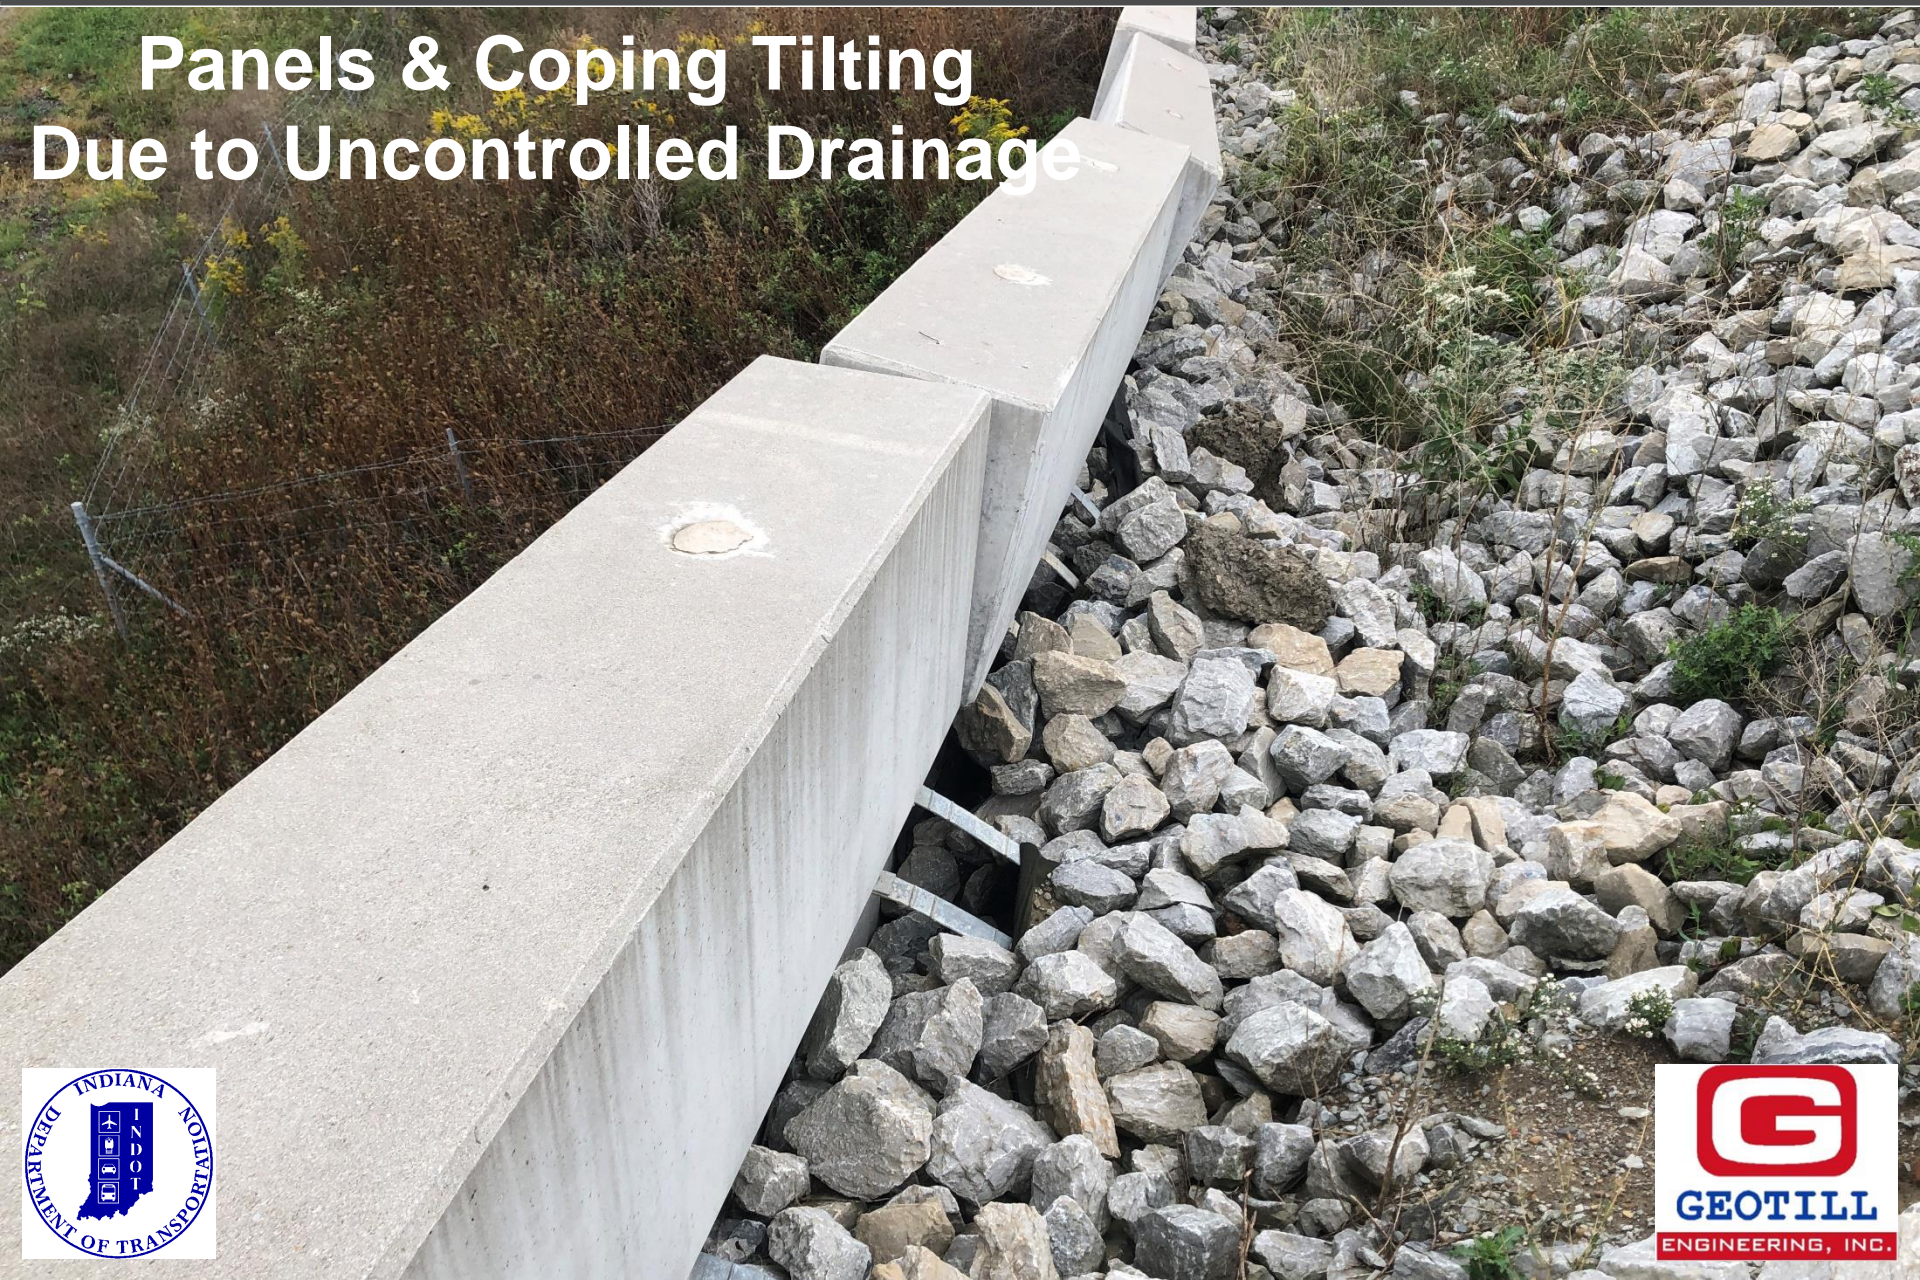
Panels & Coping Tilting
Due to Uncontrolled Drainage

**Uncontrolled
Drainage
Weephole**
