OCENA STANJA, ODRŽAVANJE I SANACIJA
GRAĐEVINSKIH OBJEKATA
CONDITION ASSESSMENT, MAINTENANCE AND REHABILITATION
OF CIVIL ENGINEERING FACILITIES

Milan Spremić¹, Isidora Jakovljević², Aljoša Filipović³

**ENVIRONMENTAL EFFECTS ON THE DURABILITY OF STEEL
STRUCTURE – A CASE STUDY OF ADVERTISING BILLBOARD POLES**

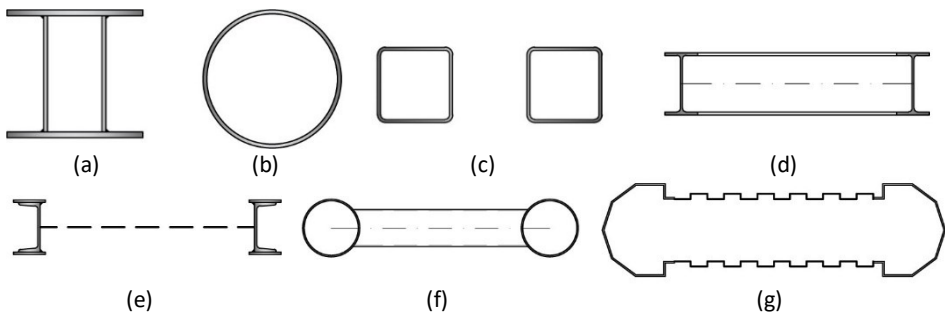
Figure 1. Cross-sections of billboard poles: (a) a massive box cross-section, (b) a circular hollow section, (c) two square hollow sections, (d) two hot rolled I sections with a horizontal strut, (e) two hot rolled U sections with truss bracing, (f) two circular hollow sections and a horizontal strut, (g) two cold-formed sections in the form of a half polygon.

composed of cold-formed sections in the shape of a half polygon. The provided findings show that using massive cross-sections, excluding bracings and avoiding thin-walled sections is favourable in terms of corrosion protection.

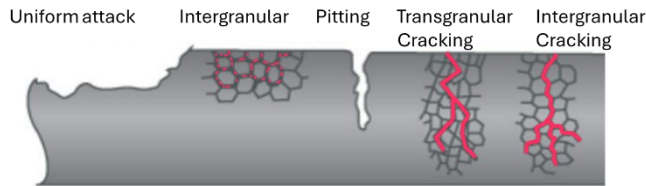
- Stage of Corrosion 2: The granular powder deposits on the steel surface. Only steel surfaces could be etched or pitted.
- Stage of Corrosion 3: The same as stage 2, but small holes in the steel could be visible. The corrosion is accompanied by etching and pitting, and extensive steel surface degradation is evident. Loose of granular steel condition.
- Stage of Corrosion 4: The corrosion has advanced to the point where the metal has been penetrated throughout. There are holes in the surface area, and the steel is completely missing along the edges.

Figure 2. Types of corrosion [3]

In the case of the stages of corrosion 0, 1 and 2, it is possible to rehabilitate the surface treatment and steel structure. Structures with corrosion stage 3 can be rehabilitated and reconstructed in certain cases. Structures with corrosion stage 4 require a detailed reconstruction and complete replacement of steel structure elements.

- Stage of Corrosion 0 – No rehabilitation needed,
- Stage of Corrosion 1 – Surface treatment rehabilitation is required in the next 4 years.
- Stage of Corrosion 2 – Surface treatment and structure rehabilitation are required in the next 2 years.
- Stage of Corrosion 3 – Urgent rehabilitation of the steel structure is required.
- Stage of Corrosion 4 – Urgent replacement of the steel structure elements (with new elements) is required.

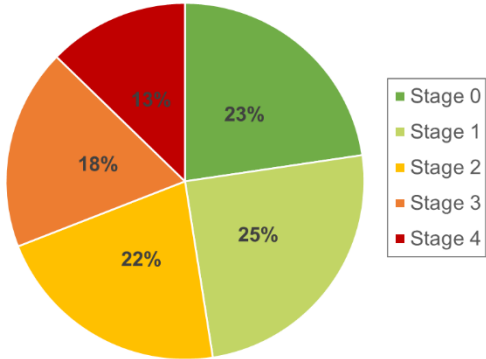
According to the described classification of corrosion stages, the inspected billboard structures may be divided into five groups, corresponding to the estimated damage level. The share of billboard poles corresponding to each stage of corrosion is illustrated in Figure 3. Rehabilitation is not needed for almost a quarter of 181 inspected poles (23%), while 13% of structures require urgent replacement. About one-third of poles have corrosion stage 3 or 4, needing urgent rehabilitation or replacement work.

Figure 3. Inspected billboards according to the stage of corrosion

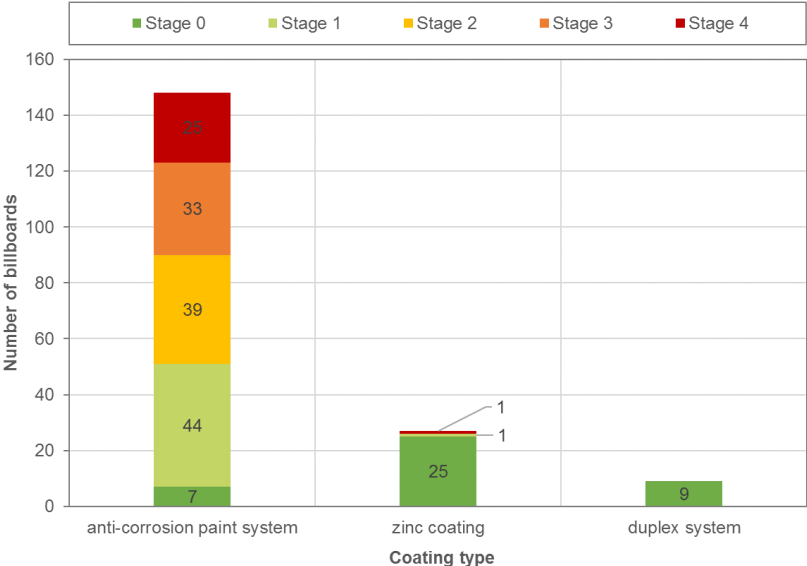
The correlation between the steel structure's surface treatment and the stage of corrosion is illustrated in Figure 4. To the majority of the inspected billboard structures, the anti-corrosion paint system was applied. Considerably smaller is the number of billboards with zink coating applied through the hot-dip galvanisation. Even smaller is the number of billboards with duplex system for corrosion protection, formed by painting or powder coating over hot-dip galvanised steel. The relation between the steel surface

treatment and the structure damage level is evident – rehabilitation work is not needed for any of the poles with the duplex system and almost all poles with zink coating. On the contrary, less than 5% of poles with the applied anti-corrosion paint system do not require rehabilitation work. Almost 40% of billboard structures with anti-corrosion paint system have corrosion stage 3 or 4. Results demonstrate the advantages of zink coating and duplex system as long-lasting corrosion protection, reducing the need for frequent maintenance and rehabilitation work.

Figure 4. The stage of corrosion: Steel surface treatment

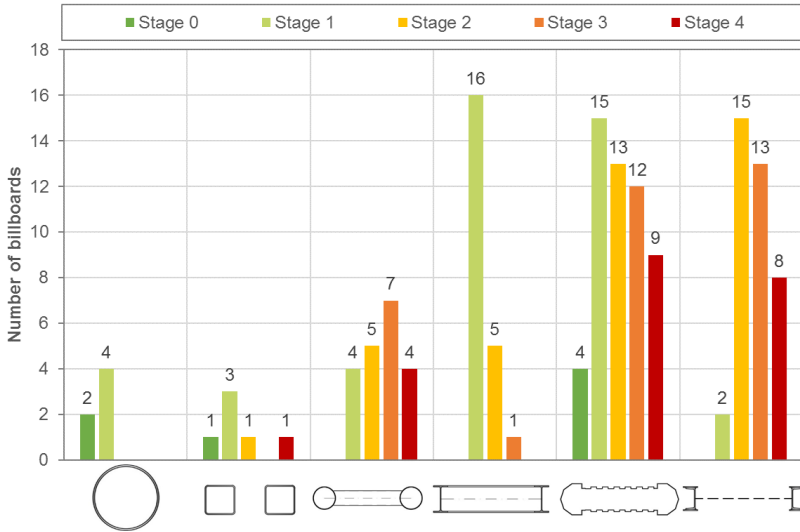
Figure 5. The stage of corrosion of billboards with applied anti-corrosion paint: Different cross-sections

The effect of applied structural design on the corrosion of billboard pole steel structure is shown in Figure 5. All examined poles of a circular hollow section were assigned a corrosion stage of 0 or 1. On the opposite, almost all billboards with chords made of hot rolled U sections and truss bracing have a corrosion stage of 2, 3, or 4. A high percentage of poles in corrosion stages 2, 3, or 4 is also present on billboards

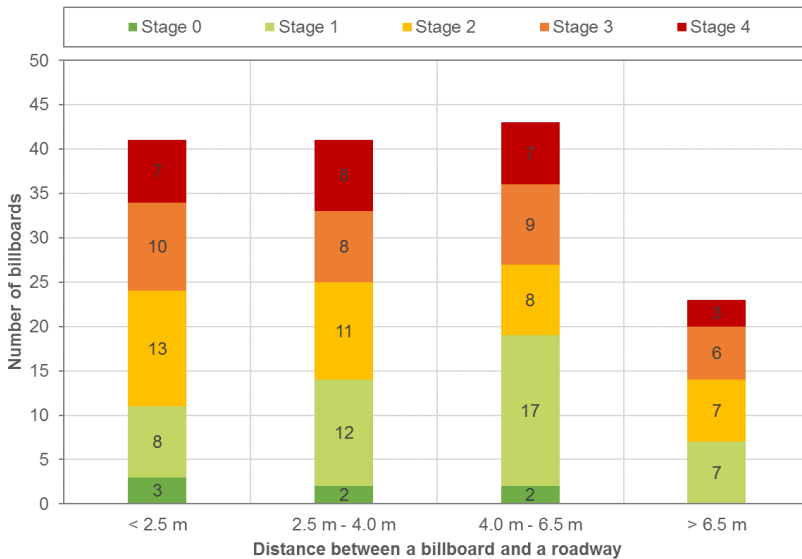
Figure 6. The stage of corrosion of billboards with applied anti-corrosion paint: Distance from the roadway

The relation between the distance from the billboard pole to the roadway and the damage level due to corrosion is discussed in Figure 6. Inspected billboards are classified into four groups depending on their position relative to the roadway: shorter than 2.5 m, between 2.5 and 4.0 m, between 4.0 and 6.5 m, and longer than 6.5 m. The overall number of billboards in the first three groups is roughly equal. When comparing the first three groups, the number of billboards with corrosion stage 1 increases as the distance between the pole and the roadway increases. There is also a decrease in billboards with corrosion stage 2 as the pole-to-roadway distance gets longer. Although the number of billboards with corrosion stages 0, 3, or 4 remains nearly constant over the first three groups, the overall data demonstrate a higher average level of corrosion for billboards closer to the roadway.
