Environmental effects caused by the Mw 7.7, September 19, 2022, Michoacán (Mexico)

Descriptive table

This document presents a collection of Earthquake Environmental Effects (EEEs) triggered by the Mw 7.7 Michoacan earthquake occurred on 19 September 2022. Data derive from original field surveys, published reports and papers, and from a search for EEEs posted online in social media and other websites.

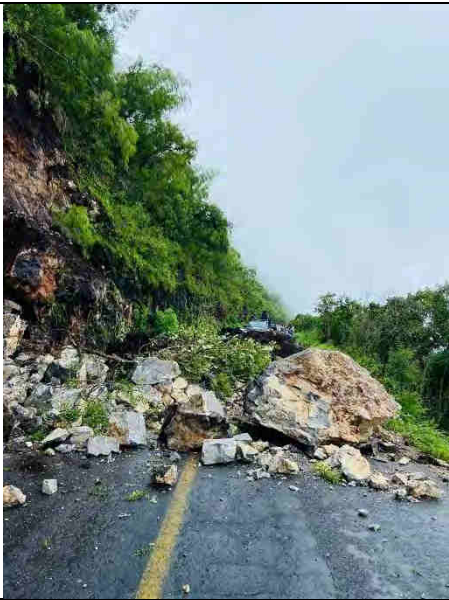
SITE	9
LATITUDE	18.714399317660607
LONGITUDE	-103.28685423055916
DISTANCE FROM EPICENTER	53
CITY	Aquila, Michoacán tramo El Tejon a Tehuantepec
EEE TYPE	Slope movement
EEE DESCRIPTION	Modest rock falls 10^3 - 10^5 m ³
ESI INTENSITY	VII
PHOTOGRAPIC DOCUMENTATION

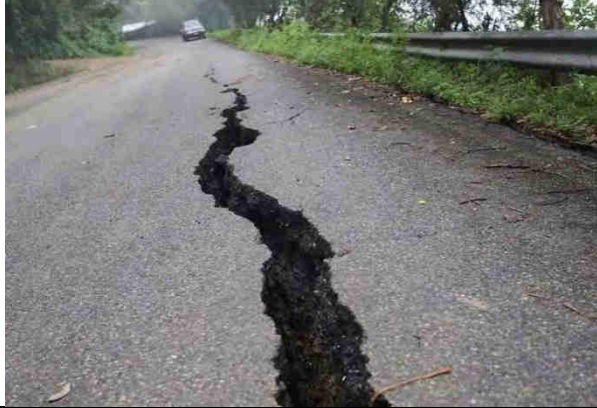
SITE	10
LATITUDE	19.994463558119616
LONGITUDE	-102.19674103101453
DISTANCE FROM EPICENTER	226
CITY	Ojo de Agua, Michoacán
EEE TYPE	Ground cracks
EEE DESCRIPTION	dm-width cracks developed in paved roads
ESI INTENSITY	VII
PHOTOGRAPIC DOCUMENTATION

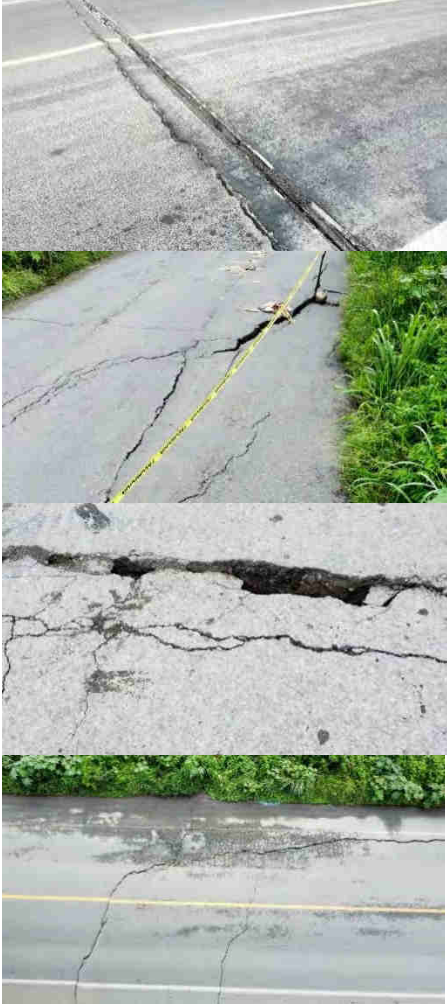
SITE	18
LATITUDE	18.71868725315544
LONGITUDE	-103.7172537326771
DISTANCE FROM EPICENTER	70
CITY	Manzanillo, Michoacán
EEE TYPE	Ground cracks
EEE DESCRIPTION	significant cracks in paved roads, 50 cm of depth
ESI INTENSITY	IX
PHOTOGRAPIC DOCUMENTATION

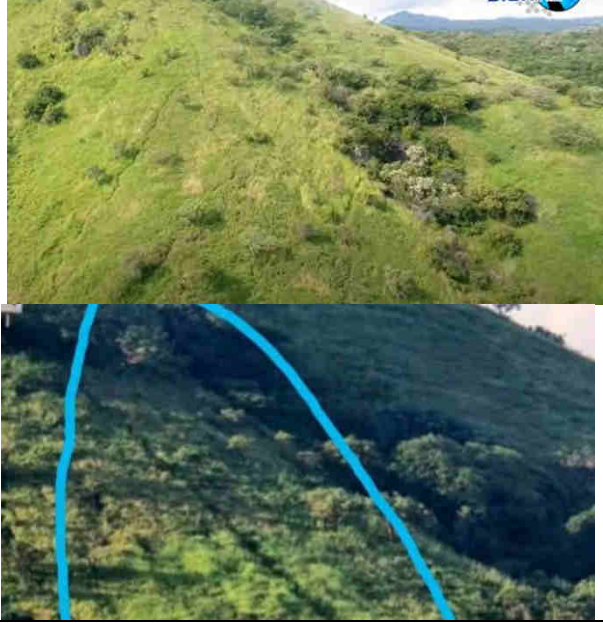
SITE	19
LATITUDE	19.083169415391964
LONGITUDE	-102.33126536307233
DISTANCE FROM EPICENTER	138
CITY	Apatzingán, Michoacán
EEE TYPE	Slope movements
EEE DESCRIPTION	Landslide of 10 ³ m ³
ESI INTENSITY	VIII
PHOTOGRAPIC DOCUMENTATION

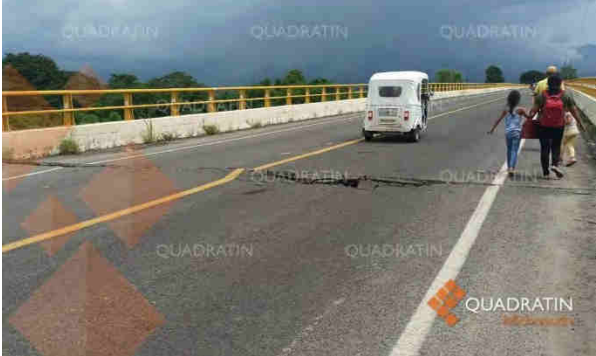
SITE	26
LATITUDE	18.71722264268297
LONGITUDE	-103.71627500458622
DISTANCE FROM EPICENTER	69
CITY	La Zapotera, Colima
EEE TYPE	Ground cracks
EEE DESCRIPTION	significant cracks in paved roads
ESI INTENSITY	IX
PHOTOGRAPIC DOCUMENTATION

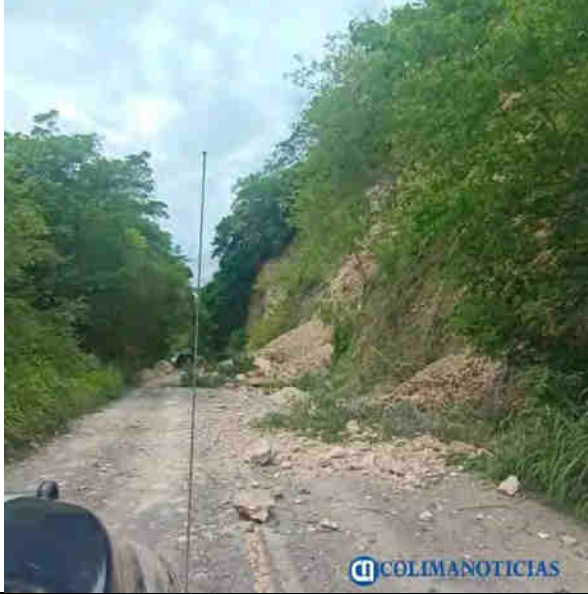
SITE	27
LATITUDE	19.317430467307585
LONGITUDE	-103.84160220346493
DISTANCE FROM EPICENTER	133
CITY	Villa de Alvarez - Minatitlàn road, Juluapan, Colima
EEE TYPE	Slope movements
EEE DESCRIPTION	Landslide 10-10 ³ m ³
ESI INTENSITY	VI
PHOTOGRAPIC DOCUMENTATION

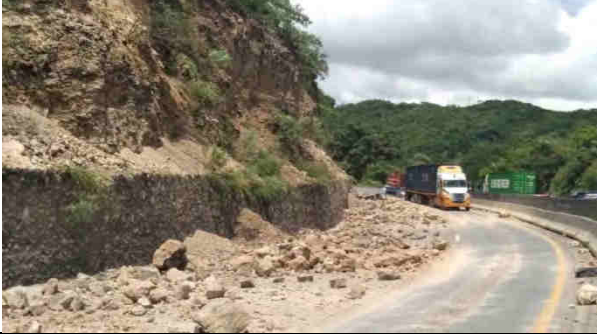
SITE	28
LATITUDE	18.945603974066128
LONGITUDE	-103.90488717870942
DISTANCE FROM EPICENTER	102
CITY	Guadalajara-Manzanillo highway, Tecomán, Colima
EEE TYPE	Slope movements
EEE DESCRIPTION	Landslide 10^3 - 10^5 m ³
ESI INTENSITY	IX
PHOTOGRAPIC DOCUMENTATION

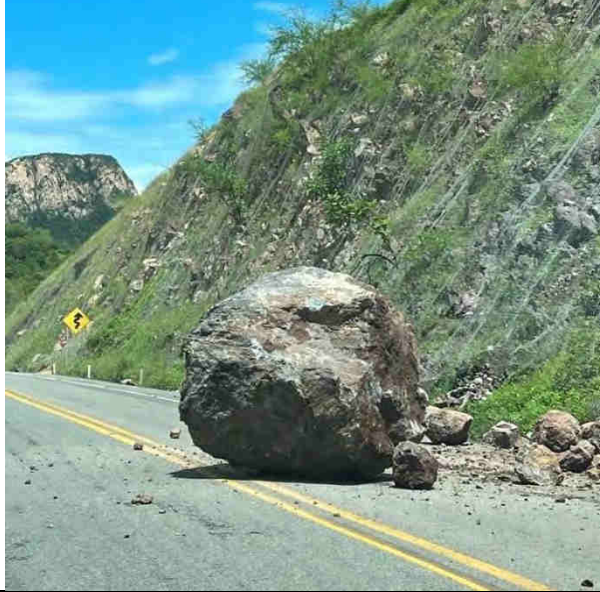
SITE	35
LATITUDE	17.95789505507067
LONGITUDE	-102.19482791163014
DISTANCE FROM EPICENTER	120
CITY	Siglo XXI highway, Lázaro Cárdenas, Michoacán
EEE TYPE	Slope movements
EEE DESCRIPTION	Stone of > 1 m diameter detached from slope and move away for long distance
ESI INTENSITY	VII
PHOTOGRAPIC DOCUMENTATION

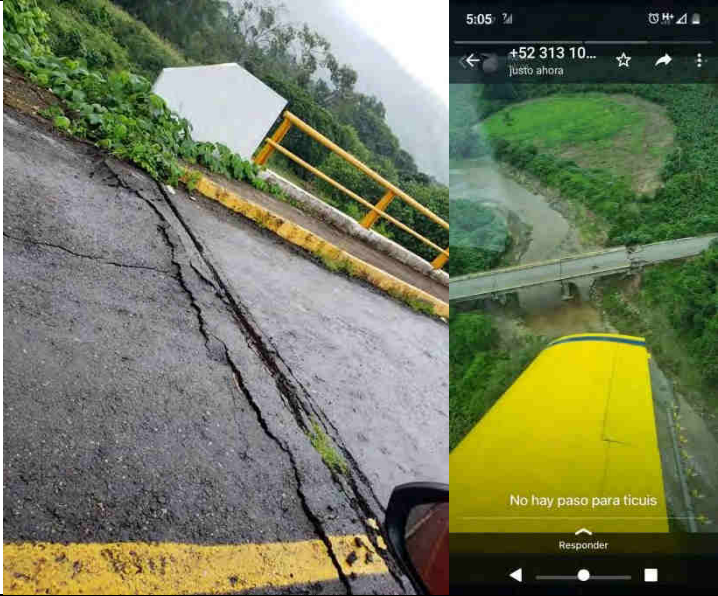
SITE	36
LATITUDE	18.673228219770984
LONGITUDE	-103.67655945815727
DISTANCE FROM EPICENTER	63
CITY	Puente Ticuiz, Coahuayana, Michoacán
EEE TYPE	Ground cracks
EEE DESCRIPTION	Cracks of Cm width in paved roads
ESI INTENSITY	VII
PHOTOGRAPIC DOCUMENTATION

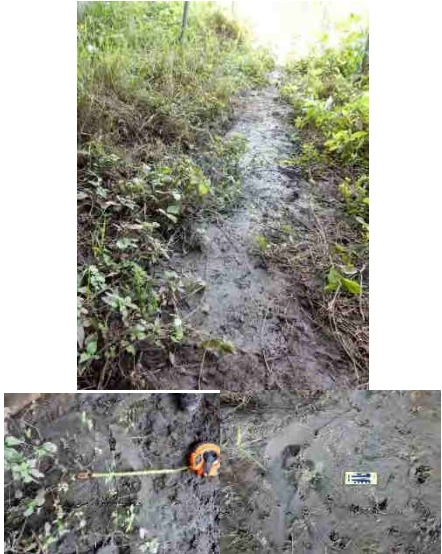
SITE NUMBER	44
LATITUDE	18.730000
LONGITUDE	-103.726389
DISTANCE FROM EPICENTER	71
CITY	San Miguel bridge, Tecomán – Coalcomán road, Tecomán, Colima
EEE TYPE	Liquefaction processes
EEE DESCRIPTION	Sand volcanoes with a diameter of 40 to 60 cm. Liquefaction and sand volcanoes extend for a length exceeding 30 meters in length.
ESI INTENSITY	IX
PHOTOGRAPHIC DOCUMENTATION

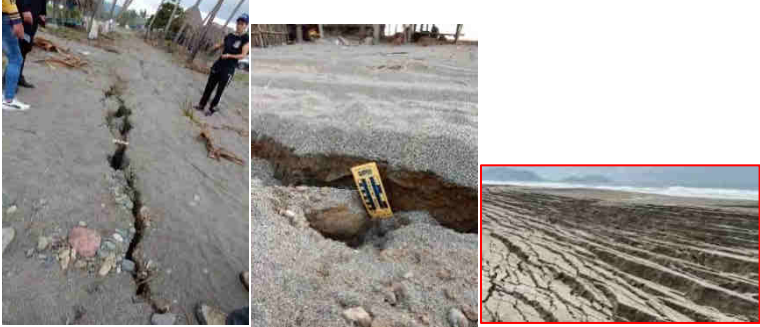
SITE NUMBER	45
LATITUDE	18.6530556
LONGITUDE	-103.70055555555555
DISTANCE FROM EPICENTER	63
CITY	Mezcala, Michoacán
EEE TYPE	Liquefaction processes
EEE DESCRIPTION	Cracks up to 18 m long. 30 to 50 cm wide. Depth up to 53 cm. In the cracks one sees a difference in strata; beach sand on the surface and more compact material at depths
ESI INTENSITY	IX
PHOTOGRAPHIC DOCUMENTATION

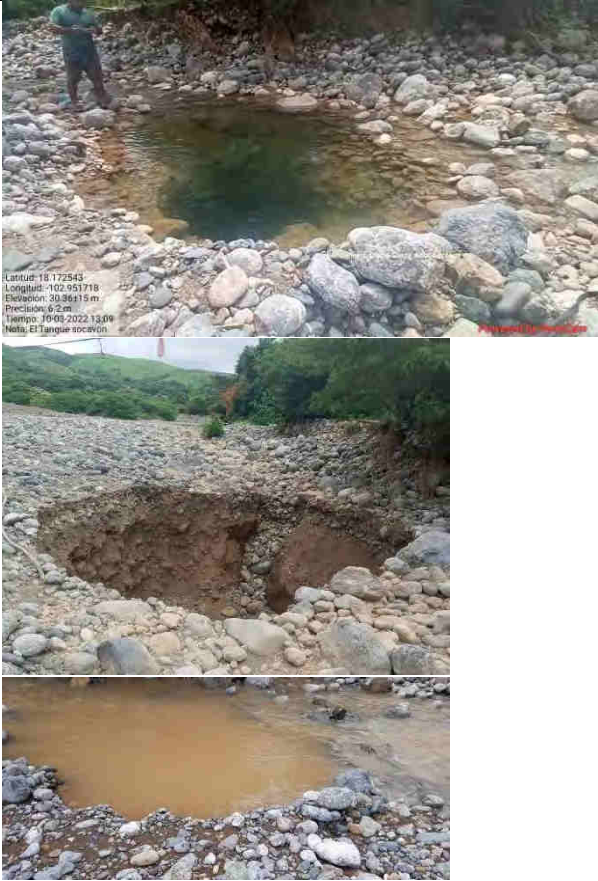
SITE NUMBER	46
LATITUDE	18.172543
LONGITUDE	-102.951718
DISTANCE FROM EPICENTER	37
CITY	Aguila, Michoacán
EEE TYPE	Hydrogeological anomalies
EEE DESCRIPTION	Spring that appeared with the 1985 earthquake, a few days after the earthquake of September 19, 2022, showed turbidity in the water and then completely dried up. Small spring run dry
ESI INTENSITY	IX
PHOTOGRAPHIC DOCUMENTATION

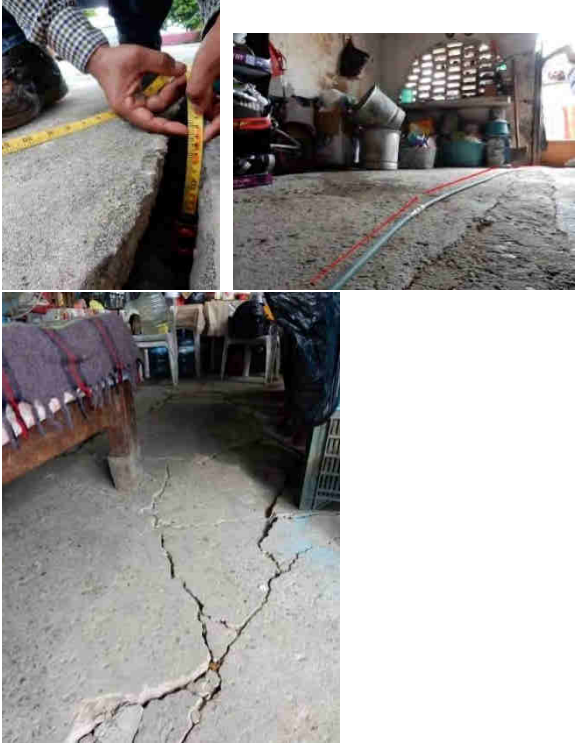
SITE NUMBER	47
LATITUDE	18.6855556
LONGITUDE	-103.7175
DISTANCE FROM EPICENTER	67
CITY	Boca de Apiza, Coahuayana, Michoacán
EEE TYPE	Ground cracks
EEE DESCRIPTION	Cracks of cm width in paved floor
ESI INTENSITY	VII
PHOTOGRAPHIC DOCUMENTATION

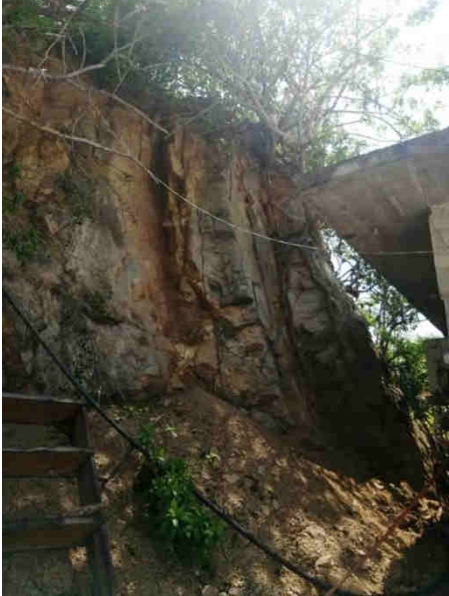
SITE NUMBER	48
LATITUDE	18.3475
LONGITUDE	-103.50944444444444
DISTANCE FROM EPICENTER	26
CITY	Faro de Bucerias, Michoacán
EEE TYPE	Slope movements
EEE DESCRIPTION	Detachment of small blocks from a rock wall; sub-vertical strata
ESI INTENSITY	VII
PHOTOGRAPHIC DOCUMENTATION

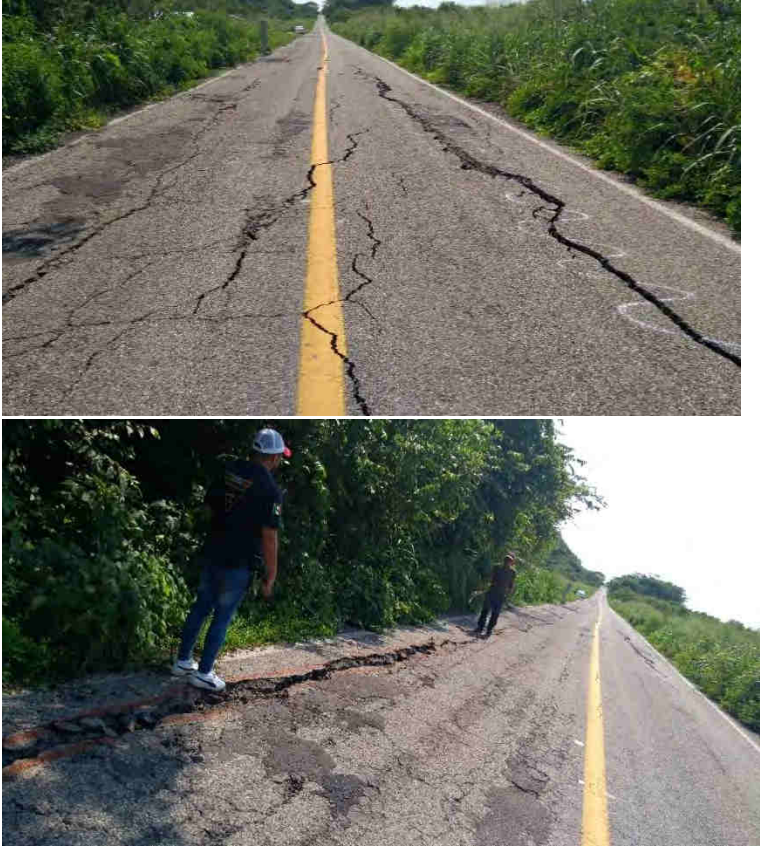
SITE NUMBER	49
LATITUDE	18.2822222
LONGITUDE	-103.35833333333333
DISTANCE FROM EPICENTER	9
CITY	Colola - Faro de Bucerias road, Aquila, Michoacán
EEE TYPE	Ground cracks
EEE DESCRIPTION	Cracks of cm width in paved floor
ESI INTENSITY	VII
PHOTOGRAPHIC DOCUMENTATION

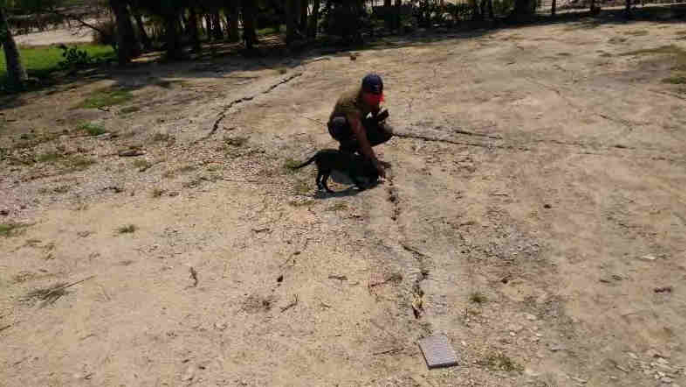
SITE NUMBER	53
LATITUDE	18.2680556
LONGITUDE	-103.35
DISTANCE FROM EPICENTER	7
CITY	Maruata, Michoacán
EEE TYPE	Ground cracks
EEE DESCRIPTION	Cracks of 5 – 10 cm width and 0 – 700 length
ESI INTENSITY	VII
PHOTOGRAPHIC DOCUMENTATION

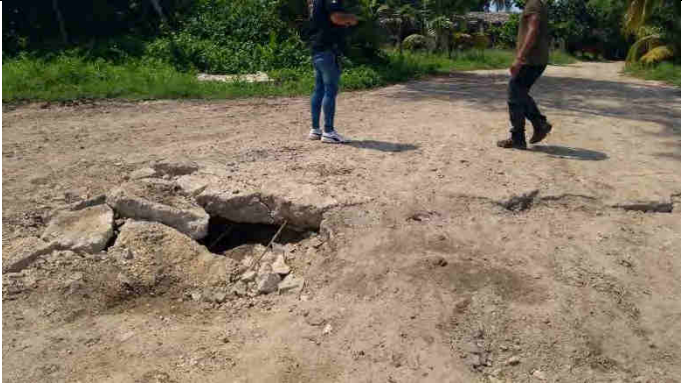
SITE NUMBER	54
LATITUDE	18.2727778
LONGITUDE	-103.34944444444444
DISTANCE FROM EPICENTER	7
CITY	Maruata, Michoacán
EEE TYPE	Ground cracks
EEE DESCRIPTION	Cracks of 30 – 100 cm width and 0 – 200 length
ESI INTENSITY	IX
PHOTOGRAPHIC DOCUMENTATION

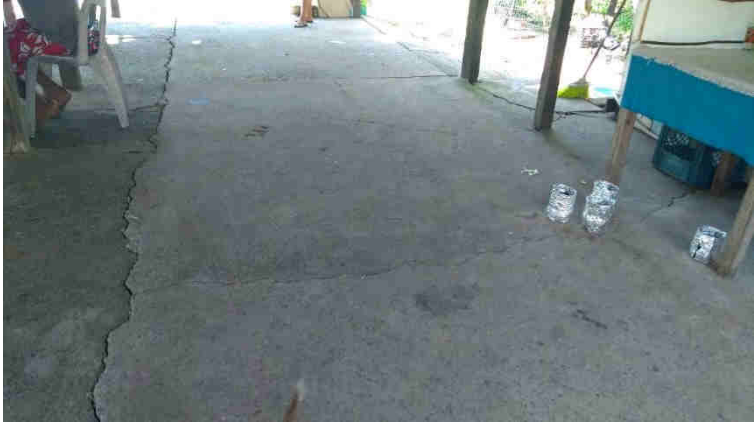
SITE NUMBER	55
LATITUDE	18.2686111
LONGITUDE	-103.35249999999999
DISTANCE FROM EPICENTER	7
CITY	Maruata, Michoacán
EEE TYPE	Ground cracks
EEE DESCRIPTION	Cracks of cm width in paved floor
ESI INTENSITY	VII
PHOTOGRAPHIC DOCUMENTATION

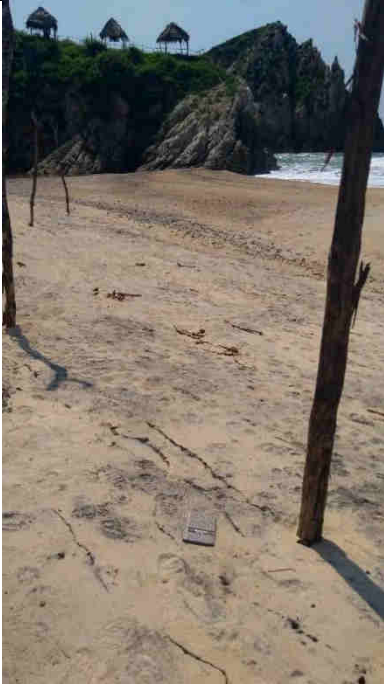
SITE NUMBER	56
LATITUDE	18.2683333
LONGITUDE	-103.35194444444444
DISTANCE FROM EPICENTER	7
CITY	Maruata, Michoacán
EEE TYPE	Liquefaction processes
EEE DESCRIPTION	Cracking and lateral spreading of > 30 cm of heave and fissuring parallel to waterfront area
ESI INTENSITY	IX
PHOTOGRAPHIC DOCUMENTATION

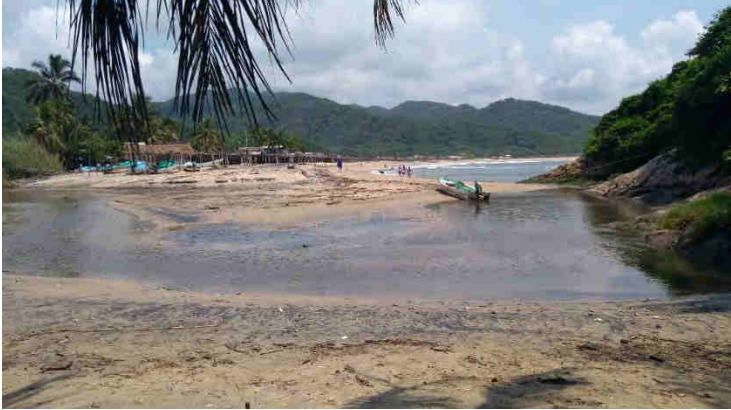
SITE NUMBER	58
LATITUDE	18.2769444
LONGITUDE	-103.34777777777778
DISTANCE FROM EPICENTER	7
CITY	Maruata, Michoacán
EEE TYPE	Anomalous waves and tsunamis
EEE DESCRIPTION	Tsunamis and runups of up to several m
ESI INTENSITY	IX
PHOTOGRAPHIC DOCUMENTATION

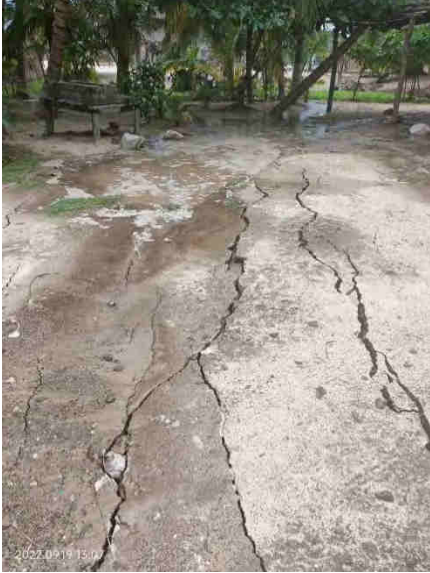
SITE NUMBER	59
LATITUDE	18.2686111
LONGITUDE	-103.34805555555555
DISTANCE FROM EPICENTER	7
CITY	Maruata, Michoacán
EEE TYPE	Liquefaction processes
EEE DESCRIPTION	Cracking and lateral spreading of > 30 cm of heave and fissuring parallel to waterfront area
ESI INTENSITY	IX
PHOTOGRAPHIC DOCUMENTATION

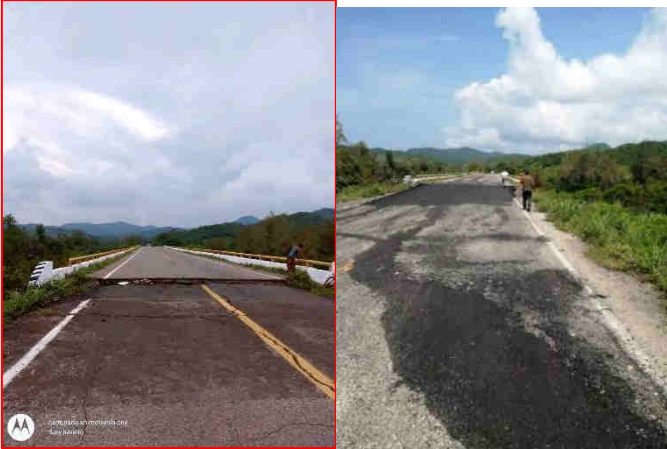
SITE NUMBER	60
LATITUDE	18.2780556
LONGITUDE	-103.35222222222221
DISTANCE FROM EPICENTER	8
CITY	Paso la Noria bridge, Maruata, Michoacán
EEE TYPE	Ground cracks
EEE DESCRIPTION	significant cracks in paved floor
ESI INTENSITY	IX
PHOTOGRAPHIC DOCUMENTATION

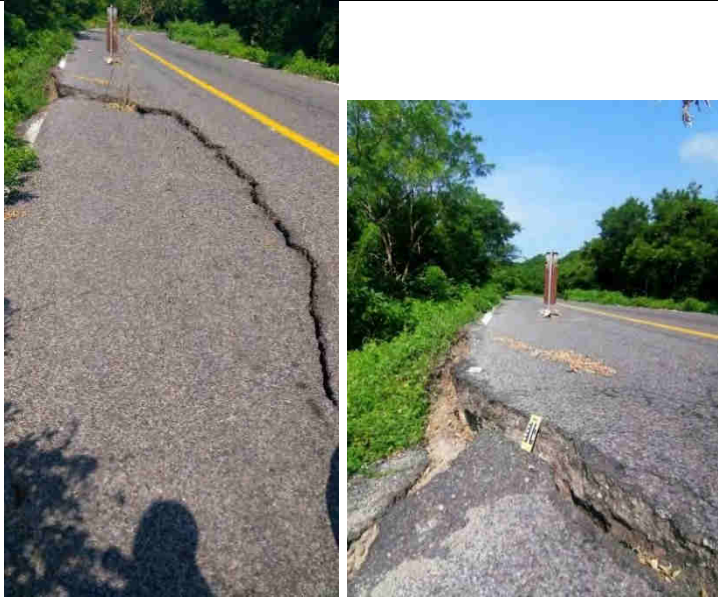
SITE NUMBER	61
LATITUDE	18.2875
LONGITUDE	-103.38583333333334
DISTANCE FROM EPICENTER	11
CITY	Faro de Bucerias – Maruata road, Maruata, Michoacán
EEE TYPE	Liquefaction processes
EEE DESCRIPTION	Cracking and lateral spreading of > 30 cm of heave and fissuring parallel to waterfront area
ESI INTENSITY	IX
PHOTOGRAPHIC DOCUMENTATION

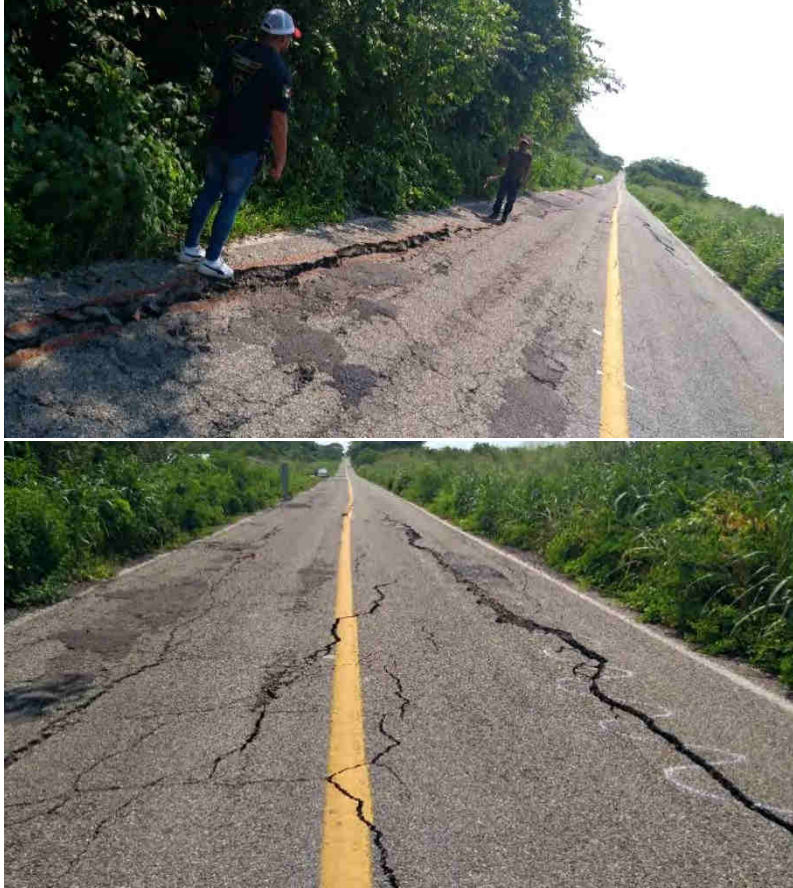
SITE NUMBER	62
LATITUDE	18.2825
LONGITUDE	-103.35833333333333
DISTANCE FROM EPICENTER	9
CITY	Colola – Maruata road, Aquila, Michoacán
EEE TYPE	Ground cracks
EEE DESCRIPTION	Significant cracks of dm width in paved floor
ESI INTENSITY	IX
PHOTOGRAPHIC DOCUMENTATION

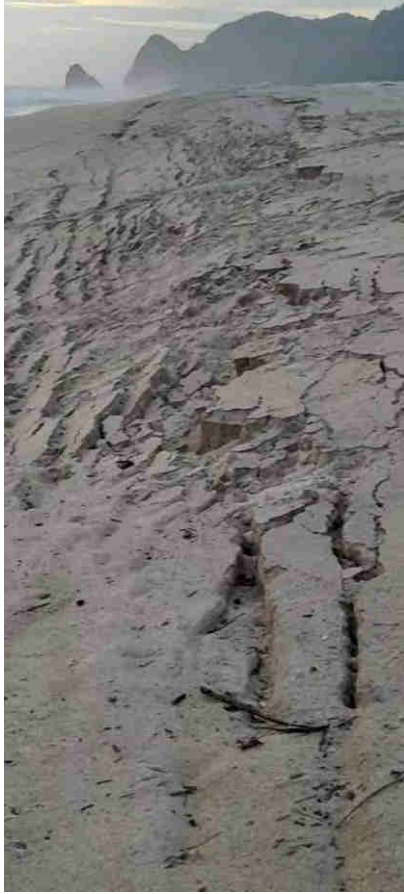
SITE NUMBER	63
LATITUDE	18.2911111
LONGITUDE	-103.40416666666667
DISTANCE FROM EPICENTER	13
CITY	Colola, Michoacán
EEE TYPE	Liquefaction processes
EEE DESCRIPTION	Cracking and lateral spreading of > 30 cm of heave and fissuring parallel to waterfront area
ESI INTENSITY	IX
PHOTOGRAPHIC DOCUMENTATION

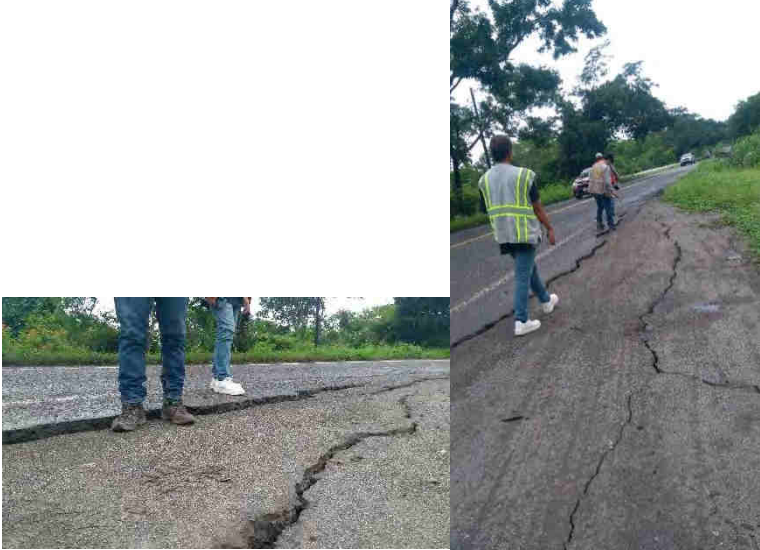
SITE NUMBER	115
LATITUDE	18.6383333
LONGITUDE	-103.66711111111111
DISTANCE FROM EPICENTER	59
CITY	Puente La Zorrillera, Coahuayana – San Telmo road, Coahuayana, Michoacán
EEE TYPE	Liquefaction processes
EEE DESCRIPTION	Cracking and lateral spreading of 0 – 30 cm of heave and fissuring parallel to waterfront area
ESI INTENSITY	VIII
PHOTOGRAPHIC DOCUMENTATION

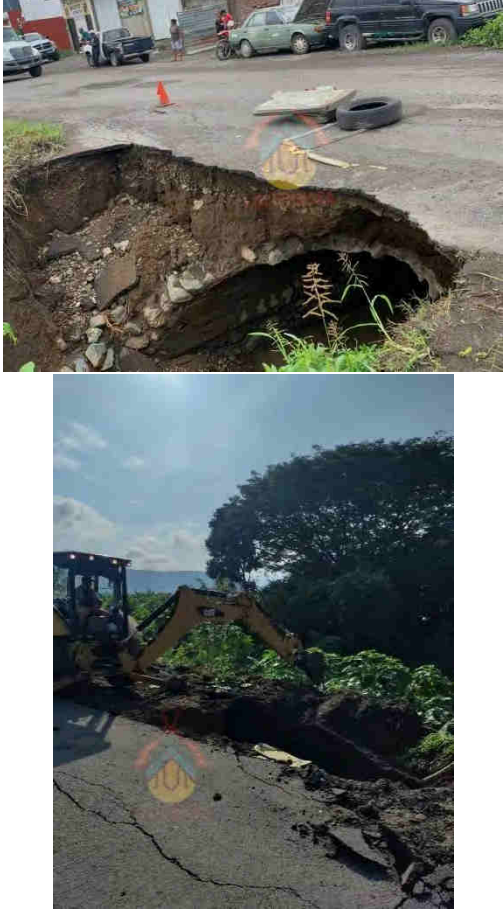
SITE NUMBER	123
LATITUDE	18.75289
LONGITUDE	-103.6612
DISTANCE FROM EPICENTER	69
CITY	Coahuayana Viejo, Coahuayana, Michoacán
EEE TYPE	Liquefaction processes
EEE DESCRIPTION	>30 cm localized lateral spreading and settlements with fissuring parallel to waterfront areas
ESI INTENSITY	IX
PHOTOGRAPHIC DOCUMENTATION

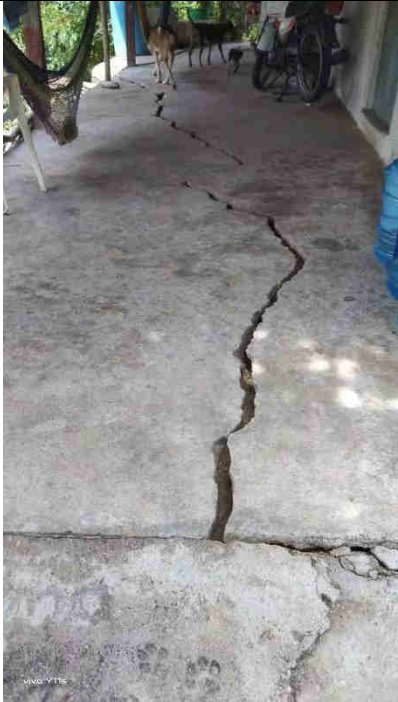
SITE NUMBER	124
LATITUDE	18.27213
LONGITUDE	-103.34664
DISTANCE FROM EPICENTER	7
CITY	Maruata, Aquila, Michoacán
EEE TYPE	Ground cracks
EEE DESCRIPTION	wide cracks developed in paved roads
ESI INTENSITY	IX
PHOTOGRAPHIC DOCUMENTATION

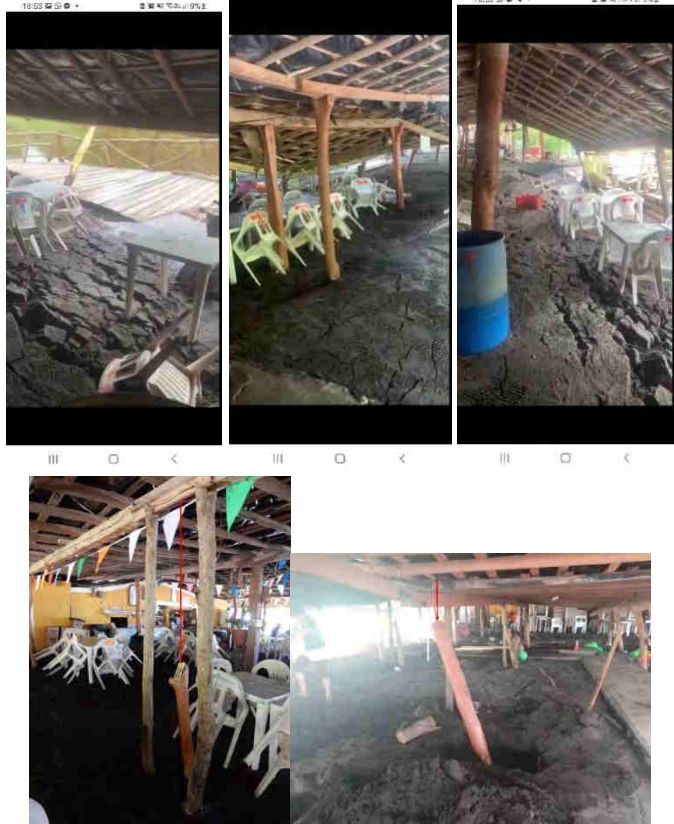
SITE NUMBER	125
LATITUDE	18.8609
LONGITUDE	-103.96
DISTANCE FROM EPICENTER	99
CITY	Tecomán, Michoacán
EEE TYPE	Liquefaction processes
EEE DESCRIPTION	Localized lateral spreading and settlements with height of > 30 cm, and with fissuring parallel to waterfront areas. At the time of the earthquake, the structure of the ramada sank approximately 1.5 m.
ESI INTENSITY	IX
PHOTOGRAPHIC DOCUMENTATION

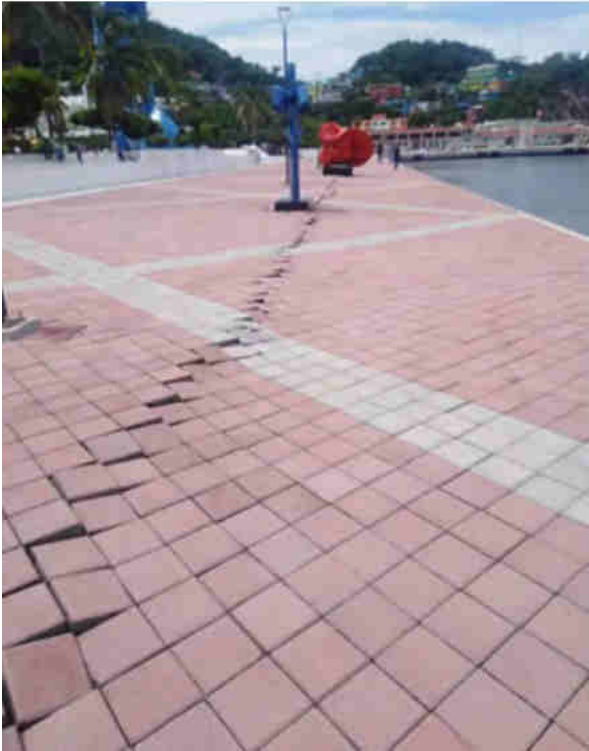
SITE NUMBER	129
LATITUDE	19.054057
LONGITUDE	-104.316662
DISTANCE FROM EPICENTER	141
CITY	Public square Jardín Álvaro Obregón, Manzanillo, Colima
EEE TYPE	Liquefaction processes
EEE DESCRIPTION	Cracking and lateral spreading of 0 – 30 cm of heave and fissuring parallel to waterfront area
ESI INTENSITY	VIII
PHOTOGRAPHIC DOCUMENTATION

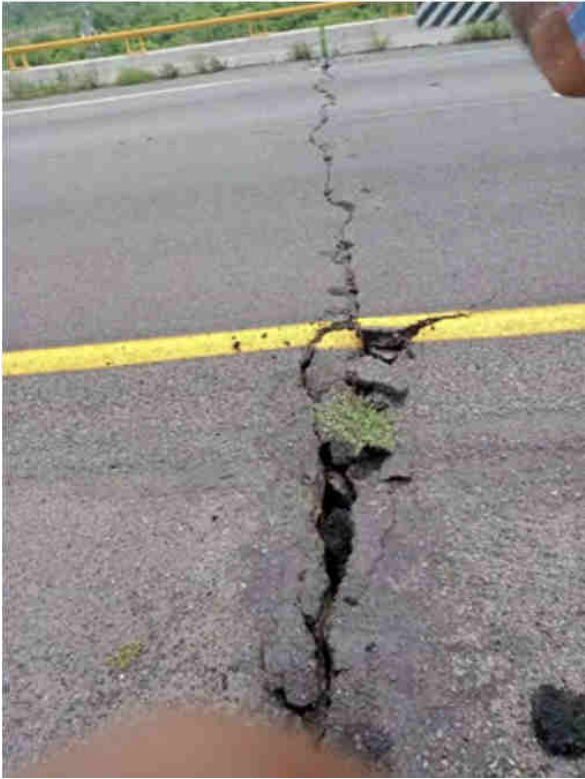
SITE NUMBER	135
LATITUDE	18.9347
LONGITUDE	-103.9432
DISTANCE FROM EPICENTER	103
CITY	Colima-Tecomán road, Puente Armería, Colima
EEE TYPE	Ground cracks
EEE DESCRIPTION	Dm cracks in paved roads
ESI INTENSITY	VIII
PHOTOGRAPHIC DOCUMENTATION

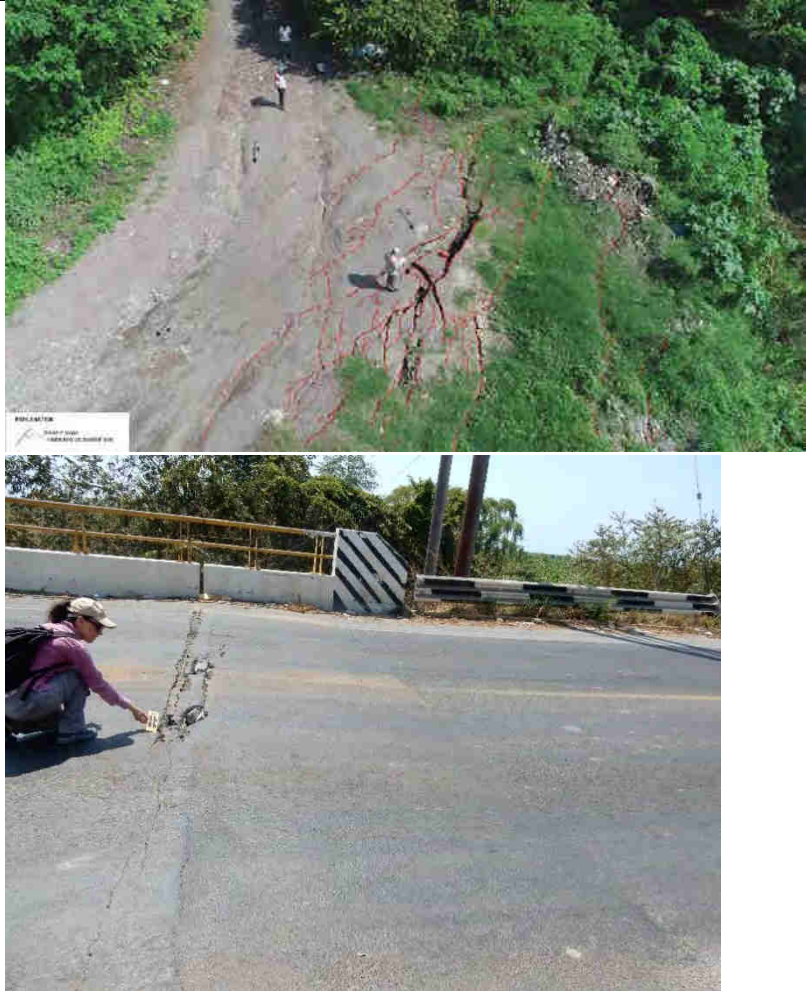
SITE NUMBER	136
LATITUDE	18.7177684
LONGITUDE	-103.716589
DISTANCE FROM EPICENTER	69
CITY	La Zapotera, Colima
EEE TYPE	Lateral spreading and ground cracks
EEE DESCRIPTION	Lateral spread and fractures up to 67 cm wide and several meters in length. Ground crack also on the pavement road.
ESI INTENSITY	IX
PHOTOGRAPHIC DOCUMENTATION

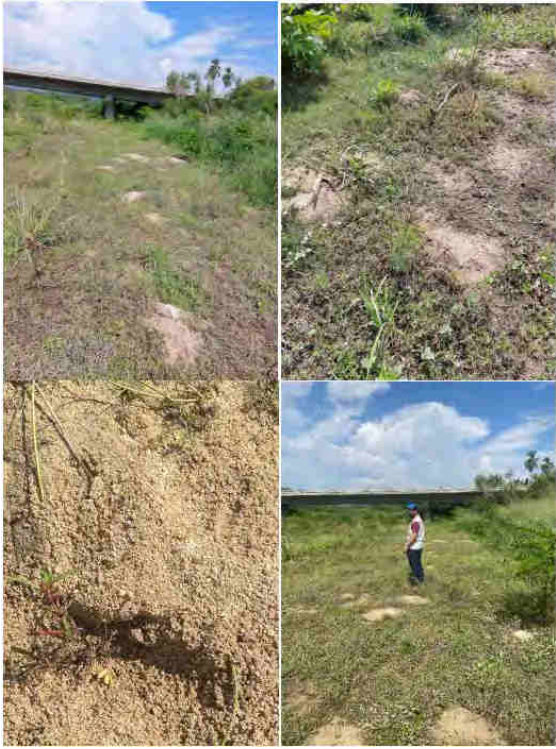
SITE NUMBER	138
LATITUDE	18.41615
LONGITUDE	-103.532373
DISTANCE FROM EPICENTER	32
CITY	Ixtapilla
EEE TYPE	Liquefaction processes.
EEE DESCRIPTION	Sand volcanoes in a riverbed levee near Ixtapilla, Michoacan. "The sand was ejected from points along a linear natural levee and buried nearby vegetation. There were over a dozen sand boils total, all with similar volumes of ejecta (<1 cubic meter). Fissures were evident near the sand boils but no ejecta from the fissures was observed" (Geer report, 2022).
ESI INTENSITY	VII
PHOTOGRAPHIC DOCUMENTATION

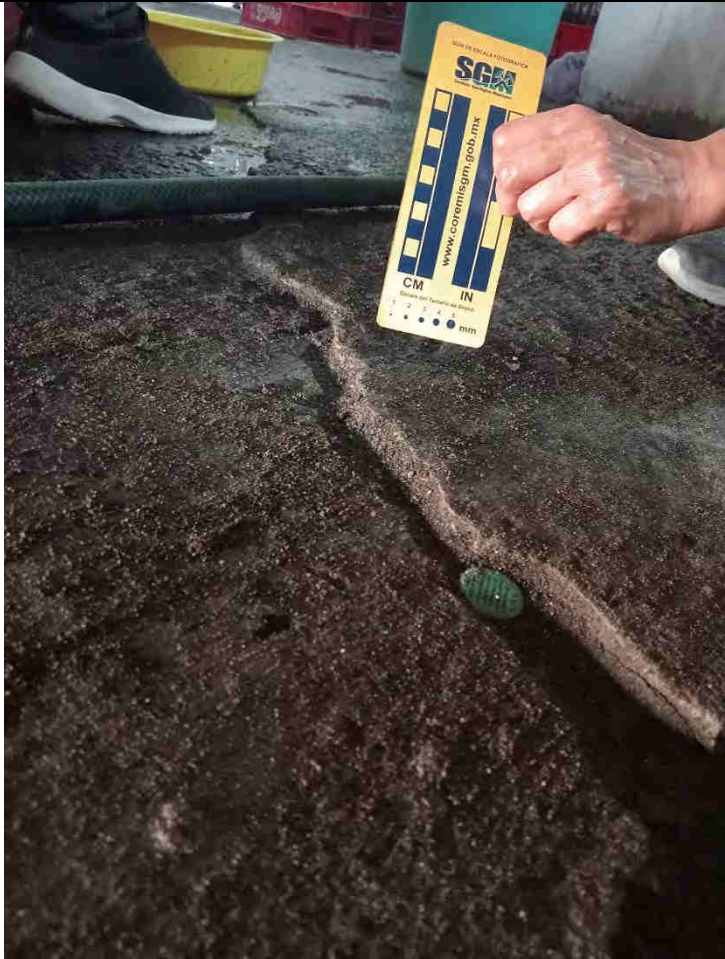
SITE NUMBER	140
LATITUDE	18.859297621
LONGITUDE	-103.96419881
DISTANCE FROM EPICENTER	99
CITY	Tecomán, Colima (Boca de Pascuales)
EEE TYPE	Ground cracks
EEE DESCRIPTION	Cracks in natural soil (beach sand) and pavement. The cracks reach up to 2 meters in length and up to 3 cm in width.
ESI INTENSITY	VI
PHOTOGRAPHIC DOCUMENTATION

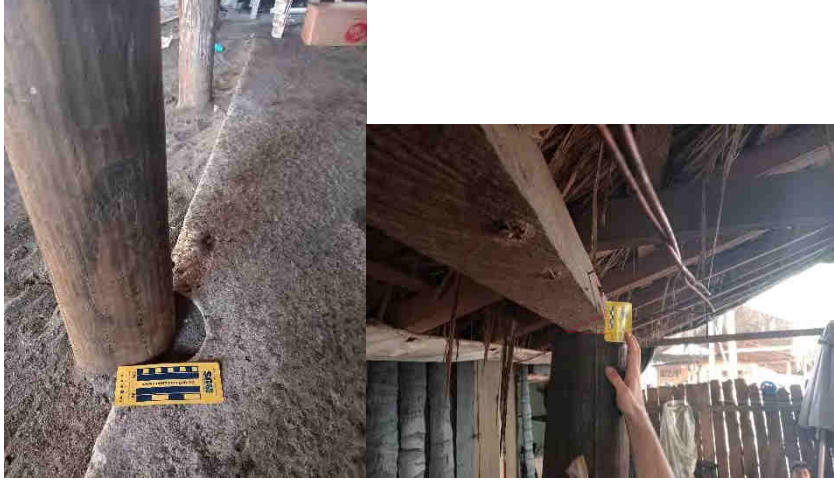
SITE NUMBER	141
LATITUDE	18.859297
LONGITUDE	-103.964198
DISTANCE FROM EPICENTER	99
CITY	Tecomán, Colima (Boca de Pascuales)
EEE TYPE	Liquefaction processes
EEE DESCRIPTION	Liquefaction in beach sand caused the movement of the structure supported by wooden posts. These moved 7-8 cm laterally and 4-5 cm vertically.
ESI INTENSITY	VII
PHOTOGRAPHIC DOCUMENTATION

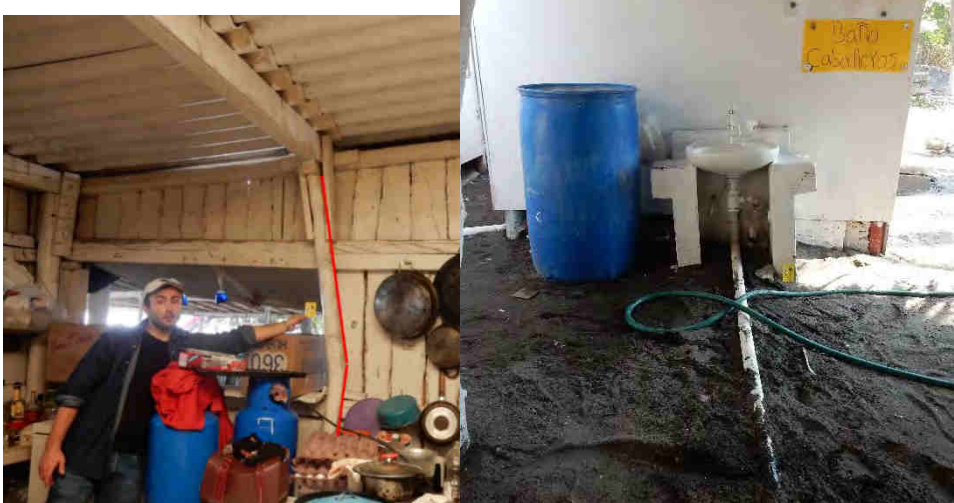
SITE NUMBER	142
LATITUDE	18.8596505
LONGITUDE	-103.964273
DISTANCE FROM EPICENTER	99
CITY	Tecomán, Colima (Boca de Pascuales)
EEE TYPE	Liquefaction processes
EEE DESCRIPTION	Liquefaction process produced ejection of water and sand and caused the destabilization of structures such as palm and wood constructions, concrete, swimming pools.
ESI INTENSITY	VII
PHOTOGRAPHIC DOCUMENTATION

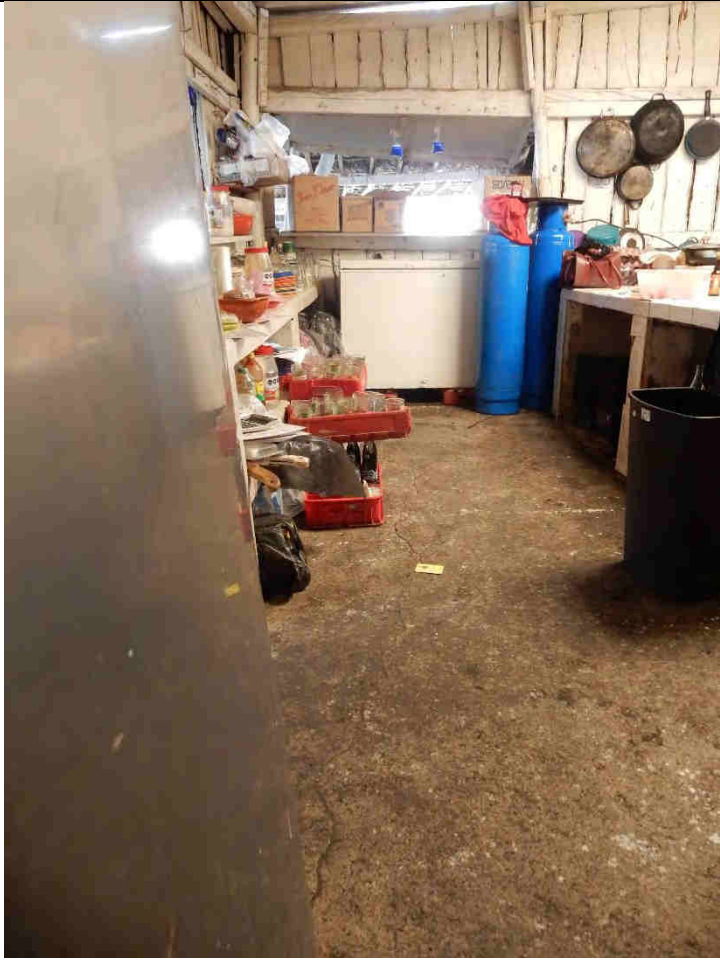
SITE NUMBER	143
LATITUDE	18.8596505
LONGITUDE	-103.964273
DISTANCE FROM EPICENTER	99
CITY	Tecomán, Colima (Boca de Pascuales)
EEE TYPE	Ground cracks
EEE DESCRIPTION	Cracks in natural soil (beach sand) and pavement. The cracks reach up to 5 meters in length and up to 3 cm in width.
ESI INTENSITY	VII
PHOTOGRAPHIC DOCUMENTATION

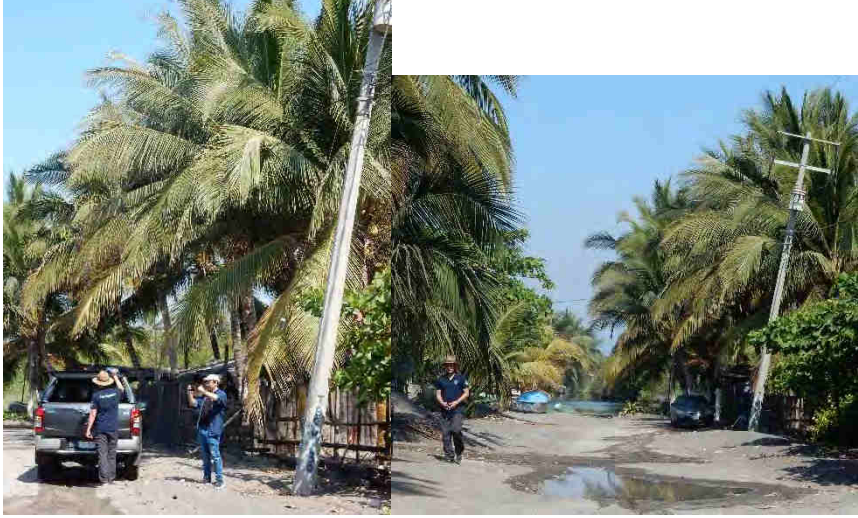
SITE NUMBER	144
LATITUDE	18.8598772
LONGITUDE	-103.964414
DISTANCE FROM EPICENTER	99
CITY	Tecomán, Colima (Boca de Pascuales)
EEE TYPE	Liquefaction processes
EEE DESCRIPTION	At the base of the light pole there was ejection of water and sand that caused the pole to tilt. 48 meters away from the river.
ESI INTENSITY	VIII
PHOTOGRAPHIC DOCUMENTATION

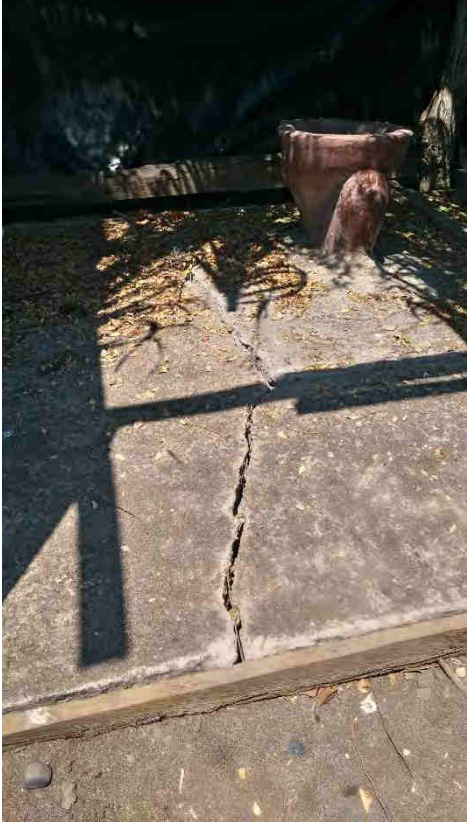
SITE NUMBER	145
LATITUDE	18.6875407
LONGITUDE	-103.738985
DISTANCE FROM EPICENTER	69
CITY	Boca de Apiza, Colima
EEE TYPE	Ground cracks
EEE DESCRIPTION	Cracks in beach sand and pavement along the beach and on the road near the river about 2m in length
ESI INTENSITY	VII
PHOTOGRAPHIC DOCUMENTATION

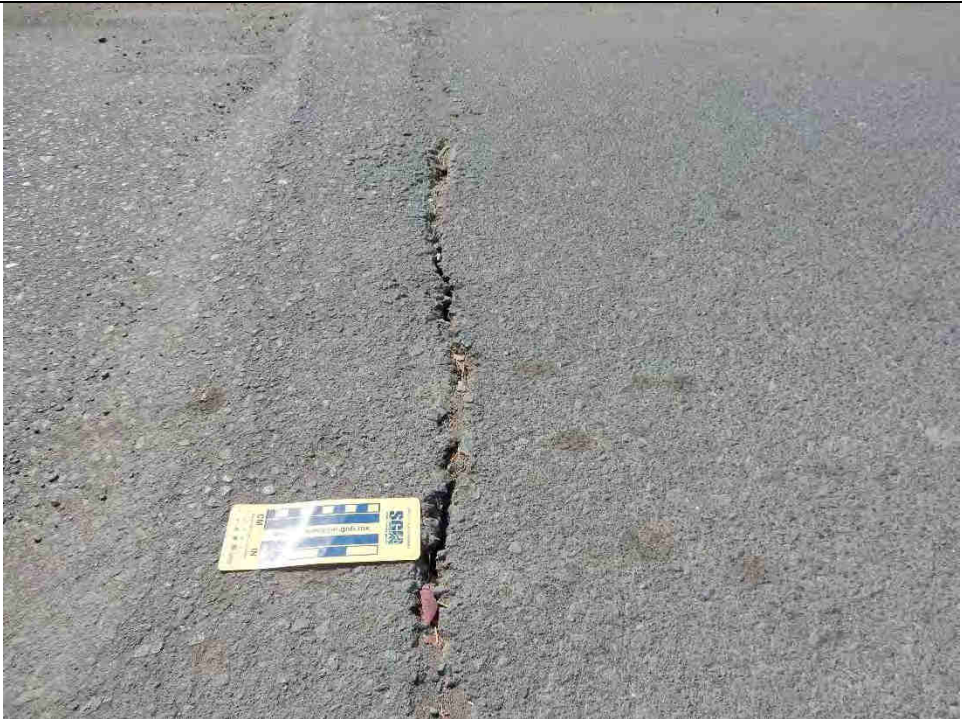
SITE NUMBER	146
LATITUDE	18.6943013
LONGITUDE	-103.74325
DISTANCE FROM EPICENTER	69
CITY	Boca de Apiza, Colima
EEE TYPE	Ground cracks
EEE DESCRIPTION	Cracks along the beach and on the road near the river about 2m in length
ESI INTENSITY	VII
PHOTOGRAPHIC DOCUMENTATION

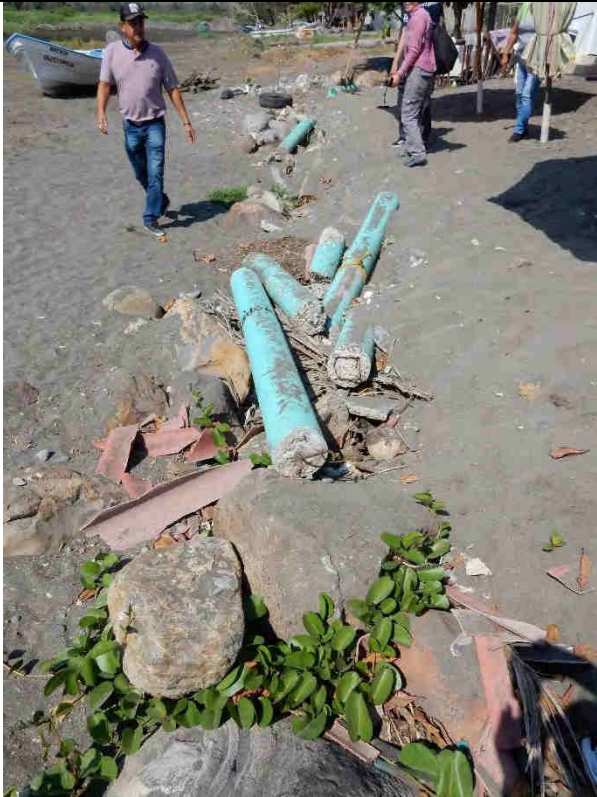
SITE NUMBER	148
LATITUDE	18.6854462
LONGITUDE	-103.736583
DISTANCE FROM EPICENTER	68
CITY	Boca de Apiza, Coahuayana, Michoacán
EEE TYPE	Ground cracks
EEE DESCRIPTION	With coseismic uplift, a crack opened on the limit between what was the estuary and the populated area. The crack was more than 1 meter deep and people have filled it in with rocks and waste material.
ESI INTENSITY	IX
PHOTOGRAPHIC DOCUMENTATION

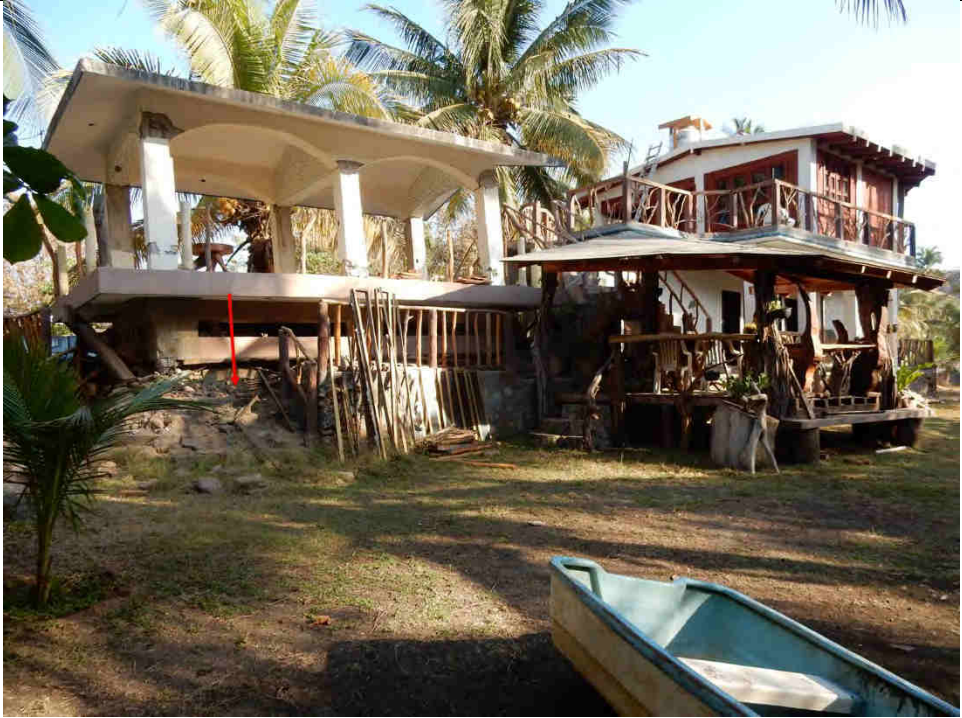
SITE NUMBER	149
LATITUDE	18.5863214
LONGITUDE	-103.679057
DISTANCE FROM EPICENTER	56
CITY	San Juan de Alima, Michoacán
EEE TYPE	Liquefaction
EEE DESCRIPTION	The natural soil near the river (10m aprox.), suffered liquefaction, which also caused the collapse of structures
ESI INTENSITY	VIII
PHOTOGRAPHIC DOCUMENTATION

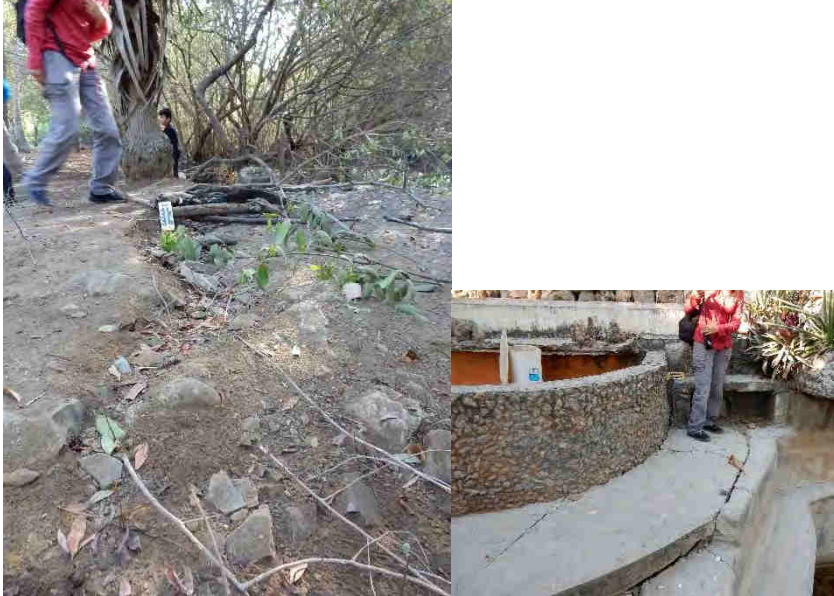
SITE NUMBER	150
LATITUDE	18.5863214
LONGITUDE	-103.679057
DISTANCE FROM EPICENTER	56
CITY	San Juan de Alima, Michoacán
EEE TYPE	Ground cracks
EEE DESCRIPTION	Riverside cracks several meters long and less than 10cm deep and 10-25cm wide, occurred in natural soil and pavement. The cracks produced fractures in structures such as roads and houses.
ESI INTENSITY	IX
PHOTOGRAPHIC DOCUMENTATION

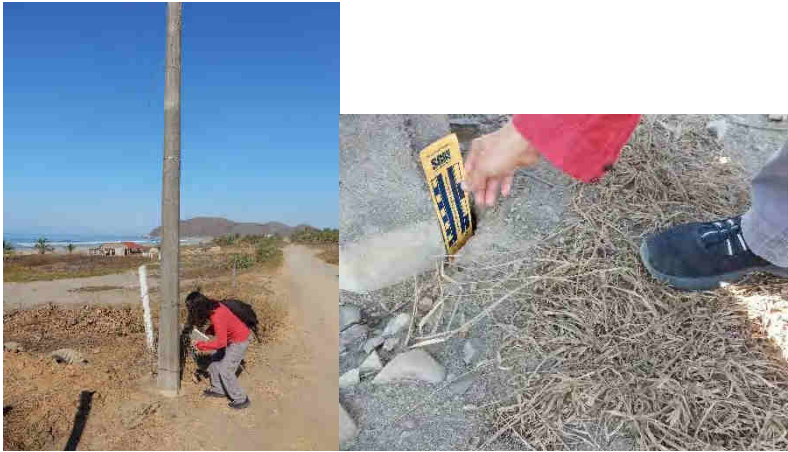
SITE NUMBER	151
LATITUDE	18.5886254
LONGITUDE	-103.682896
DISTANCE FROM EPICENTER	57
CITY	San Juan de Alima, Michoacán
EEE TYPE	Liquefaction processes
EEE DESCRIPTION	Liquefaction in natural soil caused damage and destabilization in artificial structures, such as several fallen walls. On this site, caused a light pole to tilt.
ESI INTENSITY	IX
PHOTOGRAPHIC DOCUMENTATION

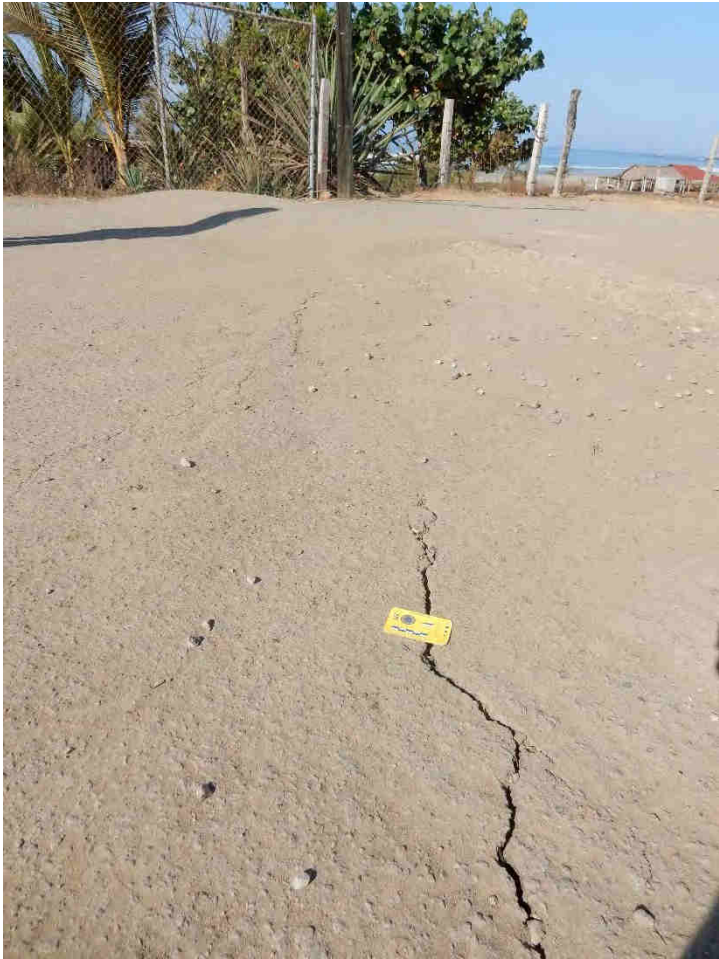
SITE NUMBER	152
LATITUDE	18.5886254
LONGITUDE	-103.682896
DISTANCE FROM EPICENTER	57
CITY	San Juan de Alima, Michoacán
EEE TYPE	Ground cracks
EEE DESCRIPTION	Cracks 1-2m long and less than 5cm, occurred in natural soil and pavement road.
ESI INTENSITY	VIII
PHOTOGRAPHIC DOCUMENTATION
