Environmental effects caused by the Mw 7.7, September 19, 2022, Michoacán (Mexico)

Descriptive table

This document presents a collection of Earthquake Environmental Effects (EEEs) triggered by the Mw 7.7 Michoacan earthquake occurred on 19 September 2022. Data derive from original field surveys, published reports and papers, and from a search for EEEs posted online in social media and other websites.

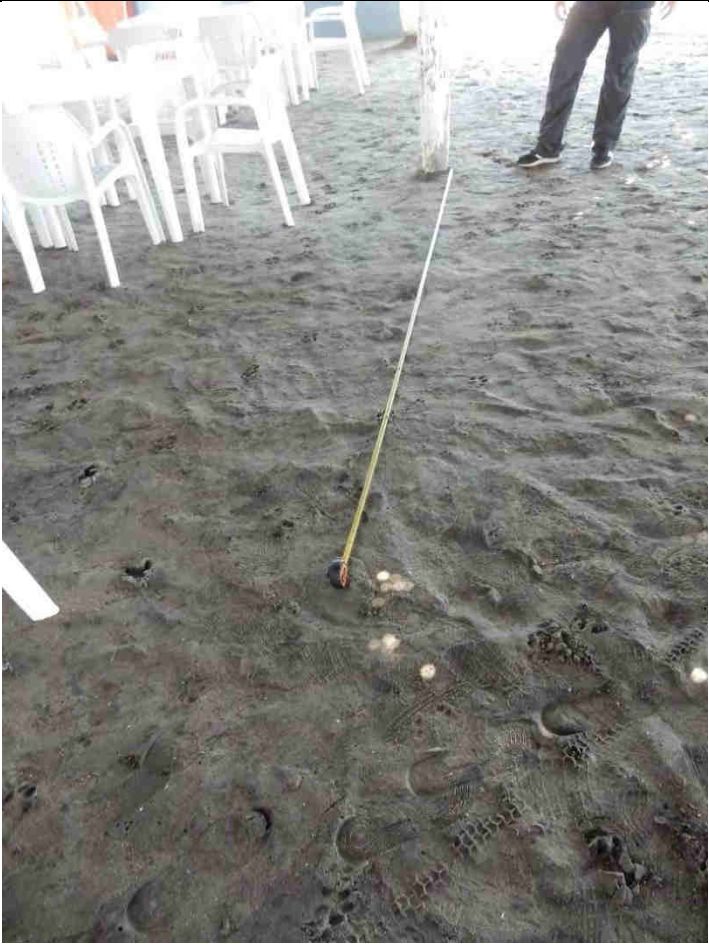
SITE NUMBER	155
LATITUDE	18.525819
LONGITUDE	-103.6017809
DISTANCE FROM EPICENTER	46
CITY	La Placita, Michoacán
EEE TYPE	Ground cracks
EEE DESCRIPTION	Cracks in the natural sandy soil of about 4 m in length parallel to the coastline.
ESI INTENSITY	VIII
PHOTOGRAPHIC DOCUMENTATION
