Study of the Failure Mechanism of a High-Density Polyethylene Liner in a Type IV High-Pressure Storage Tank

Alfredo Rondinella ^{1,*}, Giovanni Capurso ^{1,*}

Abstract: The use of Type IV cylinders for gas storage is becoming more widespread in various sectors, especially in transportation, owing to the lightweight nature of this type of cylinder, which is composed of a polymeric liner that exerts a barrier effect and an outer composite material shell that primarily imparts mechanical strength. In this work, the failure analysis of an HDPE liner in a Type IV cylinder for high-pressure storage was carried out. The breakdown occurred during a cyclic pressure test at room temperature and manifested in the hemispherical head area, as cracks perpendicular to the liner pinch-off line. The failed sample was thoroughly investigated and its characteristics were compared with those of other liners at different stages of production of a Type IV cylinder (blow molding, curing of the composite material). An examination of the liner showed that no significant chemical and morphological changes occurred during the production cycle of a Type IV cylinder that could justify the liner rupture, and

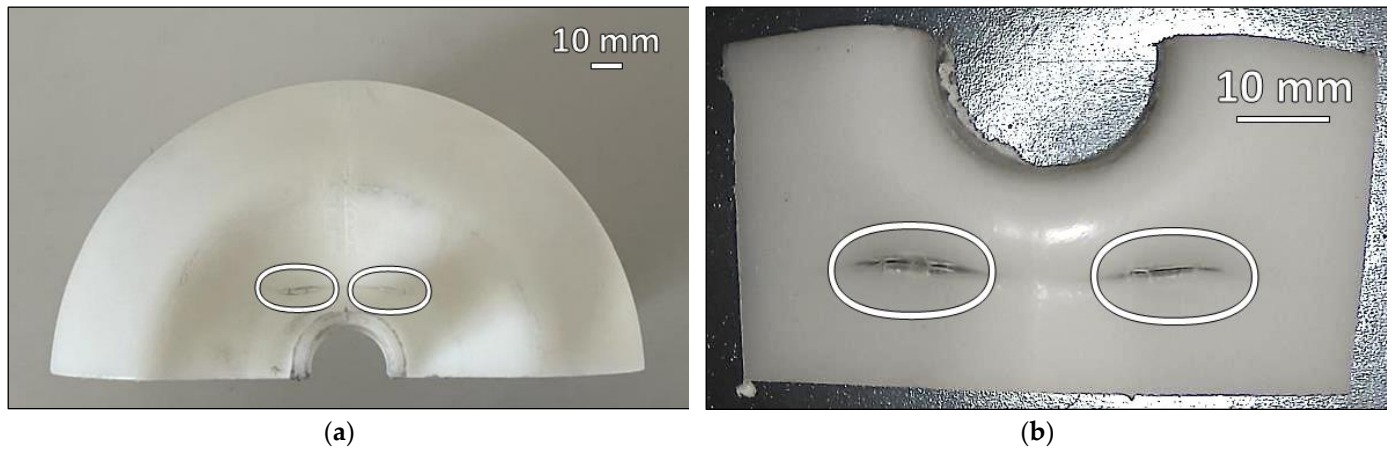
A visual inspection of the Failed specimen revealed cracks perpendicular to the liner mold parting line (pinch-off line) with a length of about 2.5 cm, as visible clearly from above in Figure 1a, where such defects are marked with ovals. In Figure 1b, these cracks are seen from below and highlighted with ovals; their extension, from this perspective, seems to be shorter. The morphology in the two photographs clearly shows plastic deformation and polymeric material pushing outward.

Figure 1. Photographs of the Failed specimen with highlighted failure points: (a) half of the hemispherical head area of the failed liner and (b) a detail of the cracks as seen from inside the cylinder.

As shown in Figure 1, the liner failed in the hemispherical head area, causing cracks to form perpendicularly to the mold parting line, on both the sides, with similar sizes, morphological characteristics, and features. The appearance of the area surrounding the cracks clearly suggests plastic deformation, a reduction of the thickness of the liner, the formation of oriented variation of opacity in the thinner areas, and a flow of deformed material pushing outward, presumably a few moments before the crack initiated. A closer look at the area where the failure occurred (*cf.* Figure 2) confirmed a severe plastic deformation, probably due to the prescribed standard test loading and unloading cycles. The characterization technique and the magnification used for the micrographs do not allow the discernment of macromolecular orientation, but the fiber fraying visible in Figure 2c and the changes to the surface morphology with the characteristic texture and rugosity observable in Figure 2d, suggest the formation of craze-like features in the material.

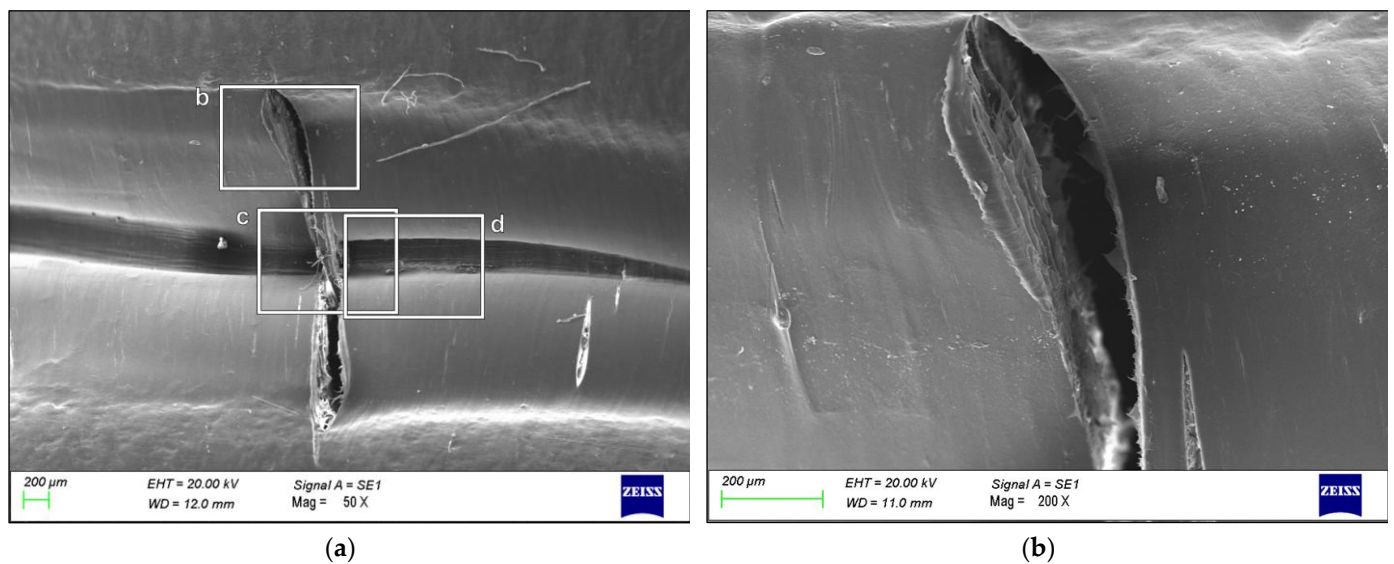
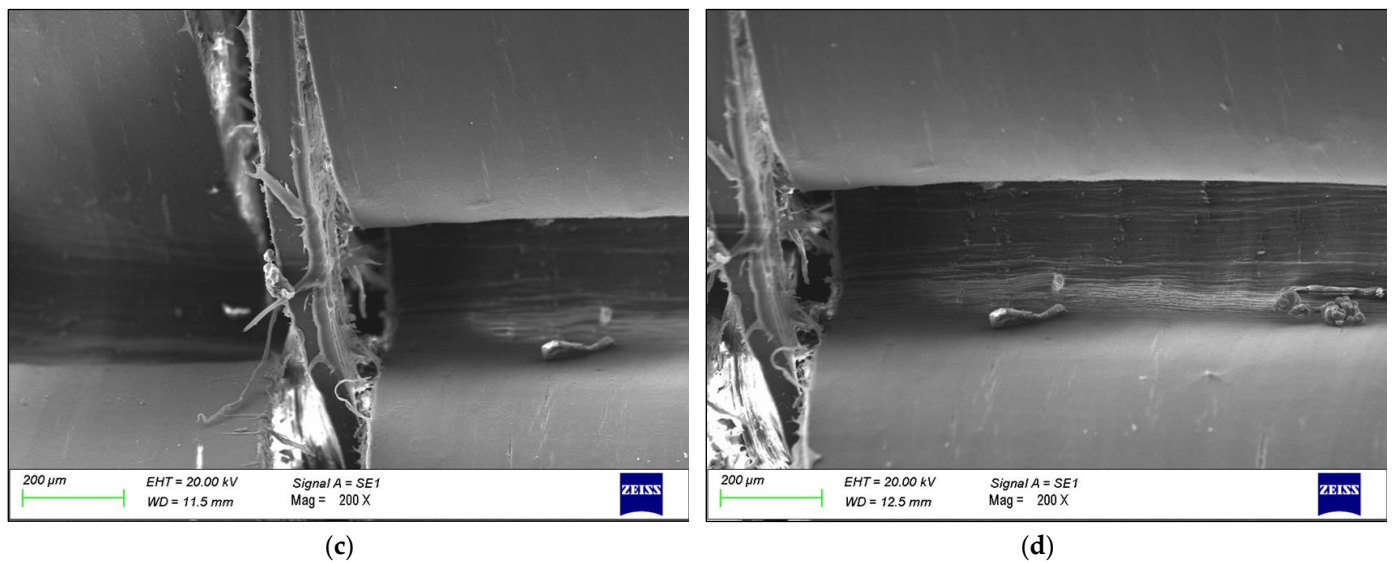
Figure 2 shows more clearly the plastic deformation that occurred during the prescribed cyclic test (already highlighted in Figure 1). Figure 2b, 2c, and 2d underline some of the details of Figure 2a by showing one of the breaking points, polymer fiber fraying and a change in surface morphology, respectively. In particular, looking at the micrographs in Figure 2, it is possible to assume a reorientation of the polymer caused by the phenomenon that led to the rupture.

Figure 2. SEM micrographs of (a) one of the cracks occurred in the Failed specimen highlighted in the photographs in Figure 1, and details of several areas highlighting: (b) the fracture point, (c) fiber fraying, and (d) a change in surface morphology.

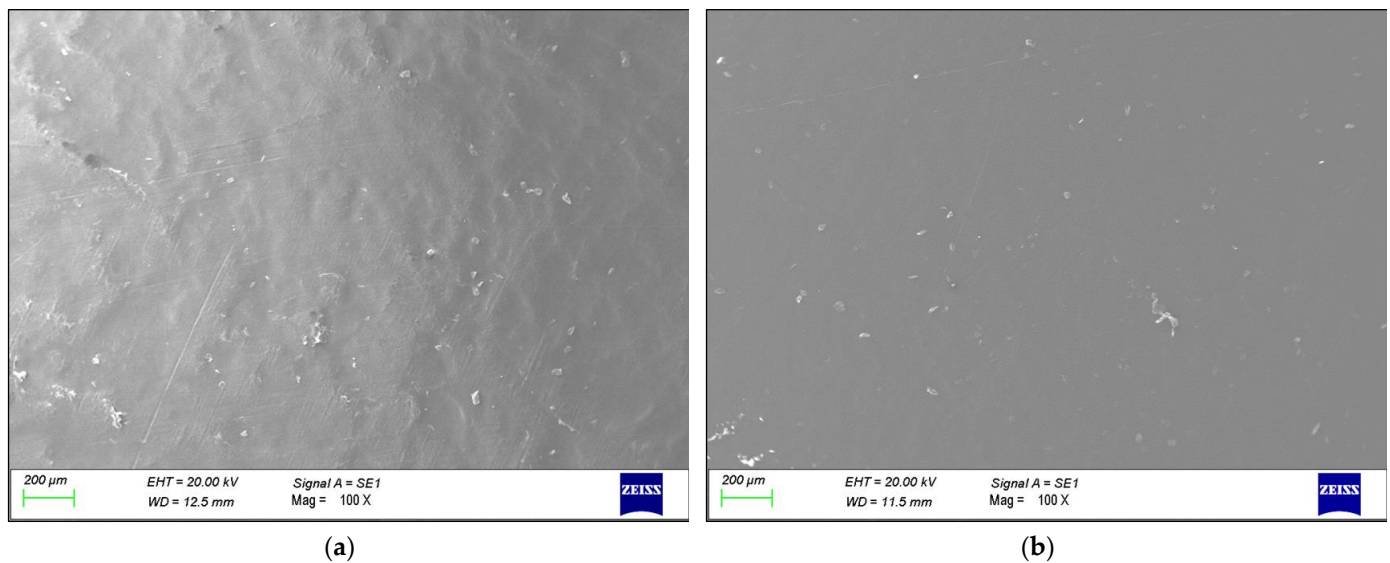
The SEM micrographs in Figure 3 show the surface of the Blow Molded and Cured samples, the reference material before the fatigue tests. Although a slight morphological change of the surface seems to occur from one step to the next, no major imperfections are detectable, suggesting that the manufacturing process does not cause surface changes that would trigger a cracking phenomenon.

Figure 3. Surface morphology of the polyethylene liner in the (a) “Blow Molded” and (b) “Cured” samples.

A comparison of the failure morphology with the surfaces of samples from different stages of the production process (*cf.* Figure 3) showed that there were no major changes in the surface morphology and its texture before the test. Figure 4, on the other hand, showed that one of the most plausible causes of the failure was a significant reduction in cross-sectional area compared to the Cured sample. This thinner portion was obviously more prone to yielding and failure, due to the combined effect of the high pressure reached during the loading phase of the cyclic test with mechanical fatigue and the concentration of the stress in the already deformed area, which is clearly visible in Figure 4b.

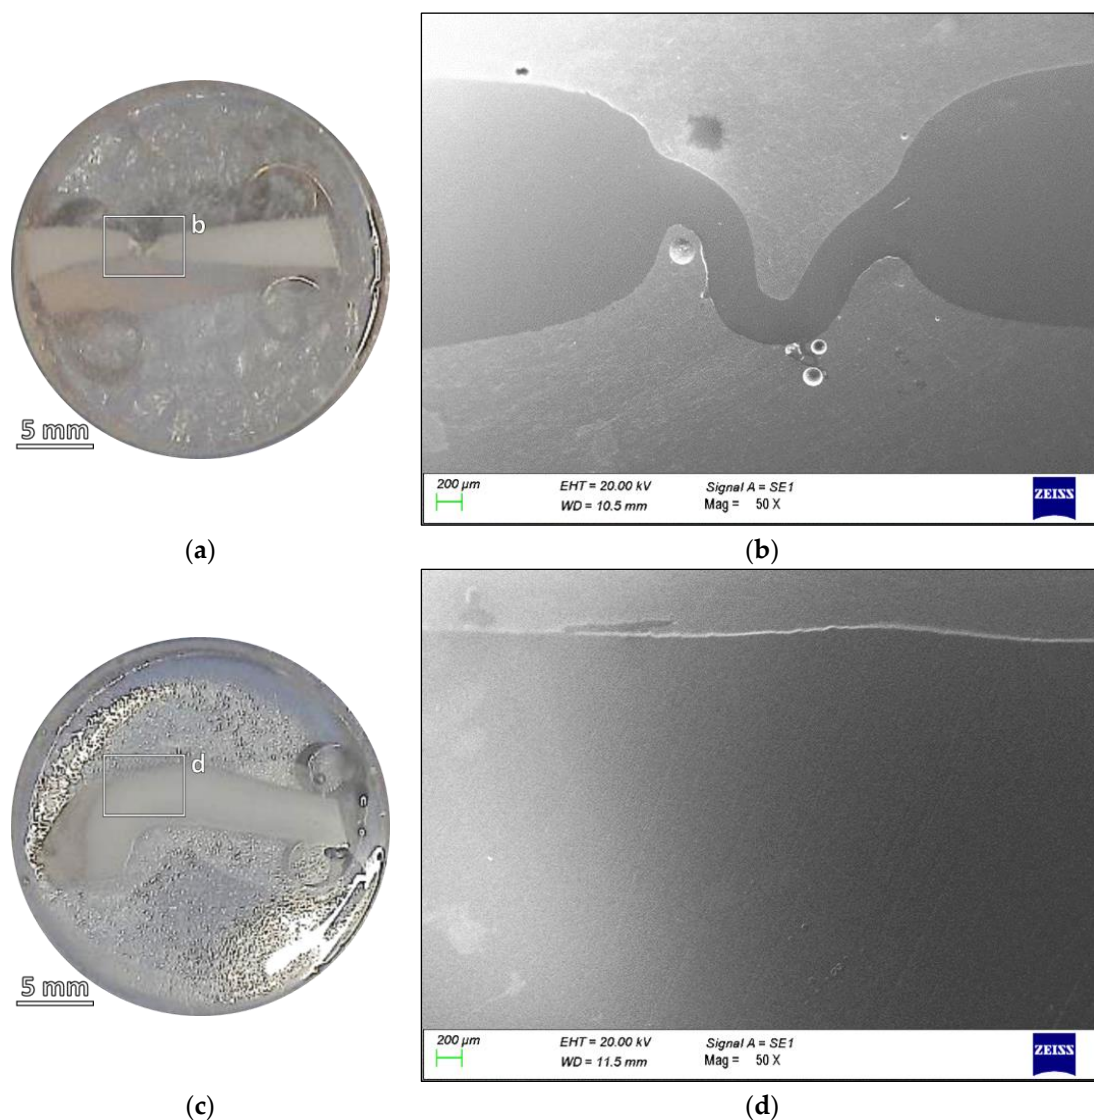
In Figure 4a,c, cross-sectional photographs of liners are shown, from the Failed and the Cured sample, respectively. The portion of the liners are those close to the pinch-off line, where the decreased thickness and the cracks are observed; the same piece is cut from the Cured sample. The SEM micrographs, corresponding to the areas highlighted in the photographs, can be seen in Figure 4b,d.

Figure 4. (a) Photograph and (b) SEM micrograph of the section of a Failed sample compared with (c) the photograph and (d) the SEM micrograph of the section of a Cured specimen.

By comparing the two samples, the plastic deformation that occurred in the Failed sample is again confirmed, and a strong reduction in the cross section is observable. Moreover, it is possible to see how the thickness reduction was followed by a bending deformation that very plausibly led to the fracture initiation.

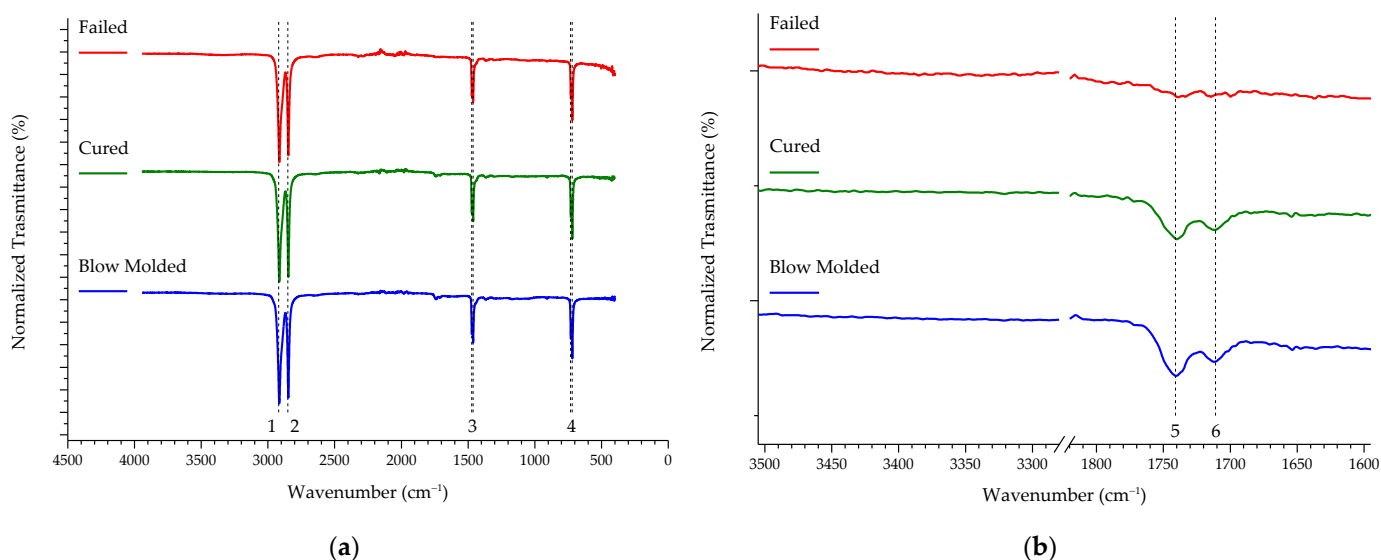
The results of the FTIR analyses can be seen in Figure 5. The peaks recorded in the spectra, well identifiable in Figure 5a and listed below in Table 2, are those typical of PE [33,34] and display no significant variations between the different samples. The possible oxidation of the Failed sample, observed by EDXS, could not be undeniably confirmed from a first inspection of the spectra. Indeed, as can be seen in Figure 5b, which contains an extract of Figure 5a with a ten-fold magnification in the vertical scale, the peaks for the carbonyl group (C=O) in the carboxyl group ($-\text{C}(=\text{O})-\text{OH}$), with a wave number of 1741 cm^{-1} , are decreasing in intensity in the Failed sample. A weaker, but similar

development is observed when focusing on the peak at 1711 cm^{-1} , which is associated with C=O stretching vibration. In addition, in Figure 5b, a portion of the spectra centered on the wavenumber 3400 cm^{-1} is shown, as well, in a range usually associated with hydroperoxides, also involved in the oxidation of polyethylene. In this instance, no peak and no change in the background could be detected.

Figure 5. ATR-FTIR spectra of the analyzed samples: (a) full range of the spectra and (b) two specific ranges at ten-fold magnification, compared to the first panel.

In fact, considering spectrometric analyses, no noticeable oxidation or other difference among the different samples used was detected. In particular, the peaks for the carbonyl group (1741 cm^{-1} and 1711 cm^{-1}) barely show in the spectra and went unnoticed in the noise (*cf.* Figure 5a). Nonetheless, the decreased intensity in the Failed sample (Figure 5b) would suggest the opposite of an increase in oxidation in the polymer. While the extent of oxidation measured with EDXS was not confirmed by FTIR analysis (*cf.* Figure 5), a minor oxidation phenomenon is entirely possible. Fatigue, failure, and subsequent bond breaking may have in fact caused the reaction with oxygen. In fact, while the phenomenon of oxidative degradation of PE usually occurs after heating in the molten polymer, it is not possible to exclude the circumstance of the auto-oxidation of the solid PE, happening at relatively low temperatures [36]. For instance, it could be caused by factors such as the presence of structural defects, or rapid heating. The exposure of a surface to oxygen can also facilitate the phenomenon, obviously. Even the interaction with high pressure hydrogen is among the causes for the formation of oxidized groups, including carbonyl groups in ester compounds [29].

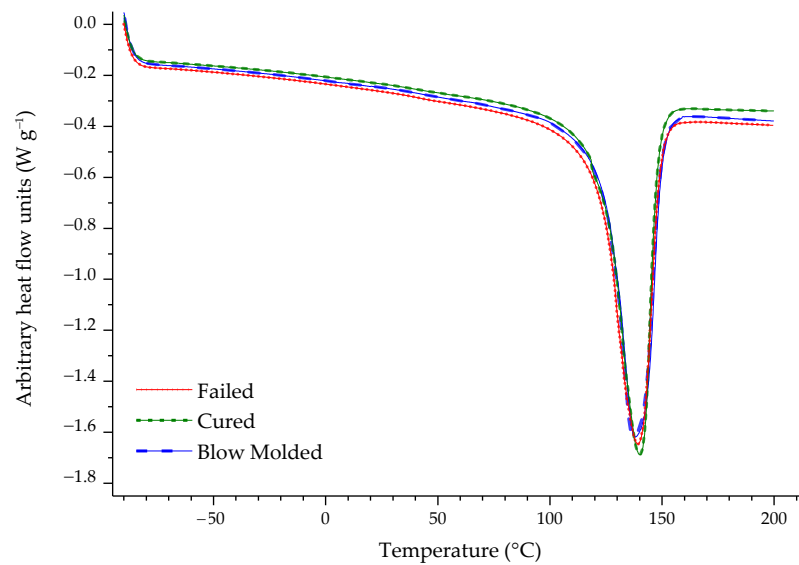
The DSC profiles are reported in Figure 6 and their shape and aspect, with overlapping curves and extremely similar main features, suggests that almost negligible differences in the results derived from the thermograms are to be expected. These important parameters are reported in Table 3, which lists the data obtained through DSC analysis, specifically the values of melting enthalpy, crystallinity, onset temperature, and peak temperature. As can be read in Table 3 and also observed from the graphs in Figure S2, there are no significant differences among the calculated parameters.

Figure 6. DSC profiles of all the analyzed samples.

The results of the DSC analysis (*cf.* Table 3 and Figure S2) confirmed that there are no major differences among the Blow Molded, Cured, and Failed samples. It has already been pointed out that the DSC profiles themselves (displayed in Figure 6) are practically superimposable and they do not differ in any peculiar aspect. Since there were no changes in the calculated parameters, *i.e.*, melting enthalpy, crystallinity, onset temperature, and peak temperature, the possibility of the thermal processes implemented on the HDPE liner, including the autoclave transition (needed for the composite shell material resin curing), affecting the polymer properties in any way could be ruled out.

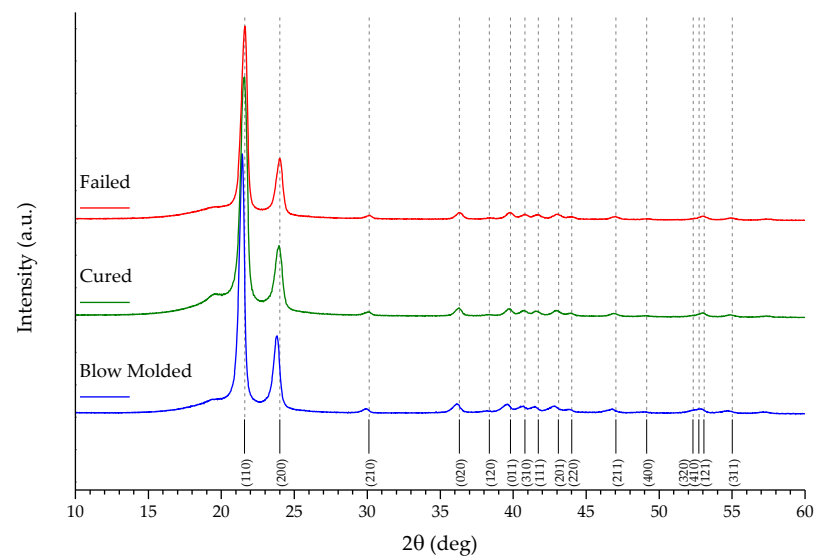
The XRD patterns of the three samples are reported in Figure 7. The three lines do not display remarkable differences and are in good agreement with each other and also with the reference [35].

Figure 7. XRD patterns of the analyzed samples, with labels and notations for the Miller indices of the main lattice planes.

The XRD patterns (*cf.* Figure 7) reinforce, with the presence of several sharp peaks, the data for the percentage of crystalline phase in the sample. After noticing the good alignment of all the peaks with the reference (for HDPE, an orthorhombic crystal structure with a *Pnam* space group [35]), it can be assessed that the peak width is similar in all three samples (*cf.* Table S3), meaning that the cell parameters are not distorted by any of the steps of the manufacturing or the subsequent testing. The amorphous phase is represented by the bump at around 20° and it can be better noticed in the expanded graphs in Figure S3, focusing on the range $10^\circ < 2\theta < 40^\circ$. In this range, by resolving the X-ray diffraction patterns, an estimation of the crystallinity index has been evaluated from the diffraction area relative to the crystalline peaks compared to the one relative to the amorphous halo [37,38]. The percentages of crystalline phase are reported in Table S2 and are in agreement with the results calculated from the DSC profiles and displayed in Table 3; estimations from the XRD patterns, however, may be slightly distorted from the cutting of the specimen, which could deform and overheat some layers of the analyzed samples. The detailed graphs in Figure S3, together with the data reported in Table S3, allow, in addition, a better observation of the position of the peaks, which in the case of the Blow molded sample, are to some extent shifted left, suggesting a minuscule deformation/expansion of the cells. One hypothesis to explain this evidence is the minor effect of the manufacturing process that then disappears with the curing procedure and is, therefore, absent in the other two samples.

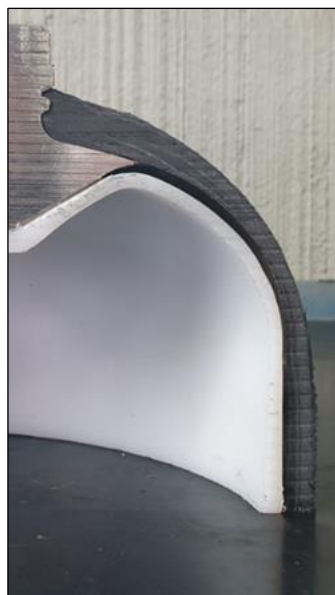
A section of a Cured Type IV cylinder was cut for observation and the result can be seen in Figure 8. The picture shows that the metal boss is glued to the HDPE liner. At the end of the boss, the composite material shell should be well adhered to the liner, but a gap of a few millimeters can be seen between the composite itself and the polymer.

Figure 8. Section of the cured high-pressure storage tank.

- The failure was caused by strong plastic deformation resulting in a decrease in cross-section thickness.
- Morphological and chemical analyses performed by means of SEM/EDXS, FTIR, XRD, and DSC did not show any major changes occurring during the production cycle of the liner, which could justify the creation of a trigger point for failure.
- The reason for the failure was plausibly due to a geometric issue. In a fatigue test with pressure cycles, the physical gap between liner and shell causes small deformations that can lead to the observed thickness reduction. The improvement of the interface between liner and shell, for example with the use of improved adhesives, could solve or mitigate the issue.
